# **FIRE SAFETY INSPECTION REPORT**

**ROMO FASHION TODAY LTD.**

**ACCORD ID: 9373**

**RAIL STATION ROAD, MOUCHAK , GAZIPUR**

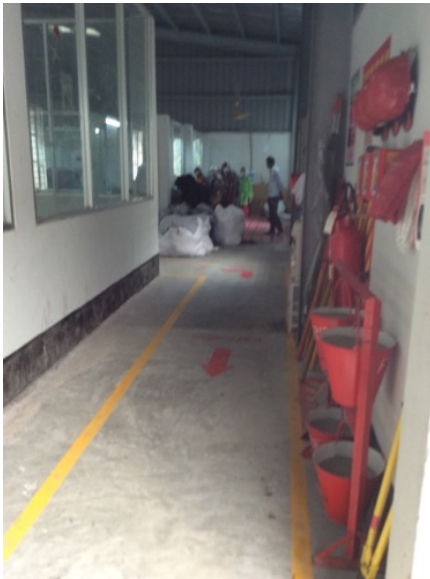
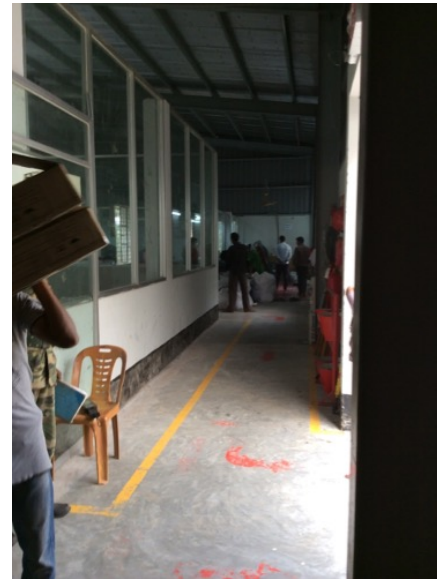
| No. | Category | Finding | Recommendation | Remediation Timeframe |
|---|---|---|---|---|
| F-1 | Fire Rated Construction | Exit access corridors are not provided with 1 hr fire resistance rating or approved NFPA 13 sprinkler system. | Provide exit access corridors with 1 hr fire resistance rating or approved NFPA 13 sprinkler system. | Within 3 months |

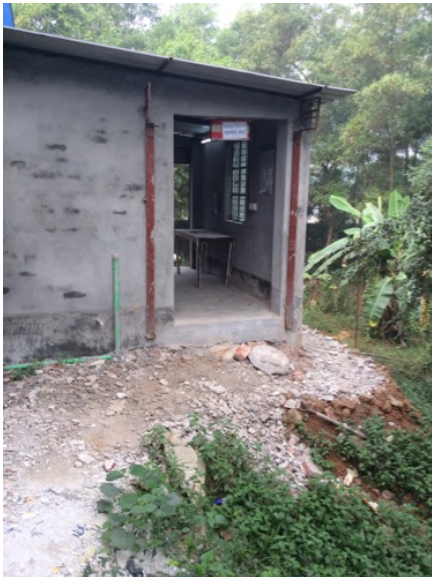
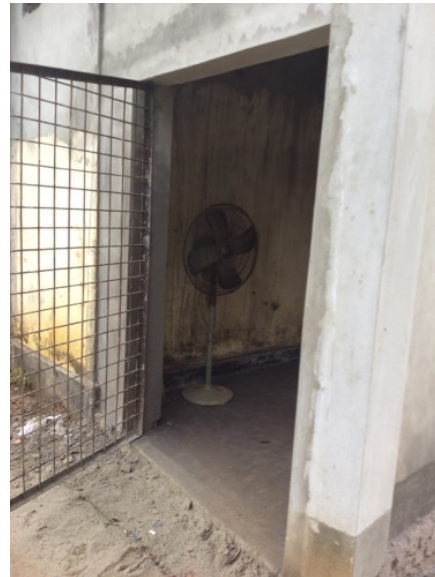
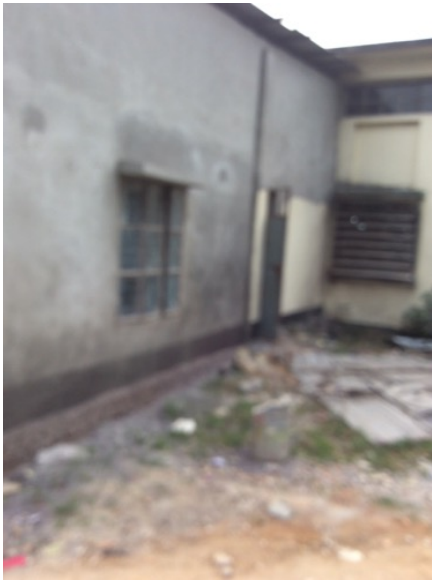
| F-2 | Fire Rated Construction | The boiler and compressor room are not separated by fire-rated construction due to openings, non-rated doors, and penetrations in a separated shed on ground floor east and northeast of the building. | Separate the boiler and compressor rooms by a minimum 1-hr fire-rated construction for non-high rise. Seal and protect all openings to maintain the required fire separations. Provide proper ventilation and consult a qualified engineer.<br>AND<br>When located to the exterior of a building, separate the boiler and compressor by a minimum distance of 3m (10 ft). | Within 3 months |

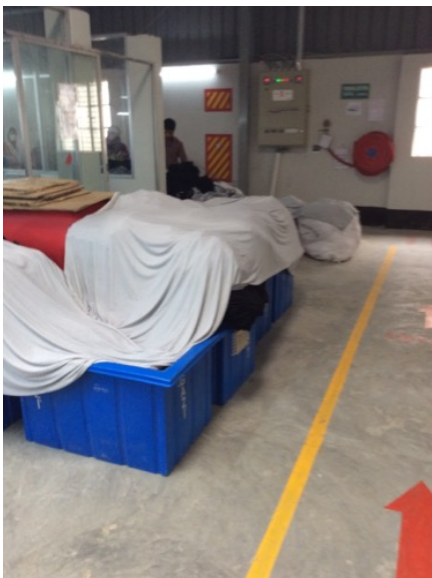
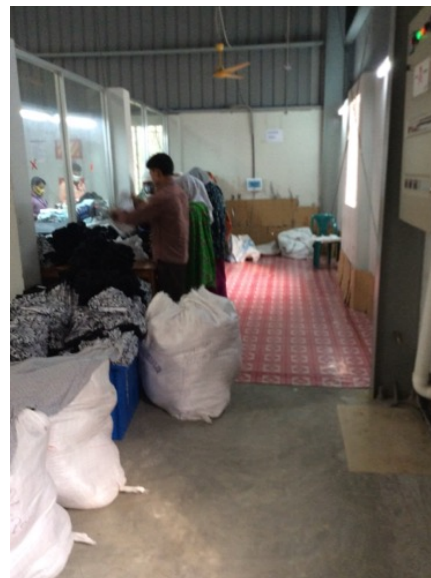
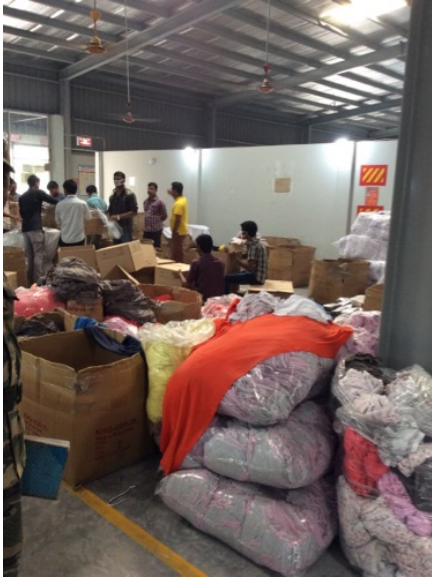
| F-3 | Fire Rated Construction | Areas used for combustible storage open to the factory are not properly defined and not within limits on ground floor. | Provide defined storage areas and limit the storage arrangement as follows:<br><br>Maximum height of 2.45m (8 ft) and maximum area of 23m <sup>2</sup> (250 ft <sup>2</sup> )<br>AND<br>Separate areas of unenclosed combustible storage by a minimum clear distance of 3m (10 ft). | Within 3 months |

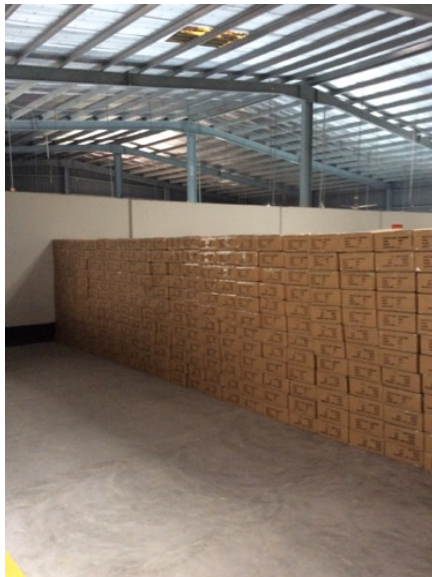
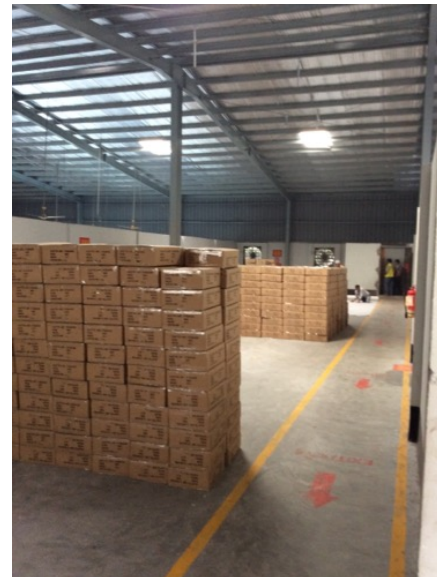
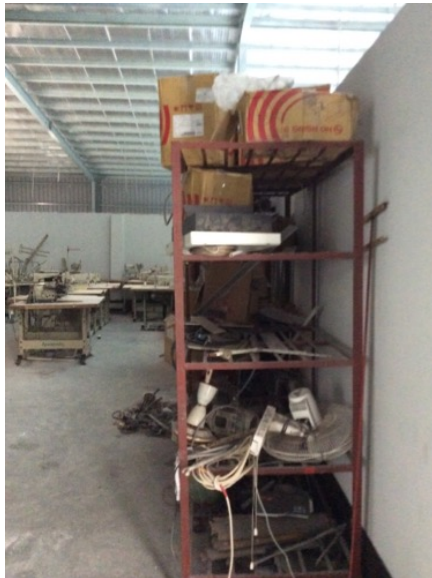
| F-4 | Fire Rated Construction | Rooms used for combustible storage are not separated by a minimum 1-hr fire-rated construction in the finish goods carton and idle machine store on ground floor. | <p>Provide dedicated storage rooms separated by minimum 1-hr fire-rated construction.</p> <p>Where separate storage rooms are not feasible, provide defined storage areas and limit the storage arrangement as follows:</p> <p>Maximum height of 2.45m (8 ft) and maximum area of 23m<sup>2</sup> (250 ft<sup>2</sup>)</p> <p>OR</p> <p>If sprinkler protected: maximum height of 3.66m (12 ft) and maximum area of 93m<sup>2</sup> (1000 ft<sup>2</sup>)</p> <p>AND</p> <p>Separate areas of unenclosed combustible storage by a minimum clear distance of 3m (10ft).</p> | Within 3 months |

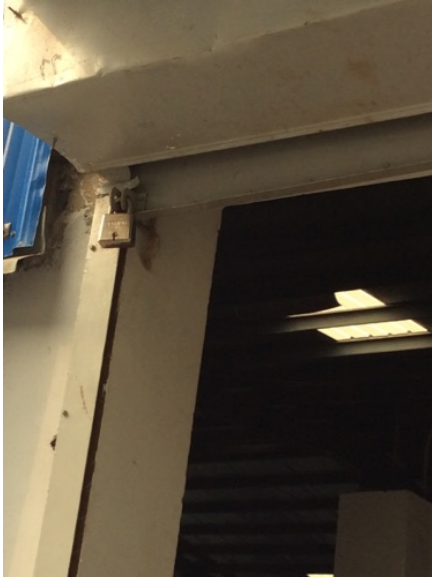
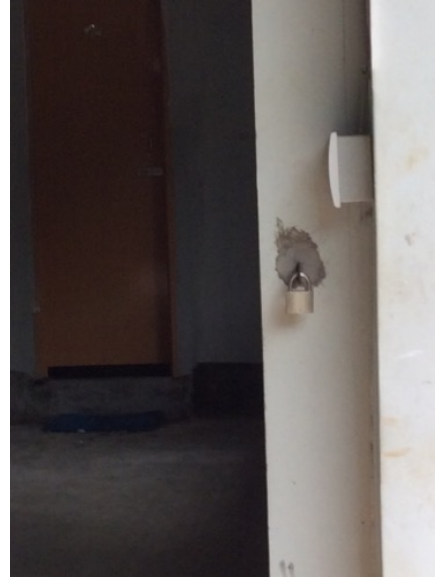
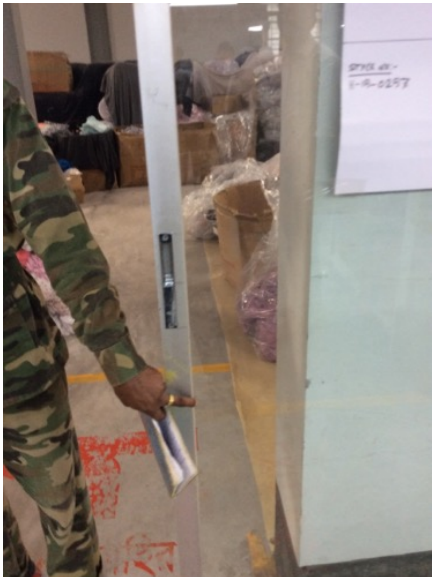
| F-6 | Egress | Egress doors with locking features are provided at building exits, along egress routes and exit discharge on ground floor. All gates/doors were open and unlocked during the inspection. | <p>Remove locking features from all egress doors.</p> <p>If locks are required for security reasons, utilize special door locking features complying with ACCORD standard 6.8.2.</p> | Immediately |

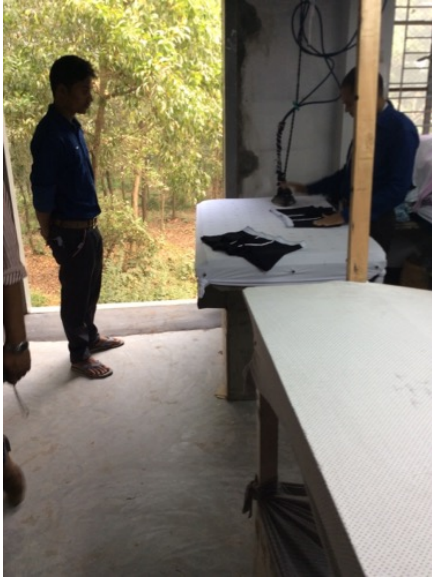
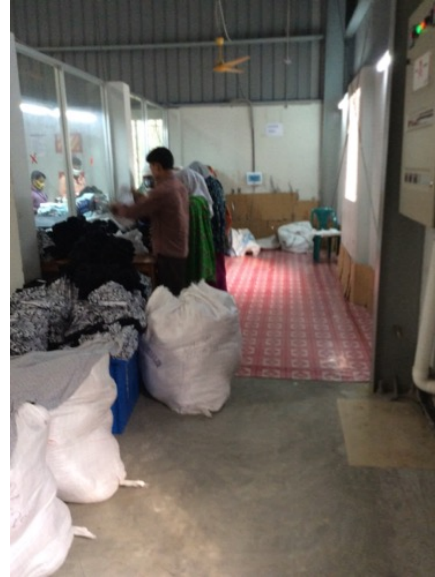
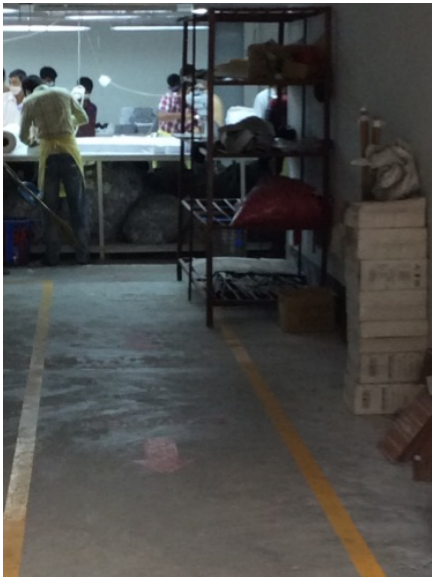
| F-7 | Egress | Storage was located in the egress path on ground floor. | Keep egress paths and stairs clear of storage. | Immediately |

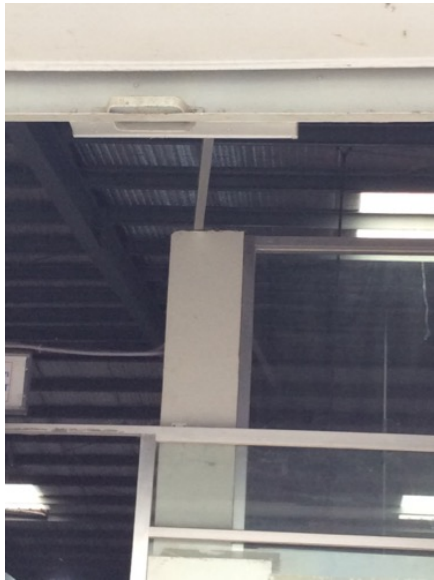
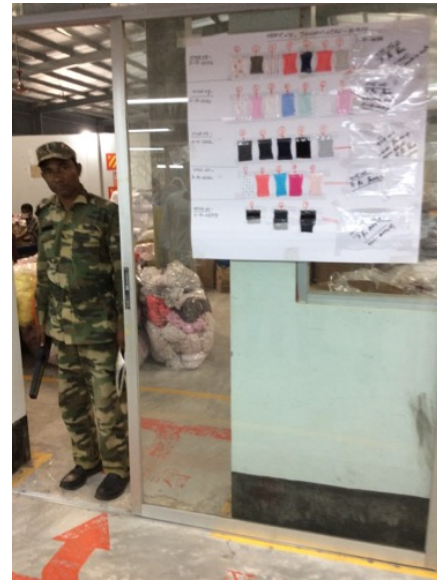
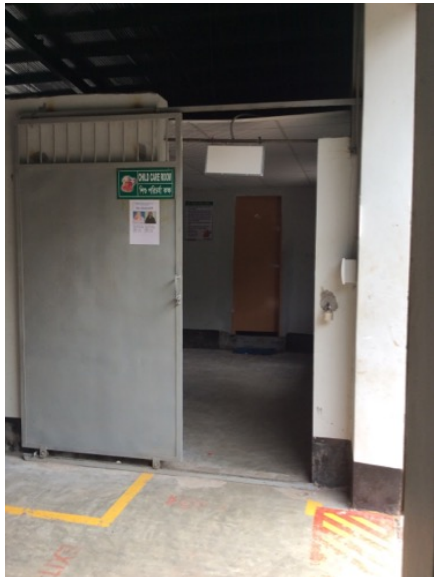
| F-8 | Egress | Sliding and roll up doors are provided at building exits, along egress routes, exit discharge on ground floor. | Replace all sliding and roll up doors along the means of egress with side-hinged, swinging egress doors in accordance with ACCORD standard 6.8.1. | Within 1 month |

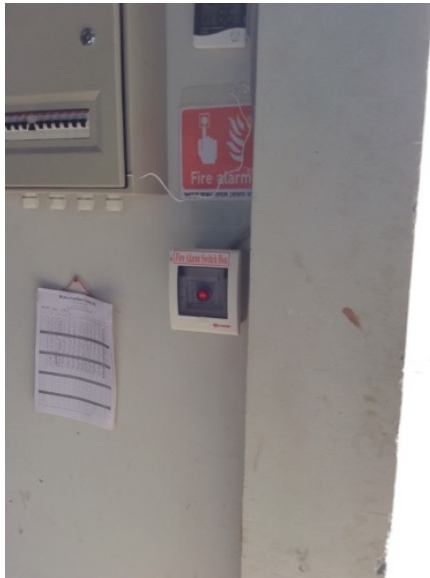
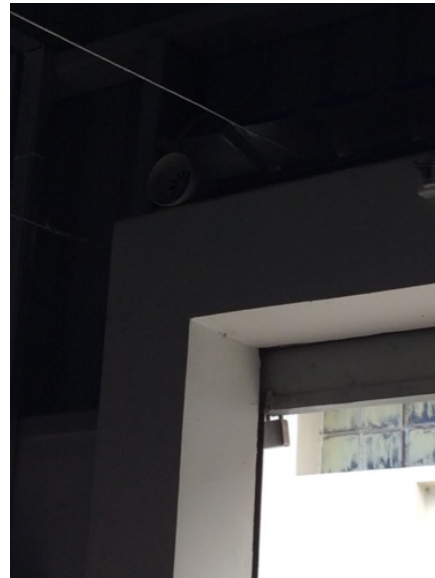
| F-9 | Fire Protection | The fire alarm system is antiquated, not a listed system and does not provide alarm and notification features consistent with acceptable standards. | Replace the fire alarm system with a new, listed automatic fire alarm system in accordance with NFPA 72 and ACCORD standards. | Design within 4 months, install within 9 months |

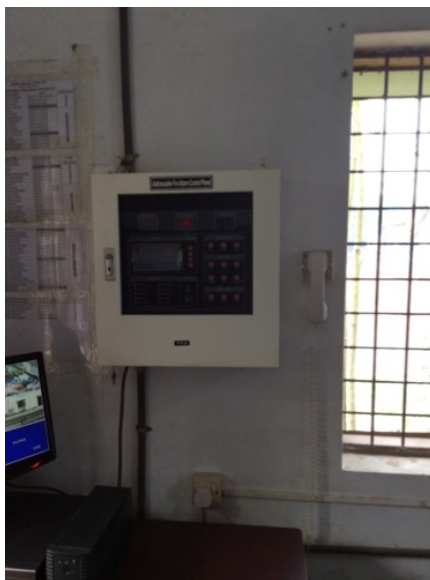
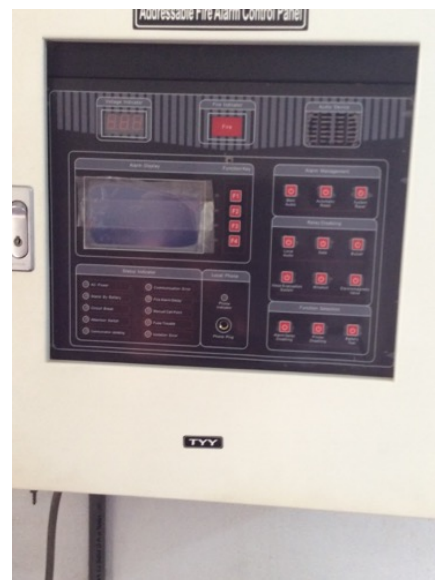
| F-10 | Fire Protection | Fire alarm system installation requires detailed review to confirm compliance with NFPA 72 and ACCORD standards. | Submit as-built drawings, testing records, equipment certification and other relevant documentation to the ACCORD for review and approval. | Within 1 month |

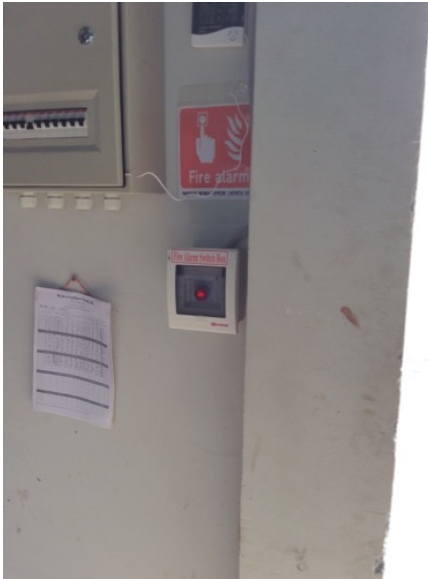
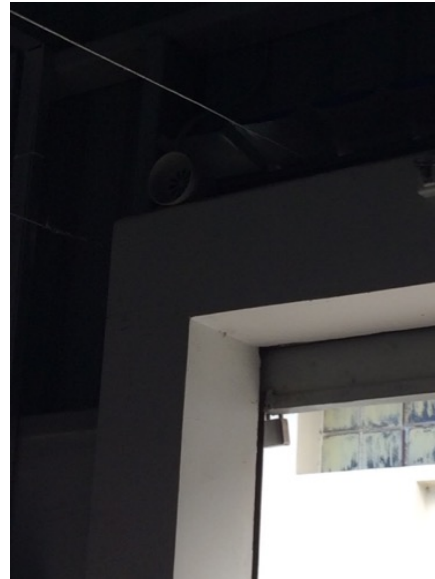
| F-16 | Fire Protection | Visible and audible notification was not provided for the building in accordance with NFPA 72. | Provide visible and audible notification for the building in accordance with NFPA 72. | Within 9 months |

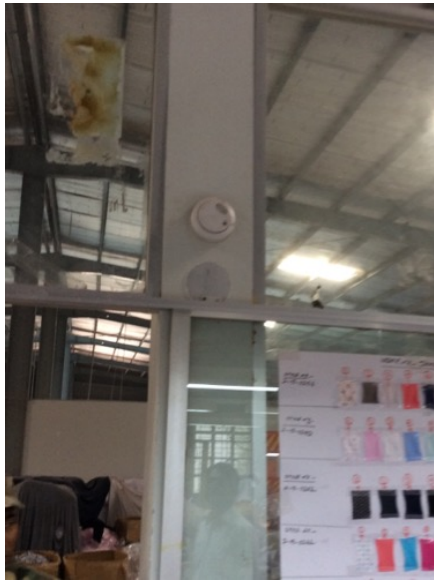
| F-17 | Fire Protection | The building is equipped with single-station smoke alarms. Smoke alarm activation sounds only a local alarm and does not provide automatic fire alarm notification of occupants. | Remove single-station smoke alarms. Provide automatic smoke detection throughout the building, tied into the fire alarm system, in accordance with NFPA 72 and ACCORD standards. | Within 9 months |

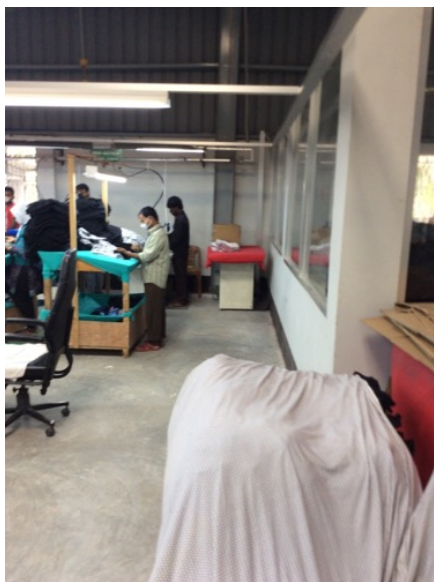
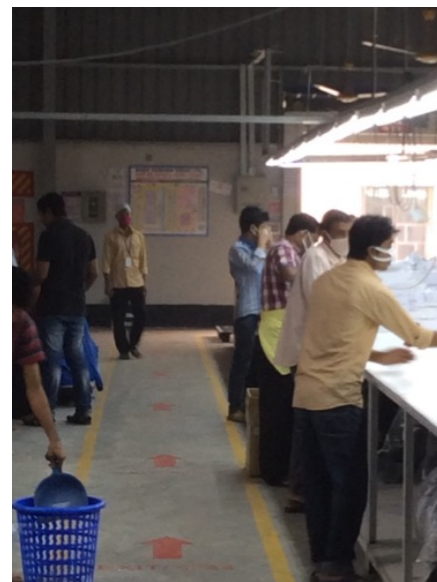
| F-18 | Egress Lighting | Exit signage was not provided along a path of egress and in a readily visible location on ground floor. | Provide exit signs above all building exits to the exterior, all doors to the exit stairs and along all paths of travel where a change of direction is not obvious. | Within 1 month |

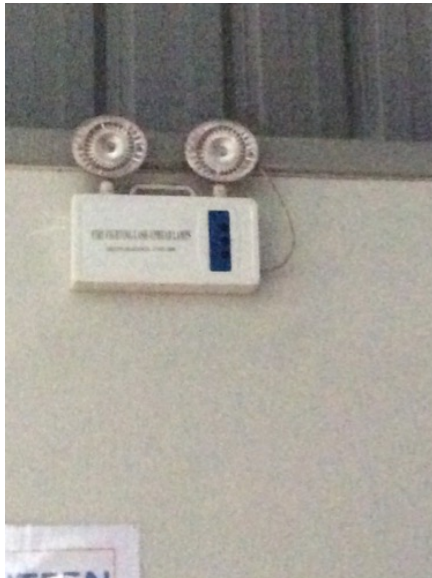
| F-19 | Egress Lighting | Emergency lighting did not function in test mode burned out in dining area on ground floor. | Regularly test the emergency lighting system on each floor and replace/repair lights as needed. | Within 1 month |

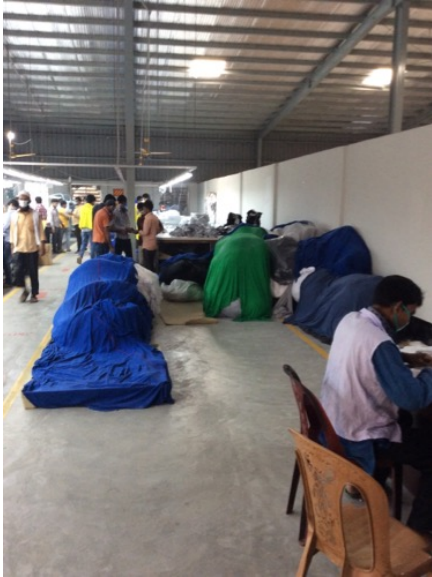
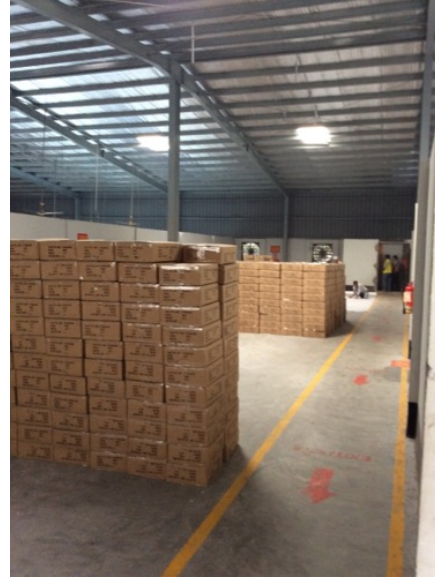
| F-21 | Egress Lighting | Based on the number and location of emergency lights observed, adequate illumination levels are not anticipated along egress routes on ground floor. | Test the emergency lighting system on each floor and provide additional emergency fixtures to supply adequate illumination along the means of egress. Provide a minimum illumination of 10 lux at the floor level within exit stairs and along exit discharge paths and a minimum 2.5 lux along exit access aisles. | Within 3 months |
