# Elite Garments Ind. Ltd.

Bade Kalmeswer, Board Bazar, Gazipur, Bangladesh  
(23.954199, 90.380240)

5th April 2014  
8th April 2015

**Building N7**

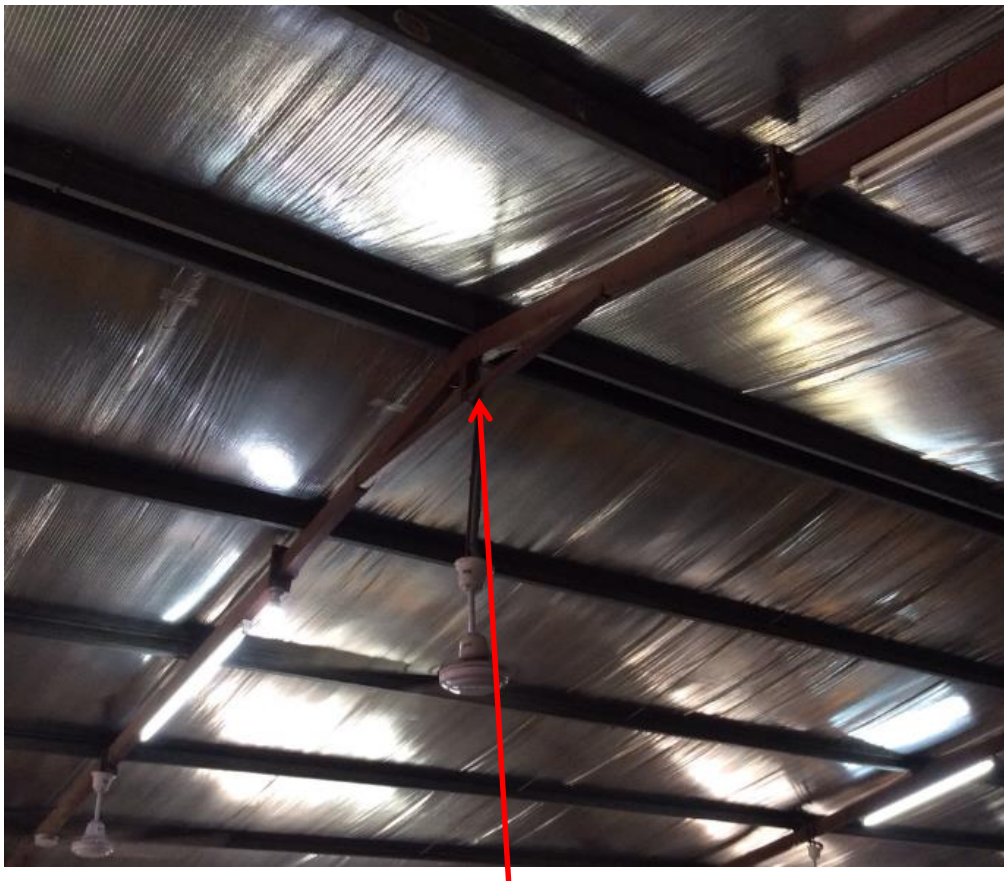
Main span varies from 12.5m at the back of the shed up to 14.5m at the front. Beam section appears inadequate to support this span and is in danger of buckling under high wind loads.

**Building Engineer to assess structure to show that it is adequate.**

| Item No. | Observation | Recommended Action Plan | Recommended Timeline |
|---|---|---|---|
| 1 | Building 5 - Structural design and stability System for the steel framed portal structure | Building Engineer to check all section sizes and connections in Building 5, as well as perform a stability analysis. | 6-weeks |
| 2 | Building 5 - Structural design and stability System for the steel framed portal structure | Install temporary support & bracing as required by building engineer ensure building is safe for occupation | 6-weeks |
| 3 | Building 5 - Structural design and stability System for the steel framed portal structure | Implement any Building Engineer's recommendations once assessment is complete. | 6-months |

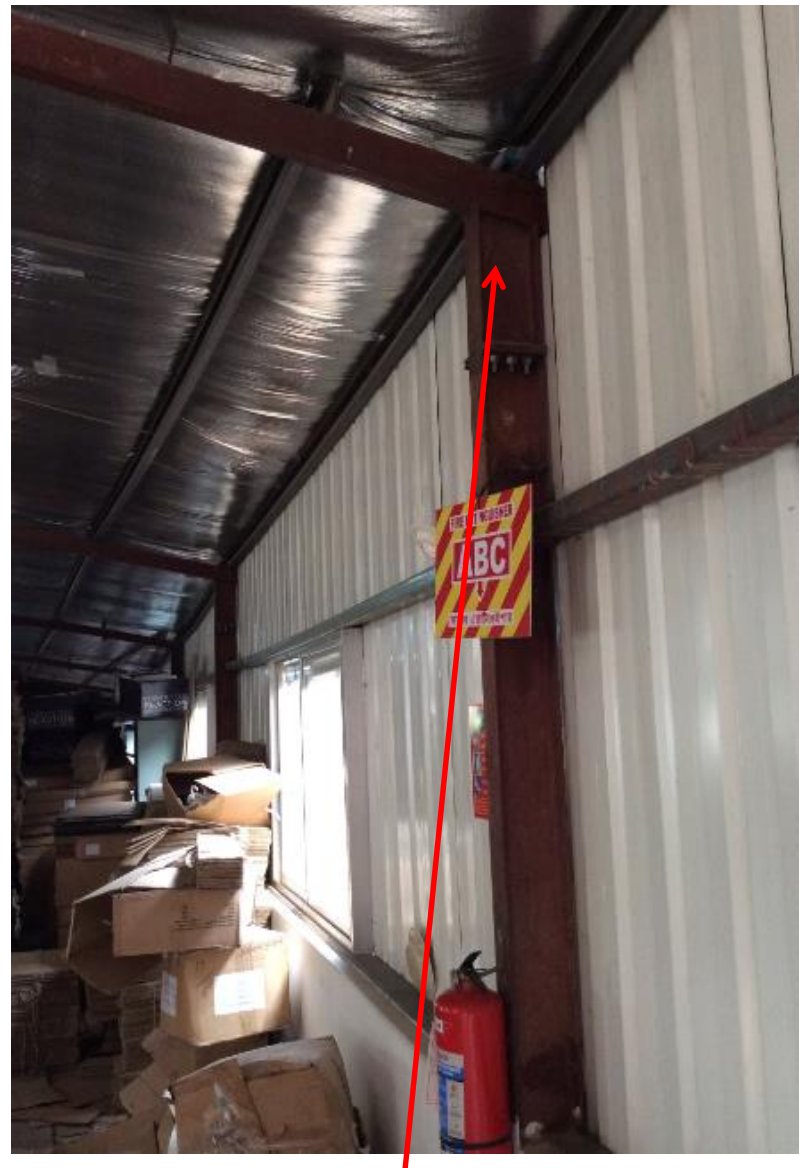
Portal section does not appear adequate to resist and lateral forces.

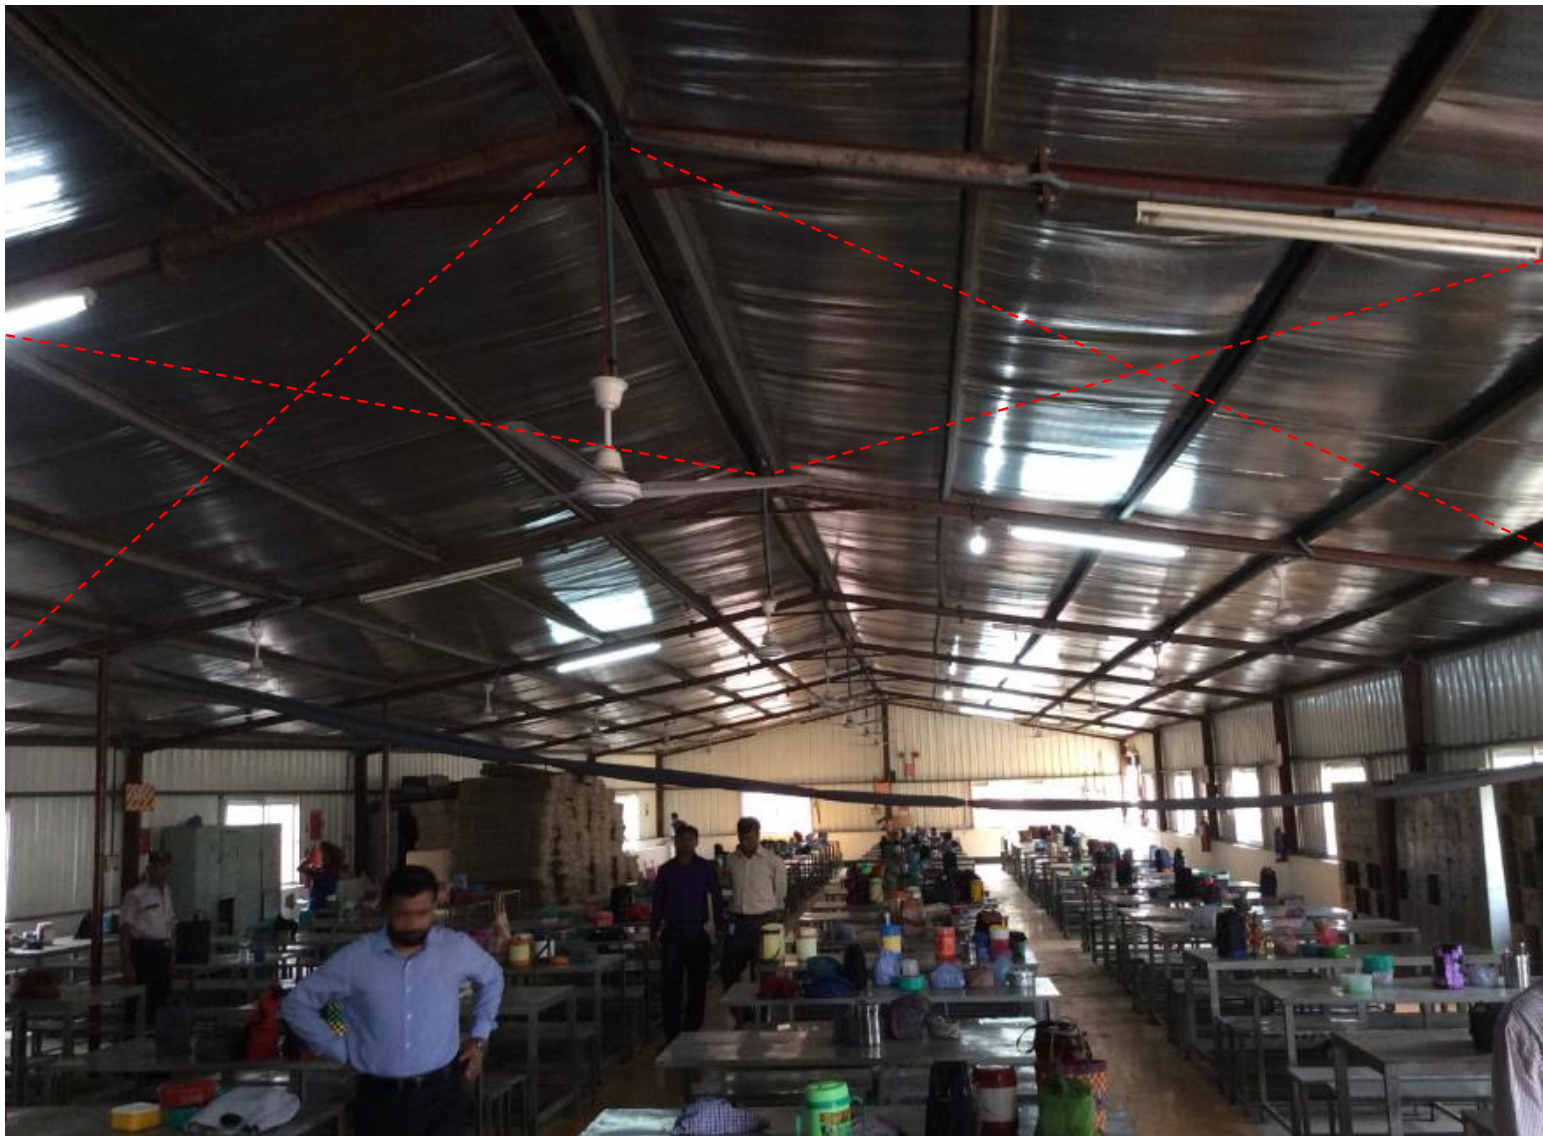
No bracing provided in the roof or in the elevation sections to resist lateral forces.  
Building Engineer to make recommendations once assessment is complete.

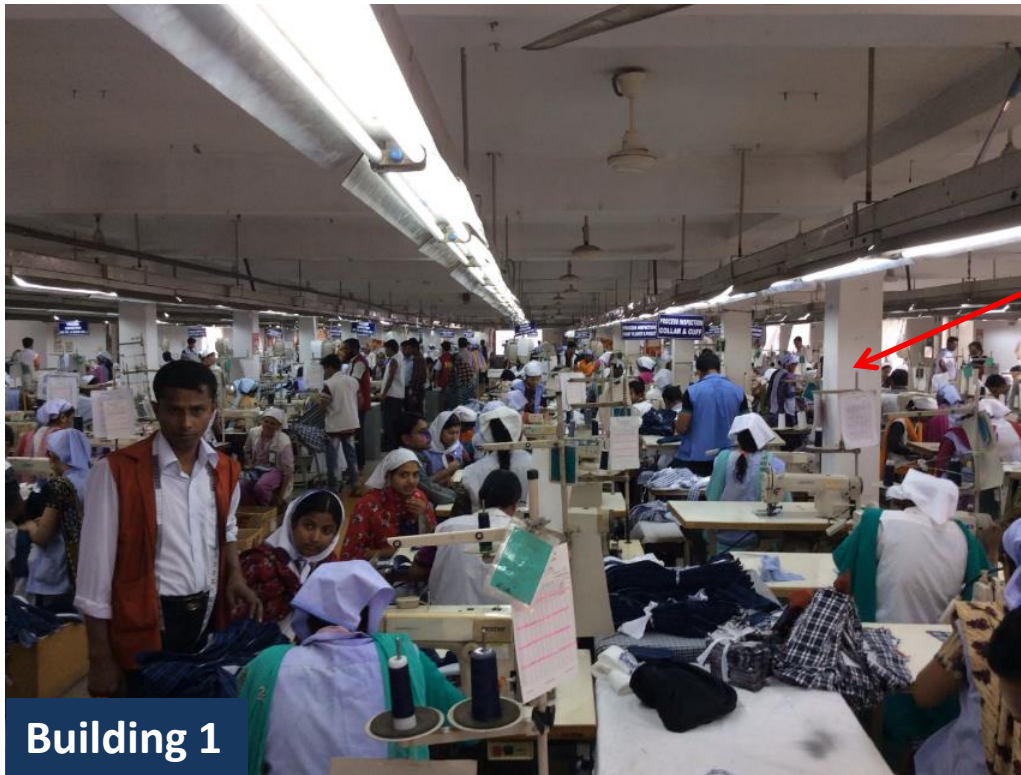
**Building 1**

Cursory calculations indicate that the column working stress in Building 1 & Building 3 is at a high level.

A Building Engineer should review the Design Loads, Design Stresses in the internal columns in Building 1 & Building 3

| Item No. | Observation | Recommended Action Plan | Recommended Timeline |
|---|---|---|---|
| 4 | Internal Columns in Buildings 1 & 3 are highly stressed and should be checked by a Building Engineer. | Factory Engineer to review design, loads and columns stresses in area identified above. | 6-weeks |
| 5 | Internal Columns in Buildings 1 & 3 are highly stressed and should be checked by a Building Engineer. | Verify in-situ concrete stresses either by cores or existing cylinder strength data for the internal columns in Buildings 1 & 3. | 6-weeks |
| 6 | Internal Columns in Buildings 1 & 3 are highly stressed and should be checked by a Building Engineer. | Produce and actively manage a loading plan for all floor plates within the factory giving consideration to floor capacity and column capacity. | 6-months |

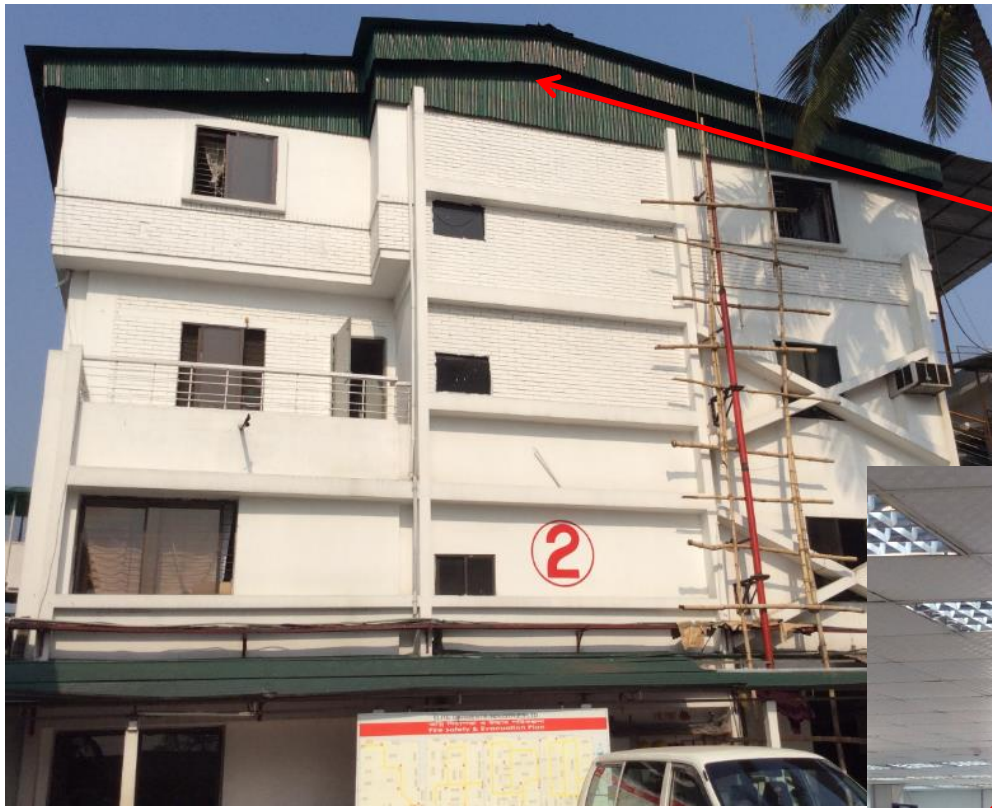
Steel roof over Building 2

Steel Roof support connections in Building 2 could not be inspected due to drop ceiling in place. These should be design checked by Building Engineer.

| Item No. | Observation | Recommended Action Plan | Recommended Timeline |
|---|---|---|---|
| 7 | Check design of steel roofs and connections for Buildings 2, 3 and 4. | Building Engineer to check the design of steel roof trusses and steel to column connection details for likely uplift forces due to wind loading. | 6-weeks |
| 8 | Check design of steel roofs and connections for Buildings 2, 3 and 4. | Implement any recommendations made by the Building Engineer for the steel roofs. | 6-months |

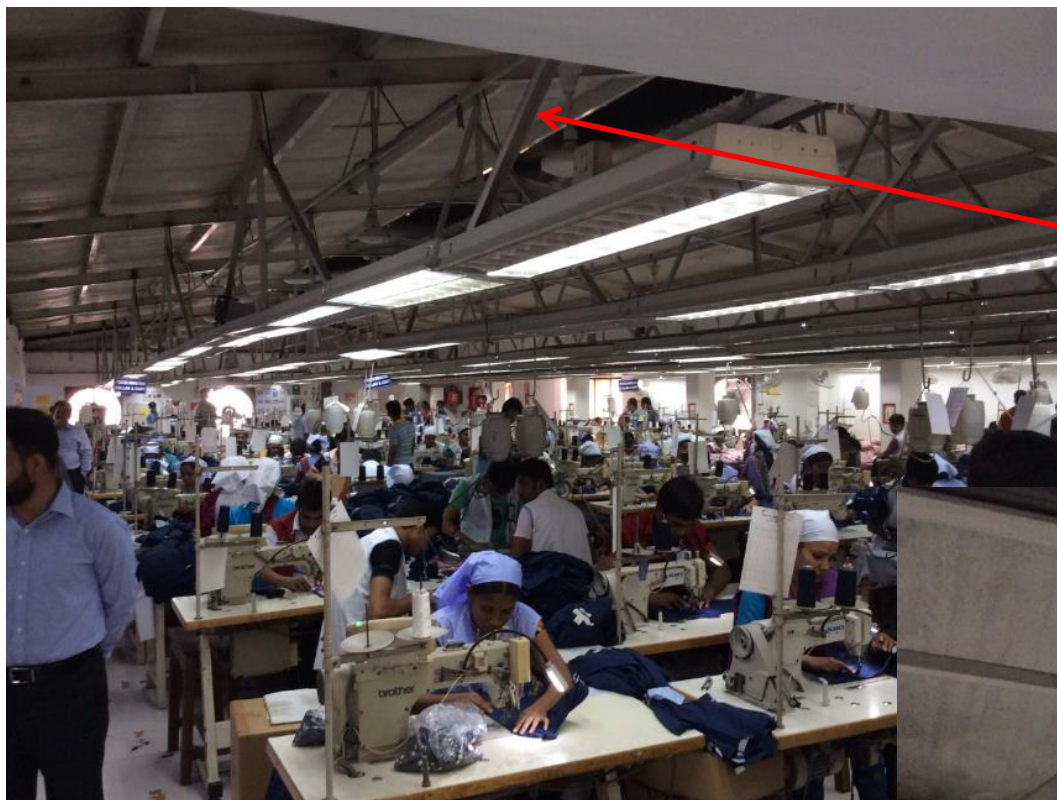
Steel roof over Phase I section of Building 3

Steel Roof connections in Building 3 appear inadequate to resist high wind loading and should be checked by a Building Engineer.

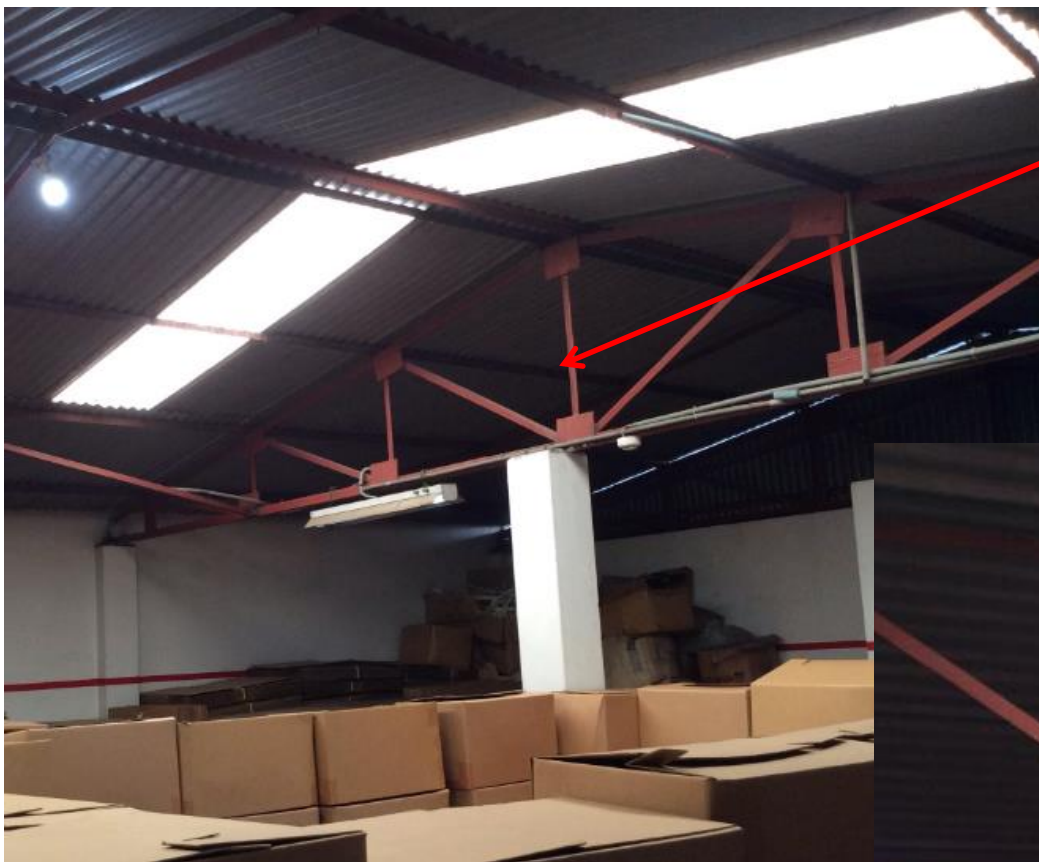
Steel roof over 4 storey section of Building 4.

Central Truss Section does not sit directly onto column below.

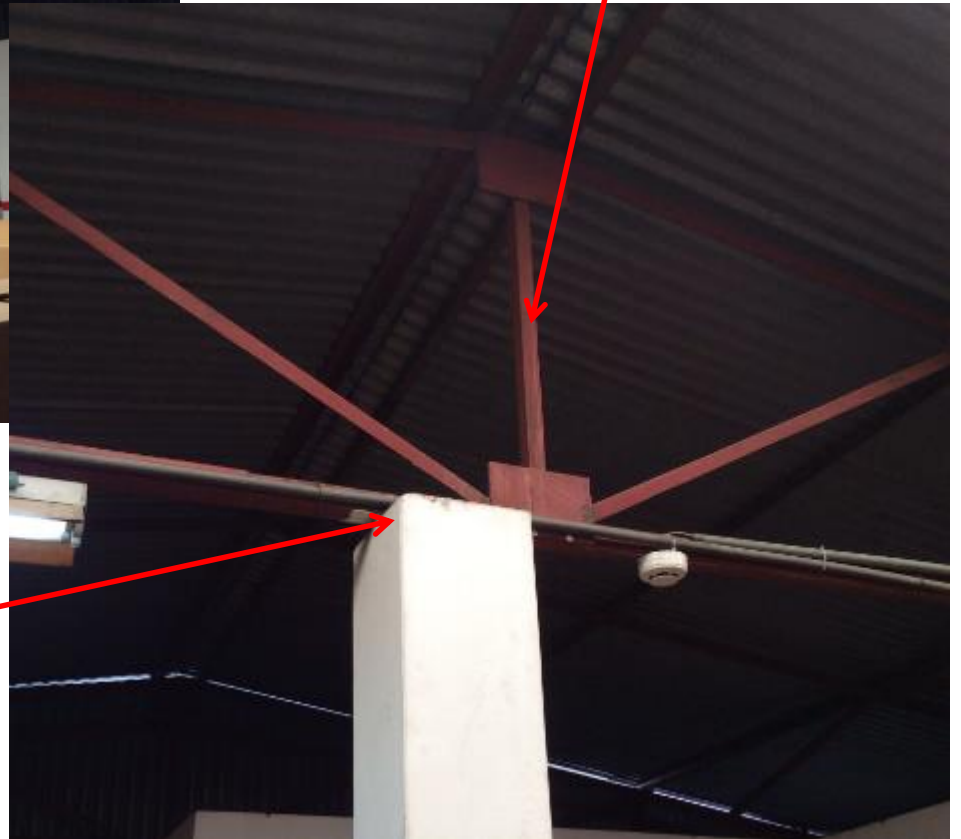
Steel Roof connections in Building 4 appear inadequate to resist high wind loading and should be checked by a Building Engineer.

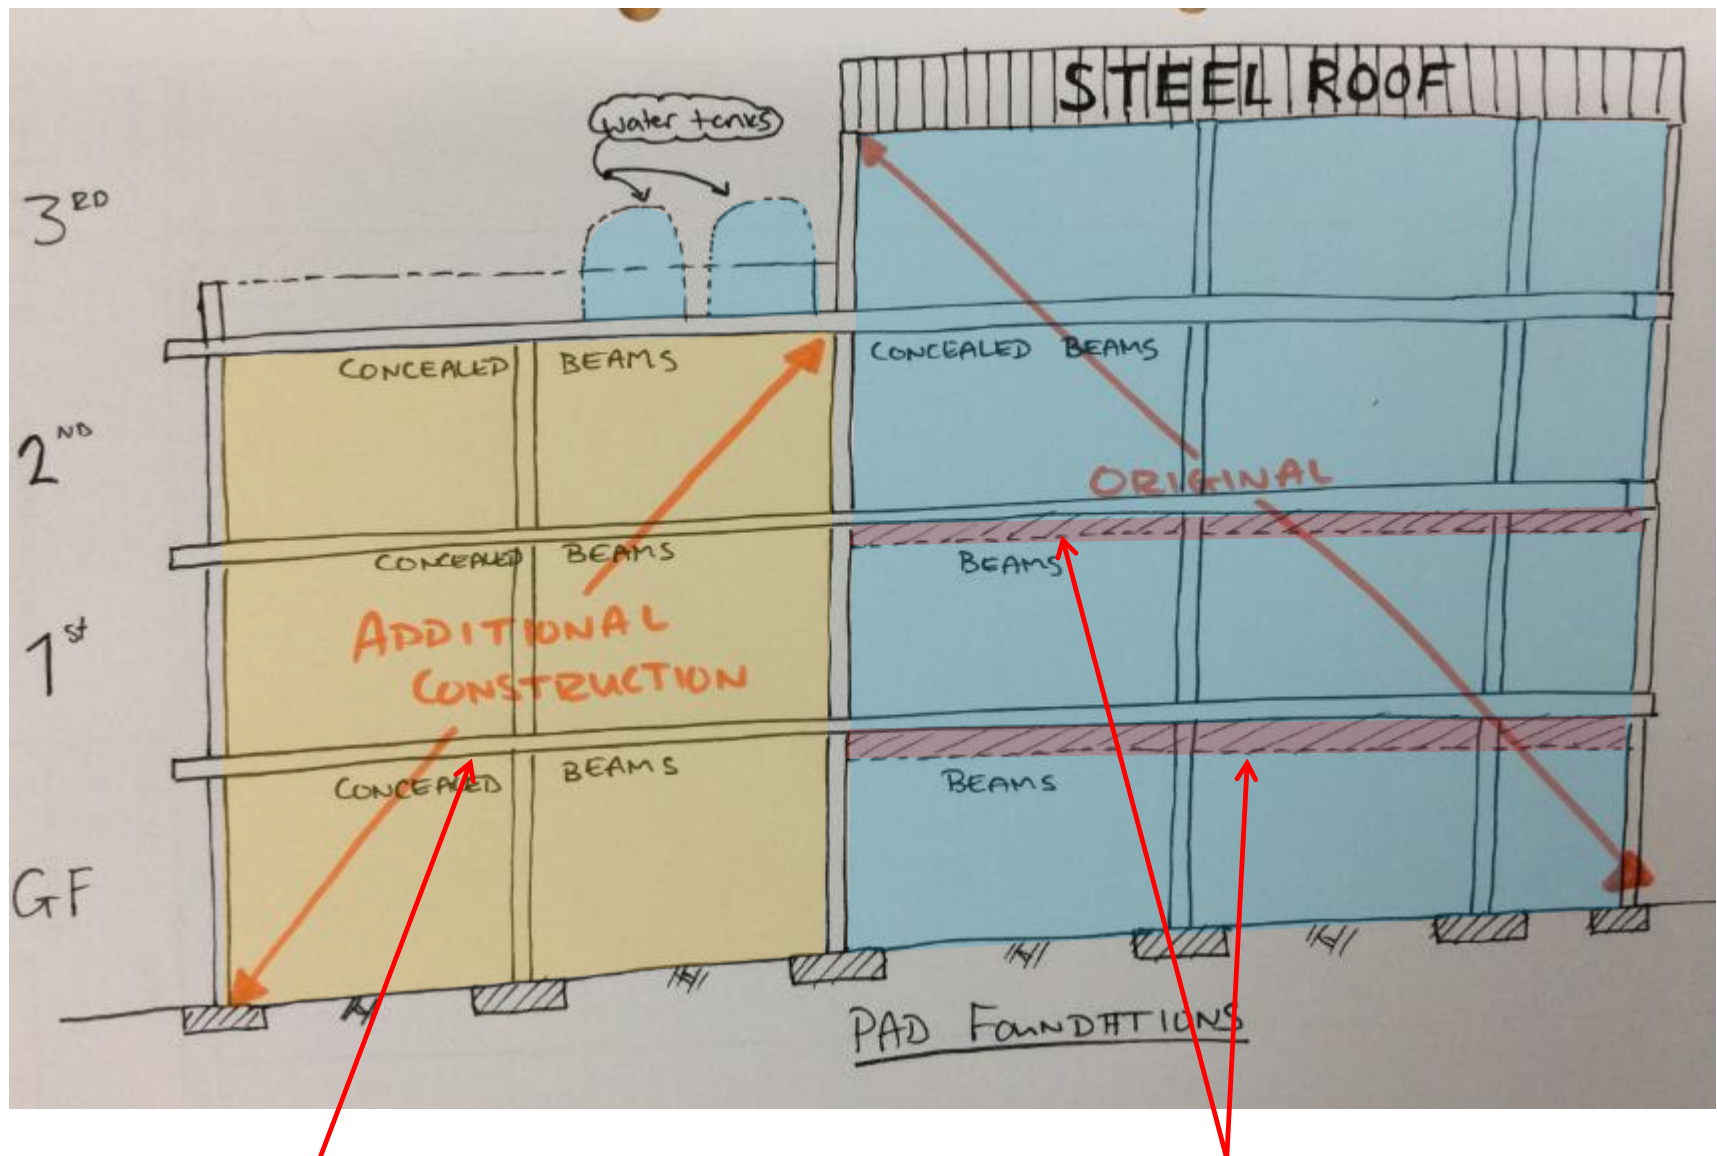
Concealed beams detailed within slab at all other levels

Moment Frame System with beams and slabs on 1<sup>st</sup> and 2<sup>nd</sup> Floors in one section of building.

| Item No. | Observation | Recommended Action Plan | Recommended Timeline |
|---|---|---|---|
| 9 | Building 4 – Lateral Stability System | Building Engineer to assess the stability of Building 4. Apparently constructed as one building, the building appears to consist of two different structural systems; beam and slab in one section (with beams strips within the slab depth at one level) and flat slab in the other. | 6-weeks |
| 10 | Building 4 – Lateral Stability System | Implement any Building Engineer's recommendations once assessment is complete. | 6-months |

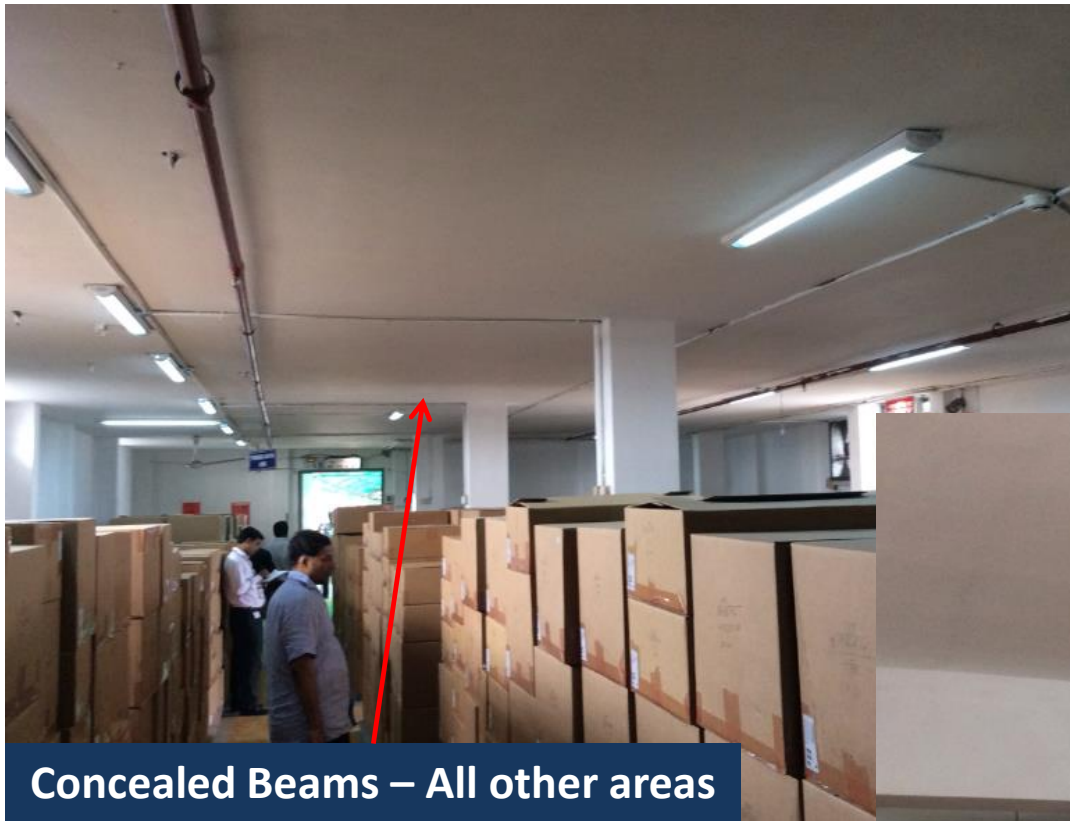
**Concealed Beams – All other areas**

**With the new portion of the Building Constructed, and no apparent beams on some levels, that Lateral stability system of Building 4 should be checked by a Building Engineer.**

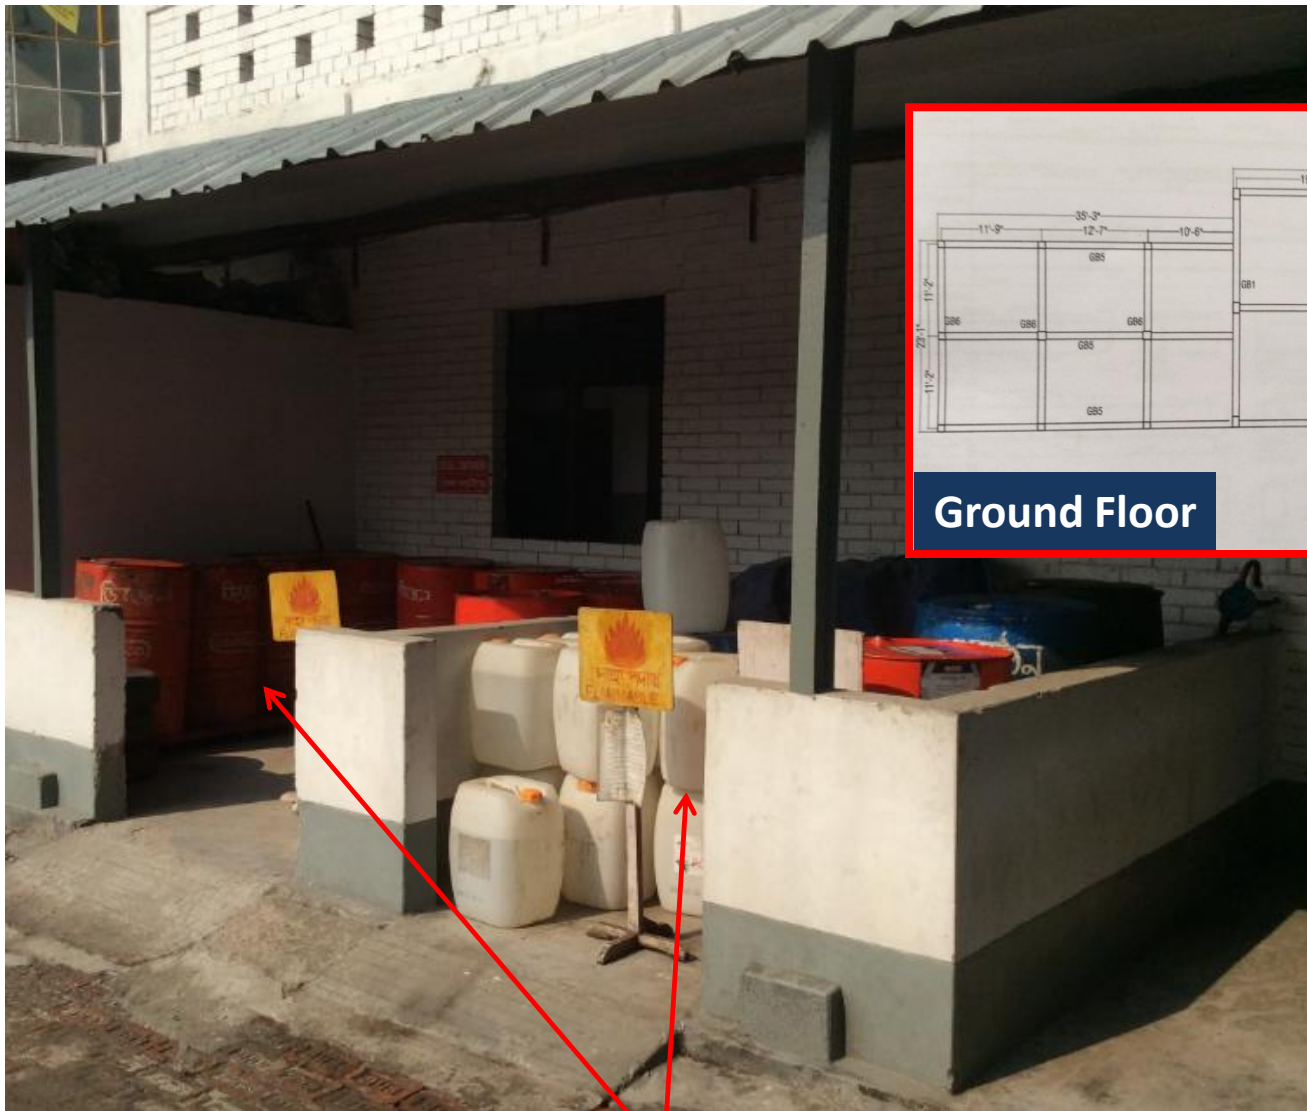
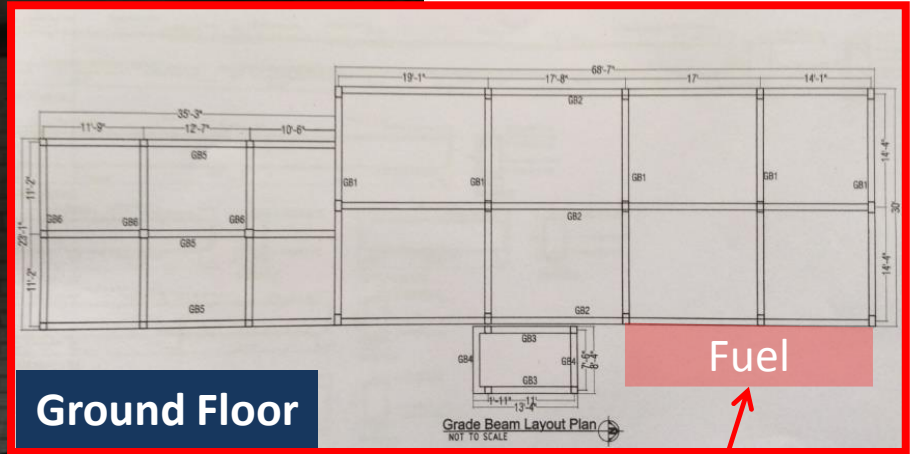
**Location of Fuel storage outside of Building 4**

**Fuel storage at ground floor of Building 4 – Danger of fire removing a critical column**

| Item No. | Observation | Recommended Action Plan | Recommended Timeline |
|---|---|---|---|
| 12 | Building 4 – Factory to move the location of the fuel storage away from any critical structure based on Building Engineer's recommendations. | Building Engineer to propose new location of fuel storage away from critical structural elements. | 6-weeks |
| 13 | Building 4 – Factory to move the location of the fuel storage away from any critical structure based on Building Engineer's recommendations. | Fuel to be moved from current location within 6 weeks of receiving this report. | 6-weeks |
| 14 | Building 4 – Factory to move the location of the fuel storage away from any critical structure based on Building Engineer's recommendations. | Ensure safe storage of fuel. | 6-months |

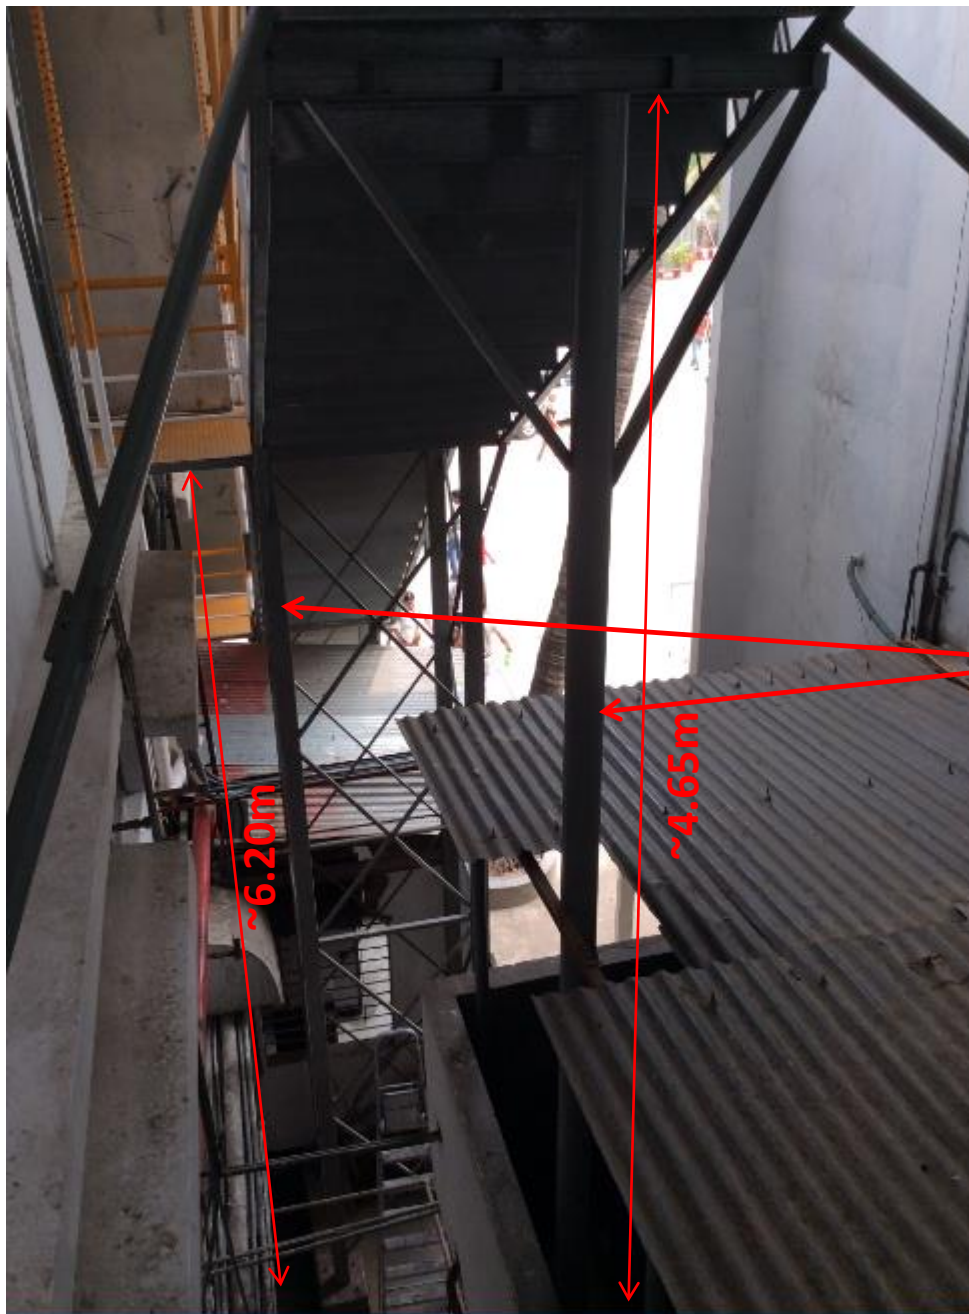
**Slender Columns Supporting Steel Stairs**

Steel sections supporting the steel stairs adjacent to Building 1 and Building 2 appear to be slender and should be checked by a Building Engineer.

| Item No. | Observation | Recommended Action Plan | Recommended Timeline |
|---|---|---|---|
| 15 | Building 2 - Slender column to external steel staircase | The external lightweight steel staircase between Buildings 1 and 2 is supported on what appears to be slender columns. This in turn is supported as a point load on the external slab adjacent to Building 2. | 6-weeks |

| Item No. | Observation | Recommended Action Plan | Recommended Timeline |
|---|---|---|---|
| 16 | Building 2 - Slender column to external steel staircase | Building Engineer to Check design of supporting columns and slab. | 6-weeks |
| 17 | Building 2 - Slender column to external steel staircase | Implement any recommendations made by Building Engineer. | 6-months |

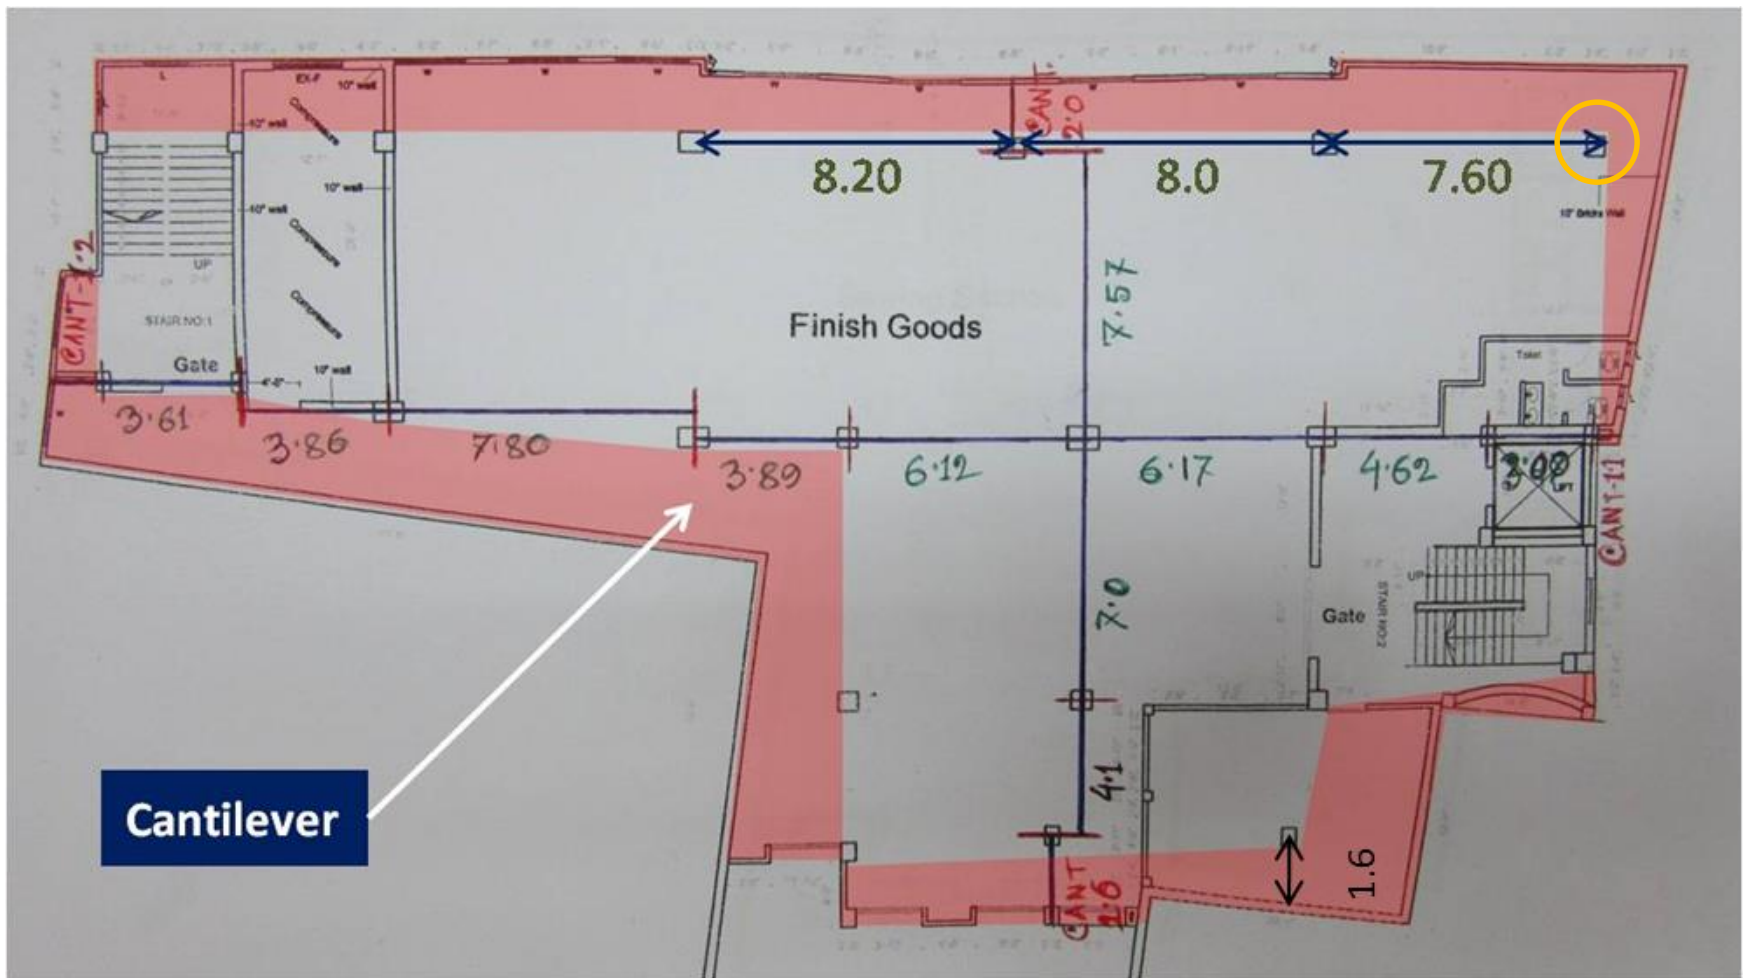
Cursory result shows high stress in the highlighted column due to heavy load coming from toilet present on different floors and water tank on roof top.

| Item No. | Observation | Recommended Action Plan | Recommended Timeline |
|---|---|---|---|
| 20 | Apparently high stress level column | No further construction and extension is permitted after the storey currently being built until the confirmation of the Building engineer on the current loads. | 6-weeks |
| 21 | Apparently high stress level column | Building Engineer to review design, loads and column stresses in the edge toilet columns attracting loads from cantilevers and toilets. | 6-weeks |
| 22 | Apparently high stress level column | Verify in-situ concrete stresses by 100mm dia. cores from min. 4 no. columns at ground floor level. | 6-weeks |
| 23 | Apparently high stress level column | Precise the reinforcement in the column (size and quantity). | 6-weeks |
| 24 | Apparently high stress level column | Produce and actively manage a loading plan for all floor plates within the Building, giving consideration to floor capacity and column capacity. | 6-weeks |

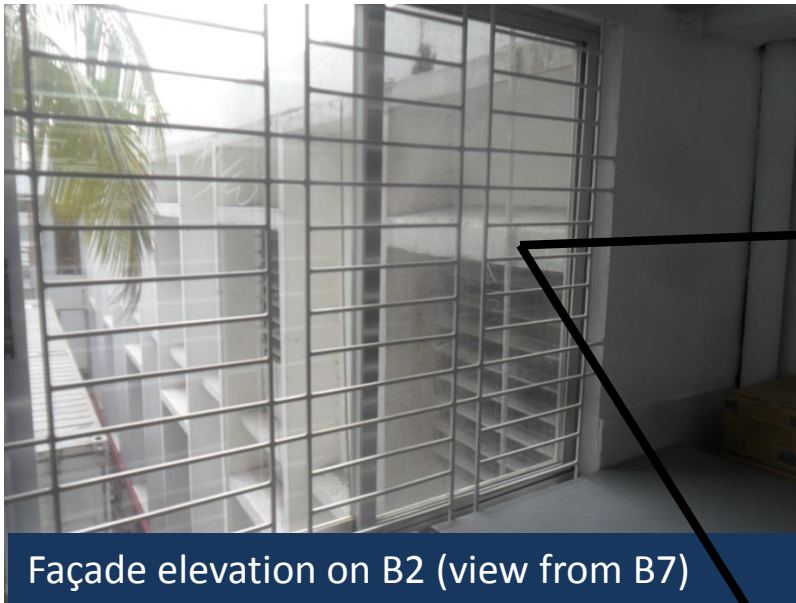
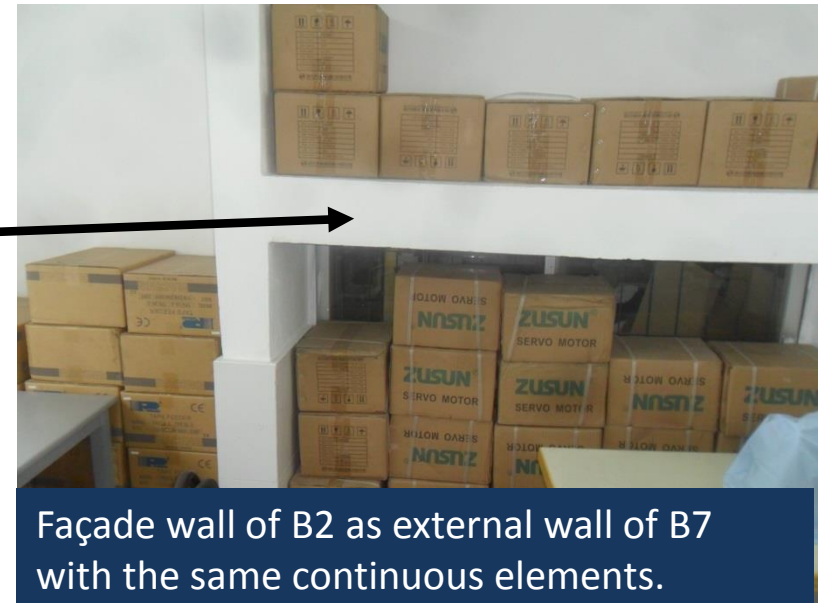
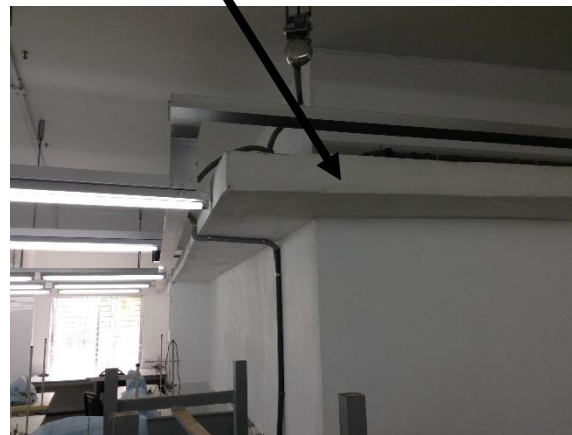
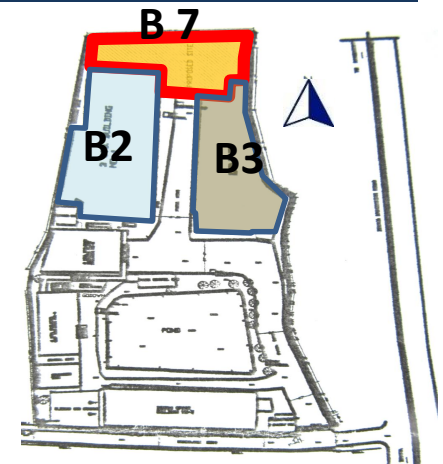
The construction joints between B7 and B1 and B3 is not apparent. In some places there are small construction joints and in other places the structural elements look connected. The façade walls of B1 and B3 are used as a common wall with B7.

| Item No. | Observation | Recommended Action Plan | Recommended Timeline |
|---|---|---|---|
| 25 | Apparently poor construction joints between buildings | The Building Engineer to investigate the construction joint between the buildings. Code adequacy to be ensured and eventual alterations to be defined. | 6-months |
| 26 | Apparently poor construction joints between buildings | Make any structural alterations as advised by Factory Engineer. | 6-months |

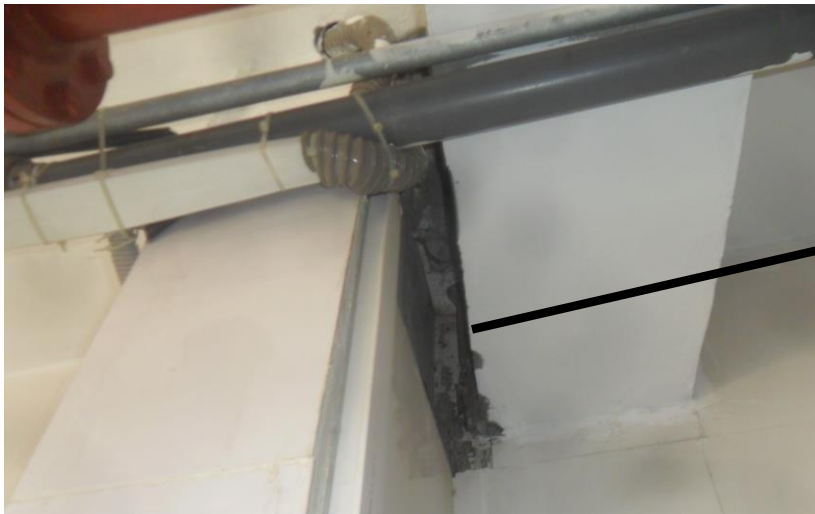
Construction joints are not clearly observed between inspected building and building - 2

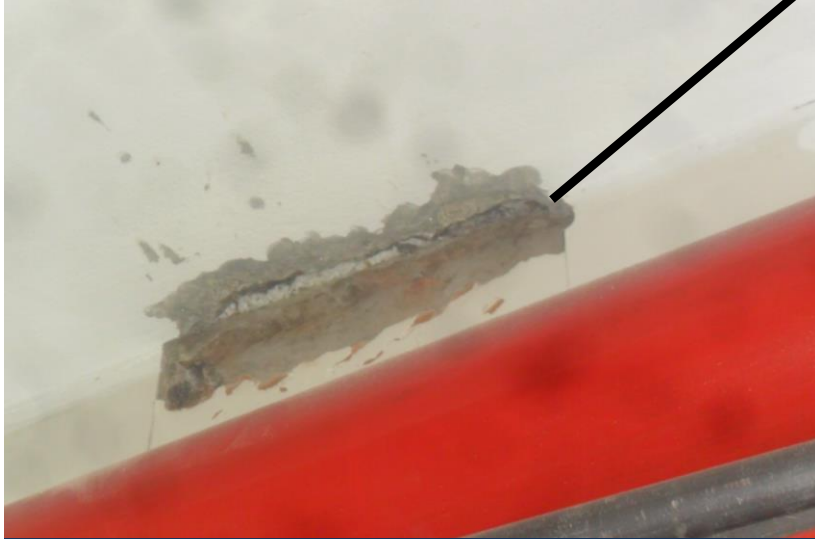
Construction joints observed between inspected building and building - 3

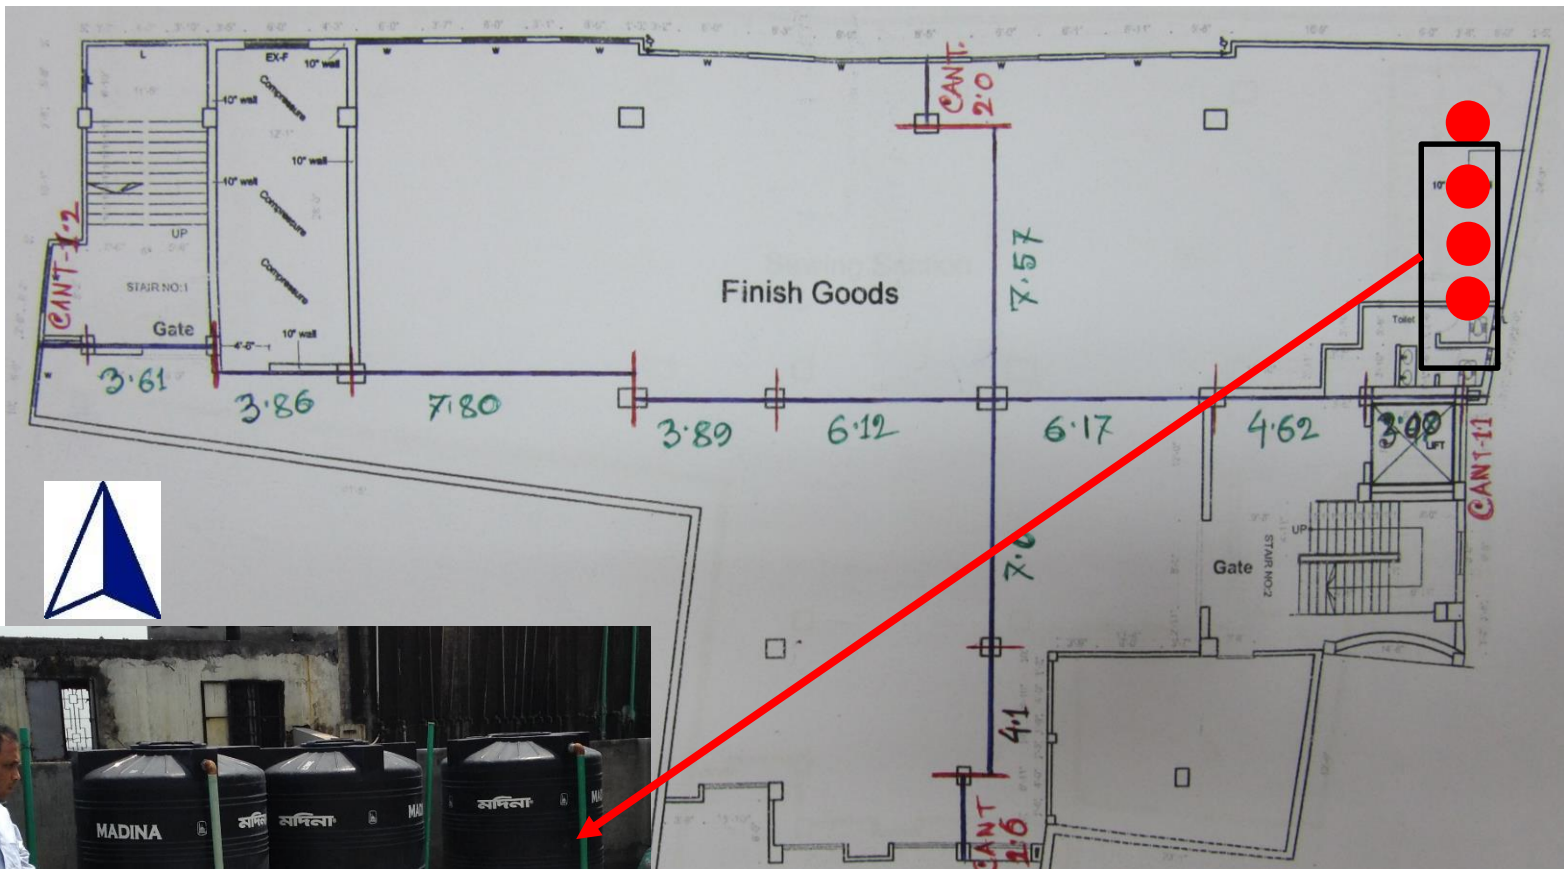
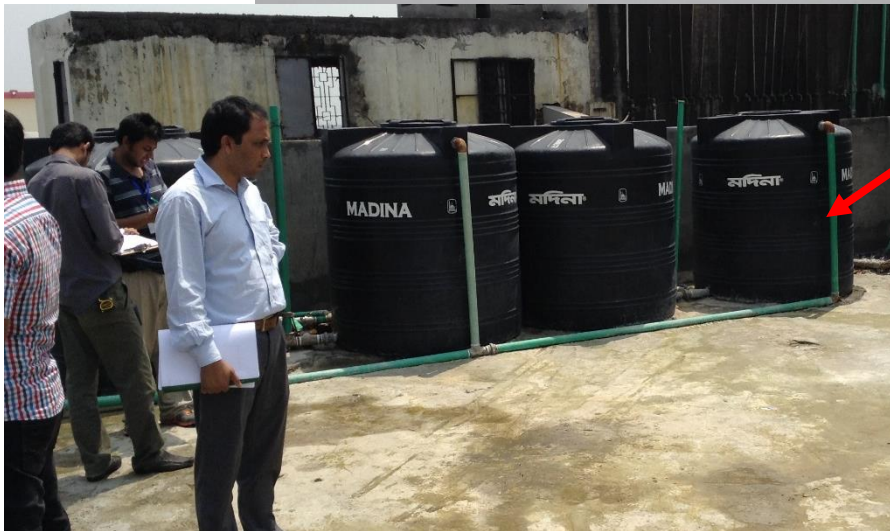
Apparently high loading in the toilet area

| Item No. | Observation | Recommended Action Plan | Recommended Timeline |
|---|---|---|---|
| 27 | Apparently heavy loaded areas | Building Engineer to check and verify the design capacity of the structural elements supporting the water tanks. | 6-weeks |
| 28 | Apparently heavy loaded areas | Building Engineer to design a loading plan for the building including the temporary water tank. | 6-weeks |
| 29 | Apparently heavy loaded areas | The location of the future water tanks to be confirmed. | 6-weeks |
| 30 | Apparently heavy loaded areas | If necessary Building Engineer to take appropriate action by reducing or removing water tanks loads where required and/or spread the load of the roof water tanks over a bigger and more appropriate area as required. | 6-months |

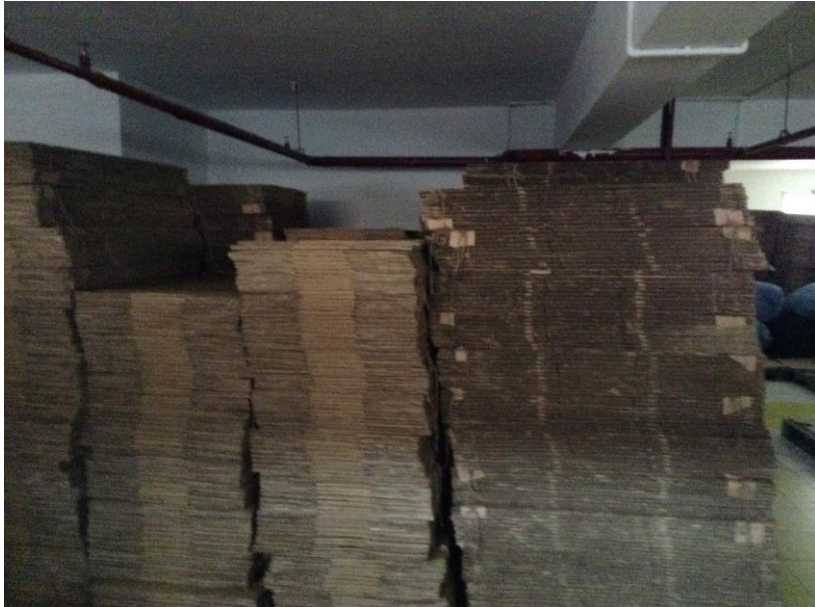
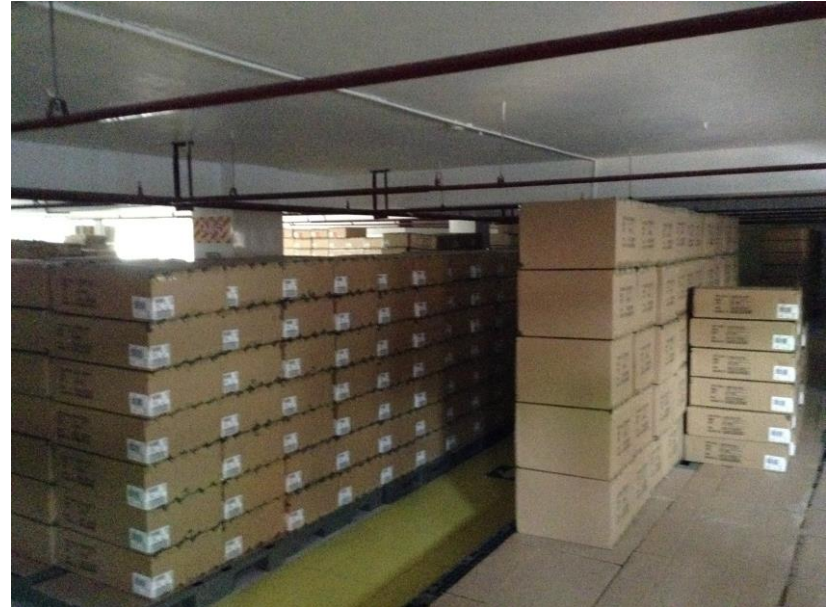
Heavy loading observed on 1<sup>st</sup> floor
