# Elite Garments Ind. Ltd.

Bade Kalmeswer, Board Bazar, Gazipur, Bangladesh  
(23.954199, 90.380240)

5th April 2014  
8th April 2015

**Building N7**

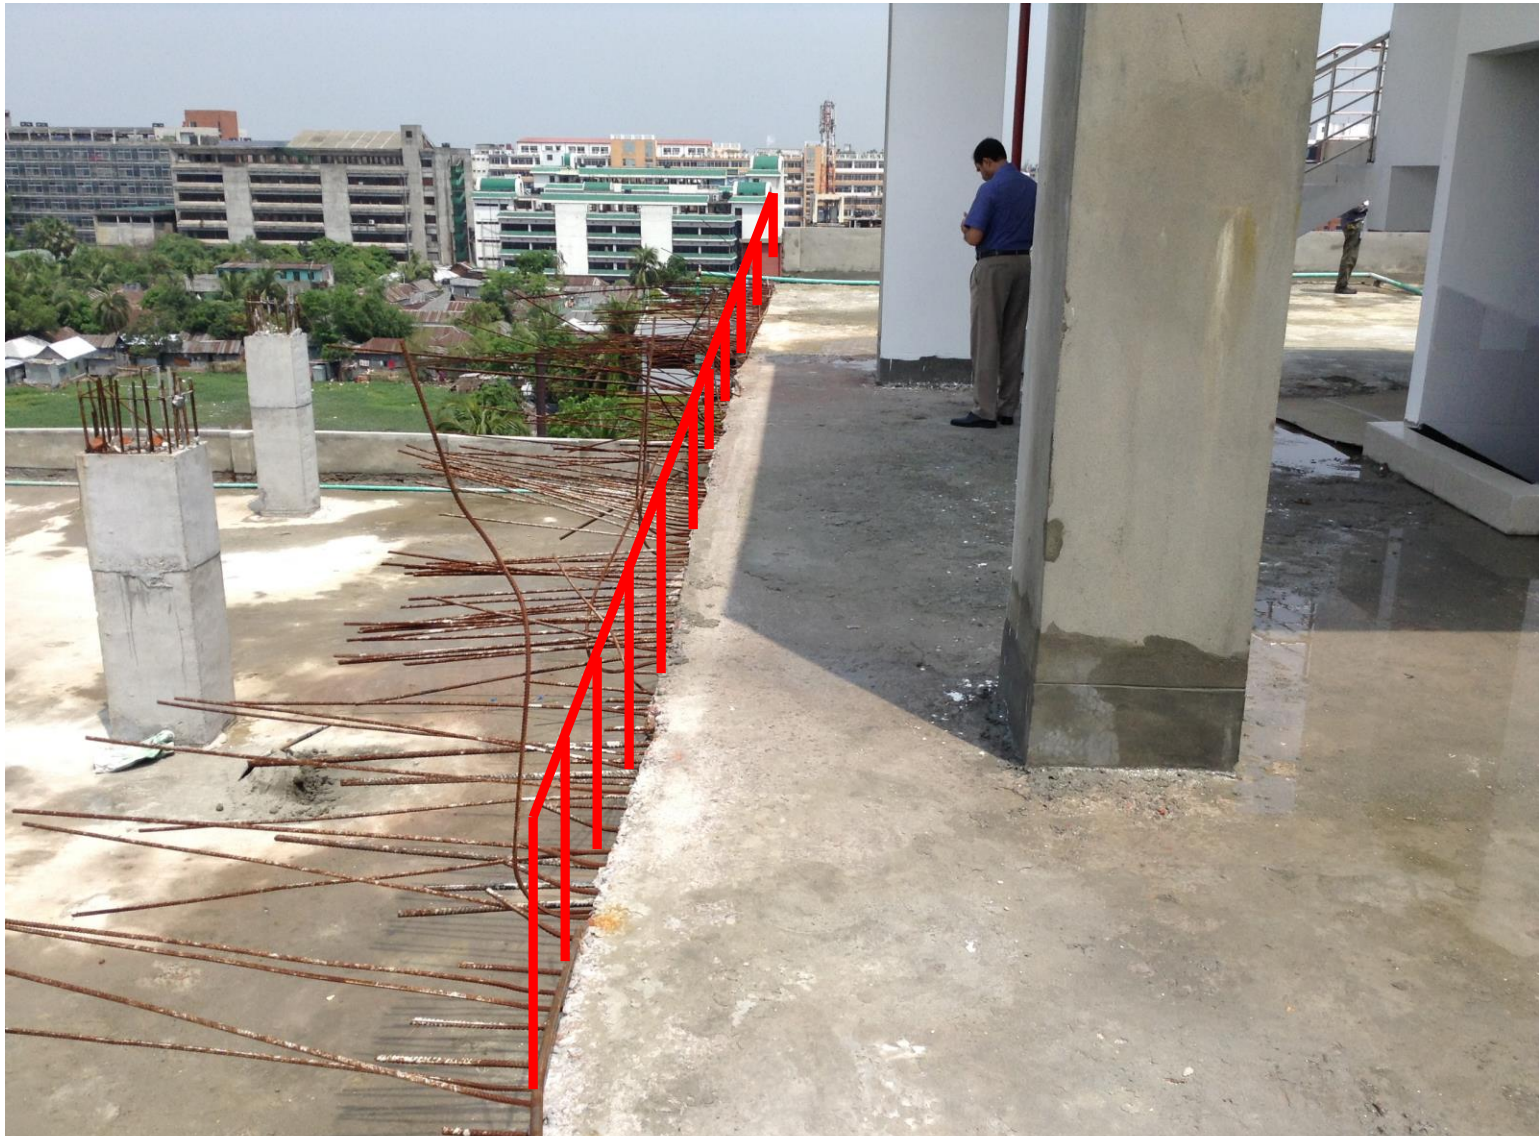
Lack of handrails on the 7<sup>th</sup> floor.

| Item No. | Observation | Recommended Action Plan | Recommended Timeline |
|---|---|---|---|
| 32 | Falling hazard | Secure constructed area around the staircases to exclude any possible falling hazard. | 6-weeks |
