FIRE SAFETY INSPECTION REPORT

GEEBEE (BANGLADESH) LIMITED
KARNAPHULI, EPZ, NORTH PATENGA

ACC   **RD**
on Fire and Building Safety in Bangladesh

May 22, 2014

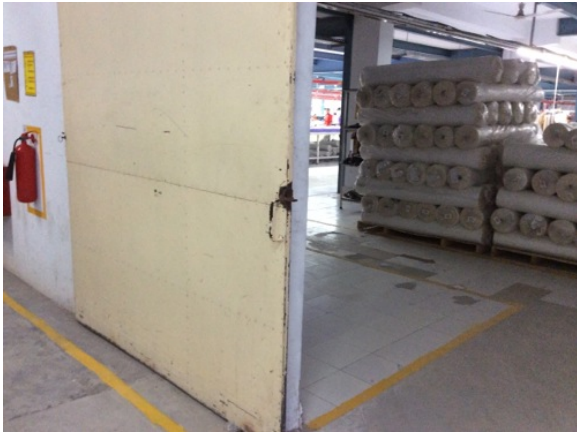
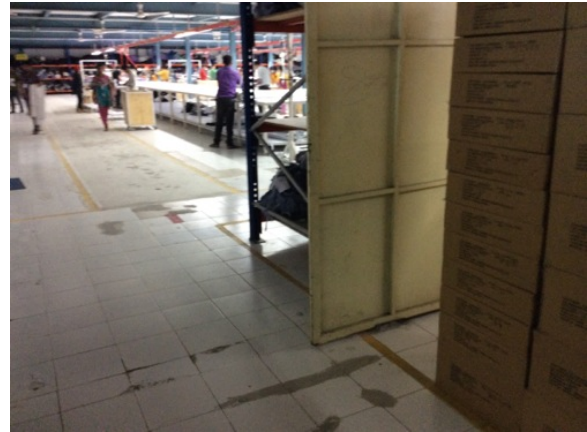
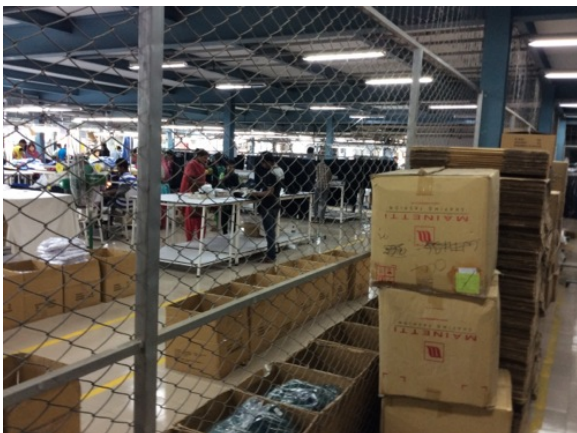
No.	Category	Finding	Recommendation	Remediation Timeframe
F-1	Fire Rated Construction	Areas used for combustible storage were not separated by fire-rated construction on all the floors.	Provide dedicated storage rooms separated by minimum 1-hr fire-rated construction.	Within 3 months

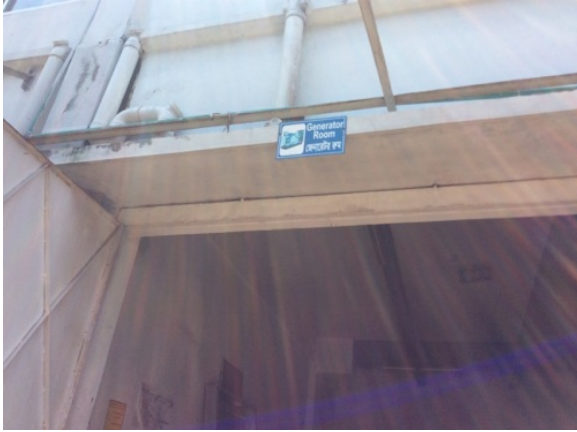
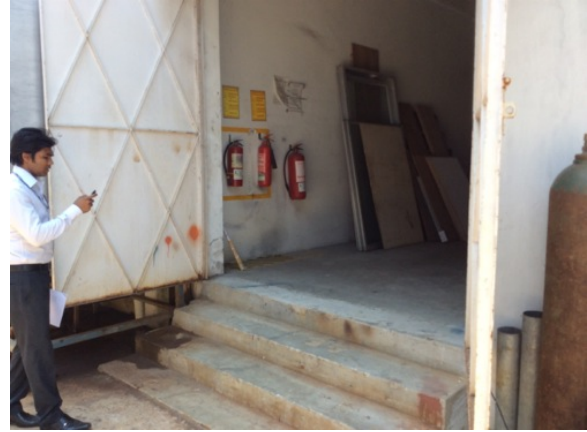
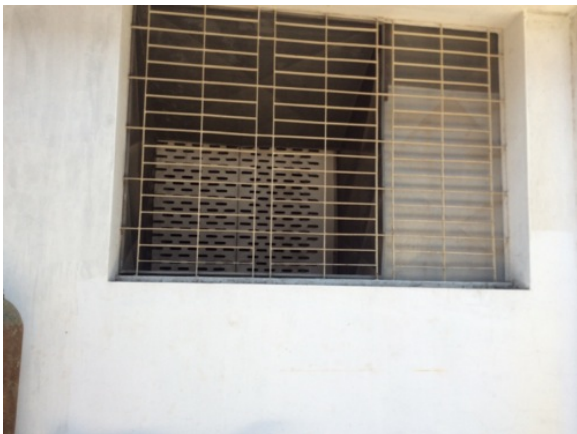
F-2	Fire Rated Construction	The boiler, generator, transformer room was not separated by fire-rated construction on the ground floor. There were openings and non-rated doors.	Separate the boiler, generator and transformer room by a minimum 2-hr fire-rated construction. Seal and protect all openings to maintain the required fire separations	Within 3 months
-----	-------------------------	--	--	-----------------

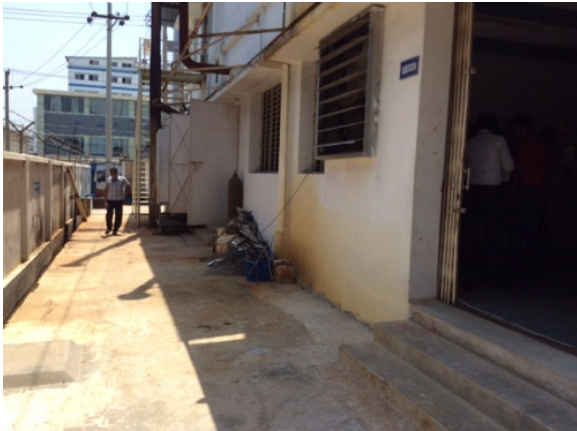
F-3	Fire Rated Construction	The exit discharge path serving West, North West and North East exit was less than 10 ft wide and was not separated from the building interior.	Seal all penetrations and openings to the interior of the building along the discharge path, up to a height of 10 ft., to provide a minimum 1-hr fire separation.	Within 6 months
-----	-------------------------	---	---	-----------------

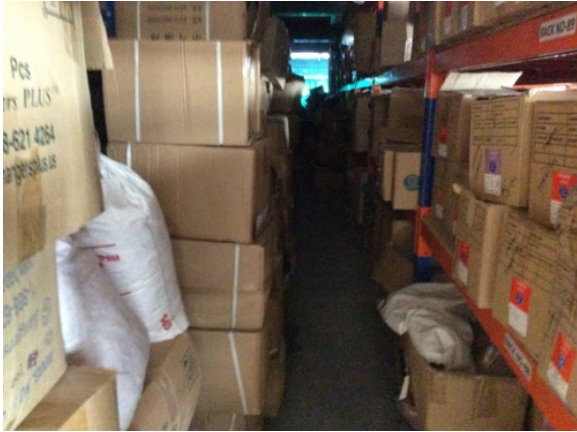
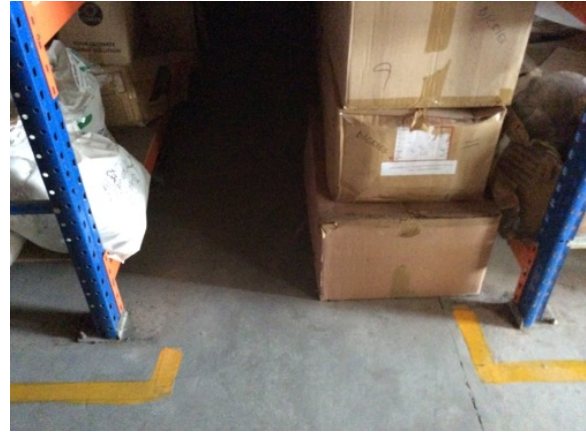
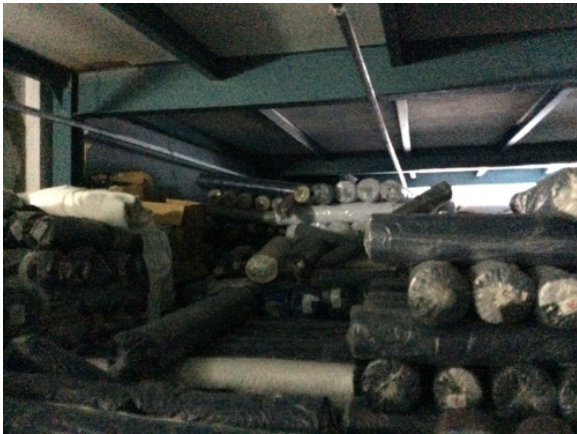
F-5	Egress	Storage was located in the egress path on the ground floor.	Keep egress paths and stairs clear of storage.	Immediate
-----	--------	---	--	-----------

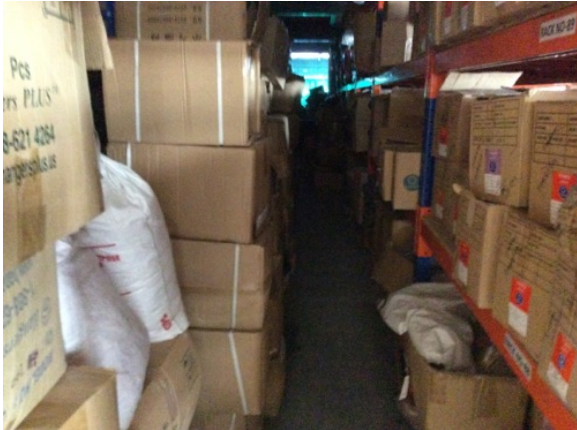
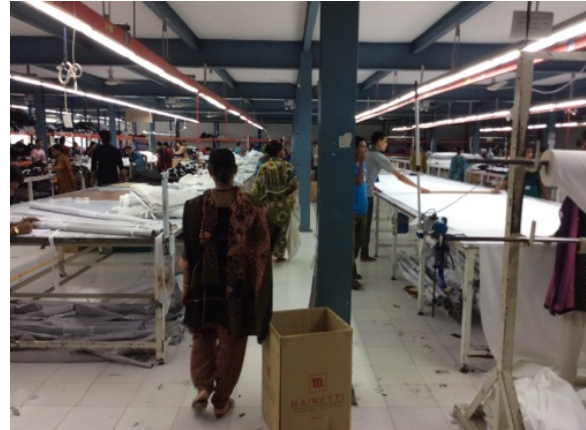
F-8	Egress	The width of egress aisles were less than 36-in. on the ground floor.	Provide minimum aisle widths of 36-in.	Within 3 months
-----	--------	---	--	-----------------

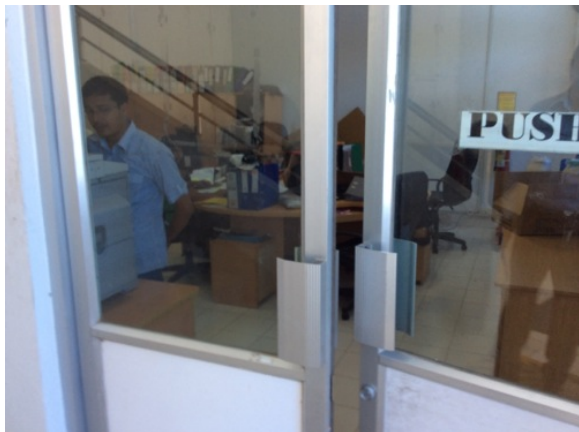
F-11	Egress	Exit stair door and egress door serving 50 or more occupants did not swing in the direction of egress travel on the ground floor.	Modify the egress door to swing in the direction of egress travel.	Within 3 months
------	--------	---	--	-----------------

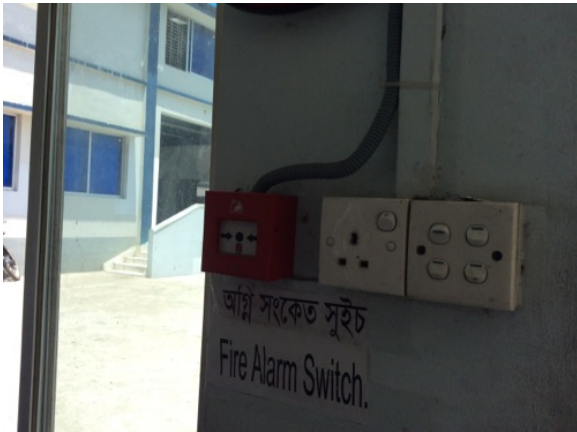
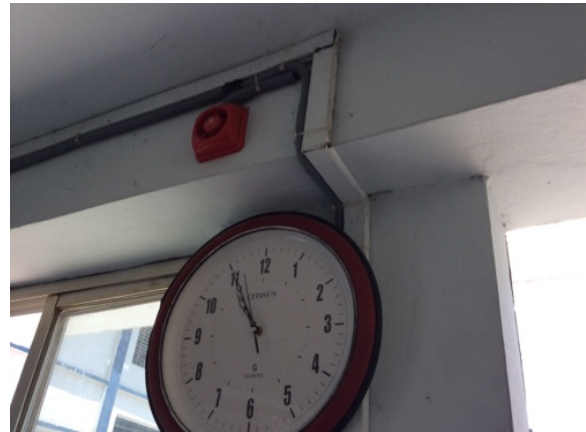
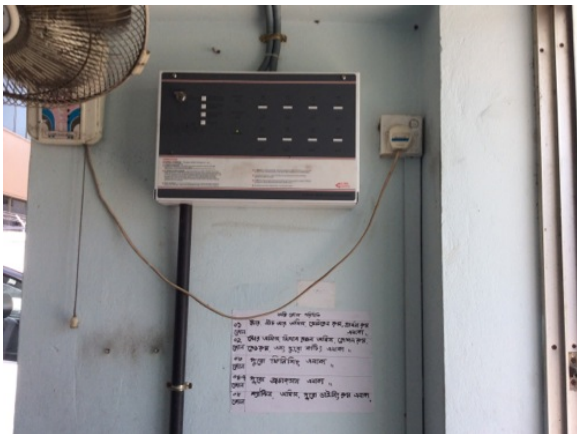
F-12	Egress	The exits are not remotely located from each other such that a single fire event could compromise both exits on all the floors except the fifth floor.	Provide additional exits.	Within 6 months
F-13	Fire Protection	The fire alarm system was antiquated, not a listed system, and does not provide alarm and notification features consistent with acceptable standards.	Replace the fire alarm system with a new, listed addressable fire alarm system in accordance with NFPA 72.	Design within 4 months, install within 9 months

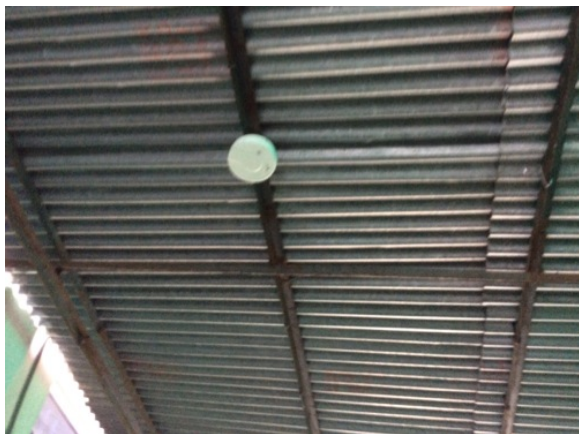
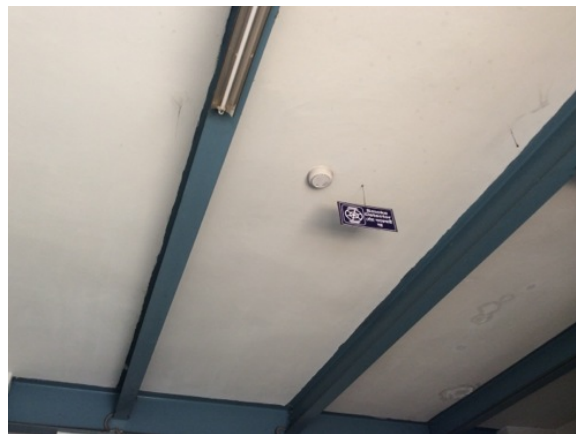
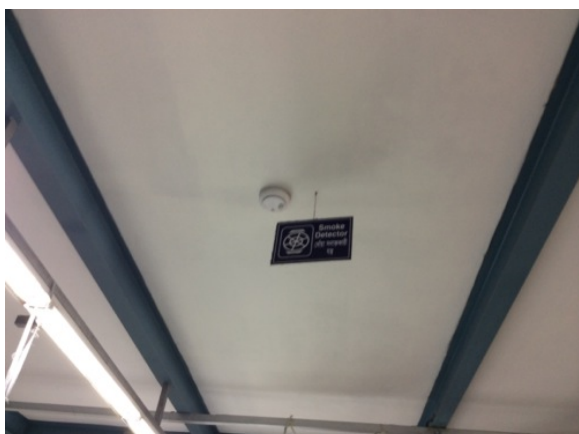
F-15	Fire Protection	The building was equipped with single-station smoke alarms. Smoke alarm activation sounds only a local alarm and did not provide automatic fire alarm notification of occupants.	Remove single-station smoke alarms. Provide automatic smoke detection throughout the building, tied into the fire alarm system, in accordance with NFPA 72.	Within 6 months
------	-----------------	--	---	-----------------
