# **FIRE SAFETY INSPECTION REPORT**

**KDS APPARELS LTD.**

**251 / 252 NASIRABAD INDUSTRIAL AREA**

May 20, 2014

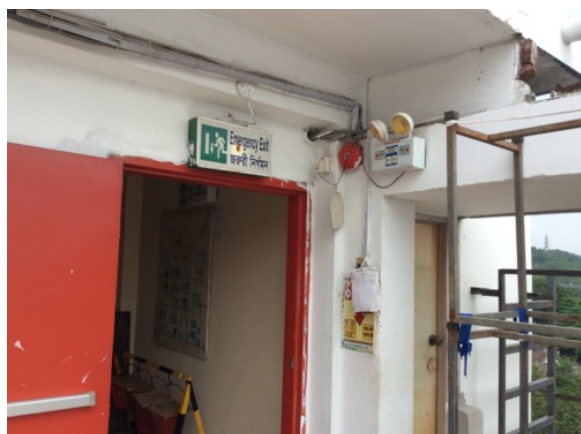
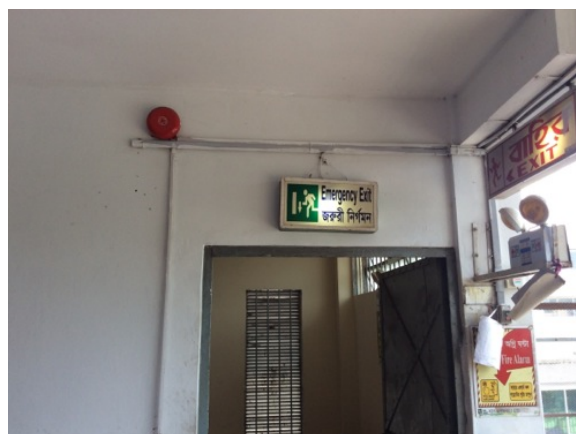
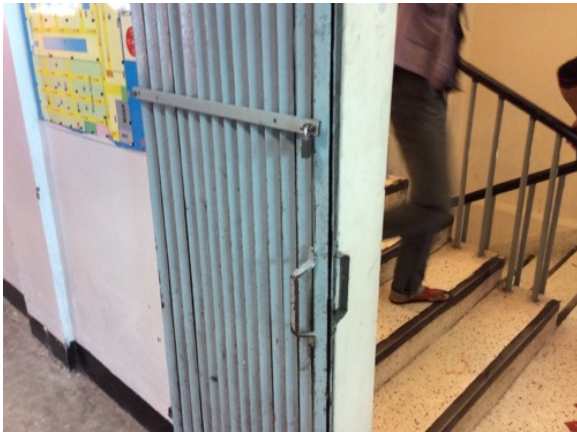
| No. | Category | Finding | Recommendation | Remediation Timeframe |
|---|---|---|---|---|
| F-1 | Fire Rated Construction | The exit stairs were not separated from work areas and other spaces on each floor by fire-rated construction. | <p>Provide minimum 1.5-hr fire rated doors and seal all unprotected openings to separate the exit stairs from work areas and other building spaces on all floor levels. Ensure that the fire doors are self-closing and positive latching and that they are provided with fire exit (panic) hardware where serving production floors.</p> <p>If fire doors are required to be held open for functional reasons, provide automatic-closing devices tied to the fire alarm system.</p> | Within 3 months |

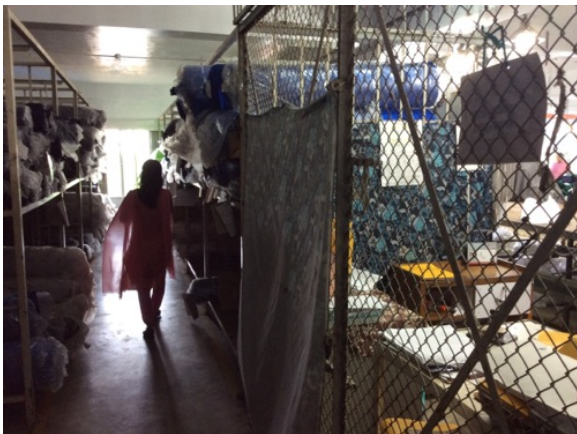
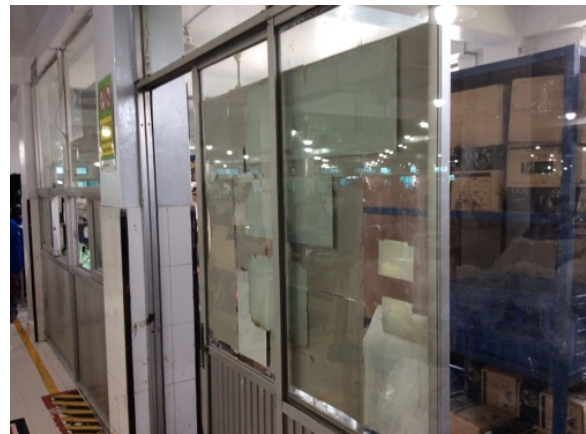
| F-2 | Fire Rated Construction | Areas used for combustible storage were not separated by fire-rated construction on all the floors. | Provide dedicated storage rooms separated by minimum 1-hr fire-rated construction. | Within 3 months |

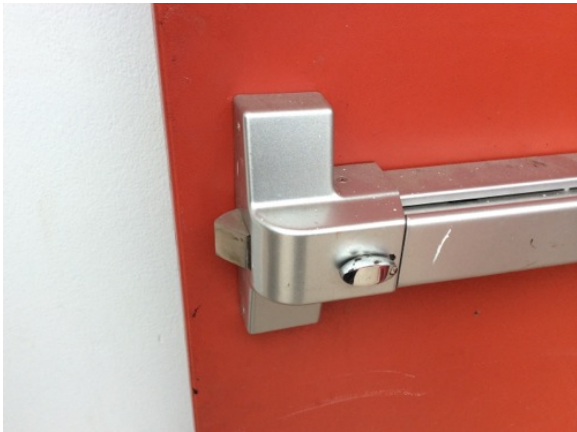
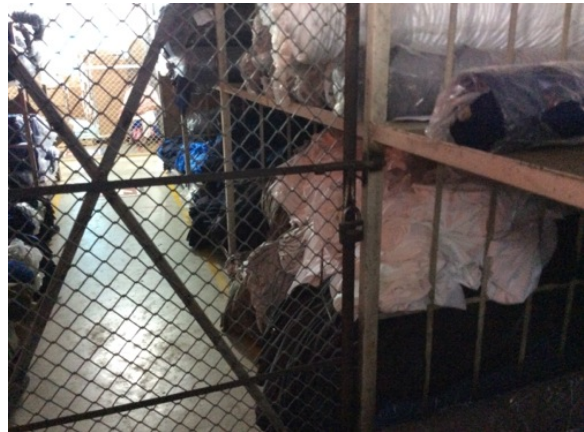
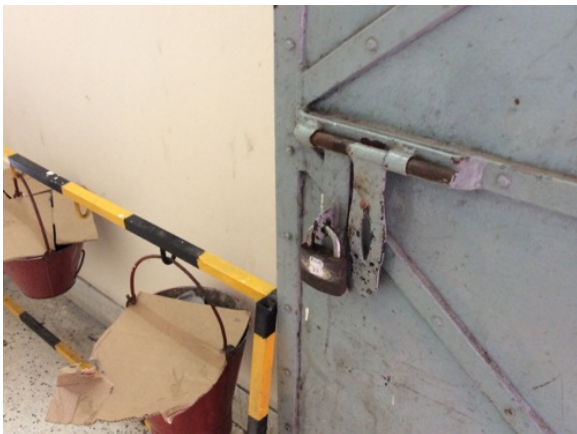
| F-3 | Egress | Egress doors and gates with locking features were provided along egress routes, exit stairs, exit discharges and building exits. | <p>Remove locking features from all egress doors and gates.</p> <p>If locks are required for security reasons, utilize special door locking features complying with NFPA 101.</p> | Immediate |

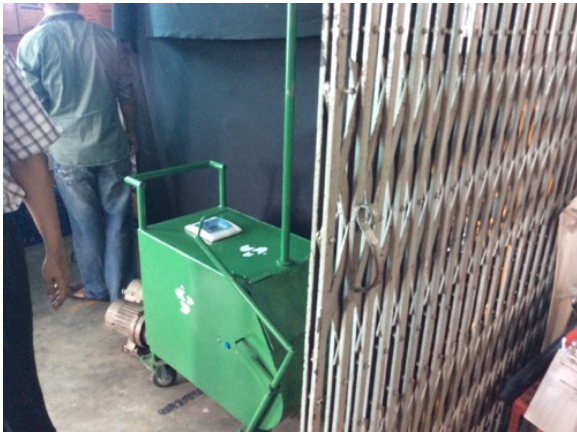
| F-5 | Egress | Storage was located in the egress path on all the floors except the fifth floor. | Keep egress paths and stairs clear of storage. | Immediate |

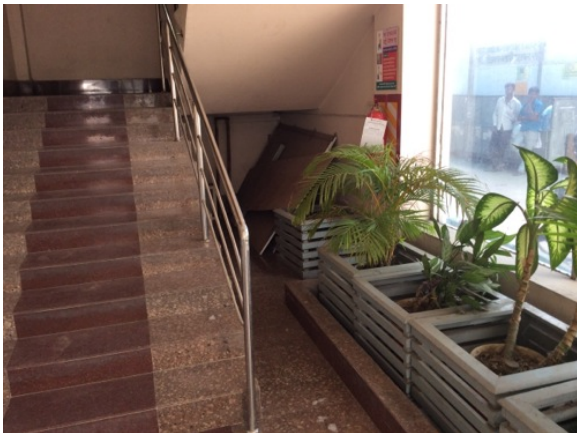
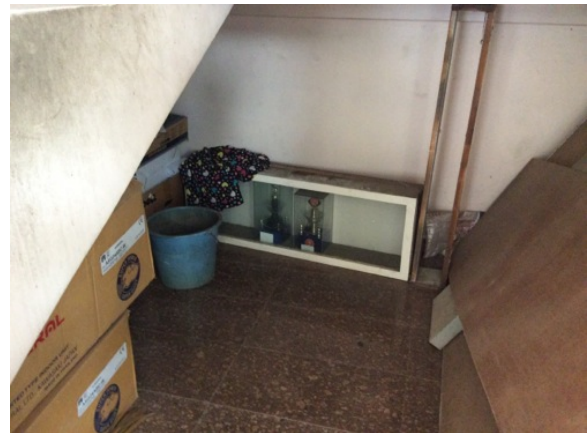
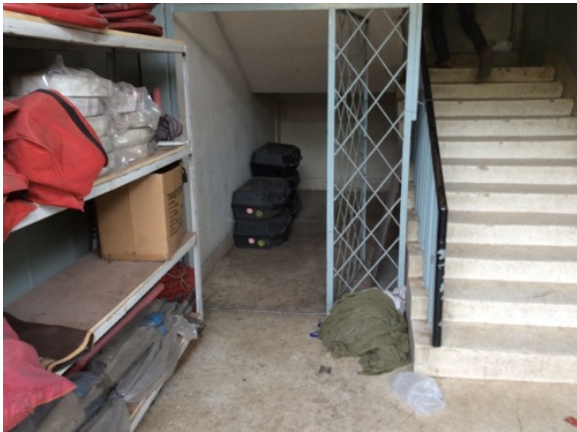
| F-6 | Egress | Storage was located in all the exit stairs on the ground floor. | Remove all storage from exit stairs and egress paths. | Immediate |

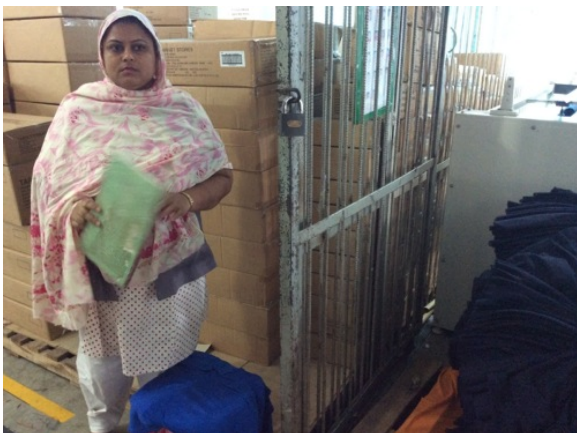
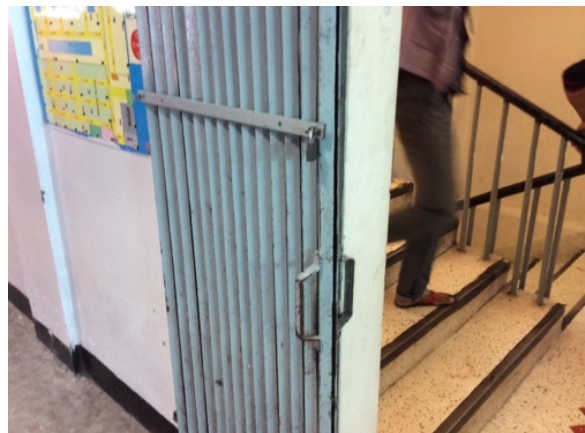
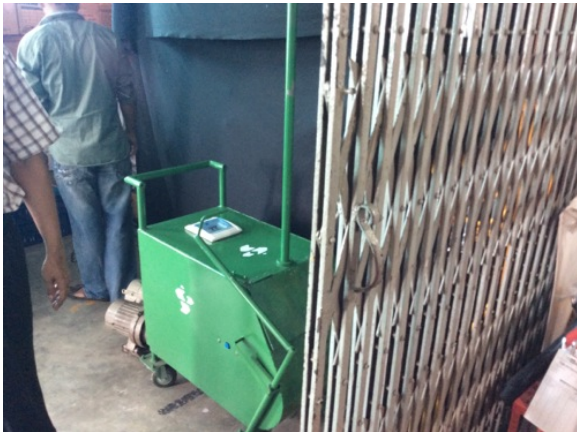
| F-7 | Egress | Collapsible gates and sliding doors were provided along egress routes, exit stairs, exit discharges and building exits. | Replace all sliding gates and sliding doors along the means of egress with side-hinged, swinging egress doors.<br><br>If locks are required for security reasons, utilize special door locking features complying with NFPA 101. | Within 1 month |

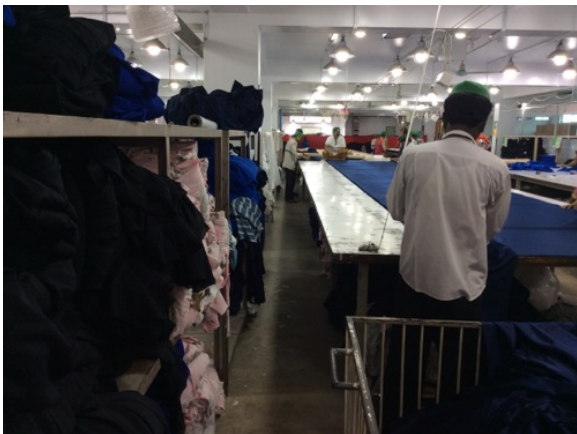
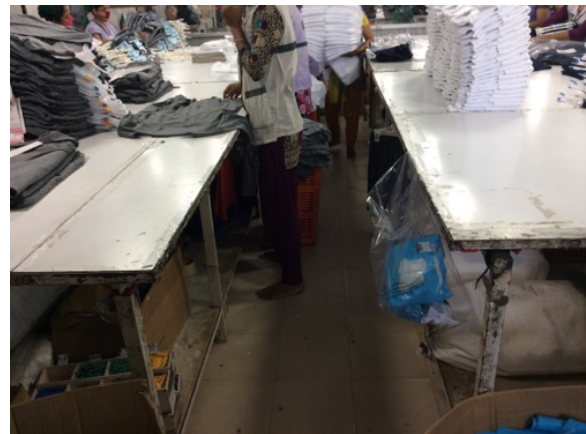
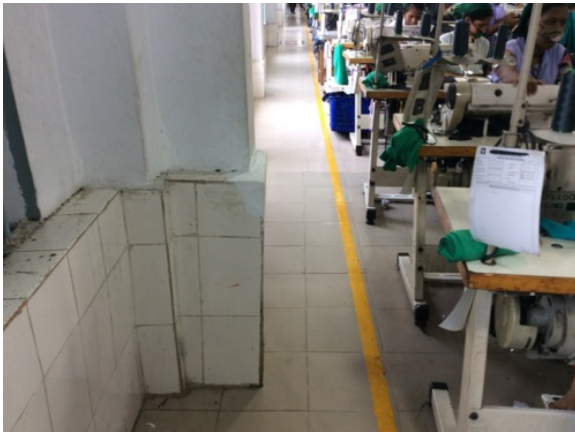
| F-8 | Egress | The width of egress aisles were less than 36-in. on all the floors except the fifth floor. | Provide minimum aisle widths of 36-in. | Within 3 months |
