# **FIRE SAFETY INSPECTION REPORT**

**OCEAN APPARELS LIMITED**  
**BUILDING DS 02, EAST WING 1ST FLOOR, ROAD# 02,**  
**CEPZ**

**ACCORD**  
on Fire and Building Safety in Bangladesh

June 1, 2014

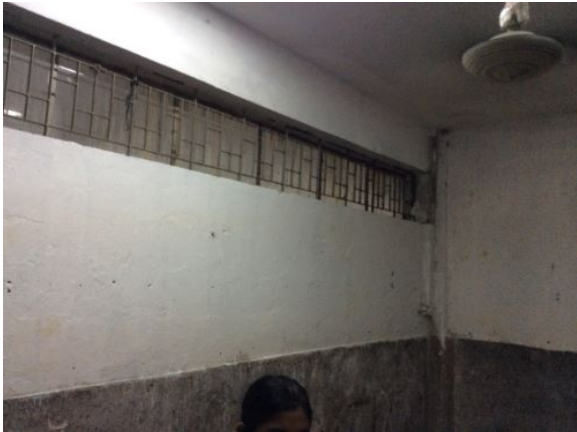
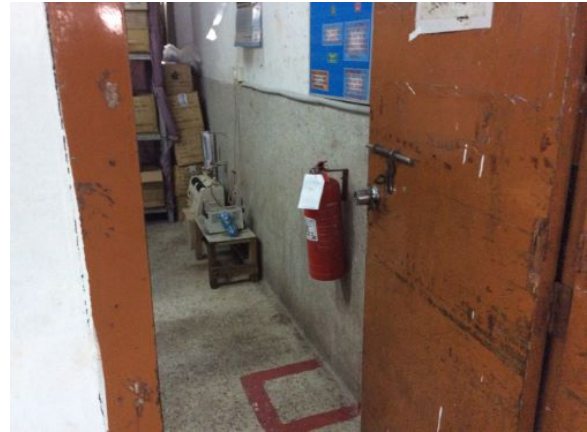
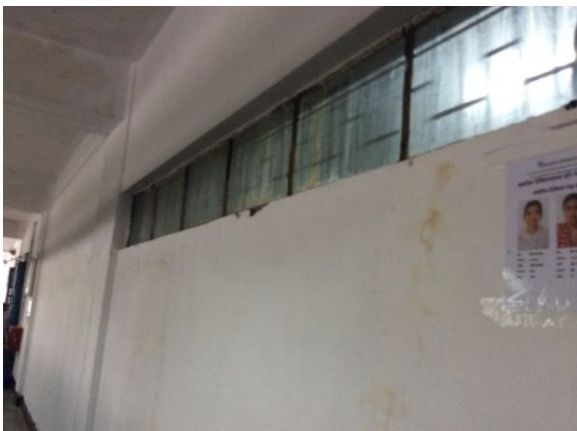
No.	Category	Finding	Recommendation	Remediation Timeframe
F-1	Fire Rated Construction	Storerooms used for combustible storage are not separated by fire-rated construction from the factory floor.	Provide dedicated storage rooms separated by minimum 1-hr fire-rated construction.	Within 3 months

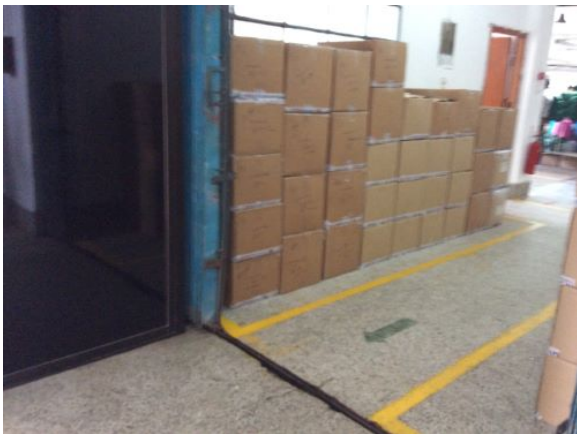
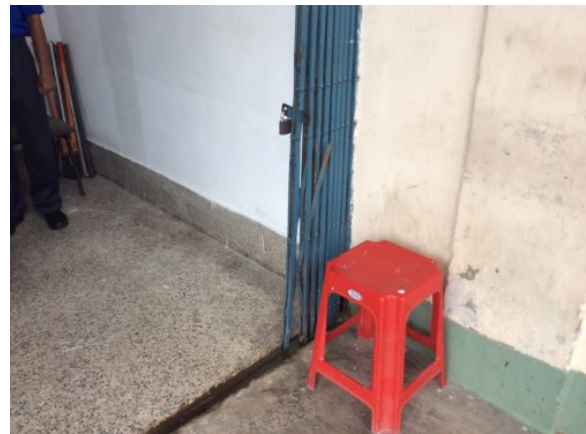
F-2	Fire Rated Construction	The exit stairs are not separated from work areas and other spaces on the factory floor by fire-rated construction.	Provide minimum 1.5-hr fire rated doors and seal all unprotected openings to separate the exit stairs from work areas and other building spaces on all floor levels. Ensure that the fire doors are self-closing and positive latching and that they are provided with fire exit (panic) hardware where serving production floors.  If fire doors are required to be held open for functional reasons, provide automatic-closing devices tied to the fire alarm system.	Within 3 months
-----	-------------------------	---	---	-----------------

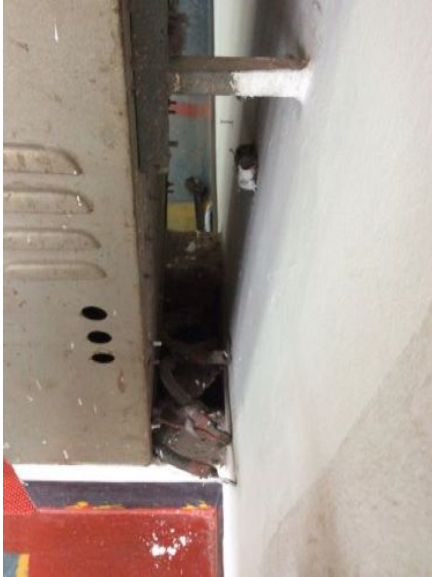
F-3	Fire Rated Construction	Unsealed penetrations and openings are located in the fire-rated floor and ceiling assemblies.	Provide a minimum 2-hr fire-rated shaft to separate the utility risers from each floor level.  Seal all penetrations and openings in floor and ceiling assemblies to maintain the fire separation.	Within 3 months
-----	-------------------------	--	--	-----------------

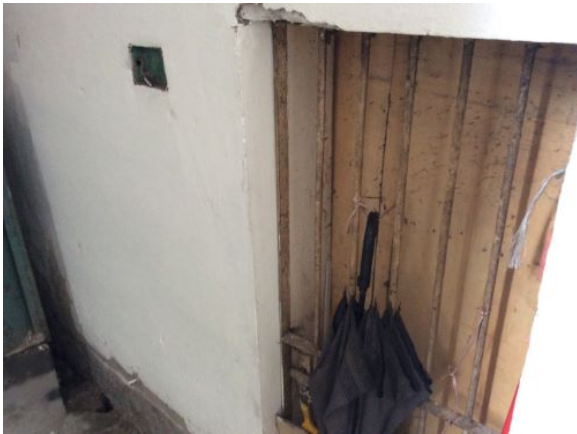
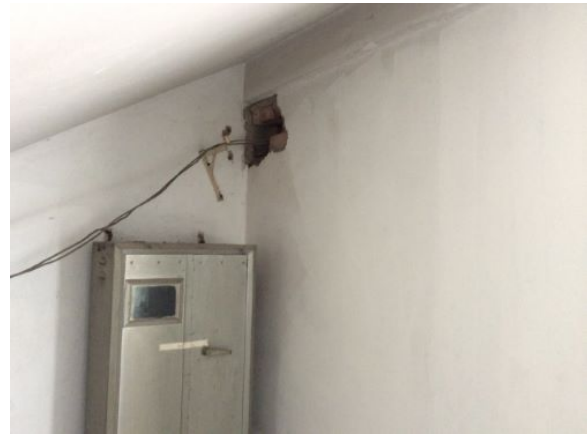
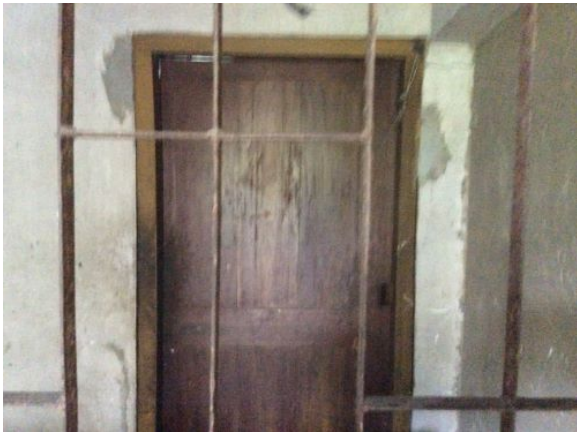
F-4	Fire Rated Construction	Unsealed penetrations and openings are located in exit stair enclosures.	Seal all penetrations and openings in exit stair enclosure walls to maintain the fire separation.	Within 3 months
-----	-------------------------	--	---	-----------------

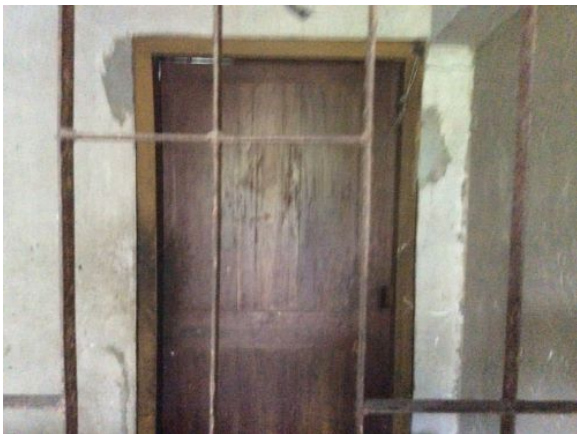
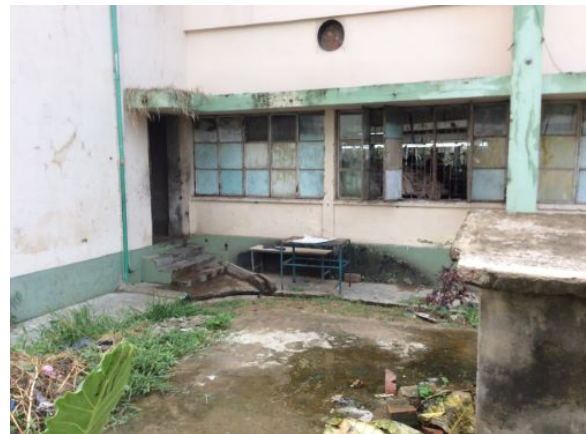
F-5	Fire Rated Construction	The North West exit stair on ground floor is not enclosed in fire rated construction.	Provide 2-hr continuous stairwell enclosure to exterior ground level.	Within 3 months
-----	-------------------------	---	---	-----------------

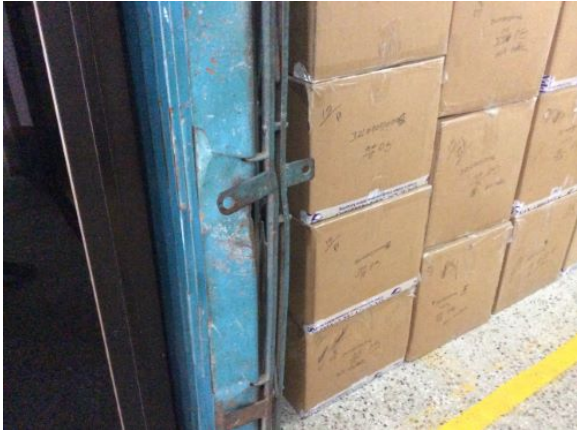
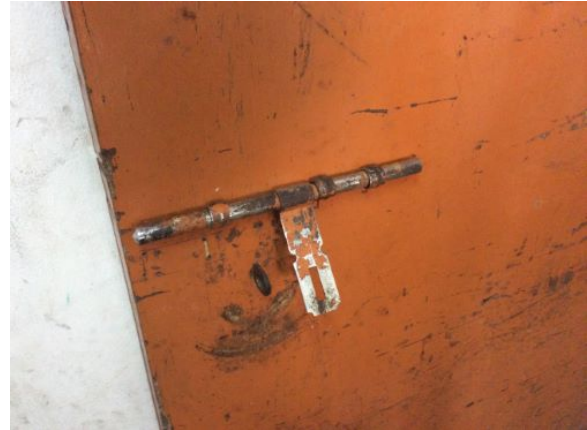
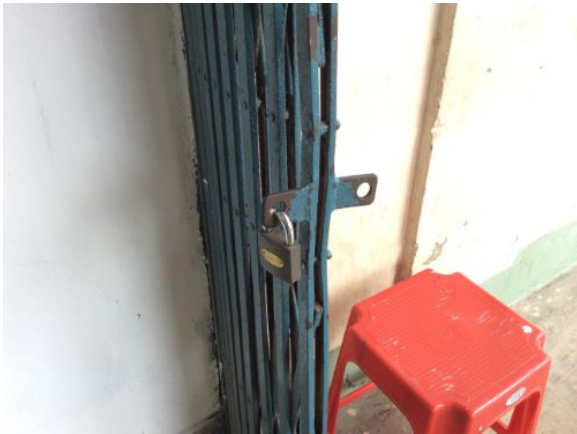
F-6	Egress	Egress doors and gates with locking features (provision for padlocks) are provided at building exits, exit stairs, along egress routes and exit discharges.	Remove locking features from all egress doors and gates.  If locks are required for security reasons, utilize special door locking features complying with NFPA 101.	Immediate
-----	--------	---	--	-----------

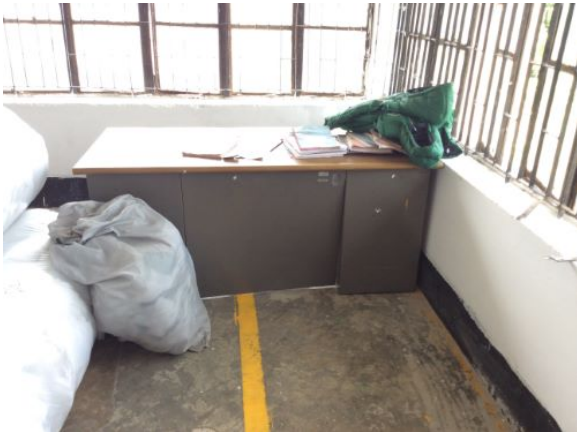
F-7	Egress	Storage is located in the egress path on the factory floor.	Keep egress paths and stairs clear of storage.	Immediate
-----	--------	---	--	-----------

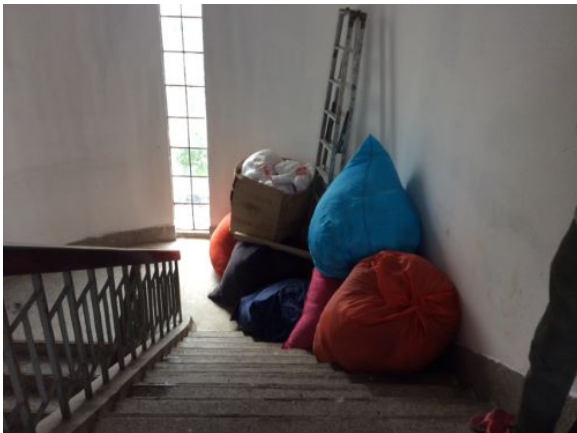
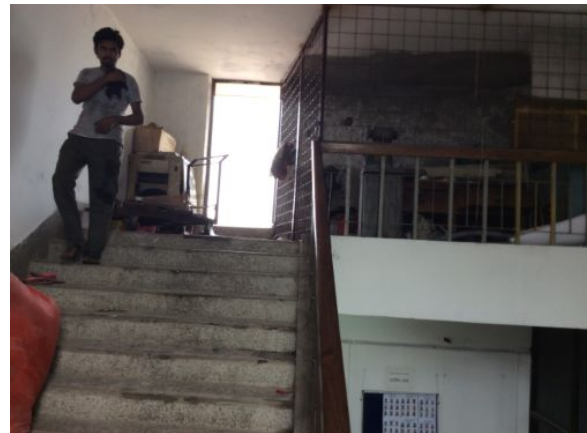
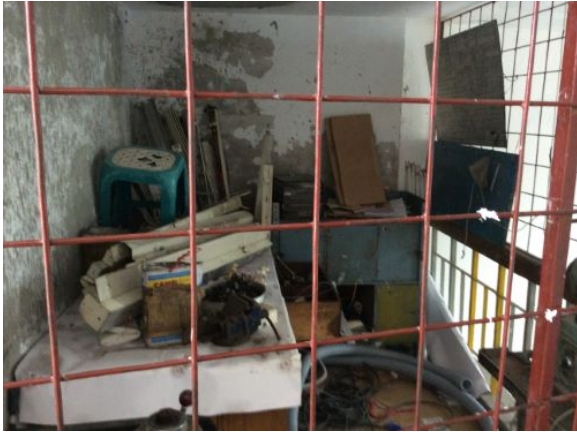
F-8 Egress

Storage is located in the exit stair on the ground floor and roof.

Remove all storage from exit stairs and egress paths.

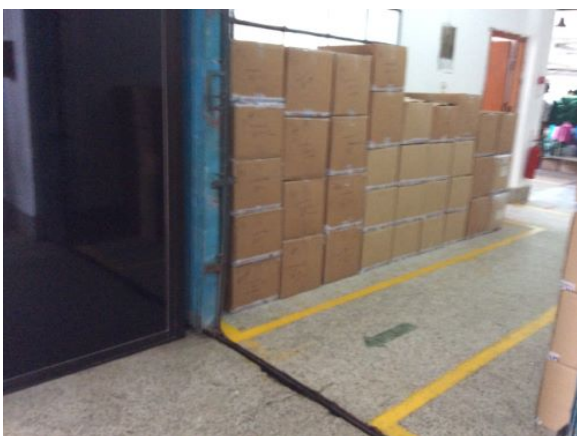
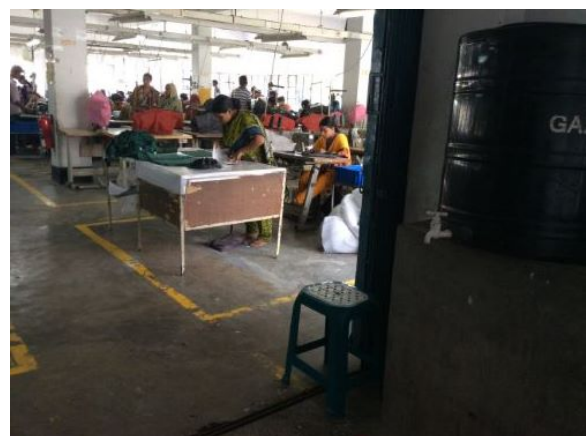
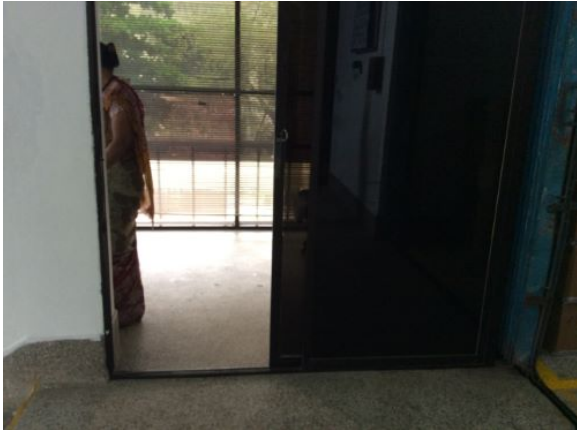
F-9 Egress

Collapsible gates and sliding doors are provided at building exits, exit stairs, along egress routes and exit discharges.

Replace all gates and sliding doors along the means of egress with side-hinged, swinging egress doors.

If locks are required for security reasons, utilize special door locking features complying with NFPA 101.

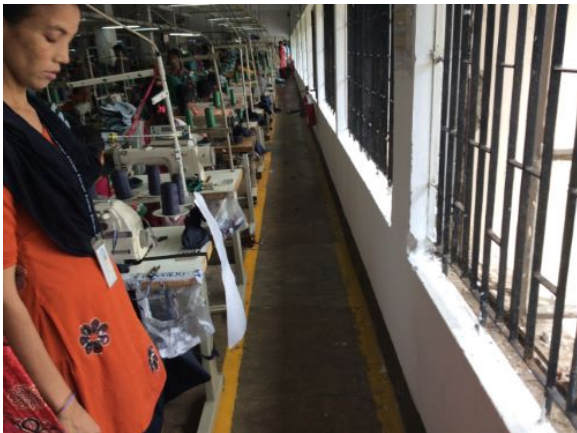
F-10	Egress	The width of egress aisles is less than 36-in. in the factory floor.	Provide minimum aisle widths of 36-in.	Within 3 months
------	--------	--	--	-----------------

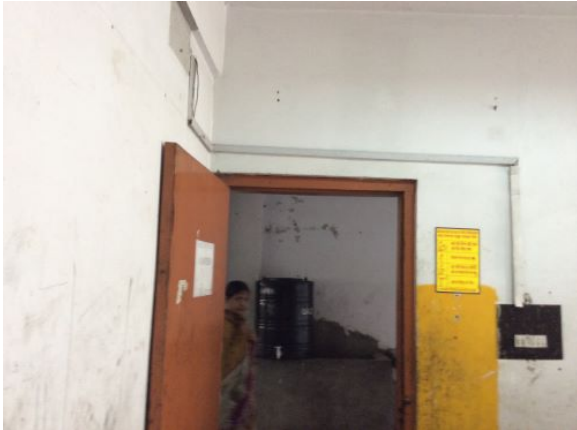
F-11	Egress	Egress door serving 50 or more occupants does not swing in the direction of egress travel in the dining space.	Modify the egress door to swing in the direction of egress travel.	Within 3 months
------	--------	--	--	-----------------

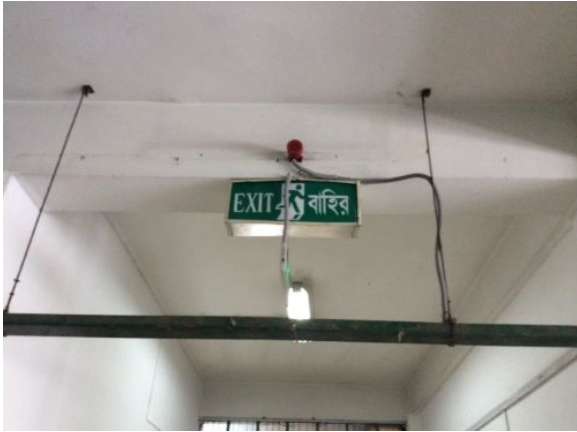
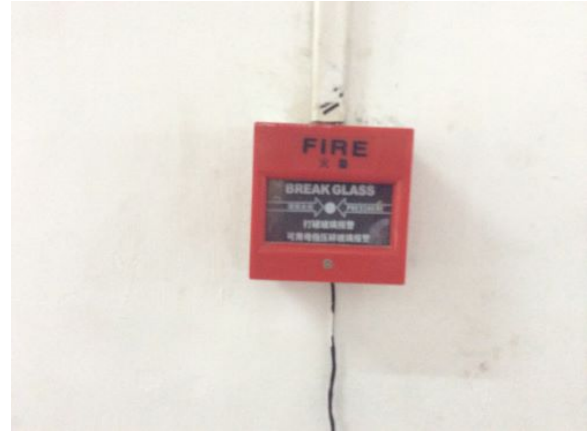
F-12	Egress	A single means of egress is provided from Dining space where the occupant load exceeds 49 persons.	Reduce occupant load to not more than 49 persons.	Within 3 months
F-13	Fire Protection	The fire alarm system is antiquated, not a listed system, and does not provide alarm and notification features consistent with acceptable standards.	Replace the fire alarm system with a new, listed addressable fire alarm system in accordance with NFPA 72.	Design within 4 months, install within 9 months

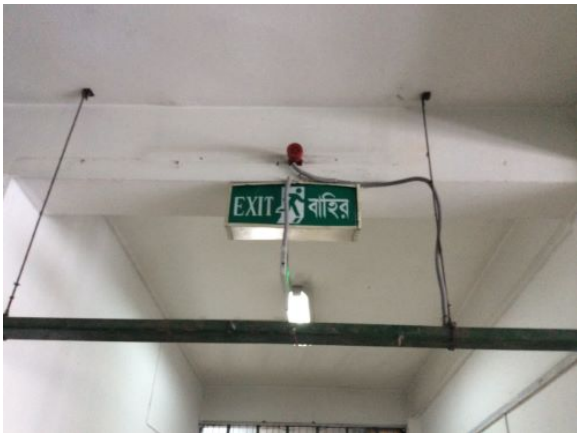
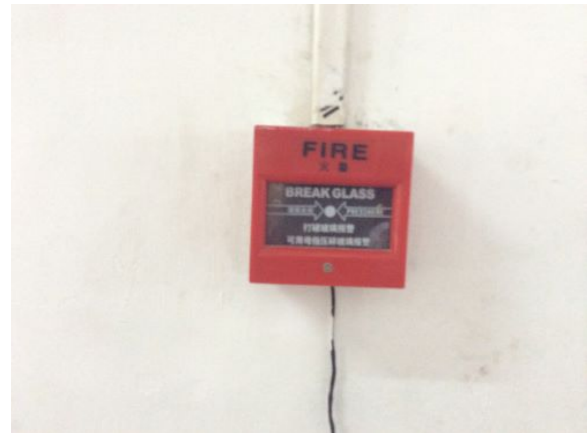
F-14	Fire Protection	Activation of the fire alarm system by a manual fire alarm station provides automatic occupant notification only on the floor of alarm and not throughout the building.	Configure the fire alarm system to initiate automatic occupant notification on all floor levels to facilitate whole-building evacuation upon any manual fire alarm station activation.	Within 1 months
------	-----------------	---	--	-----------------

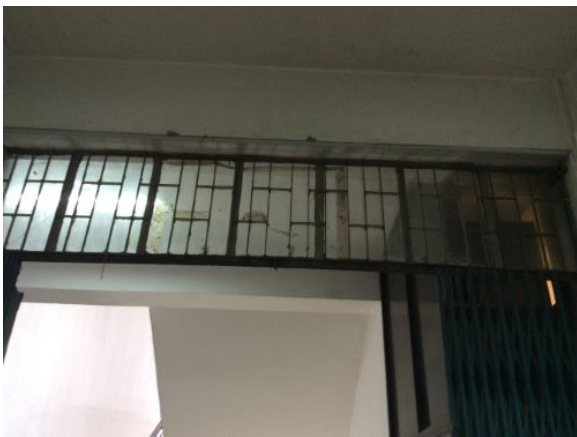
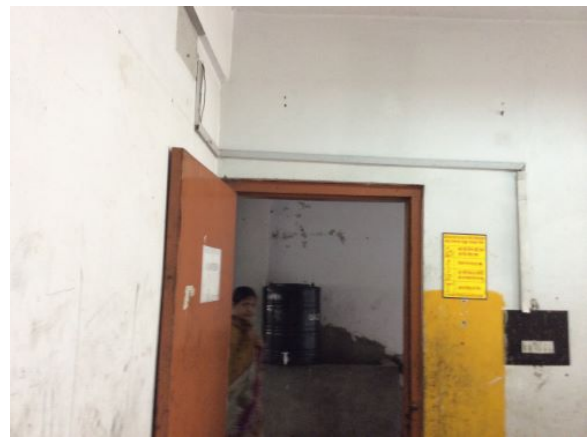
F-15	Fire Protection	Inspection, testing, and maintenance for the fire alarms system are not in accordance with NFPA 72.	Inspect, test and maintain the fire alarm system, and keep written records on-site, in accordance with NFPA 72.	Within 3 months
F-16	Egress Lighting	Exit sign not provided at exit on the factory floor.	Provide exit signs above all exits to the exterior and all doors to the exit stairs.	Within 1 month

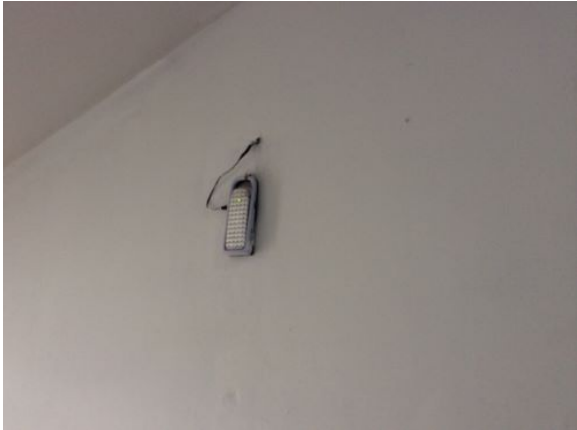
F-17	Egress Lighting	Manual on-off switch is provided for emergency lighting units on the body of the lighting units.	Remove manual on/off switches from emergency lighting units to prevent them from being switched off.	Within 1 month
------	-----------------	--	--	----------------

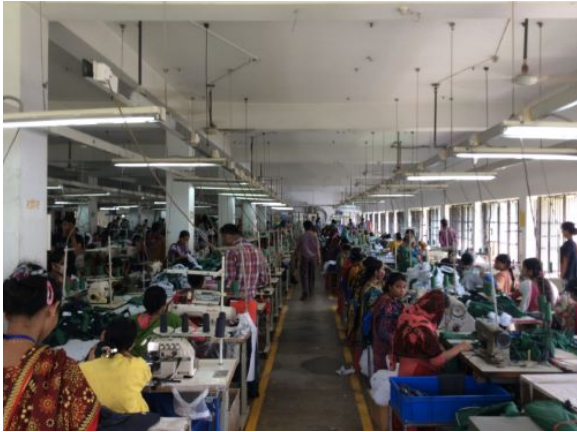
F-18	Egress Lighting	Inspection, testing, and maintenance for the emergency lighting system are not in accordance with The ACCORD Standard.	Inspect, test and maintain the emergency lighting system in accordance with The ACCORD standard. Keep written records on-site.	Within 3 months
F-19	Egress Lighting	Based on the number and location of emergency lights observed, adequate illumination levels are not anticipated along egress routes on the factory floor.	Test the emergency lighting system on each floor and provide additional emergency fixtures to provide adequate illumination along the means of egress. Provide a minimum illumination of 10 lux at the floor level within exit stairs and exit discharge paths and minimum 2.5 lux along exit access aisles.	Within 3 months
