Youngone (CEPZ) Limited (Extension 2)

Plot 03-06, 09-16, Sector # 2, Chattogram Export Processing Zone
(22.288646, 91.778393)

22 July 2025

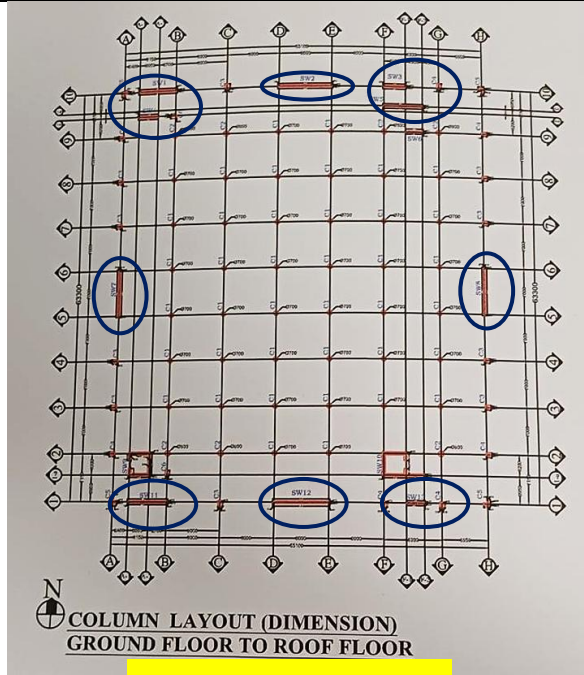
Construction drawing

Mismatch in the shear wall layout with the as-built condition

Description: During inspection, the shear wall shown in the construction drawing was missing in the as-built drawing. Additionally, the tie bar arrangement for the circular columns does not match the construction drawing, and the slab thickness also differs from the construction drawing. The building engineer is required to verify the as-built condition, including the pile foundation, through Non-Destructive Testing (NDT).

Building engineer is required to check the design philosophy of the building and confirm the seismic requirements of the building as per BNBC.

Item No	Observation	Action Plan	Timeline
1.	Inconsistency in design philosophy between the Construction Drawings and the As-Built Drawings. [Youngone (CEPZ) Ltd. (YCL-5)]	Building engineer is required to check the design philosophy of the building and confirm the seismic requirements of the building as per BNBC as part of the Engineering Assessment (EA)	within 6 weeks

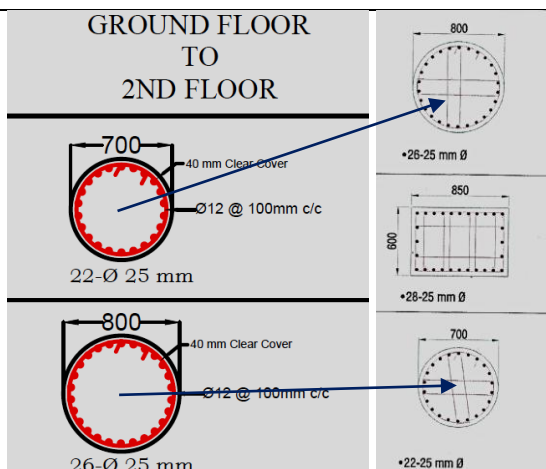
Tie bar missing in the construction drawing

2.		Building engineer is required to investigate the on-site condition by visual inspection and Non Destructive Testing (NDT) to confirm the accuracy of the as-built drawing.	within 6 weeks

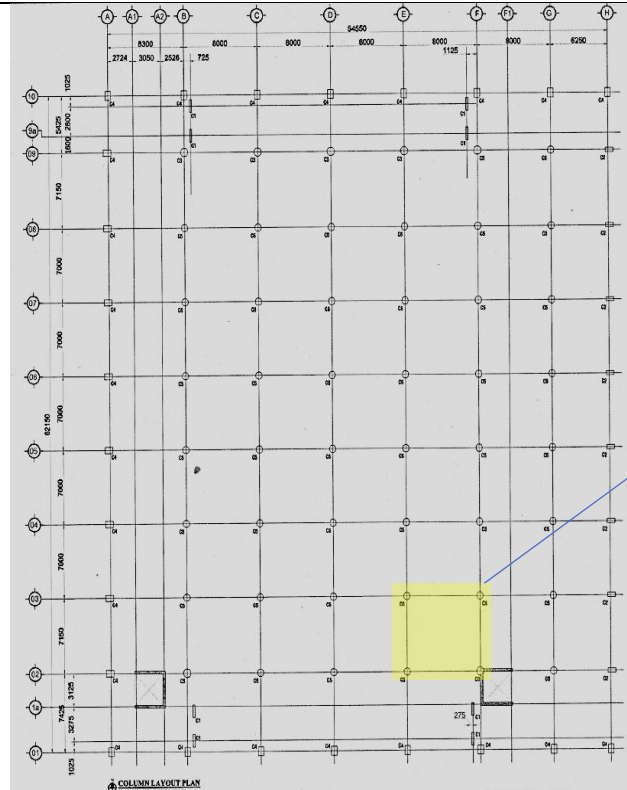
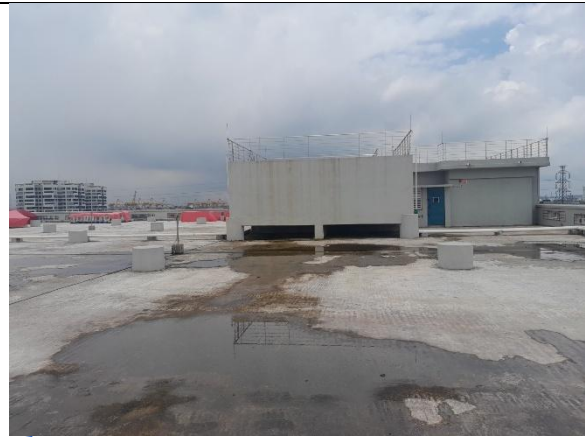
Observation-02: Columns to be marginally stressed above the normal design limit. [Youngone (CEPZ) Ltd. (YCL-5)]

Description: cursory calculation indicates that the columns under the OHWT marginally stressed above the normal design limit, considering the minimum concrete strength and prepared live load plan.

Building engineer is required to review the design load and column stress.

3.	Columns to be marginally stressed above the normal design limit. [Youngone (CEPZ) Ltd. (YCL-5)]	Building engineer is required to review design load and column stress.	within 6 weeks

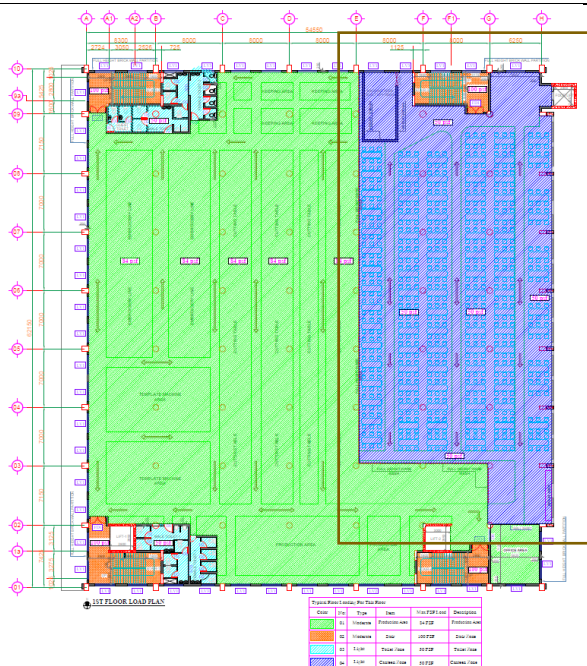
Observation-04: Prepared load plan doesn't comply with Table 6.2.3, BNBC 2020. [Youngone (CEPZ) Ltd. (YCL-5)]

Description: During inspection, the allowable load at the canteen area is considered 50 psf, which doesn't comply with Table 6.2.3, BNBC 2020. Building engineer is required to revise the floor live load plan as per BNBC 2020.

6.	Prepared load plan doesn't comply with Table 6.2.3, BNBC 2020. [Youngone (CEPZ) Ltd. (YCL-5)]	Building engineer is required to revise the floor live load plan as per BNBC 2020. Implement the floor load management plan.	within 6 weeks

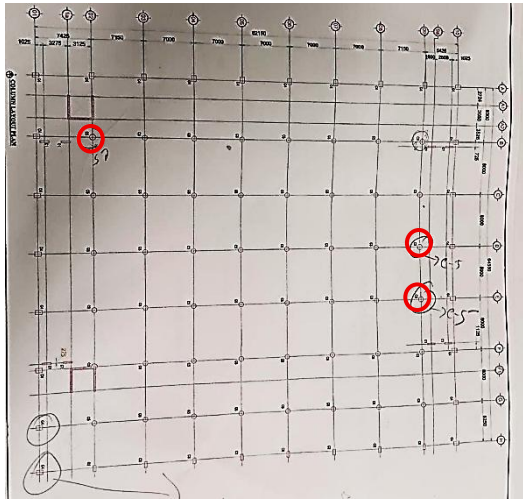
Column Dia. found 700mm instead of 800mm.

Description: Discrepancies observed in the as-built drawing. Building engineer is required to survey the structure and prepare accurate and detailed as-built drawings.

7.	Discrepancies in the As-Built Drawings. [Youngone (CEPZ) Ltd. (YCL-5)]	Building engineer is required to survey the structure and prepare accurate and detailed as-built drawings.	within 6 weeks

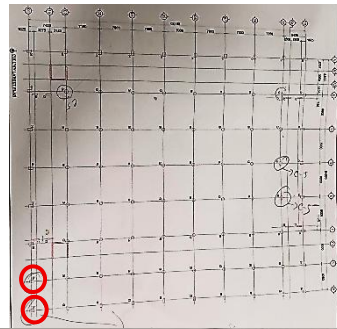
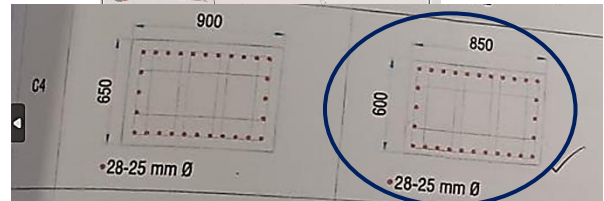
20 nos. rebar found instead of 28 nos. (C-4)

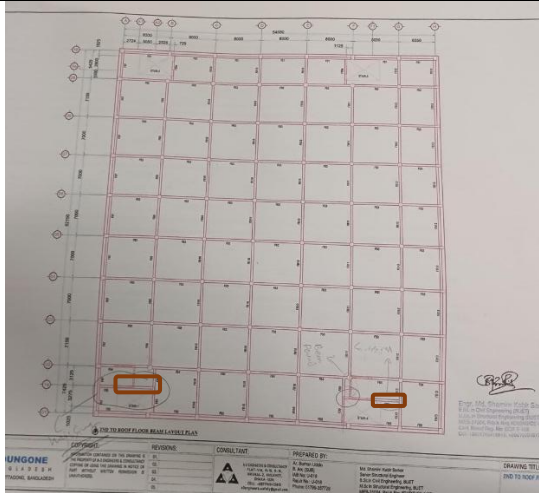
Beam missing.

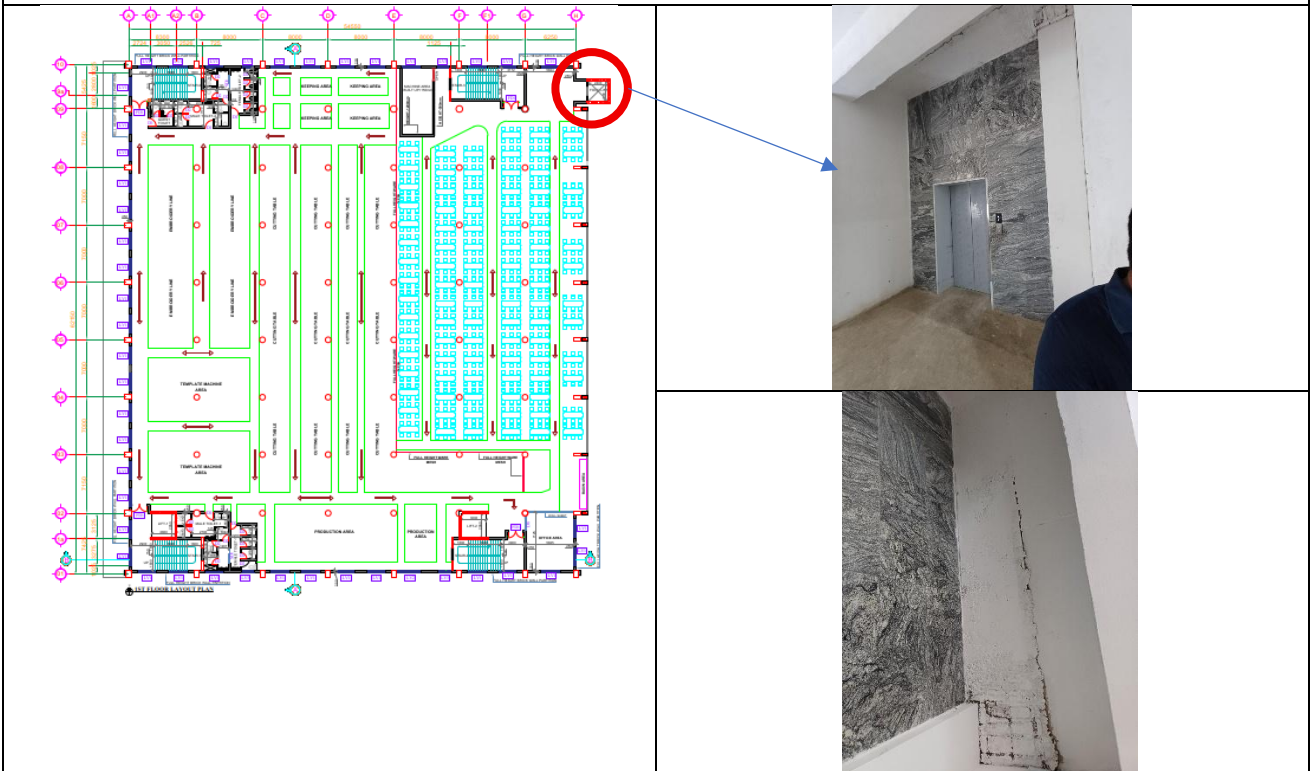
Observation-06: Verification required for the Structural connection and contribution to the lateral load-resisting system of the lift core. [Youngone (CEPZ) Ltd. (YCL-5)]

Description: An external lift core was constructed up to the 3rd floor of the building. The structural connection and contribution to the lateral load-resisting system of the lift core is required to be verified. If the building is separated from the building, the building engineer is required to check the lateral stability of the lift core.

8.	Verification required for the Structural connection and contribution to the lateral load-resisting system of the lift core. [Youngone (CEPZ) Ltd. (YCL-5)]	The structural connection and contribution to the lateral load-resisting system of the lift core is required to be verified. If the building is separated from the building, the building engineer is required to check the lateral stability of the lift core.	within 6 weeks

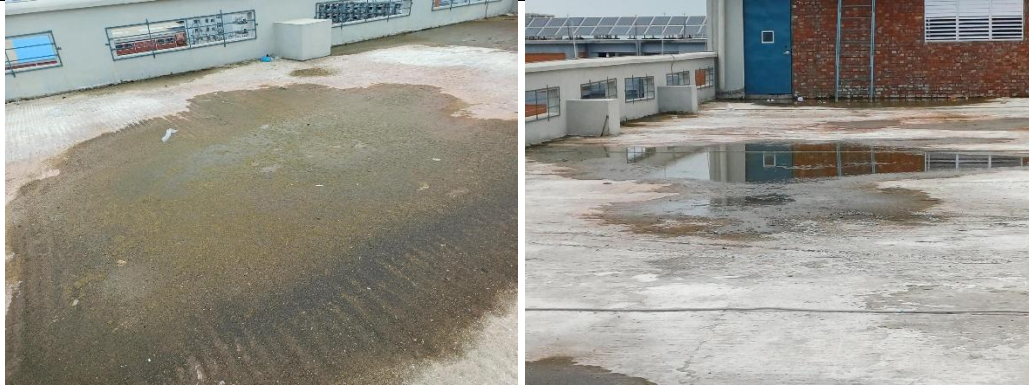
Observation-07: Water ponding on the roof. [Youngone (CEPZ) Ltd. (YCL-5)]

Description: During inspection, water ponding was found on the roof. Building engineer is required to improve the drainage system, maintaining adequate slope and drainage pipe.

9.	Water ponding on the roof. [Youngone (CEPZ) Ltd. (YCL-5)]	Building engineer is required to improve the drainage system, maintaining adequate slope and drainage pipe.	within 6 weeks

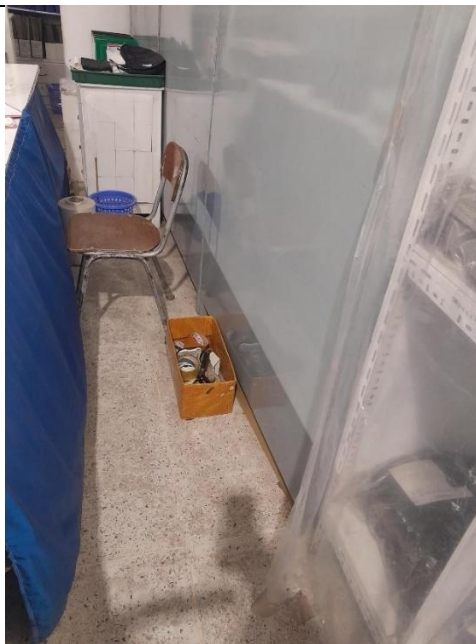
Observation-08: Non-structural elements found unbraced/not anchored. [Youngone (CEPZ) Ltd. (YCL-5)]

Description: During inspection, non-anchored racking system was found on-site. Building engineer is required to adequately brace or anchor all the non-structural elements.

10.	Non-structural elements found unbraced/not anchored. [Youngone (CEPZ) Ltd. (YCL-5)]	Building engineer is required to adequately brace or anchor all the non-structural elements.	within 6 weeks

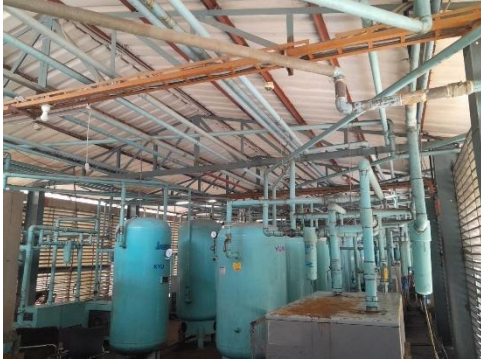
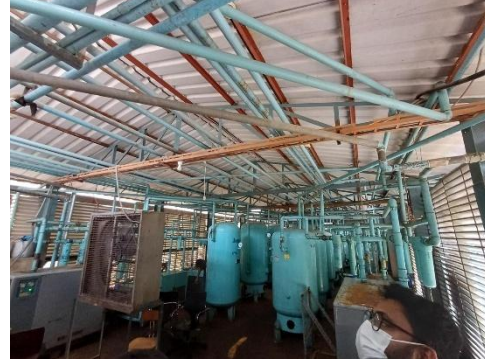
Observation-09: Lack of lateral load resisting system. (Compressor Shed)

Description: Lack of lateral load resisting system observed (No Bracing, Compression Strut, Flexible diaphragm system) in the Compressor Shed. Building engineer is required to check the lateral stability system as part of the Engineering Assessment (EA).

11.	Lack of lateral load resisting system. (Compressor Shed)	Building engineer is required to check the lateral stability system as part of the Engineering Assessment (EA).	within 6 weeks

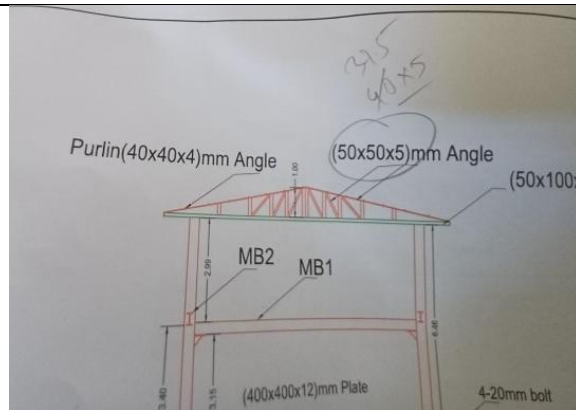
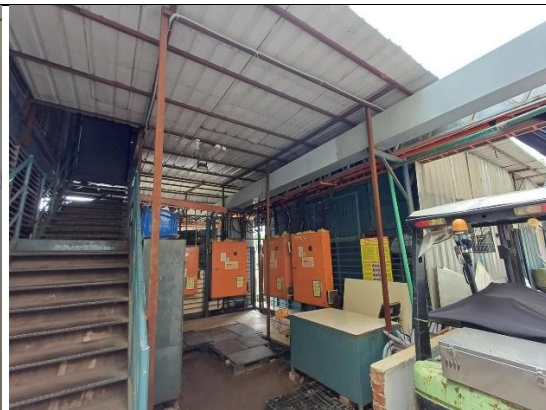
Observation-10: Discrepancies in the as-built drawing. (Compressor Shed)

Description: Mismatch found in the as-built drawing, angle size found 37.5mm X 37.5mm X 5mm instead of 50mm X 50mm X 5mm. Additionally, extended north portion was not incorporated in the as-built drawings. Building engineer is required to prepare a detailed and accurate as-built drawing.

12.		Carry out suggested remedial works where required.	within 6 months
13.	Discrepancies in the as-built drawing. (Compressor Shed)	Building engineer is required to survey the structure and prepare accurate and detailed as-built drawings.	within 6 weeks

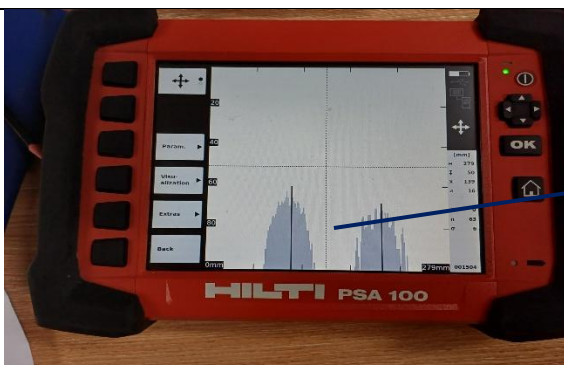
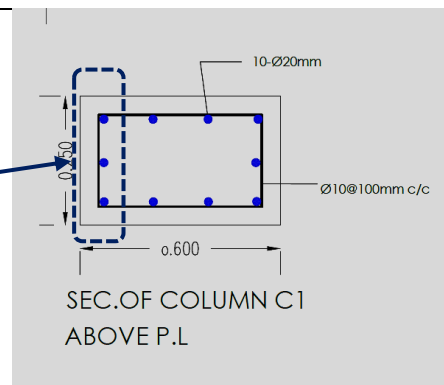
Observation-11: Discrepancies in the as-built drawing. (Security Office-01)

Description: Column rebar found 2 on one side by ferro scanning, whereas the drawing shows 3 rebar on that side. Building engineer is required to prepare a detailed and accurate as-built drawing and keep it on site.

14.	Discrepancies in the as-built drawing. (Security Office-01)	Building engineer is required to prepare a detailed and accurate as-built drawing and keep it on site.	within 6 weeks

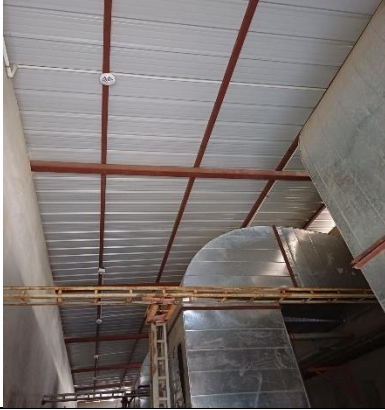
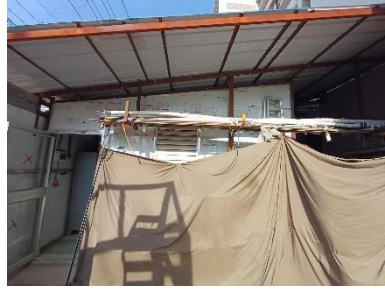
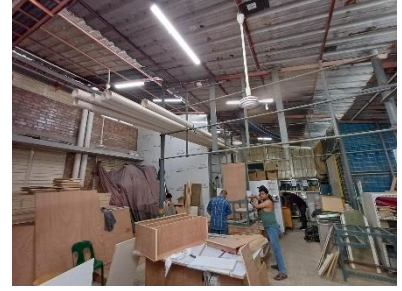
Observation-12: Lack of lateral stability and as-built drawing. (YCL-5 Compressor, AC Maintenance Room and Carpenter Shed)

Description: Inadequate member sizes, poor connection details were observed on the sheds. A safety check report according to the Accord Building Standard is required to be prepared to check the inadequacies.

15.	Lack of lateral stability and as-built drawing. (YCL-5 Compressor)	A safety check report according to the Accord Building Standard is required to be prepared to check the inadequacies.	within 6 weeks

18.	Lack of lateral stability and as-built drawing. (AC Maintenance Room)	A safety check report according to the Accord Building Standard is required to be prepared to check the inadequacies.	within 6 weeks

21.	Lack of lateral stability and as-built drawing. (Carpenter Shed)	A safety check report according to the Accord Building Standard is required to be prepared to check the inadequacies.	within 6 weeks
