# ZALO KNITTING LIMITED

Tea Garden Road, Mouchak, Kaliakoir, Gazipur.1751, Bangladesh.

29 July 2025

## 2. Observation

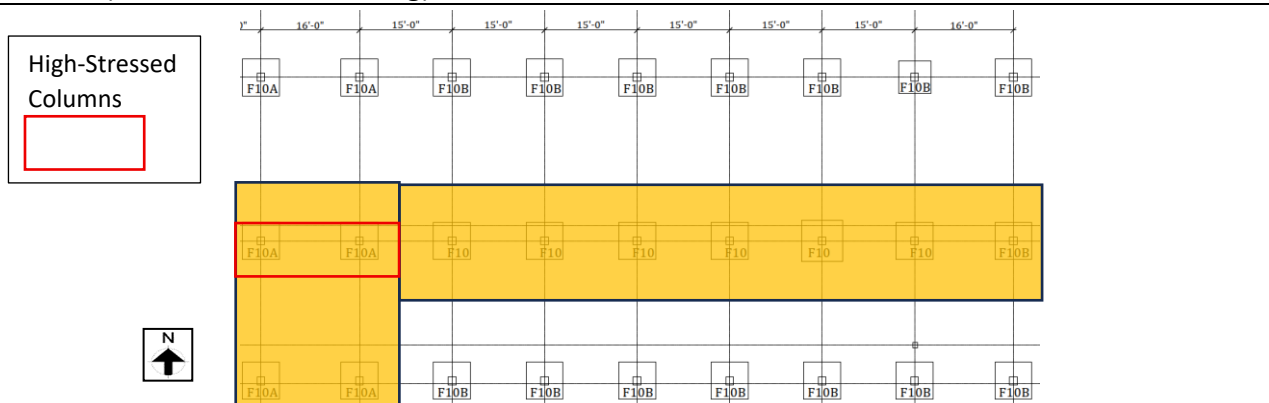
**Observation-01:** High stress in the column and foundation, which requires immediate design review (Old Production Building).

**Description:** Cursory calculation indicates high stress in the column, and punching shear of the foundation exceeds the normal design limit at the marked locations, considering the live load of 3 kPa, concrete strength 15.5 MPa (Column), 11 MPa (Footing) from the available core test report of the column and foundation, and minimum rebar strength 248 MPa.

Also, the calculation indicates that the bearing stress in the marked footing exceeds the normal design limit, considering the allowable soil bearing capacity of the adjacent “New Production building” (1 tsf, FoS:3).

1. The two PVC water tanks on the roof and the stair roof at the 4-storied extension parts must be removed/relocated with immediate effect.
2. The roof (Open to Sky) should remain 0.5 kPa live load, and the live load of the 1st floor, 2nd floor, and 3rd floor must not exceed 1.0 kPa; the live load in the stairs must not exceed 4 kPa.
3. An interim live load plan must be prepared by the consultant and used by the factory with immediate effect.
4. A Detailed Engineering Assessment (DEA) must be commenced immediately.
5. Review design, load column, and foundation stress.
6. Produce and actively manage a loading plan according to the floor capacity.

| Item No | Observation | Action Plan | Timeline |
|---|---|---|---|
| 1. | High stress in the column and foundation, which requires immediate design review (Old Production Building). | The two PVC water tanks on the roof and the stair roof at the 4-storied extension parts must be removed/relocated with immediate effect. | Immediate |
| 2. | | The roof (Open to Sky) should remain 0.5 kPa live load, and the live load of the 1st floor, 2nd floor, and 3rd floor must not exceed 1.0 kPa; the live load in the stairs must not exceed 4 kPa. | Immediate |
| 3. | | An interim live load plan must be prepared by the consultant and used by the factory with immediate effect. | Immediate |
| 4. | | Detailed Engineering Assessment (DEA) should be commenced. | Immediate |
| 5. | | The building engineer is required to review the design, load, and stress. | within 6 weeks |
| 6. | | Verify the steel grade by testing. | within 6 weeks |
| 7. | | Produce and actively manage the loading plan according to the floor capacity. | within 6 weeks |
| 8. | | Implement remediation work after acceptance from RSC. | within 6 months |
| 9. | | Implement floor load plan. | within 6 months |

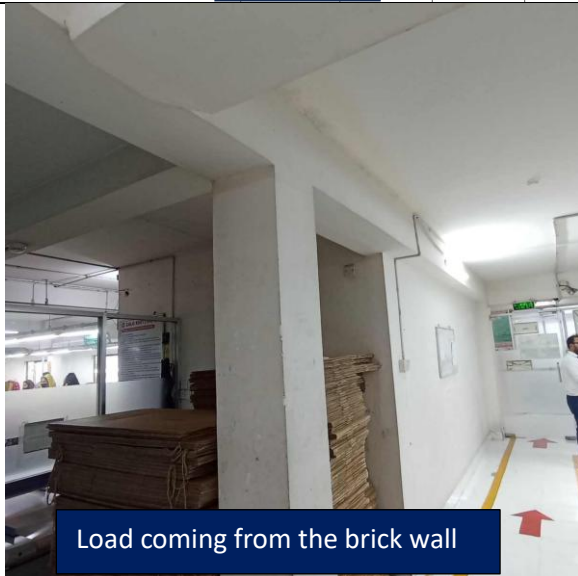
Load coming from the brick wall

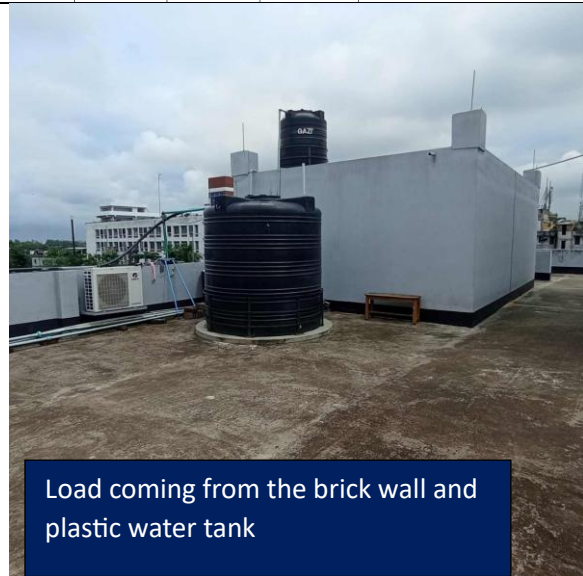
Load coming from the brick wall and plastic water tank

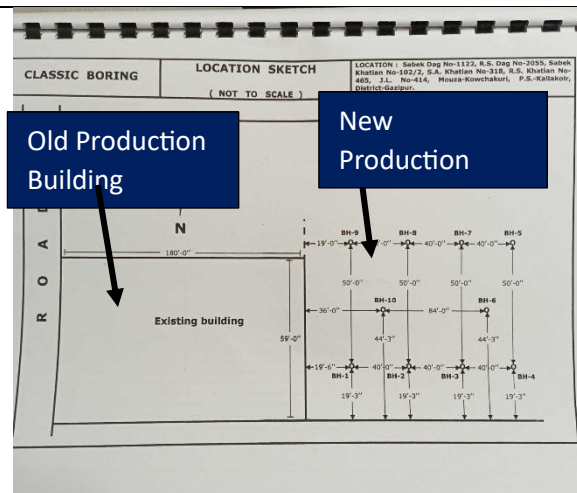
**Observation-02:** Lack of geotechnical investigation report (Old Production Building).

**Description:** A geotechnical investigation report was available on site, and the borehole layout shows that it covers only the area of the New Production Building. A geotechnical engineer must be engaged to prepare a new geotechnical investigation report to determine the actual soil bearing capacity of the Old Production Building.

| Item No | Observation | Action Plan | Timeline |
|---|---|---|---|
| 10. | Lack of geotechnical investigation report (Old Production Building). | A geotechnical engineer must be engaged to prepare a new geotechnical investigation report to determine the actual soil bearing capacity of the Old Production Building. | within 6 weeks |

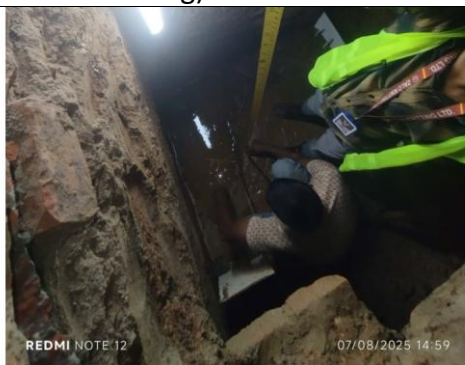
Figure 12: Footing top is 70 inches from PL at the edge.

So, the footing thickness difference is 5 inches between center and edge due to slope as top surface.

**Description:** In the provided as-built drawing, the thickness of footing F10 was shown as 300 mm, but after earth excavation, the footing thickness was found to be 300 mm~425 mm (with a slope), 300 mm~375 mm (with a slope), 300 mm~400 mm (with a slope). The building engineer is required to survey the whole structure and produce an accurate as-built drawing.

| Item No | Observation | Action Plan | Timeline |
|---|---|---|---|
| 11. | Discrepancy between the as-built drawing and the onsite condition (Old Production Building). | The building engineer is required to survey the whole structure and produce an accurate & detailed as-built drawing. | within 6 weeks |

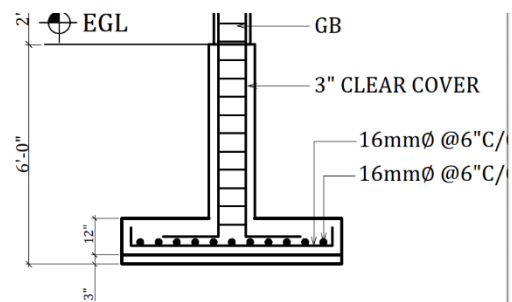
**SECTION X9-X9**

Provided drawing during inspection

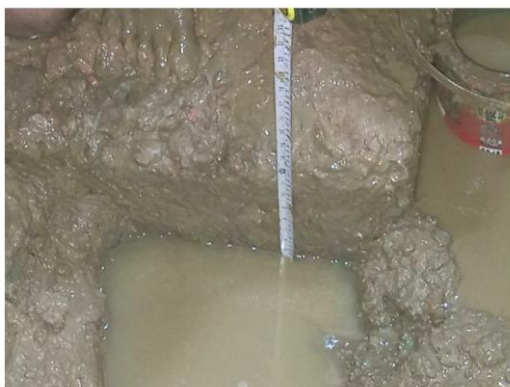
Figure 6: Footing thickness is 12 inches at edge. And at least 4 inches more at column end.

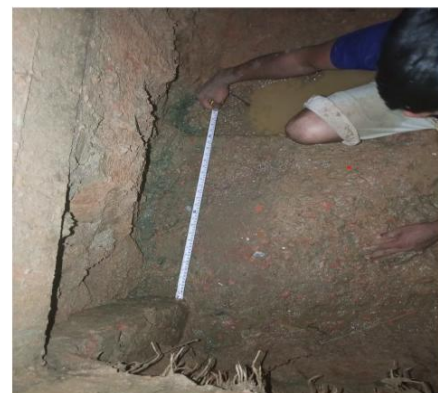
Figure 5: Footing edge is 2ft from column face. And footing top is sloped.

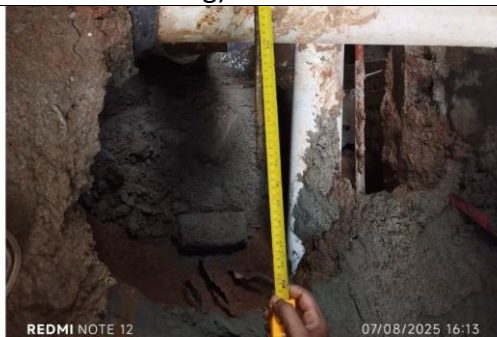
Figure 29: Footing thickness is 18 inches at edge.

**Description:** In the provided as-built drawing, the thickness of footing F-2 was shown as 300 mm, but after earth excavation, the footing thickness was found as 450 mm. The building engineer is required to survey the whole structure and produce an accurate as-built drawing.

| 14. | Discrepancy between the as-built drawing and the on-site condition (New Production Building). | The building engineer is required to survey the whole structure and produce an accurate & detailed as-built drawing. | within 6 weeks |

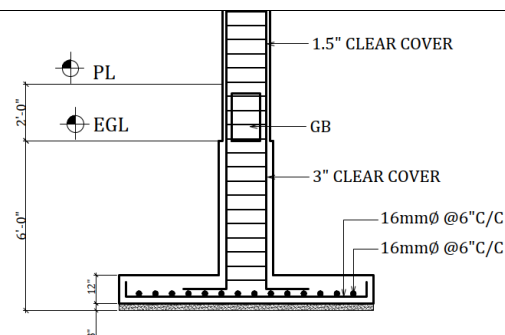
SECTION X1-X1

Provided drawing during inspection

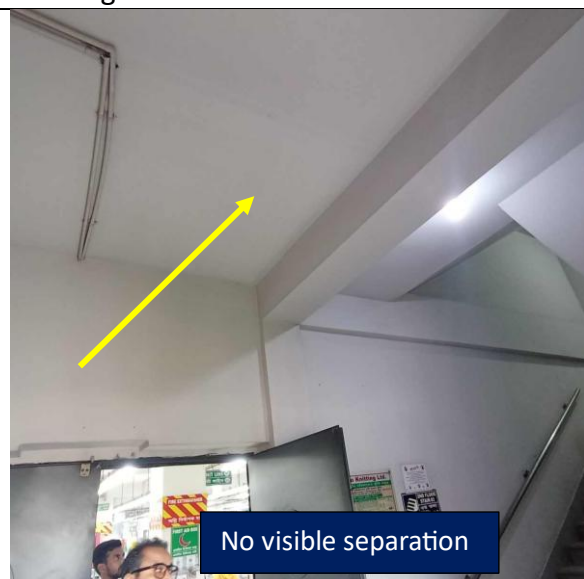
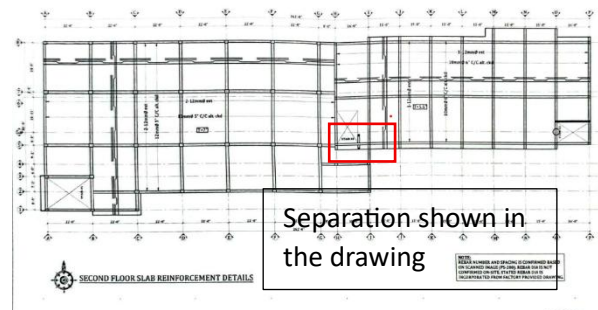
**Observation-06:** Unclear separation between Old Production Building and New Production Building on several floors.

**Description:** As per the provided drawing Old Production Building and New Production Building are separated along the marked line, but the separation was not visible on several floors. The building engineer is required to verify the separation between two buildings.

| 15. | Unclear separation between Old Production Building and New Production Building on several floors. | The building engineer is required to verify the separation between two buildings and the requirements of the expansion joint. | within 6 weeks |

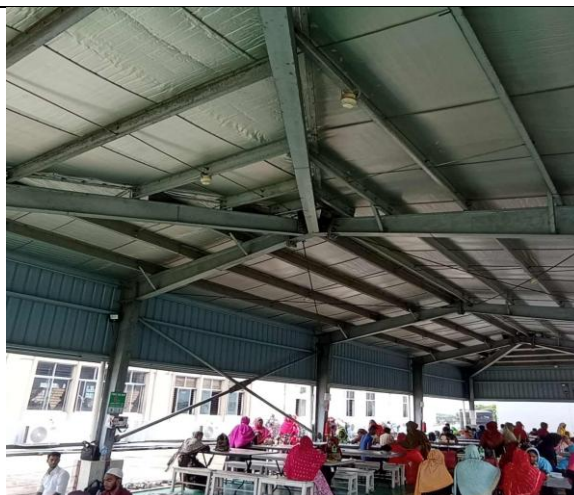
**Observation-07:** Lack of lateral stability of roof shed (New Production Building).

**Description:** Load transfer media is not provided to transmit the lateral load. The building engineer is required to check the lateral stability of the shed and propose a remediation plan.

| 16. | Lack of lateral stability of roof shed (New Production Building). | The building engineer is required to check the lateral stability of the shed and propose a remediation plan. | within 6 weeks |
| 17. | | Implement remediation work after acceptance from RSC. | within 6 months |

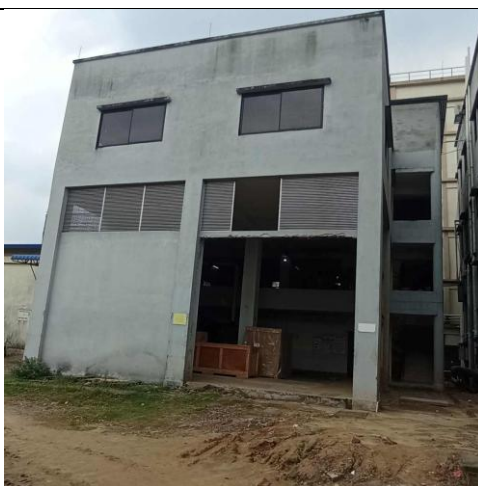
**Observation-8:** Lack of design documents and test reports (Utility Building).

**Description:** As per BNBC, every building or structure designed shall have its design documents prepared in accordance with the provisions of Section 1.9.1. The design document shall include a design report and a set of structural drawings, which shall be prepared in compliance with section 1.9.1.1 and section 1.9.1.2 as per BNBC. At the time of inspection, the design report, concrete cylinder test report, and geotechnical investigation report were not available. The building engineer is required to prepare the design report based on in situ concrete strength in compliance with section 1.9.1 (part 6, BNBC). Also, prepare a geotechnical investigation report.

| 18. | Lack of design documents and test reports (Utility Building). | The building engineer is required to verify in-situ material strength by taking a minimum of 4 concrete cores from the existing building column & floor (beam/slab) each. Also, provide a rebar test report to confirm the rebar strength. | within 6 weeks |
| 19. | | The building engineer is required to prepare the design report based on in situ concrete strength in compliance with section 1.9.1 (part 6, BNBC). | within 6 weeks |
| 20. | | Also, prepare a geotechnical investigation report. | within 6 weeks |
| 21. | | Implement remediation work after acceptance from RSC. | within 6 months |

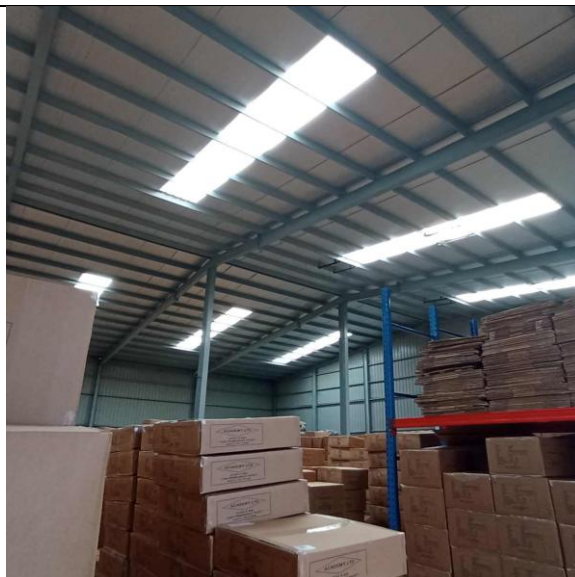
**Observation-9:** Lack of lateral stability (Bonded Warehouse Shed).

**Description:** No bracing system (strut, horizontal/vertical bracing) is provided for the shed to transmit and resist the lateral load. The building engineer is required to check the lateral stability of the shed and propose a remediation plan.

| 22. | Lack of lateral stability (Bonded Warehouse Shed). | The building engineer is required to check the lateral stability of the shed and propose a remediation plan. | within 6 weeks |
| 23. | | Implement remediation work after acceptance from RSC. | within 6 months |

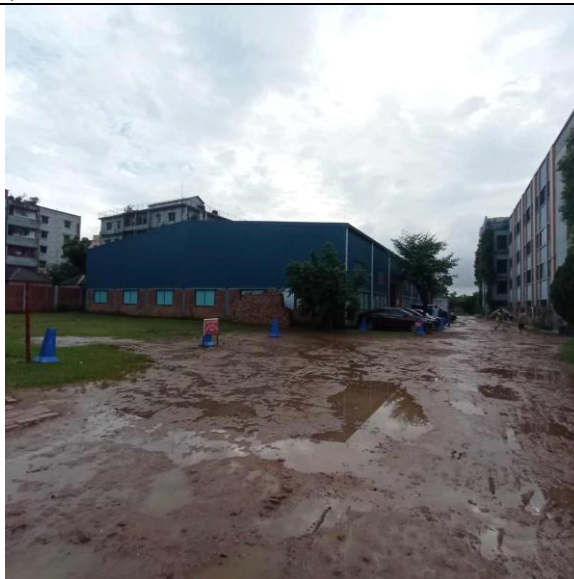
**Observation-10:** Lack of a geotechnical investigation report and incomplete as-built drawing (Bonded Warehouse Shed).

**Description:** No geotechnical investigation report was available for the structure. Also, the as-built drawing for the superstructure was not available. A geotechnical engineer must be engaged to prepare a geotechnical investigation report to determine the soil bearing capacity. Based on geotechnical data, check the foundation adequacy. Also, a building engineer produces a full set of as-built drawings.

| 24. | Lack of a geotechnical investigation report (Bonded Warehouse Shed). | A geotechnical engineer must be engaged to prepare a geotechnical investigation report to determine the soil bearing capacity. | within 6 weeks |

| 25. | Incomplete as-built drawing (Bonded Warehouse Shed). | The building engineer produces a full set of as-built drawings. | within 6 weeks |

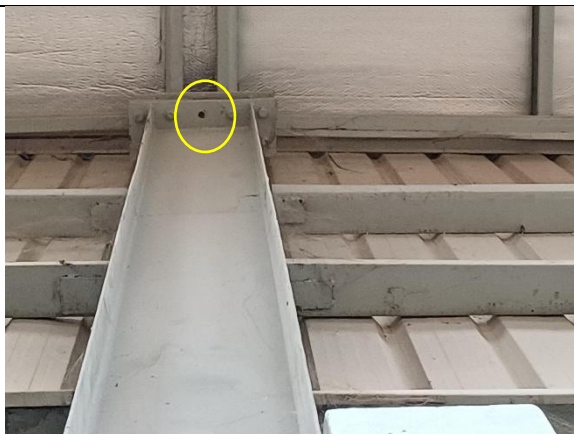
**Observation-11:** Missing bolts at steel connections (Bonded Warehouse Shed).

**Description:** Bolts were missing from steel connections at several locations. Identify all locations and install all missing bolts.

| 26. | Missing bolts at steel connections (Bonded Warehouse Shed). | Install all missing bolts. | within 6 weeks |

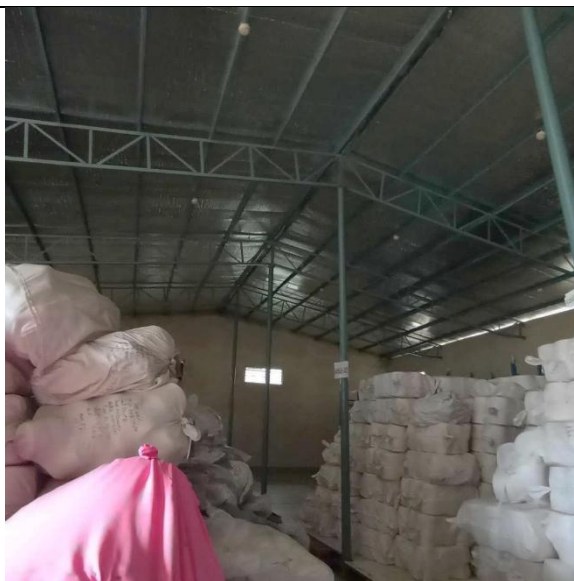
**Observation-12:** Lack of lateral stability (Yarn Store Shed).

**Description:** No bracing system (strut, horizontal/vertical bracing) is provided for the shed to transmit and resist the lateral load. The building engineer is required to check the lateral stability of the shed and propose a remediation plan.

| 27. | Lack of lateral stability (Yarn Store Shed). | The building engineer is required to check the lateral stability of the shed and propose a remediation plan. | within 6 weeks |
| 28. | | Implement remediation work after acceptance from RSC. | within 6 months |

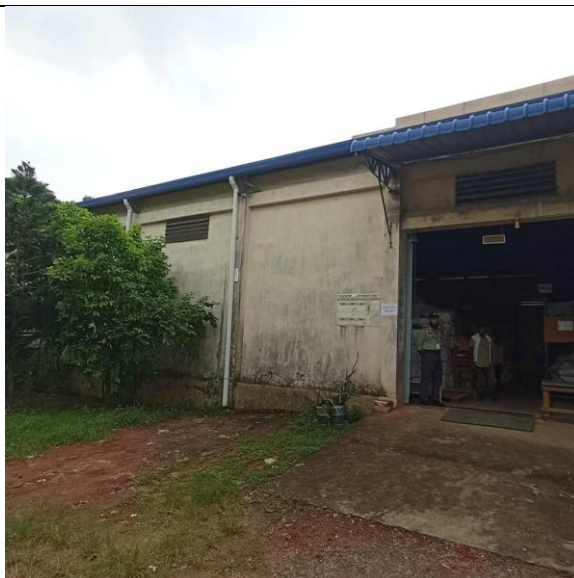
**Observation-13:** Lack of a geotechnical investigation report (Yarn Store Shed).

**Description:** No geotechnical investigation report was available for the structure. A geotechnical engineer must be engaged to prepare a geotechnical investigation report to determine the soil bearing capacity.

| 29. | Lack of a geotechnical investigation report (Yarn Store Shed). | A geotechnical engineer must be engaged to prepare a geotechnical investigation report to determine the soil bearing capacity. | within 6 weeks |

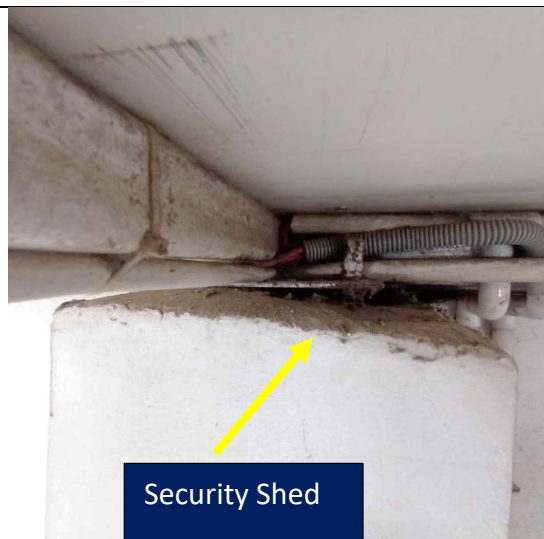
**Observation-14:** Poor connection of steel members (Security Shed, Fire Pump Shed).

**Description:** Poor connection was found in the steel members at Security Shed and the Fire Pump Shed. The building engineer is required to prepare a connection adequacy check with a remediation plan and submit to RSC for review.

| 30. | Poor connection of steel members (Security Shed, Fire Pump Shed). | The building engineer is required to prepare a connection adequacy check with a remediation plan and submit to RSC for review. | within 6 weeks |
| 31. | | Implement remediation work after acceptance from RSC. | within 6 months |

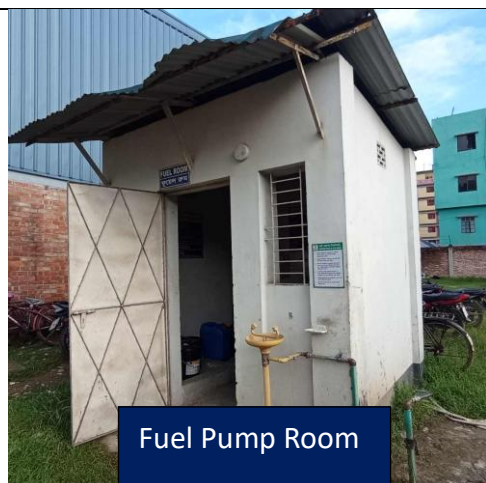
Fuel Pump Room

**Observation-15:** Incomplete as-built drawing (RMS Room, Fuel Room, Fire Pump Shed).

**Description:** A Full set of as-built drawings was not available for any of these structures. The building engineer produces a full set of as-built drawings.

| 32. | Incomplete as-built drawing (RMS Room, Fuel Room, Fire Pump Shed). | The building engineer produces a full set of as-built drawings. | within 6 weeks |

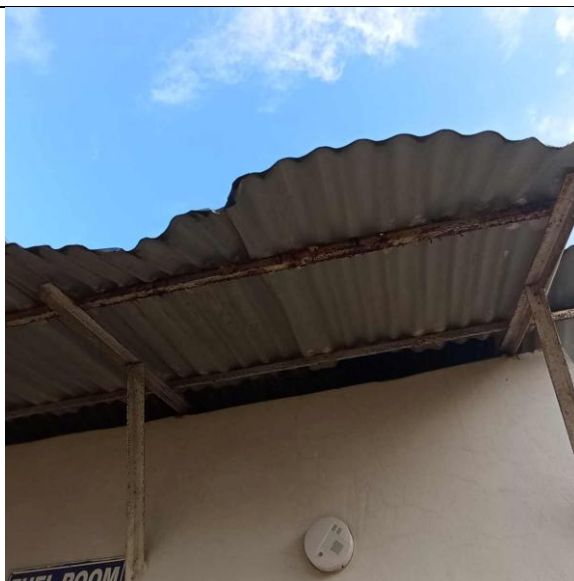
**Observation-16:** Corroded steel members and deflected roof sheet (Fuel Room).

**Description:** Corroded steel members and deflected roof sheets were found in the Fuel Room. Provide rust-proof coating on steel members and repair/replace the deflected roof sheet.

| 33. | Corroded steel members and deflected roof sheet (Fuel Room). | Provide rust-proof coating on steel members and repair/replace the deflected roof sheet. | within 6 weeks |

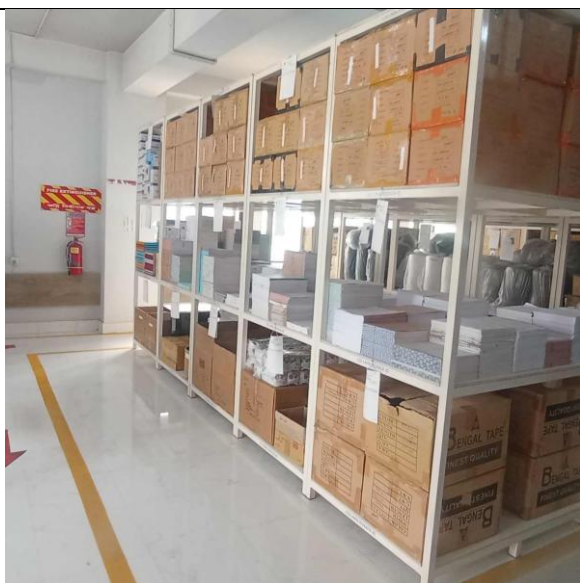
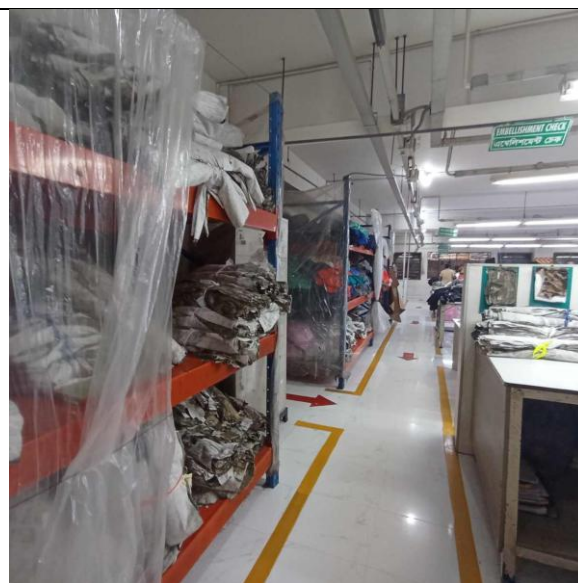
**Observation-17:** Non-structural elements found unbraced/unanchored (Old Production Building, New Production Building, Bonded Warehouse Shed).

**Description:** Non-structural elements were found unbraced/unanchored at Old Production Building, New Production Building, and Utility Building. The building engineer is required to brace/anchor all non-structural elements.

| 34. | Non-structural elements found unbraced/unanchored (Old Production Building, New Production Building, Bonded Warehouse Shed). | The building engineer is required to brace/anchor all non-structural elements. | within 6 weeks |

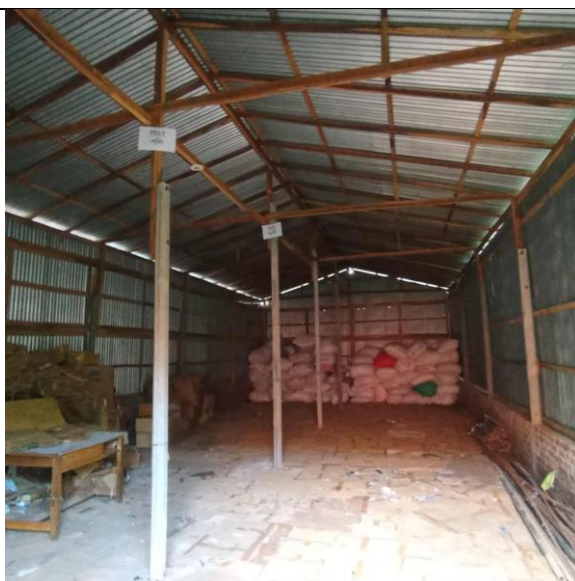
**Observation-18:** Flimsy wooden structure (Jhute Store Shed).

**Description:** A wooden shed was found in factory premises, which appeared to be flimsy against lateral loading. The factory is required to demolish the shed or replace the shed with a well-designed structure.

| 35. | Flimsy wooden structure (Jhute Store Shed). | The factory is required to replace the shed with a well-designed structure. | within 6 months |
