# Ahsan Composite Ltd. (Extension 2)

Ward No-08, Holding No99/D, Chandra Pollibidyut Road, Kalikoir, Gazipur.

7 August 2025

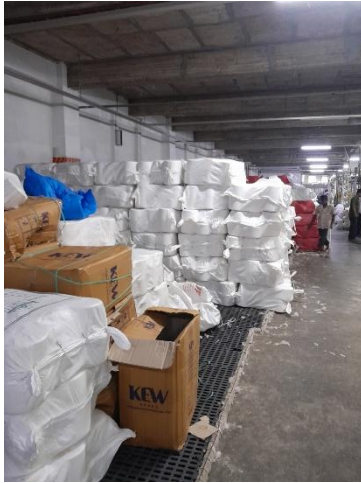
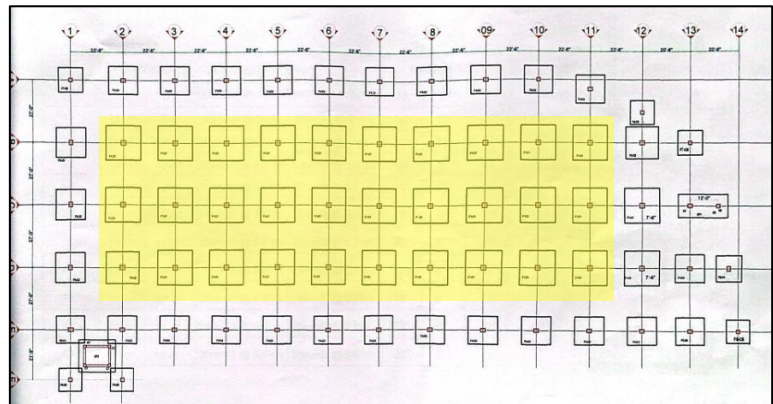
**Observation 01:** Punching Stress in the foundation exceeds the normal design limit. (Building-15)

**Description:** The cursory calculation indicates that punching shear of the typical foundation exceeds the normal design limit, considering the observed live load of 3 kPa for the typical production area & 6 kPa for the store area, minimum concrete strength of concrete & rebar, and minimum soil bearing capacity. The building engineer is required to review the design load and punching stress of the foundation.

| Item No. | Observation | Action Plan | Timeline |
|---|---|---|---|
| 1. | Punching Stress in the foundation exceeds the normal design limit. (Building-15) | Verify in-situ concrete material strength by taking concrete cores (minimum 100 mm diameter) from lower-tier columns and beam-slabs of different floors. | within 6 weeks |
| 2. | | The building engineer is required to conduct a Detail Engineering Assessment (DEA) and review the design, loads, and column stresses in the area identified above. | within 6 weeks |
| 3. | | Produce and actively manage a loading plan for all floor plates within the factory, considering floor capacity and foundation capacity. | within 6 weeks |
| 4. | | Carry out remedial work if required. | within 6 months |

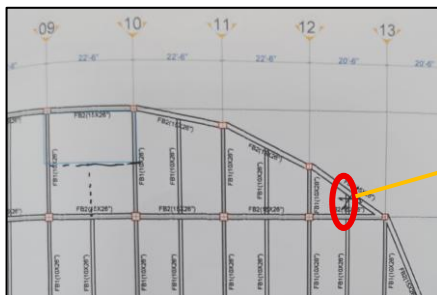
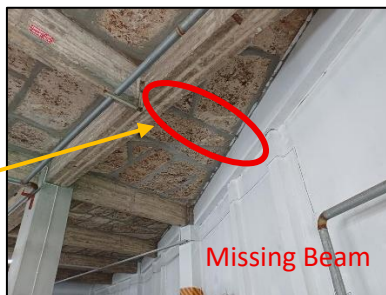
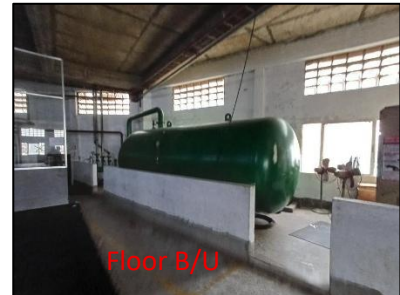
**Observation 02:** Discrepancy in the as-built drawings. (Building-15)

**Description:** During inspection, mismatch was found on the beam layout between grid 12B & 13B. Also, build-up area was found in the compressor room & toilet area, which was not mentioned in the as-built drawing. The building engineer is required to update the as-built drawing as per the actual site condition.

| Item No. | Observation | Action Plan | Timeline |
|---|---|---|---|
| 5. | Discrepancy in the as-built drawings. (Building-15) | The building engineer is required to update the as-built drawing as per the actual site condition. | within 6 weeks |

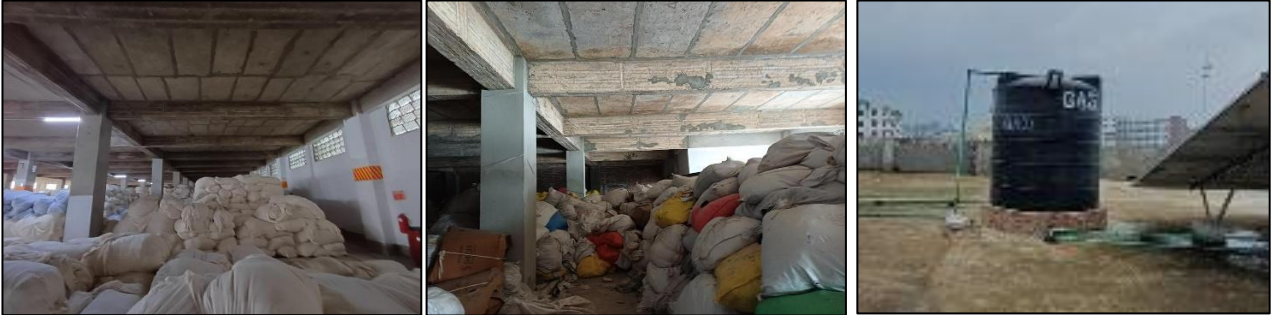
**Observation 03:** Uncontrolled loading on all floors. (Building-15)

**Description:** During inspection, dedicated storage was found on several floors, and a heavy loading (5,000-litre water tank) was found on the roof. But, no load plan, no load height Marking & no load management program were found for Building-15. The building engineer is required to post the load plan, load height marking, and maintain the loading accordingly.

| Item No. | Observation | Action Plan | Timeline |
|---|---|---|---|
| 6. | Uncontrolled loading on all floors. (Building-15) | Continue implementing the load management plan (allowable load plan posting, storage area and marking, load maintaining). | within 6 weeks |

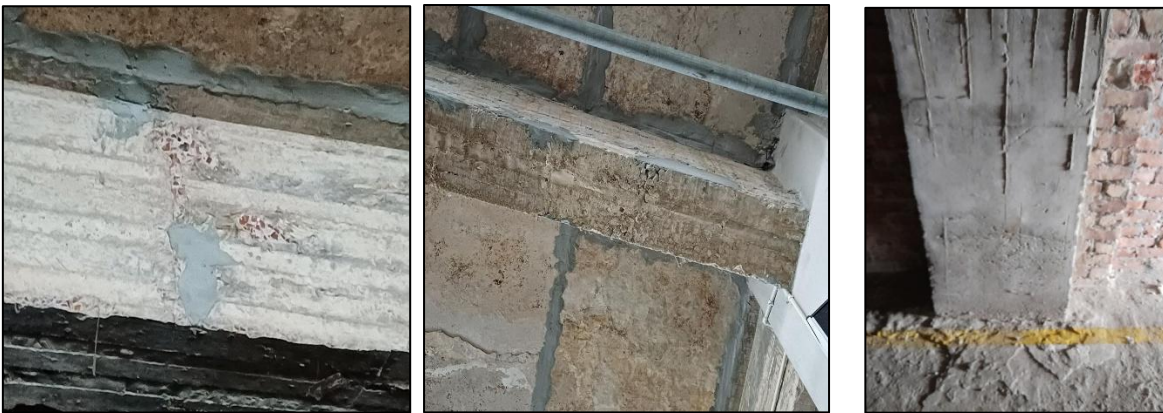
**Observation 04:** Poor construction quality. (Building-15)

**Description:** During inspection, segregation, honeycomb, popout & bug holes of concrete were found in several locations. The building engineer is required to identify the locations and carry out NDT and/or DT tests to check the quality of the concrete.

| Item No. | Observation | Action Plan | Timeline |
|---|---|---|---|
| 7. | Poor construction quality. (Building-15) | The building engineer is required to carry out NDT/DT tests to check the quality of the concrete and produce a report with pictorial evidence & with remedial measures. | within 6 weeks |
| 8. | | Carry out remedial work if required. | within 6 months |

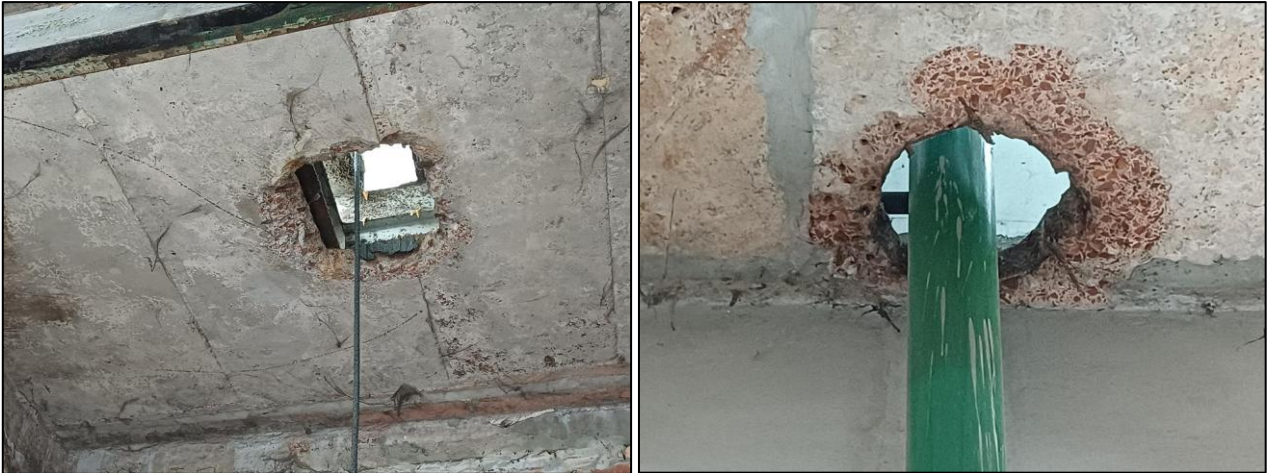
**Observation 05:** Perforation through the slab. (Building-15)

**Description:** During inspection, perforation was found through the slab in several locations. The building engineer is required to identify the locations and check the adequacy & rebar requirements of the perforated slab and repair accordingly.

| Item No. | Observation | Action Plan | Timeline |
|---|---|---|---|
| 9. | Perforation through the slab. (Building-15) | The building engineer is required to identify the locations and check the adequacy & rebar requirements of the perforated slab and repair accordingly. | within 6 weeks |

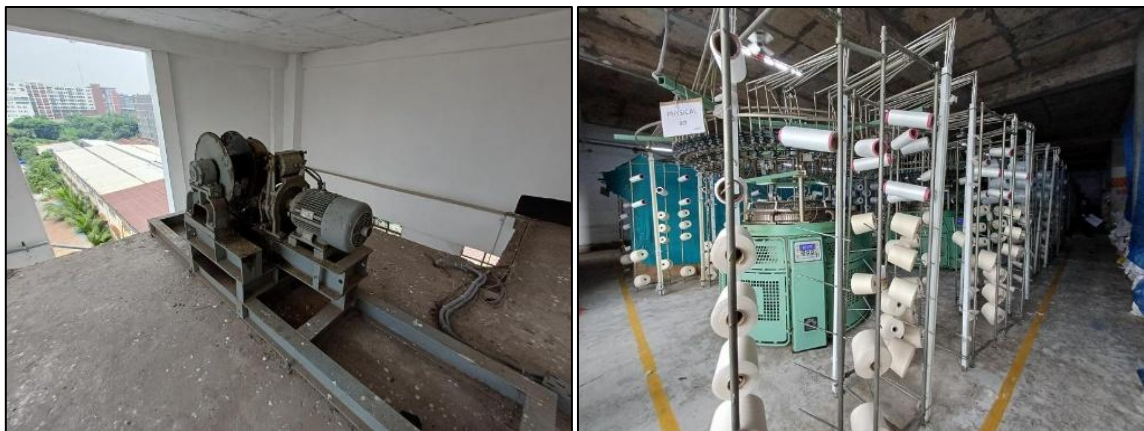
**Observation 06:** Vibration observed on the floors. (Building-15)

**Description:** During inspection, vibration was observed on several floors. The building engineer is required to install adequate anti-vibration rubber pads to reduce the vibrations.

| Item No. | Observation | Action Plan | Timeline |
|---|---|---|---|
| 10. | Vibration observed on the floors. (Building-15) | The building engineer is required to install adequate anti-vibration rubber pads to reduce the vibrations. | within 6 weeks |

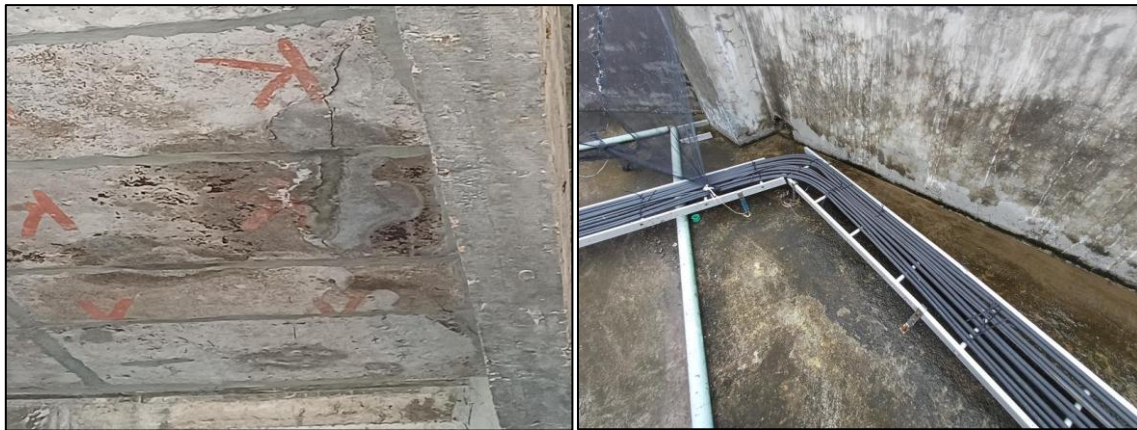
**Observation 07:** Water leakage on the ceiling of the 4<sup>th</sup> floor and water ponding on the roof.  
(Building-15)

**Description:** During inspection, water leakage was found on the 4<sup>th</sup> floor ceiling, and water ponding was found on the roof. The building engineer is required to apply a waterproofing membrane on the roof for the MCAC concrete with an adequate slope.

| Item No. | Observation | Action Plan | Timeline |
|---|---|---|---|
| 11. | Water leakage on the ceiling of the 4 <sup>th</sup> floor and water ponding on the roof. (Building-15) | The building engineer is required to apply a waterproofing membrane on the MCAC roof with an adequate slope and provide an adequate number of water outlets. | within 6 weeks |

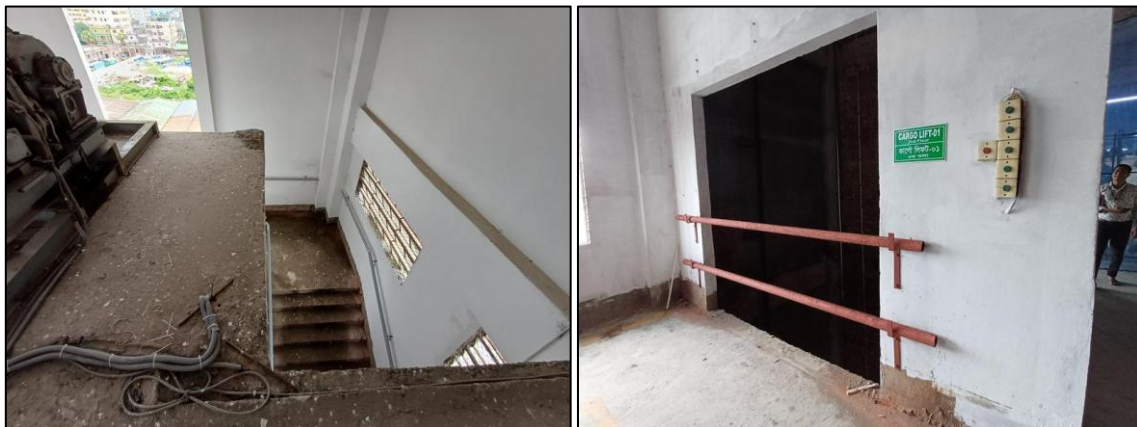
**Observation 08:** Falling hazard on the roof. (Building-15)

**Description:** During inspection, falling hazard was found on the roof & around the lift cores. The building engineer is required to provide an adequate barrier to avoid the falling hazard.

| <b>12.</b> | Falling hazard on the roof & lift cores. (Building-15) | The building engineer is required to provide an adequate (height & spacing) barrier to avoid the falling hazard. | Immediate |

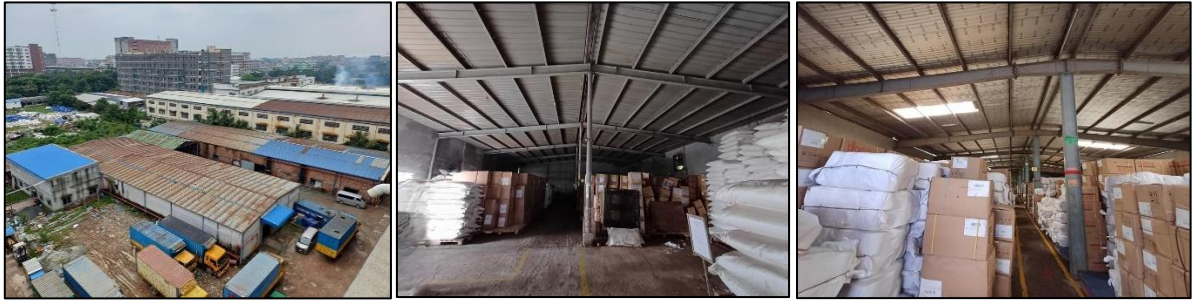
**Observation 09:** Lack of lateral stability. (Shed-16 and Shed-17)

**Description:** During inspection, no lateral load transfer media were found on Shed-16 and Shed-17 to resist the lateral load. The building engineer is required to check the lateral stability of the Sheds and prepare an Engineering Assessment (EA) as per BNBC (sec 1.9.1).

| <b>13.</b> | Lack of lateral stability. (Shed-16 ) | The building engineer is required to check the lateral stability of the Shed-16 and prepare a Detail Engineering Assessment (DEA) as per BNBC (sec 1.9.1). | within 6 weeks |
| <b>14.</b> | | Carry out remedial work if required. | within 6 months |
| <b>17.</b> | Lack of lateral stability. (Shed-17) | The building engineer is required to check the lateral stability of the Shed-17 and prepare a Detail Engineering Assessment (DEA) as per BNBC (sec 1.9.1). | within 6 weeks |
| <b>18.</b> | | Carry out remedial work if required. | within 6 months |

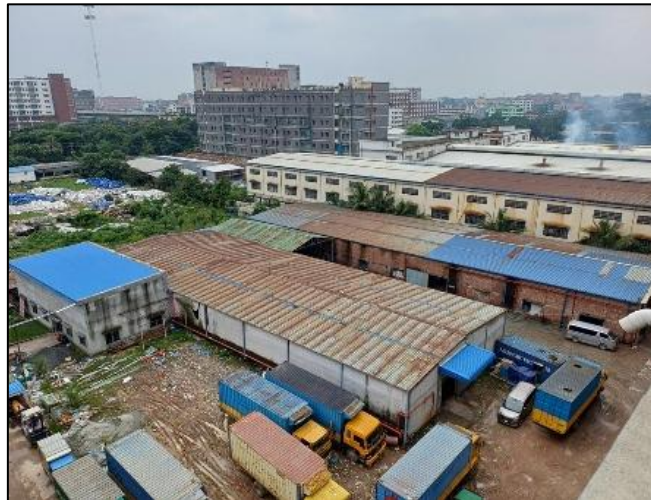
**Observation 10:** Lack of as-built drawing. (Shed-16, Shed-17, Wastage shed, and Turning shed)

**Description:** During inspection, no as-built drawing was found for all sheds. The building engineer is required to prepare an as-built drawing with foundation and connection details as per the actual site condition.

| <b>15.</b> | Lack of as-built drawing. (Shed-16 ) | The building engineer is required to prepare an as-built drawing with foundation & connection details as per the actual site condition. | within 6 weeks |
| <b>19.</b> | Lack of as-built drawing. (Shed-17) | The building engineer is required to prepare an as-built drawing with foundation & connection details as per the actual site condition. | within 6 weeks |
| <b>21.</b> | Lack of as-built drawing. (Wastage shed) | The building engineer is required to prepare an as-built drawing with foundation & connection details as per the actual site condition. | within 6 weeks |
| <b>25.</b> | Lack of as-built drawing. (Turning shed) | The building engineer is required to prepare an as-built drawing with foundation & connection details as per the actual site condition. | within 6 weeks |

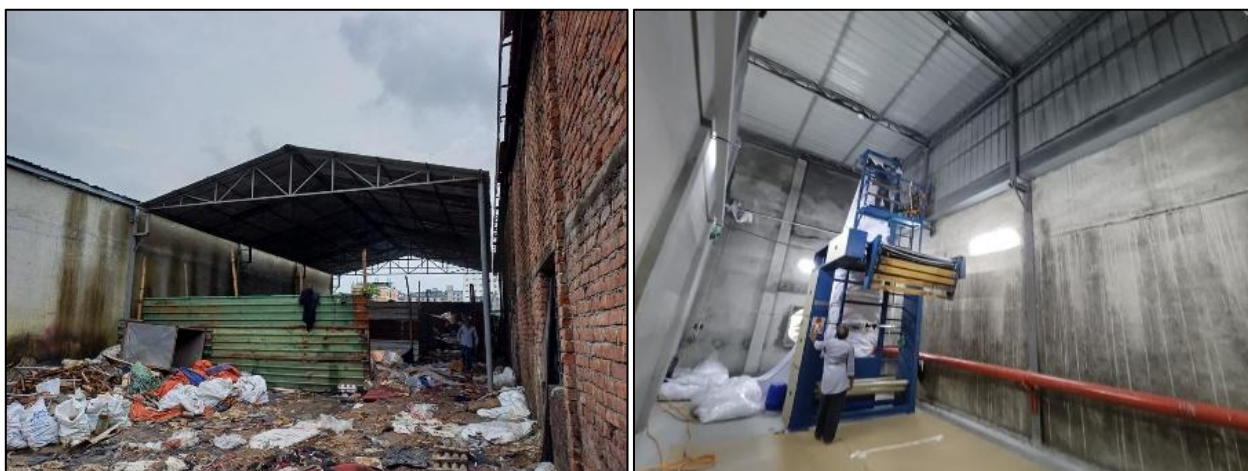
**Observation 11:** Lack of lateral stability and inadequate member size. (Wastage shed and Turning shed)

**Description:** During inspection, no lateral load transfer media were found on Wastage shed and Turning shed to resist the lateral load. Also, member sizes and their connections were found to be inadequate. The building engineer is required to prepare a safety check report along with connection and member adequacy and propose remediation where required.

| <b>22.</b> | Lack of lateral stability and inadequate member size. (Wastage shed) | The building engineer is required to prepare a safety check report for the Wastage shed, along with connection and member adequacy and propose remediation if required. | within 6 weeks |
| <b>23.</b> | | Carry out remedial work if required. | within 6 months |

| <b>26.</b> | Lack of lateral stability and inadequate member size. (Turning shed) | The building engineer is required to prepare a safety check report for the Turning shed, along with connection and member adequacy and propose remediation if required. | within 6 weeks |
| <b>27.</b> | | Carry out remedial work if required. | within 6 months |

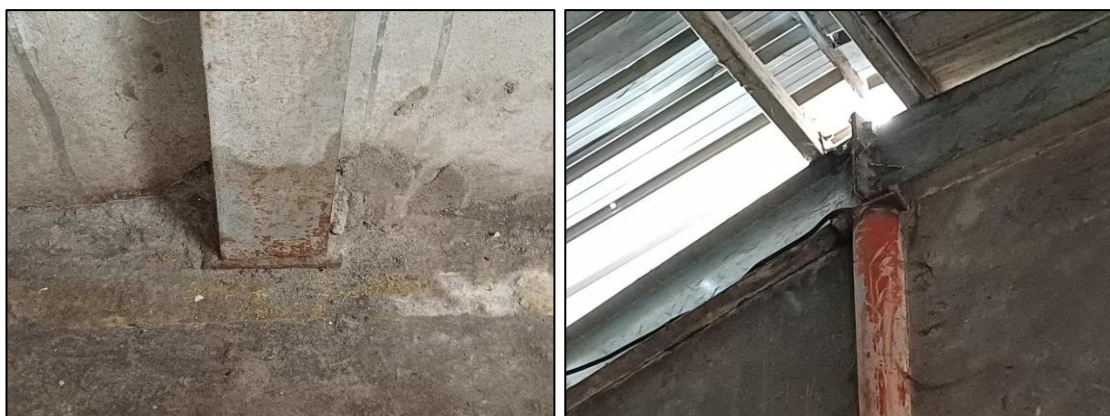
**Observation 12:** Corrosion on the steel member. (Shed-16, Shed-17, Wastage shed, and Turning shed)

**Description:** During inspection, corrosion was found on steel member of all sheds. The building engineer is required to remove corrosion and provide anti-corrosive coating.

| <b>16.</b> | Corrosion on the steel member. (Shed-16) | The building engineer is required to remove corrosion and provide anti-corrosive coating. | within 6 weeks |
| <b>20.</b> | Corrosion on the steel member. (Shed-17) | The building engineer is required to remove corrosion and provide anti-corrosive coating. | within 6 weeks |
| <b>24.</b> | Corrosion on the steel member. (Wastage Shed) | The building engineer is required to remove corrosion and provide anti-corrosive coating. | within 6 weeks |

| <b>28.</b> | Corrosion on the steel member. (Turning shed) | The building engineer is required to remove corrosion and provide anti-corrosive coating. | within 6 weeks |
