MASHIYAT APPAREL LTD

Holding no: 33/1, Durgapur, Mondolpara, Zirabo, Ashulia, Dhaka-1341, Bangladesh
(23.903359, 90.302952)

12 August 2025

1. Building Information

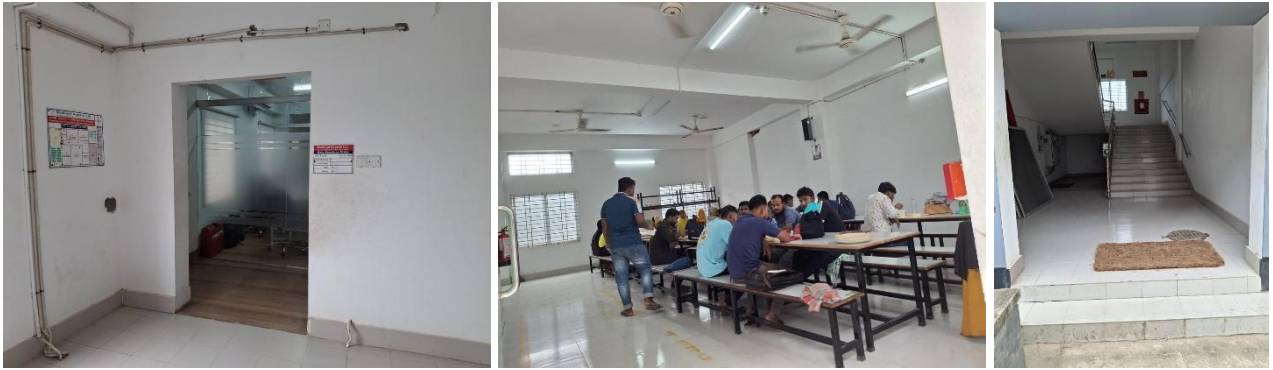
Observation 01: Lack of load plan & management system - Admin Building

Description: Floor load plan not found posted on suspended floors. Prepare and post the floor load plan on each suspended floor and maintain accordingly.

Item No	Observation	Action Plan	Timeline
1.	Lack of load plan & management system – Admin Building	Prepare load plan along with design report & submit it to RSC. Post floor load plan on each floor, mark storage area & height (if any) & maintain floor loading accordingly.	within 6 weeks

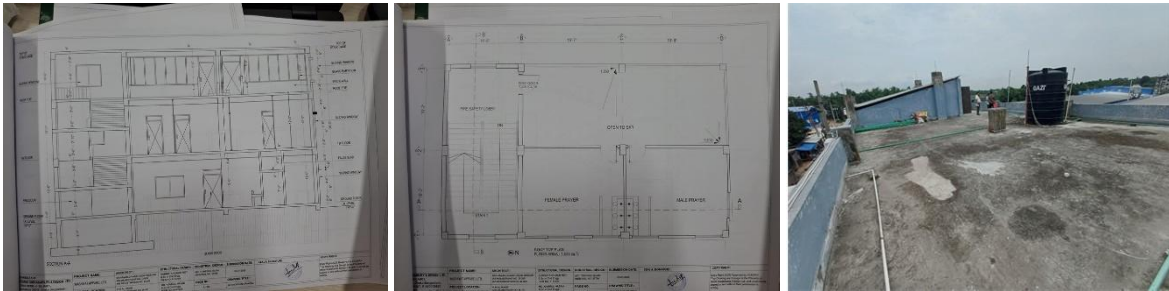
Observation 02: Mismatch in as-built drawing- Admin Building

Description: The building is two storied where drawing shown partially 3 storied. Also, the plastic water tank and stair roofing detail were not shown in the drawing. Update as-built drawing.

2.	Mismatch in as-built drawing – Admin Building	Building engineer is required to survey the structure and prepare accurate as-built drawings.	within 6 weeks

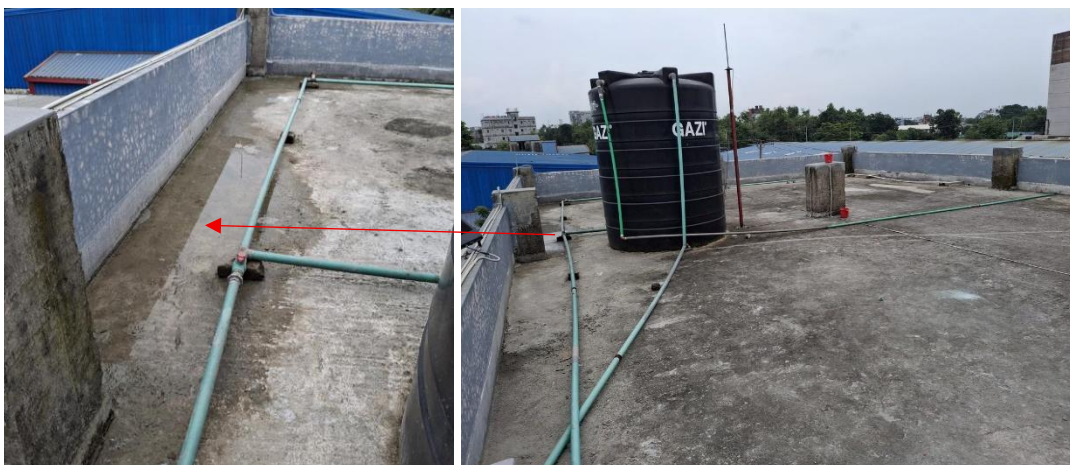
Observation 03: Water ponding on roof - Admin Building

Description: During inspection, minor water ponding observed on the roof due to improper slope and inadequate number of water outlets. Improve the roof drainage system.

3.	Water ponding on roof - Admin Building	Improve roof drainage system (water proofing layer with proper slope, and adequate water outlets).	within 6 months

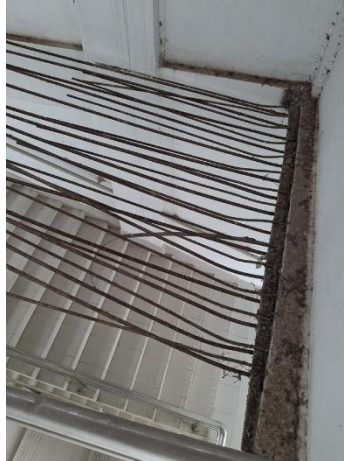
Observation 04: Exposed rebar in stair landing – Admin Building

Description: During inspection, exposed rebar observed on stair landing. Provide coating on exposed rebar.

4.	Exposed rebar in stair landing – Admin Building	Provide anti-rusting coating on exposed rebar.	within 6 weeks
5.	Potential falling hazard due to low height parapet - Admin Building	Increase the roof parapet wall height as per BNBC-2020 requirements.	within 6 weeks

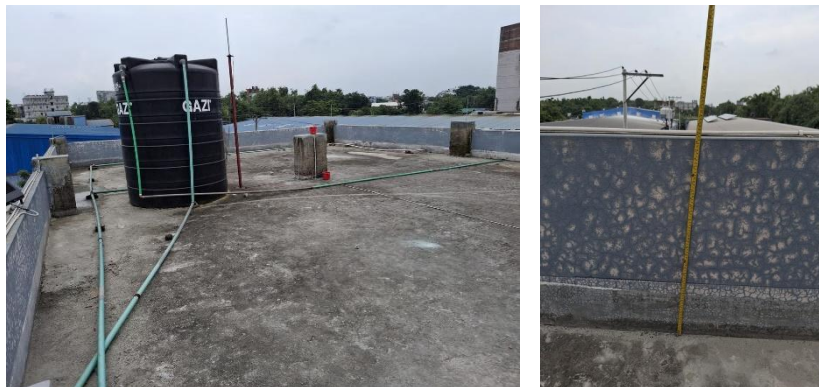
Observation 05: Potential falling hazard due to low height parapet - Admin Building

Description: Parapet wall height was found less than 750mm (30 inches) on the roof. Increase the parapet wall height.

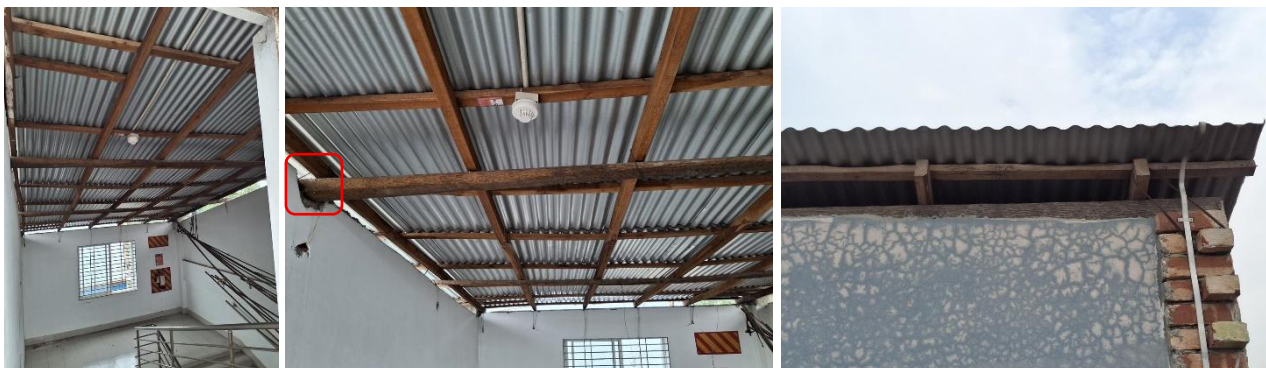
Observation 06: Improper anchorage for lightweight stair roof – Admin Building

Description: Light weight roof was braced with some wires which seemed to be improper. Provide necessary anchorage following engineer’s suggestion.

6.	Improper anchorage for lightweight stair roof – Admin Building	Provide necessary anchorage following engineer’s suggestion.	within 6 weeks
7.	Minor damage on cornice slab due to vehicle impact – Admin Building	Repair the damage area and install a proper mechanism to avoid further impact.	within 6 weeks

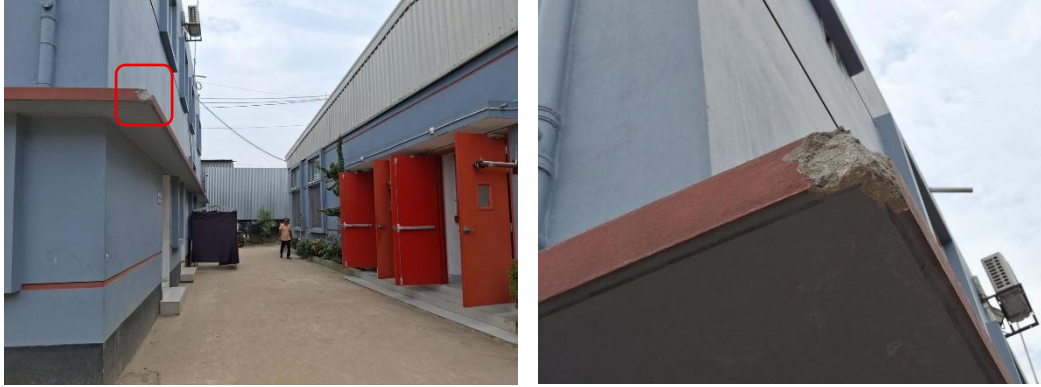
Observation 07: Minor damage on cornice slab due to vehicle impact – Admin Building

Description: Minor damage was observed to the cornice due to vehicle impact on it. Repair the damage area and install a proper mechanism to avoid further impact.

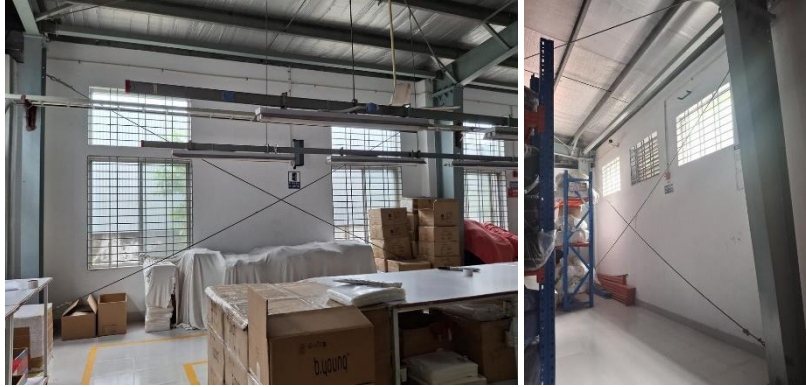
Observation 9: Loose cable bracing- Production Shed

Description: Loose cable bracing observed in different locations. Factory should tighten those braces.

10.		Carry out suggested remedial works if required.	within 6 months
11.	Loose cable bracing – Production Shed	Identify the locations & tighten the loose braces.	within 6 weeks

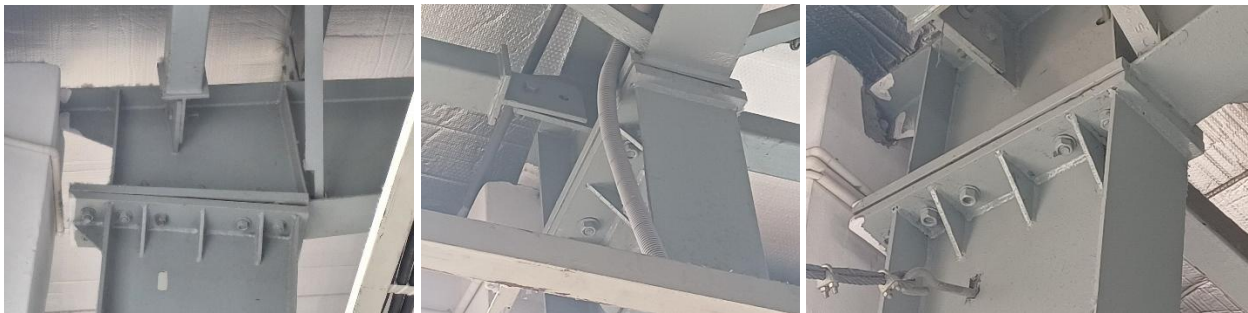
Observation 10: Connection Gap, bolt missing, inadequate bolt length- Production Shed

Connection Gap

Bolt Missing

Inadequate Bolt Length

Description: Connection Gap between two plates observed. Bolt missing found in compression strut to column joint and inadequate bolt length observed in several locations. Building engineer is required to identify the locations and re-install/repair with suitable method.

12.	Connection Gap, bolt missing, inadequate bolt length- Production Shed	Building engineer is required to identify the locations, re-install missing bolts, repair connection gaps with suitable method and replace inadequate length bolt where required.	within 6 weeks

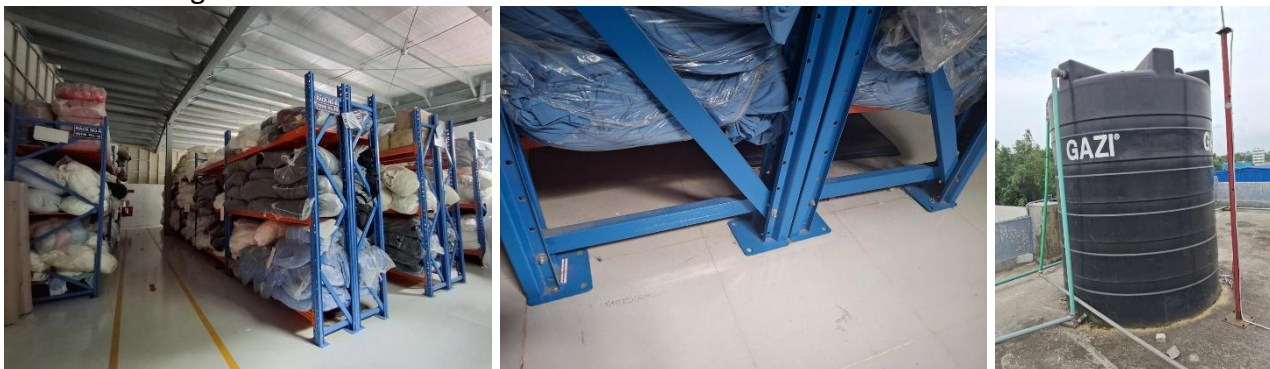
Observation 11: Lack of anchorage /bracing for non-structural elements (storage racks, water tanks) – Admin Building & Production Shed

Description: Storage rack and PVC water tank were found without anchorage to the ground or braces internally.

8.	Lack of anchorage /bracing for non-structural elements (water tank) – Admin Building	Provide anchorage/braces to the non-structural plastic water tank.	within 6 weeks

13.	Lack of anchorage /bracing for non-structural elements (storage rack) – Production Shed	Provide anchorage/braces to the non-structural storage racks.	within 6 weeks
