# Alpha Clothing (New) (Extension)

Tenguri, BKSP, Ashulia, Savar

13 August 2025

## Structural Inspection Report

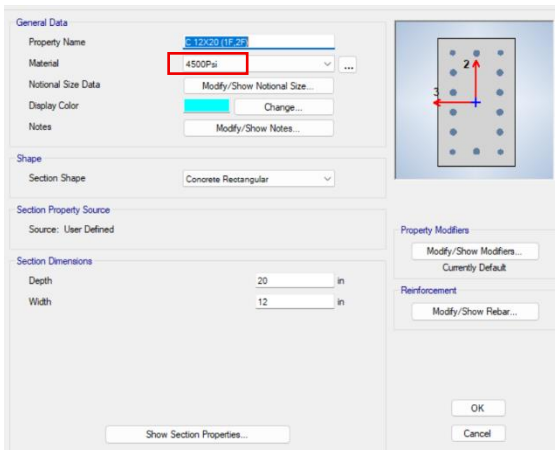
Fig:  $f'_c$  consider in FEA model

- The Response Modification Coefficient ( $R = 5$ ) has been considered in the design which indicates the IMRF framing system, but the required detailing and serviceability checks were not provided in the report.
- Six sets of cylinder test reports (column=2 set, Beam & Slab = 1 set, Foundation=3 set) were available which does not comply with the testing-frequency requirements of BNBC 5.12.1. In the design report,  $f'_c$  was considered 27.58 MPa for the column & foundation and 24.14 MPa for the beam & slab. The FEA model, however,  $f'_c$  was considered 31 MPa.
- In the design report, the average allowable bearing capacity of the foundation at the 8 ft level from EGL (F.S.= 2.5) is considered 4.69 ksf. but the required calculations were not provided in the report, also the lateral load was not considered in the foundation adequacy check.

The building engineer is required to verify the in-situ concrete strength by extracting 100mm diameter cores from four columns (preferably from the lower tier of the building), as well as from the beam and slab, or by referring to existing cylinder test reports from the specific concrete mix ratio and address all the inconsistencies in the revised EA report and submit the revised EA to RSC.

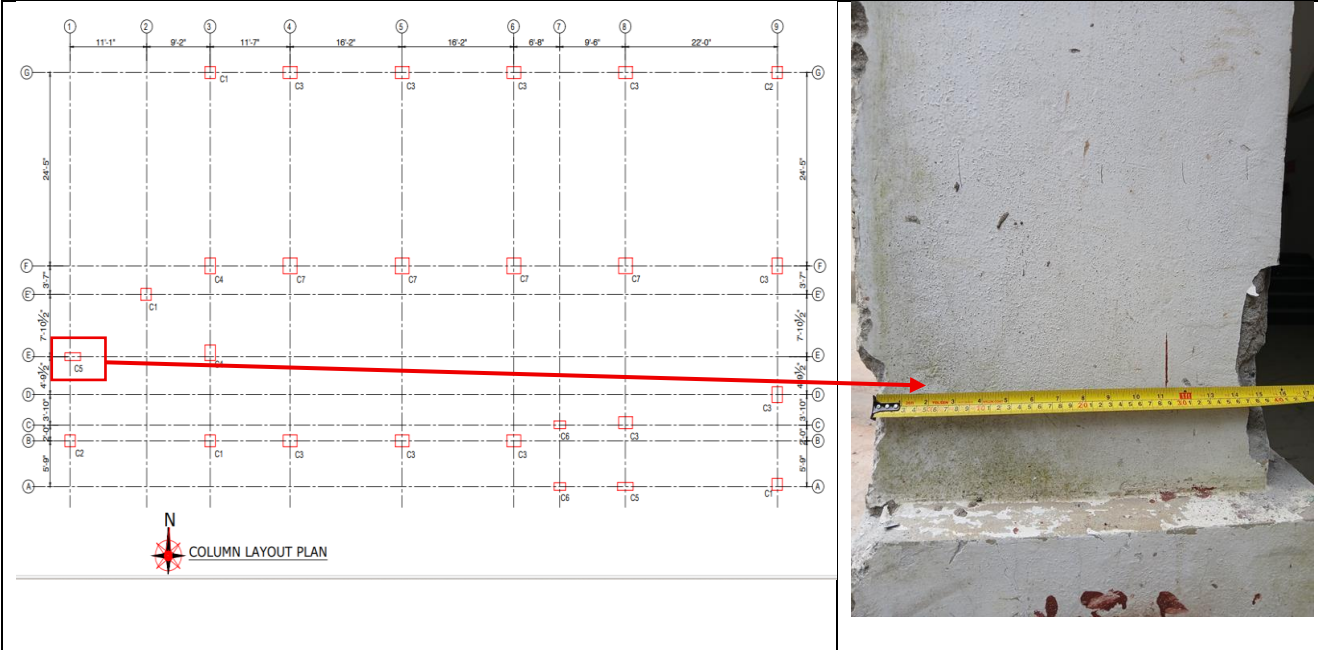
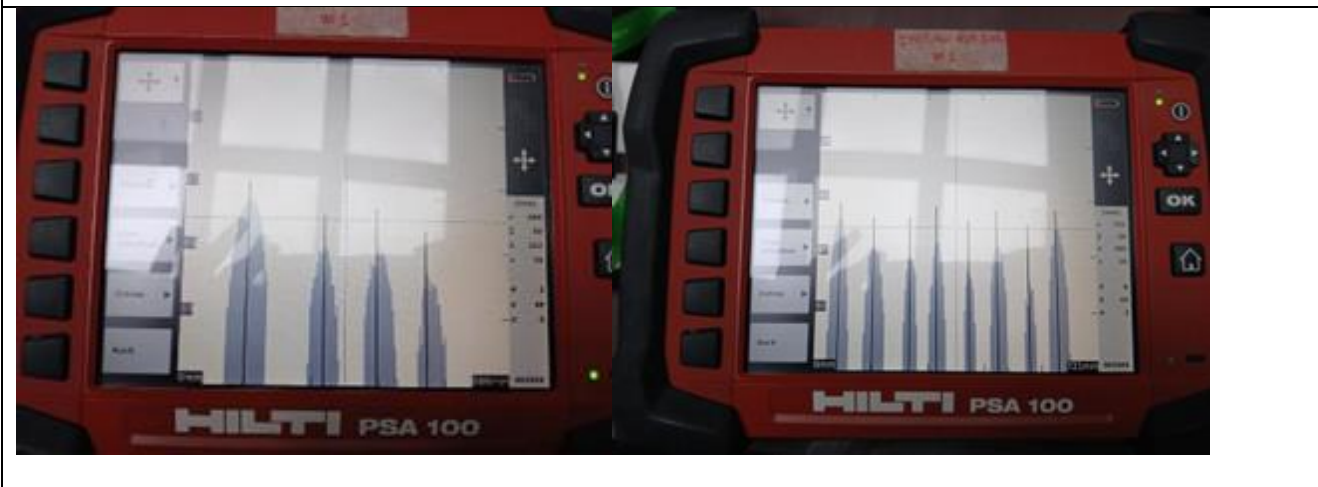
**Description:** At grid E-01, the C5 column at ground floor was found 15"x27" instead of 12"x27", and the rebar was found 20 nos instead of 18 nos.

5.	Mismatch in as-built drawing (Tower-3)	The building engineer is required to survey the structures and prepare detailed & accurate as-built drawings.	within 6 weeks

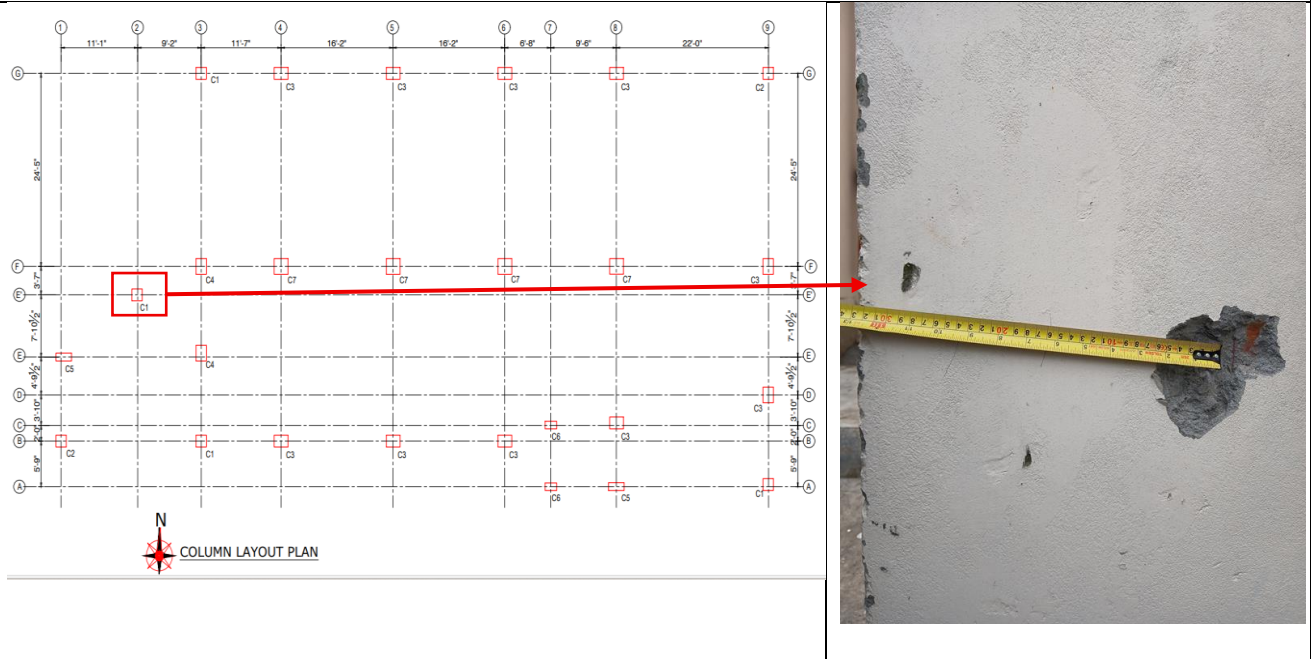
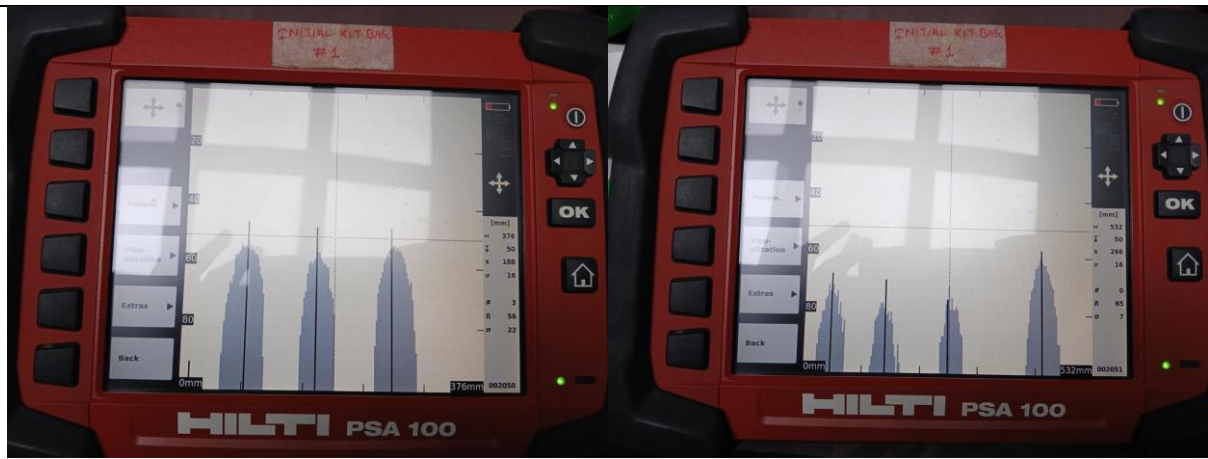
**Description:** At grid E'-02, the C1 column at ground floor was found 12"x18" instead of 18"x18", and the rebar was found 10 nos.. instead of 12 nos.

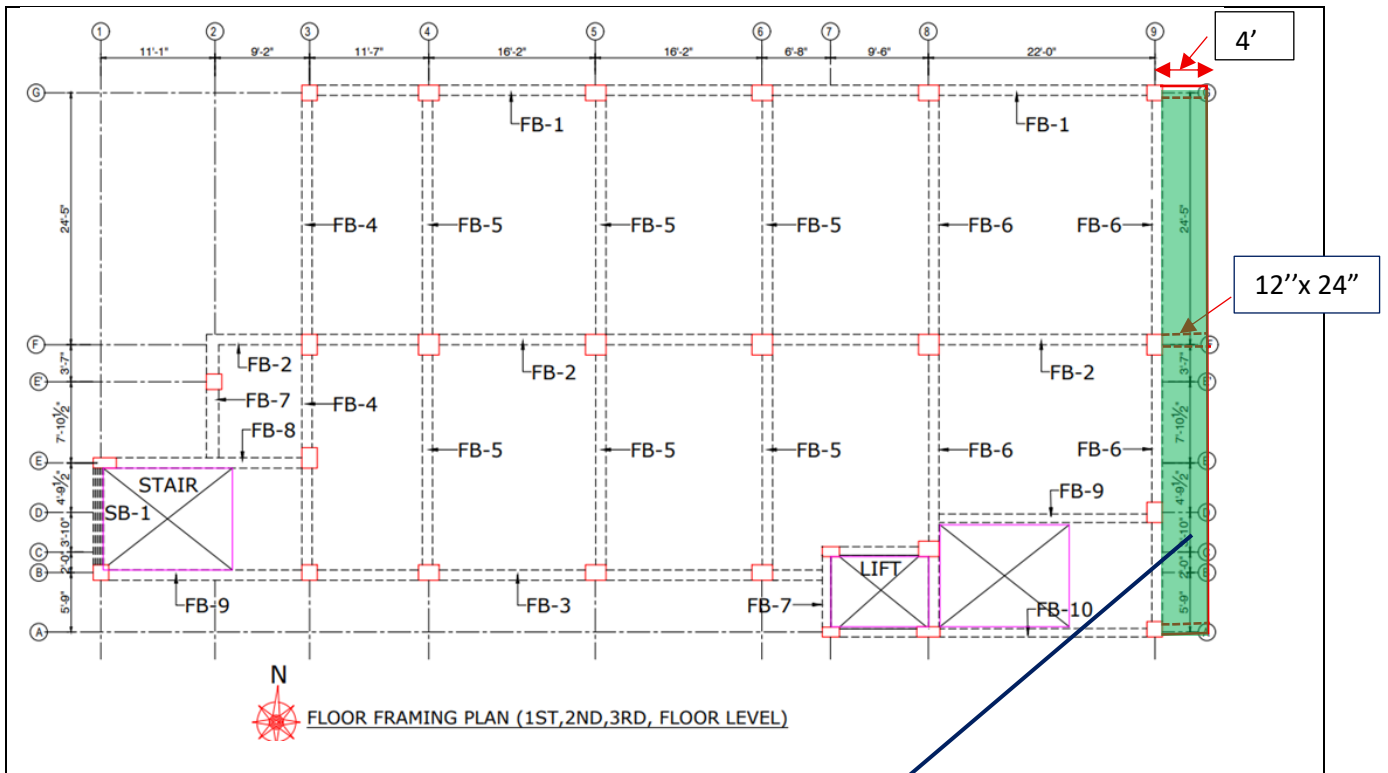
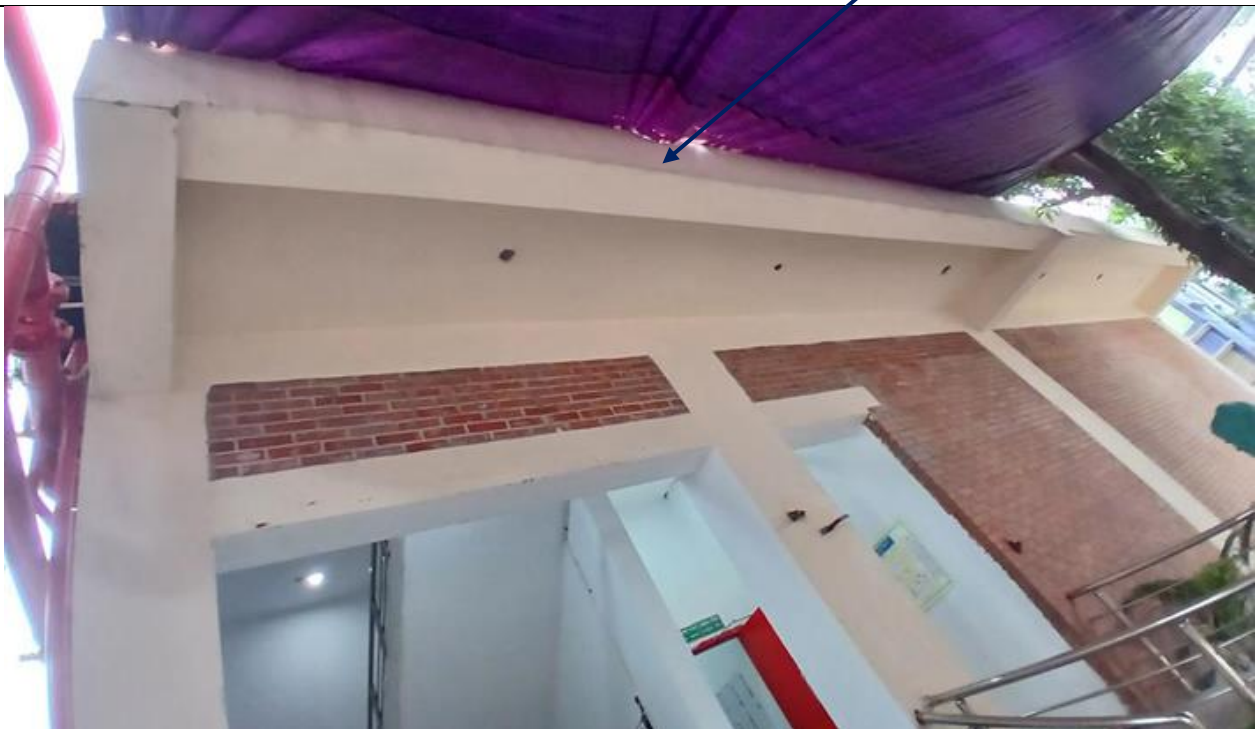
**Description:** A cantilever portion on the 1st floor was found on-site, which was not mentioned in the as-built drawings. The building engineer is required to survey the structures and prepare comprehensive as-built drawings, including necessary foundation details.

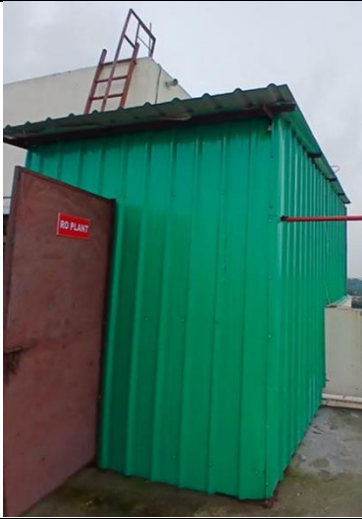
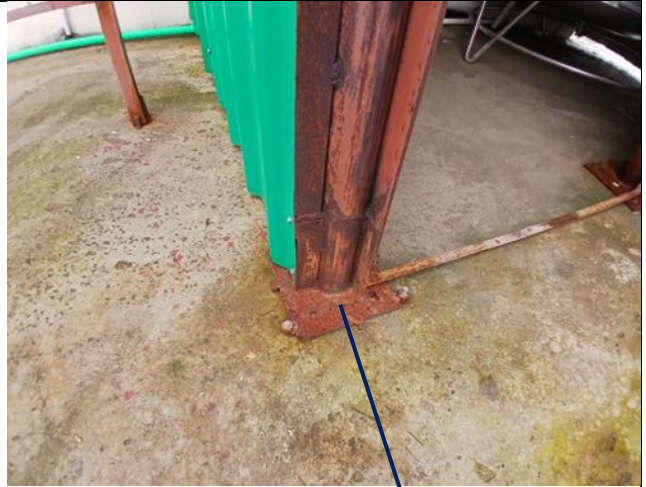
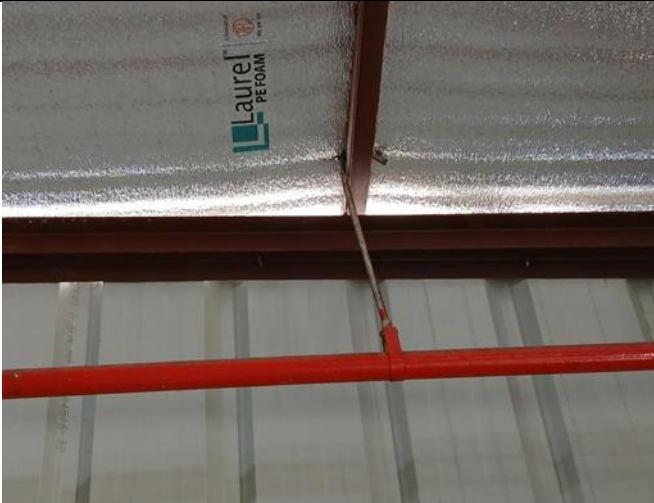
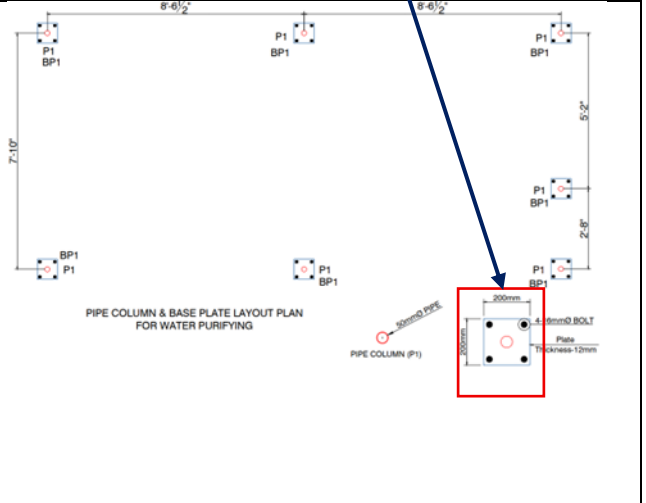
**Observation-03:** Missing anchorage on column support and inadequate lateral stability features on the rooftop shed (RO plant).

**Description:** During the inspection, the RO plant was found on the roof of Tower-3, where anchorage was found missing. The building engineer is required to install lateral stability features (bracing, connection improvement, etc.) to the shed. Also, provide anchorage to the column support.

6.	Missing anchorage on column support and inadequate lateral stability features on the rooftop shed (RO plant).	The building engineer is required to install lateral stability features (bracing, connection improvement, etc.) to the shed. Also, provide anchorage to the column support.	within 6 weeks

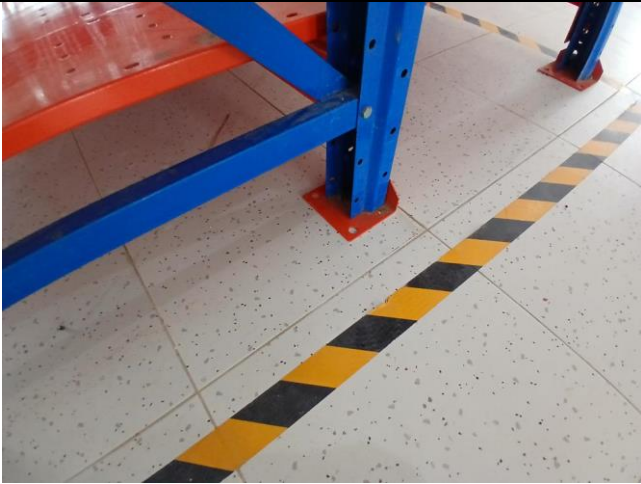
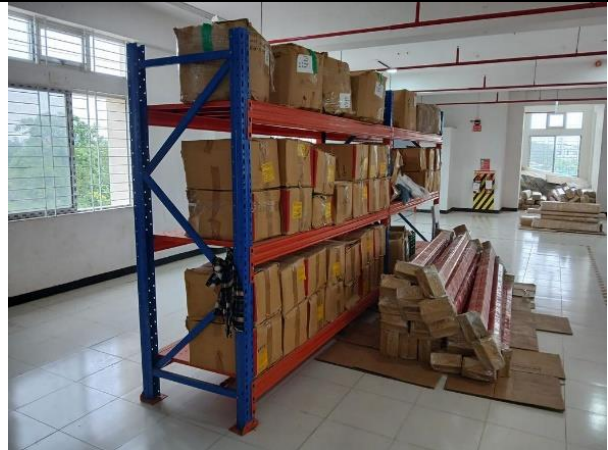
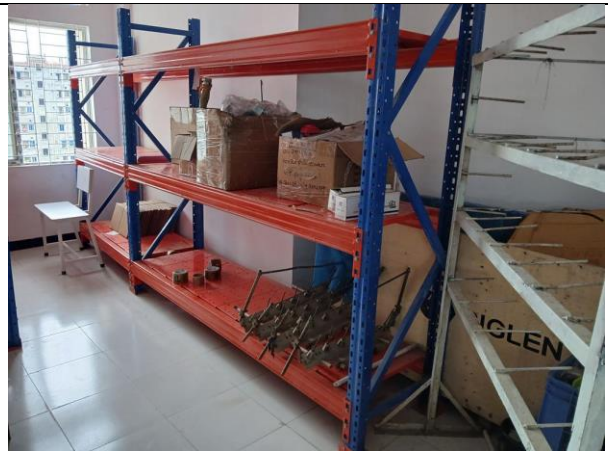
**Observation-04:** Non-structural elements not fully anchored or braced (Tower-3)

**Description:** Non-structural elements were found on different floors of the building which were not fully anchored or braced. The building engineer is required to anchor or brace all non-structural elements to avoid falling hazard during earthquake.

7.	Non-structural elements not fully anchored or braced (Tower-3)	The building engineer is required to anchor or brace all non-structural elements to avoid falling hazard during an earthquake.	within 6 weeks

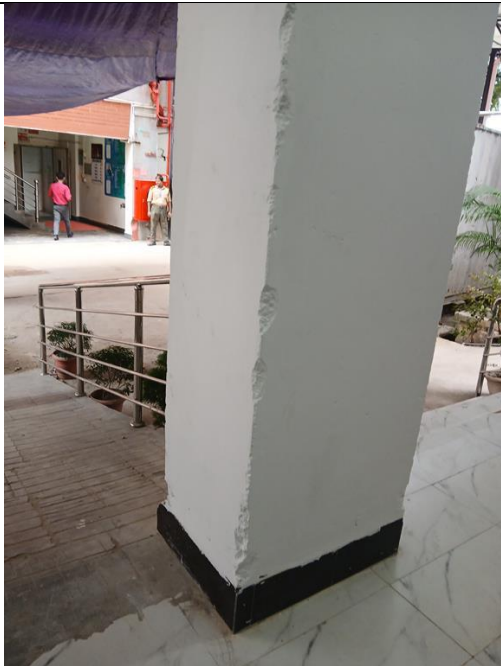
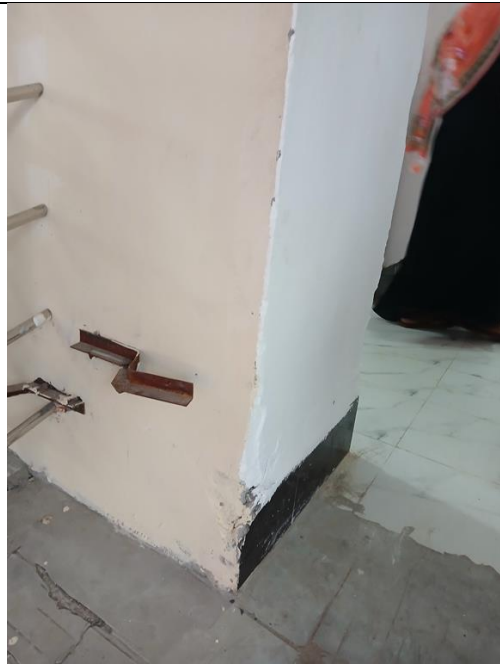
**Observation-05:** Damage column due to trolley impact (Tower-3).

**Description:** Damage was observed on column due to trolley impact. The factory is required to provide column guards to protect the trolley impact.

8.	Damage column due to trolley impact (Tower-3).	The factory is required to provide column guards to protect against the trolley impact.	within 6 weeks

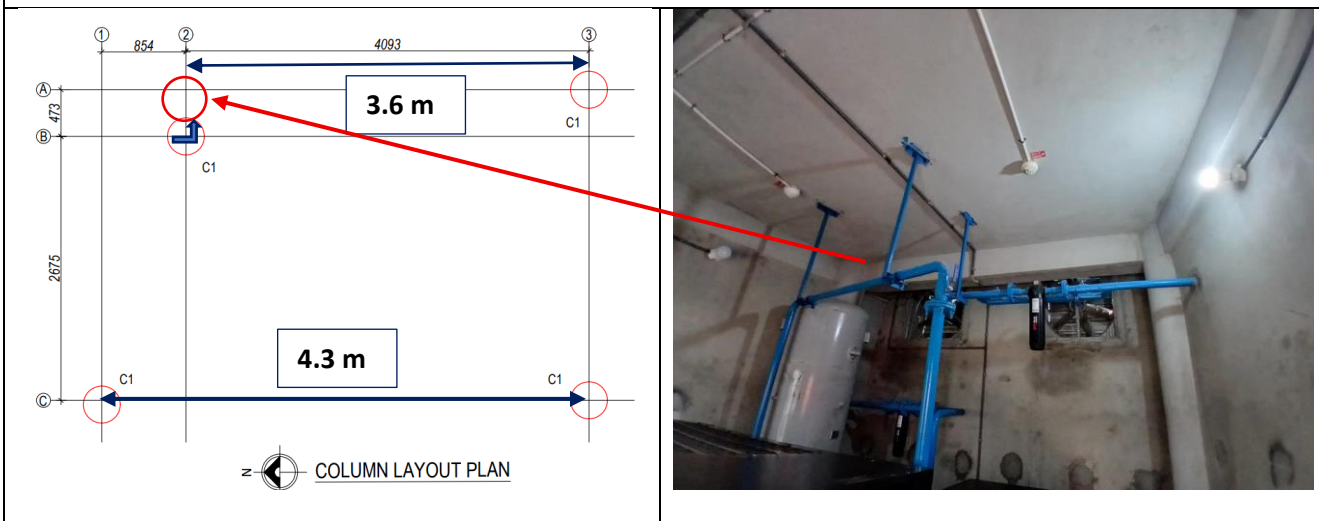
**Observation-06: Mismatch in as-built drawing (Compressor Room-2)**

**Description:** During the inspection, mismatch was found in grid dimension and column layout. The building engineer is required to survey the structures and prepare comprehensive as-built drawings, including necessary foundation details.

9.	Mismatch in as-built drawing (Compressor Room-2)	The building engineer is required to survey the structures and prepare detailed & accurate as-built drawings.	within 6 weeks
