# Advance World Limited (New)

289 Shiachar, Lalkha, Fatullah, Narayangonj.  
(23.647464, 90.483301)

2 September 2025

## Structural Inspection Report

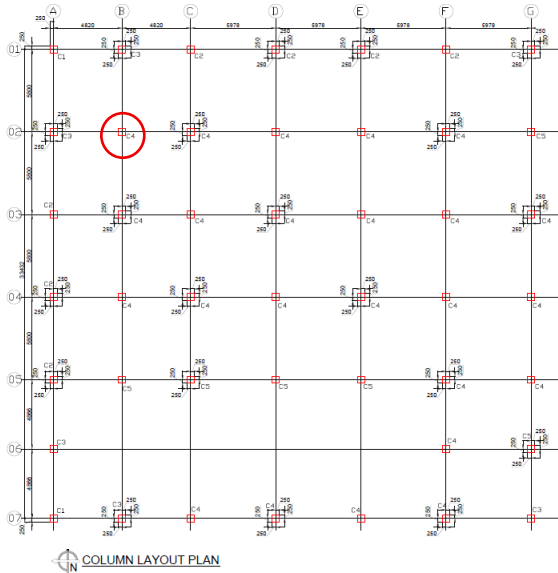
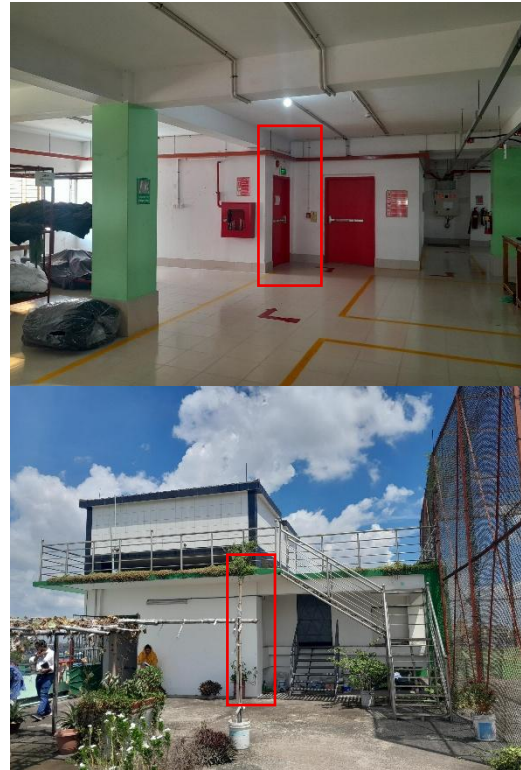
**Observation-01:** Stress in the column above normal design limit (Production building).

**Description:** The cursory calculation indicates that columns are stressed above normal design limits under gravity loading at the marked locations, considering floor live load of 3 kPa for the typical floors, 5 kPa for the stairs, 1.5 kPa for the roof, minimum concrete strength based on aggregate type (16.3 MPa), and minimum rebar strength (415 MPa). The building engineer is required to review the design, loads, and column stresses. Take a minimum 4-100mm diameter concrete core for the structural elements (column, beam/slab) to verify the in-situ concrete strength. Produce and actively manage the loading plan according to the floor capacity.

| Item No | Observation | Action Plan | Timeline |
|---|---|---|---|
| 1. | Stress in the column above normal design limit (Production building). | The building engineer is required to review the design, loads, and column stresses. | within 6 weeks |
| 2. | | Verify in-situ material strength by taking a minimum 4-100mm dia. core from the lower tier of the building (column, beam/slab). | within 6 weeks |
| 3. | | Produce and actively manage the loading plan according to the floor capacity. | within 6 weeks |
| 4. | | Carry out the suggested remedial works. | within 6 months |
| 5. | | Implement floor load plan. | within 6 months |

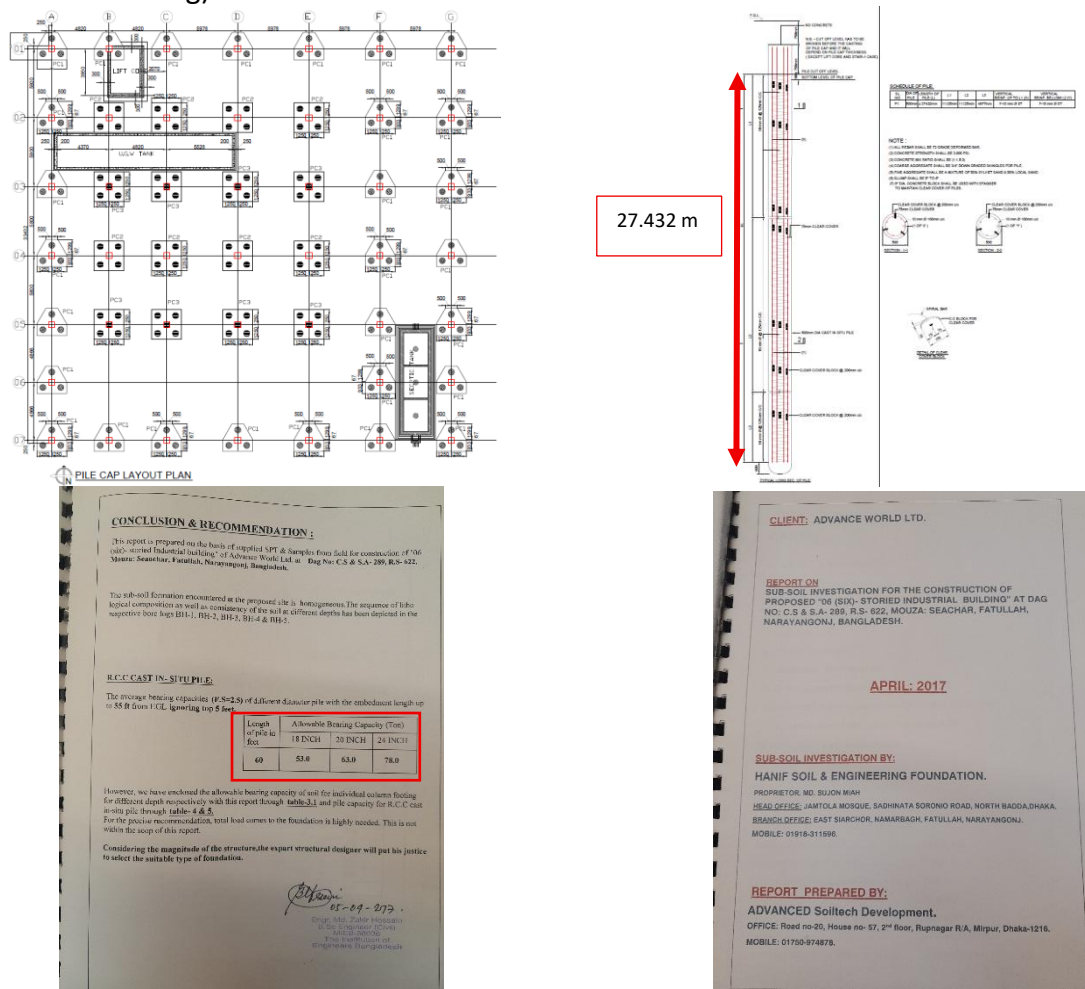
**Observation-02:** Absence of credible structural drawing and inadequate soil test report.  
(Production Building)

**Description:** During the inspection, no credible structural drawing was available on-site for the Production Building. A soil investigation report was found prepared by the “Hanif Soil & Engineering Foundation” in April 2017. In the prepared as-built drawing, the pile length was shown as 27.432 m with a pile diameter of 500 mm. However, in the provided soil test report indicated data for only 18.29 m pile length. The allowable pile capacity for 18.29 m (500 mm Dia) was reported as 63.3 tons (F.S: 2.5), which appears to represent a lower factor of safety. The building engineer is required to verify the actual pile length by conducting a PIT (Pile Integrity Test), carry out a new soil investigation considering the actual pile length, and review the foundation stresses as part of a Detailed Engineering Assessment (DEA) based on the updated soil and pile information.

| Item No | Observation | Action Plan | Timeline |
|---|---|---|---|
| 6. | Absence of credible structural drawing and inadequate soil test report. (Production Building) | The building engineer is required to verify the actual pile length by conducting a PIT (Pile Integrity Test). | within 6 weeks |
| 7. | | Carry out a new soil investigation considering the actual pile length and review the foundation stresses as part of a Detailed Engineering Assessment (DEA) based on the updated soil and pile information. | within 6 weeks |

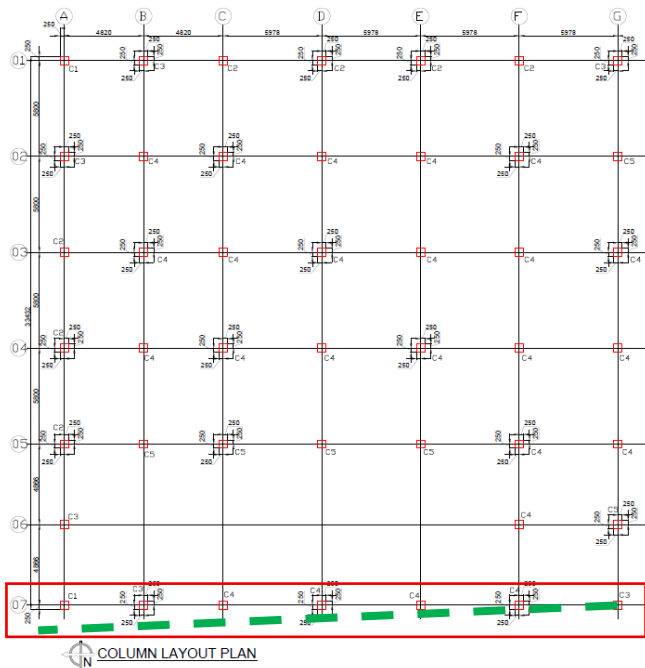
Mismatch in grid dimension (Grid 7 marked in column layout) was found column layout. Grid 7 was found slightly tapered.

**Description:** During inspection, mismatches and lack of information were observed between drawings & existing condition. The building engineer is required to survey the structural components and produce accurate structural drawings.

| Item No | Observation | Action Plan | Timeline |
|---|---|---|---|
| 8. | Mismatch in as-built drawing (Production Building). | The building engineer is required to survey the structural components and produce accurate structural drawings. | within 6 weeks |

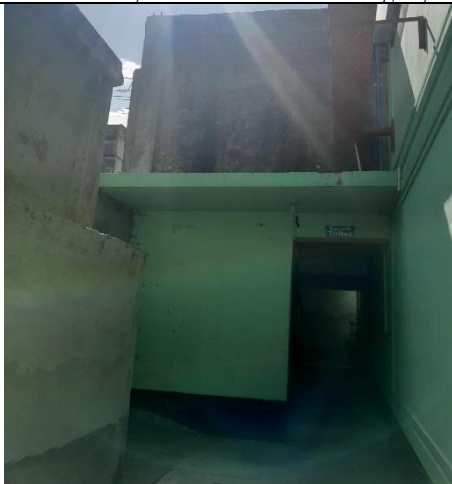
Undocumented 2 storied toilet zone (south side) not shown in drawing.

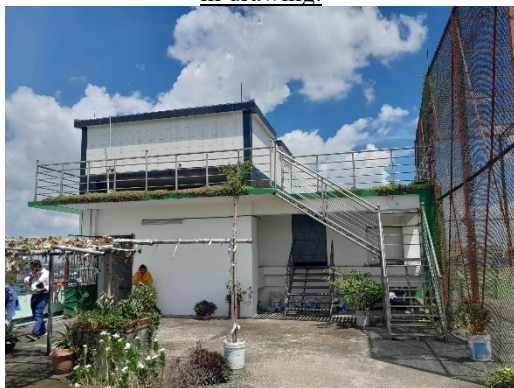
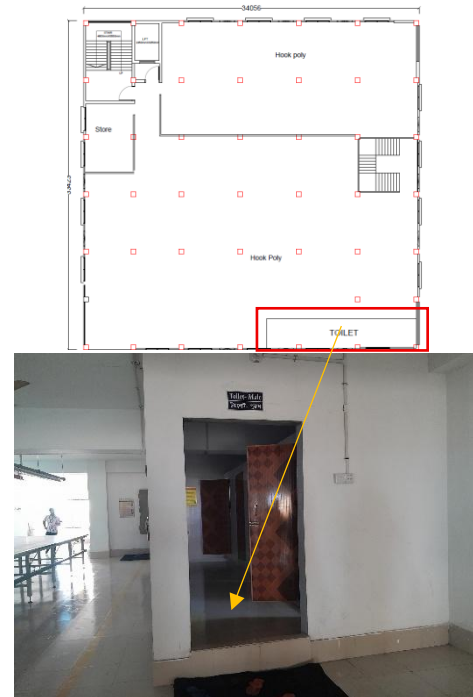
The toilet floor build-up was not shown in the drawing.

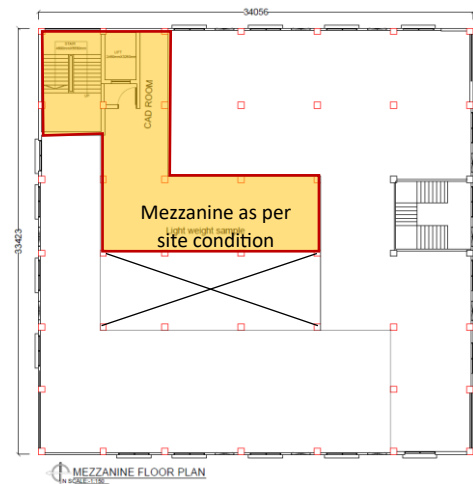
Mezzanine floor layout was not matched with onsite condition.

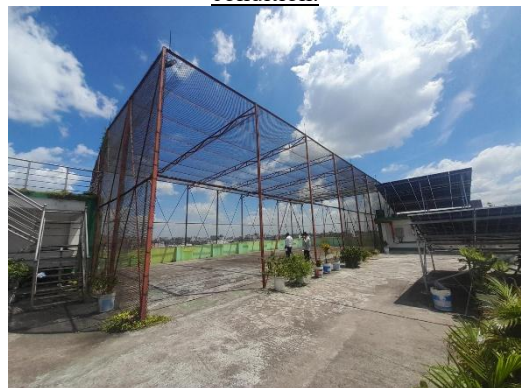
Undocumented O.H.W.T and roof shed not shown in drawing

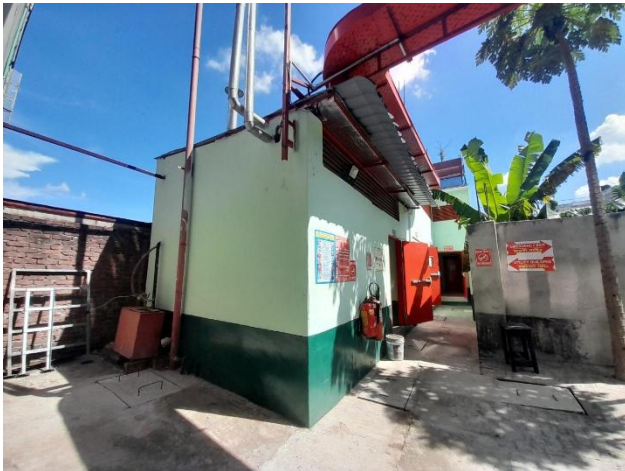
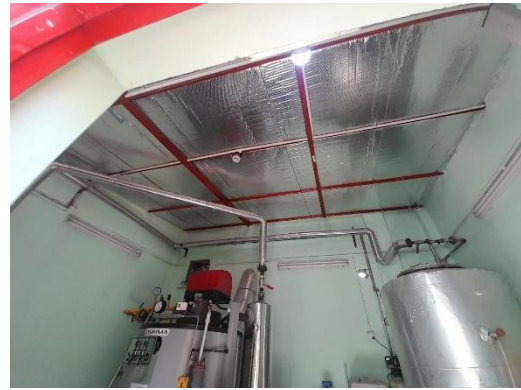
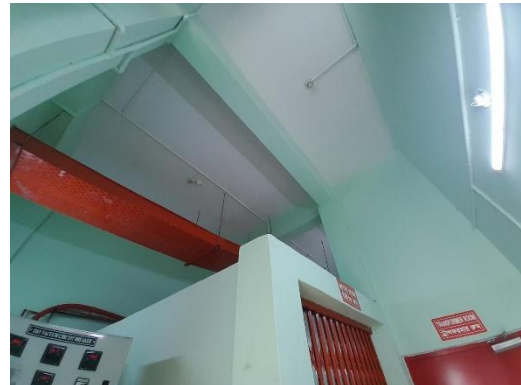
**Observation-04:** Lack of design report and permit drawing. (Utility Building)

**Description:** As per BNBC, every building or structure designed shall have its design documents prepared in accordance with the provisions of Section 1.9.1. The design document shall include a design report and a set of structural drawings, which shall be prepared in compliance with section 1.9.1.1 and section 1.9.1.2, part 6 of BNBC. At the time of inspection, only a set of incomplete drawings was available, also no design report & load plan (mezzanine) were available which are required to be prepared in compliance with section 1.9.1.1 (part- 6, BNBC). Also, collect permit drawings from the local authority.

| Item No | Observation | Action Plan | Timeline |
|---|---|---|---|
| 9. | Lack of design report and permit drawing. (Utility Building) | Building engineer to prepare the design document including a design report, and a set of structural drawings in compliance with section 1.9.1.1 and section 1.9.1.2 as per BNBC. | within 6 weeks |
| 10. | | Carry out the suggested remedial works. | within 6 months |
| 11. | | Collect permit drawings from the local authority. | within 6 months |

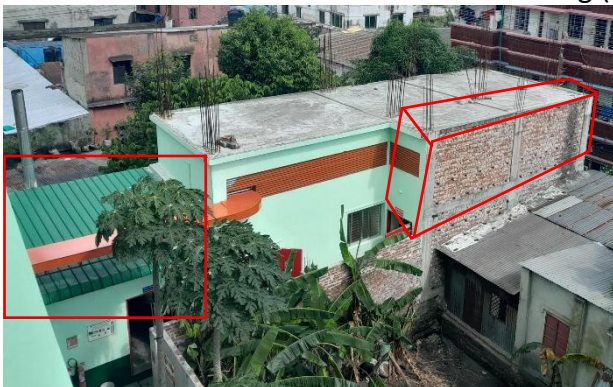
Undocumented column and extended portion

**Description:** During inspection, mismatches were observed between the provided drawings & existing condition. The building engineer is required to survey the structural components and produce accurate as-built drawings.

| 12. | Mismatch in as-built drawing (Utility Building). | The building engineer is required to survey the structural components and produce accurate as-built drawings. | within 6 weeks |

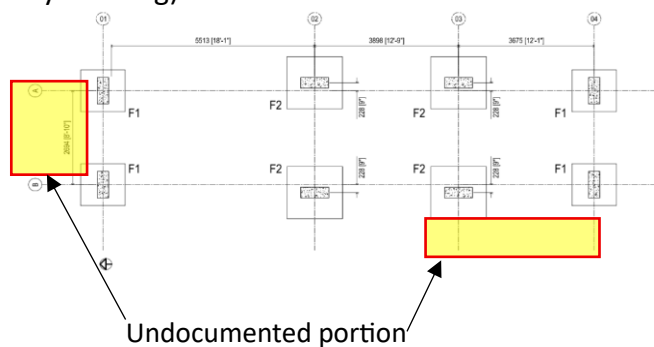
Column and foundation layout

Marked columns are not shown in the drawing.

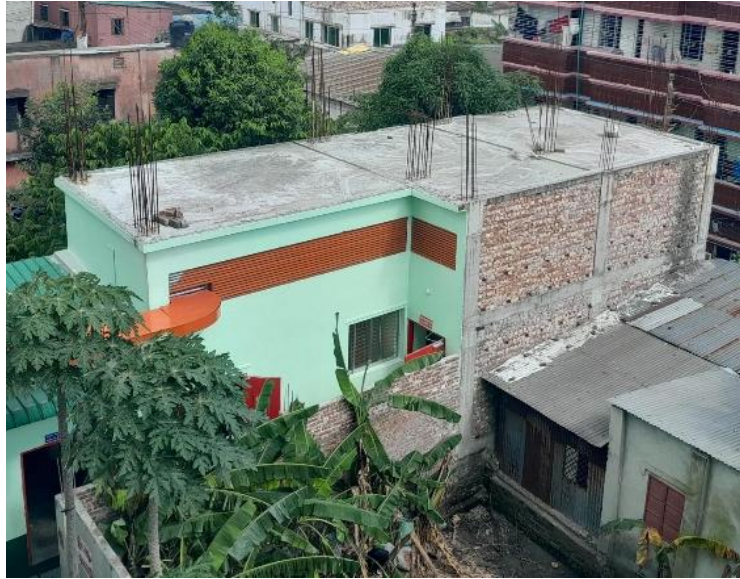
**Observation-6:** Exposed rebar. (Utility Building)

**Description:** Exposed reinforcement was observed on the roof of the Utility Building. All exposed reinforcement is to be protected from corrosion which may cause degradation of the concrete. Factory engineer is required to take necessary measures to prevent corrosion in exposed rebar.

| 13. | Exposed rebar. (Utility Building) | Factory engineer is required to take necessary measures to prevent corrosion in exposed rebar. | within 6 weeks |

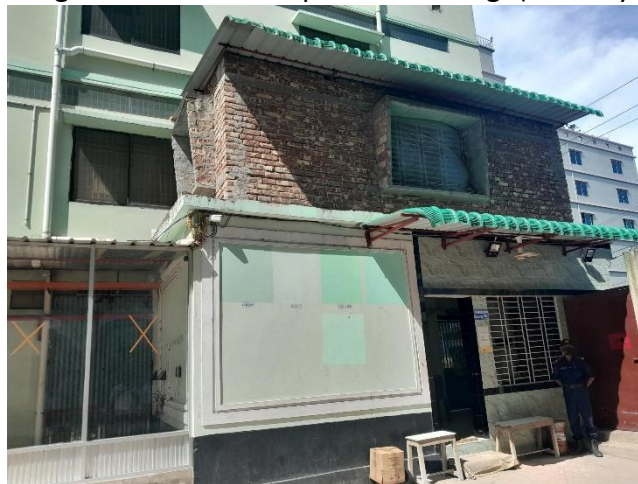
**Observation-07:** Lack of design documents and permit drawing. (Security post)

**Description:** As per BNBC, every building or structure designed shall have its design documents prepared in accordance with the provisions of Section 1.9.1. The design document shall include a design report and a set of structural drawings, which shall be prepared in compliance with section 1.9.1.1 and section 1.9.1.2, part-6 of BNBC. At the time of inspection, no drawing, design report & load plan (mezzanine) were available, which are required to be prepared in compliance with section 1.9.1.1 (part 6, BNBC). Also, collect permit drawings from the local authority.

| 14. | Lack of design documents and permit drawing. (Security post) | Building engineer to prepare the design document including a design report, and a set of structural drawings in compliance with section 1.9.1.1 and section 1.9.1.2 as per BNBC. | within 6 weeks |
| 15. | | Carry out the suggested remedial works. | within 6 months |
| 16. | | Collect permit drawings from the local authority. | within 6 months |
