# SQ Celsius Ltd.

Beraiderchala, Keowa, Maona, Sreepur, Gazipur, Bangladesh.  
(24°12'36"N, 90°24'58" E)  
3<sup>rd</sup> June 2014

## Structural Inspection Report

### Observations & Actions

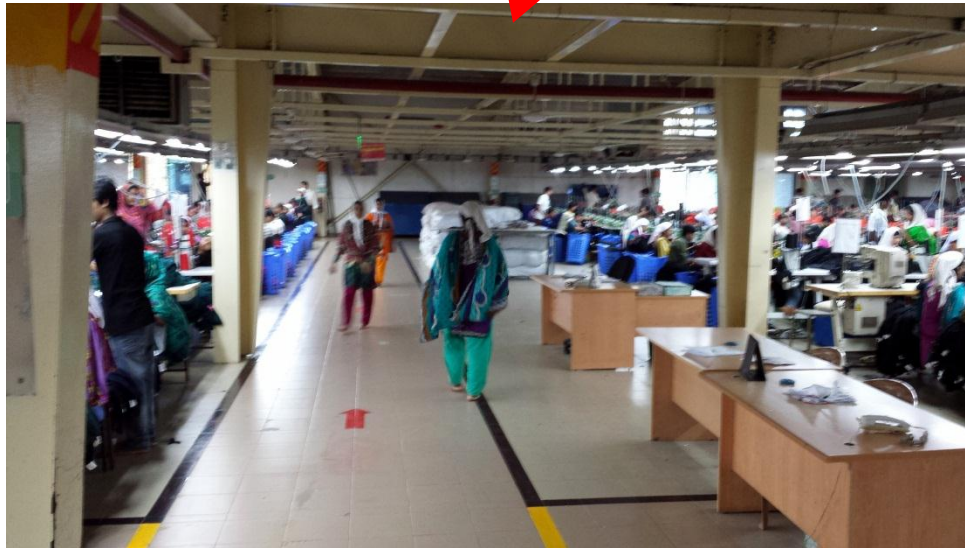
Extended 2nd floor structure present during factory inspection – changed beams layout

Mezzanine extension not shown on drawings

- Factory Engineer to review design, loads and column stresses in area identified above. The current “as-built” structure is more symmetrical, much more regular scheme that shown in the Design.

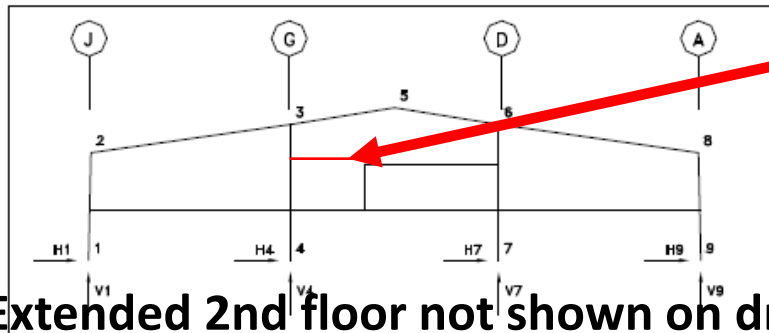
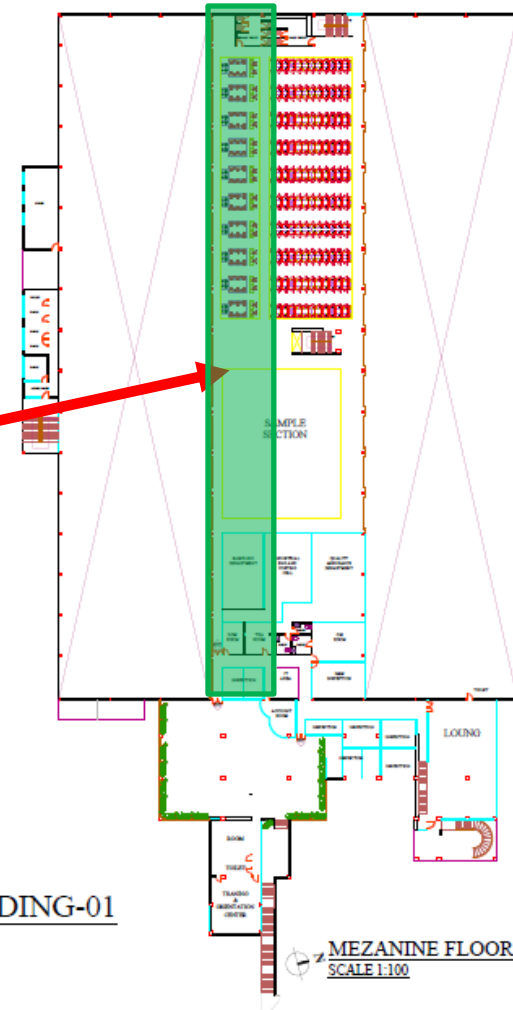
Extended 2nd floor not shown on drawings

Differences between the computational model and built

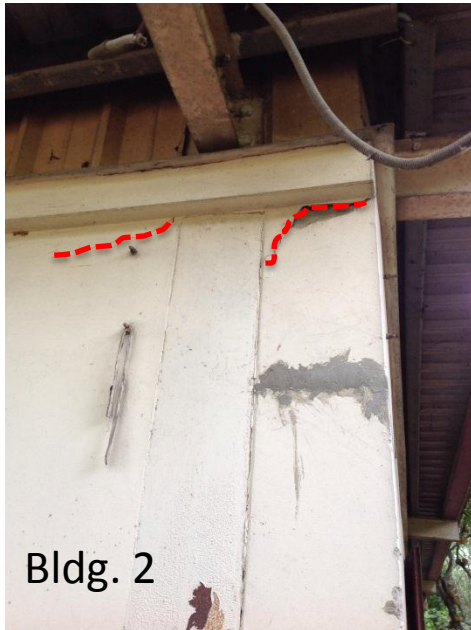
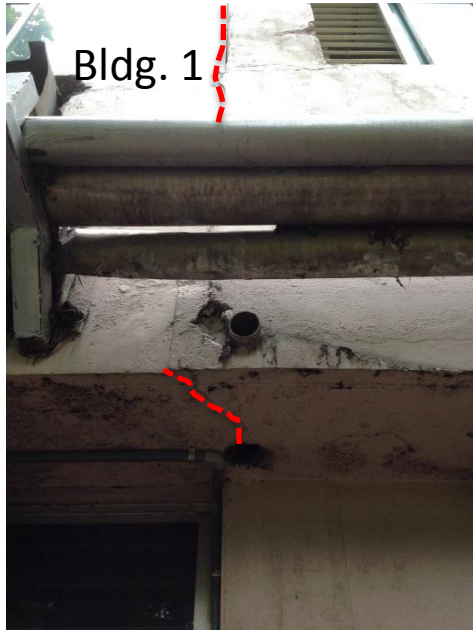
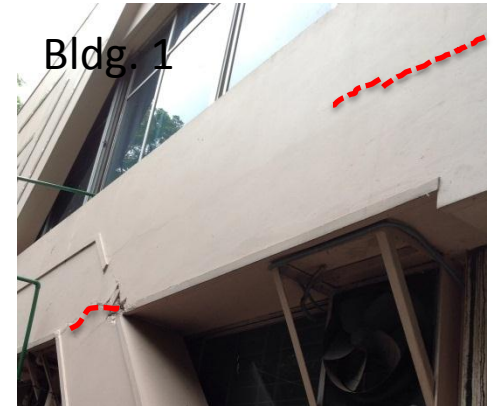
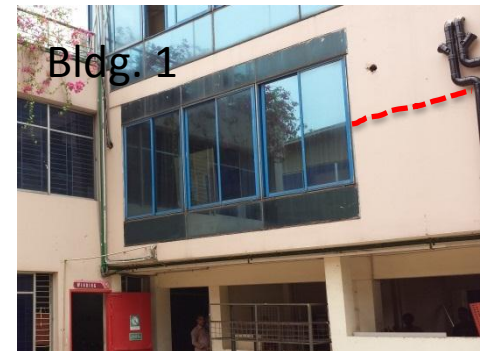
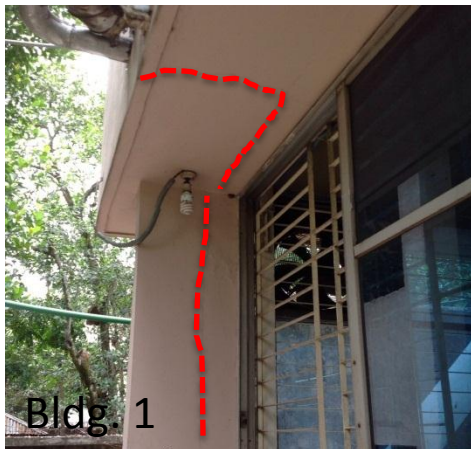
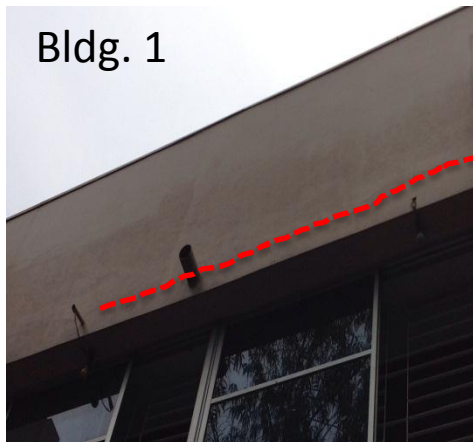
Cracks on the masonry walls. It is recommended to repair and maintain.

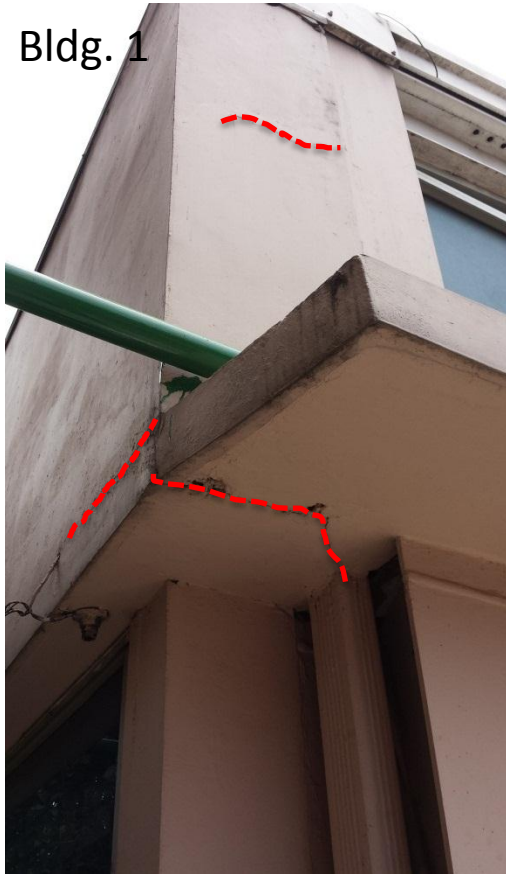
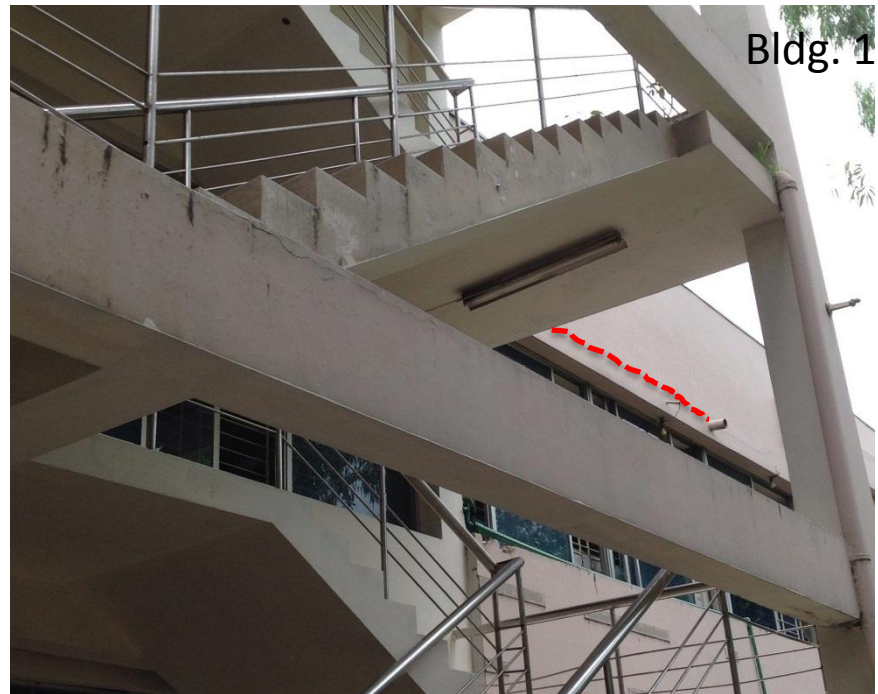
Bldg. 1

Cracks on the masonry walls.  
It is recommended to repair and maintain.

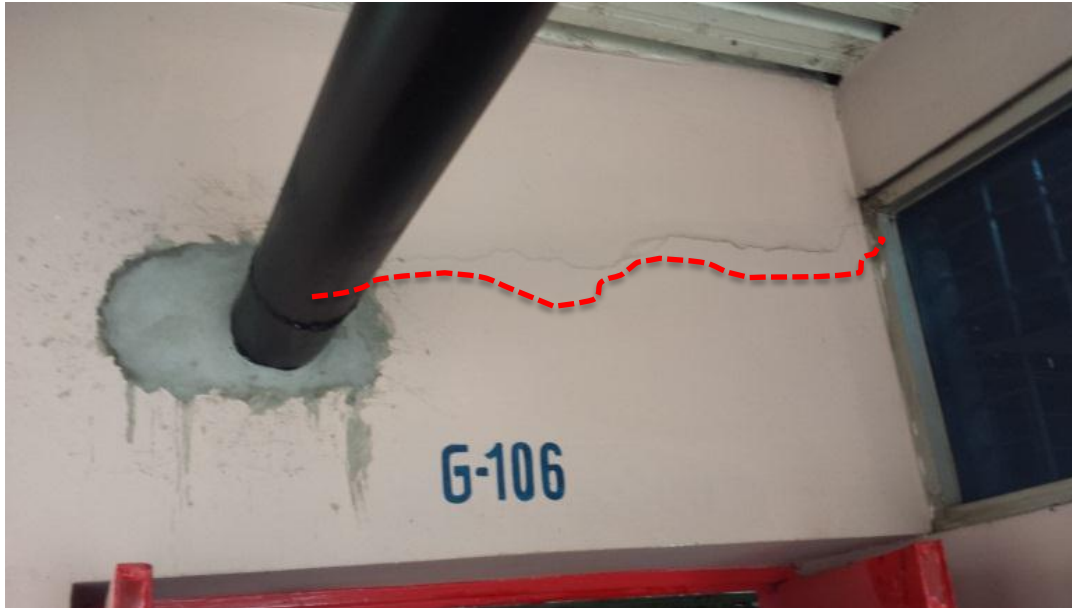
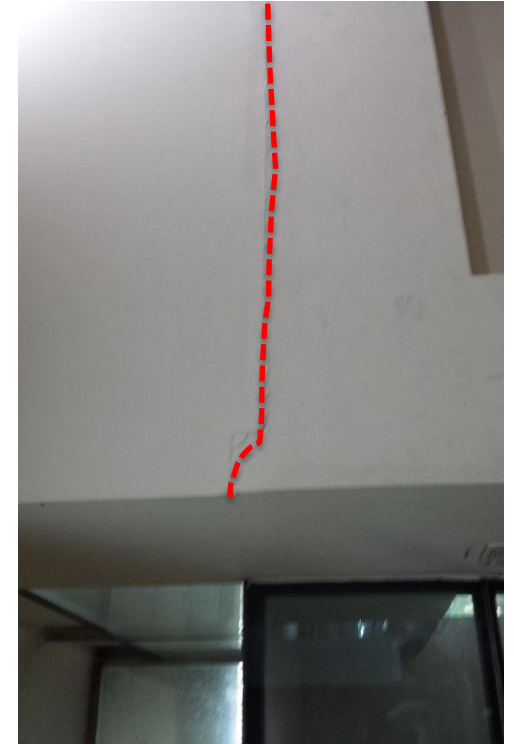
Cracks on the masonry walls.  
It is recommended to repair and maintain.

- Local refurbishment on the movement joints on the walls

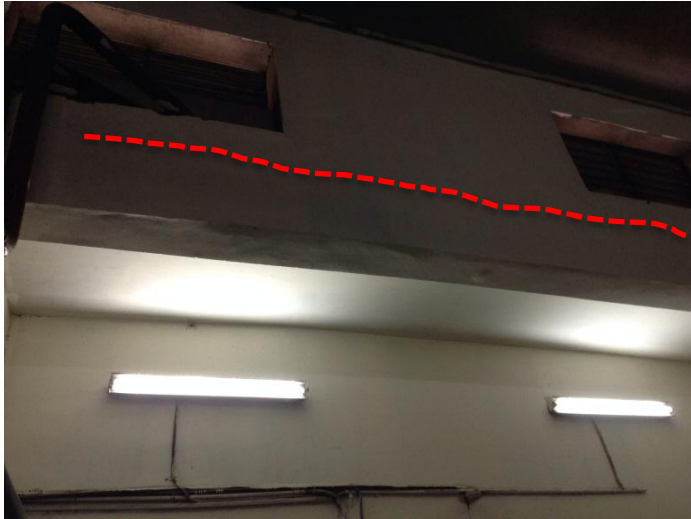
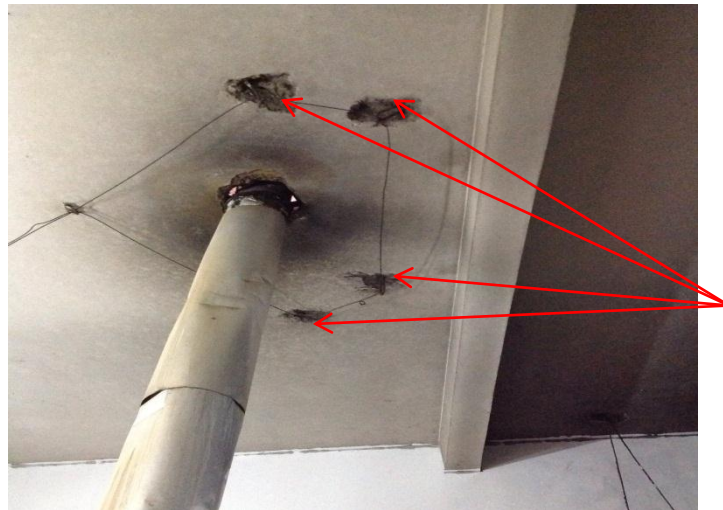
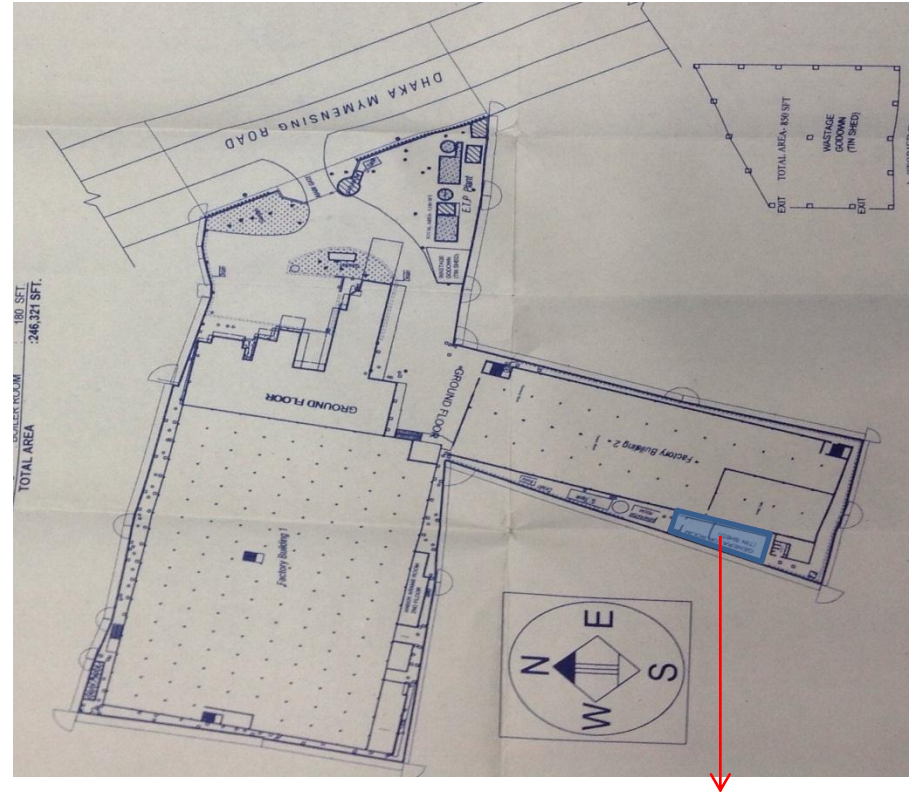
Generator room

Local cavern in roof slab

Cracks in the generator room.  
It is recommended to repair and maintain.

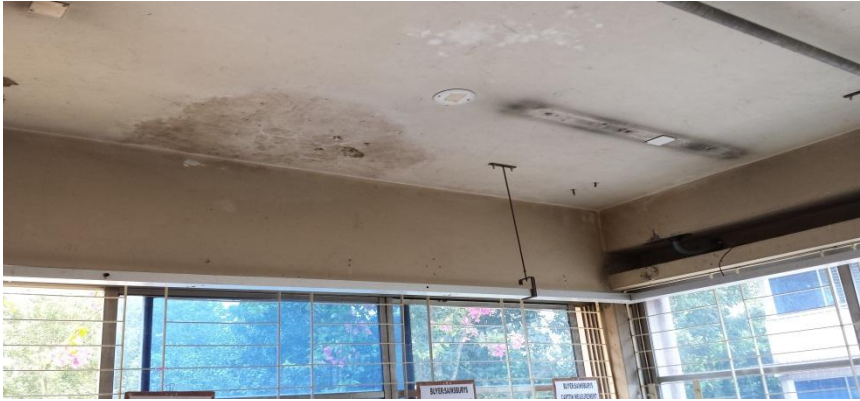
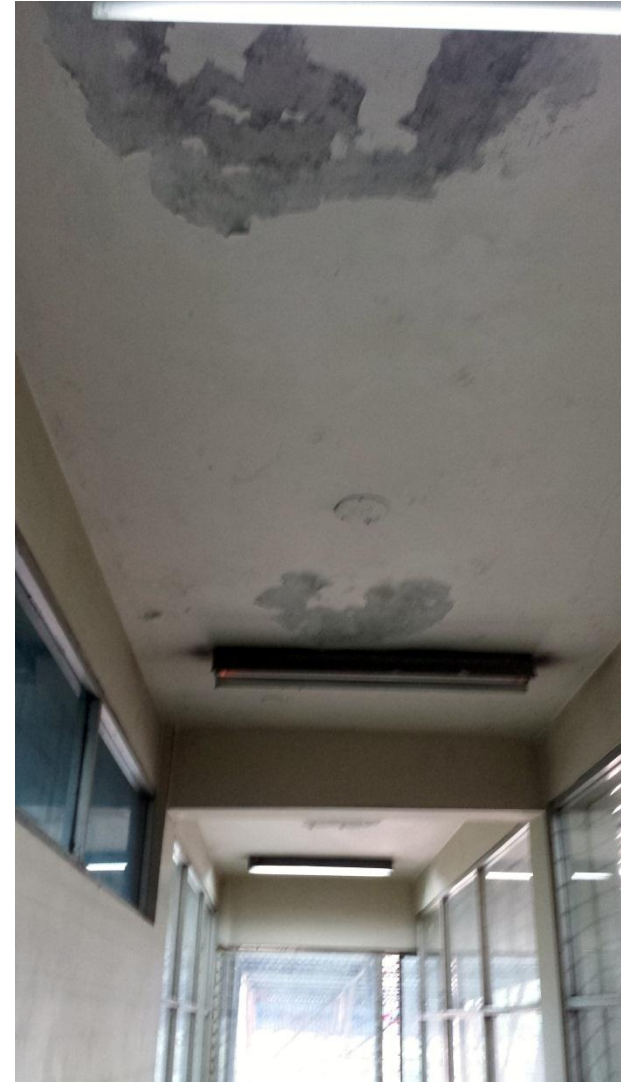
Located on the ceiling leak.  
It is recommended to repair and maintain.

- Repair and maintain waterproof of the slab exposed to rain water.

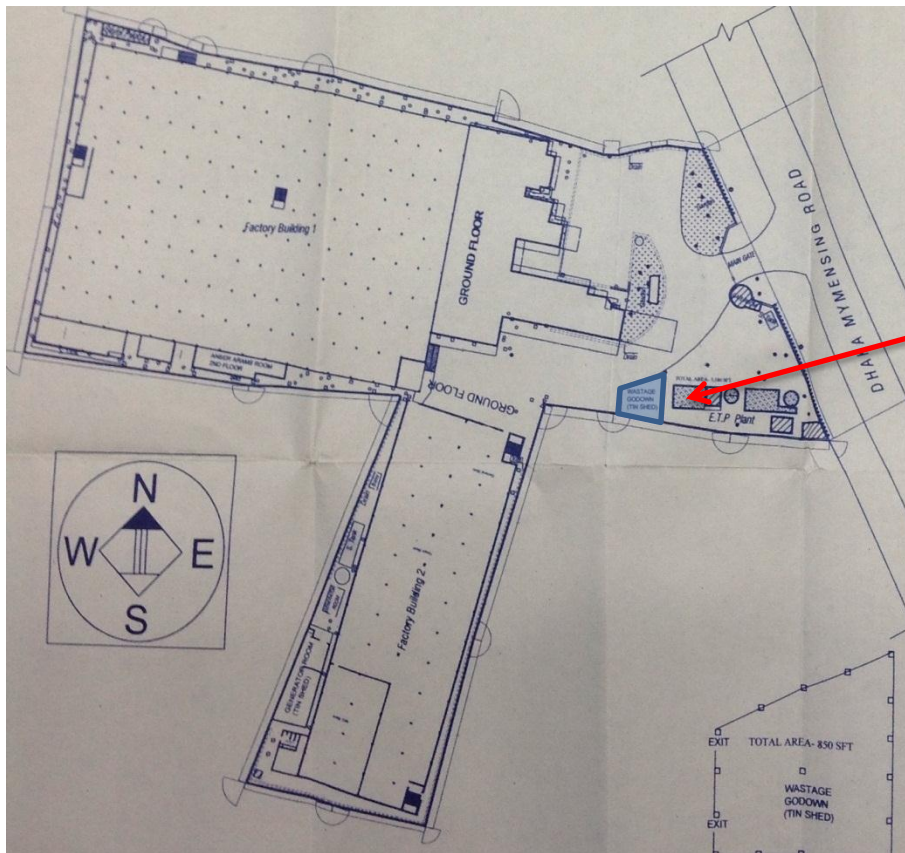
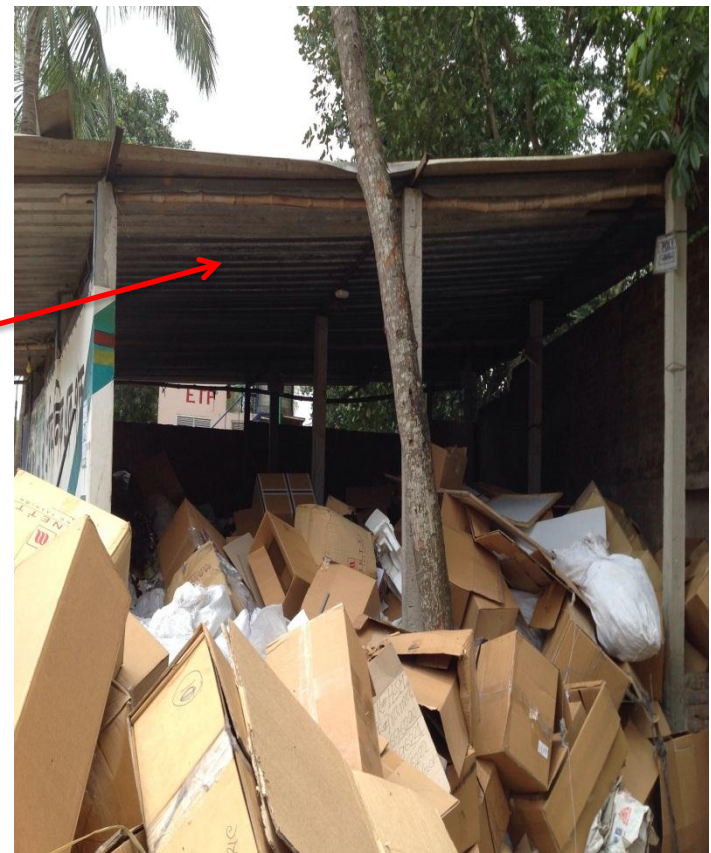
Non-engineered lightweight steel roof.

These structures do not appear to be engineered, and drawings were not available to show structural intent. Building Engineer to review the design of these structures and to implement any upgrade works if required.
