GREEN ARROW SWEATER IND.LTD

25 August 2025

1. Building Information

2. Observation:

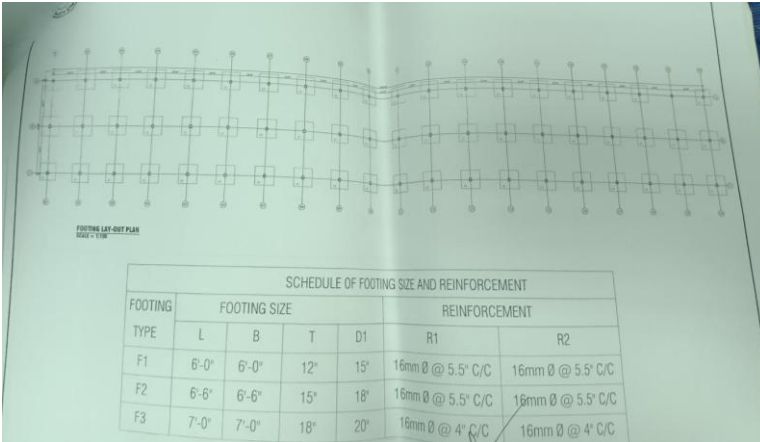
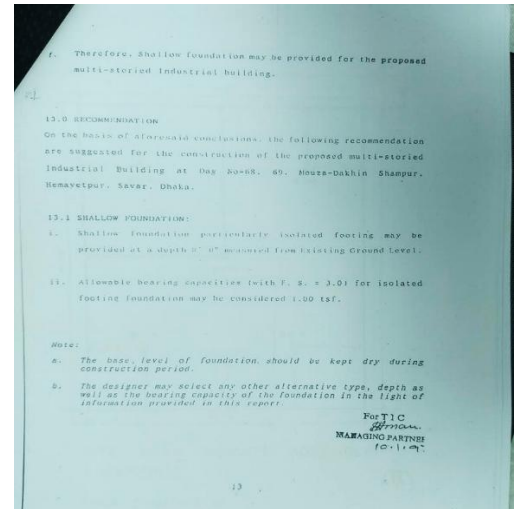
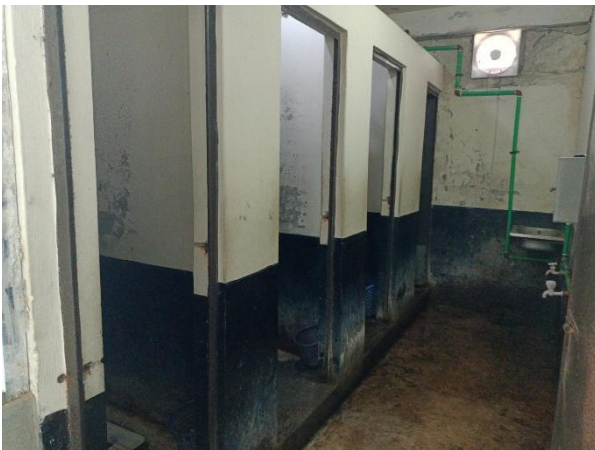
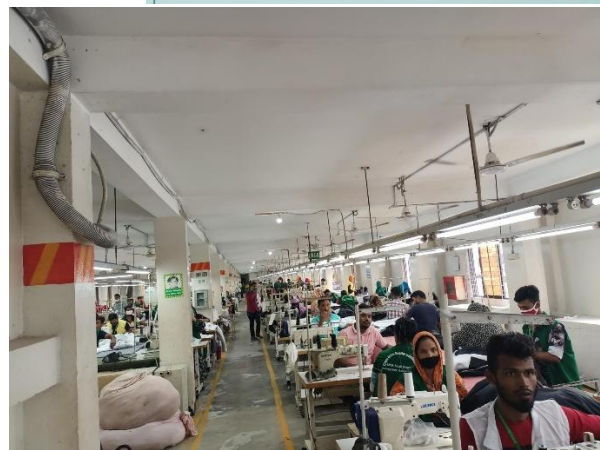
Observation-01: High Stress in column and foundation. (Production Building)

Description: Cursory calculation indicates the internal footings and columns under the toilet zone are highly stressed for allowable bearing capacity and minimum concrete strength of brick aggregate. We considered the observed live load 2 kPa for typical floor. Also, the ultimate bearing capacity of the soil was considered 2 ksf, as per the soil test report.

The building engineer is required to commence a Detailed Engineering Assessment (DEA) to which required immediate review of the design, load and foundation & column stresses.

Item No	Observation	Action Plan	Timeline
1.	High Stress in column and foundation. (Production Building)	The factory must engage an expert structural and geotechnical consultant to prepare accurate as-built drawings, verify foundation size and thickness, conduct a Detailed Engineering Assessment (DEA), perform material testing (concrete and rebar), and carry out a geotechnical investigation.	Immediate

2.	High Stress in column and foundation. (Production Building)	Verify in-situ test from each class of concrete at least 4 nos. (column, beam & slab).	Immediate

3.	High Stress in column and foundation. (Production Building)	The building engineer is required to carry out Detail Engineering Assessment (DEA) to review the design, load and foundation stresses.	within 6 weeks

4.	High Stress in column and foundation. (Production Building)	Verify rebar tensile strength and incorporate the value in DEA.	within 6 weeks
5.	High Stress in column and foundation. (Production Building)	Produce and actively manage a loading plan for all floor plates within the factory, considering floor, column, and foundation capacity.	within 6 weeks

6.	High Stress in column and foundation. (Production Building)	Carry out the suggested remedial work if required.	within 6 months
7.	High Stress in column and foundation. (Production Building)	Implement floor loading plan.	within 6 months

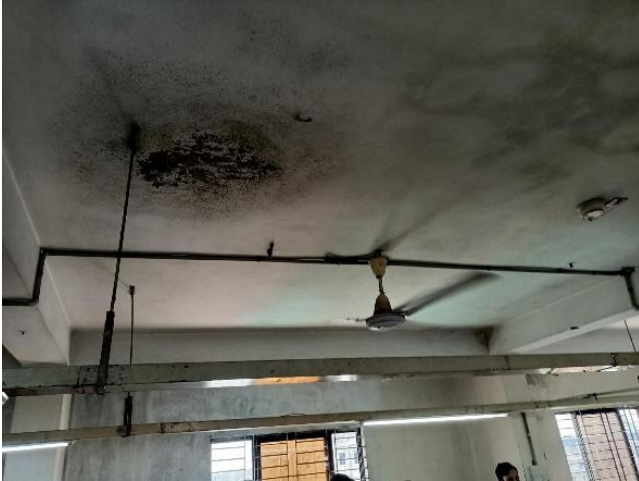
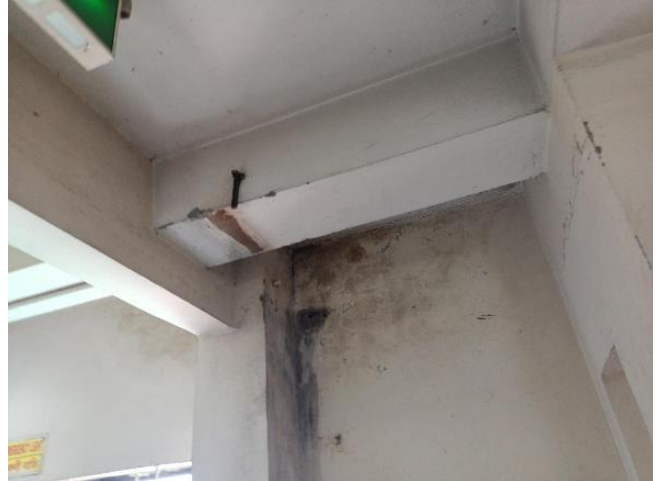
Observation-02: Concrete condition assessment. (Production Building)

Description: During the preliminary visual inspection, it is apparent that the condition of the concrete structure is deteriorating. Some of the key signs of concrete deterioration include cracking, discolouration, leaks, damp patches. In these cases, further tests required to be of use to the Engineer in diagnosing the cause of deterioration and therefore in designing a method to prevent it from compromising the adequacy of the structure.

It is recommended that a qualified structural engineer conduct a thorough visual inspection of each floor to identify key signs of concrete deterioration, including cracking, spalling, discoloration, leaks, damp patches, reinforcement corrosion, and evidence of previous repairs. All findings should be photographed, mapped, and recorded.

Where deterioration is observed, further investigations shall be carried out using appropriate non-destructive and destructive testing methods, including:

- Full delamination (hammer tap) survey in accordance with ASTM D4580-23.
- Cover survey to confirm reinforcement depth.
- Ultrasonic pulse velocity (UPV) testing to identify voids or cracks.
- Half-cell potential survey in accordance with ASTM C-876-22b.
- Carbonation depth measurement.
- Chloride profile testing where necessary.

The results of these investigations should be used to determine the extent, cause, and severity of deterioration, thereby providing appropriate repair and remediation strategies.

8.	Investigation of concrete strength and deterioration. (Production Building)	It is recommended that a qualified structural engineer conduct a thorough visual inspection of each floor to identify key signs of concrete deterioration, including cracking, spalling, discoloration, leaks, damp patches, reinforcement corrosion, and evidence of previous repairs. All findings should be photographed, mapped, and recorded. (See details in observation-2 of this initial report)	within 6 weeks

9.	Investigation of concrete strength and deterioration. (Production Building)	Carry out the suggested remedial work if required.	within 6 months

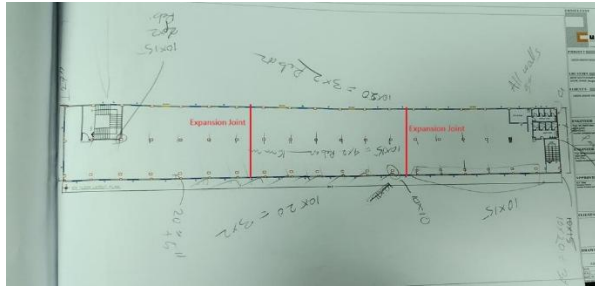
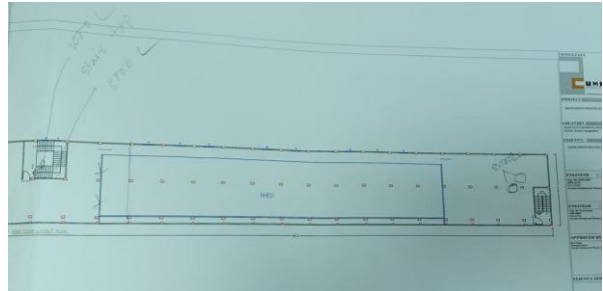
Observation-03: Discrepancy in as-built drawing. (Production Building)

Description: Floor layouts are not fully matched with the as-built condition. PVC water tanks were not shown in drawings. No structural details were found for roof shed. Also, columns sizes, amount of rebar and orientation were not fully matched with structural drawings. Moreover, 2 nos of expansion joint were found on site which were not mentioned in any drawings. The building engineer is required to survey the full structure and prepare as-built drawing which reflects the on-site condition.

10.	Discrepancy in as-built drawing. (Production Building)	The building engineer is required to survey the full structure and prepare as-built drawing which reflects the on-site condition.	within 6 weeks

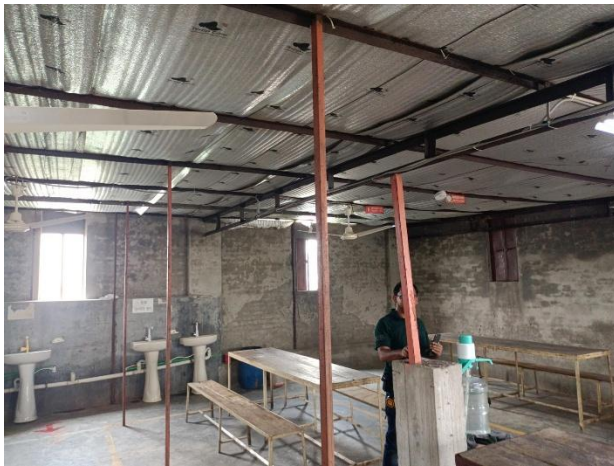
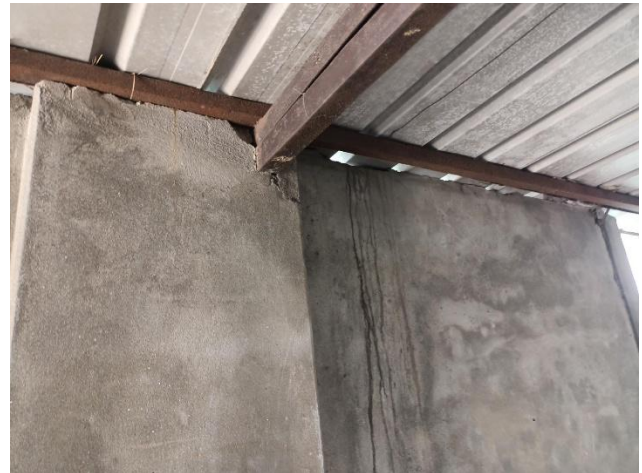
Observation-04: Lack of stability, Inadequate steel column & connection of roof shed. (Production Building)

Description: Truss frames were poorly connected with brick walls at the roof of Production Building. Also, incomplete lateral stability and inadequate steel box columns were observed. The building engineer is required to check the lateral stability, member & connection adequacy of the roof truss and suggest proper remedial measures.

11.	Lack of stability, Inadequate steel column & connection of roof shed. (Production Building)	The building engineer is required to check the lateral stability, member & connection adequacy of the roof truss and suggest proper remedial measures.	within 6 weeks

12.	Lack of stability, Inadequate steel column & connection of roof shed. (Production Building)	Carry out the suggested remedial work if required.	within 6 months

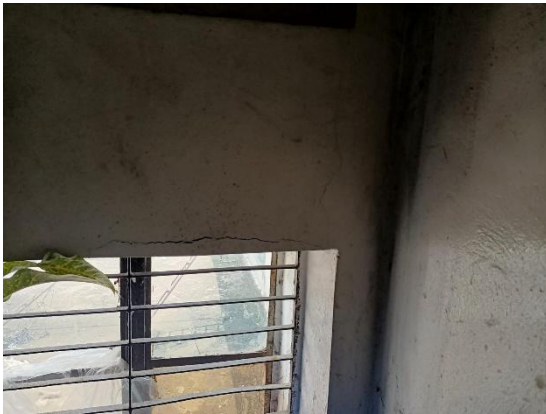
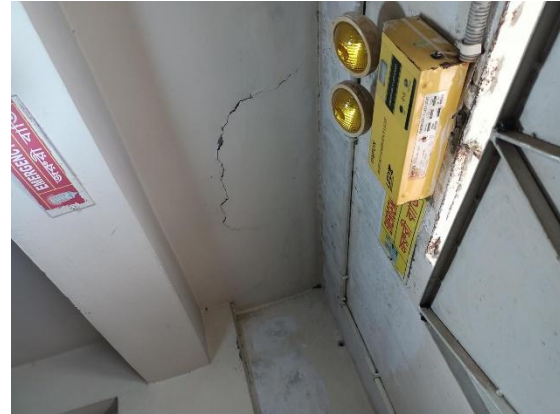
Observation-05: Cracks on slab and beam (Production Building)

Description: Cracks were observed on stair beam and cantilever slab. Building engineer is required to investigate the cracks and suggest proper remedial measures. Carry out remedial work as per recommendation of the investigation report.

13.	Cracks on slab and beam (Production Building)	Building engineer is required to investigate the cracks and suggest proper remedial measures.	within 6 weeks

14.	Cracks on slab and beam (Production Building)	Carry out remedial work as per recommendation of the investigation report.	within 6 weeks
15.	Vibration on floor due to operation of heavy machine. (Production Building)	The building engineer is required to investigate the long-term effect of the vibration and suggest proper remediation accordingly.	within 6 weeks

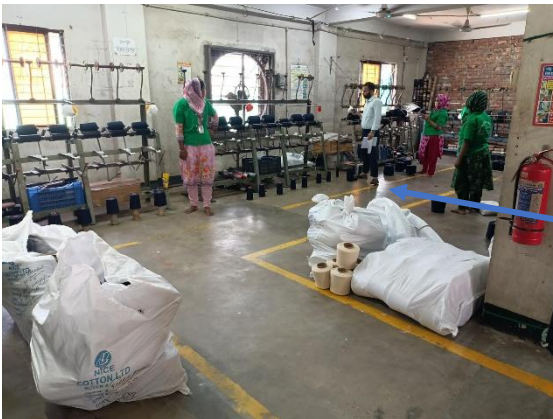
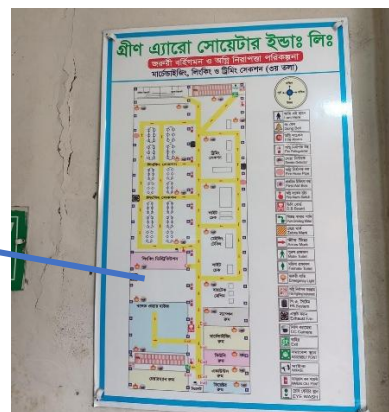
Observation-06: Vibration on floor due to operation of heavy machine. (Production Building)

Description: Significant vibration was felt on the 2nd floor due to the operation of winding machines. The building engineer is required to investigate the long-term effect of the vibration and suggest proper remediation accordingly.

16.	Vibration on floor due to operation of heavy machine. (Production Building)	Carry out the suggested remedial work if required.	within 6 months
17.	Lack of water proofing and inadequate drainage. (Production Building)	The building engineer is required to provide a waterproofing layer with proper installation of the adequate number of drainage outlets	within 6 months

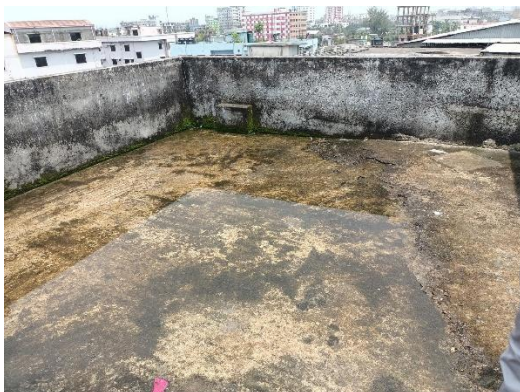
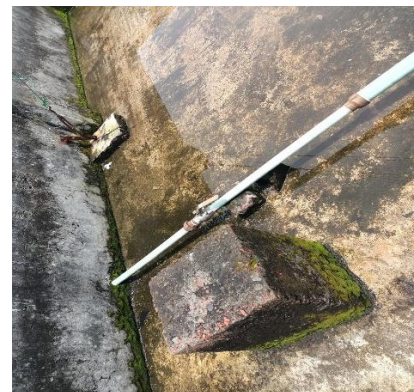
Observation-07: Lack of water proofing and inadequate drainage. (Production Building)

Description: The slab of the building is constructed with MCAC. But water proofing layer has not been applied. Also, inadequate drainage was observed. The building engineer is required to provide a waterproofing layer with proper installation of the adequate number of drainage outlets.

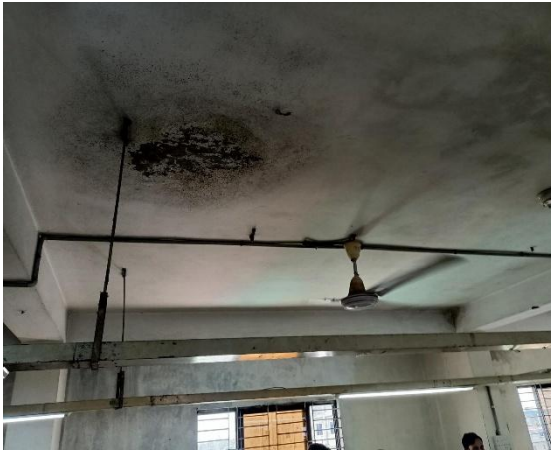
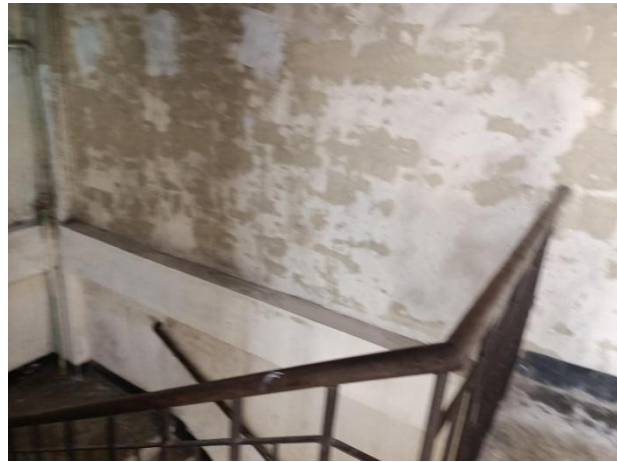
Observation-08: Severe dampness in the slab and walls. (Production Building)

Description: Dampness was found in the floor slab and walls. Building Engineer is required to investigate the damped portion and repair accordingly

18.	Severe dampness in the slab and walls. (Production Building)	Building Engineer is required to investigate the damped portion and repair accordingly	within 6 weeks

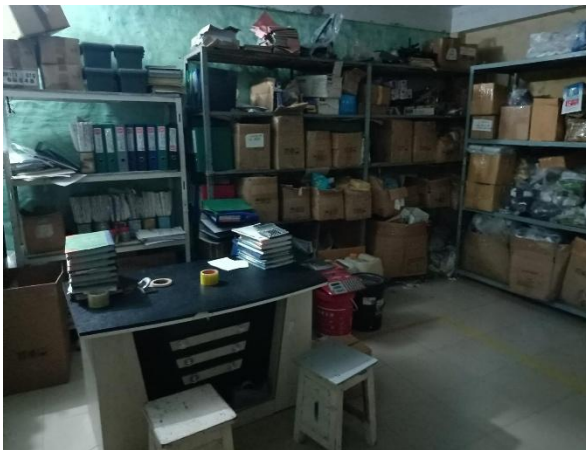
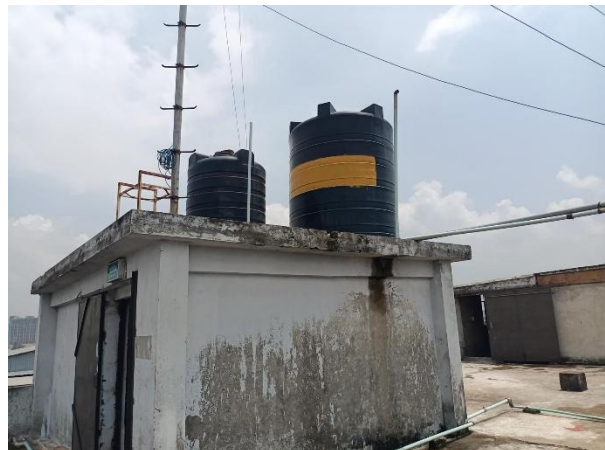
Observation-09: Non-structural elements not anchored or braced. (Production Building)

Description: Non-structural elements (PVC tank and Racks) were found on different floors of the building. Which were not properly anchored or braced. Building engineer is required to anchor or brace all non-structural elements to avoid falling hazard during earthquake or any lateral loading.

19.	Non-structural elements not anchored or braced. (Production Building)	Building engineer is required to anchor or brace all non-structural elements to avoid falling hazard during earthquake or any lateral loading.	within 6 weeks

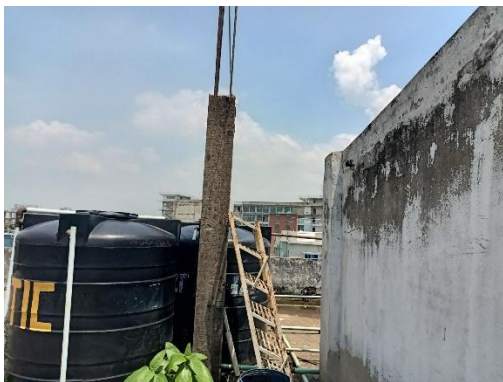
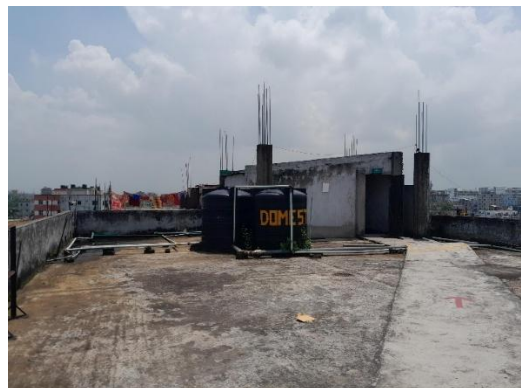
Observation-10: Exposed rebar on roof. (Production Building)

Description: During inspection, the exposed rebar was found on the roof. The building engineer is required to apply anti-rust proof coating on exposed rebar.

20.	Exposed rebar on roof. (Production Building)	The building engineer is required to apply anti-rust proof coating on exposed rebar.	within 6 weeks
21.	Lack of as-built drawings (Shed1: Washing)	The building engineer is required to survey the structure and prepare as-built drawings.	within 6 weeks

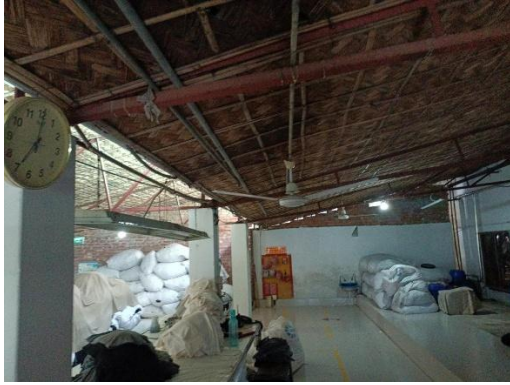
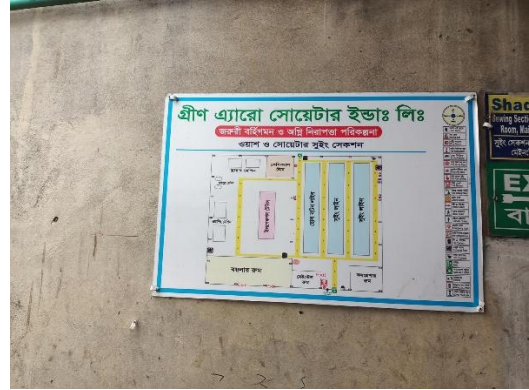
Observation-11: Lack of as-built drawings (Shed1: Washing)

Description: As-built structural & architectural drawings were not available for the structure. The building engineer is required to survey the structure and prepare as-built drawings.

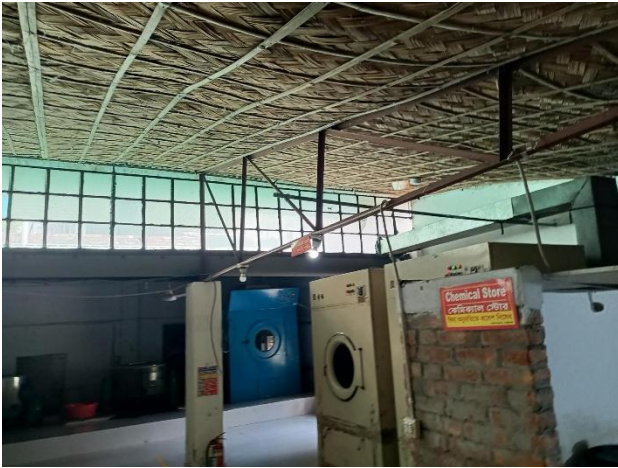
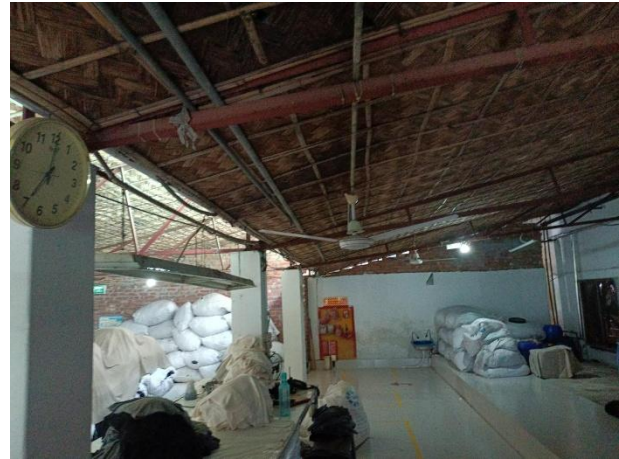
Observation-12: Lack of lateral stability. (Shed1: Washing)

Description: Load transfer media (bracing & strut) were found missing along the perpendicular direction of truss. The building engineer is required to carry out an Engineering Assessment (EA) to check the lateral stability, connection and member adequacy of these structures.

22.	Lack of lateral stability. (Shed1: Washing)	The building engineer is required to carry out an Engineering Assessment (EA) to check the lateral stability, connection and member adequacy of these structures.	within 6 weeks

23.	Lack of lateral stability. (Shed1: Washing)	Carry out the suggested remedial work if required.	within 6 months
24.	Lack of as-built drawings. (Shed 02)	The building engineer is required to survey the structures and prepare as-built drawings.	within 6 weeks

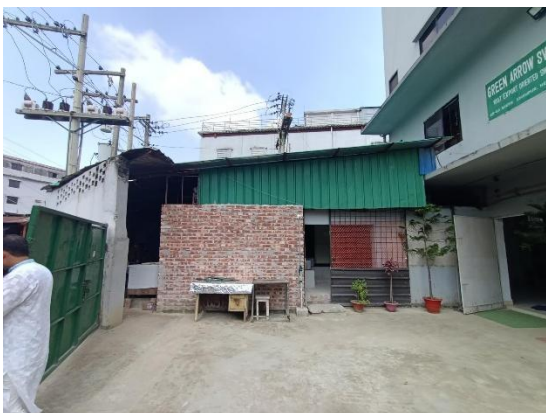
Shed 02

Observation-13: Lack of as-built drawings. (Shed 02 & Shed 03)

Description: As-built structural & architectural drawings were not available for those structures. The building engineer is required to survey the structures and prepare as-built drawings.

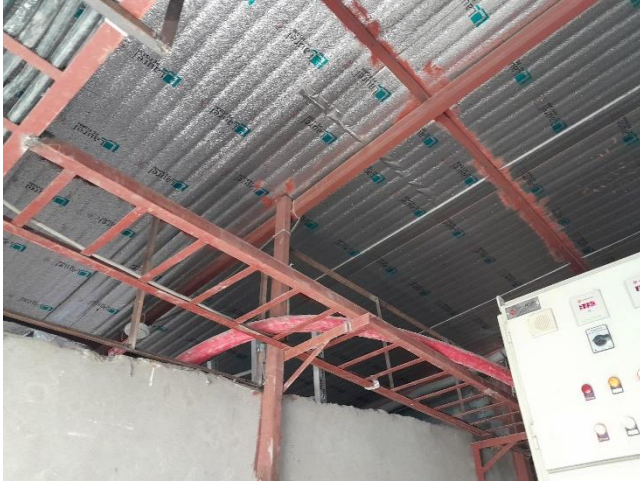
Shed 02

Observation-14: Incomplete framing and inadequate connection. (Shed 02 & Shed 03)

Description: Truss frames were poorly connected with brick walls. Also, incomplete farming and inadequate steel members were observed. The building engineer is required to check the framing system, member & connection adequacy of the sheds and prepare safety check report following Accord standard.

25.	Incomplete framing and inadequate connection. (Shed 02)	The building engineer is required to check the framing system, member & connection adequacy of the sheds and prepare safety check report following Accord combination.	within 6 weeks

26.	Incomplete framing and inadequate connection. (Shed 02)	Carry out the suggested remedial work if required.	within 6 months
27.	Lack of as-built drawings. (Shed 03)	The building engineer is required to survey the structures and prepare as-built drawings.	within 6 weeks
