Gumti Textile Ltd. (Extension)

Shafipur, Anser Academy, Kalikour, Gazipur

21 August 2025

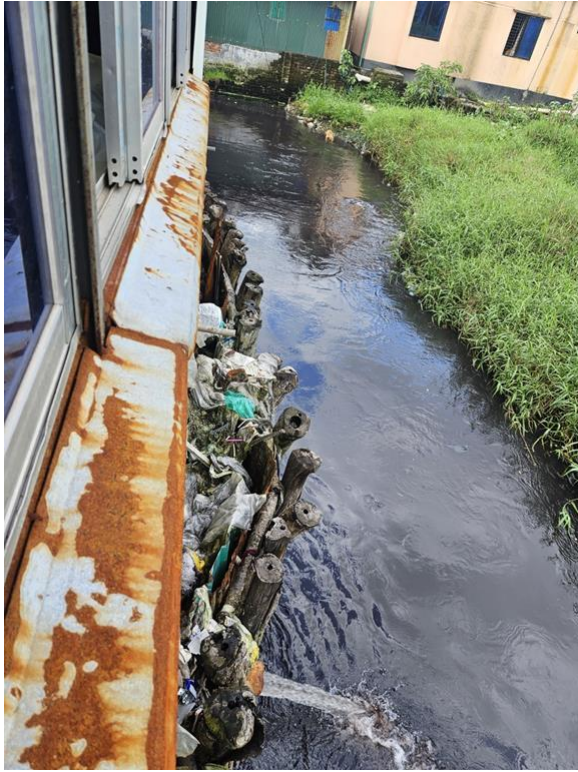
Observation-01: Settlement of floor, crack and tilting of wooden shore pile in Shed 2 & 3.

Tilting of wooden shore pile

Description: Settlement of the floor and settlement cracks were observed on the edges of the sheds 2 & 3 near the water body. Also, the tilting of the wooden shore pile was observed.

1. Building Engineer to check the shore protection and retaining wall capacity to assess the risk of collapse.
2. Appoint a Geotechnical Expert to investigate cracks, settlement, and pile tilting.
3. Implement interim safety measures recommended by the Geotechnical Expert.

Item No	Observation	Action Plan	Timeline
1.	Settlement of the floor, crack and tilting of the wooden shore pile in Shed 2 & 3.	Building engineer is required to commence the checking of the shore protection and the retaining wall capacity to evaluate the potential collapse at the edges of the shed 2, 3 near the water body.	Immediate

2.		Building engineer is required to appoint a geotechnical expert to investigate the cracks, settlement and tilting of the wooden pile. Any immediate safety measures need to be suggested in the investigation report.	Immediate

3.		Implement the interim safety measures as per the recommendation of the geotechnical expert.	Immediate
4.		Building engineer is required to submit the investigation report to the RSC for review.	within 6 weeks

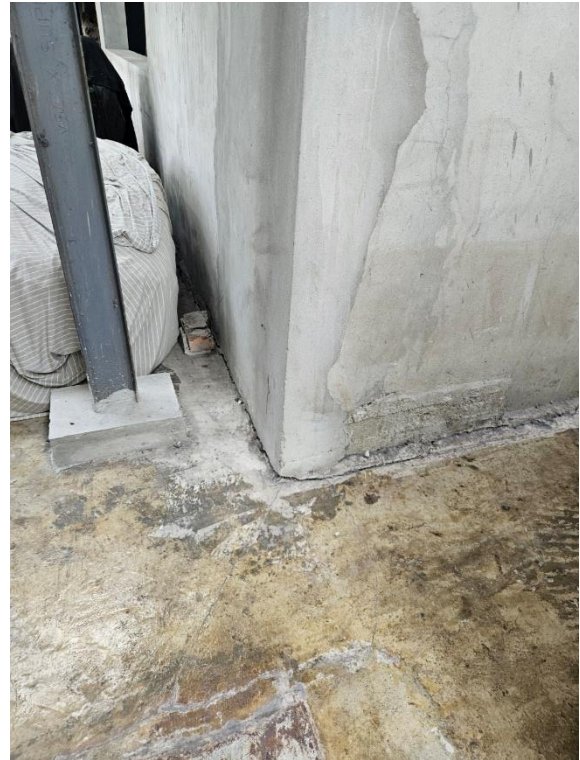
Settlement of the floor and cracks

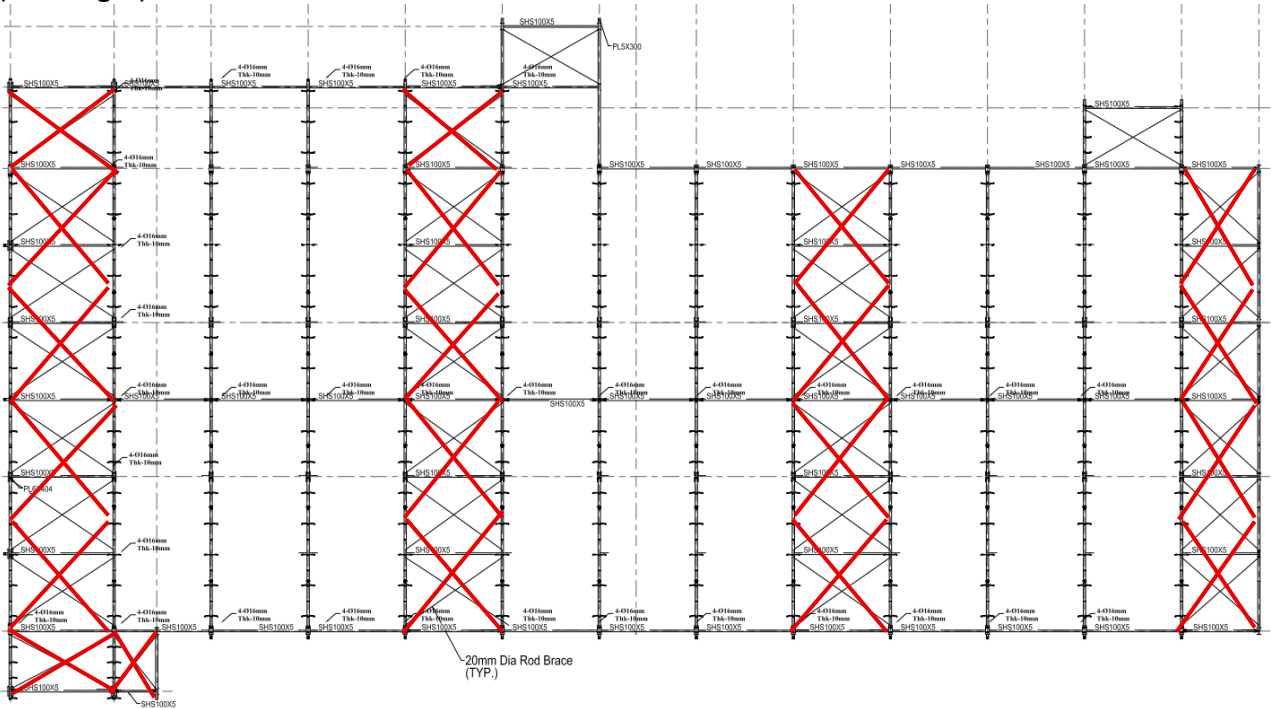
Observation-02: Inconsistency between the construction drawing and the onsite condition (Building D)

Bracing layout as per site condition (red marked)

Description: Discrepancies were observed between the construction drawings and onsite conditions regarding the roof bracing and compression strut layout. Eccentric connections (highlighted in yellow) were found where concentric connections were specified. The building engineer is required to survey the entire structure and prepare as-built drawings that accurately reflect site conditions.

5.		Carry out the required remedial work where required.	within 6 months
6.	Inconsistency between the construction drawing and the on-site conditions (Building D)	The building engineer is required to survey the entire structure and prepare as-built drawings that accurately reflect the actual site conditions.	within 6 weeks

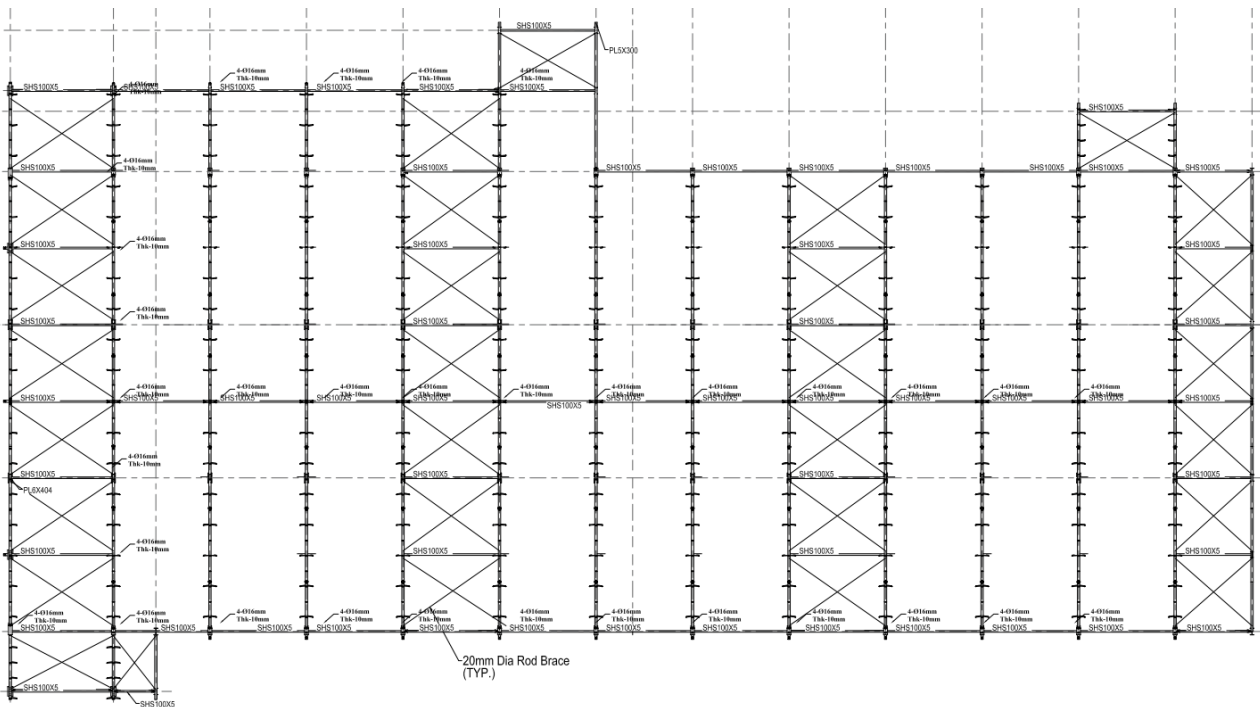
Bracing layout as a drawing

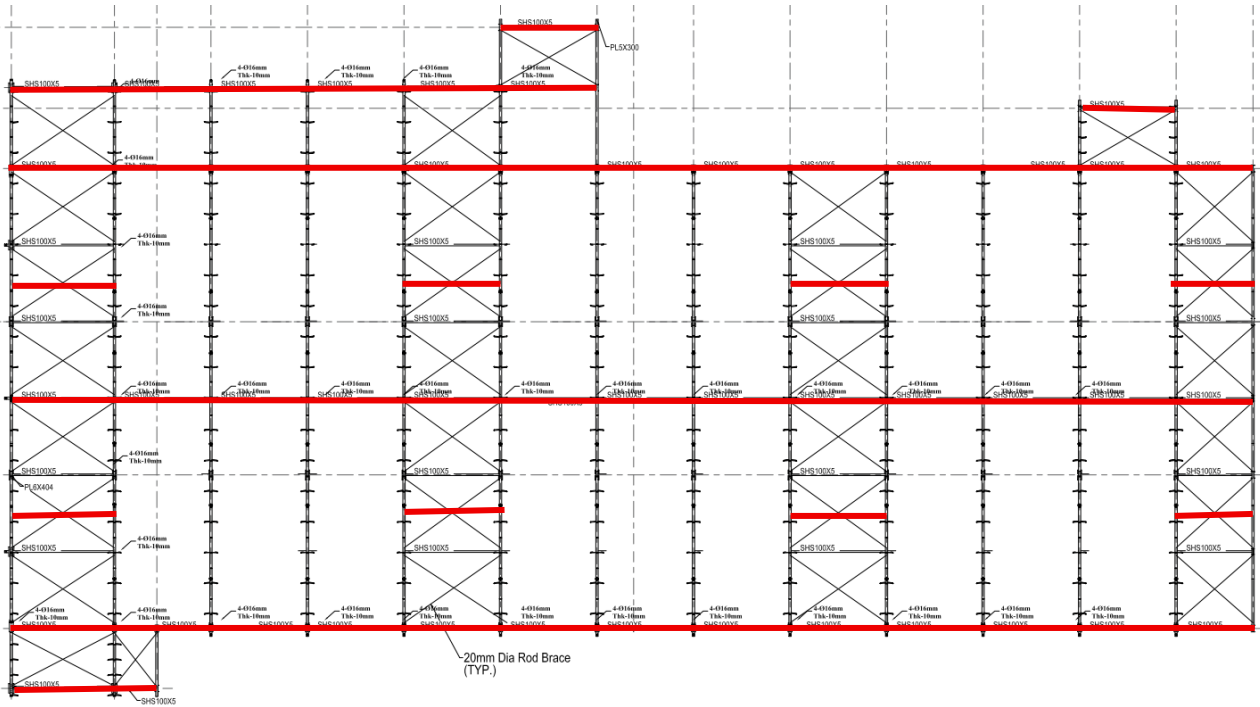
Strut layout as per site condition (red marked)

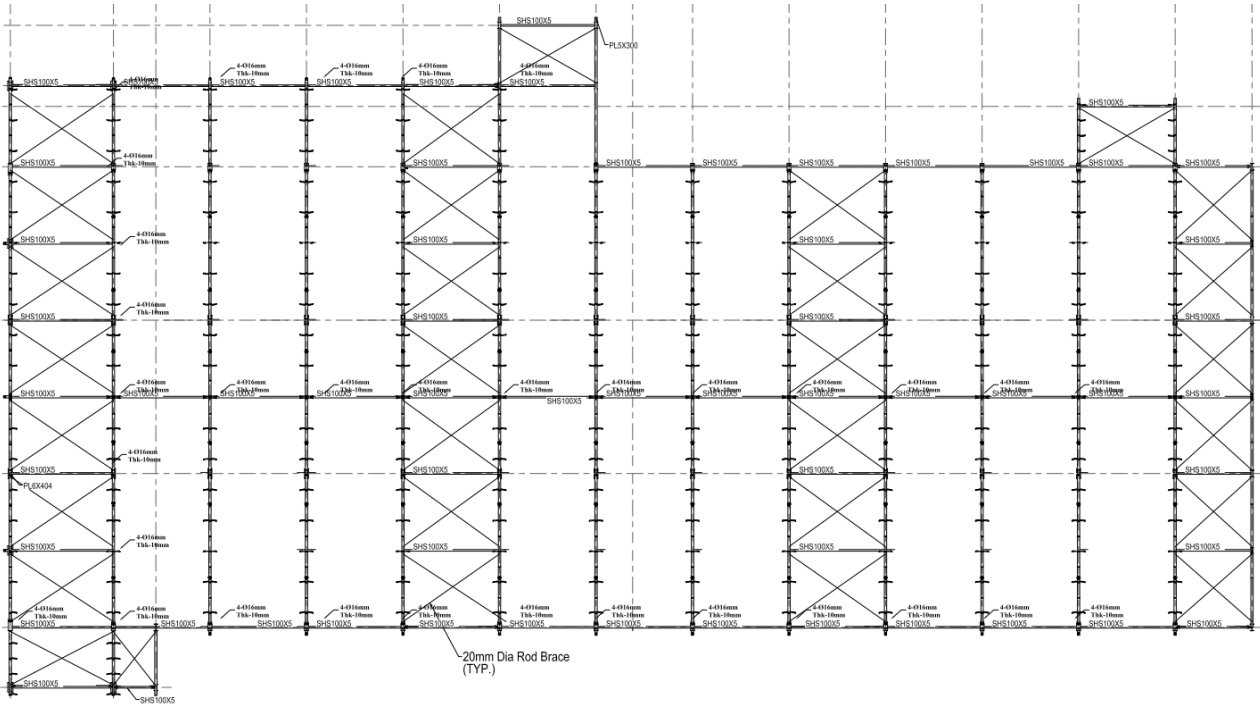
Strut layout as per drawing

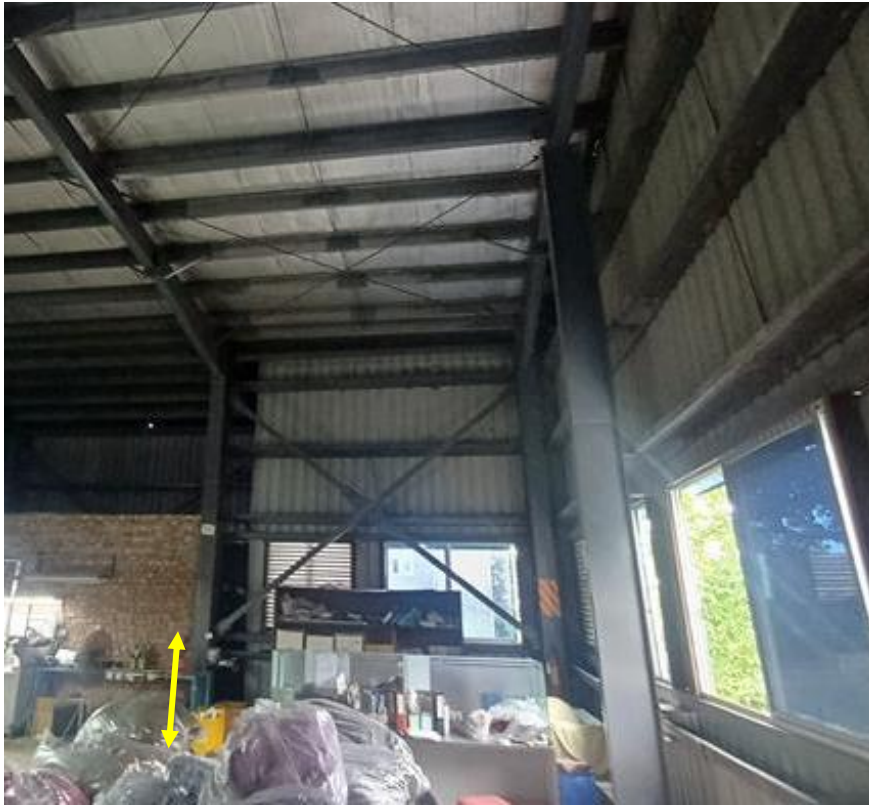
Eccentric connection

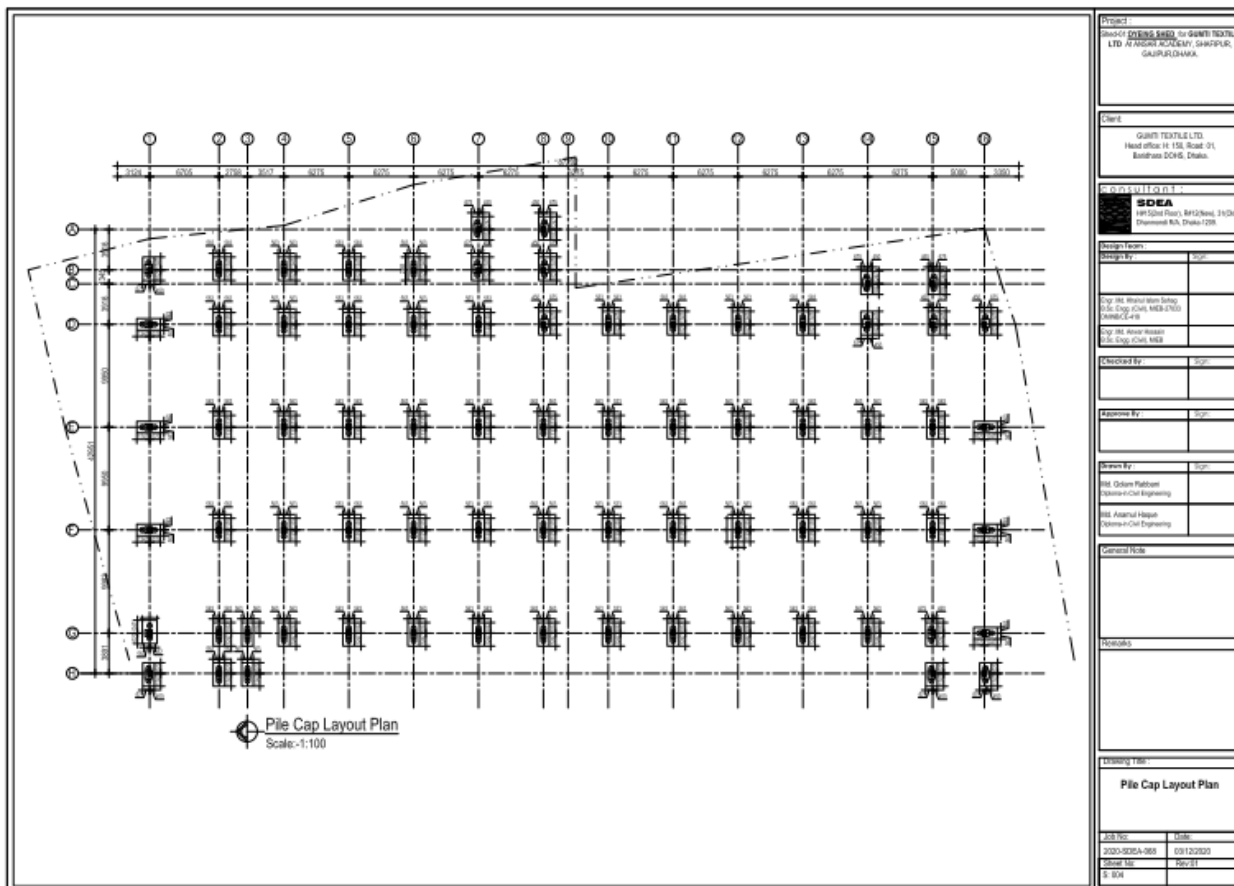
Observation-03: Non-credible as-built drawings & documentation, load plan missing. (Building D)

Description: Seal & signature were missing in the construction drawing, so these documents became non-credible; also load plan was found missing. The building engineer is required to carry out a Detail Engineering Assessment (DEA).

7.	Non-credible as-built drawings & documentation, load plan missing. (Building D)	The building engineer is required to carry out a Detail Engineering Assessment (DEA).	within 6 weeks

8.		Produce a floor live load plan for all floor plates following BNBC requirements and based on column & foundation capacity.	within 6 weeks
9.		Carry out the required remedial works where required.	within 6 months

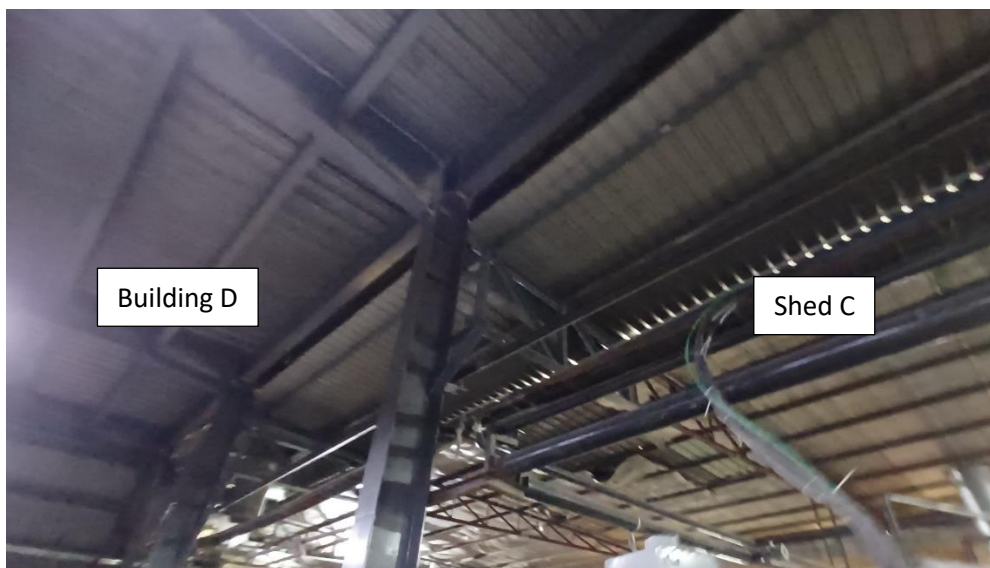
Observation-04: Structural connection between Building D and Shed C.

Description: Building D and Shed C (covered under RSC ID: 10974) are structurally connected. The building engineer is required to either physically separate the two structures or assess them as a single structural entity.

10.	Structural connection between Building D and Shed C	The building engineer is required to either physically separate the two structures or assess them as a single structural entity.	within 6 weeks

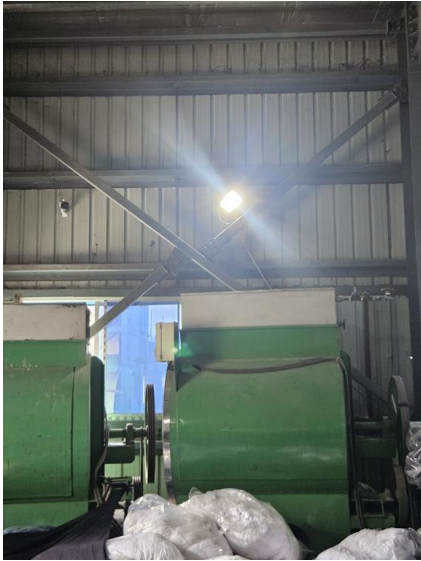
Misaligned vertical bracing

Description: During inspection, faulty erection was observed at several locations. The building engineer is required to investigate, identify & rectify all fabrication faults by suitable methods.

11.	Faulty erection (Building D)	Building engineer is required to investigate, identify & rectify all fabrication faults by suitable methods.	within 6 weeks

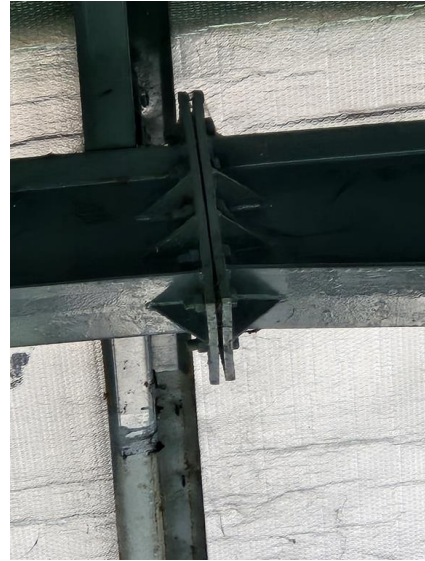
Connection gap

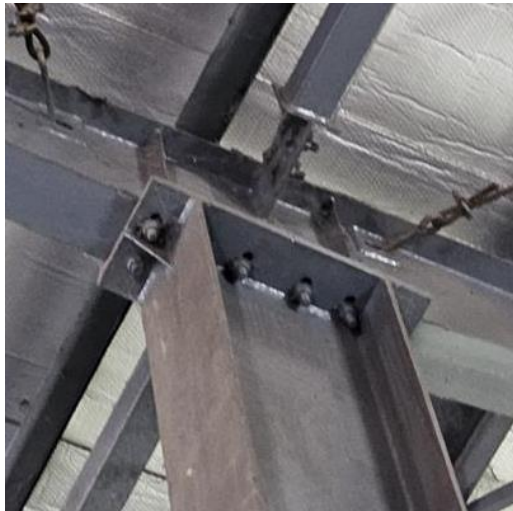
extra hole in the connection

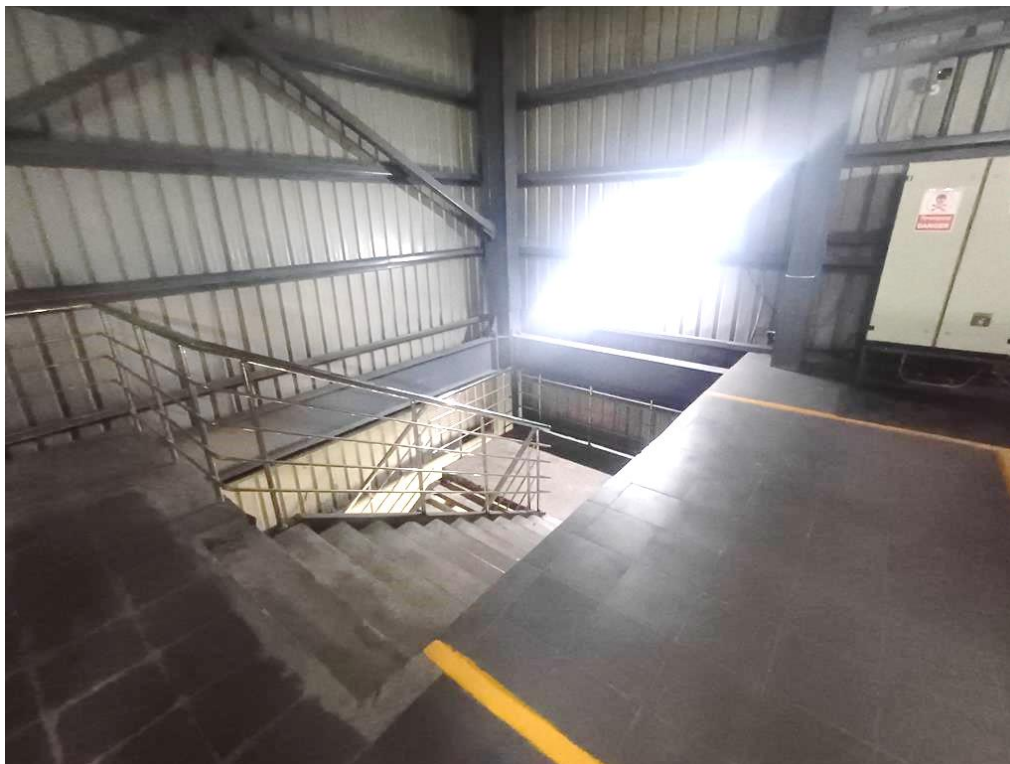
Observation-06: Falling hazard (Building D)

Description: A falling hazard was observed on the stairs. The factory is required to provide railing on stairs.

12.	Falling hazard (Building D)	The factory is required to provide railing or fall protection on the stairs.	within 6 weeks
13.	Corrosion on the steel member (Building D)	The building engineer is required to remove rust and apply anti-corrosive paint on steel members.	within 6 weeks

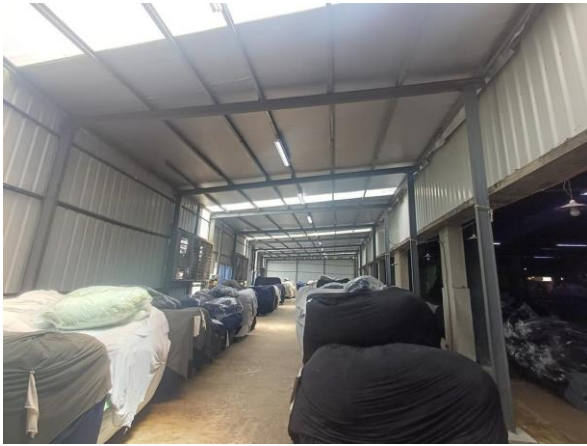
Shed 2

Observation-07: Lack of lateral stability system (Shed 2, Shed 3, LPG Storage & Vaporizer Room, Jhut Boiler Shed, Chemical Shed)

Description: A Portal frame was observed in the short direction. A compression strut or load transfer media was not observed in the long direction. Check the lateral stability of the structures.

15.	Lack of lateral stability system (Shed 2)	The building engineer is required to check the lateral stability of the shed as part of the Engineering Assessment (EA) and submit the EA to RSC.	within 6 weeks

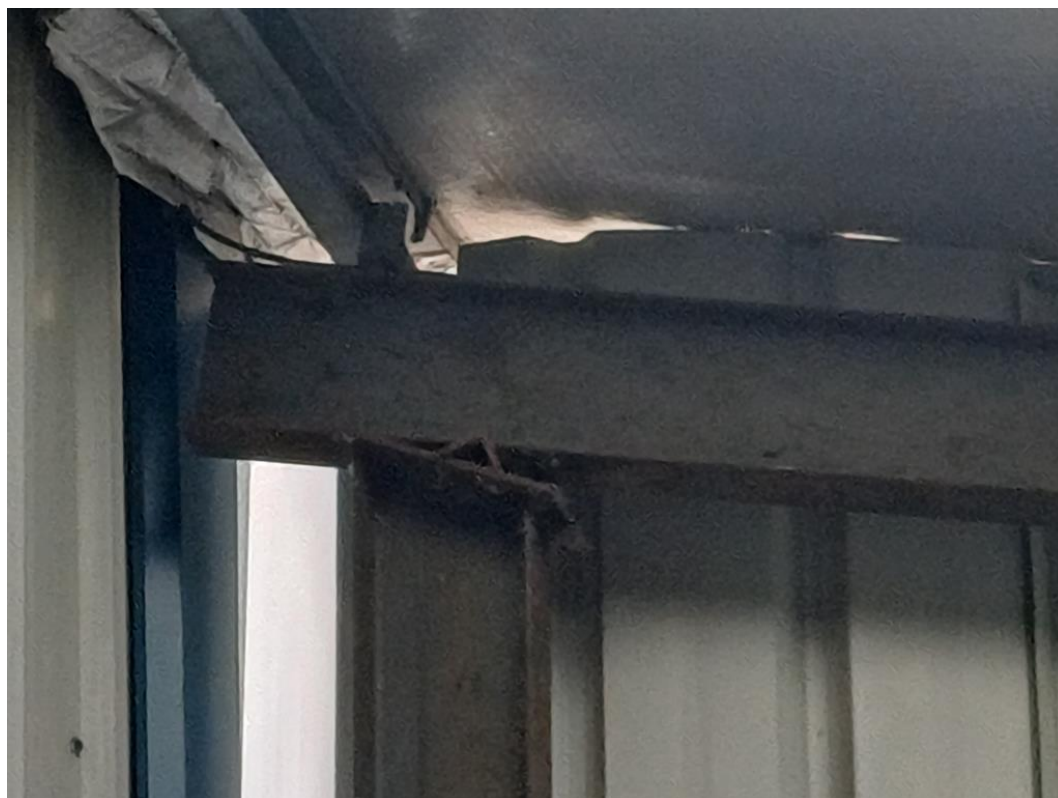
Improper connection

Description: During inspection, an improper connection was observed. The building engineer is required to rectify all faulty connections by suitable methods.

16.		Carry out the required remedial works where required.	within 6 months
17.	Improper connection (Shed 2)	The building engineer is required to rectify all faulty connections by suitable methods.	within 6 weeks

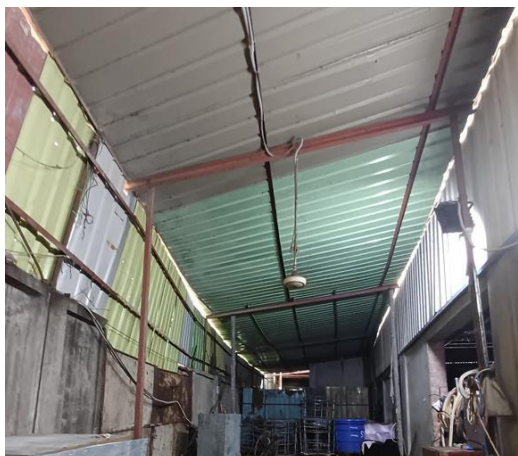
Toilet Zone

Observation-09: Inadequate connection & member size [Toilet Zone, Compressor room, Mini Boiler shed, CNG RCU]

Description: Inadequate connection and member size were observed. The building engineer is required to check the adequacy of the connection & member size.

24.	Inadequate connection & member size [Toilet Zone]	The building engineer is required to check the adequacy of the connection & member size as part of the EA and submit the EA to RSC.	within 6 weeks

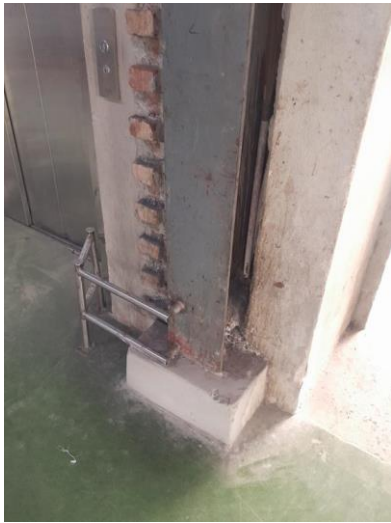
Building D

Observation-10: Corrosion on steel member (Building D, Shed 2, Shed 3, Toilet Zone, CNG RCU, LPG Storage & Vaporizer)

Description: During inspection, corrosion was observed at several locations. The building engineer is required to remove rust and apply anti-corrosive paint on steel members.

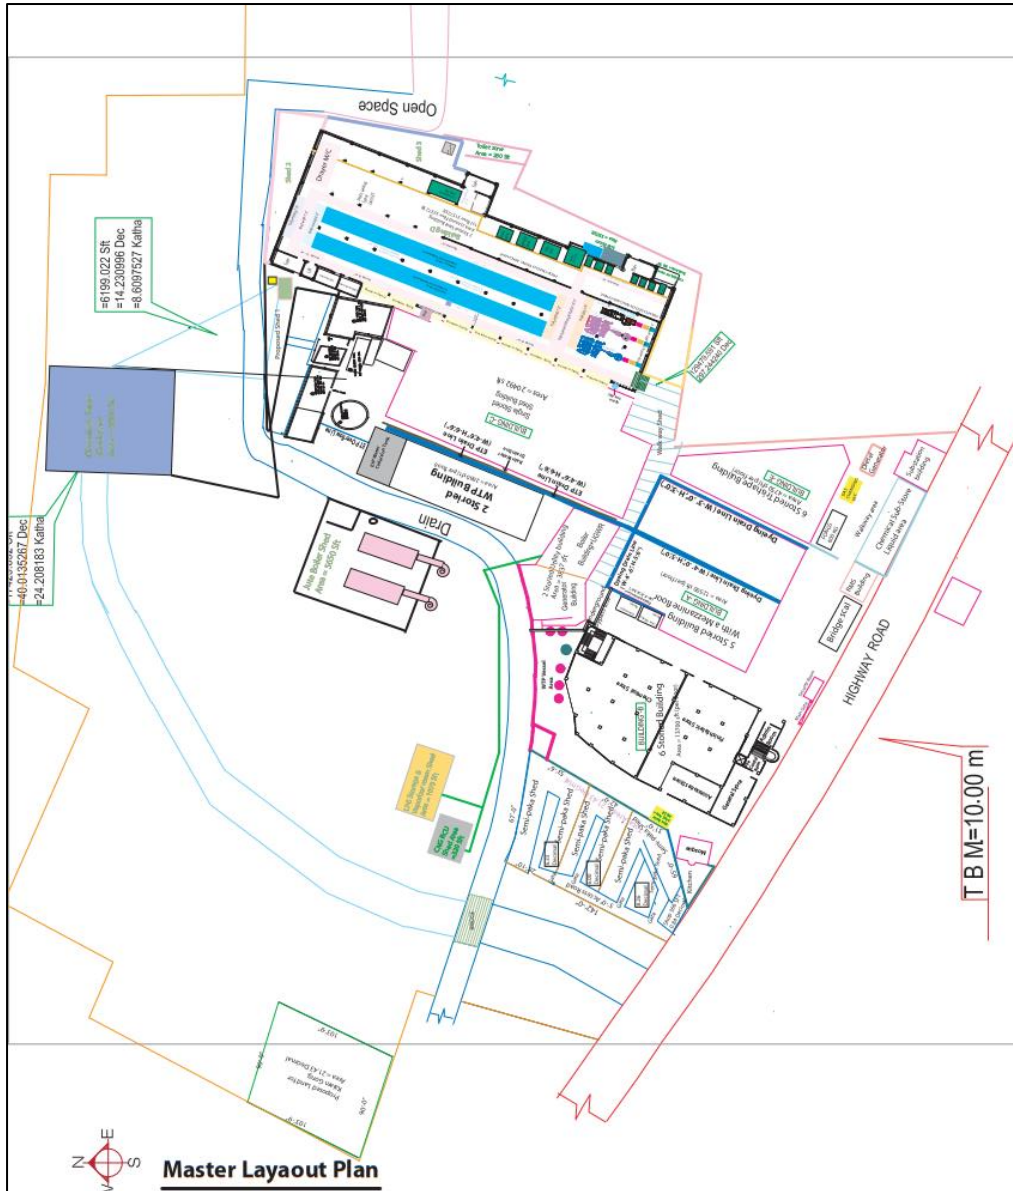
Observation-11: Lack of as-built drawing and building permit approval from the local authority (all structures)

Description: During the inspection, building permits from the local authority were not available for any structure. The factory authority is required to collect building permits from the local authority for all structures.

47.		Carry out the required remedial works where required.	within 6 months
48.	Lack of building permit approval from the local authority (all structures)	The factory authority is required to collect building permits from the local authority for all structures.	within 6 months
