# Knit Plus Limited (Unit-2)

09 December 2024 & 29 December 2024

## Structural Inspection Report

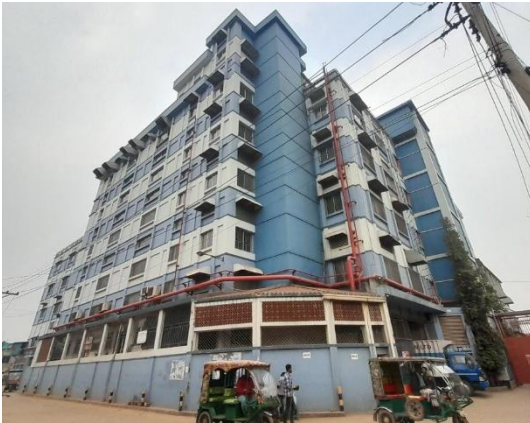
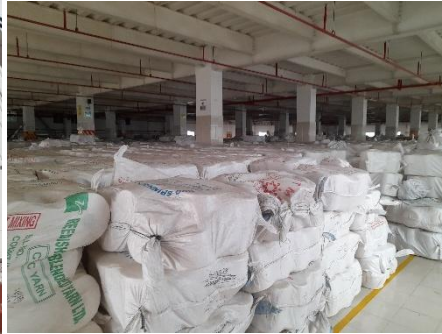
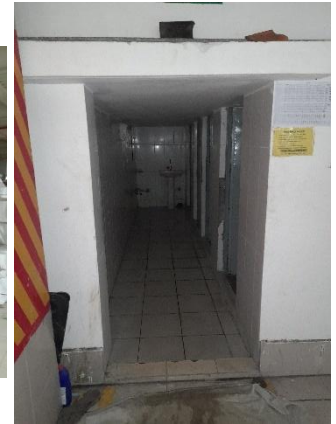
**Observation 1:** No credible document is available. Detail Engineering Assessment (DEA) needs to be performed. (Building-1A and 1B).

The building-1 consists of two parts. The five storied steel part (Building-1A) and the ten storied RC part (Building-1B). Both parts are structurally separate. During inspection, no drawing and design documents were available for the structures except an incomplete structural drawing for the steel part. The foundation information for both parts is unknown.

The Factory engineer is required to survey the whole structure and prepare accurate as built drawing. Also building engineer is required to perform Detail Engineering Assessment (DEA) for the structure based on in-situ material strength, floor live load and geotechnical investigation report and prepare DEA report based on the FEA model.

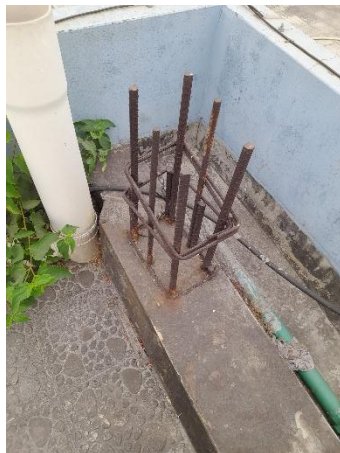
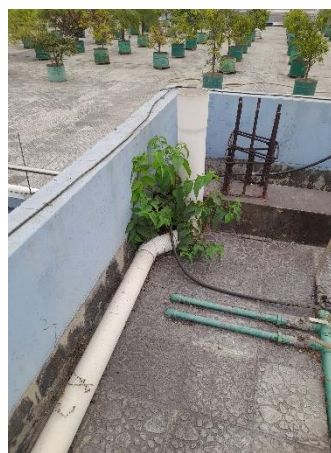
**Observation-2:** Vegetation and exposed re-bar at roof (Building-1B).

Exposed re-bar and vegetation at roof

Exposed reinforcement was found on rooftop for columns. The factory engineer is required to provide anti-corrosive coating in the re-bar to prevent corrosion in exposed rebar.

Also, vegetation was found on the roof. The building engineer is required to remove the vegetation from the roof.

| Item No. | Observation | Action Plan | Timeline |
|---|---|---|---|
| 8. | Vegetation and exposed re-bar at the roof (Building-1B). | The building engineer is required to repair the corrosion in the rebar and provide an anti-corrosive coating. | within 6 weeks |
| 9. | | The building engineer is required to remove all the vegetation. | within 6 weeks |

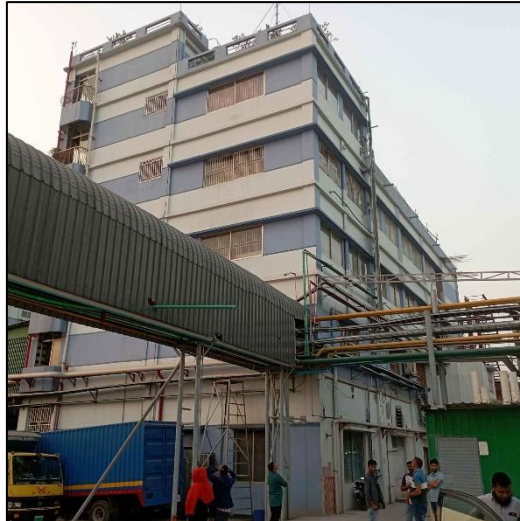
**Observation 3:** Lack of design documents (Building-2-Office building)

**Description:** As per BNBC, every building or structure designed shall have its design documents prepared by the provision of Section 1.9.1. The design document shall include a design report, and a set of structural drawings, which shall be prepared in compliance with section 1.9.1.1 and section 1.9.1.2 as per BNBC. At the time of inspection, the design report and structural drawing were unavailable. Besides, a set of architectural drawings was available without any elevation. Also, no load plan or test report (geotechnical investigation report/cylinder test report/rebar test report) was available. The building engineer is required to prepare a load plan, and geotechnical investigation report, verify concrete strength by taking 4 (minimum) cores from the column, and prepare a Detailed Engineering Assessment (DEA).

| Item No. | Observation | Action Plan | Timeline |
|---|---|---|---|
| 10. | Lack of design documents (Building-2-Office building). | The building engineer is required to prepare a Detailed Engineering Assessment (DEA) and submit it to RSC for review. | within 6 weeks |

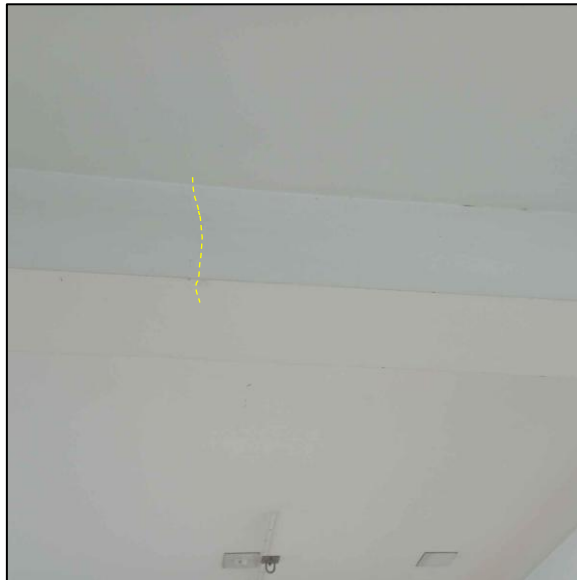
**Observation 4:** Hairline crack on floor beam (Building-2-Office building).

**Description:** A hairline crack was found on the roof floor beams. The building engineer is required to repair the crack with a suitable method.

| 16. | Hairline crack on the floor beam<br>(Building-2-Office building). | The building engineer is required to repair the crack with a suitable method. | within 6 weeks |

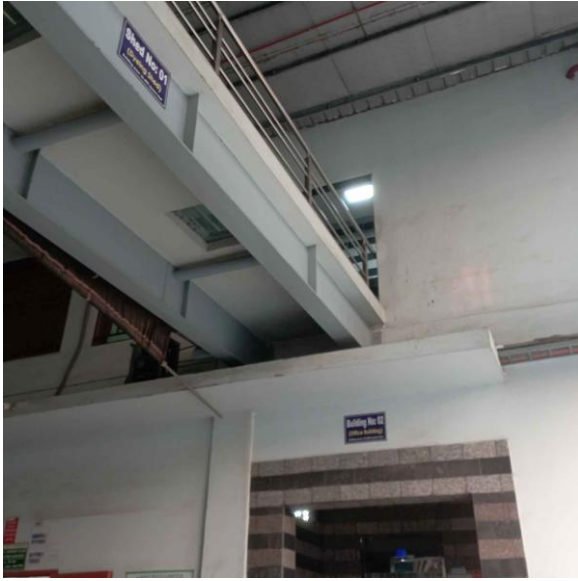
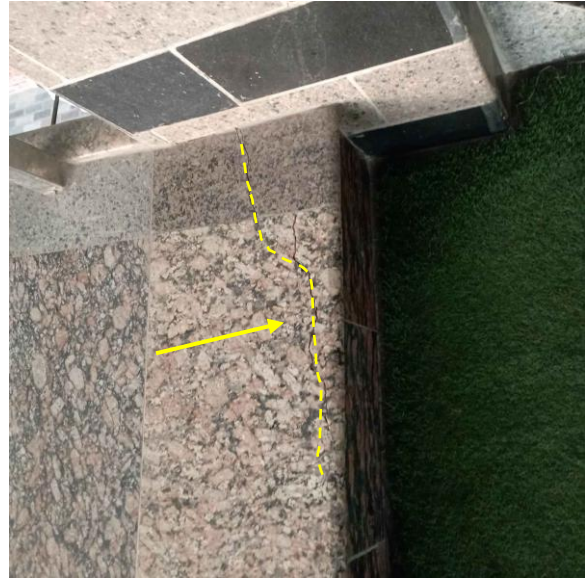
**Observation 5:** Crack observed at connecting bridge area (Building-2-Office building).

**Description:** A connecting bridge was observed between Building 2 and the adjacent structure. However, a crack was observed on the slab of the connecting bridge at the Building-2 side. The building engineer is required to investigate the cracked area and prepare an investigation report. Also, prepare an assessment report on the bridge connecting as per onsite conditions. Implement remediation work accordingly.

| 17. | Crack was observed at the connecting bridge area<br>(Building-2-Office building). | The building engineer is required to investigate the cracked area and prepare an investigation report. Also, prepare an assessment report on the bridge connecting as per onsite conditions. | within 6 weeks |
| 18. | | Implement remediation work accordingly. | within 6 months |

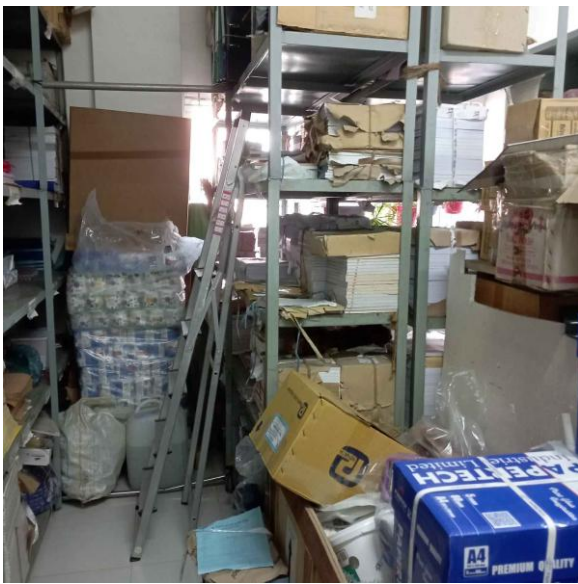
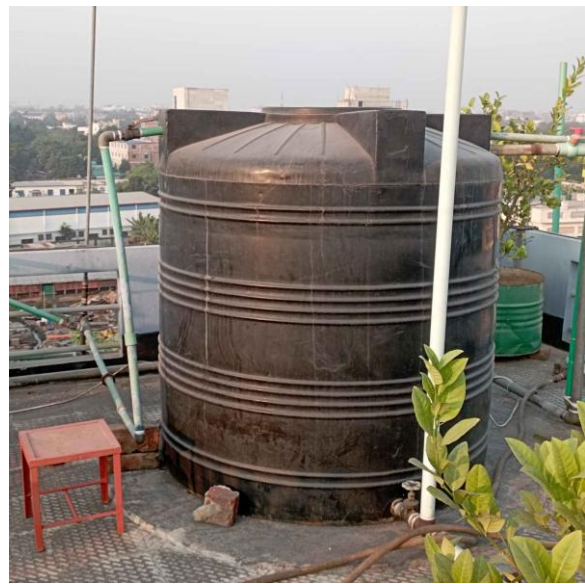
**Observation 6:** Non-structural elements found unbraced/not anchored (Building-2-Office building).

**Description:** Non-structural elements found unbraced/not anchored. The building engineer is required to brace/anchor all non-structural elements.

| 20. | Nonstructural elements were found not anchored/braced<br>(Building-2-Office building). | The building engineer is required to anchor/brace all nonstructural elements within the factory. | within 6 months |

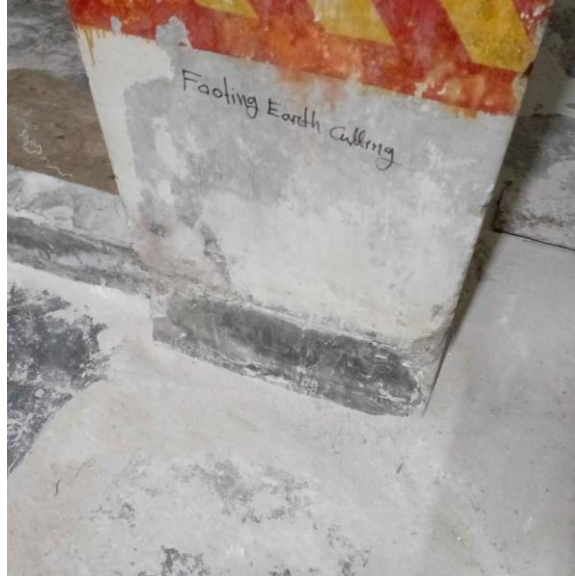
**Observation 7:** Column plaster damage due to trolley impact (Building-2-Office building).

**Description:** Column plaster damage was found due to trolley impact. The building engineer is required to repair the plaster and provide a column guard to prevent trolley impact.

| 19. | Column plaster damage due to trolley impact (Building-2-Office building). | The building engineer is required to repair the plaster and provide a column guard to prevent trolley impact. | within 6 weeks |

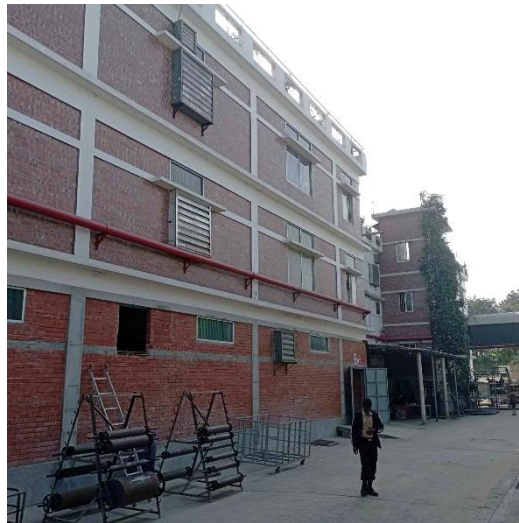
**Observation 8:** Lack of design documents. (Building 3-Sub-station Building).

**Description:** As per BNBC, every building or structure designed shall have its design documents prepared following the provision of Section 1.9.1. The design document shall include a design report, and a set of structural drawings, which shall be prepared in compliance with section 1.9.1.1 and section 1.9.1.2 as per BNBC. At the time of inspection, the design report was unavailable. Besides, a set of architectural drawings was available without any elevation. Also, no load plan or test report (geotechnical investigation report/cylinder test report/rebar test report) was available. The building engineer is required to prepare a load plan, and geotechnical investigation report, verify concrete strength by taking 4 (minimum) cores from the column, and prepare a Detailed Engineering Assessment (DEA).

| 21. | Lack of design documents.<br>(Building 3-Sub-station Building). | The building engineer is required to prepare a Detailed Engineering Assessment (DEA) and submit it to RSC for review. | within 6 weeks |

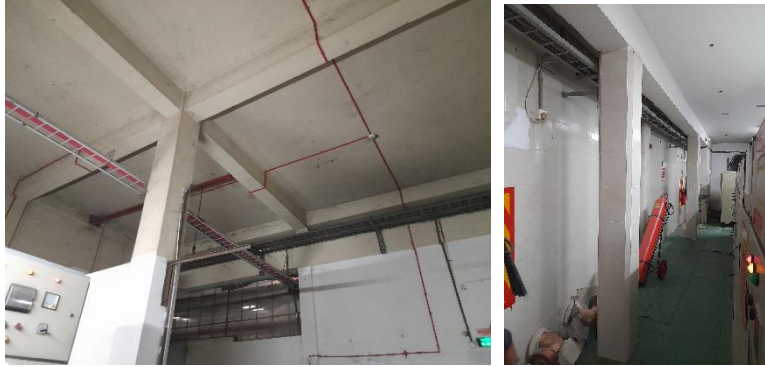
**Observation-9:** No credible document available. Detail Engineering Assessment (DEA) needs to be performed. (Building-4).

**Description:** During the inspection, no drawing and design documents were available for the structures. Also, foundation information is unknown.

The Factory engineer is required to survey the whole structure and prepare accurate as-built drawings. Also building engineer is required to perform Detailed Engineering Assessment (DEA) for the structure based on in-situ material strength, floor live load and geotechnical investigation report and prepare DEA report based on the FEA model.

| 27. | No credible document was available. Detail Engineering Assessment (DEA) needs to be performed. (Building-4). | The building engineer is required to survey the whole structure and prepare accurate as-built drawings. | within 6 weeks |

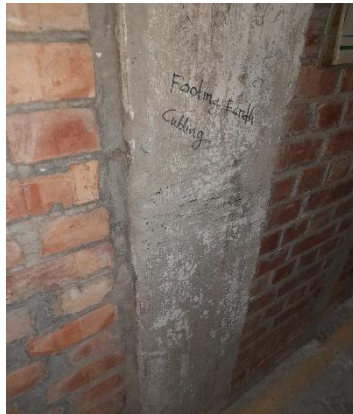
**Observation-10:** Trolley impact in column (Building-4).

**Description:** During inspection, trolley impact was found in the RC column. The building engineer is required to provide the barrier in the column to mitigate the trolley impact.

| 30. | Trolley impact in column<br>(Building-4). | The building engineer is required to provide a column guard to mitigate the trolley impact. | within 6 weeks |

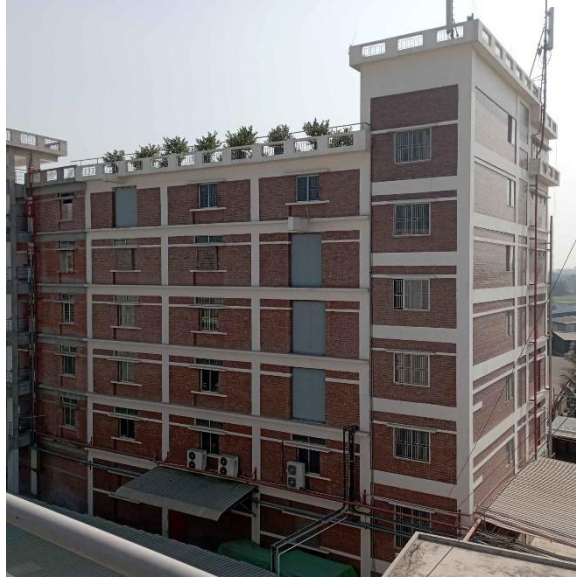
**Observation 11:** Lack of design documents. (Building 5-Embroidery Building).

**Description:** As per BNBC, every building or structure designed shall have its design documents prepared by the provision of Section 1.9.1. The design document shall include a design report, and a set of structural drawings, which shall be prepared in compliance with section 1.9.1.1 and section 1.9.1.2 as per BNBC. At the time of inspection, the design report and structural drawing were unavailable. Besides, a set of architectural drawings was available without any elevation. Also, no load plan or test report (geotechnical investigation report/cylinder test report/rebar test report) was available. The building engineer is required to prepare a load plan, and geotechnical investigation report, verify concrete strength by taking 4 (minimum) cores from the column, and prepare a Detailed Engineering Assessment (DEA).

| 31. | Lack of design documents (Building 5-Embroidery Building). | The building engineer is required to prepare a Detailed Engineering Assessment (DEA) and submit it to RSC for review. | within 6 weeks |

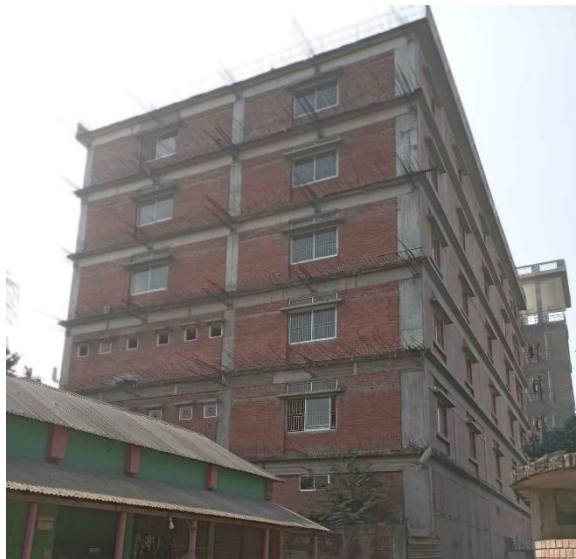
**Observation 12:** Exposed reinforcement (Building 5-Embroidery Building).

**Description:** Exposed rebar was found on the east side of the building which is prone to corrosion. The building engineer is required to provide rust-proof paint on the exposed rebar.

| 37. | Exposed reinforcement (Building 5-Embroidery Building). | The building engineer is required to provide rust-proof paint on the exposed rebar. | within 6 months |

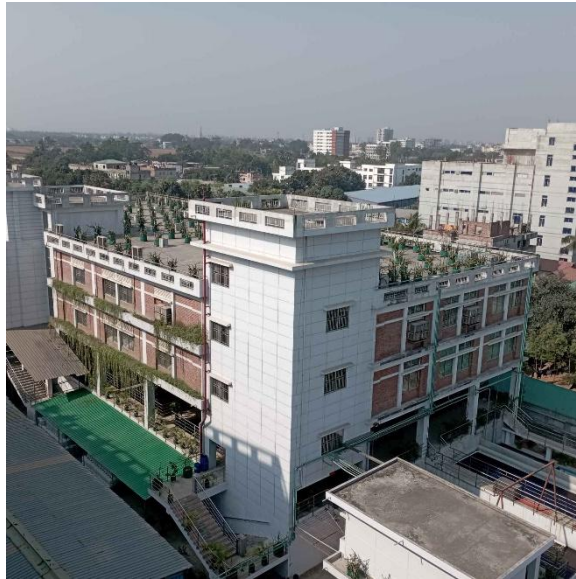
**Observation 13:** Lack of design documents. (Building 6-E.T.P Building).

**Description:** As per BNBC, every building or structure designed shall have its design documents prepared in accordance with the provision of Section 1.9.1. The design document shall include a design report, and a set of structural drawings, which shall be prepared in compliance with section 1.9.1.1 and section 1.9.1.2 as per BNBC. At the time of inspection, the design report and structural drawing were unavailable. Besides, a set of architectural drawings was available without any elevation. Also, no load plan or test report (geotechnical investigation report/cylinder test report/rebar test report) was available. The building engineer is required to prepare a load plan, and geotechnical investigation report, verify in-situ concrete strength by taking 4 (minimum) cores from the column, and prepare a Detailed Engineering Assessment (DEA).

| 38. | Lack of design documents. (Building 6-E.T.P Building). | The building engineer is required to prepare a Detailed Engineering Assessment (DEA) and submit it to RSC for review. | within 6 weeks |

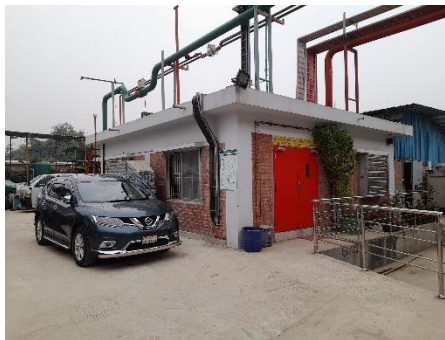
**Observation-14:** No credible document available. Detail Engineering Assessment (DEA) needs to be performed. (Building-7).

**Description:** During inspection, no drawing and design documents were available for the structures. Also, foundation information are unknown.

The Factory engineer is required to survey the whole structure and prepare accurate as built drawing. Also building engineer is required to perform Detail Engineering Assessment (DEA) for the structure based on in-situ material strength, floor live load and geotechnical investigation report and prepare DEA report based on the FEA model.

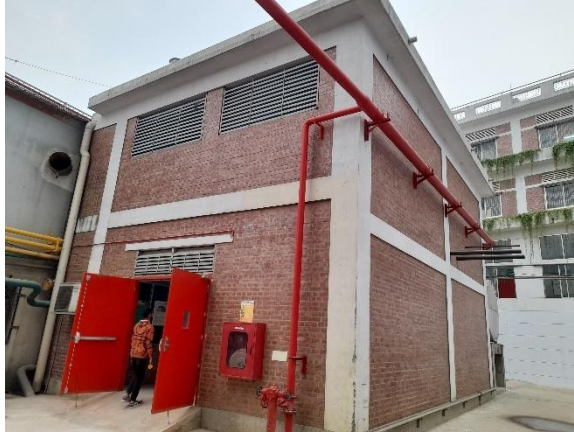
**Observation-15:** No credible document available. Detail Engineering Assessment (DEA) needs to be performed. (Building-8).

**Description:** During the inspection, no drawing and design documents were available for the structures. Also, foundation information is unknown.

The Factory engineer is required to survey the whole structure and prepare accurate as built drawings. Also building engineer is required to perform Detail Engineering Assessment (DEA) for the structure based on in-situ material strength, floor live load and geotechnical investigation report and prepare DEA report based on the FEA model.

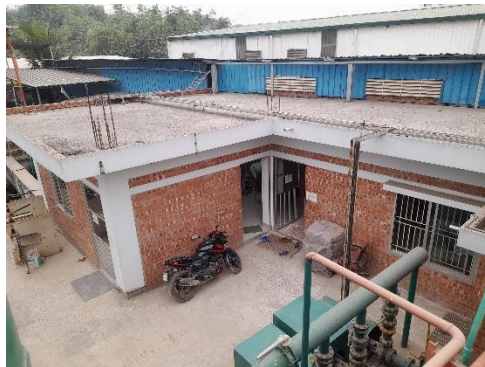
**Observation-16:** No credible document is available. Detail Engineering Assessment (DEA) needs to be performed. (Building-9).

**Description:** During the inspection, no drawing and design documents were available for the structures. Also, foundation information are unknown.

The Factory engineer is required to survey the whole structure and prepare accurate as-built drawings. Also building engineer is required to perform a Detail Engineering Assessment (DEA) for the structure based on in-situ material strength, floor live load and geotechnical investigation report and prepare a DEA report based on the FEA model.

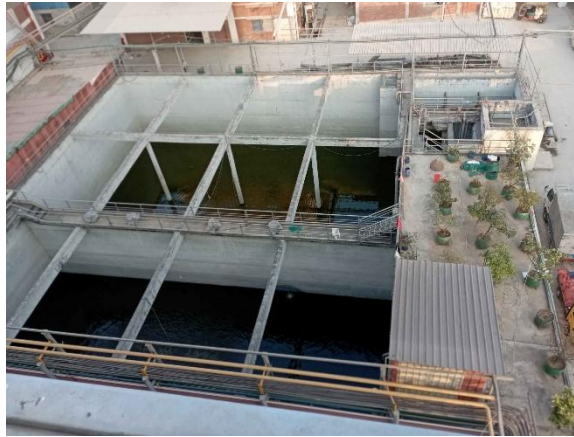
**Observation 17:** Lack of design documents. (Building 10- Old ETP Building).

**Description:** As per BNBC, every building or structure designed shall have its design documents prepared by the provision of Section 1.9.1. The design document shall include a design report, and a set of structural drawings, which shall be prepared in compliance with section 1.9.1.1 and section 1.9.1.2 as per BNBC. At the time of inspection, the design report and structural drawing were unavailable. Also, no load plan or test report (geotechnical investigation report/cylinder test report/rebar test report) was available. The building engineer is required to prepare a load plan, and geotechnical investigation report, verify concrete strength by taking 4 (minimum) cores from the column, and prepare a Detailed Engineering Assessment (DEA).

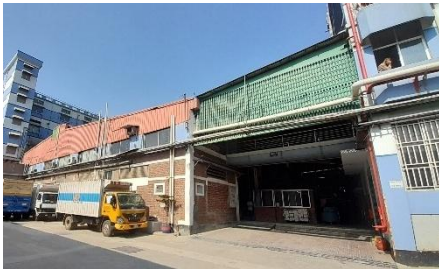
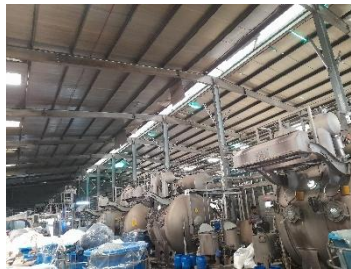
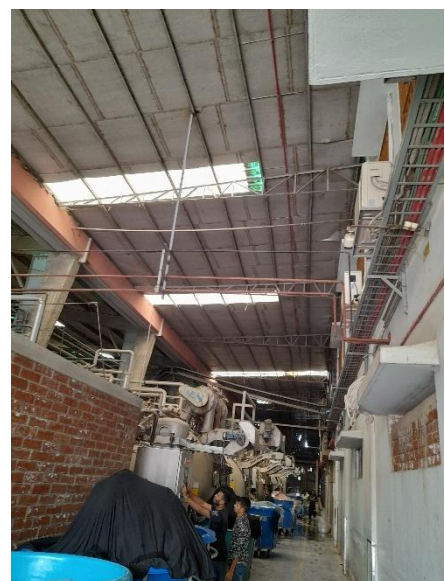
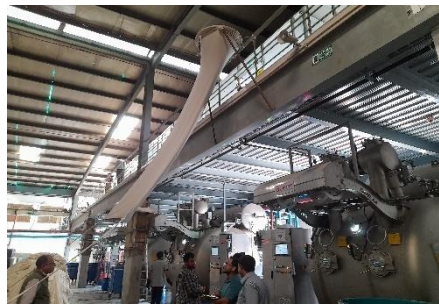
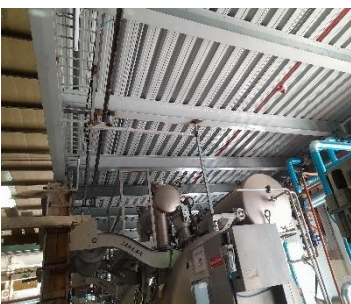
**Observation-18:** No credible document available. Detail Engineering Assessment (DEA) needs to be performed. (Shed-1).

**Description:** During the inspection, no drawing and design documents were available for the structures. The lack of the lateral stability was found along the long direction of shed. Also, foundation information are unknown.

The Factory engineer is required to survey the whole structure and prepare accurate as built drawing. Also building engineer is required to perform Detail Engineering Assessment (DEA) for the structure based on in-situ material strength and geotechnical investigation report and prepare DEA report based on the FEA model.

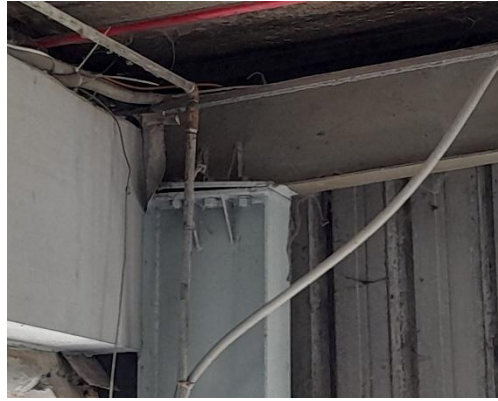
**Observation-19:** Connection gap (Shed-1).

**Description:** During the inspection, a connection gap was found in the steel joint. The building engineer is required to repair the connection gap with a suitable method.

| 68. | Connection gap (Shed-1). | The building engineer is required to repair the connection gap. | within 6 weeks |

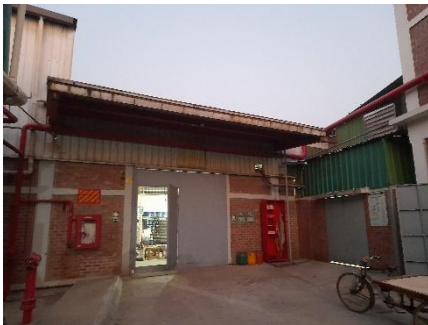
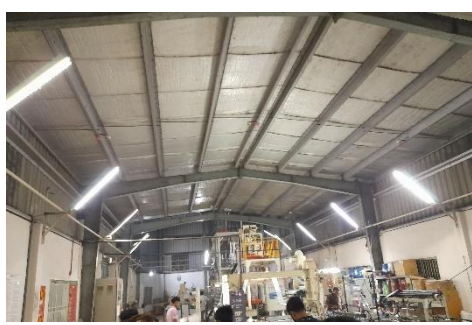
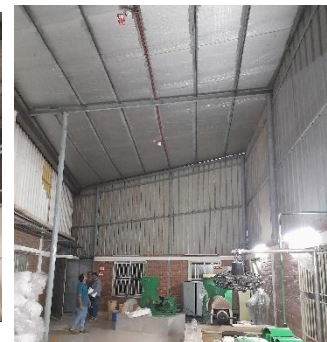
**Observation-20:** No credible document is available. Detail Engineering Assessment (DEA) needs to be performed. (Shed-2).

**Description:** During the inspection, no drawing and design documents were available for the structures. An incomplete structural drawing was available for the shed. Also, foundation information is unknown. The lack of lateral stability was found along the long direction for the shed. The Factory engineer is required to survey the whole structure and prepare accurate as built drawing. Also building engineer is required to perform Detail Engineering Assessment (DEA) for the structure based on in-situ material strength and geotechnical investigation report and prepare DEA report based on the FEA model.

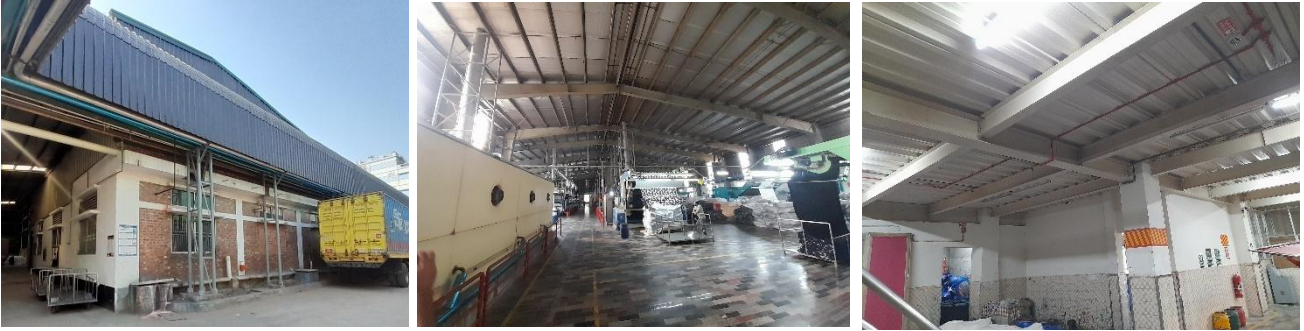
**Observation-21:** Lack of a full set of design documents. Detail Engineering Assessment (DEA) needs to be performed. (Shed-3).

**Description:** During inspection, only structural drawing was available for the shed. Architectural drawing, load plan for the mezzanine and foundation information were not available. The Factory engineer is required to survey the whole structure and prepare accurate as built drawing. Also building engineers are required to perform Detail Engineering Assessment (DEA) for the structure based on in-situ material strength, floor live load and geotechnical investigation report and prepare DEA report based on the FEA model.

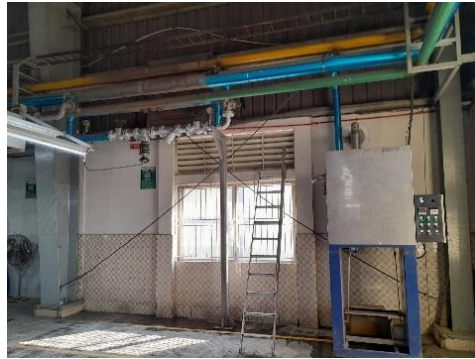
**Observation-22:** Loose cable bracing. (Shed-3)

**Description:** During the inspection, loose cable bracing was found. Building engineer is required to tighten the loose cable bracing.

| 77. | Loose cable bracing. (Shed-3) | The building engineer is required to tighten the loose bracing. | within 6 months |

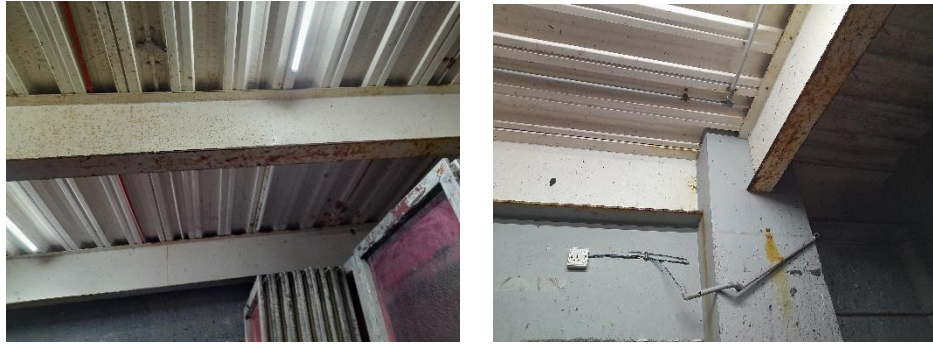
**Observation-23:** Corrosion was found in steel section (Shed-3).

**Description:** During the inspection, corrosion was found in the steel section. The Building engineers are required to repair the corrosion and provide the anti-corrosive coating to avoid further corrosion.

| 78. | Corrosion was found in the steel section (Shed-3). | The building engineer is required to repair the corrosion and provide an anti-corrosive coating. | within 6 weeks |

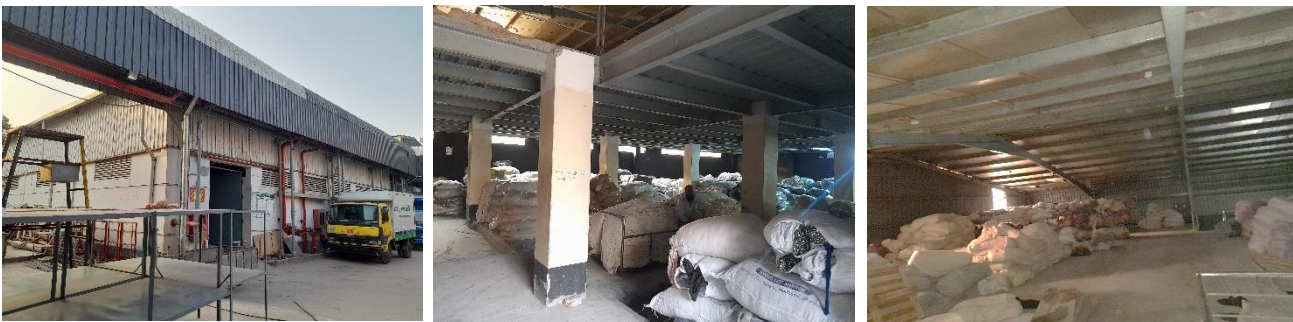
**Observation-24:** No credible document available. Detail Engineering Assessment (DEA) needs to be performed. (Shed-4).

**Description:** During the inspection, no drawing, load plan and design documents were available for the structures. Also, foundation information is unknown. The lack of lateral stability was found along the long direction of the shed.

The Factory engineer is required to survey the whole structure and prepare accurate as-built drawings. Also building engineer is required to perform a Detail Engineering Assessment (DEA) for the structure based on in-situ material strength and geotechnical investigation report and prepare a DEA report based on the FEA model.

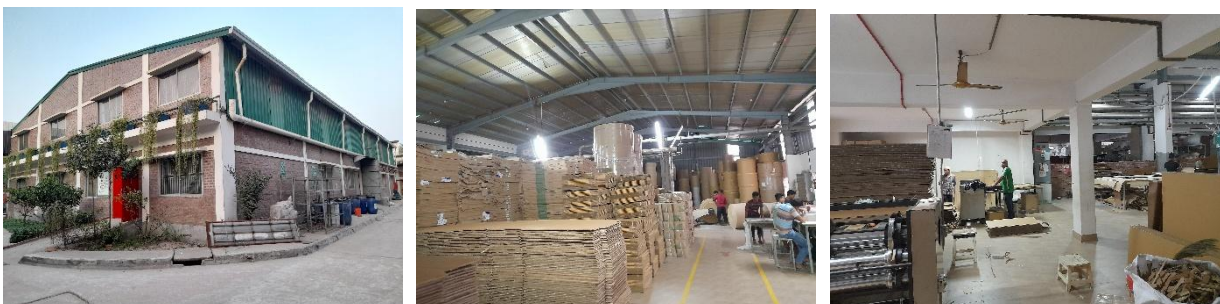
**Observation-25:** No credible document available. Detail Engineering Assessment (DEA) needs to be performed. (Shed-5).

**Description:** During the inspection, no drawing, load plan and design documents were available for the structures. Also, foundation information is unknown. The lack of lateral stability was found along the long direction of the shed.

The Factory engineer is required to survey the whole structure and prepare accurate as built drawings. Also building engineer is required to perform a Detail Engineering Assessment (DEA) for the structure based on in-situ material strength and geotechnical investigation report and prepare a DEA report based on the FEA model.

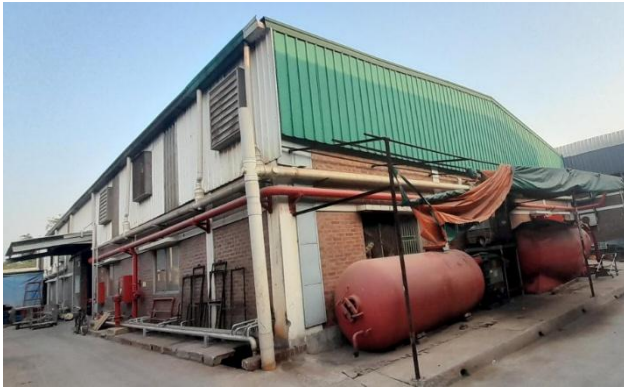
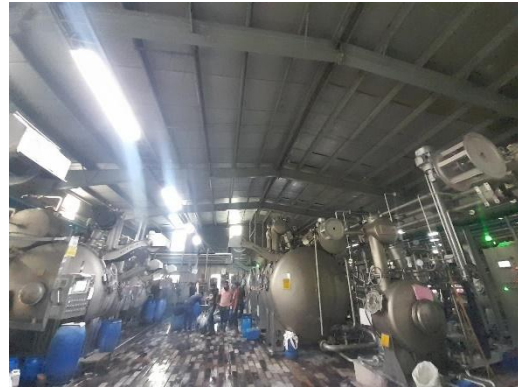
Shed 6

**Observation 26:** Absence of design documents (Shed-6)

**Description:** As per BNBC, every building or structure designed shall have its design documents prepared in accordance with the provision of Section 1.9.1. The design document shall include a design report, and a set of structural drawings, which shall be prepared in compliance with section 1.9.1.1 and section 1.9.1.2 as per BNBC. However, at the time of inspection, the design report and as-built drawing were not available. The building engineer is required to check the lateral stability of the sheds and prepare the design report and as-built drawing in compliance with section 1.9.1 (Part 6, BNBC).

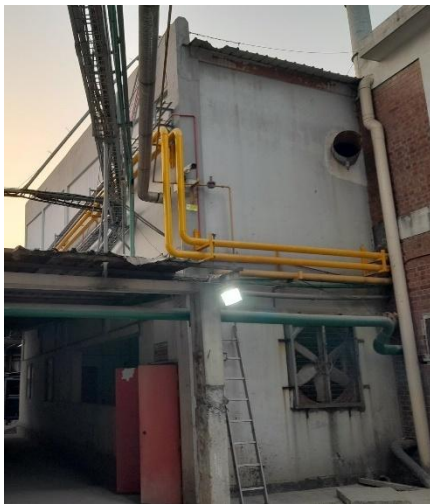
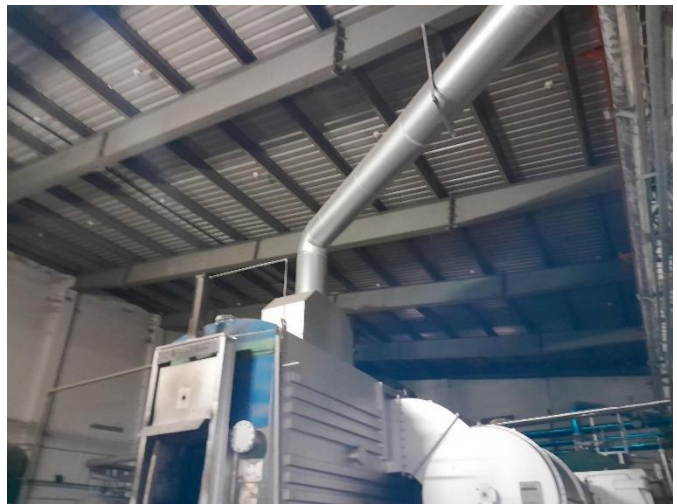
**Observation 27:** Absence of design documents (Shed- 7)

**Description:** As per BNBC, every building or structure designed shall have its design documents prepared in accordance with the provision of Section 1.9.1. The design document shall include a design report, and a set of structural drawings, which shall be prepared in compliance with section 1.9.1.1 and section 1.9.1.2 as per BNBC. However, at the time of inspection, the design report and as-built drawing were not available. The building engineer is required to check the lateral stability of the sheds and prepare the design report and as-built drawing in compliance with section 1.9.1 (Part 6, BNBC).

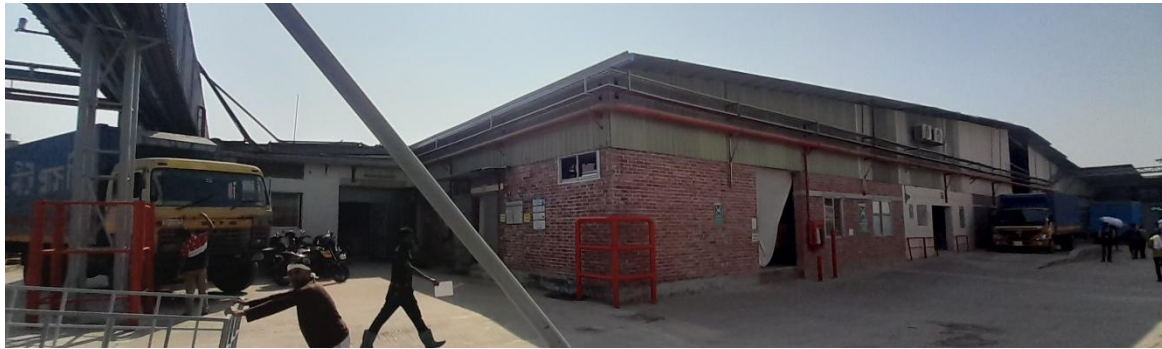
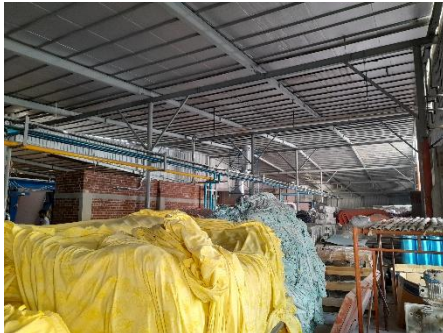
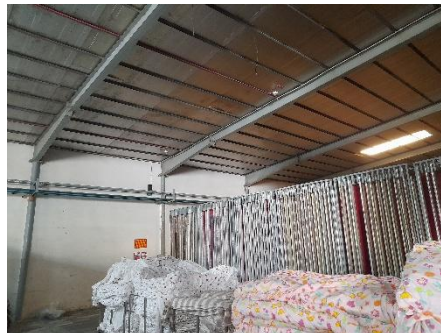
**Observation-28:** No credible document available. Detail Engineering Assessment (DEA) needs to be performed. (Shed-8).

**Description:** During the inspection, no drawing, load plan and design documents were available for the structures. Also, foundation information is unknown. The lack of lateral stability was found along the long direction of the shed.

The Factory engineer is required to survey the whole structure and prepare accurate as built drawings. Also building engineer is required to perform a Detail Engineering Assessment (DEA) for the structure based on in-situ material strength and geotechnical investigation report and prepare a DEA report based on the FEA model.

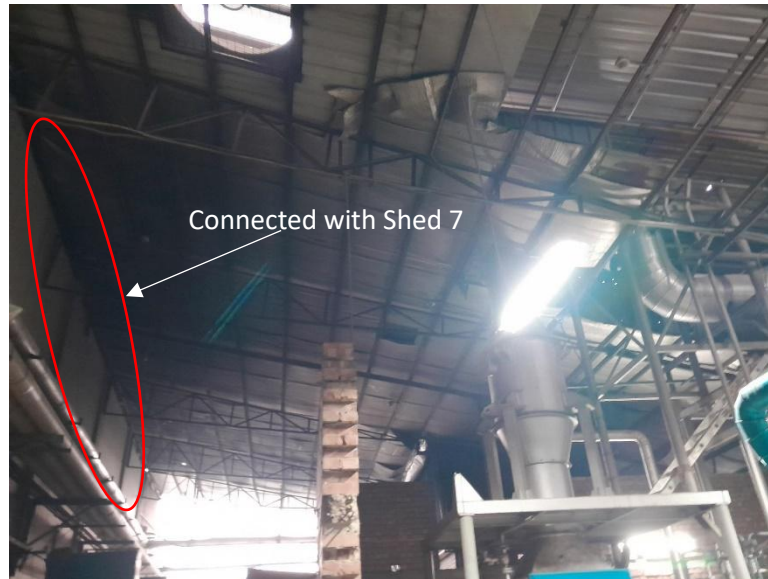
**Observation 29:** Lack of lateral stability and absence of design documents (Shed- 9)

**Description:** During the inspection, it was observed that Shed 9 is partially connected with Shed 7. However, no lateral load transfer mechanism is provided to adequately transfer lateral loads between the sheds. Additionally, a bracing system is absent in the structure, which raises concerns about lateral stability. Also, as per BNBC, every building or structure designed shall have its design documents prepared following the provision of Section 1.9.1. The design document shall include a design report, and a set of structural drawings, which shall be prepared in compliance with section 1.9.1.1 and section 1.9.1.2 as per BNBC. During the inspection, neither the design report nor the as-built drawings were available for review. The building engineer must verify the lateral stability of Shed 9 and Shed 7 and prepare the design report and as-built drawing in compliance with section 1.9.1 (Part 6, BNBC).

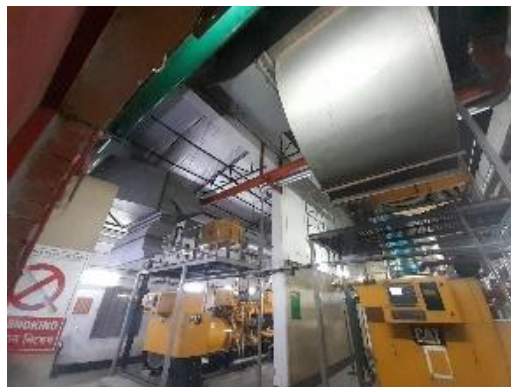
Shed 10

**Observation 30:** Lack of lateral stability and absence of design documents (Shed- 10)

**Description:** Lateral load transfer media is not provided to transfer the lateral load. Also, the bracing system is not provided. Also, as per BNBC, every building or structure designed shall have its design documents prepared following the provision of Section 1.9.1. The design document shall include a design report, and a set of structural drawings, which shall be prepared in compliance with section 1.9.1.1 and section 1.9.1.2 as per BNBC. However, at the time of inspection, the design report and as-built drawing were not available. The building engineer is required to check the lateral stability of the sheds and prepare the design report and as-built drawing in compliance with section 1.9.1 (Part 6, BNBC).

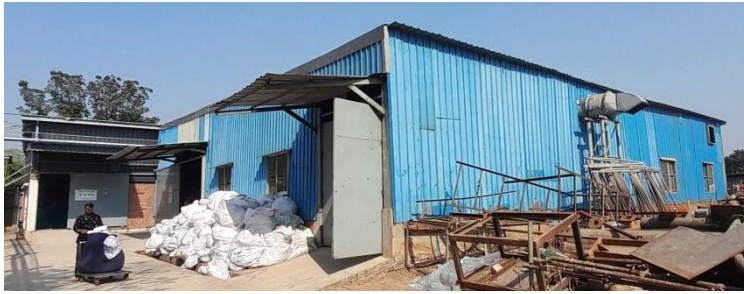
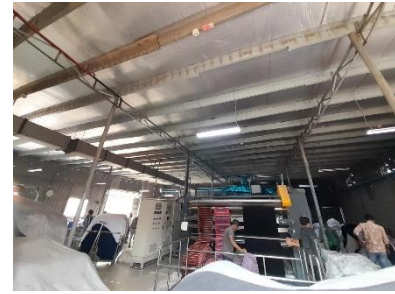
Shed 11

**Observation 31:** Lack of lateral stability and absence of design documents (Shed- 11)

**Description:** Lateral load transfer media is not provided to transfer the lateral load. Also, the bracing system is not provided. Also, as per BNBC, every building or structure designed shall have its design documents prepared in accordance with the provision of Section 1.9.1. The design document shall include a design report, and a set of structural drawings, which shall be prepared in compliance with section 1.9.1.1 and section 1.9.1.2 as per BNBC. However at the time of inspection, the design report and as-built drawing were not available. The building engineer is required to check the lateral stability of the sheds, and prepare the design report and as-built drawing in compliance with section 1.9.1 (Part 6, BNBC).

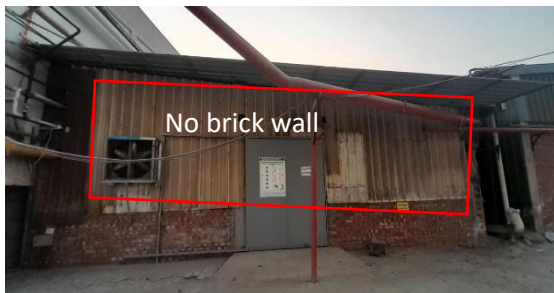
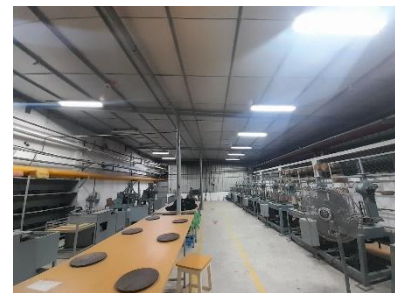
Shed 14

**Observation 32:** Lack of lateral stability and improper connection in roof shed. (Shed- 14)

**Description:** Lateral load transfer media is not provided to transfer the lateral load. Also, improper connection was observed in the roof shed. The building engineer is required to check the lateral stability and connection adequacy of the shed, and prepare the safety check report and as-built drawing.

| 108. | Lack of lateral stability and improper connection in the roof shed. (Shed- 14) | The building engineer is required to check the lateral stability and connection adequacy of the shed and prepare the safety check report and as-built drawing. | within 6 weeks |

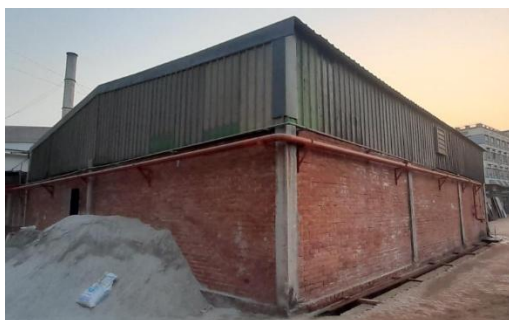
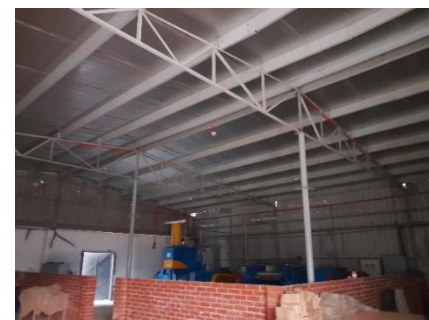
Shed 15

**Observation 33:** Lack of lateral stability and absence of design documents (Shed- 15).

**Description:** Lateral load transfer media is not provided to transfer the lateral load. Also, the bracing system is not provided. Also, as per BNBC, every building or structure designed shall have its design documents prepared following the provision of Section 1.9.1. The design document shall include a design report, and a set of structural drawings, which shall be prepared in compliance with section 1.9.1.1 and section 1.9.1.2 as per BNBC. However, at the time of inspection, the design report and as-built drawing were not available. The building engineer is required to check the lateral stability of the sheds and prepare the design report and as-built drawing in compliance with section 1.9.1 (Part 6, BNBC).

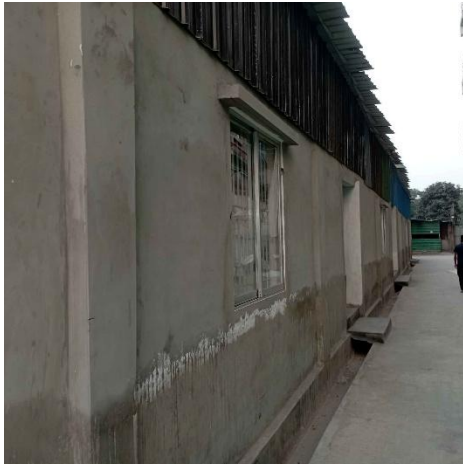
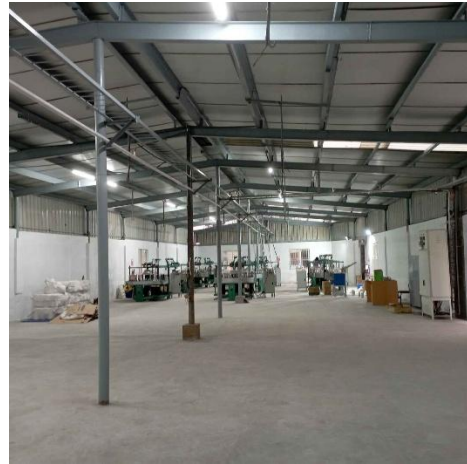
**Observation 34:** Lack of lateral stability/design documents. (Shed 16 Embroidery Shed).

**Description:** As per BNBC, every building or structure designed shall have its design documents prepared following the provision of Section 1.9.1. The design document shall include a design report, and a set of structural drawings, which shall be prepared in compliance with section 1.9.1.1 and section 1.9.1.2 as per BNBC. At the time of inspection, the design report and structural drawing were unavailable. Besides, no test report (geotechnical investigation report/cylinder test report/rebar test report) was available. Also, no bracing system (strut/vertical or horizontal bracing) was observed. The building engineer is required to check lateral stability, prepare a geotechnical investigation report, verify steel strength, and prepare a Detailed Engineering Assessment (DEA).

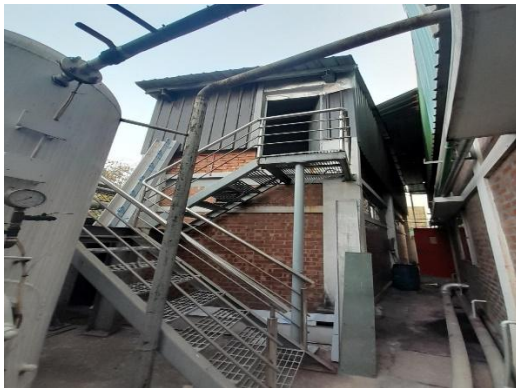
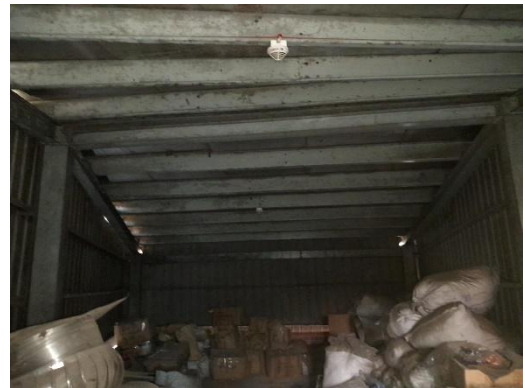
Shed 18

**Observation 35:** Absence of design documents (Shed- 18).

**Description:** As per BNBC, every building or structure designed shall have its design documents prepared following the provision of Section 1.9.1. The design document shall include a design report, and a set of structural drawings, which shall be prepared in compliance with section 1.9.1.1 and section 1.9.1.2 as per BNBC. However, at the time of inspection, the design report and as-built drawing were not available. The building engineer is required to check the lateral stability of the sheds and prepare the design report and as-built drawing in compliance with section 1.9.1 (Part 6, BNBC).

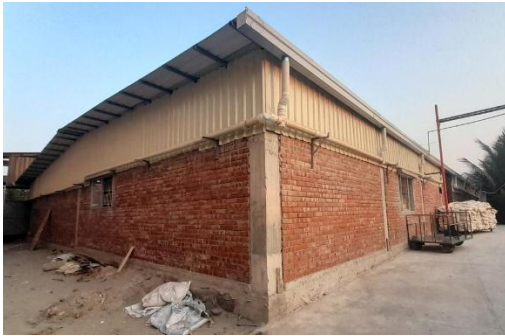
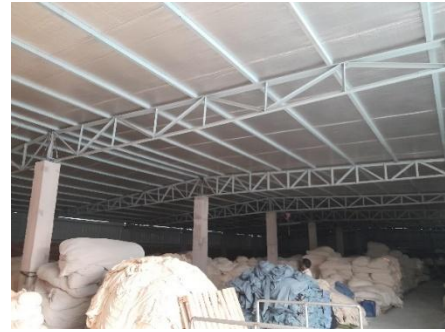
Shed 19

**Observation 36:** Lack of lateral stability and absence of design documents (Shed- 19).

**Description:** Lateral load transfer media is not provided to transfer the lateral load. Also, the bracing system is not provided. Also, as per BNBC, every building or structure designed shall have its design documents prepared by the provision of Section 1.9.1. The design document shall include a design report, and a set of structural drawings, which shall be prepared in compliance with section 1.9.1.1 and section 1.9.1.2 as per BNBC. However, at the time of inspection, the design report and as-built drawing were not available. The building engineer is required to check the lateral stability of the sheds and prepare the design report and as-built drawing in compliance with section 1.9.1 (Part 6, BNBC).

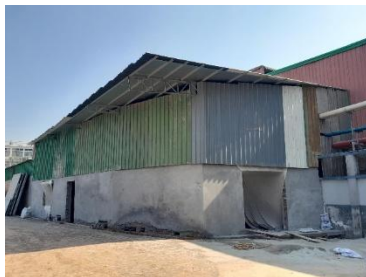
**Observation 37:** Lack of lateral stability and improper connection in the roof shed. (Shed- 20)

**Description:** Lateral load transfer media is not provided to transfer the lateral load. Also, improper connection was observed in the roof shed. The building engineer is required to check the lateral stability and connection adequacy of the shed and prepare the safety check report and as-built drawing.

| 121. | Lack of lateral stability and improper connection in the roof shed. (Shed- 20) | The building engineer is required to check the lateral stability and connection adequacy of the shed and prepare the safety check report and as-built drawing. | within 6 weeks |

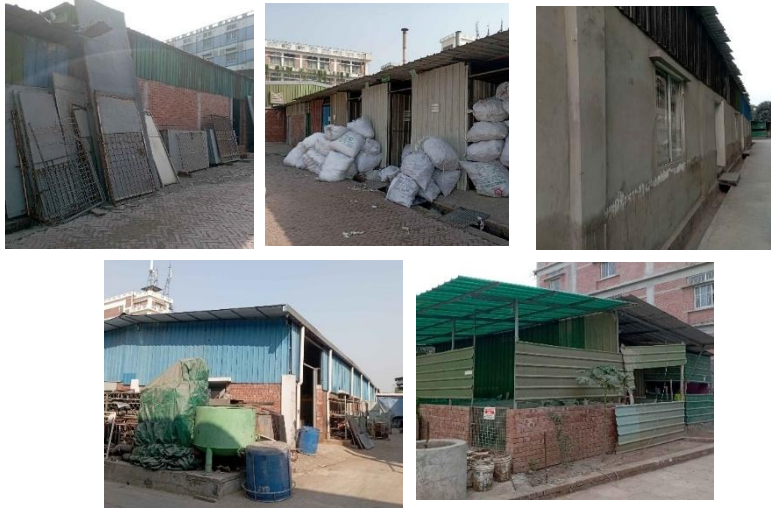
**Observation 38:** Lack of as-built drawing (Shed-12, Shed-13, Shed-17, Shed-21).

**Description:** At the time of the inspection only an architectural layout was available, but an as-built structural drawing was not available for any of these structures. The building engineer is required to prepare a full set of as-built drawings including structural drawings.

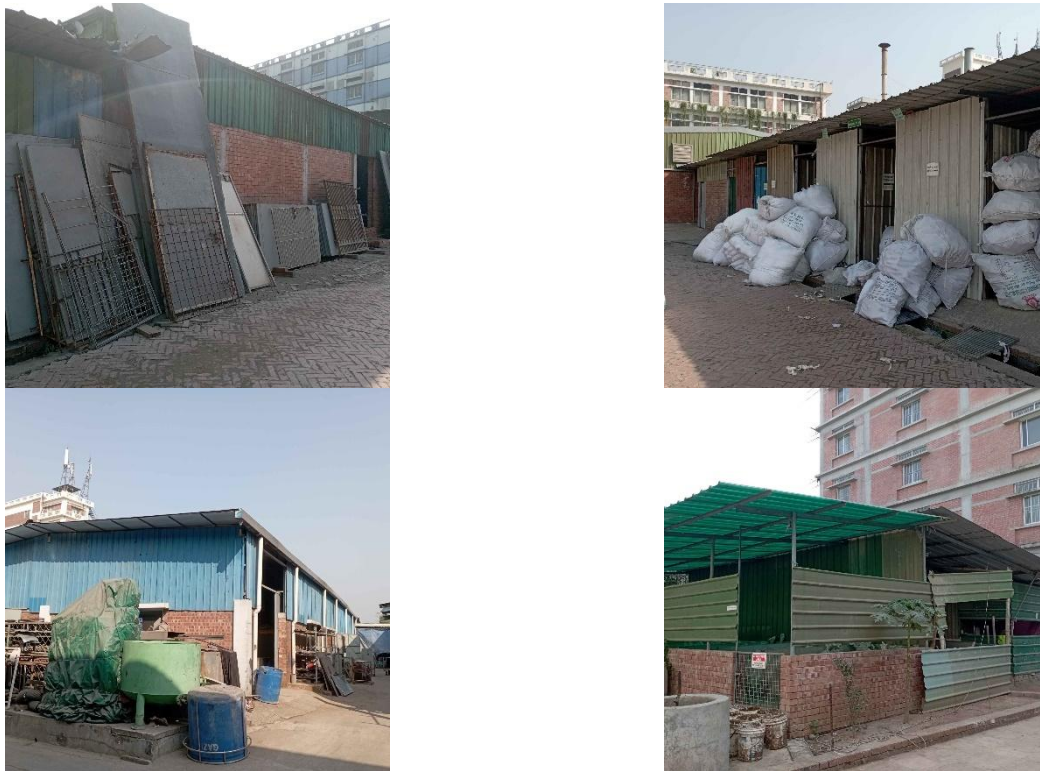
**Observation 39:** Absence of bracing system and poor connection (Shed-12, Shed-13, Shed-17, Shed-21).

**Description:** No bracing system (strut/vertical or horizontal bracing) was observed to transmit and resist the lateral load. The building engineer is required to prepare a safety check report for the bracing system and prepare a remediation plan for connection and lateral bracing (strut, bracing). Submit to RSC for review.
