# Knit Plus Limited (Unit-2)

09 December 2024 & 29 December 2024

## Structural Inspection Report

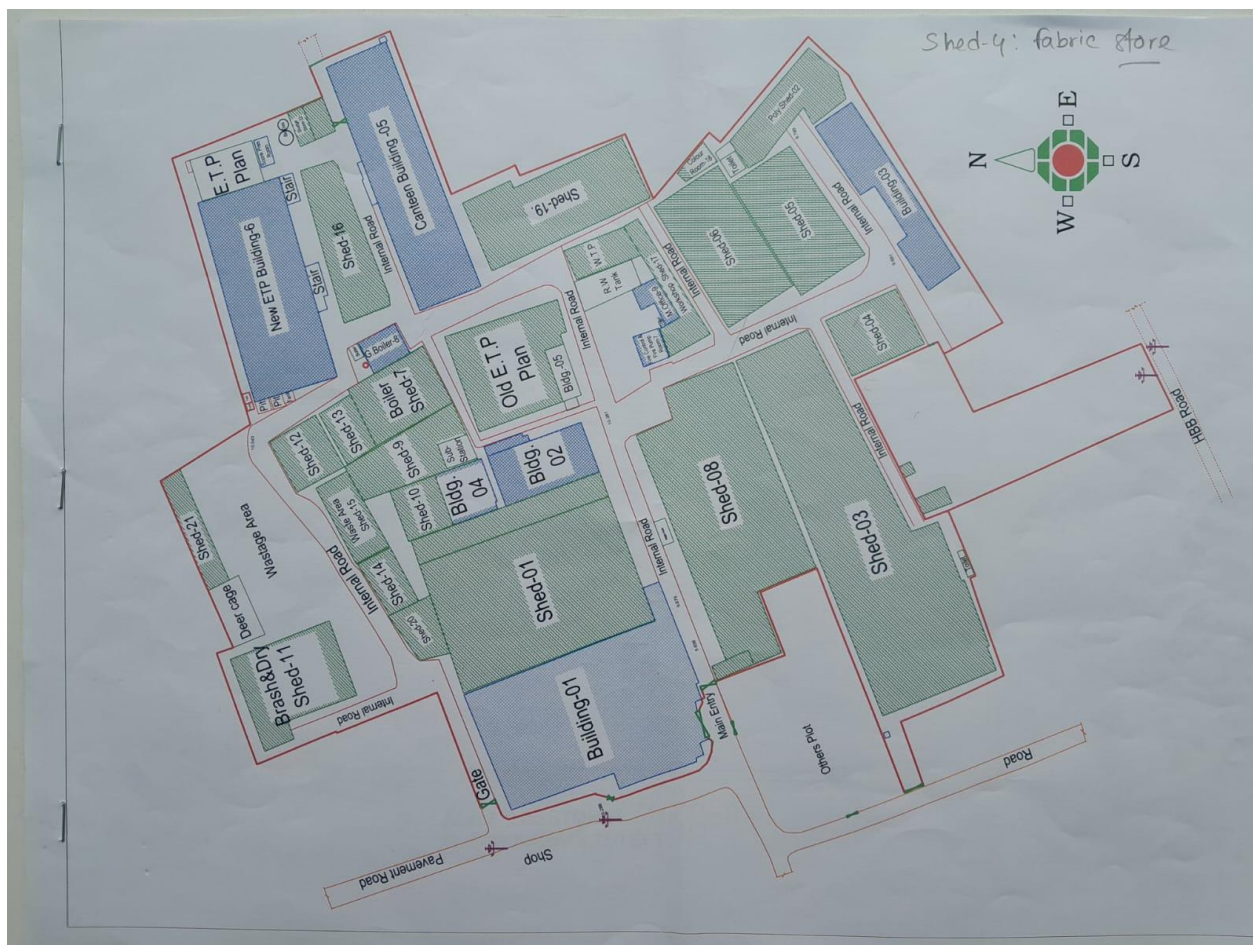
Master layout of the premises

**Observation 40:** Absence of local authority permit drawing for all structure.

**Description:** At the time of inspection approval drawing from local authority was not available for any of the structures. Factory is required to collect approval drawing from local authority for all the structures.
