# Babylon Garments & Dresses LTD

30 March 2014

# Building Observations

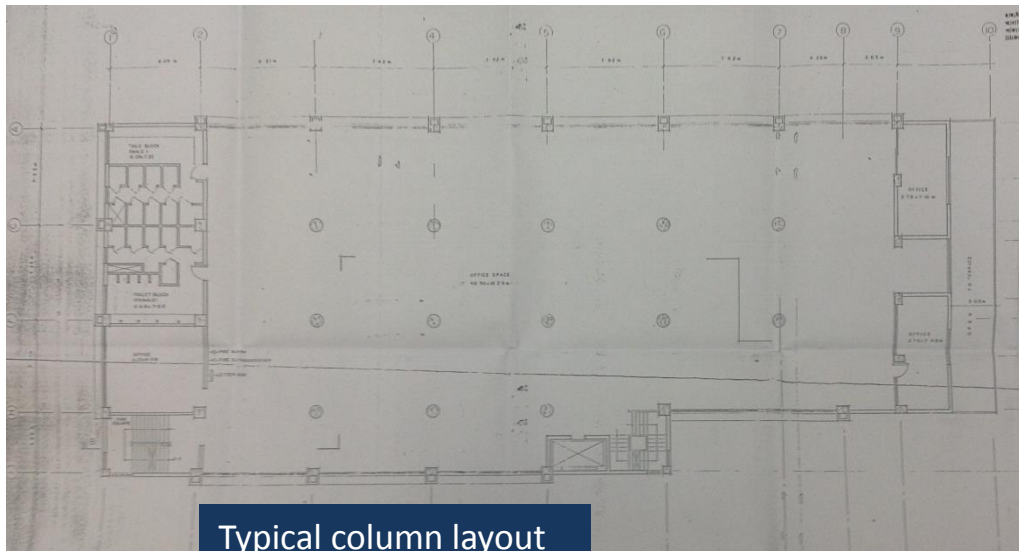
Typical column layout

**Columns appear to be stressed in excess of  
normal design limits**

Outline calculations indicate column working stress is in excess of normal design limits.

Building Engineer is to perform detailed calculations and concrete tests to prove column size and (if required):

- Reduce loads by vacating floors
- Reinforce columns

| Item No. | Observation | Recommended Action Plan | Recommended Timeline |
|---|---|---|---|
| 1 | A check on column loads and column design is required | Building Engineer to provide calculations showing the structural adequacy of all columns, taking into account the loading plans and all built structure including additions beyond the original design. | 6-weeks |
| 2 | A check on column loads and column design is required | Verify insitu concrete stresses either by cores (min of 4 no. 100mm dia.) or existing cylinder strength data for ground floor columns. | 6-weeks |
| 3 | A check on column loads and column design is required | Create controlled loading plans for all floors, designating where storage can be placed and can not be placed. | 6-months |

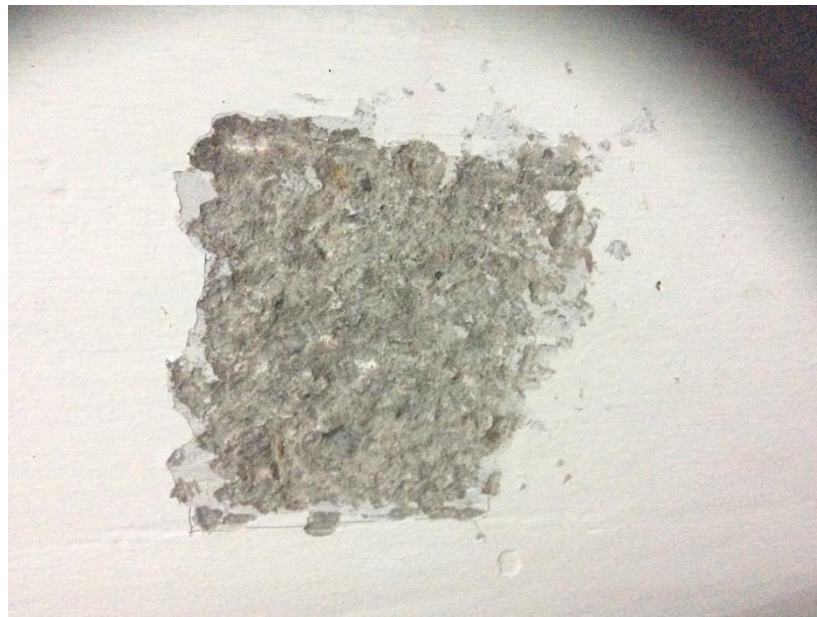
Tested Basement Floor Column – Stone Chips

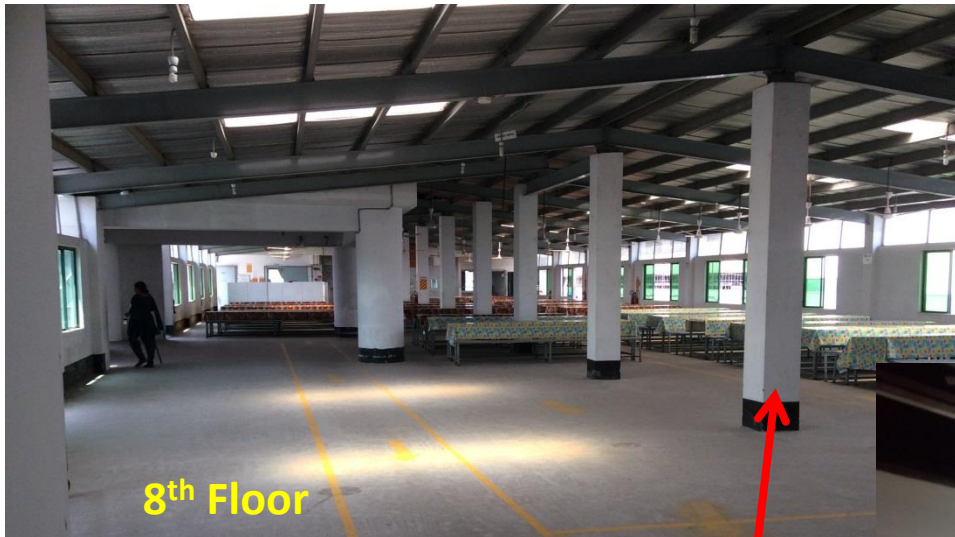
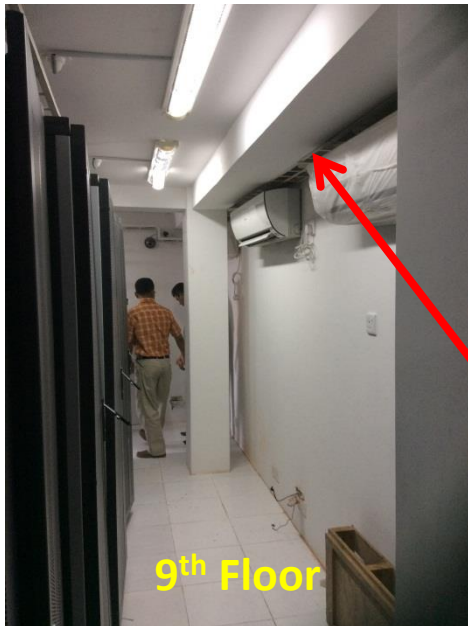
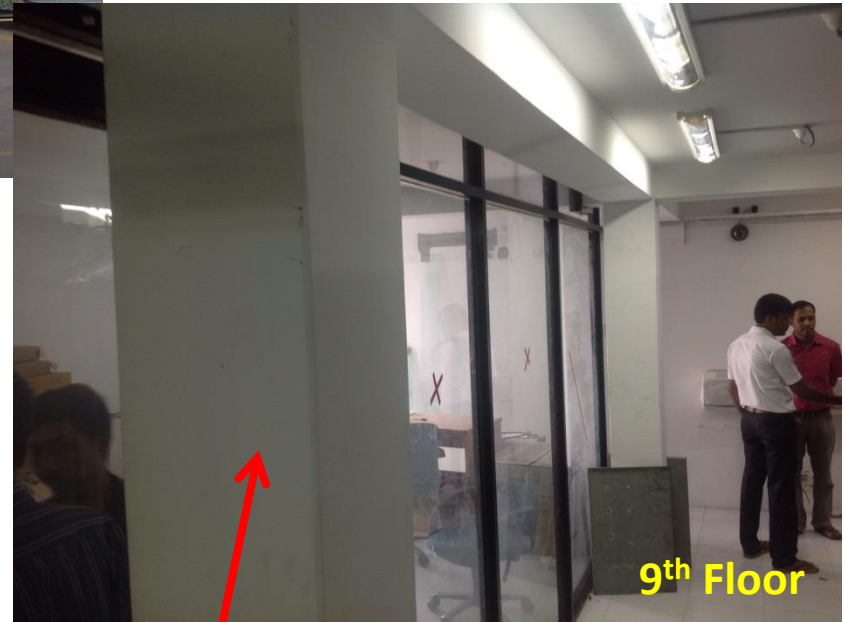
# **Columns supported by the slab on the 8<sup>th</sup> and 9<sup>th</sup> floors**

Columns not on Grid at 8<sup>th</sup> and 9<sup>th</sup> floors level.

| Item No. | Observation | Recommended Action Plan | Recommended Timeline |
|---|---|---|---|
| 4 | Columns supported by the slab alone on the 8th and 9th floors. | Building Engineer to provide calculations showing the structural adequacy of all Slab/Beams to take point loading of columns, taking into account the proposed loading and all built structure including additions beyond the original design. Verify insitu concrete stresses either by 4 cores or existing cylinder strength data for the slabs. | 6-weeks |

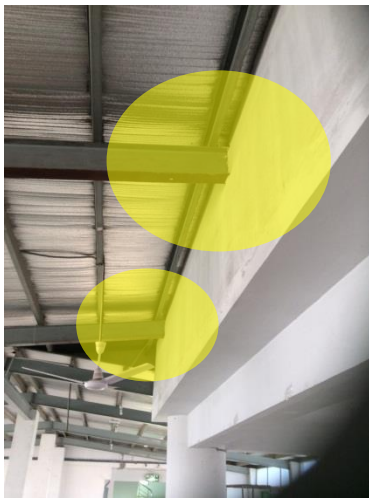
**Stability of steel roof to dining area to  
be reviewed by Building Engineer**

**Building Engineer to confirm support/connection detail at these locations.**

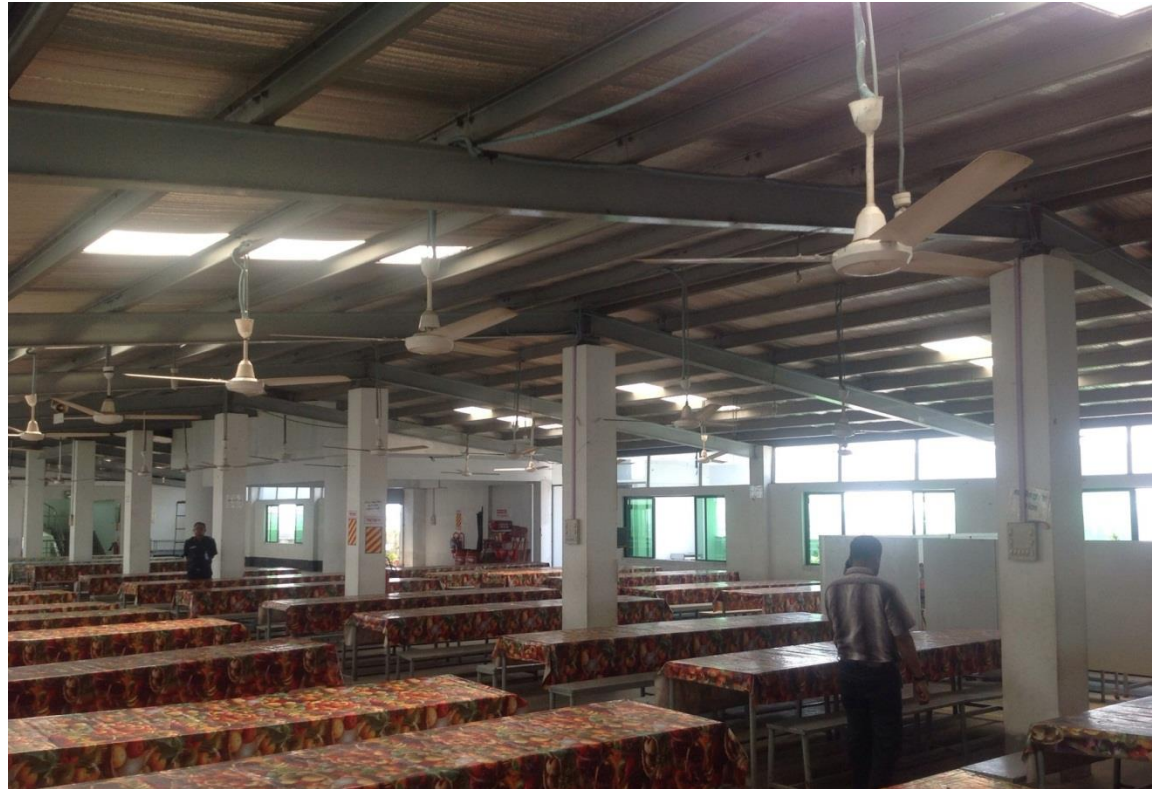
**Roof structure to Dining Area not shown on the structural design drawings, no bracing visible, may be susceptible to wind uplift. Building Engineer to review.**

| Item No. | Observation | Recommended Action Plan | Recommended Timeline |
|---|---|---|---|
| 5 | No bracing observed in steel roof structure. Stability of steel roof to Dining Area to be reviewed by Building Engineer to confirm that it is braced and adequately designed to resist high wind loading | The steel roof over the Dining Area should be reviewed by the Building Engineer and, if required, upgraded to support code vertical and wind loads or the area should be vacated and removed. | 6-weeks |

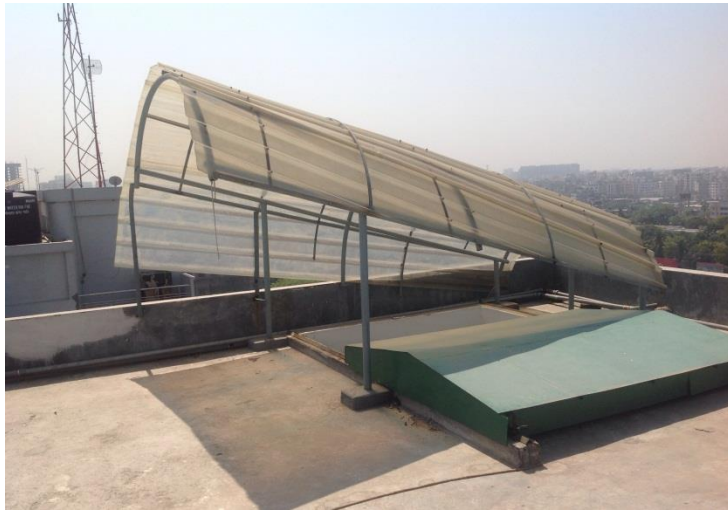
**Stairwell canopy construction very light,  
may be susceptible to wind uplift.  
Building Engineer to review.**

| Item No. | Observation | Recommended Action Plan | Recommended Timeline |
|---|---|---|---|
| 6 | Falling hazards – stairwell canopies, mast at roof level. | Lightweight canopies over stair-cores access to roofs to be strengthened or removed | 6-weeks |

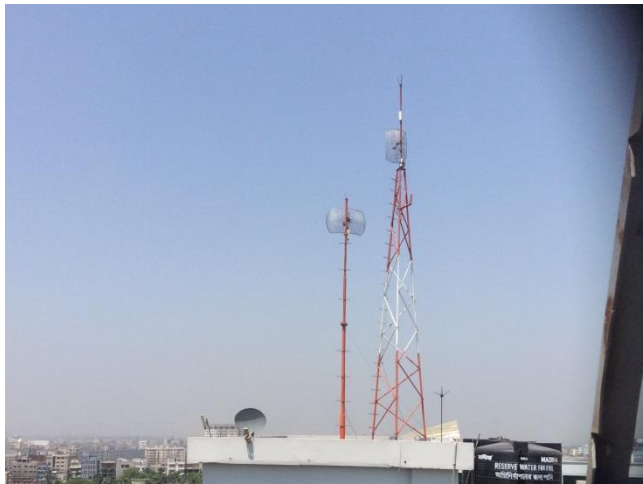
**Stability of mast unknown.  
Building Engineer to review.**

| Item No. | Observation | Recommended Action Plan | Recommended Timeline |
|---|---|---|---|
| 7 | Falling hazards – stairwell canopies, mast at roof level. | The connection of the mast to the roof structure is to be assessed by the building engineer for stability. | 6-weeks |

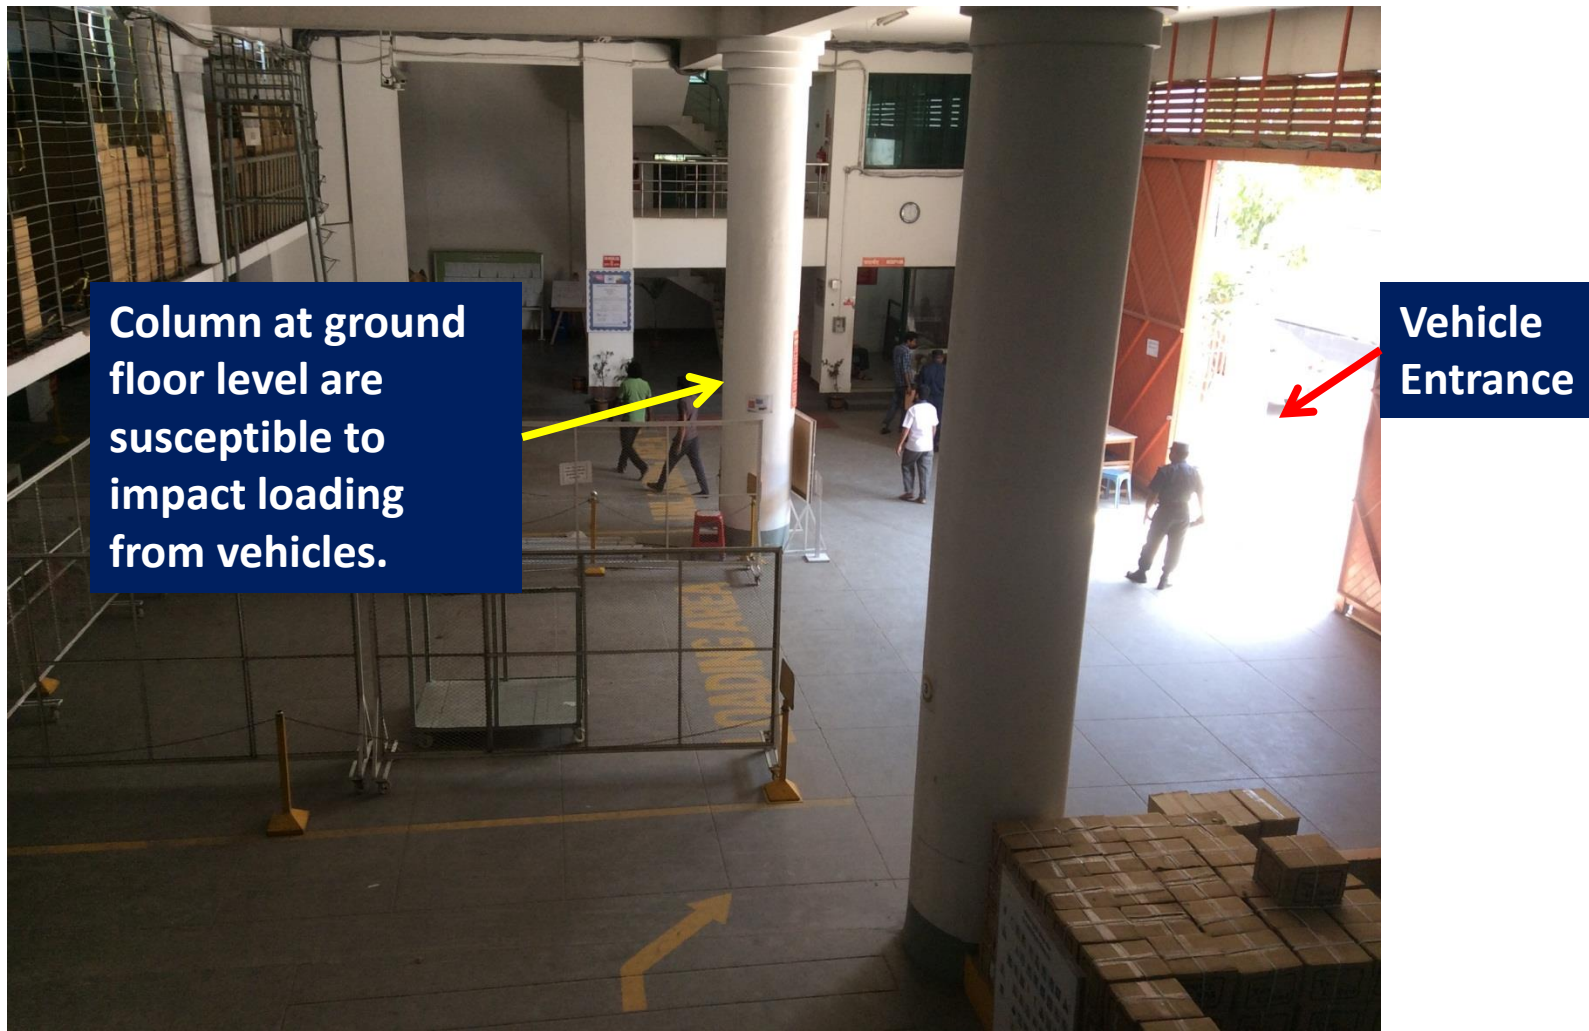
**Columns at ground floor level are susceptible to impact loading from vehicles.**

**Vehicle impact loading.**

| Item No. | Observation | Recommended Action Plan | Recommended Timeline |
|---|---|---|---|
| 9 | Columns at ground floor level are susceptible to impact loading from vehicles | Column to be protected from vehicle impact. | 6-weeks |

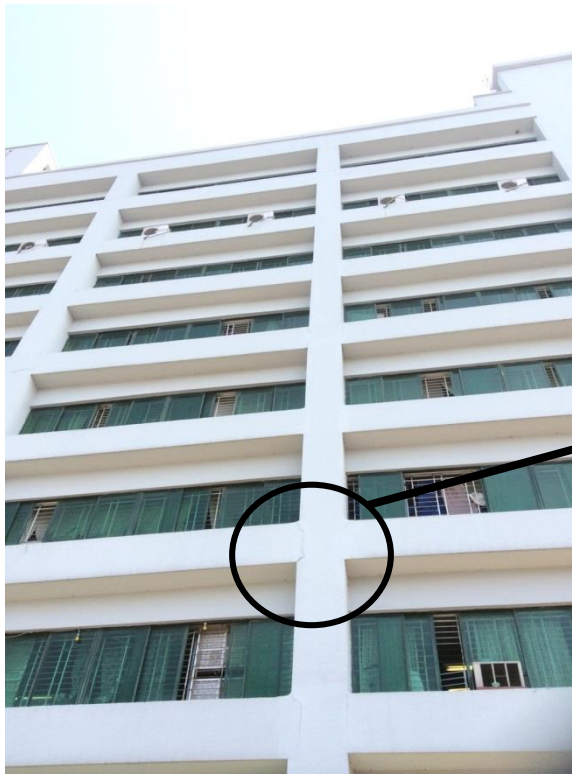
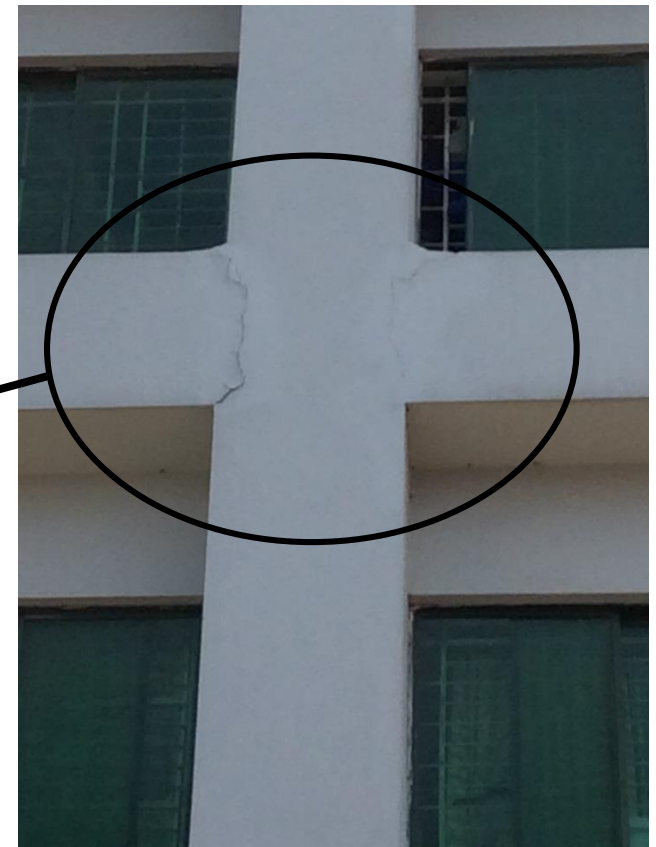
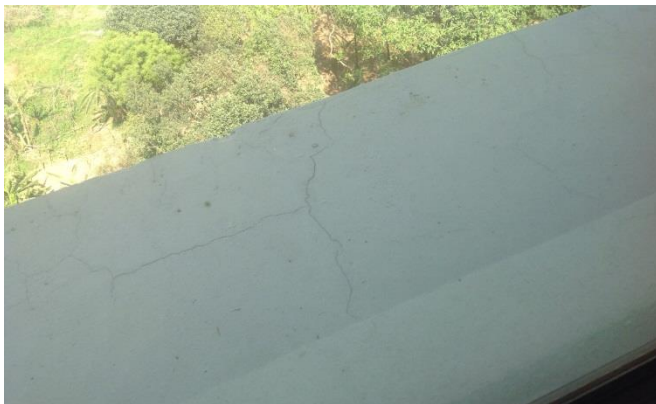
**Building engineer to monitor/review  
movement of brickwork upstands on  
cantilever slabs**

**Cracking noted on cills. Building engineer to  
monitor.**

| Item No. | Observation | Recommended Action Plan | Recommended Timeline |
|---|---|---|---|
| 10 | Cantilevered Window Cills/Brick Infill | Building Engineer to monitor these elements of the structure for signs of further cracking/movement and take preventative action if necessary. | 6-months |

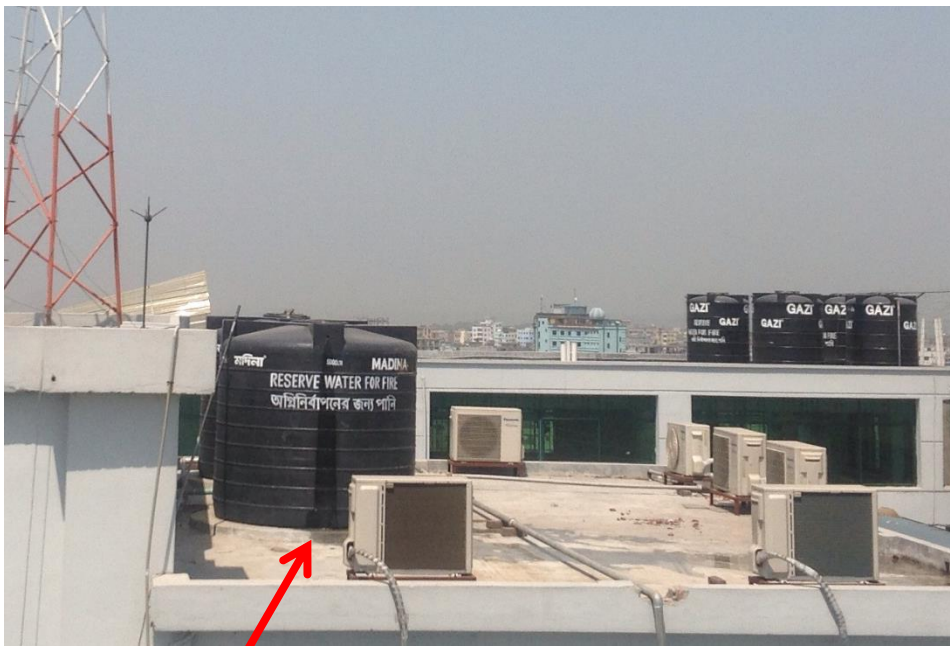
**Tank overflow spills onto  
roofs.  
Building engineer to monitor  
water ingress and take  
preventative measures if  
necessary**

| Item No. | Observation | Recommended Action Plan | Recommended Timeline |
|---|---|---|---|
| 11 | Water ingress into building | Building Engineer to identify locations/sources of water ingress and remove/divert source to avoid contact with concrete/reinforcement of structure. | 6-months |

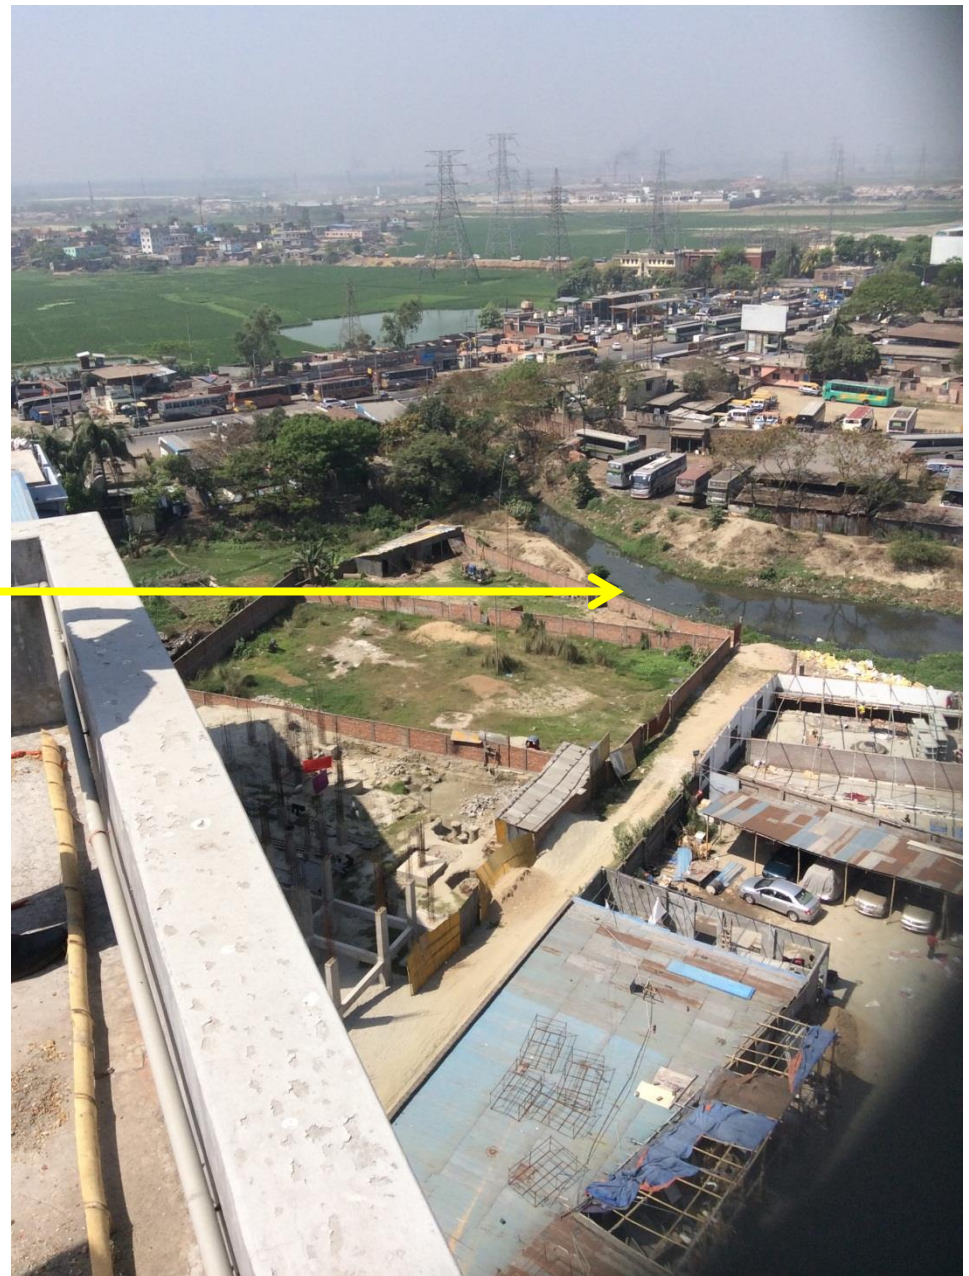
**River is very close to structure though management say the building has never flooded.**

**Visual evidence of damp in basement.**

**Building engineer to monitor building for signs of water ingress and appropriate action to be taken if ingress occurs.**

| Item No. | Observation | Recommended Action Plan | Recommended Timeline |
|---|---|---|---|
| 12 | Proximity of River | Building Engineer to monitor the structure for signs of water ingress and take preventative action if necessary. | 6-months |
