# GAVA Private Limited

Plot # 114-120, Dhaka Export Processing Zone (old area),  
(23.948083, 90.272639)

26 August 2025

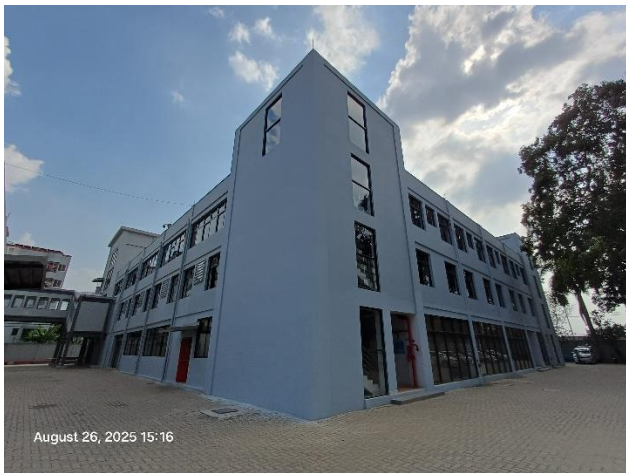
### Observation-1: Lack of information in design documents. (Office Building)

**Description:** A detailed engineering assessment report was available for the office building. In the DEA report, 3038 psi (21 MPa) strength was mentioned for the concrete strength of old columns (not jacketed). But material test reports were not available to verify the strength of the old concrete of columns. Also, no adequacy check was available for the slab. No adequacy check provided for adjacent lift core.

The building construction period is unknown, possession taken in Sep 2022 & approval taken in July 2025. Therefore, the building should be assessed in accordance with BNBC 2020 unless availability of building permit before Feb 2021.

The building engineer is required to confirm the material's strength and incorporate the slab & lift core adequacy check in the design report following BNBC 2020 and submit it to the RSC for review.

| Item No. | Observation | Action Plan | Timeline |
|---|---|---|---|
| 1. | Lack of information in design documents. (Office Building) | Verify in situ material strength (concrete compressive strength) | within 6 weeks |
| 2. | | The building should be assessed in accordance with BNBC 2020 unless availability of building permit from BEPZA dated before Feb 2021.<br>The building engineer is required to confirm the material's strength and incorporate the slab & lift core adequacy check in the design report following BNBC 2020 and submit it to the RSC for review. | within 6 weeks |
| 3. | | Carry out the suggested remedial works. | within 6 months |

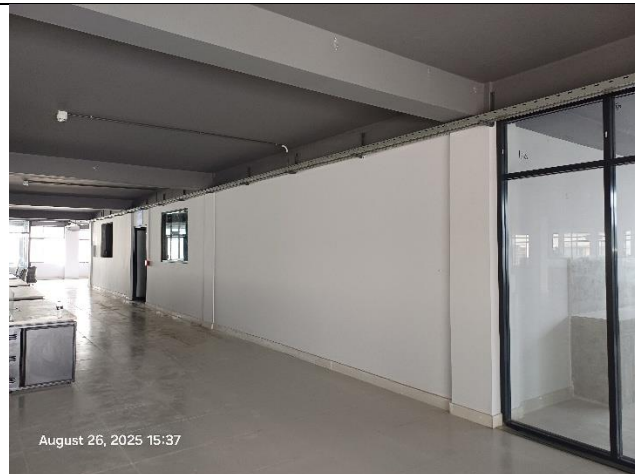
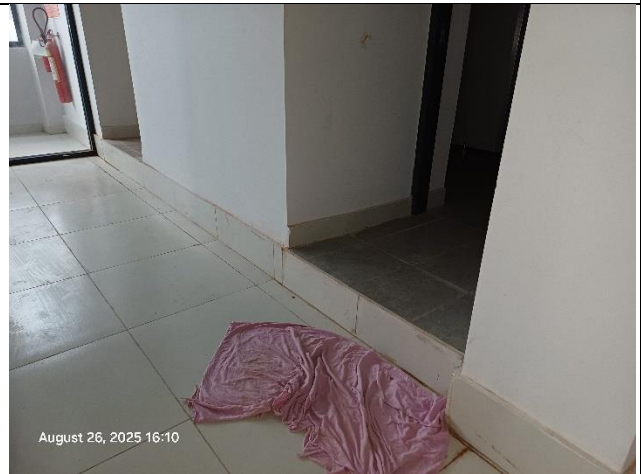
### Observation-2: Mismatch in prepared as-built drawings. (Office Building)

**Description:** Brick wall layout, toilet block details and built-up of second floor were not properly provided in the architectural drawings.

Building engineer is required to survey the structure and prepare the as-built drawing.

| Item No. | Observation | Action Plan | Timeline |
|---|---|---|---|
| 4. | Mismatch in the prepared as-built drawings. (Office Building) | The building engineer is required to survey the structure and update the as-built drawing. | within 6 weeks |

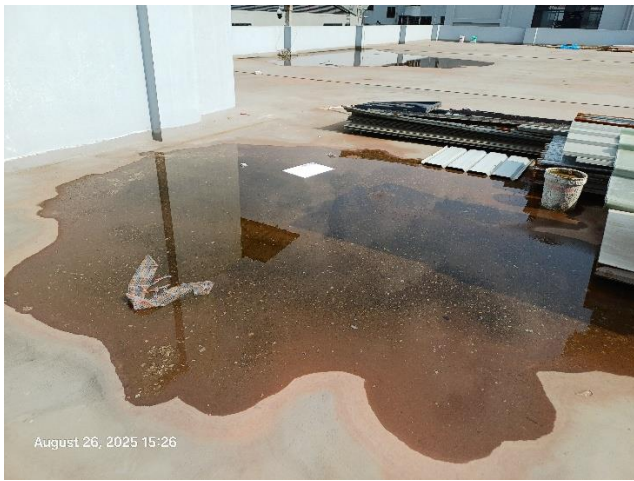
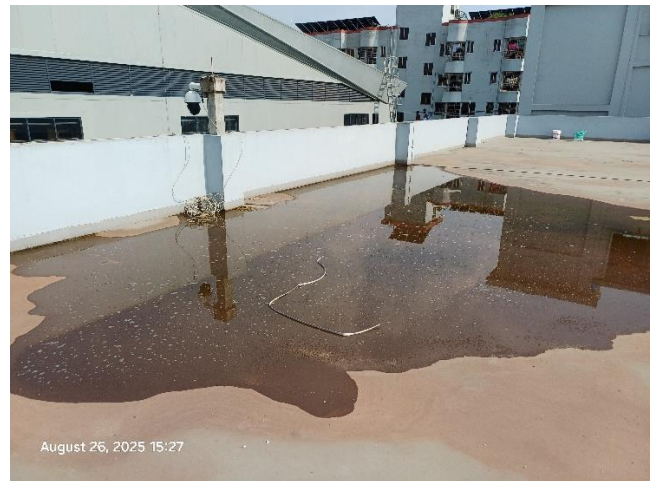
**Observation-3: Standing water on the roof. (Office Building)**

**Description:** Standing water was observed on the roof. Building engineer is required to improve the roof drainage system.

| Item No. | Observation | Action Plan | Timeline |
|---|---|---|---|
| 5. | Standing water on the roof. (Office Building) | The building engineer is required to improve the roof drainage system. | within 6 months |

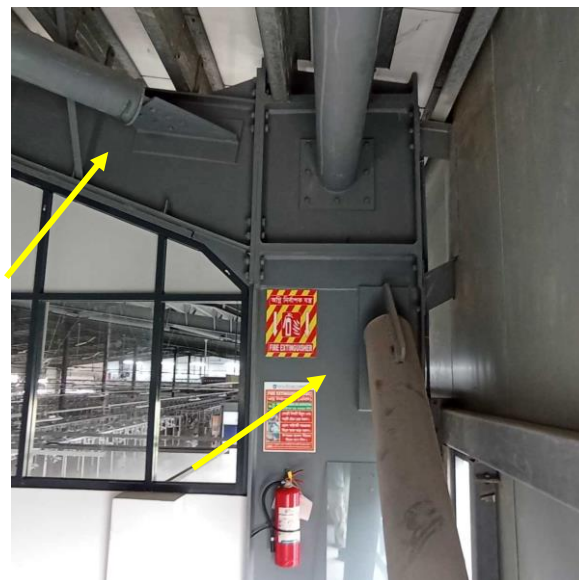
**Observation 4: Offset in bracing to the column/rafter connection (Main Factory Building).**

**Description:** Offset found in the bracing of the column/rafter connection. The building engineer is required to update the design report of the structure, considering the offset, and as per 1.9.1 BNBC.

| Item No. | Observation | Action Plan | Timeline |
|---|---|---|---|
| 6. | Offset in bracing to the column/rafter connection (Main Factory Building). | The building engineer is required to update the design report of the structure, considering the offset, and as per 1.9.1 BNBC. | within 6 weeks |
| 7. | | Implement remediation work if required. | within 6 months |

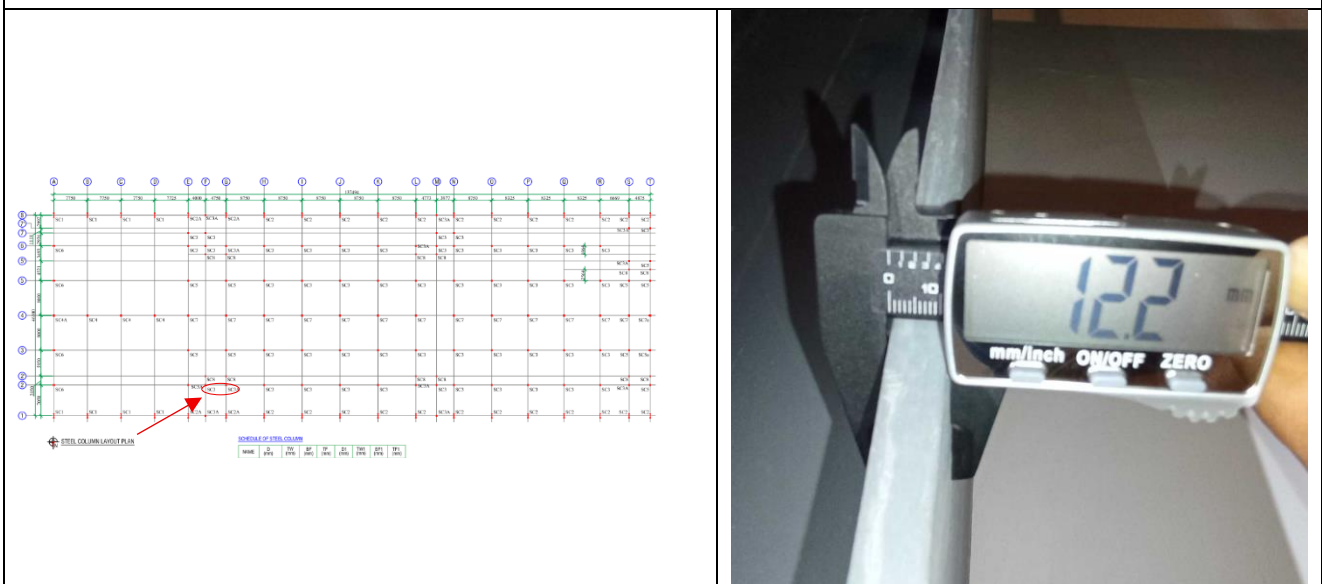
**Observation 7:** Discrepancy in the as-built drawing (Main Factory Building).

**Description:** Dimension of marked column (stair landing) was measured as F200mm (12mm) X W200mm(6mm) instead of F250mm (8mm) X W250mm(18mm). Also, a 250mm brick wall was found in the toilet area but shown as 125mm. The building engineer is required to survey the whole structure and prepare an accurate as-built drawing.

| Item No. | Observation | Action Plan | Timeline |
|---|---|---|---|
| 10. | Discrepancy in the as-built drawing (Main Factory Building). | The building engineer is required to survey the whole structure and prepare an accurate as-built drawing. | within 6 weeks |

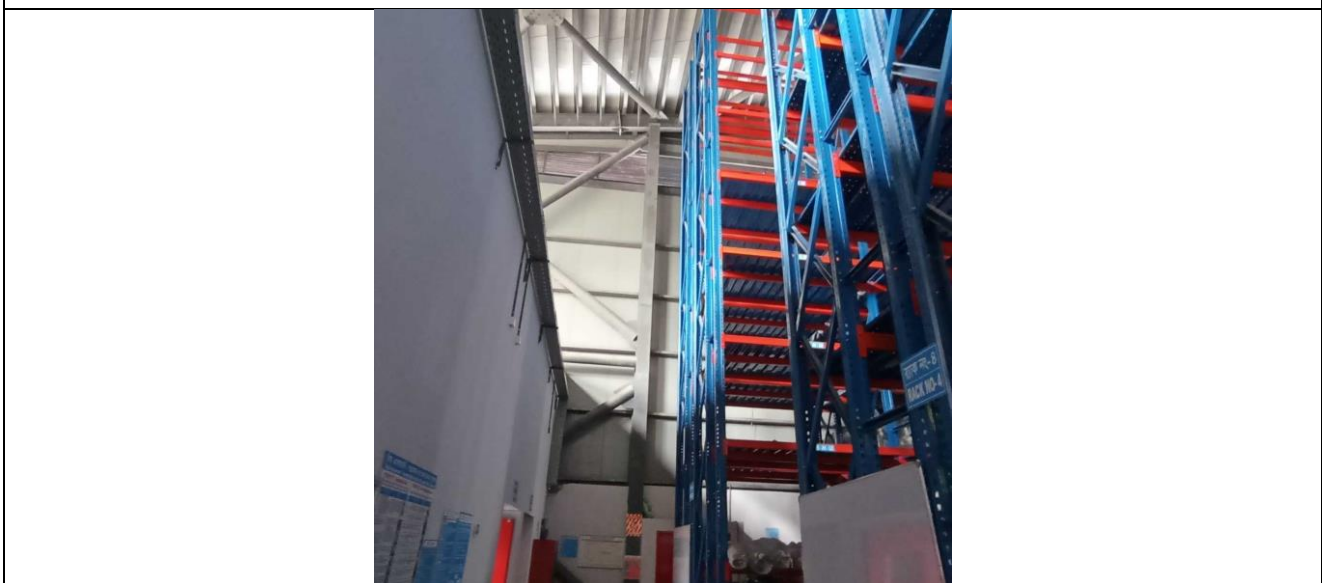
**Observation 8:** Absence of design check for slender storage racks (Main Factory Building).

**Description:** Some slender storage racks (12 m high) were found on the ground floor, but the design check was not available. The building engineer is required to prepare a design check for the slender racks and submit it to RSC for review.

| Item No. | Observation | Action Plan | Timeline |
|---|---|---|---|
| 11. | Absence of design check for slender storage racks (Main Factory Building). | The building engineer is required to prepare a design check for the slender racks and submit it to RSC for review. | within 6 weeks |
| 12. | | Implement remediation work if required. | within 6 months |

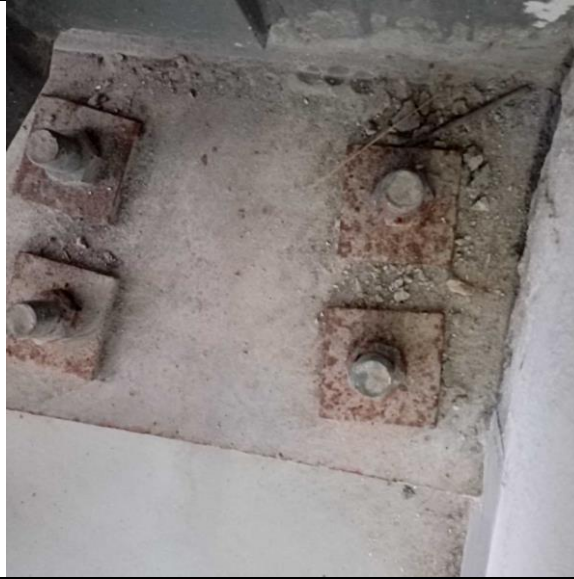
**Observation 9:** Corrosion on steel members (Main Factory Building).

**Description:** Corrosion was found on steel members at several locations. The building engineer is required to provide rust-proof coating on steel members.

| 13. | Corrosion on steel members (Main Factory Building). | The building engineer is required to provide rust-proof coating on steel members. | within 6 weeks |

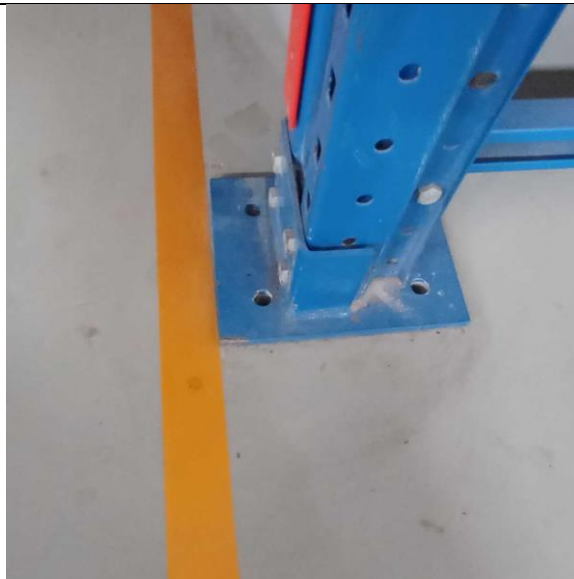
**Observation 10:** Nonstructural storage racks found unanchored/unbraced (Main Factory Building).

**Description:** Nonstructural storage racks were found unanchored/unbraced at a few locations on the ground floor. Anchor/brace all nonstructural storage racks.

| 14. | Nonstructural storage racks found unanchored/unbraced (Main Factory Building). | Anchor/brace all nonstructural storage racks. | within 6 months |

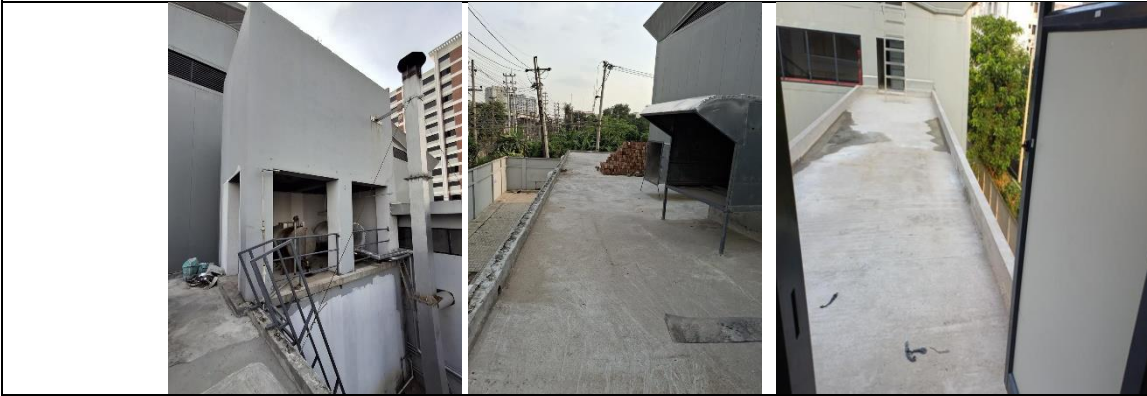
**Observation 11:** Falling hazard at the roof (Utility Building-1, Connecting Bridge).

**Description:** Access was found on the roof of the Utility Building-1 & Connecting Bridge from, but no parapet was provided. The building engineer is required to provide a parapet/railing to avoid a falling hazard. Otherwise, seal the access.

| 15. | Falling hazard at the roof (Utility Building-1). | The building engineer is required to provide a parapet/railing to avoid a falling hazard. Otherwise, seal the access. | within 6 weeks |
| 16. | Falling hazard at the roof (Connecting Bridge). | The building engineer is required to provide a parapet/railing to avoid a falling hazard. Otherwise, seal the access. | within 6 weeks |

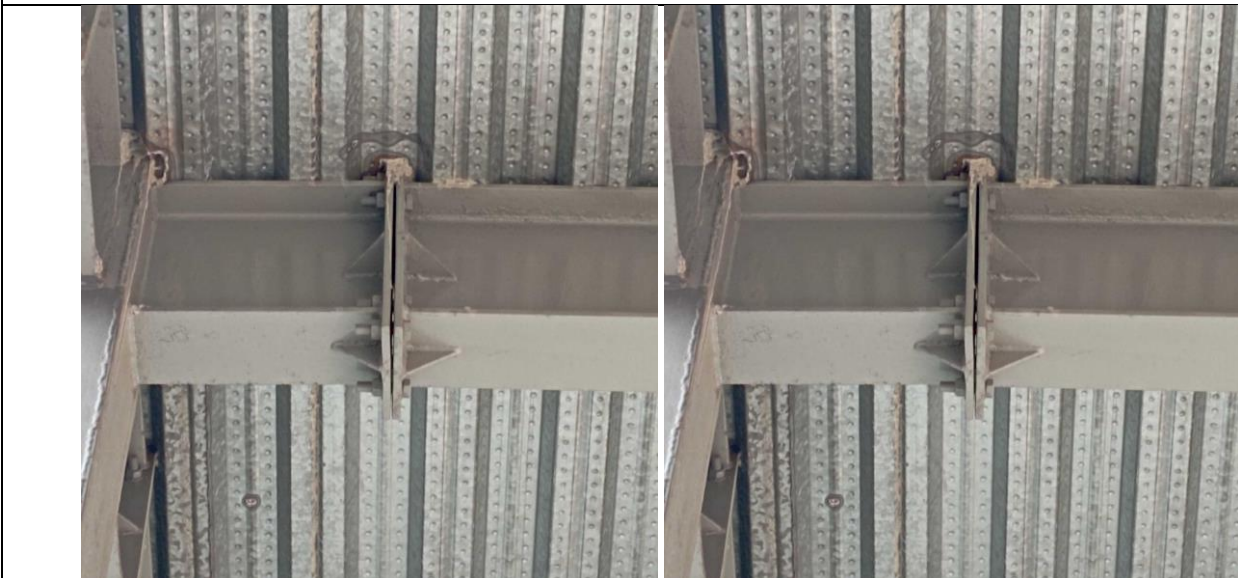
**Observation 12:** Connection gap and loose bolt (Connecting Bridge).

**Description:** Connection gap and loose bolt were found at the Connecting Bridge. The building engineer is required to repair the gap with a suitable method, tighten the loose bolt.

| 17. | Connection gap and loose bolt (Connecting Bridge). | The building engineer is required to repair the gap with a suitable method, tighten the loose bolt. | within 6 weeks |

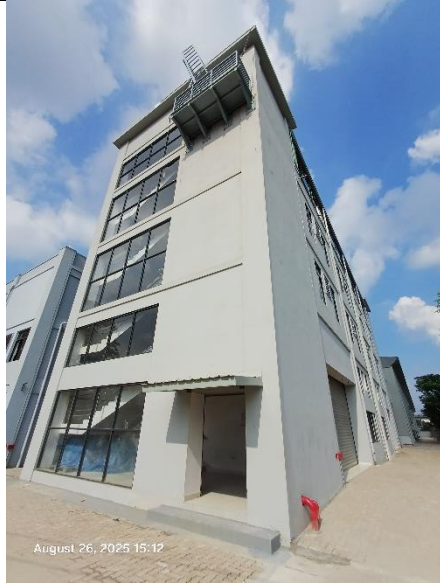
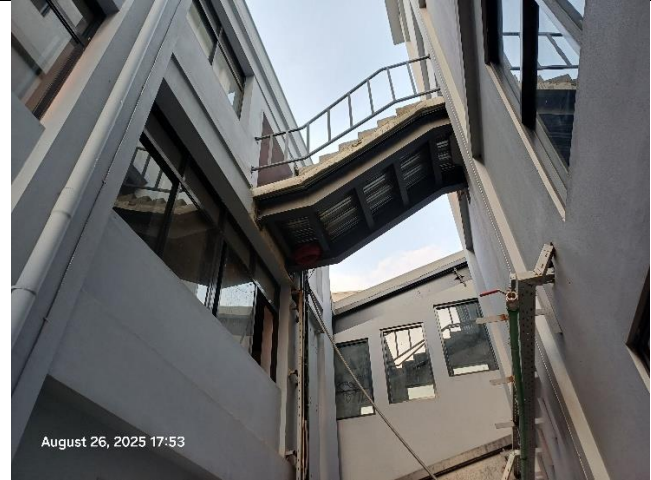
**Observation-13:** Design report required to be reviewed by RSC for lateral loading. (Dining Building)

**Description:** A set of design documents was available for the dining building. A connecting bridge was found between office building and dining building. No member adequacy and connection adequacy are provided in the design report. The building engineer is required to revise the design report considering the onsite conditions and lateral forces.

| 18. | Design report required to be reviewed by RSC for lateral loading. (Dining Building) | Verify in situ material strength (concrete compressive strength) | within 6 weeks |
| 19. | | The building engineer is required to revise the design report considering the onsite conditions and lateral forces. Submit the revised design documents to RSC for review. | within 6 weeks |
| 20. | | Carry out the suggested remedial works. | within 6 months |

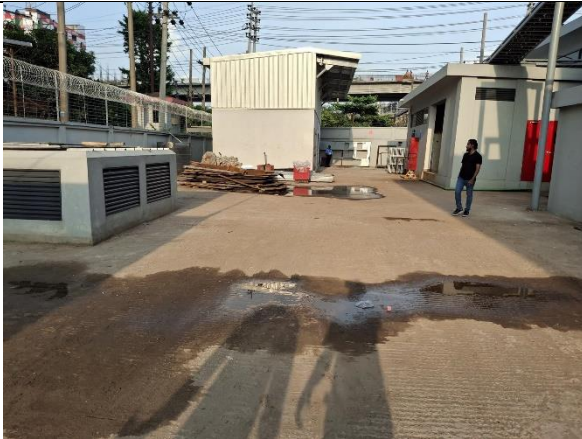
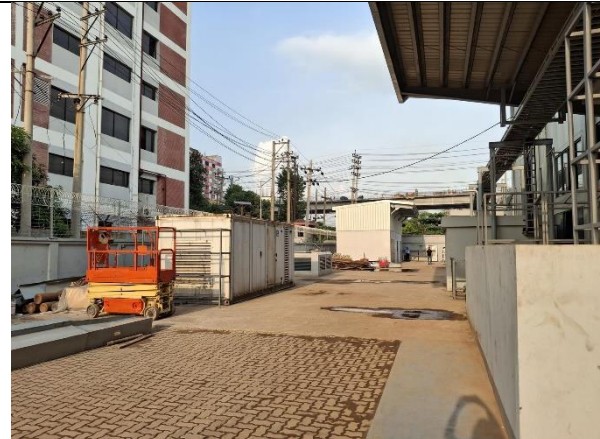
**Observation-14:** Design report required to be reviewed by RSC for lateral loading. (UGWR & Fire Pump room)

**Description:** A set of design documents was available for the structure. Top slab of the UGWR used for temporary storage & vehicle movement purposes. The building engineer is required to revise the design report considering the onsite conditions and lateral forces.

| 21. | Design report required to be reviewed by RSC for lateral loading. (UGWR & Pump Room) | The building engineer is required to revise the design report considering the onsite conditions and lateral forces. Submit the revised design documents to RSC for review. | within 6 weeks |
| 22. | | Carry out the suggested remedial works. | within 6 months |

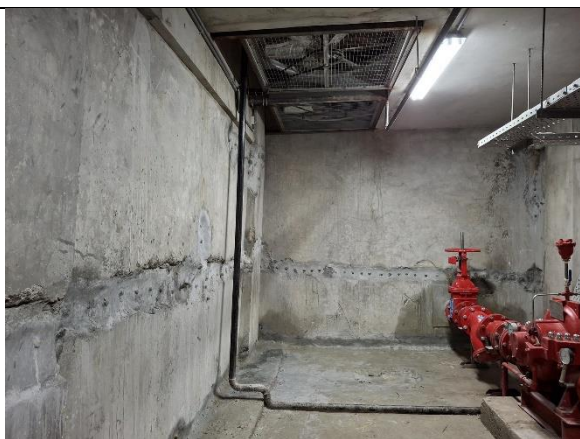
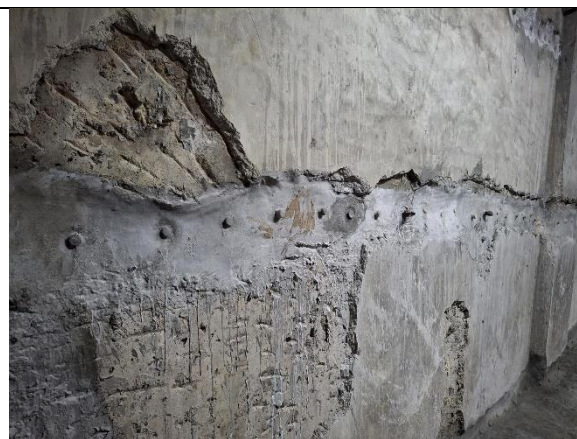
**Observation-15: Crack on retaining walls (UGWR & Fire Pump Room)**

**Description:** Crack in retaining wall was observed. Most of the crack locations have been repaired. The building engineer is required to monitor the crack locations, keep crack monitoring data and take further necessary measures if required.

| 23. | Crack on retaining walls (UGWR & Fire Pump room) | The building engineer is required to monitor the crack locations, keep crack monitoring data and take further necessary measures if required | within 6 months |
