# INITIAL FIRE SAFETY INSPECTION REPORT

**GAVA PRIVATE LIMITED**

**RSC ID: 26131**

**Plot # 114-120, Dhaka Export Processing Zone (Old Zone), Ganakbari, Ashulia, Dhaka-1349**

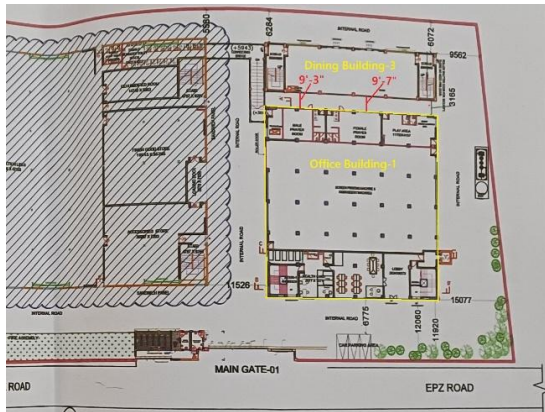
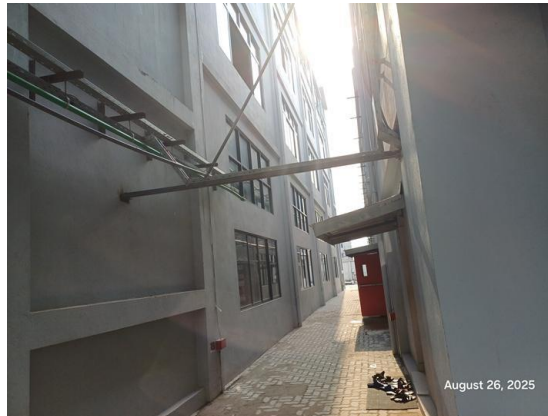
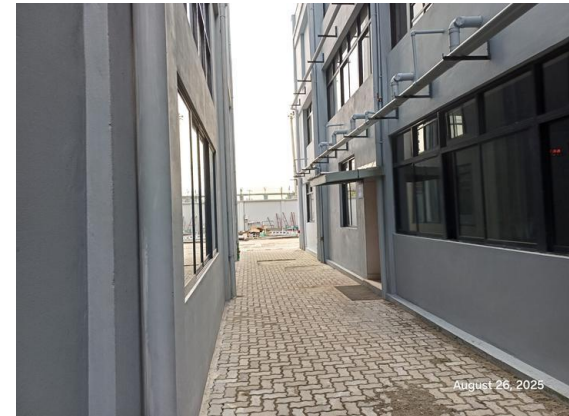
| Sl No. | Category | Findings | Required Action | Remediation Time Frame |
|---|---|---|---|---|
| F1 | Fire Rated Construction | <p>The required fire separation distance for Office Building- 1 does not comply with the requirements of BNBC 2020.</p> <p>Location: Office Building- 1 (G+2).</p> | <p>The exterior walls shall have a fire resistance and opening protection as specified in BNBC 2020 Part 3 Table 3.2.2 &amp; 3.2.3 and BNBC 2020 Part 3 Section 2.4.1.3.</p> | Within 6 Months |

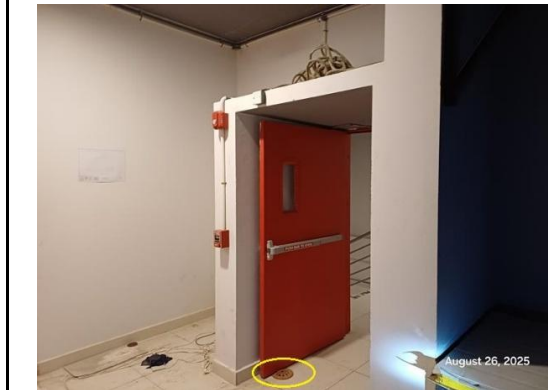
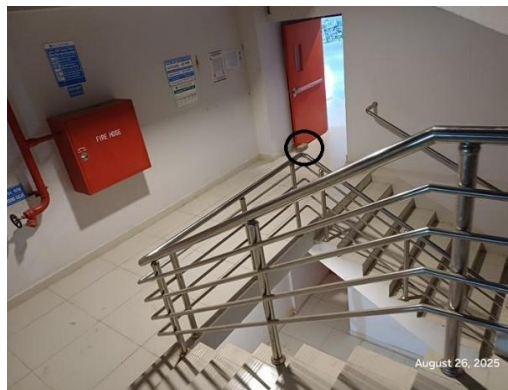
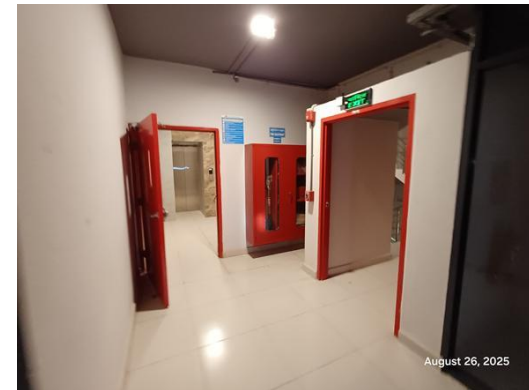
| SI No. | Category | Findings | Required Action | Remediation Time Frame |
|---|---|---|---|---|
| F2 | Means of Egress | <p>The exit stair enclosures are not separated from work areas and other spaces on each floor by fire-rated construction.</p> <p><b>Non-Compliance Reason:</b> The fire doors were found tied by unauthorized means and also interfacing with the fire alarm system &amp; door closers were not properly functional during the inspection. Proper certification was not available for fire rated doors and door accessories installed in the factory.</p> <p><b>Location:</b> Stair-1 and Stair-2 on all floors of Office Building-1</p> | <p>The exit stair enclosure shall be provided with a minimum 1-hr fire resistance rating for buildings with 3 or fewer stories and a minimum of 2-hr. fire resistance rating for buildings 4 or more stories. Provide 1-hr. fire rated door and seal all penetrations and openings by 1 hr. fire rated fire rated barrier construction for building with 3 or fewer stories. Provide 1.5 hr. fire rated door and seal all penetrations and openings by 2 hr. fire rated fire rated barrier construction for building with 4 or more stories in accordance with section 6.3.1.2 of RSC Technical Guidelines (Standard)<sup>1</sup> V1.0.</p> <p>Ensure that the fire doors are self-closing and positive latching and that they are provided with fire exit (panic) hardware where serving production floors. If fire doors are required to be held open for functional reasons, provide automatic closing devices tied to the fire alarm system.</p> <p>Keep proper datasheet &amp; certifications for installed fire doors &amp; accessories on-site for verification. The clearance under the bottom of a door shall be a maximum of 3/4 in. (19 mm).</p> | Within 3 Months |

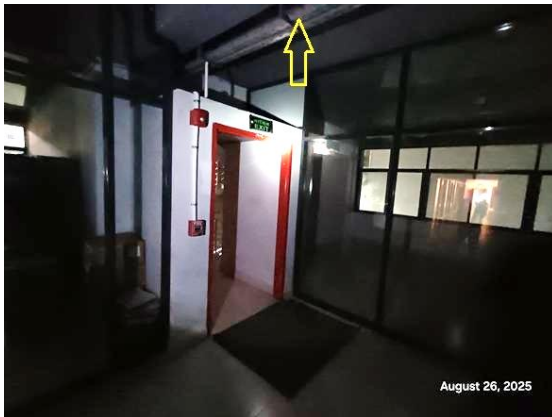
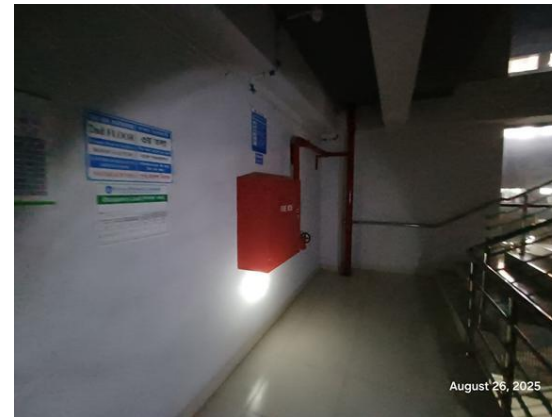
| SI No. | Category | Findings | Required Action | Remediation Time Frame |
|---|---|---|---|---|
| F3 | Means of Egress | <p>Unsealed penetrations and openings are located in exit stair enclosures.</p> <p>Electrical cable/ BBT raceway passing through the exit enclosure.</p> <p>Location: N-E Stair-1 of Office Building-1</p> | <p>No other penetration into and through the exit enclosure except for fire alarm equipment electrical raceway, required exit doors, sprinkler piping, standpipes, and electrical conduit serving the exit enclosure is permitted in accordance with section 6.14.4 of RSC Technical Guidelines (Standard)<sup>1</sup> V1.0. So, relocate the electrical wires/raceways to somewhere else avoiding the exit enclosure, and seal the created unprotected openings with a minimum of 1.5 hours listed/certified fire-rated materials. Installation shall be as per manufacturer published installation guideline and the certification authority guideline to ensure the fire-rating. Or seal the penetration by 2-hr masonry construction.</p> | Within 3 Months |

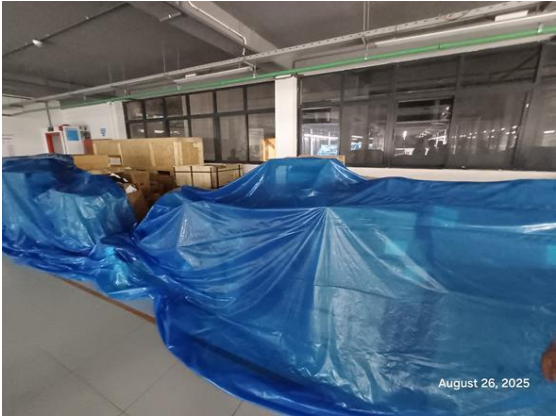
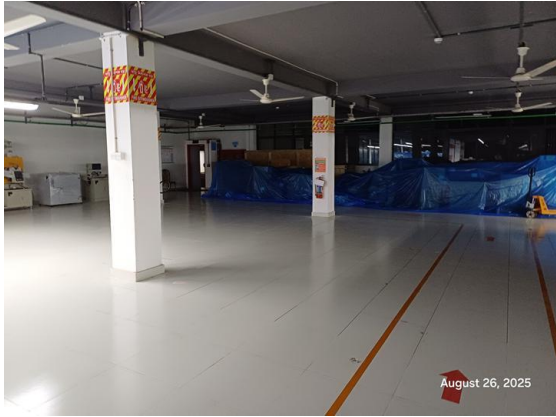
| SI No. | Category | Findings | Required Action | Remediation Time Frame |
|---|---|---|---|---|
| F4 | Fire Rated Construction | <p>Areas used for in-process storage of combustible materials are open to the surrounding occupancy.</p> <p><b>Location:</b> Ground floor of Office Building-1</p> | <p>Provide defined storage areas and limit the storage arrangement as follows:</p> <p>Maximum height of 2.45 m and maximum area of 23 m<sup>2</sup> and is separated by a minimum 3.0 m (10ft) from other storage areas and they do not exceed 10 percent of the building area of the story in which they occur.</p> <p>or,</p> <p>If sprinkler protected, Maximum height 12 ft (3.66 m) and maximum area of 1000 ft<sup>2</sup> (93 m<sup>2</sup>) and separated by a at least 25 ft (7.62 m) and does not constitute more than 10 percent of the building area or 4000 ft<sup>2</sup> (372 m<sup>2</sup>) of the sprinklered area, whichever is greater.</p> <p>or,</p> <p>Enclose the storage area from the surrounding occupancy with a minimum 1 hour construction.</p> | Within 3 Months |

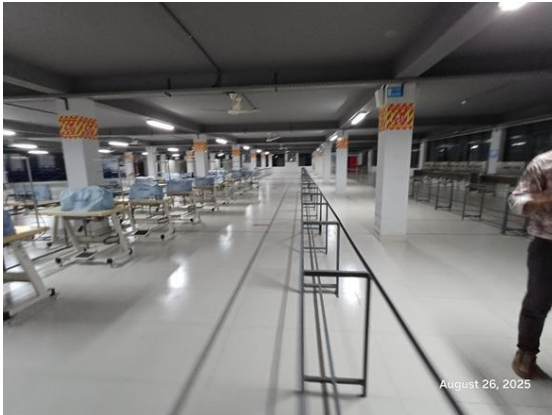
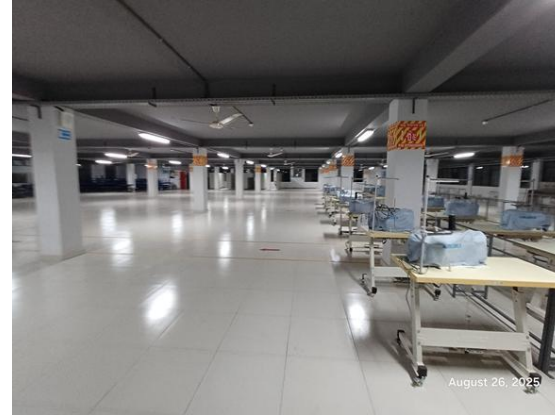
| SI No. | Category | Findings | Required Action | Remediation Time Frame |
|---|---|---|---|---|
| F7 | Means of Egress | <p>Aisles are found missing on 1st floor of office building-1 as placement work of new machines were ongoing .</p> <p><b>Location:</b> 1st floor of Office Building-1</p> | Provide minimum aisle widths of 36-in. Aisles mark shall be clearly visible. | Within 1 Month |

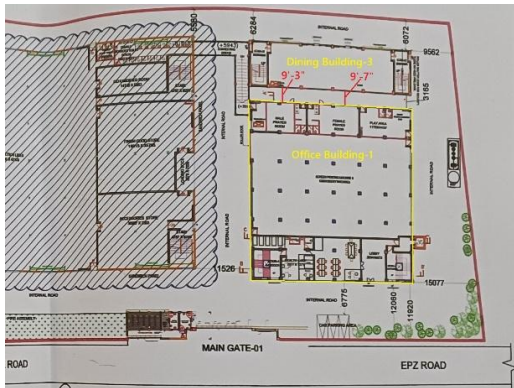
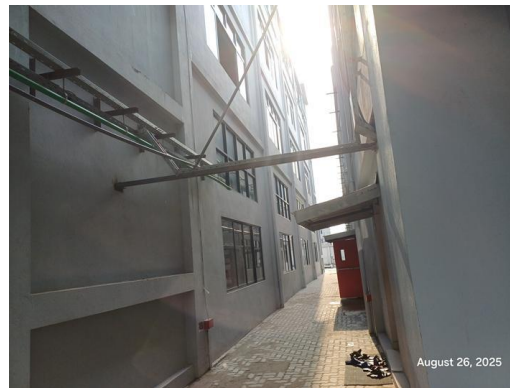
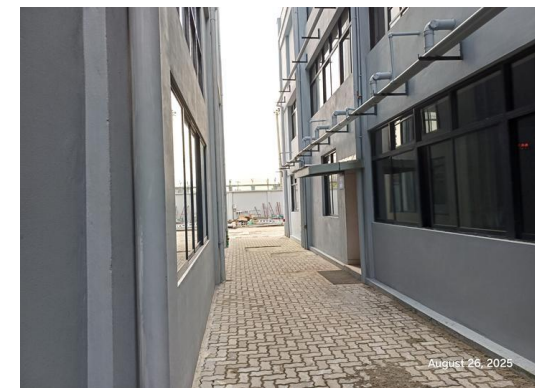
| SI No. | Category | Findings | Required Action | Remediation Time Frame |
|---|---|---|---|---|
| F9 | Means of Egress | The egress court serving south exits from male and female prayer room and childcare is less than 10 ft wide and is not separated from the adjacent building exterior which is not in accordance with section 6.17.2 of RSC Technical Guidelines (Standard) <sup>1</sup> V1.0. | <p>Egress courts less than 3050 mm (10 ft) in width (as measured from the building and the adjacent property line) shall be provided with walls having a 1-hr fire resistance rated construction for a distance of 3050 mm (10 ft) above the floor of the court.</p> <p>Seal all penetrations and openings to the interior of the building along the discharge path, up to a height of 10 ft. to provide a minimum 1-hr fire separation.</p> | Within 3 Months |

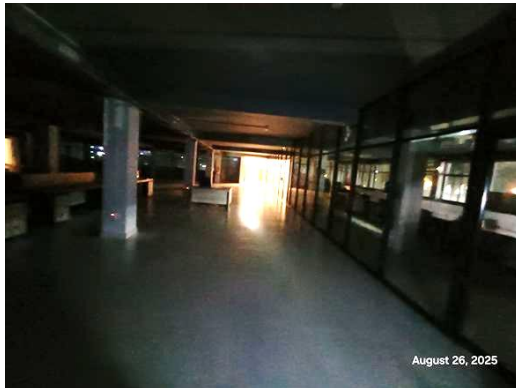
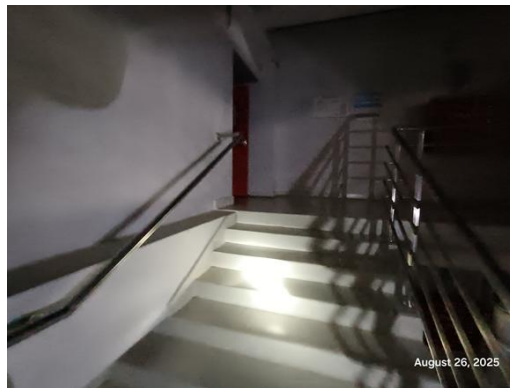
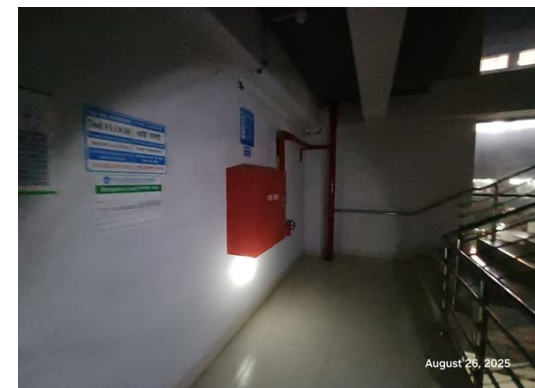
| SI No. | Category | Findings | Required Action | Remediation Time Frame |
|---|---|---|---|---|
| F10 | Means of Egress | <p>Based on the number and location of emergency lights observed, adequate illumination levels are not anticipated along egress routes.</p> <p>Location: All floors of office building-1</p> | <p>Test the emergency lighting system on each floor and provide additional emergency fixtures to provide adequate illumination along the means of egress. Provide a minimum illumination of 10 lux at the floor level within exit stairs and exit discharge paths and minimum 2.5 lux along exit access aisles. Illumination on means of egress shall meet in accordance with RSC Technical Guidelines (Standard)<sup>1</sup> V1.0 Section 10.12.2.</p> | Within 3 Months |

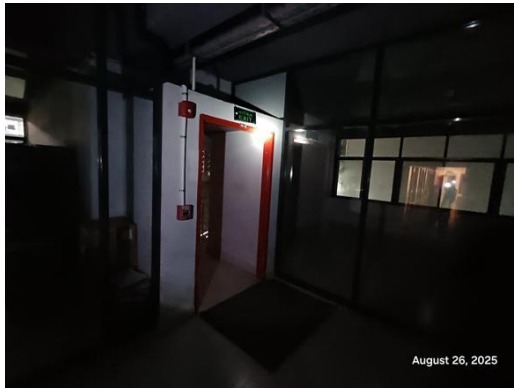
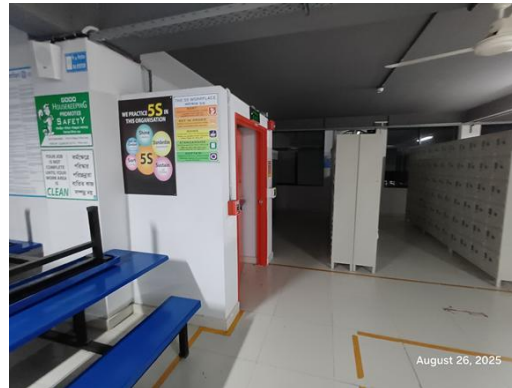
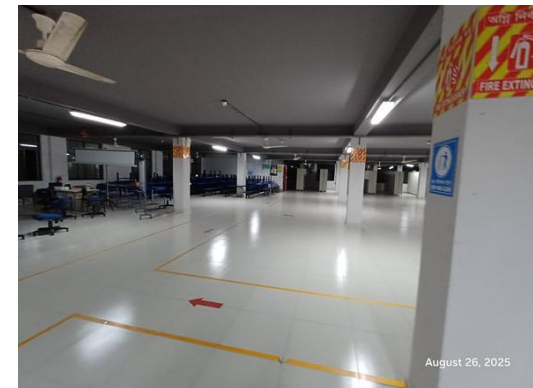
| SI No. | Category | Findings | Required Action | Remediation Time Frame |
|---|---|---|---|---|
| F11 | Means of Egress | <p>Directional signs are not provided where direction of the path of travel to an exit has changed. Exit signages are not illuminated during testing (burned out, broken, etc.).</p> <p>Location: 1st and 2nd floor of Office Building-1</p> | <p>Lighted exit signs shall be placed at entrance to an exit. Additional directional exit signs shall be placed throughout the facility anywhere the continuation of the egress is not obvious.</p> <p>Lighted exit signs shall be provided with either battery backup or uninterruptable power supply systems and shall be continuously illuminated at all times. Exit Sign shall provide in accordance with RSC Technical Guidelines (Standard)<sup>1</sup> V1.0 Section 6.11.</p> | Within 1 Month |

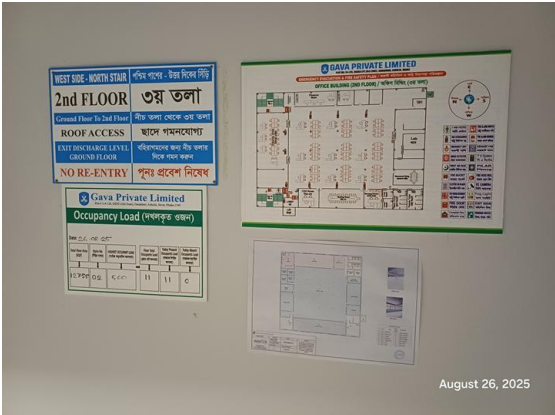
| SI No. | Category | Findings | Required Action | Remediation Time Frame |
|---|---|---|---|---|
| F15 | Means of Egress (Evacuation Plan) | <p>Fire evacuation maps are not updated as per site condition due to placement work of new machines were ongoing .</p> <p>Location: 1st &amp; 2nd Floor of Office Building</p> | <p>Update the fire evacuation map and shall be posted at the entrance to each exit stair in accordance with RSC Technical Guidelines (Standard)<sup>1</sup> V1.0 Section 13.3.</p> | Within 1 Month |

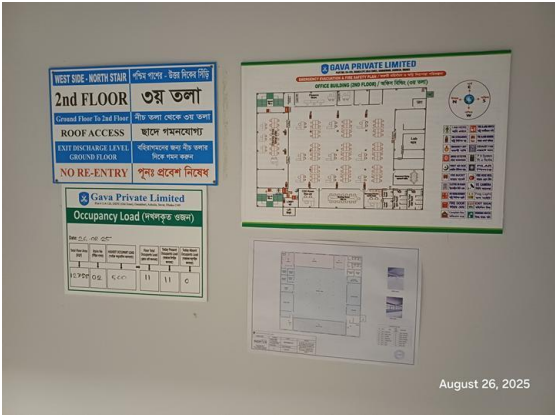
| SI No. | Category | Findings | Required Action | Remediation Time Frame |
|---|---|---|---|---|
| F16 | Means of Egress | <p>Building does not have occupant load signs as per standard at required locations on all floors.</p> <p>Location: Office Building-1</p> | <p>Post the occupant load for every assembly and production floor in a facility in a conspicuous space near the main exit or exit access doorway for the space in accordance with RSC Technical Guidelines (Standard)<sup>1</sup> V1.0 Section 6.4.4.</p> | Within 1 Month |

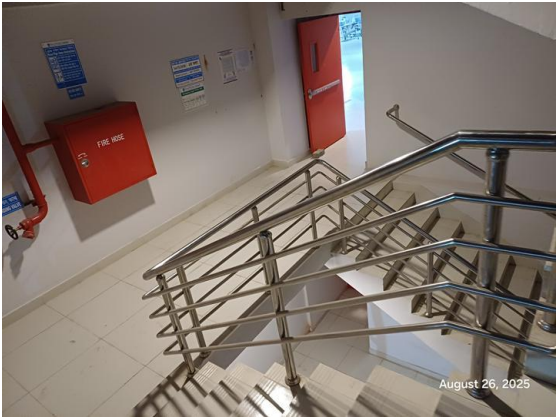
| SI No. | Category | Findings | Required Action | Remediation Time Frame |
|---|---|---|---|---|
| F17 | Means of Egress | <p>Building does not have stair/floor level designation signs at required locations on all floors.</p> <p>Location: Office Building-1</p> | <p>Provide stair designation sign at each floor entrance from the stair to the floor in English and Bengali. Signs shall indicate the name of the stair and the floor level. Signs shall be posted adjacent to the door in accordance with RSC Technical Guidelines (Standard)<sup>1</sup> V1.0 Section 6.9.3.</p> | Within 1 Month |

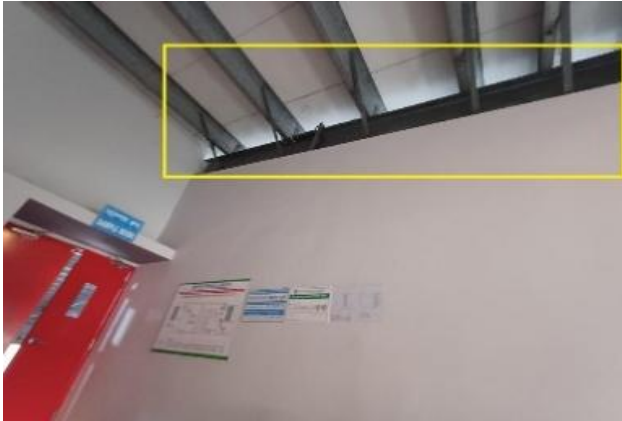
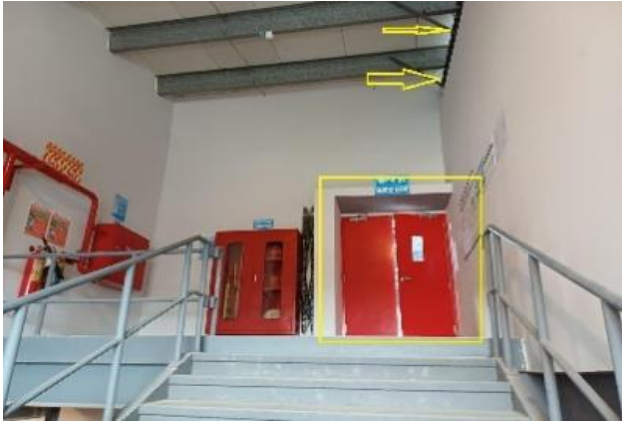
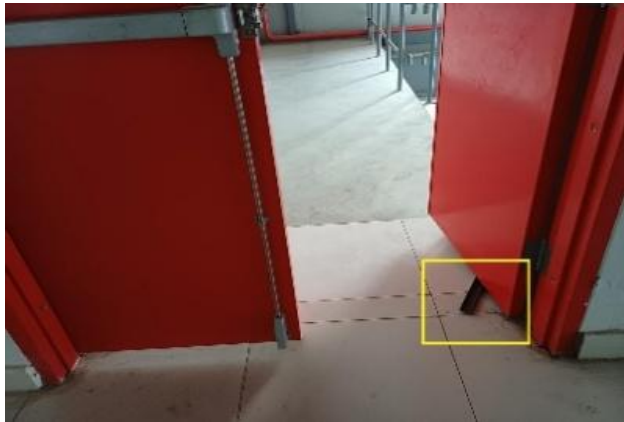
| Sl No. | Category | Findings | Required Action | Remediation Time Frame |
|---|---|---|---|---|
| F18 | Means of Egress | <p>The exit stair enclosures are not separated from work areas and other spaces on each floor by fire-rated construction.</p> <p><b>Location:</b> Main Factory Building- 2</p> <p><b>Non-compliance reason:</b> (i) Unsealed penetrations are found fire rated barrier construction; (ii) Unprotected steel structural element is found in all staircases; (iii) Proper certification is not available for fire rated doors and door accessories installed in the factory. &amp; (iv) The fire doors were found tied by unauthorized means and also interfacing with the fire alarm system &amp; door closers were not properly functional during the inspection.</p> | <p>The exit stair enclosure shall be provided with a minimum 1-hr fire resistance rating for buildings with 3 or fewer stories and a minimum of 2- hr. fire resistance rating for buildings 4 or more stories. Provide 1-hr. fire rated door and seal all penetrations and openings by 1 hr. fire rated fire rated barrier construction for building with 3 or fewer stories. Provide 1.5 hr. fire rated door and seal all penetrations and openings by 2 hr. fire rated fire rated barrier construction for building with 4 or more stories in accordance with section 6.3.1.2 of RSC Technical Guidelines (Standard)<sup>1</sup> V1.0.</p> <p>Ensure that the fire doors are self-closing and positive latching and that they are provided with fire exit (panic) hardware where serving production floors. If fire doors are required to be held open for functional reasons, provide automatic closing devices tied to the fire alarm system.</p> <p>Keep proper datasheet &amp; certifications for installed fire doors &amp; accessories on-site for verification. The clearance under the bottom of a door shall be a maximum of 3/4 in. (19 mm).</p> | Within 3 Months |

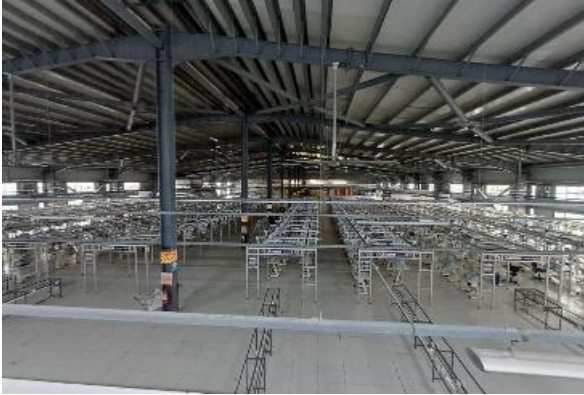
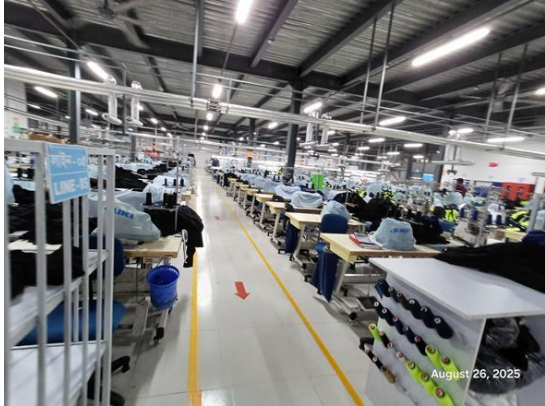
| SI No. | Category | Findings | Required Action | Remediation Time Frame |
|---|---|---|---|---|
| F19 | Fire Rated Construction (Passive Fire Protection of Steel Structure) | <p>The main structural element of the new building is constructed by steel which is non-rated and were found in exposed condition without any fire protection.</p> <p><b>Location:</b> Main Factory Building- 2</p> <p>Height of Peak = 57'-6"<br/>Height of Eave = 43'-0"</p> | <p>The construction type shall confirm to be in accordance with BNBC 2020 Part-3, Table 3.1.7. Ensure fire resistive rated construction following Table 3.3.1 (a) Part 3 Section-3, Table 3.2.2 and Table 3.2.3 Part 3 Section 2 and Table 4.1.1 from BNBC 2020 Part 4 Section 1. Provide design philosophy to determine the construction type as per BNBC 2020. If any construction rating requires, Consult a qualified fire protection engineer to achieve the require fire rating.</p> <p>Submit the design philosophy along with the required documents to RSC for review the required construction type.</p> <p>Once the design philosophy is reviewed, provide fire ratings of structural members.</p> | Within 6 Months |

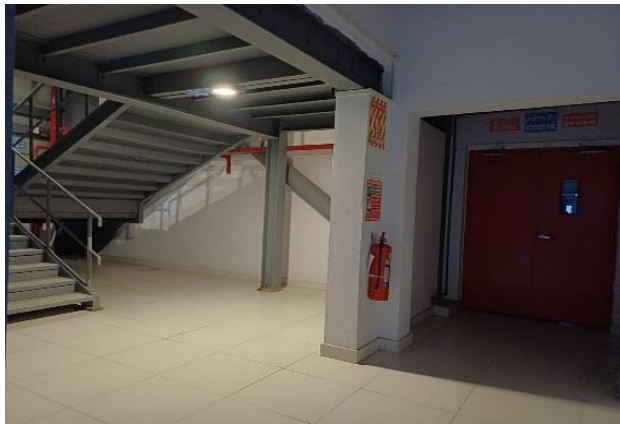
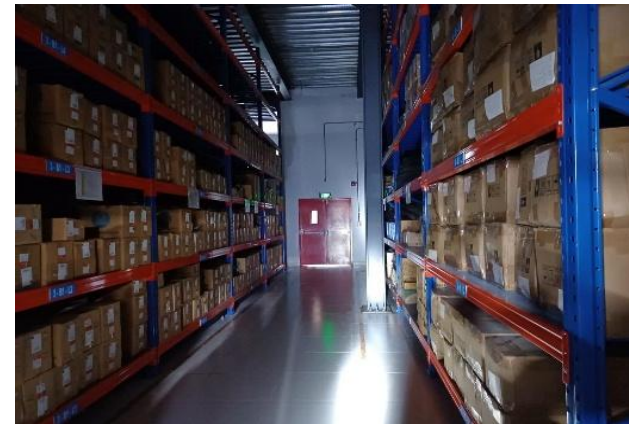
| SI No. | Category | Findings | Required Action | Remediation Time Frame |
|---|---|---|---|---|
| F21 | Means of Egress | <p>Storage areas discharges directly into the exit stair enclosure.</p> <p>Location: N-W Stair-1 located at ground floor of Main Factory Building- 2</p> | <p>Openings from exit enclosure to Storage areas/ basements/ transformer rooms/ generator rooms/ boiler rooms and similar normally unoccupied spaces shall be provided with a vestibule with fire rated construction and openings in accordance with section 6.14.3 of RSC Technical Guidelines (Standard)<sup>1</sup> V1.0. Provide a min 1-hr fire rated door on the exit stair side and a 1-hr fire rated door on the Store, generator, sub-station room side . Ensure that the fire rating of the vestibule construction matches that of the exit stair enclosure as per RSC Technical Guidelines (Standard)<sup>1</sup> V1.0. section 6.14.3. The minimum width for vestibules shall not be less than 1.1m and length 1.8m.</p> | Within 3 Months |

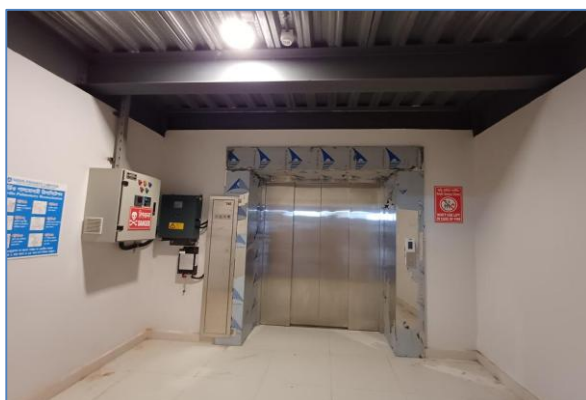
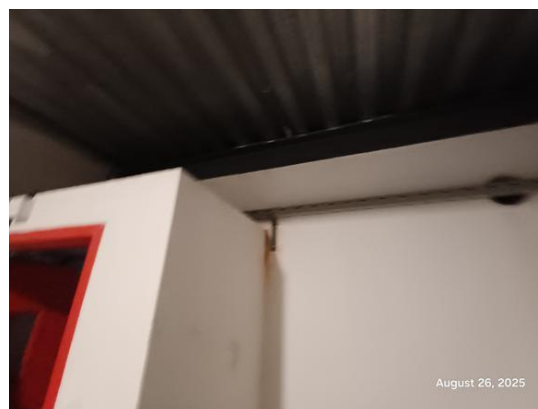
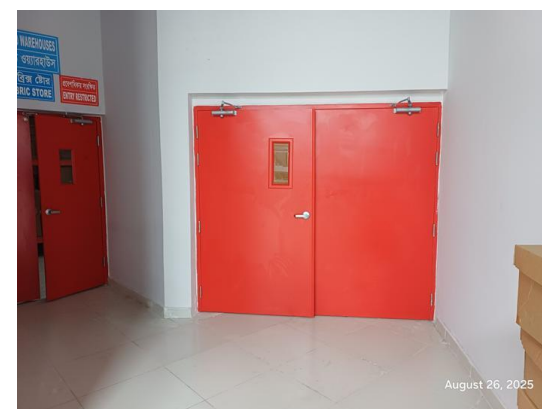
| SI No. | Category | Findings | Required Action | Remediation Time Frame |
|---|---|---|---|---|
| F22 | Fire Rated Construction | <p>Elevator shafts open directly into the production floor without proper fire separation due to unprotected barrier and opening.</p> <p><b>Location:</b> Main Factory Building-2</p> <p><b>Non-Compliance Reason:</b> (i) Unprotected steel structural element is found in all lift enclosure; (ii) Proper certification is not available for fire rated doors and door accessories installed in the factory. &amp; (iii) The fire doors were not interfaced with FACP.</p> | Elevator shaft shall be separated from production area by 2 hours fire rated construction. 2-hr fire barriers shall be protected with minimum 1.5-hr fire protective opening assemblies. | Within 3 Months |

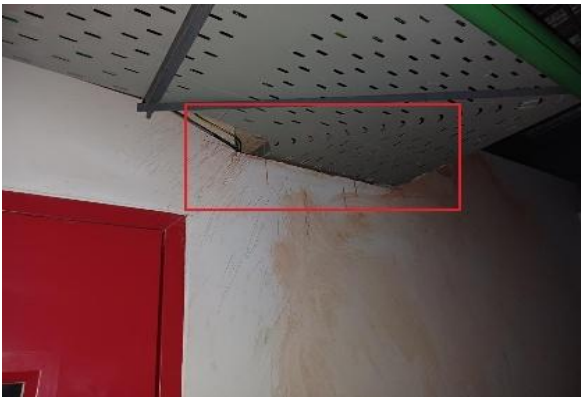
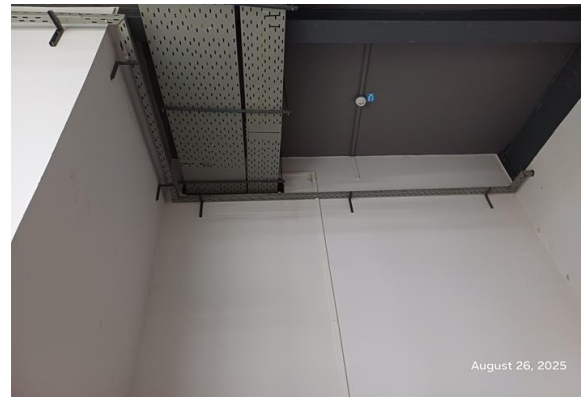
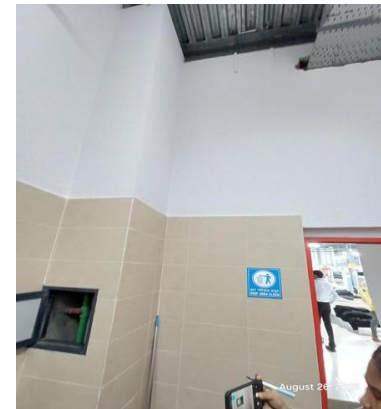
| SI No. | Category | Findings | Required Action | Remediation Time Frame |
|---|---|---|---|---|
| F23 | Fire Rated Construction | <p>Penetrations through floor/ceiling assemblies are found unsealed due to electrical cable riser and plumbing PVC Pipes.</p> <p><b>Location:</b> DB room in all floors, Toilet zones east side of main production building-2.</p> <p><b>Non-compliance Reason:</b> For electrical &amp; plumbing penetration Shaft is constructed, but there are horizontal penetration in rated wall.</p> | <p>Seal all penetrations and openings in floor/ceiling assemblies by a listed through-penetration fire stop system tested in accordance with ASTM E814 or approved alternative standard to maintain minimum 2-hr. fire resistance rating. Installation shall be as per manufacturer published installation guideline and the certification authority guideline to ensure the fire-rating in accordance with section 4.7 of RSC Technical Guideline (Standard)</p> <p>Or,</p> <p>Provide a minimum 2-hr fire rated shaft to separate the penetration from each floor if required.</p> | Within 3 Months |

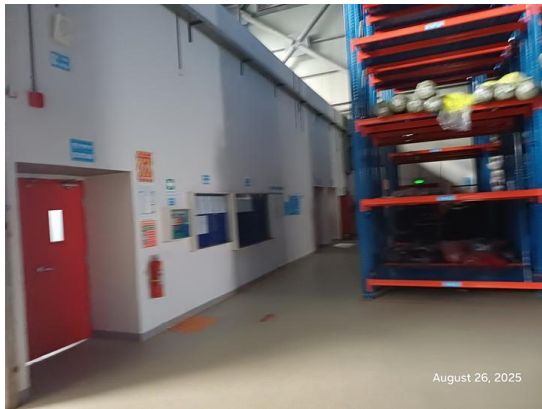
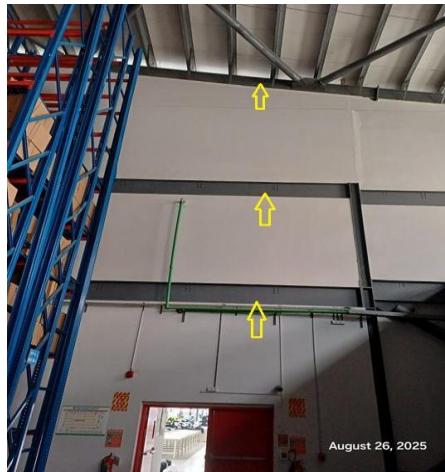
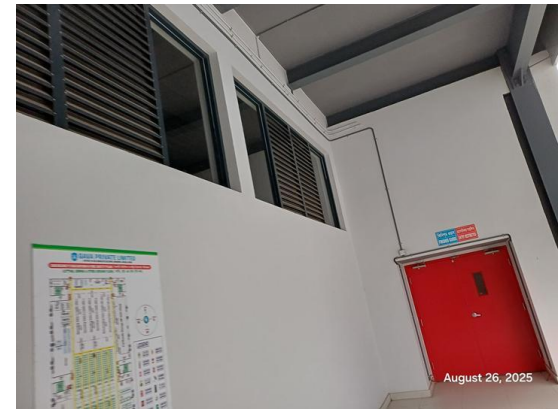
| SI No. | Category | Findings | Required Action | Remediation Time Frame |
|---|---|---|---|---|
| F24 | Fire Rated Construction | <p>Rooms used for storage of combustible materials are not separated from the surrounding occupancy.</p> <p><b>Location:</b> Raw materials store and finished goods store on ground floor of Main production building-2.</p> <p><b>Non-Compliance Reason:</b> (i) Unprotected steel structural element is found in all lift enclosure; (ii) Proper certification is not available for fire rated doors and door accessories installed in the factory. &amp; (iii) The fire doors were not interfaced with FACP.</p> | Rooms used for storage of combustible materials shall be separated from the surrounding occupancy with a minimum 1 hour construction in accordance with section 3.4.2.1.5 of RSC Technical Guideline (Standard). | Within 3 Months |

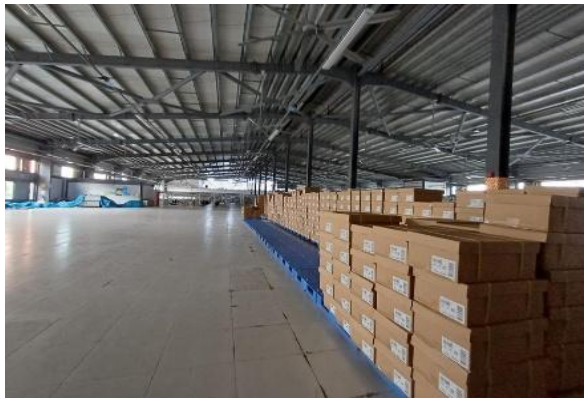
| SI No. | Category | Findings | Required Action | Remediation Time Frame |
|---|---|---|---|---|
| F25 | Fire Rated Construction | <p>Areas used for in-process storage of combustible materials are open to the surrounding occupancy.</p> <p>Location: On ground and 1st floor of Main Factory Building-2</p> | <p>Provide defined storage areas and limit the storage arrangement as follows:<br/>Maximum height of 2.45 m and maximum area of 23 m<sup>2</sup> and is separated by a minimum 3.0 m (10ft) from other storage areas and they do not exceed 10 percent of the building area of the story in which they occur.</p> <p>or,</p> <p>If sprinkler protected, Maximum height 12 ft (3.66 m) and maximum area of 1000 ft<sup>2</sup> (93 m<sup>2</sup>) and separated by a at least 25 ft (7.62 m) and does not constitute more than 10 percent of the building area or 4000 ft<sup>2</sup> (372 m<sup>2</sup>) of the sprinklered area, whichever is greater.</p> <p>or,</p> <p>Enclose the storage area from the surrounding occupancy with a minimum 1 hour construction.</p> | Within 3 Months |

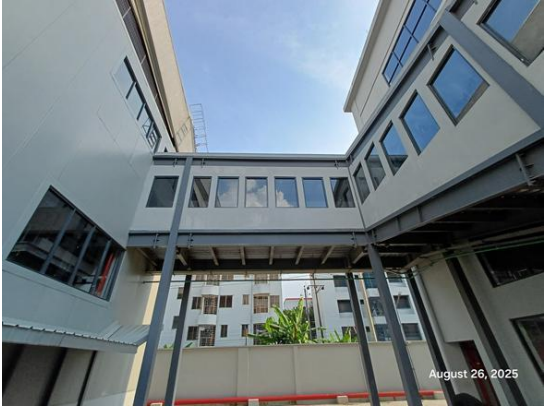
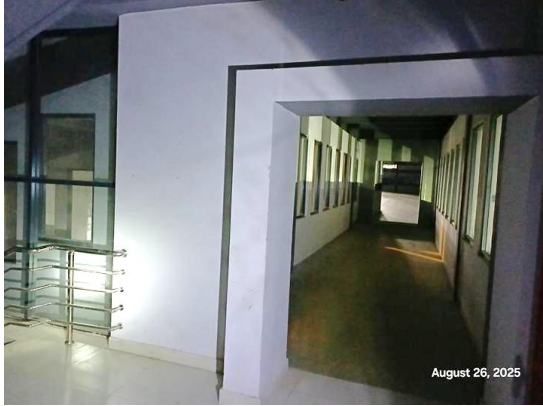
| SI No. | Category | Findings | Required Action | Remediation Time Frame |
|---|---|---|---|---|
| F26 | Fire Rated Construction | <p>A non-rated connecting corridor has been constructed between two buildings which is not fire separated from the adjacent building.</p> <p><b>Location:</b> Connecting bridge between main production building-2 and dining building-3 Stair</p> | <p>Separate the buildings with a minimum 2-hour fire-rated construction on both sides of the connecting corridor. Opening protection extending up to 10 feet beyond the connecting corridor shall meet section 4.6 of RSC Technical Guidelines (Standard)<sup>1</sup> V1.0 .</p> | Within 3 Months |

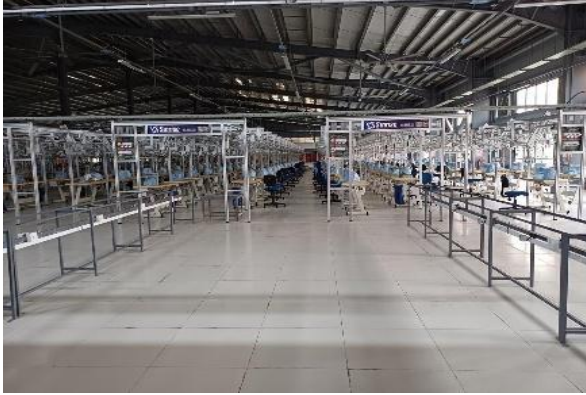
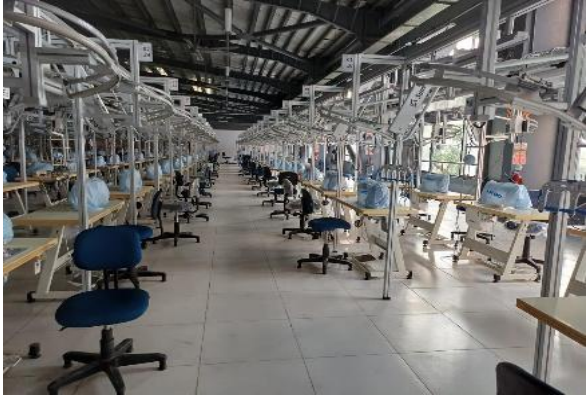
| SI No. | Category | Findings | Required Action | Remediation Time Frame |
|---|---|---|---|---|
| F27 | Means of Egress | <p>Aisles are found missing on 1st floor of main factory building-2 as placement work of new machines were ongoing .</p> <p><b>Location:</b> 1st floor of Main Factory Building-2</p> | Provide minimum aisle widths of 36-in. Aisles mark shall be clearly visible. | Within 1 Month |

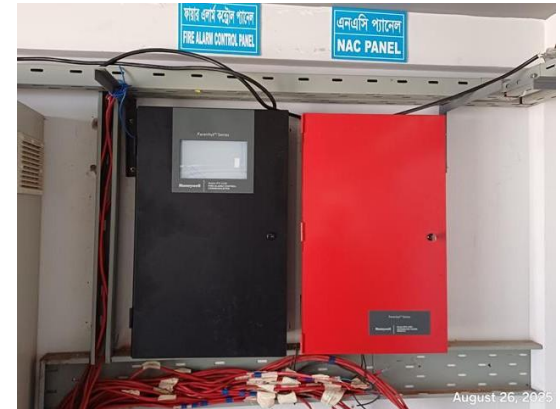
| SI No. | Category | Findings | Required Action | Remediation Time Frame |
|---|---|---|---|---|
| F28 | Fire Alarm & Detection System (FADS) | <p>The factory has installed a fire alarm and detection system that requires a detailed review to confirm compliance with NFPA 72 and RSC Technical Guidelines (Standard).</p> <p><b>Location:</b> Main Production Building-2</p> | <p>Submit the fire alarm and detection system design to RSC for review.</p> <p>Once the design is reviewed, install and modify the fire detection and alarm system throughout the building in accordance with review comment, RSC Technical Guidelines (Standard) and NFPA 72.</p> <p>After installation/modification the owner shall conduct internal testing and commissioning and then contact the RSC for witness of final acceptance testing.</p> | Design within 2 month and modification/ installation with 4 months |

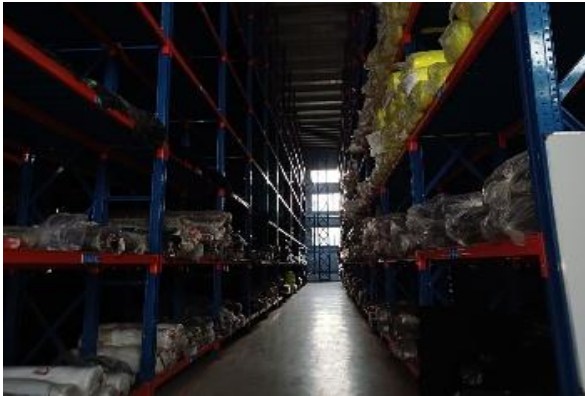
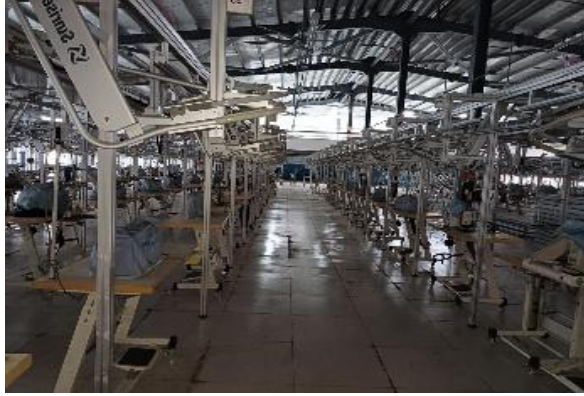
| SI No. | Category | Findings | Required Action | Remediation Time Frame |
|---|---|---|---|---|
| F-31 | Means of Egress (Egress Lighting) | <p>Based on the number and location of emergency lights observed, adequate illumination levels are not anticipated along egress routes.</p> <p><b>Location:</b> All Floors of Main Factory Building-2</p> | <p>Test the emergency lighting system on each floor and provide additional emergency fixtures to provide adequate illumination along the means of egress. Provide a minimum illumination of 10 lux at the floor level within exit stairs and exit discharge paths and minimum 2.5 lux along exit access aisles. Illumination on means of egress shall meet in accordance with RSC Technical Guidelines (Standard)<sup>1</sup> V1.0 Section 10.12.2.</p> | Within 3 Months |

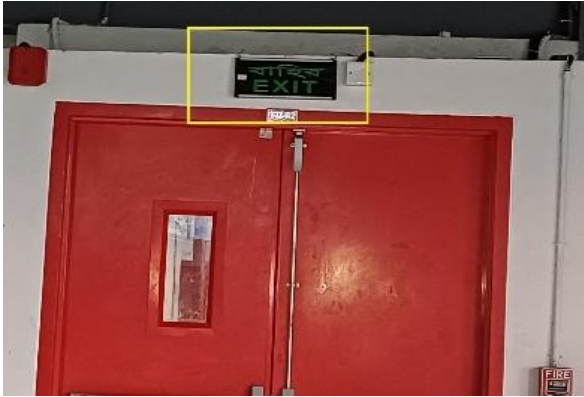
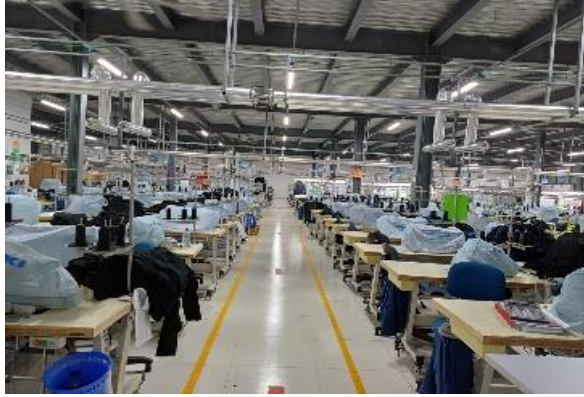
| SI No. | Category | Findings | Required Action | Remediation Time Frame |
|---|---|---|---|---|
| F-32 | Means of Egress (Exit Sign, Stair sign & occupant load sign) | <p>Few exit signs are burned out. Directional signs are not provided where direction of the path of travel to an exit has changed.</p> <p><b>Location:</b> All floors of Main Factory Building-2</p> | Illuminated directional signs shall be provided where there is a change in the direction for the path of travel and the direction to an exit is not obvious in accordance with RSC Technical Guidelines (Standard) <sup>1</sup> V1.0 Section 6.11.3. | Within 1 Month |

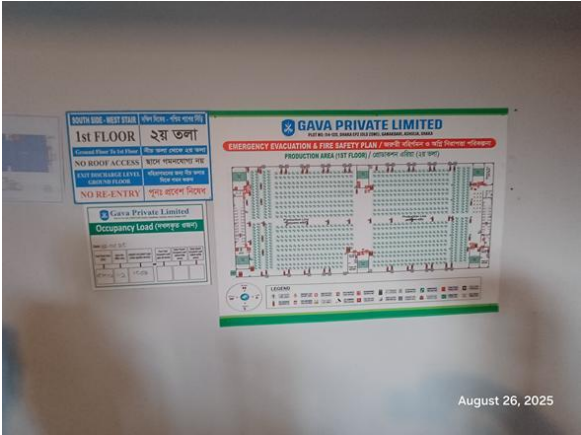
| SI No. | Category | Findings | Required Action | Remediation Time Frame |
|---|---|---|---|---|
| F-34 | Means of Egress (Evacuation plan) | <p>Fire evacuation maps are not updated as per site condition due to placement work of new machines were ongoing .</p> <p>Location: 1st &amp; mezzanine Floor of Main Production building-2</p> | Update the fire evacuation map and shall be posted at the entrance to each exit stair in accordance with RSC Technical Guidelines (Standard) <sup>1</sup> V1.0 Section 13.3. | Within 1 Month |

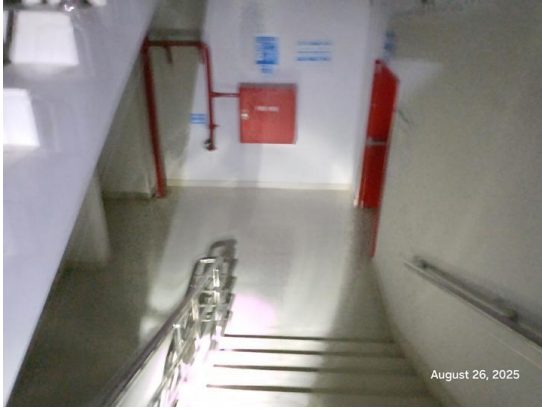
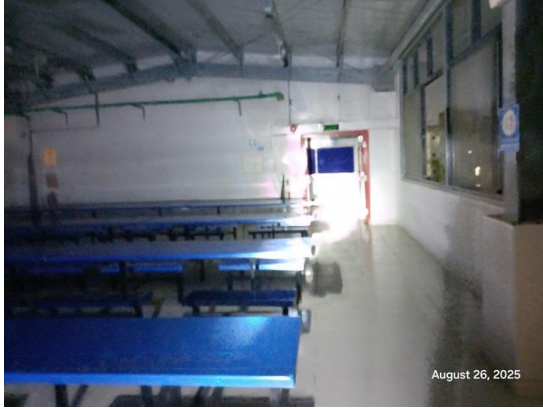
| Sl No. | Category | Findings | Required Action | Remediation Time Frame |
|---|---|---|---|---|
| F-35 | Means of Egress | <p>The exit stair enclosures are not separated from work areas and other spaces on each floor by fire-rated construction.</p> <p><b>Location:</b> Dining Building-3</p> <p><b>Non-compliance reason:</b> (i) Unsealed penetrations are found fire rated barrier construction; (ii) Unprotected steel structural element is found in all staircases; (iii) Proper certification is not available for fire rated doors and door accessories installed in the factory. &amp; (iv) The fire doors were not properly interfaced with FACP.</p> | <p>The exit stair enclosure shall be provided with a minimum 1-hr fire resistance rating for buildings with 3 or fewer stories and a minimum of 2- hr. fire resistance rating for buildings 4 or more stories. Provide 1-hr. fire rated door and seal all penetrations and openings by 1 hr. fire rated fire rated barrier construction for building with 3 or fewer stories. Provide 1.5 hr. fire rated door and seal all penetrations and openings by 2 hr. fire rated fire rated barrier construction for building with 4 or more stories in accordance with section 6.3.1.2 of RSC Technical Guidelines (Standard)<sup>1</sup> V1.0.</p> <p>Ensure that the fire doors are self-closing and positive latching and that they are provided with fire exit (panic) hardware where serving production floors. If fire doors are required to be held open for functional reasons, provide automatic closing devices tied to the fire alarm system.</p> <p>Keep proper datasheet &amp; certifications for installed fire doors &amp; accessories on-site for verification. The clearance under the bottom of a door shall be a maximum of 3/4 in. (19 mm).</p> | Within 3 Months |

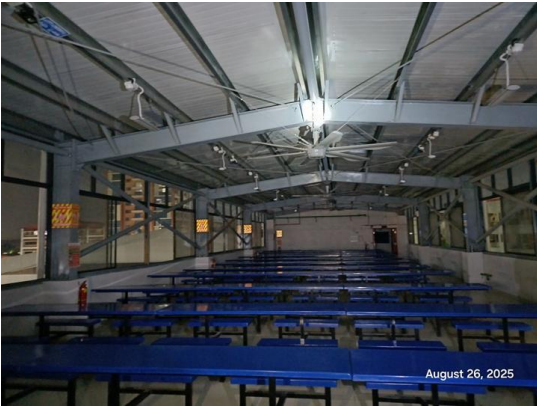
| SI No. | Category | Findings | Required Action | Remediation Time Frame |
|---|---|---|---|---|
| F-36 | Fire Rated Construction (Passive Fire Protection of Steel Structure) | <p>The main structural element of the new building is constructed by steel which is non-rated and were found in exposed condition without any fire protection.</p> <p><b>Location:</b> Dining Building-3 (3rd floor)</p> <p>Height of Peak = 17.22m<br/>Height of Eave = 16.74m</p> | <p>The construction type shall confirm to be in accordance with BNBC 2020 Part-3, Table 3.1.7. Ensure fire resistive rated construction following Table 3.3.1 (a) Part 3 Section-3, Table 3.2.2 and Table 3.2.3 Part 3 Section 2 and Table 4.1.1 from BNBC 2020 Part 4 Section 1. Provide design philosophy to determine the construction type as per BNBC 2020. If any construction rating requires, Consult a qualified fire protection engineer to achieve the required fire rating.</p> <p>Submit the design philosophy along with the required documents to RSC for review the required construction type.</p> <p>Once the design philosophy is reviewed, provide fire ratings of structural members.</p> | Within 6 Months |

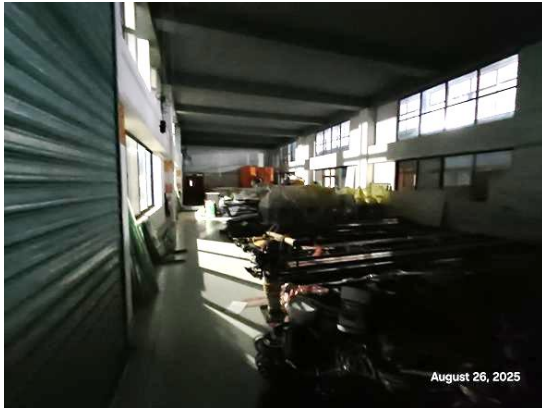
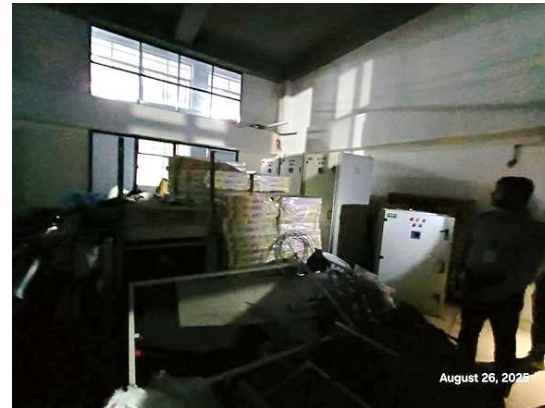
| SI No. | Category | Findings | Required Action | Remediation Time Frame |
|---|---|---|---|---|
| F-39 | Means of Egress | <p>Storage areas discharges directly into the exit stair enclosure.</p> <p>Location: Ground Floor of Dining Building-3</p> | <p>Openings from exit enclosure to Storage areas/ basements/ transformer rooms/ generator rooms/ boiler rooms and similar normally unoccupied spaces shall be provided with a vestibule with fire rated construction and openings in accordance with section 6.14.3 of RSC Technical Guidelines (Standard)<sup>1</sup> V1.0. Provide a min 1-hr fire rated door on the exit stair side and a 1-hr fire rated door on the Store, generator, sub-station room side . Ensure that the fire rating of the vestibule construction matches that of the exit stair enclosure as per RSC Technical Guidelines (Standard)<sup>1</sup> V1.0. section 6.14.3. The minimum width for vestibules shall not be less than 1.1m and length 1.8m.</p> | Within 3 Months |

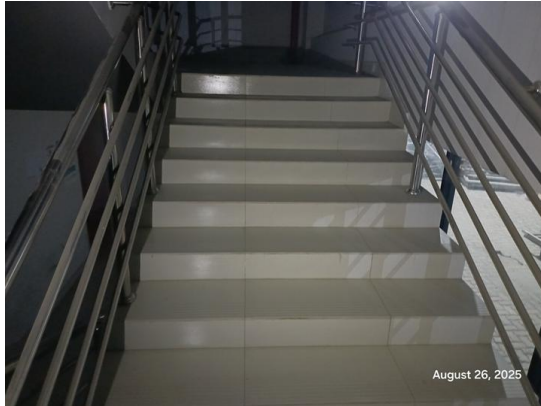
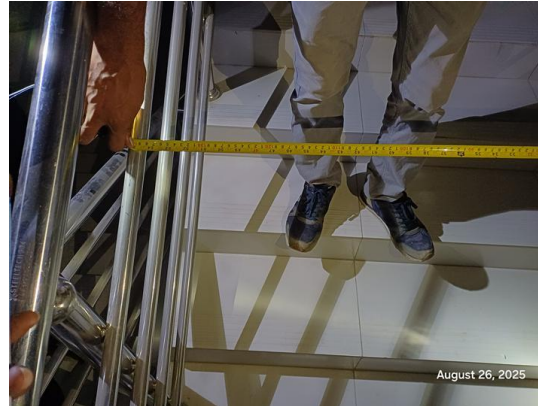
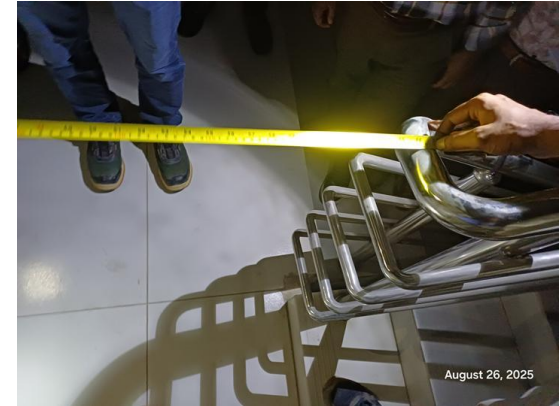
| SI No. | Category | Findings | Required Action | Remediation Time Frame |
|---|---|---|---|---|
| F-40 | Means of Egress | <p>Stair clear width was found less than 79 in.</p> <p>Location: Dining building-3<br/>Available Stair Width: 1.45m (4.75 ft)</p> | Stairs shall have a minimum clear width of 79 in (2.0m) for all industrial occupancies as per RSC Technical Guideline (Standard) section of 6.5.6 | Within 3 Months |

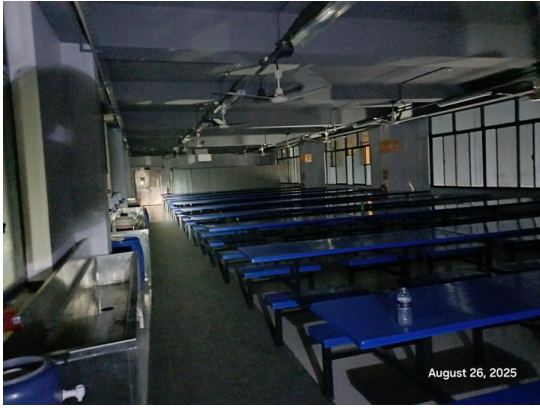
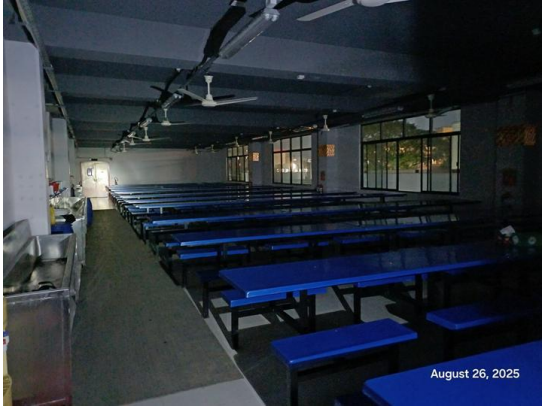
| SI No. | Category | Findings | Required Action | Remediation Time Frame |
|---|---|---|---|---|
| F-47 | Means of Egress<br>(Egress Lighting) | <p>Based on the number and location of emergency lights observed, adequate illumination levels are not anticipated along egress routes.</p> <p>Location: All Floor of Dining Building-3</p> | <p>Test the emergency lighting system on each floor and provide additional emergency fixtures to provide adequate illumination along the means of egress. Provide a minimum illumination of 10 lux at the floor level within exit stairs and exit discharge paths and minimum 2.5 lux along exit access aisles. Illumination on means of egress shall meet in accordance with RSC Technical Guidelines (Standard)<sup>1</sup> V1.0 Section 10.12.2.</p> | Within 3 Months |

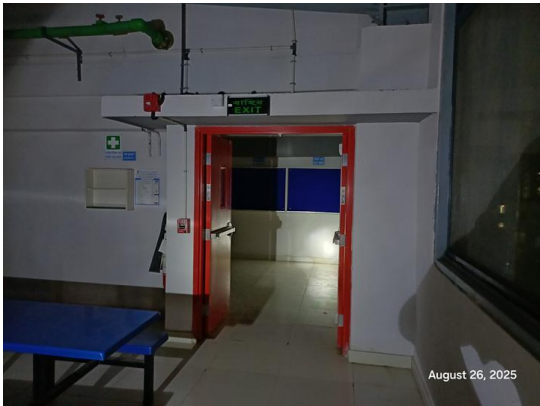
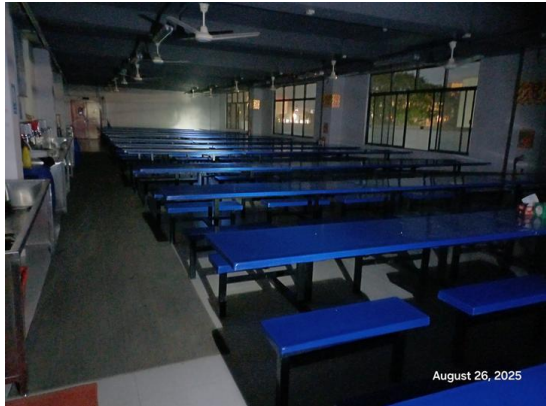
| SI No. | Category | Findings | Required Action | Remediation Time Frame |
|---|---|---|---|---|
| F-48 | Means of Egress<br>(Exit Sign, Stair sign & occupant load sign) | <p>Few Exit signs are burned-out, Directional signs are not provided where direction of the path of travel to an exit has changed.</p> <p>Location: All ancillary Structures</p> | Illuminated directional signs shall be provided where there is a change in the direction for the path of travel and the direction to an exit is not obvious in accordance with RSC Technical Guidelines (Standard) <sup>1</sup> V1.0 Section 6.11.3. | Within 1 Month |

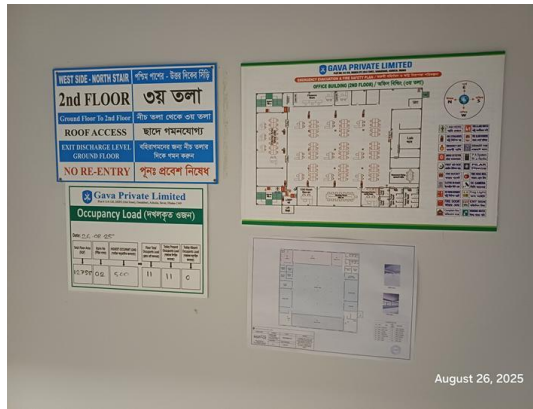
| SI No. | Category | Findings | Required Action | Remediation Time Frame |
|---|---|---|---|---|
| F-50 | Means of Egress (Evacuation Plan) | <p>Fire evacuation maps are not updated as per site condition due to placement work of new machines were ongoing .</p> <p>Location: Dining building-3.</p> | Update the fire evacuation map and shall be posted at the entrance to each exit stair in accordance with RSC Technical Guidelines (Standard) <sup>1</sup> V1.0 Section 13.3. | Within 1 Month |

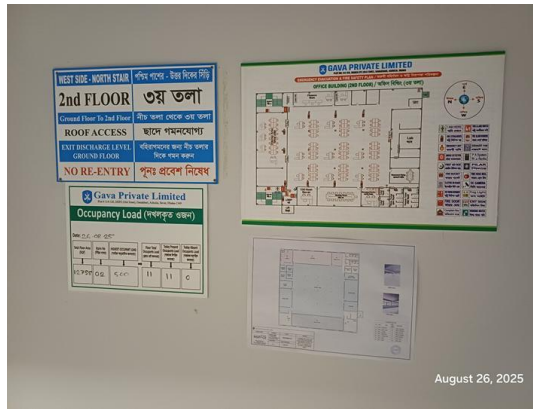
| SI No. | Category | Findings | Required Action | Remediation Time Frame |
|---|---|---|---|---|
| F-52 | Means of Egress | <p>Building does not have stair/floor level designation signs at required locations on all floors.</p> <p>Location: Office Dining Building-3</p> | <p>Provide stair designation sign at each floor entrance from the stair to the floor in English and Bengali. Signs shall indicate the name of the stair and the floor level. Signs shall be posted adjacent to the door in accordance with RSC Technical Guidelines (Standard)<sup>1</sup> V1.0 Section 6.9.3.</p> | Within 1 Month |
