# INITIAL FIRE SAFETY INSPECTION REPORT

**GAVA PRIVATE LIMITED**

**RSC ID: 26131**

**Plot # 114-120, Dhaka Export Processing Zone (Old Zone), Ganakbari, Ashulia, Dhaka-1349**

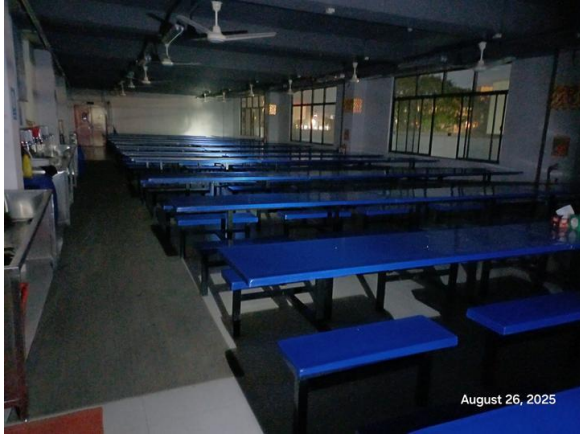
| SI No. | Category | Findings | Required Action | Remediation Time Frame |
|---|---|---|---|---|
| F-53 | Means of Egress | Aisles are found missing on all floors of Dining building-3 and wastage shed-1. | Provide minimum aisle widths of 36-in. Aisles mark shall be clearly visible. | Within 1 Month |
