Mango Tex Limited

Hossain plaza,2, Tungabari, asulia, savar, Dhaka

23 September 2025

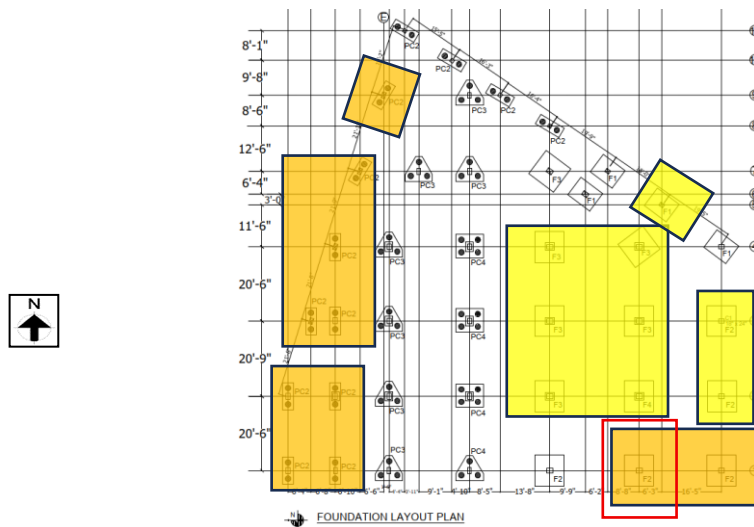
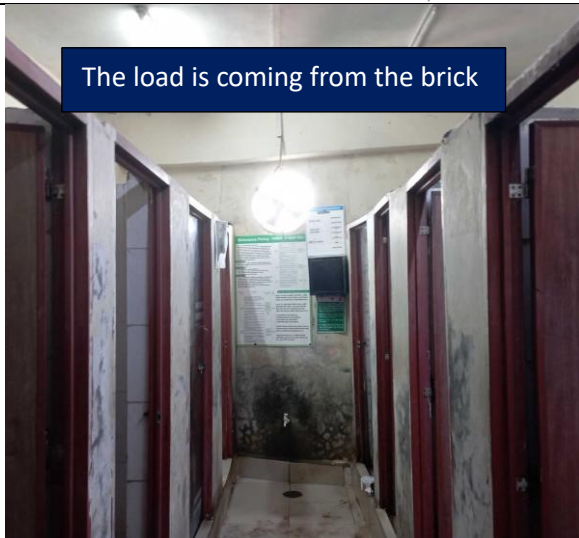
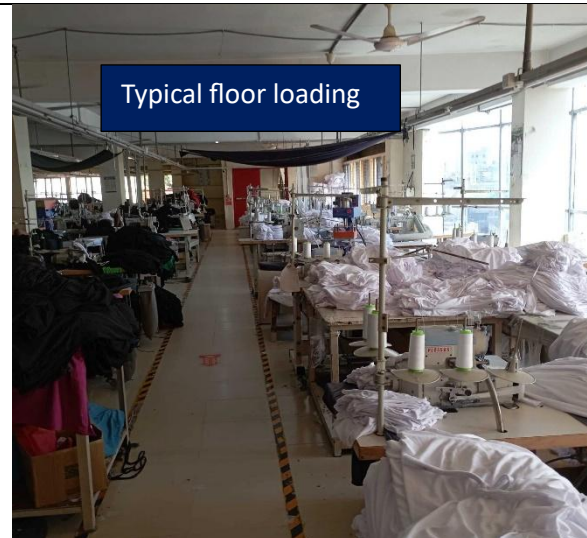
Observation-01: High stress in the foundation, considering BNBC prescribed floor live loads, which requires immediate design review (Production Building).

Description: Cursory calculation indicates high stress (bearing) in the pile foundation and isolated footing (amber marked), stress (bearing) in the foundation exceeds the normal design limit (yellow marked). Considering the allowable pile capacity of 454 KN (FoS- 2.50), the allowable soil bearing capacity is 11.46 Ton/m² (FoS- 3.0). Also, the punching shear stress of the foundation (red marked) exceeds the normal design limit.

For both cases, we considered the live load of 3 kPa for a typical floor, 6 kPa for storage, 5 kPa for stair areas, and a concrete strength of 15 MPa from the available core test report of the column. No concrete test report was available for retrofitting part of the column, but the core location was found.

The building engineer is required to take the following actions:

1. Verify the in-situ concrete strength of the footing. Also, confirm the concrete test report of the retrofitted column.
2. As part of the Detailed Engineering Assessment (DEA), review design, loads, foundation stresses, and suggest necessary remedial actions.
3. Produce and actively manage a loading plan according to the floor, column & foundation capacity.

Item No	Observation	Action Plan	Timeline
1.	High stress in the foundation, considering BNBC prescribed floor live loads, which require immediate design review (Production Building).	As part of the DEA, the building engineer is required to review the design, loads, and foundation stresses.	within 6 weeks

2.		Verify the in-situ concrete strength of the footing. Also, confirm the concrete test report of the retrofitted column.	within 6 weeks
3.		Produce and actively manage the loading plan according to the floor, column & foundation capacity.	within 6 weeks

4.		Implement remediation work after acceptance from RSC.	within 6 months
5.		Implement floor load plan.	within 6 months
6.	The load plan and design report don't comply with BNBC 2006 (Production Building).	The building engineer is required to update the live load plan as per BNBC 2006.	within 6 weeks

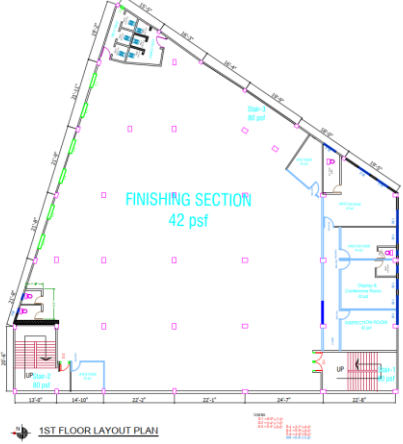
Observation-02: The load plan and design report don't comply with BNBC 2006 (Production Building).

Description: A load plan and design report were available on site, with a floor live load of 2 kPa for a typical floor. Also, the design report is prepared following the ACCORD standard. However, the building was constructed between March 2011 & January 2014, and building approval was taken from the local authority (LGED) in November 2016. As per the building construction & permit date, BNBC-2006 needs to be followed. The building engineer is required to update the live load plan and design report as per BNBC 2006.

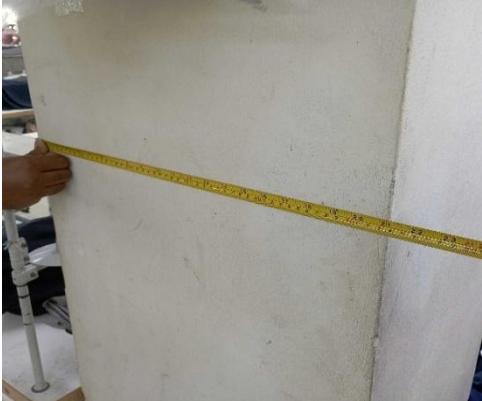
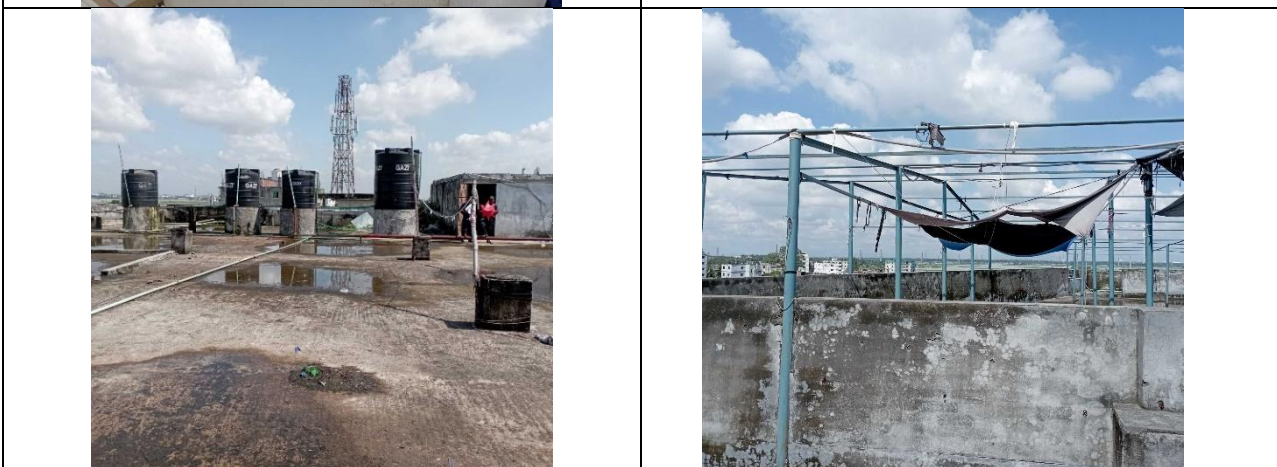
Observation-03: Discrepancy/missing information in the as-built (Production Building).

Description: Column C2 was found 500mmX375mm instead of 600 mm x 450 mm. Besides, some undocumented plastic water tanks and a steel frame were found on the roof. Also, the building has a basement, but no information was shown in the drawing. The building engineer is required to survey the whole structure and produce an accurate as-built drawing. Also, remove the undocumented steel frame.

7.	Discrepancy/missing information in the as-built (Production Building).	The building engineer is required to survey the whole structure and produce an accurate & detailed as-built drawing.	within 6 weeks

8.		Remove the undocumented steel frame from the roof.	within 6 weeks
9.	Crack and dampness on the wall (Production Building).	Identify all areas and repair cracks with a suitable method.	within 6 weeks

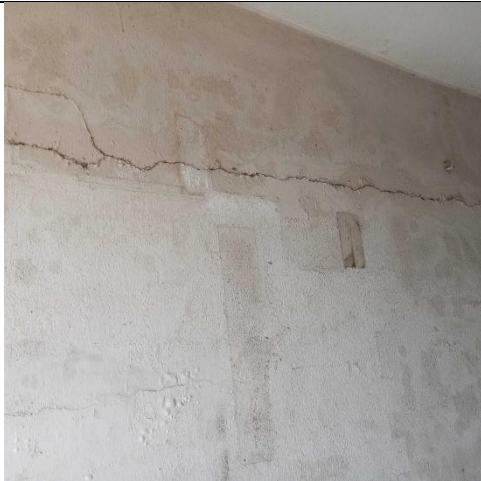
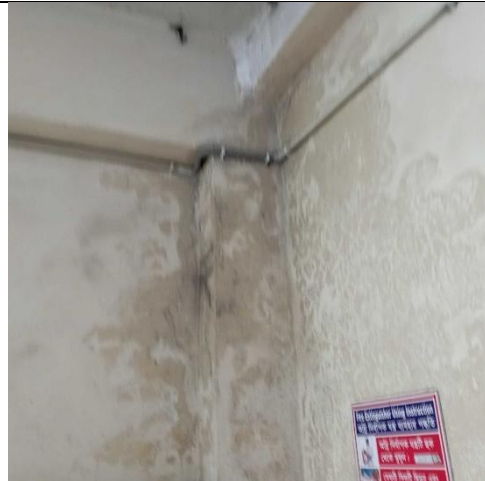
Observation-04: Crack and dampness on the wall (Production Building).

Description: Crack and dampness were found on the wall. The building engineer is required to repair cracks and dampness with a suitable method.

10.		Identify all areas and repair dampness with a suitable method.	within 6 weeks
11.	Non-structural elements found unbraced/unanchored (Production Building).	The building engineer is required to brace/anchor all non-structural elements.	within 6 weeks

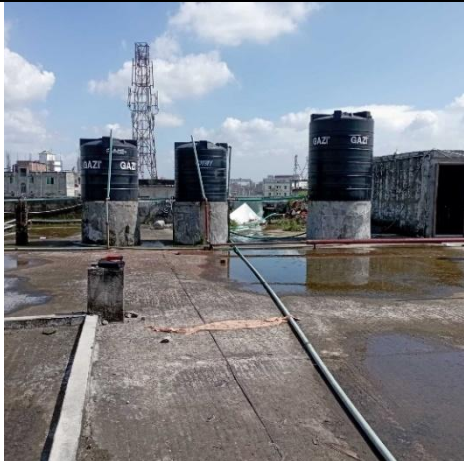
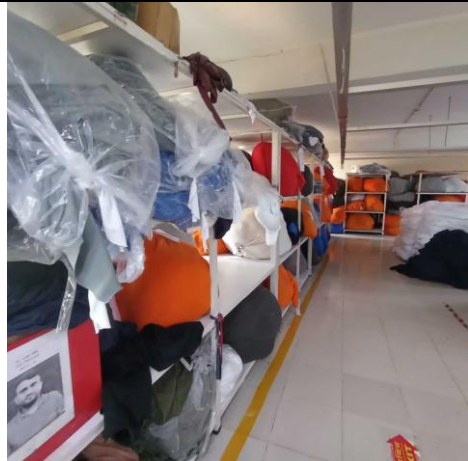
Observation-5: Non-structural elements found unbraced/unanchored (Production Building).

Description: Non-structural elements were found unbraced/unanchored. The building engineer is required to brace/anchor all non-structural elements.

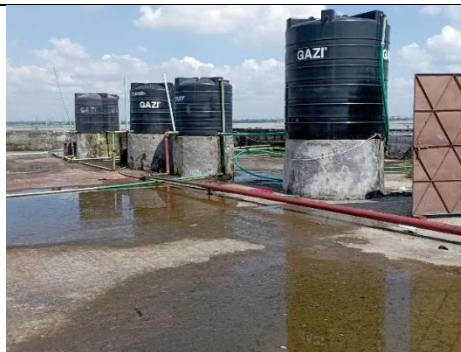
Observation-06: Water ponding/vegetation on the roof slab (Production Building).

Description: Water ponding/vegetation on the roof slab (brick chips). Remove vegetation, apply a proof layer, and improve the drainage system on the roof slab.

12.	Water ponding/vegetation on the roof slab (Production Building).	Remove vegetation, apply a proof layer, and improve the drainage system on the roof slab.	within 6 weeks

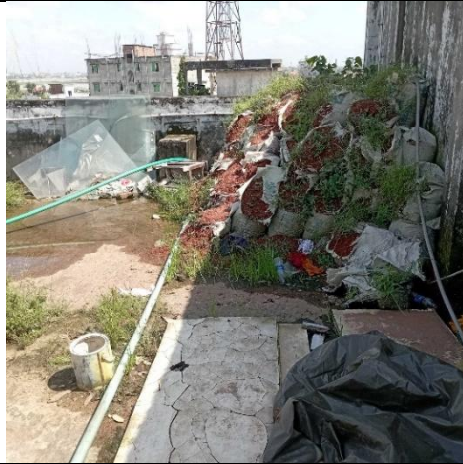
Observation-07: Stacking of construction material on the roof slab (Production Building).

Description: Stacking of construction material on the roof slab. The building engineer is required to remove the construction material from the roof slab.

13.	Stacking of construction material on the roof slab (Production Building).	The building engineer is required to remove the construction material from the roof slab.	within 6 weeks

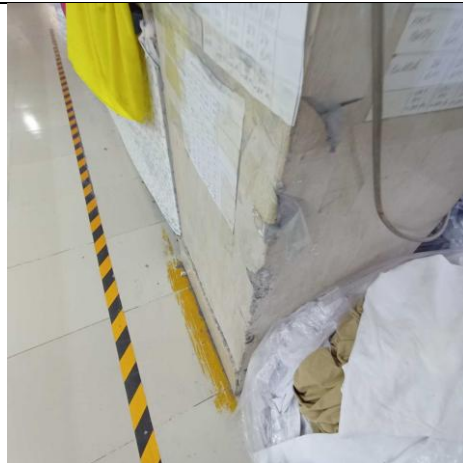
Observation-08: Column plaster damaged due to trolley impact (Production Building).

Description: Column plaster was found damaged due to the trolley impact. Repair damaged plaster and provide a column guard.

14.	Column plaster damaged due to trolley impact (Production Building).	Repair damaged plaster and provide a column guard.	within 6 weeks

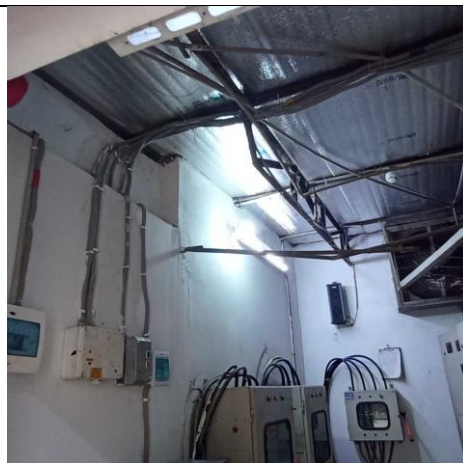
Observation-09: Cut off truss, inadequate member size and connection, Shed-1 (Utility Shed-1).

Description: Inadequate member size and connection were found. Also, some truss members were found cut off at the end. The building engineer is required to check the member and connection adequacy, submit it to RSC for review. Also, insert the cut-off members into the truss.

15.		Insert the cut-off members into the truss.	within 6 weeks
16.	Cut off truss/inadequate member size and connection, Shed-1 (Utility Shed-1).	The building engineer is required to check the member and connection adequacy as part of the safety check report, submit it to RSC for review.	within 6 weeks

17.		Implement remediation work after acceptance from RSC.	within 6 months
18.		Inadequate member size and connection of the steel part (Shed-2: Utility Shed-2).	The building engineer is required to check the member and connection adequacy as part of the safety check report, submit it to RSC for review.

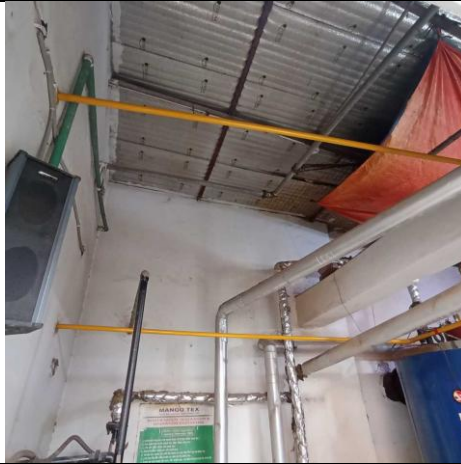
Observation-10: Inadequate member size and connection of steel part (Shed-2: Utility Shed-2).

Description: Inadequate member size and connection were found. The building engineer is required to check the member and connection adequacy, submit it to RSC for review.

19.	Implement remediation work after acceptance from RSC.		within 6 months
20.	Crack on the brick wall (Shed-2: Utility Shed-2).	The building engineer is required to repair cracks with a suitable method.	within 6 weeks

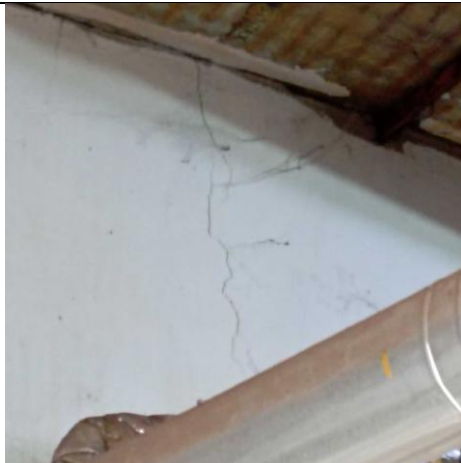
Observation-11: Crack on the brick wall (Shed-2: Utility Shed-2).

Description: A crack was found on the brick wall. The building engineer is required to repair cracks with a suitable method.

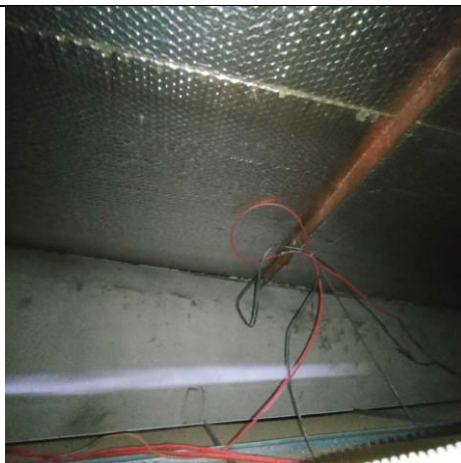
Observation-12: Inadequate member size and connection, Shed-3 (Security & Doctors' Room).

Description: Inadequate member size and connection were found. The building engineer is required to check the member and connection adequacy, submit it to RSC for review.

21.	Inadequate member size and connection (Shed-3: Security & Doctors' Room).	The building engineer is required to check the member and connection adequacy as part of the safety check report, submit it to RSC for review.	within 6 weeks

22.		Implement remediation work after acceptance from RSC.	within 6 months
23.	Dampness and vegetation on the brick wall of Shed-3 (Security & Doctors' Room).	Remove vegetation and repair dampness with a suitable method.	within 6 weeks

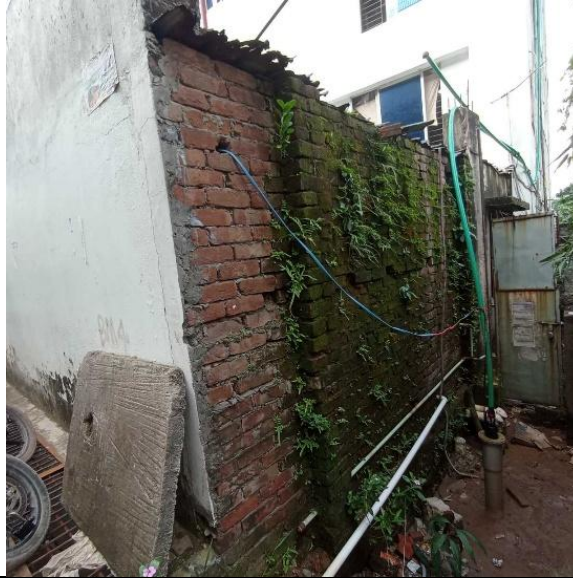
Observation-13: Dampness and vegetation on the brick wall of Shed-3 (Security & Doctors' Room).

Description: Dampness and vegetation were found on the brick wall. Remove vegetation and repair dampness with a suitable method.

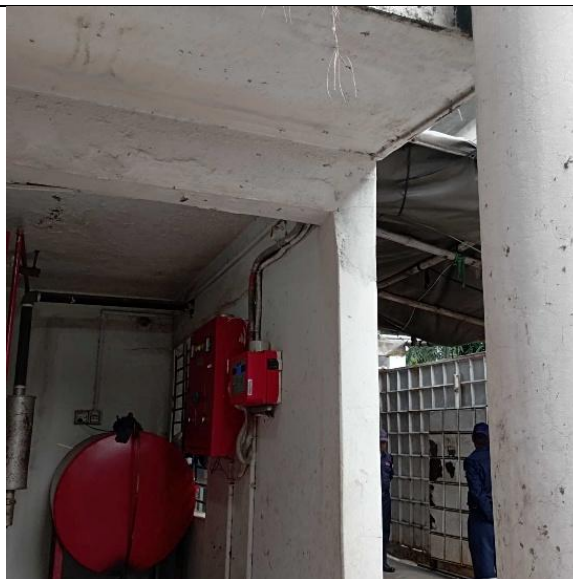
Observation-14: Slab supported on 125 mm thick brick wall (Fire Pump Room).

Description: Slab was found supported on a 125 mm thick brick wall. The building engineer is required to check the adequacy of the brick wall.

24.	Slab supported on a 125 mm thick brick wall (Fire Pump Room).	The building engineer is required to check the adequacy of the brick wall.	within 6 weeks

25.		Implement remediation work after acceptance from RSC.	within 6 months
26.	Lack of structural drawing (Shed-1, Shed-2, Shed-3, Fire Pump Room).	The building engineer produces a full set of as-built drawings, including structural drawings.	within 6 weeks

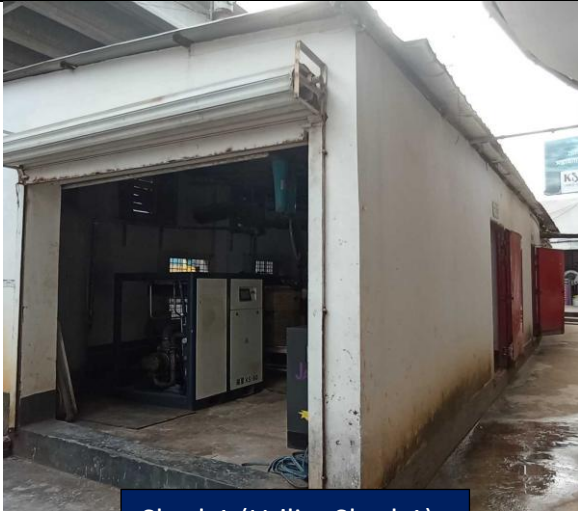
Shed-1 (Utility Shed-1)

Observation-15: Lack of structural drawing (Shed-1, Shed-2, Shed-3, and Fire Pump Room).

Description: At the time of inspection, only a set of architectural drawings was available, but no structural drawings were available for any of the structure. The building engineer produces a full set of as-built drawings, including structural drawings.
