Triple Apparels Ltd (Extension)

Holding 567, Block B, Ward no 06, Kewa, Sreepur PS, Gazipur-1740.
(24.212518, 90.431731)

5 October 2025

- Two-storied (G+1) reinforced concrete (RC) Warehouse Building (proposed 4 storied).

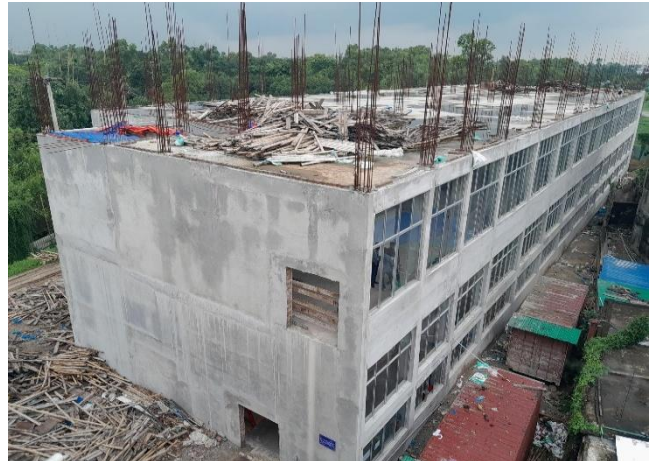
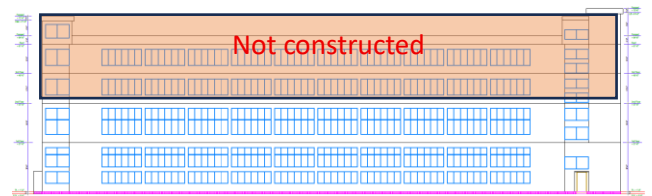
Observation-01: Prepared design report required to be reviewed by RSC. (Warehouse Building)

Description: A design report has been prepared for the four-story Warehouse Building. The prepared design report needs to be reviewed against lateral forces. Also, in the provided design report, the concrete compressive strength for columns and foundations is specified as 4000 psi. However, the available cylinder test reports appear to be insufficient to verify the concrete strength for these structural elements. The number of tests conducted does not meet the frequency requirements specified in the BNBC. The building engineer is required to justify the concrete strength in the design report by performing a core test and submitting the design report to the RSC for detailed review.

| Item No | Observation | Action Plan | Timeline |
|---|---|---|---|
| 1. | Prepared design report required to be reviewed by RSC. (Warehouse Building) | Verify in-situ concrete strength by taking 4-100 mm diameter concrete core from the column (lower level). Otherwise, provide an adequate number of cylinder test reports. | within 6 weeks |
| | | Submit the design report to the RSC for detailed review. | within 6 weeks |

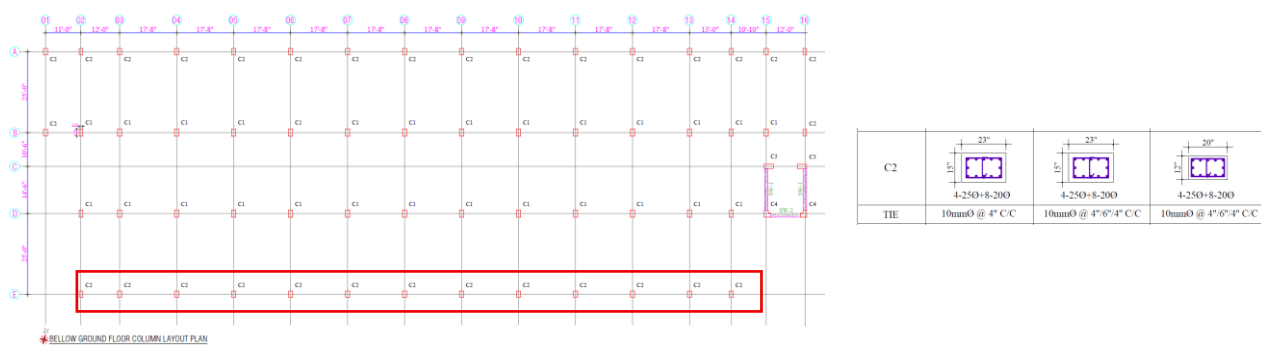
Observation-02: Mismatch in drawing and lack of construction drawing. (Warehouse Building)

Description: During inspection, mismatches were observed between drawings and the existing condition. At the grid “E”, marked columns were found 300 x 575 mm instead of 300 x 500 mm at the first-floor level. Also, during inspection credible structural/construction drawing was not available. The building engineer is required to survey the structural components and produce accurate as-built structural drawings.

| Item No | Observation | Action Plan | Timeline |
|---|---|---|---|
| 4. | Mismatch in drawing and a lack of construction drawing. | The building engineer is required to survey the structural components and produce accurate as-built structural drawings. Also, submit the original construction drawing. | within 6 weeks |

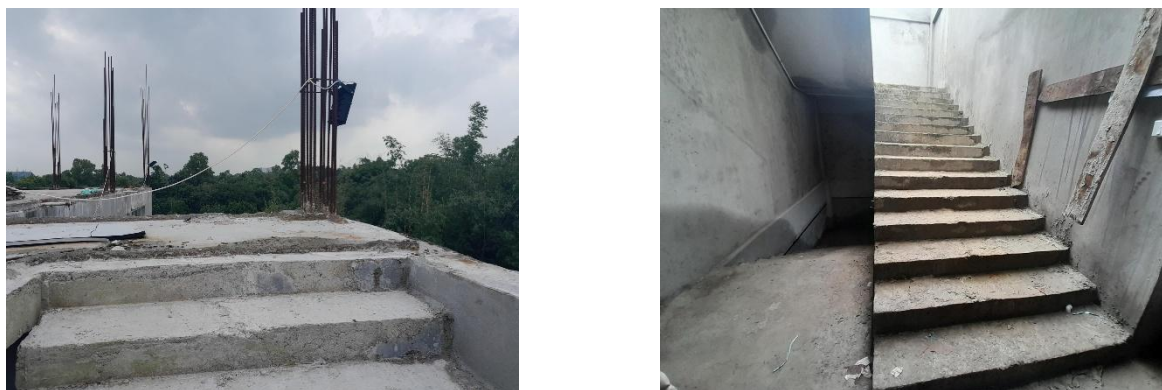
Observation-03: Falling hazard risk. (Warehouse Building)

Description: No parapet wall and hand railing were found on the roof and stairs, which may cause a falling hazard. The factory is required to increase the parapet height to avoid possible falling hazards.

| Item No | Observation | Action Plan | Timeline |
|---|---|---|---|
| 5. | Falling hazard risk. (Warehouse Building) | The factory is required to increase the parapet height to avoid possible falling hazards. | Immediate |

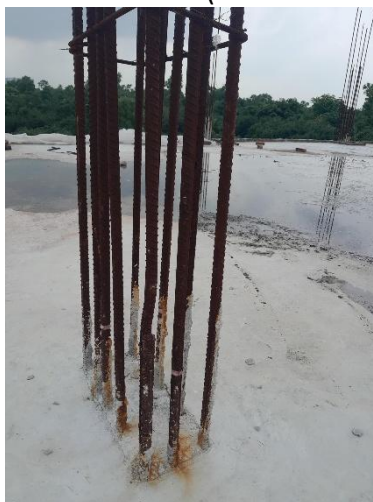
Observation-04: Exposed re-bar on the roof level. (Warehouse Building)

Description: Exposed rebar was observed on the roof, which is prone to corrosion. The building engineer is required to provide anti-corrosive coating on the exposed rebar.

| Item No | Observation | Action Plan | Timeline |
|---|---|---|---|
| 6. | Exposed rebar on the roof level. (Warehouse Building) | The building engineer is required to provide anti-corrosive coating on the exposed rebar. | within 6 months |

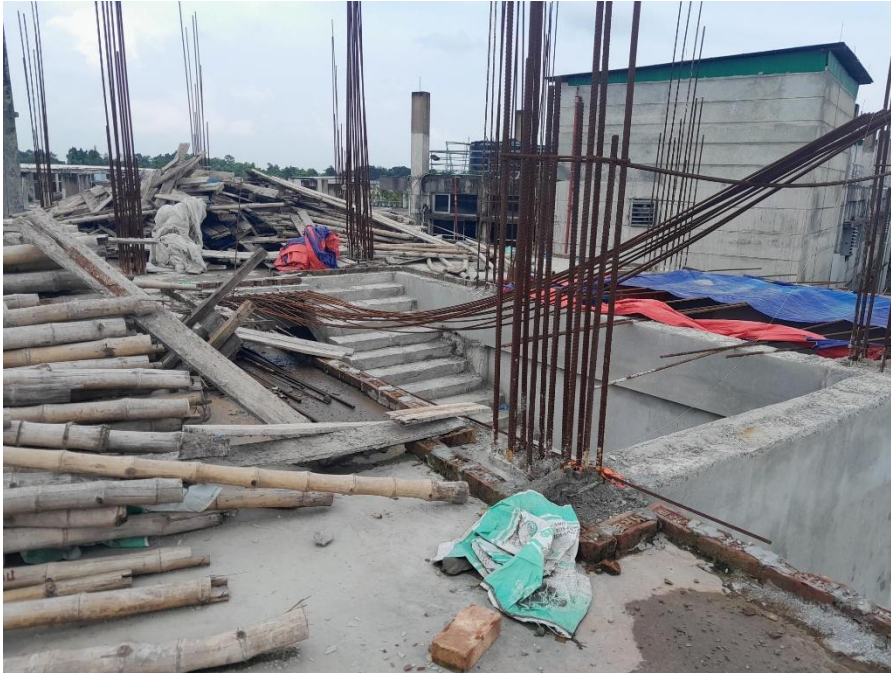
Observation-05: Construction material of the rooftop. (Warehouse Building)

Description: During inspection, construction materials were observed on the roof floor. The factory is required to remove all the construction material from the roof floor.

| Item No | Observation | Action Plan | Timeline |
|---|---|---|---|
| 7. | Construction material for the rooftop. (Warehouse Building) | The factory is required to remove all the construction material from the roof floor. | within 6 weeks |
