Revision: Issue 1
Date: 16th June 2014

Universal Menswear Ltd.

Plot 234-238, 252-254, Adamjee EPZ, Narayanganj
(23.676969, 90.518717)
7th June, 2014

Structural Inspection Report

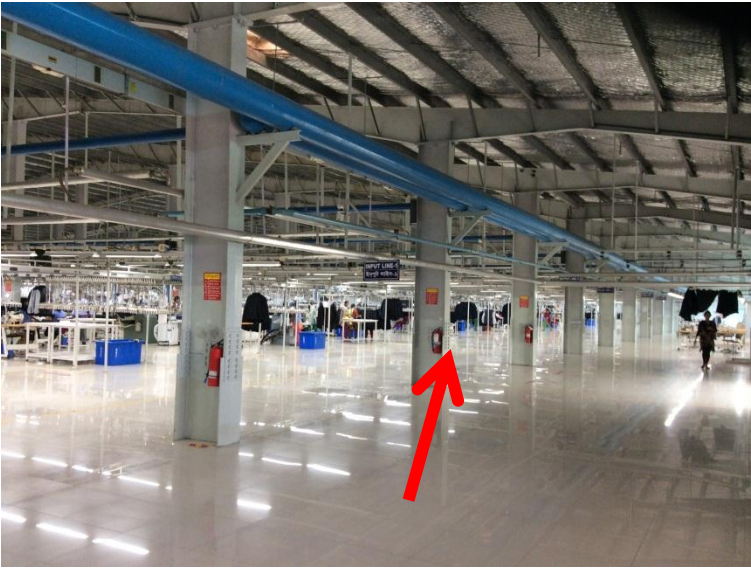
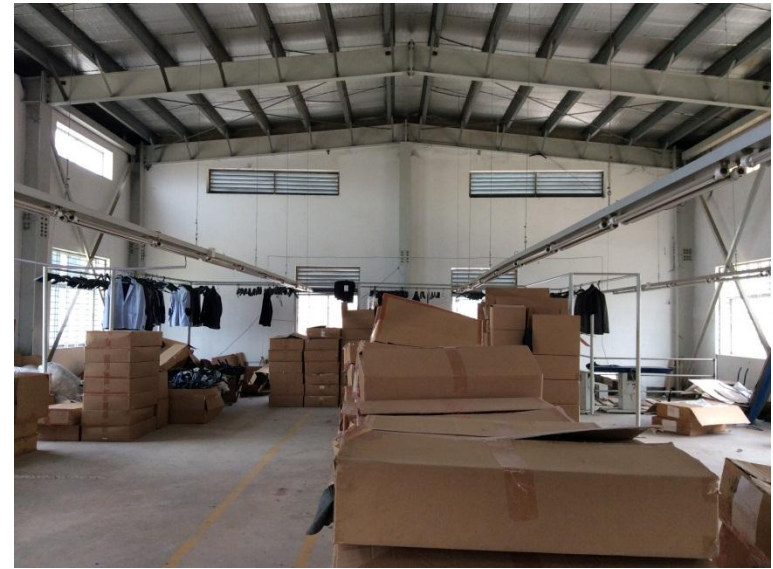
- Generally, it appears fire protection to the primary steel structure of all inspected building has not been provided

Fire protection to the primary steel structure

- The requirement, if any, for fireproofing of primary steel structure to all buildings should be established by a Fire Engineering Specialist

- Fireproofing of steelwork should be installed in accordance with the Fire Engineering Specialist's requirements if required

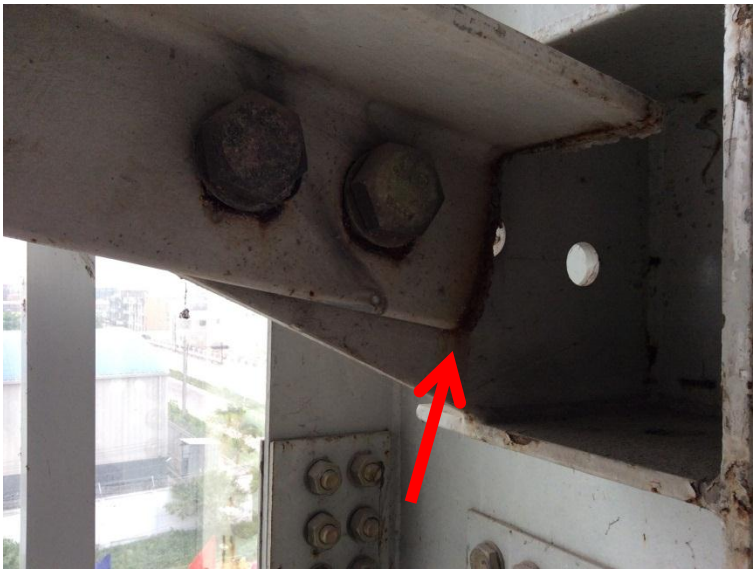
Example of modified cross bracing connection

- In a number of locations throughout Building 1, cross bracing elements were either missing, or had end connections which were cut, missing bolts or misaligned

Cross bracing elements missing or modified

- Building Engineer to assess the as-built bracing to BNBC and modify if required

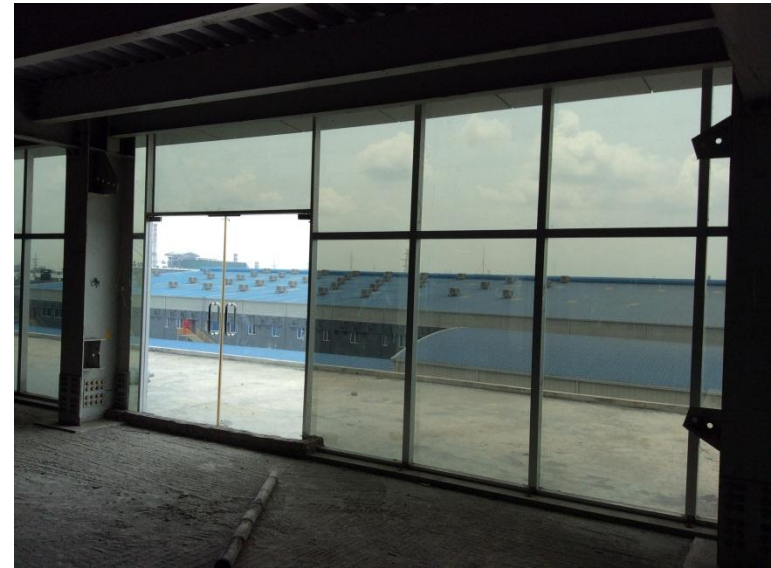
Example of cross bracing omitted on account of door

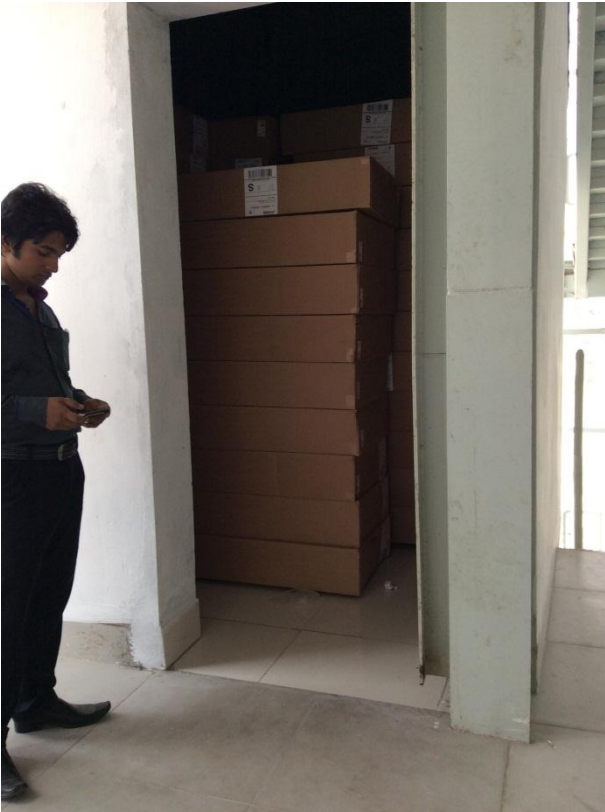
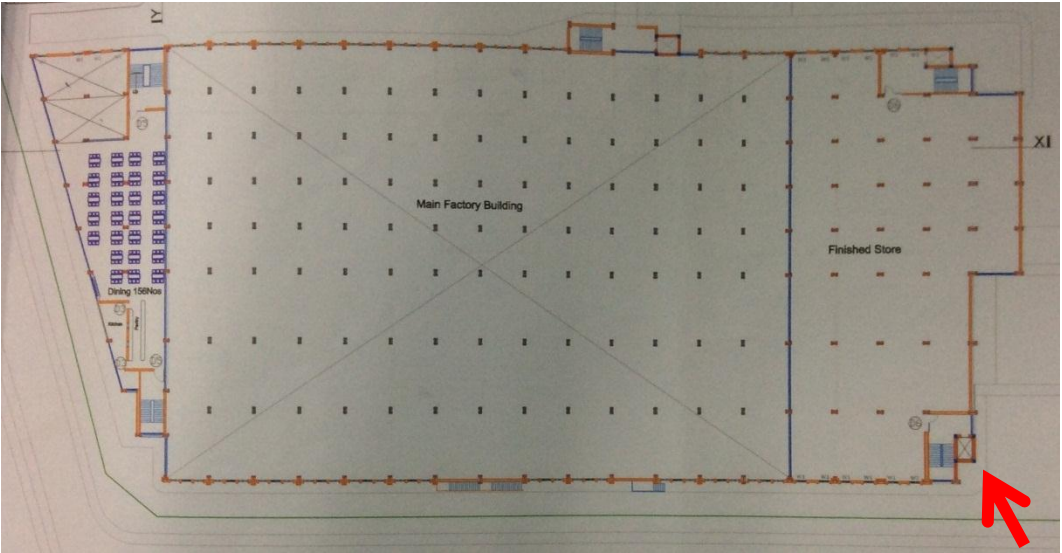
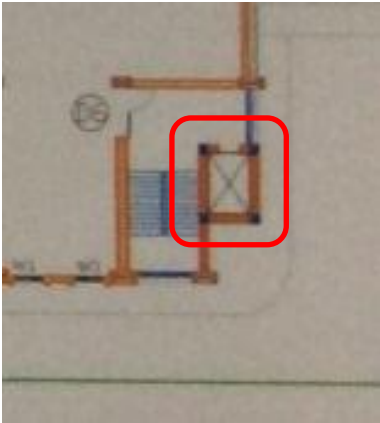
Lift core converted to storage

Lift core converted to storage at all building levels, using steel beams supporting RC floor slabs

- Building Engineer to assess the as-built construction to BNBC and modify if required
- Building Engineer to carry out as-built survey of converted area and produce accurate complete as-built drawings

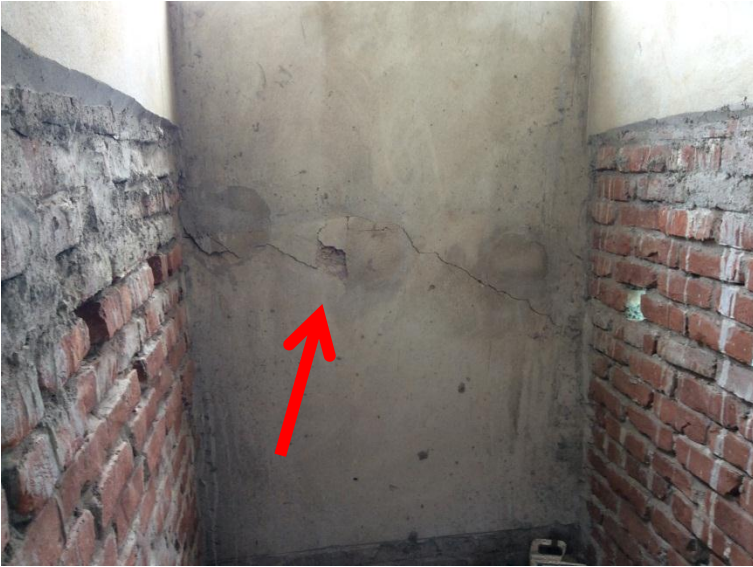
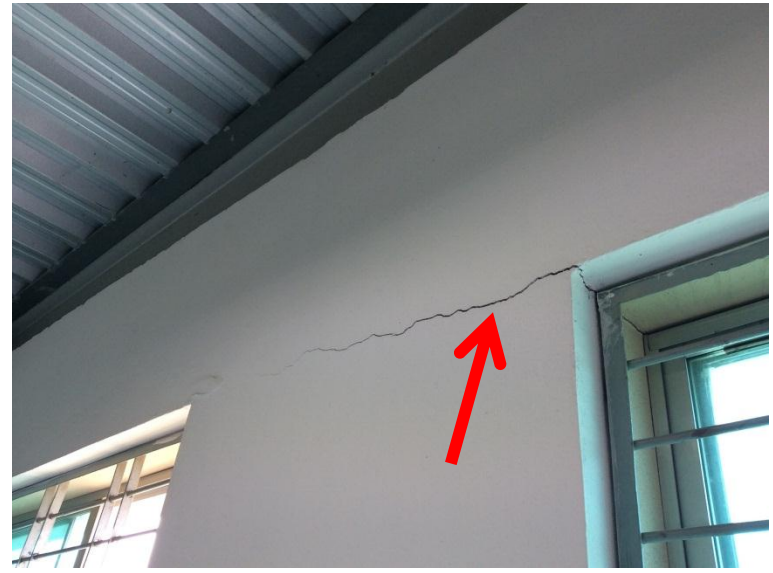
Examples of cracking to brick walls

Cracking observed to brick perimeter walls

- Building engineer to record all cracking throughout factory compound and monitor on an on-going basis
- If further cracking occurs Building Engineer to investigate and remediate as appropriate

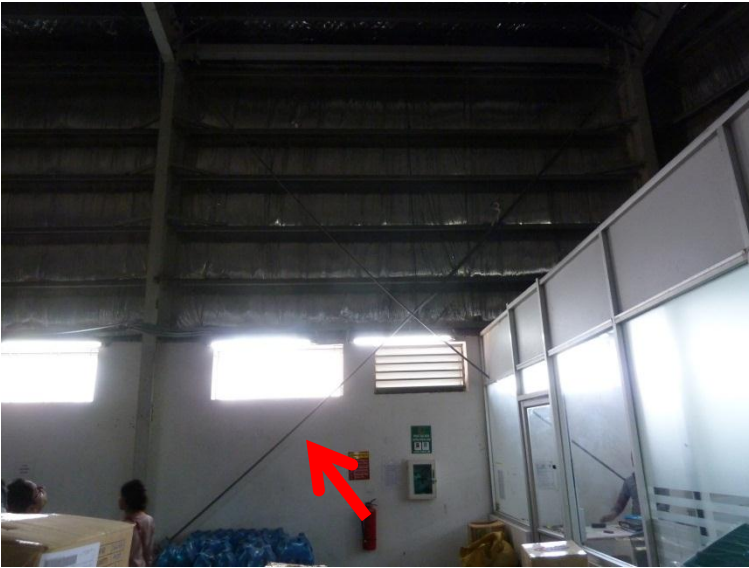
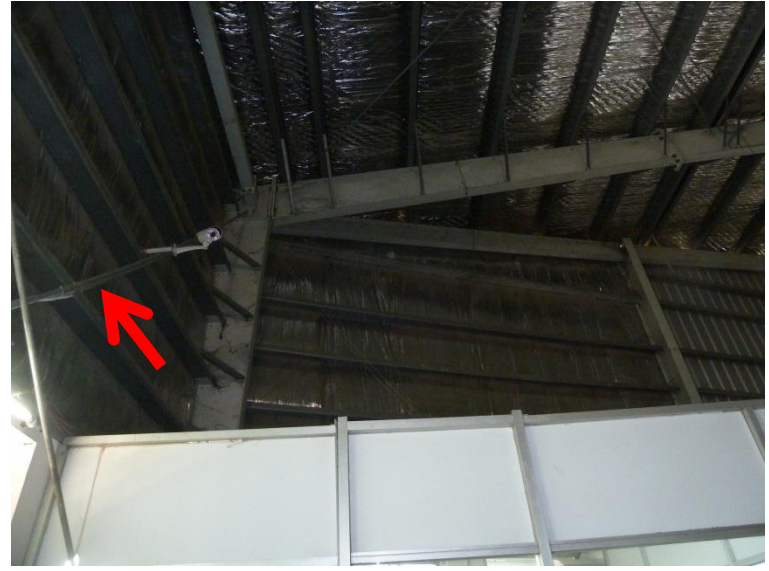
Loose wall cross bracing

Building wall cross-bracing is not tight

- Building engineer to assess if the bracing in its current configuration achieves original design intent
- Amend or adjust bracing if required

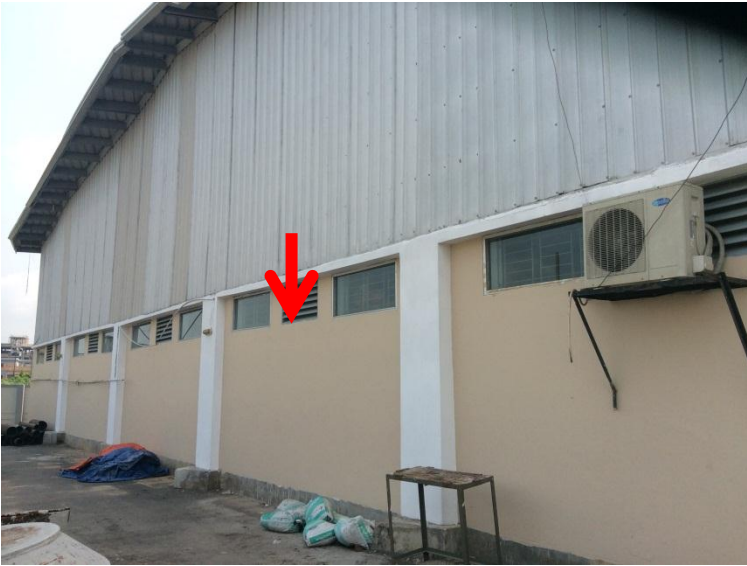
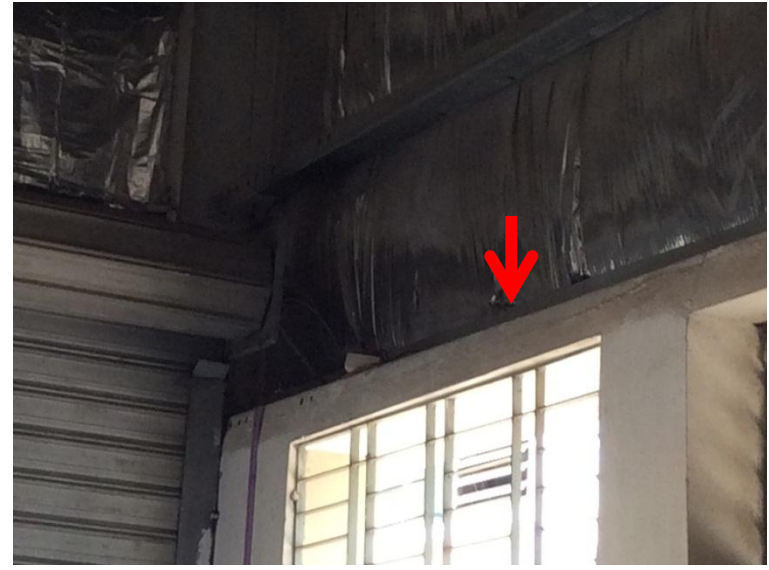
As constructed, lateral support to tops of brick walls is not clearly defined

Unclear lateral support to tops of brick walls

- Building engineer to verify stability of brick walls according to BNBC and modify if necessary

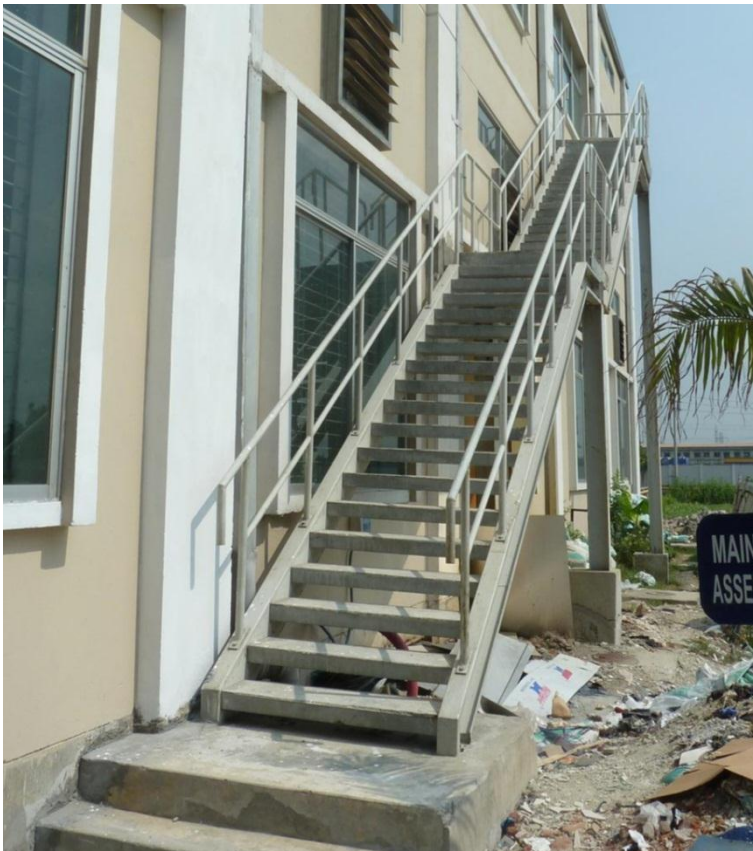
Settlement of ground beneath shallow footings to stairs

Footings to external stairs are settling

- Building footing system is piled, external stair footing system appears not to be piled
- Differential settlement and cracking of stair footings observed
- Subsequently, steel frames to stairs are deformed
- All external stairs to Buildings 1 and 3 are similarly affected

- Building Engineer to assess safety of external stairs , and effects on main building structure
- As appropriate, limit access and consider providing temporary propping system

- Building Engineer to implement a permanent solution to stairs footings settlement issue

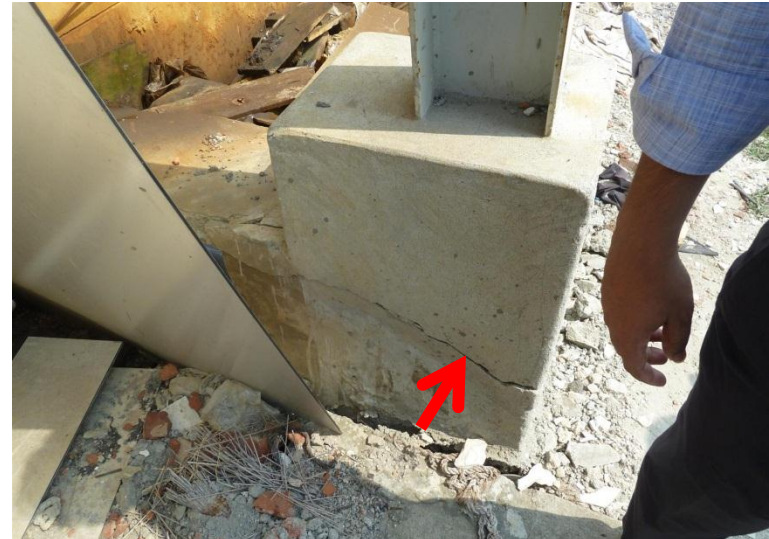
Failure of shallow footing to stairs

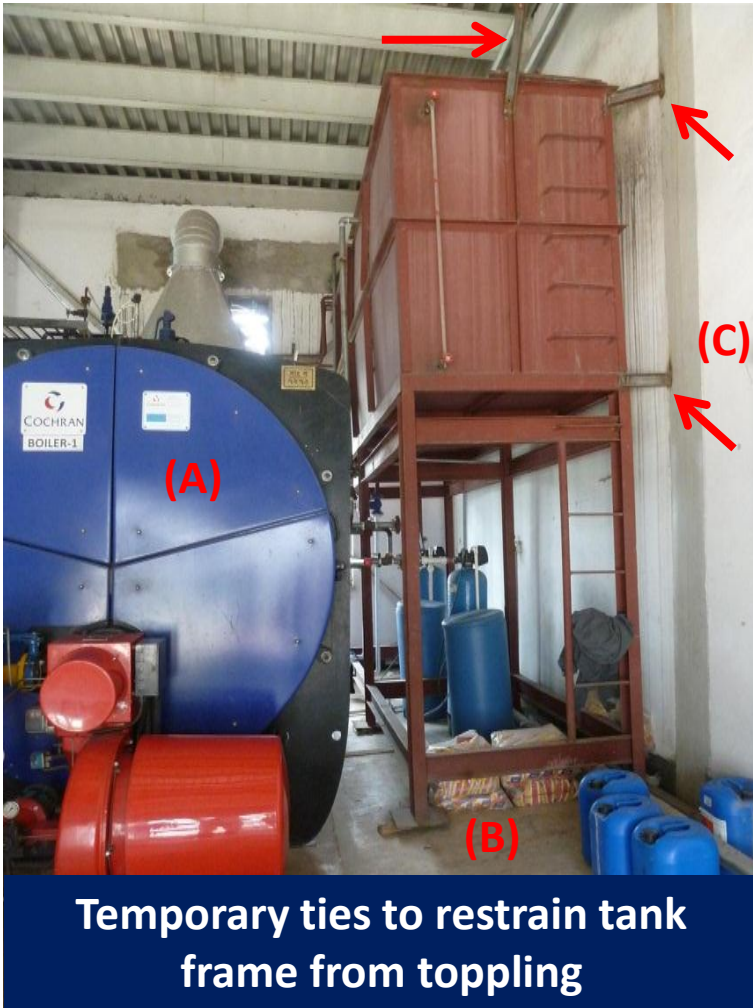
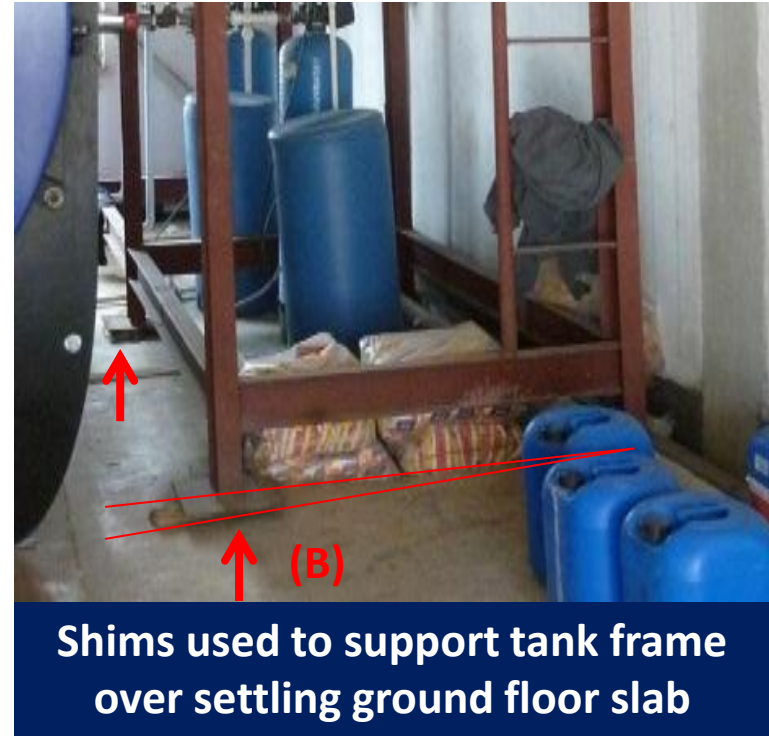
- (A) Ground slab is settling unevenly, under weight of boiler and tank
- (B) Shims have been installed beneath tank stand legs
- (C) Steel ties have been installed, connecting tank frame to building primary frame

Water tank frame tilting from uneven settlement

- Building Engineer to monitor uneven settlement
- Building Engineer to assess effect of temporary ties on the permanent structure. Ties to be substituted by an alternative safe temporary system if deemed unsafe for the permanent structure

- Building Engineer to implement a permanent solution to slab settlement issue

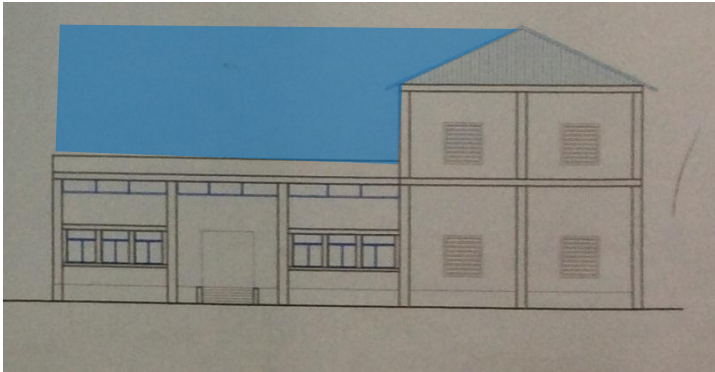
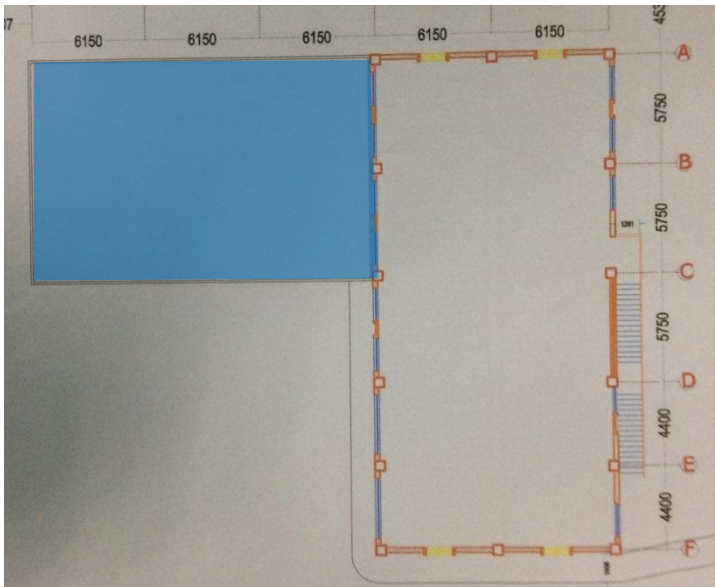
Additional roof over 1st floor

Roof structure added beyond permit drawings

- Building engineer to prepare a set of as-built drawings for all structures linked to the factory's activities. Permit documentation and drawings also to be prepared
- Building Engineer to assess stability of roof frame and capacity of connections under horizontal and vertical loading to BNBC and make all necessary alterations

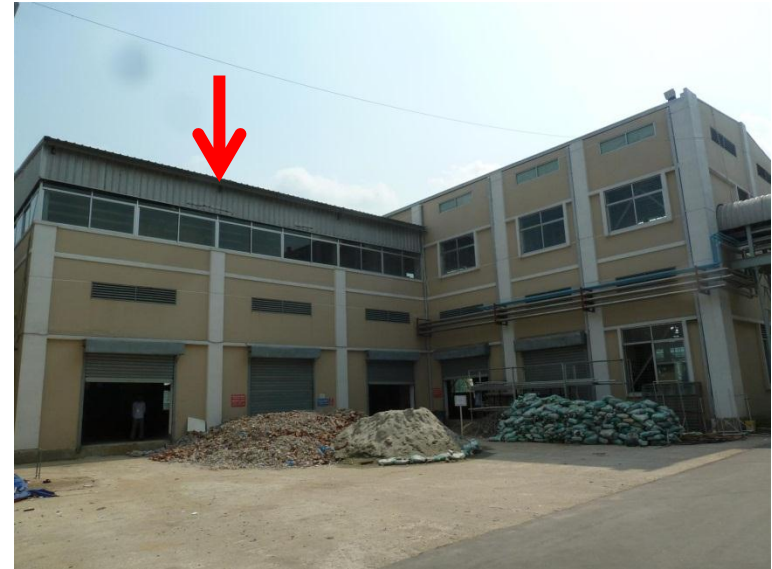
- An enclosed extension has been constructed over a portion the mezzanine floor
- Extension is not documented on permit drawings and engineering design drawings

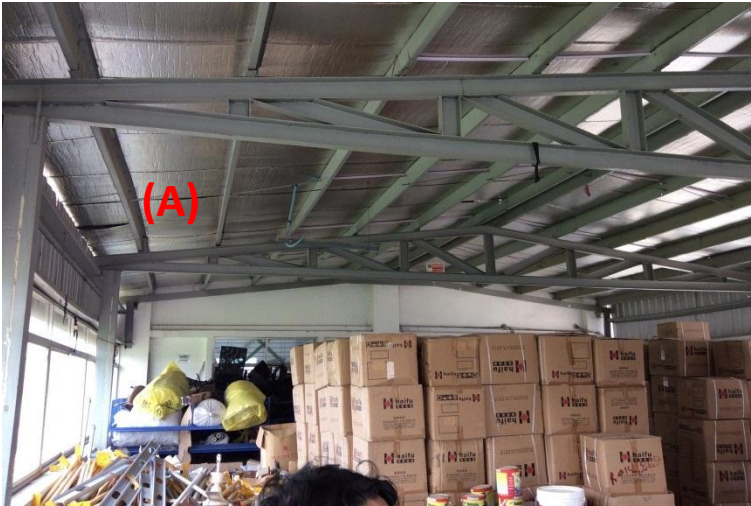
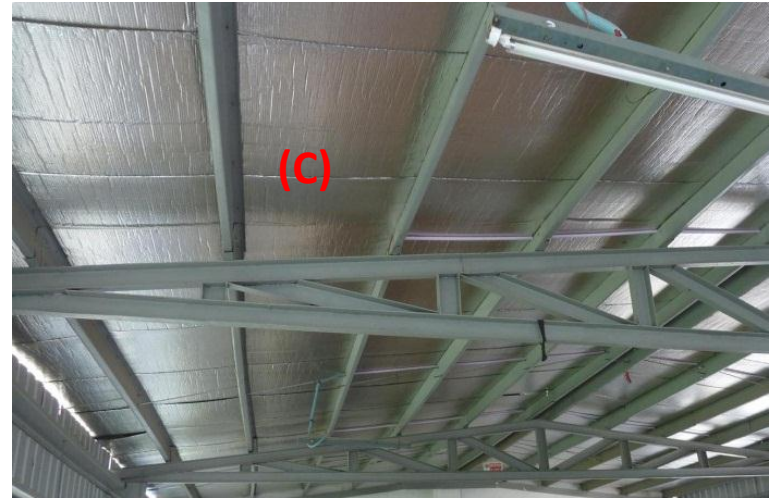
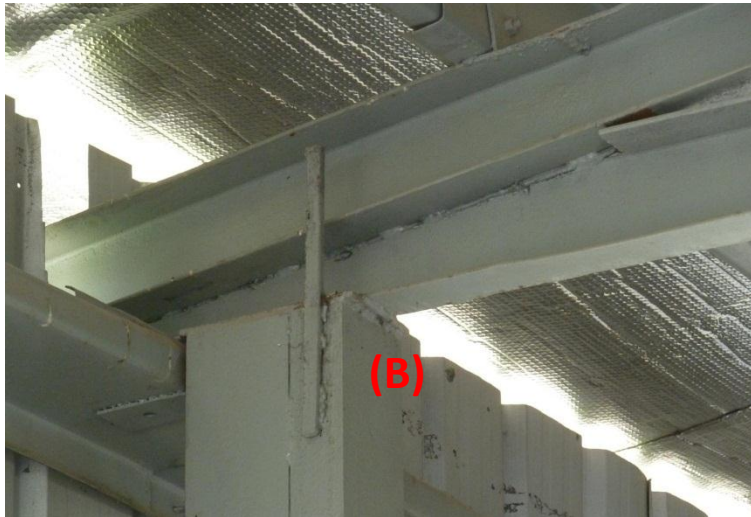
(A) Lateral stability system to roof frame is not clearly defined – absence of roof cross bracing and wall cross bracing
(B) Unclear portal frame action, column-to-truss connection details appear non-engineered
(C) Purlin lateral torsional buckling observed

**Roof structure added
beyond permit drawings**

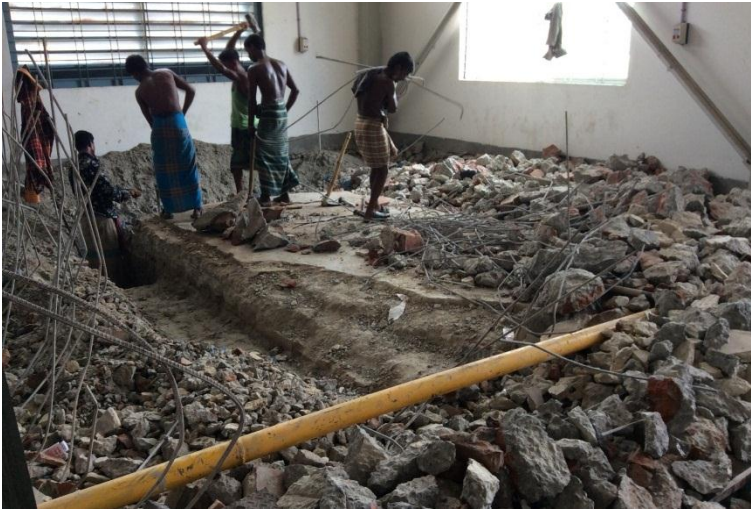
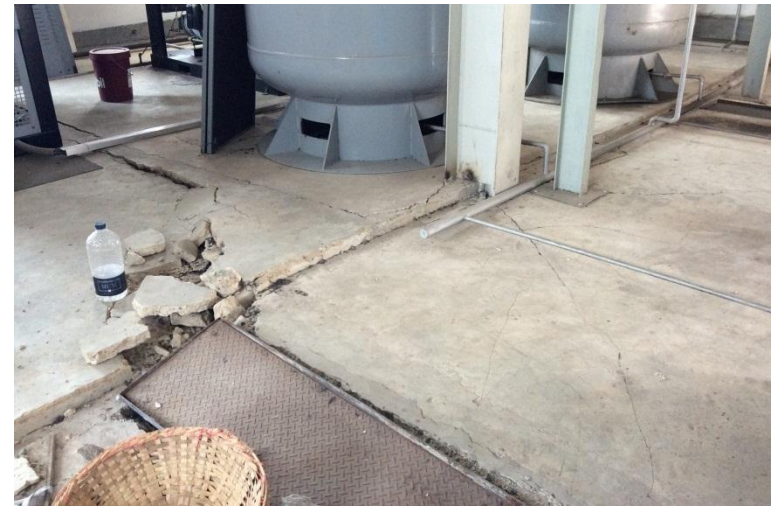
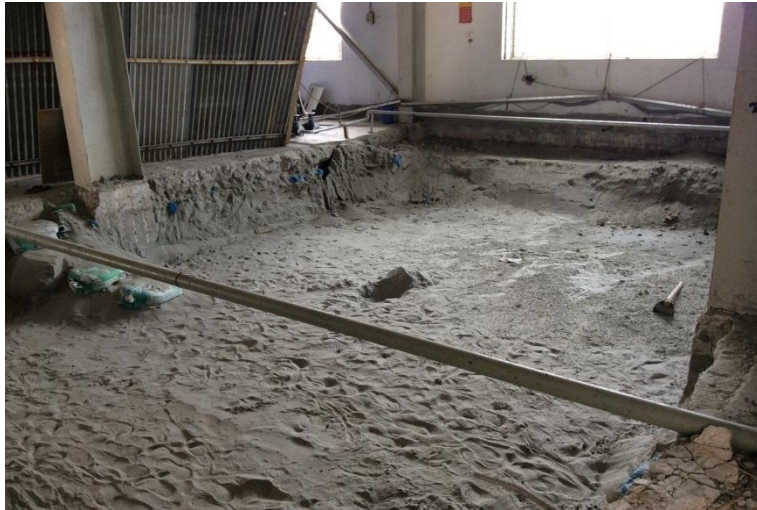
- Significant differential settlement and cracking of ground-bearing slab observed inside Building 3
- Piled foundation system to building superstructure appears unaffected
- Removal of slab was underway at time of inspection

Significant settlement of ground floor slab

- Building Engineer to continue providing a permanent solution to settlement issue

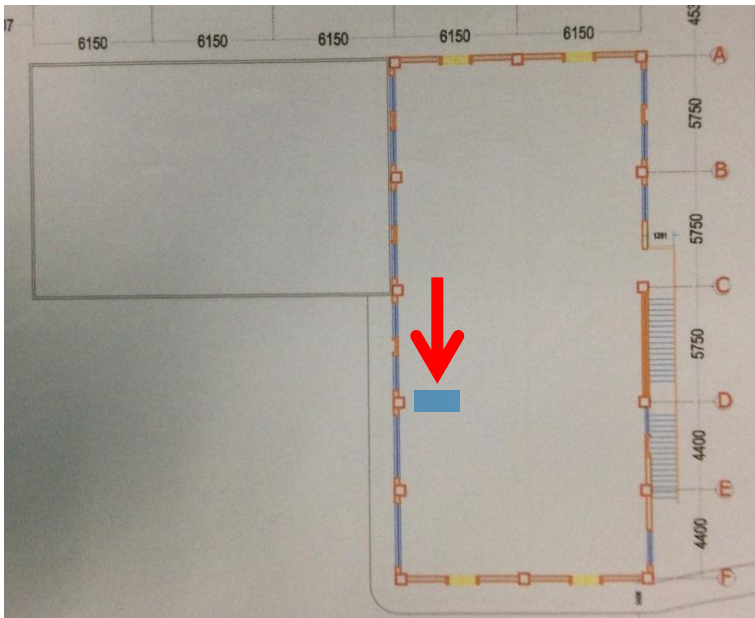
**Approximate zone of investigation
of cracking to mezzanine slab
screed**

- Building Engineer to consider local repairs to slab cracking

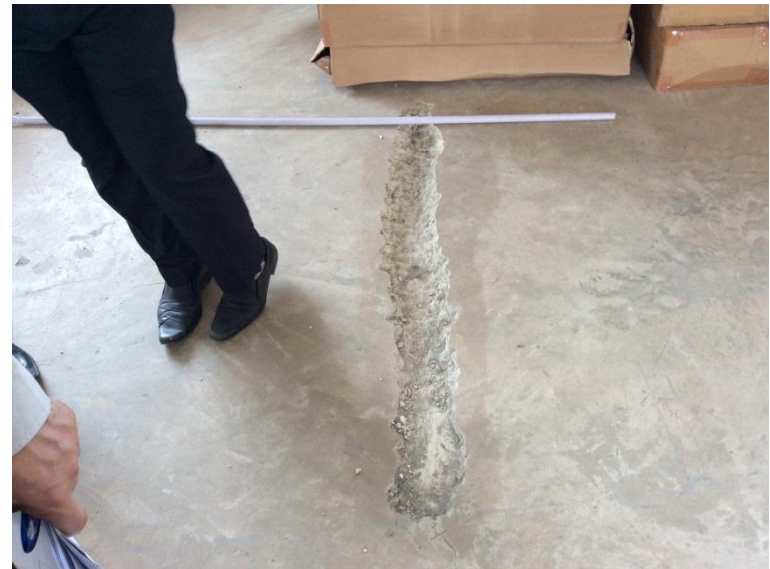
- Local removal of screed over mezzanine floor slab was observed
- Screed removal was reportedly undertaken to check the extent of cracking in structural slab

Cracking to screed and repair attempts
