# Fashion Pulse Ltd

Plot: A - 109, BSCIC Industrial Area, Tongi, Gazipur- 1710

16 September 2025

## 2. Observation:

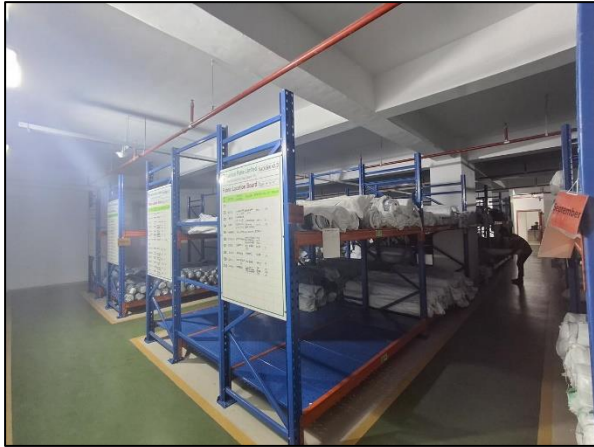
**Observation 02: Lack of floor load management plan. (Factory Building)**

Storage on suspended ground floor

**Description:** At the time of inspection, floor load plan was not found posted suspended ground floor level. Also, storage area & height marking was not observed in several storage locations. The building engineer is required to post the floor load plan on all floor levels, provide storage area & height marking, and maintain floor loading accordingly.

| Item No. | Observation | Action Plan | Timeline |
|---|---|---|---|
| 3. | Lack of floor load management plan. (Factory Building) | The building engineer is required to post the floor load plan on all floor levels, provide storage area & height marking, and maintain floor loading accordingly. | within 6 weeks |

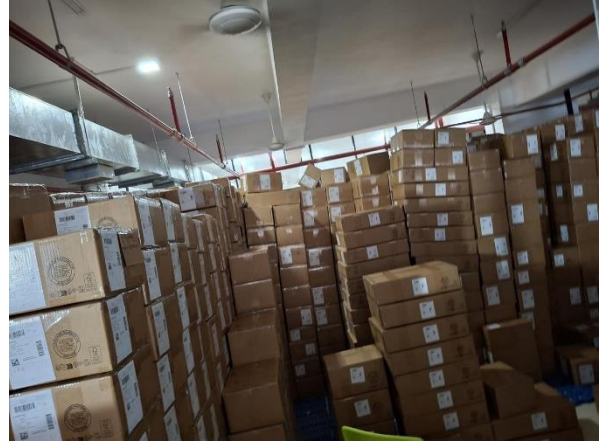
Storage area has no area/height limit

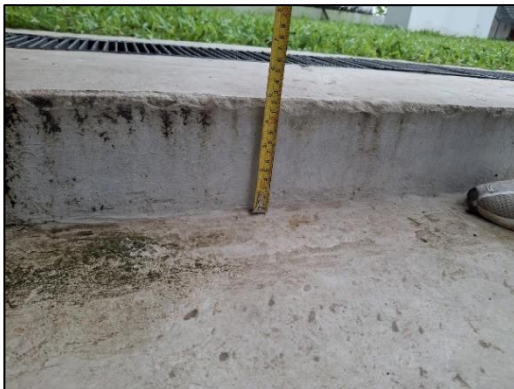
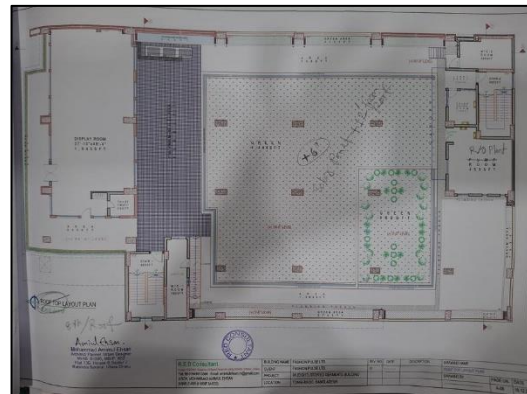
**Observation 03: Mismatch/lack of as-built drawing for Factory Building, RMS Room & Security Room**

**Description:** At the time of inspection, some minor discrepancies were observed between floor layout and drawings for factory building. Rooftop gardening soil-built ups were not properly mentioned in the drawings, solar panel on 9<sup>th</sup> floor not mentioned in the drawing. Also, structural details of Security & RMS rooms were not available on site. The building engineer is required to survey the structure and prepare accurate as-built drawings.

| Item No. | Observation | Action Plan | Timeline |
|---|---|---|---|
| 4. | Mismatch in as-built drawing for Factory Building | The building engineer is required to survey the structure and prepare accurate as-built drawings. | within 6 weeks |

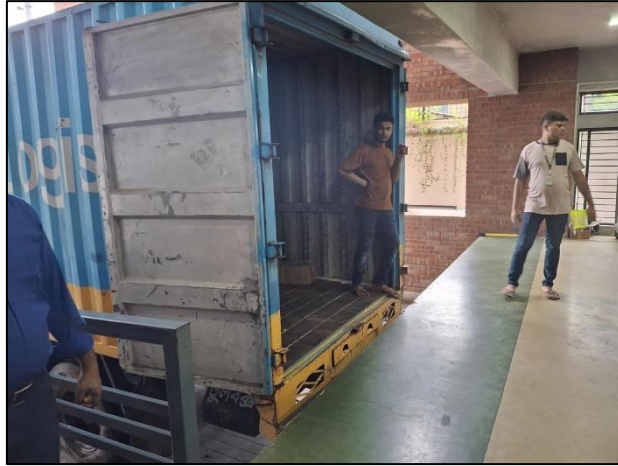
**Observation 04:** Falling hazard at elevated loading-unloading platform (Factory Building)

**Description:** Falling hazard observed on elevated loading-unloading zone due to lack of barriers. The building engineer is required to introduce mobile barrier system on the elevated platform to prevent unwanted falling hazard.

| Item No. | Observation | Action Plan | Timeline |
|---|---|---|---|
| 5. | Falling hazard at elevated loading-unloading platform (Factory Building) | The building engineer is required to introduce mobile barrier system on the elevated platform to prevent unwanted falling hazard. | within 6 weeks |

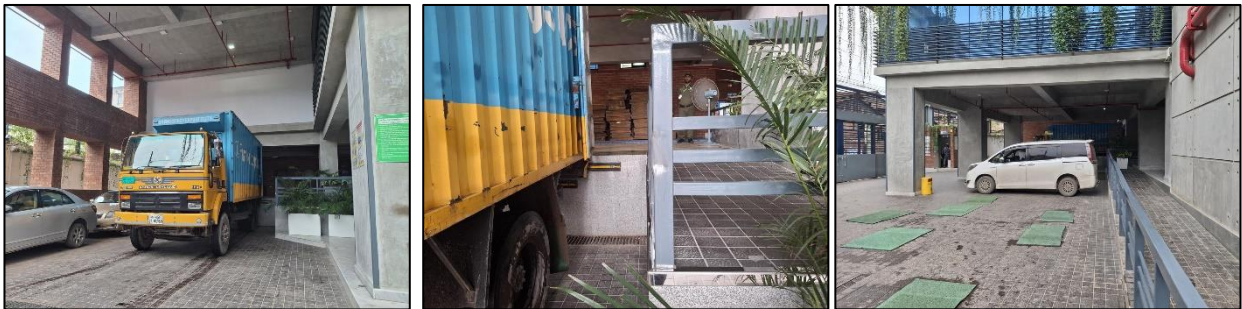
**Observation 05:** Vehicle impact risk on column (Factory Building)

**Description:** During inspection, damage due to vehicle impact on steel railing was. There was no protection system for the ground floor columns which are susceptible to vehicle impact. The building engineer is required to provide separate barriers around columns to avoid vehicle impact.

| Item No. | Observation | Action Plan | Timeline |
|---|---|---|---|
| 6. | Vehicle impact risk on column (Factory Building) | The building engineer is required to provide separate barriers around columns to avoid vehicle impact. | within 6 weeks |

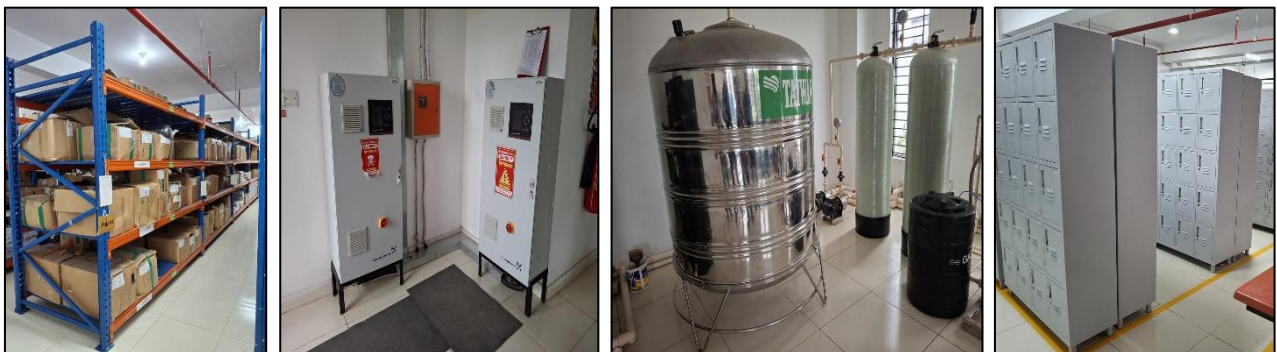
**Observation 06:** Non-structural elements were found not anchored or braced. (Factory Building)

**Description:** Non-structural elements (e.g. racks, tanks, panels) were not anchored or braced. The building engineer is required to anchor or brace all non-structural elements within the building.

| Item No. | Observation | Action Plan | Timeline |
|---|---|---|---|
| 7. | Non-structural elements were found not anchored or braced. (Factory Building) | The building engineer is required to anchor or brace all non-structural elements within the building. | within 6 months |
