# Silver Composite Textile Mills Ltd. (Extension)

Vill. B.K. Bari, Taltoli, P.O.: Mirzapur, Gazipur

7 October 2025

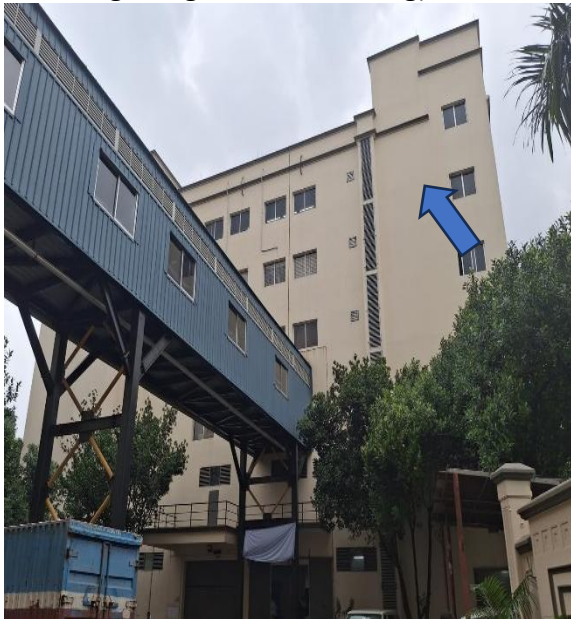
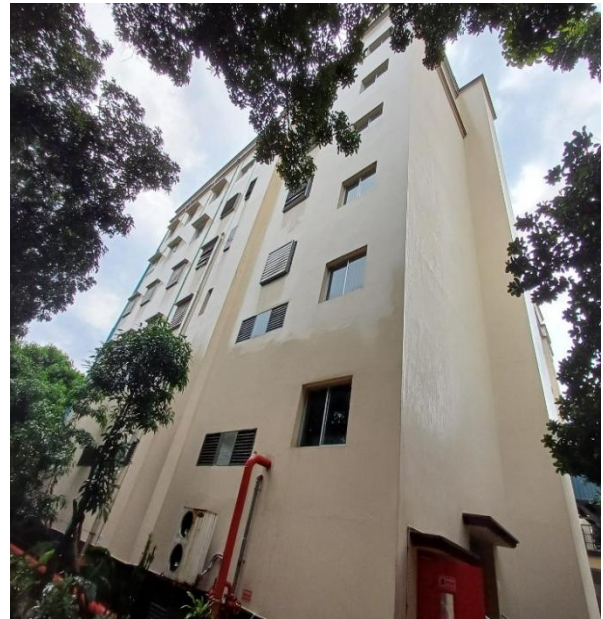
Garments Building-2

**Observation-01:** Applicable building code consideration in the design report (Garments Building-2, Connecting Bridge, Boiler Building).

**Description:** A set of design documents were prepared for the structures considering BNBC 2006. However, the structures were permitted by local authority LGED [Gazipur Sadar] dated January-2022 and the structures were constructed after February-2021. So, BNBC 2006 may not be applicable here.

Building engineer is required to review the construction history and building permits and applicability of design code. Also, the building engineer is required to prepare the design report in compliance with the BNBC code.

| Item No | Observation | Action Plan | Timeline |
|---|---|---|---|
| 1. | Applicable building code consideration in the design report (Garments Building-2) | The building engineer is required to review the construction history and building permits and applicability of design code. | within 6 weeks |
| 2. | | The building engineer is required to prepare the design report including External RC Stair in compliance with the BNBC code. | within 6 weeks |

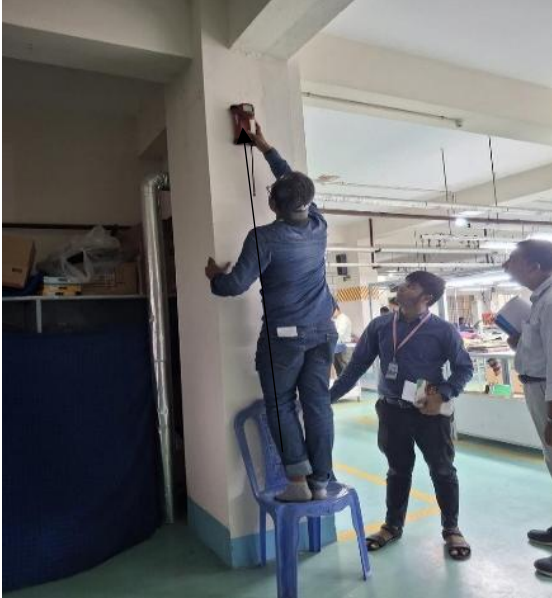
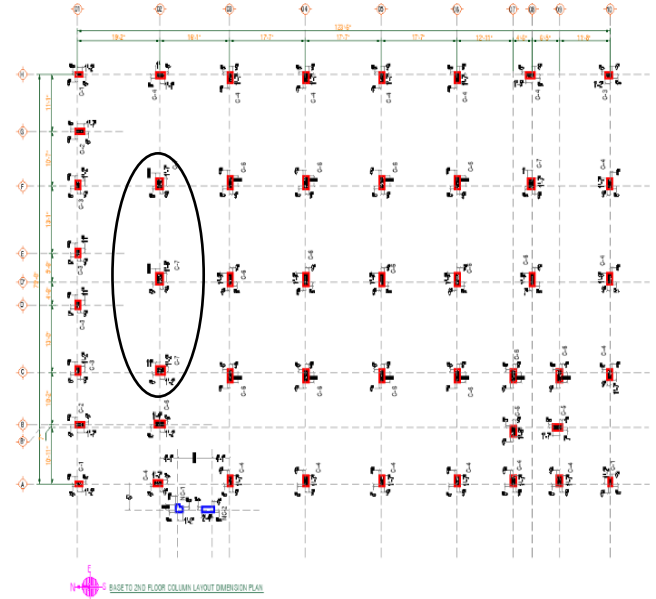
Garments Building-2: Total 18 re-bars were found by scanning instead 20 re-bars in C7 column.

**Description:** The building engineer is required to survey the structure and prepare as-built drawings with necessary details.

| Item No | Observation | Action Plan | Timeline |
|---|---|---|---|
| 4. | Mismatch in the as-built drawing for Garments Building-2 | The building engineer is required to survey the structure for (floor occupancy & column schedule) and prepare accurate as-built drawings. | within 6 weeks |

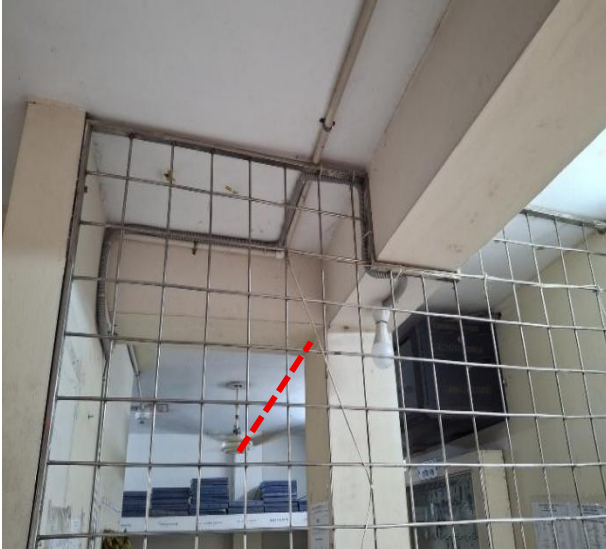
Security Control Room: Beam not found in the marked location

| Item No | Observation | Action Plan | Timeline |
|---|---|---|---|
| 23. | Mismatch in the as-built drawing for the Security Control Room | Building engineer is required to survey the structure and prepare accurate as-built drawings. | within 6 weeks |

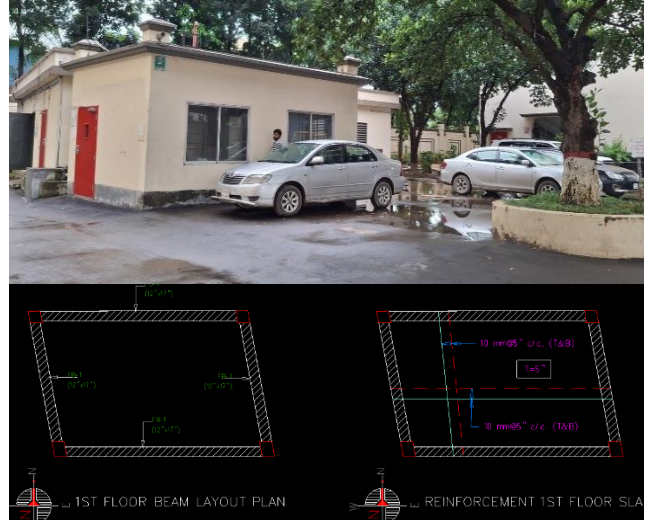
Fire Pump House: Column C2 detailing and roof beam-slab dimension-detailing were incomplete.

| Item No | Observation | Action Plan | Timeline |
|---|---|---|---|
| 17. | Incomplete as-built drawing for Fire Pump House | Building engineer is required to survey the structure and prepare accurate as-built drawings. | within 6 weeks |

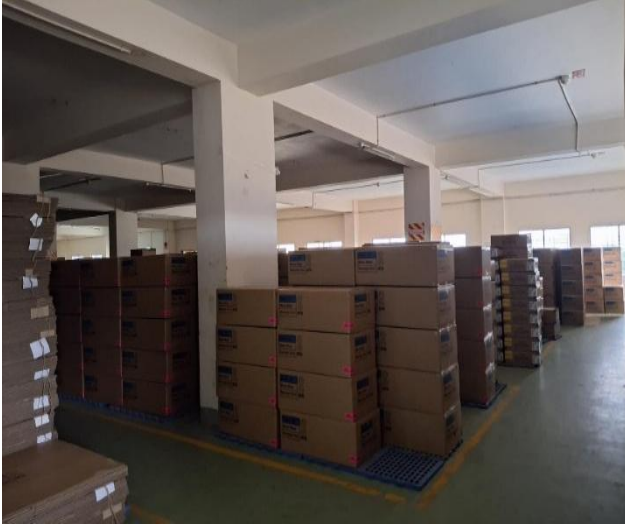
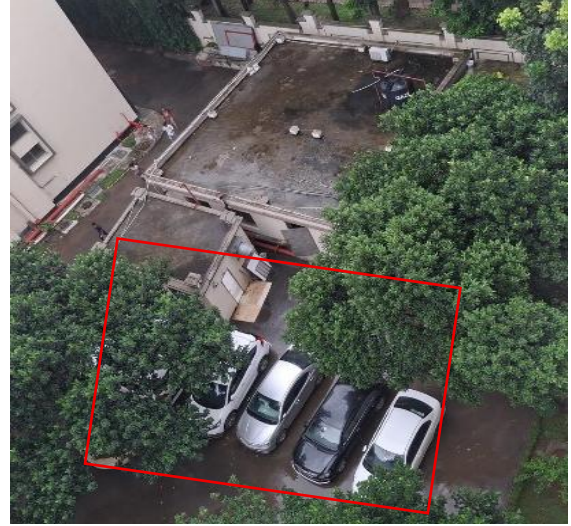
**Observation-03:** Lack of load management system and change of floor use (Garments Building-2, Fire Pump House)

**Description:** Storage observed on typical floor for Garments Building-2 and car parking on top slab of UGWR. The building engineer is required to post updated floor load plans on each floor/parking area, provide storage area & height marking and maintain floor loading accordingly.

| Item No | Observation | Action Plan | Timeline |
|---|---|---|---|
| 5. | Lack of load management system and change of floor use (Garments Building-2) | The building engineer is required to post updated floor load plans on each floor, provide a storage area & height marking and maintain floor loading accordingly. | within 6 weeks |

| Item No | Observation | Action Plan | Timeline |
|---|---|---|---|
| 16. | Lack of load management system and change of floor use (Fire Pump House) | The building engineer is required to post the floor live load plan on each floor & parking area, provide parking guidelines and maintain floor loading accordingly. | within 6 weeks |

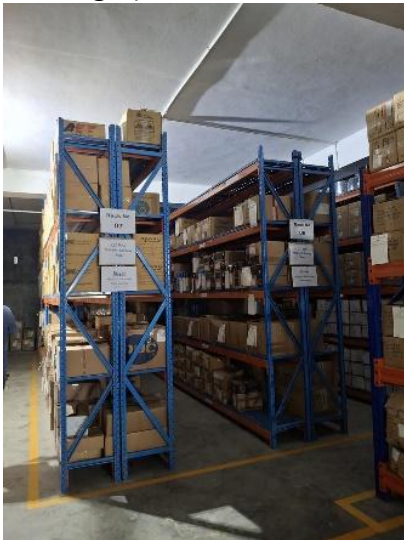
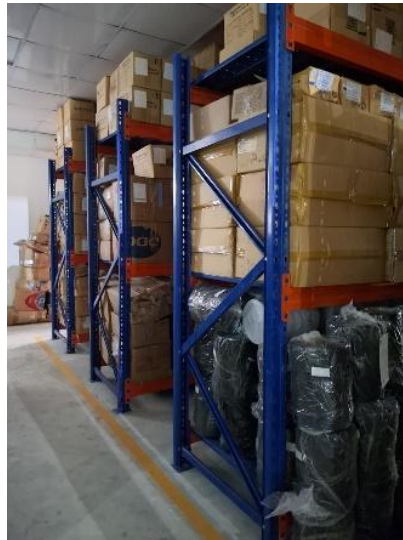
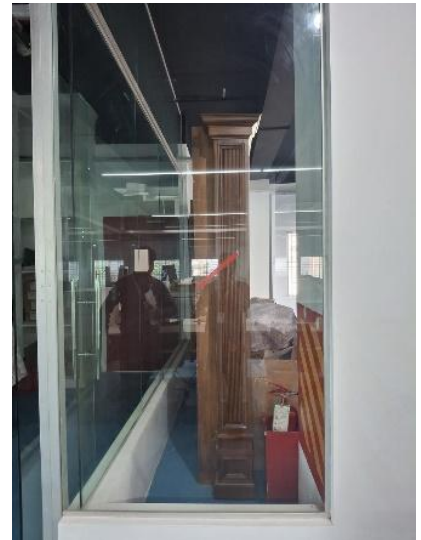
**Observation-04:** Lack of anchorage for non-structural elements including storage racks (Garments Building-2)

**Description:** Lack of anchorage or brace observed for storage racks and wardrobe/almirah. The building engineer is required to provide adequate anchorage or brace to non-structural elements.

| Item No | Observation | Action Plan | Timeline |
|---|---|---|---|
| 6. | Lack of anchorage for non-structural elements including storage racks (Garments Building-2) | The building engineer is required to provide adequate anchorage or bracing to non-structural elements. | within 6 months |

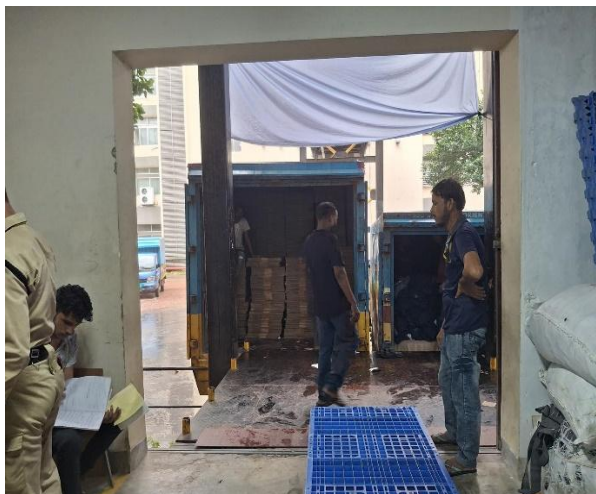
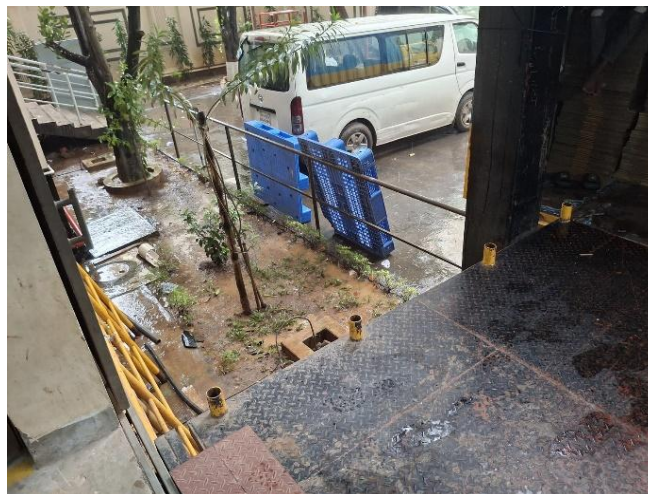
**Observation-05: Falling hazard at elevated platform (Garments Building-2)**

**Description:** A falling hazard was identified on the elevated platform at the loading and unloading zone. Provide adequate edge protection to prevent the risk of falls.

| Item No | Observation | Action Plan | Timeline |
|---|---|---|---|
| 7. | Falling hazard at the elevated platform (Garments Building-2) | Provide adequate edge protection to prevent the risk of falls. | within 6 weeks |

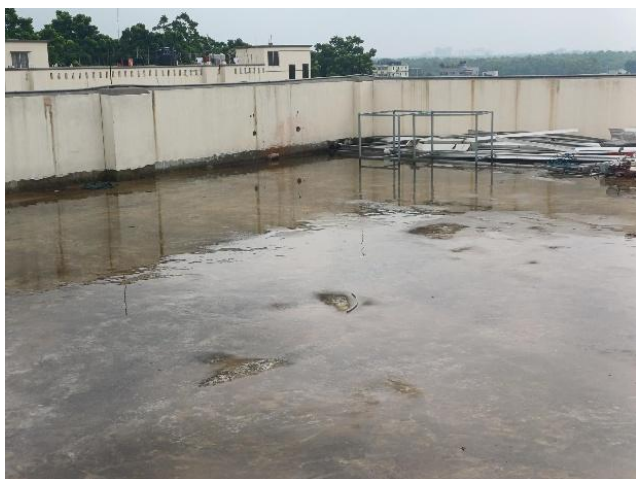
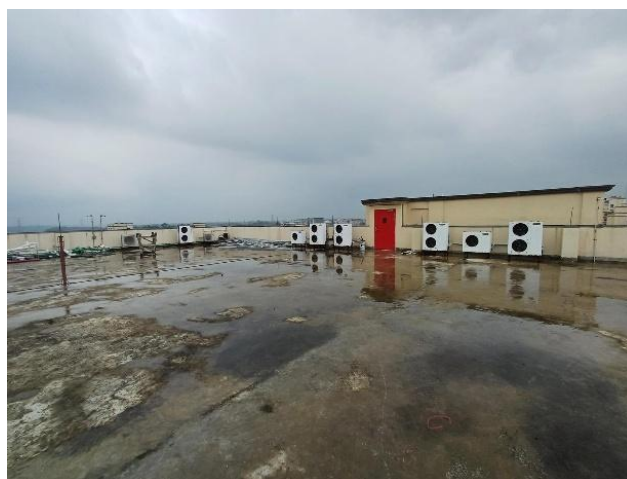
**Observation-06: Roof drainage system (Garments Building-2)**

**Description:** Slightly water ponding observed on the roof. The building engineer is required to improve the roof drainage system with an adequate slope.

| Item No | Observation | Action Plan | Timeline |
|---|---|---|---|
| 8. | Roof drainage system (Garments Building-2) | The building engineer is required to improve the roof drainage system with adequate slope. | within 6 months |

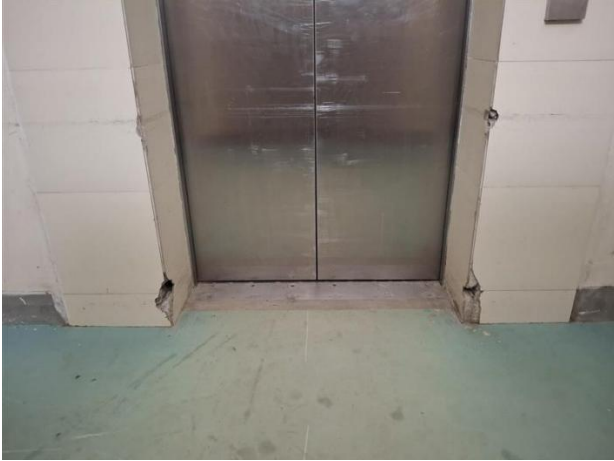
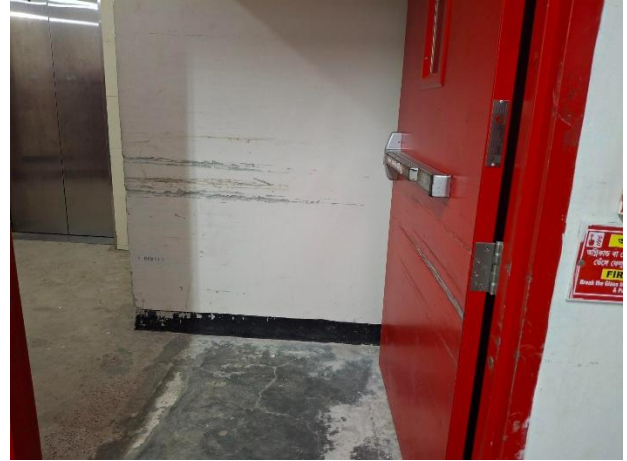
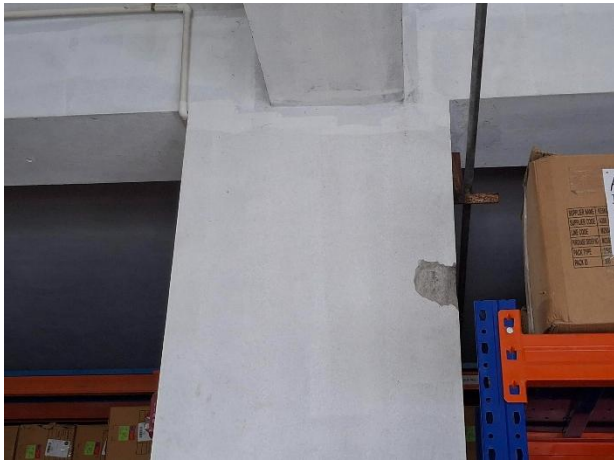
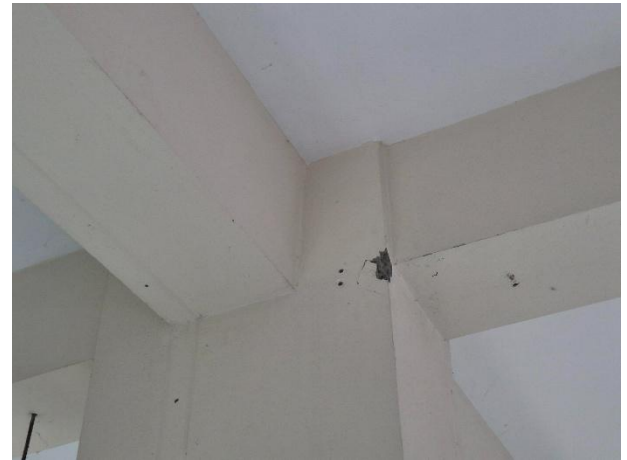
**Observation-07: Damage on column/wall surface due to trolley impact (Garments Building-2)**

**Description:** Due to trolley impacts, several column and wall surface damages were observed on every floor. The building engineer is required to repair damaged column surfaces and damage in column near beams and install column & wall guards to protect them from further trolley impacts.

| Item No | Observation | Action Plan | Timeline |
|---|---|---|---|
| 9. | Damage on column/wall surface due to trolley impact (Garments Building-2) | The building engineer is required to repair damaged column surfaces and damage in column near beams and install column & wall guards to protect them from further trolley impacts. | within 6 weeks |

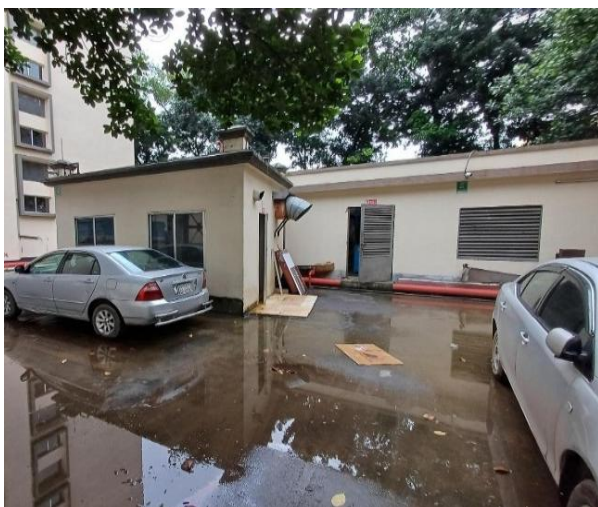
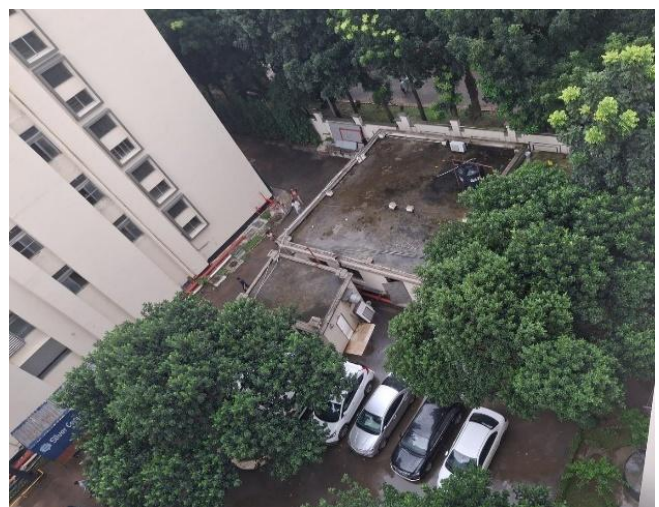
**Observation-08: Revision of design documents for lateral loads (Fire Pump House)**

**Description:** A set of design documents was available. The building engineer is required to update the design documents and submit to RSC for detailed review against lateral forces.

| Item No | Observation | Action Plan | Timeline |
|---|---|---|---|
| 13. | Revision of design documents for lateral loads. (Fire Pump House) | The prepared design report needs to be reviewed against lateral forces. Submit the design report to the RSC for detailed review. | within 6 weeks |
| 14. | | Update floor load plan in compliance with BNBC and current floor & parking occupancy. | within 6 weeks |

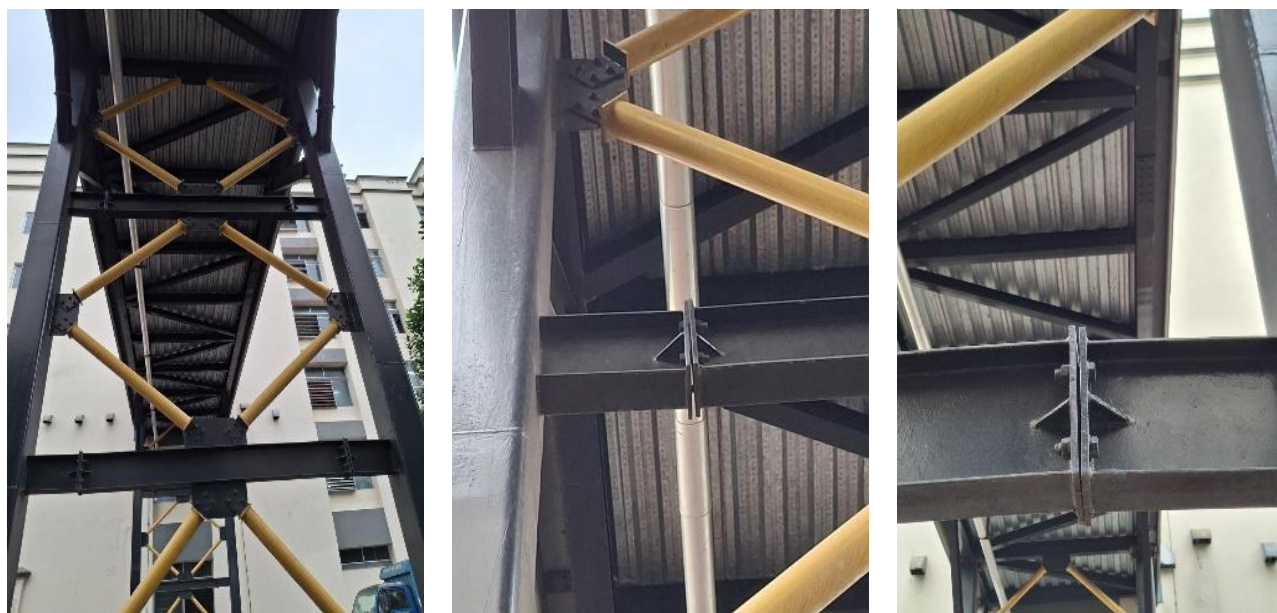
**Observation-09: Connection Gap (Connecting Bridge)**

**Description:** Gap between the connection plates was observed. The building engineer is required to fill the gap with suitable methods.

| Item No | Observation | Action Plan | Timeline |
|---|---|---|---|
| 21. | Connection Gap (Connecting Bridge) | The building engineer is required to fill the gap with suitable methods. | within 6 weeks |

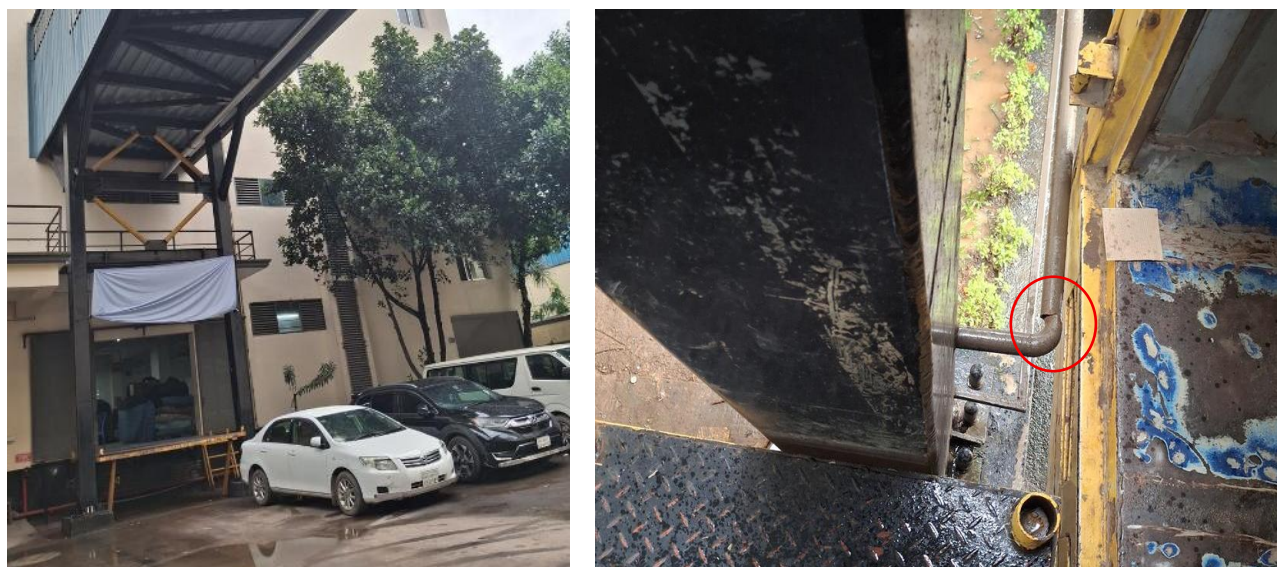
**Observation-10: Damage to vehicle impact barriers around steel columns (Connecting Bridge)**

**Description:** Damage to vehicle impact barriers around steel columns (Connecting Bridge). The vehicle impact barrier was found damaged. The building engineer is required to repair it and provide adequate barriers up to a suitable height to avoid vehicle impact on columns.

| Item No | Observation | Action Plan | Timeline |
|---|---|---|---|
| 22. | Damage to vehicle impact barriers around steel columns (Connecting Bridge) | The building engineer is required to repair it and provide adequate barriers up to suitable height to avoid vehicle impact on columns. | within 6 weeks |

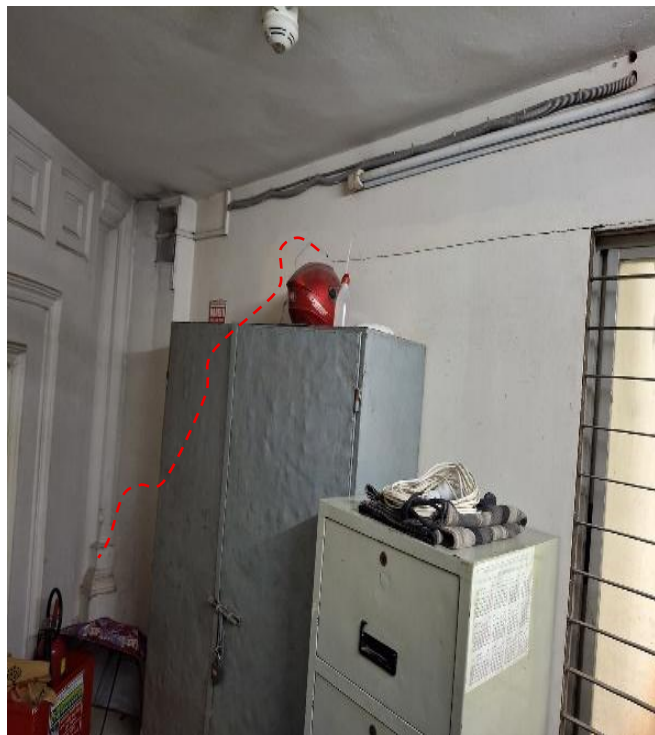
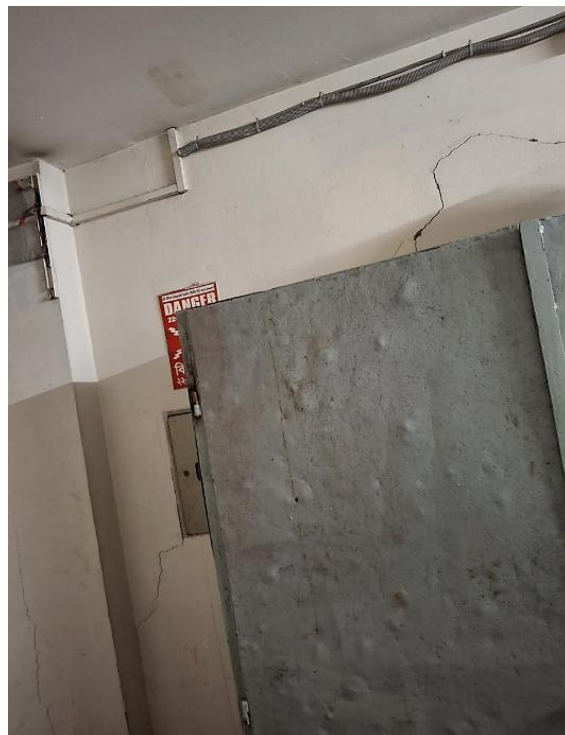
**Observation-11:** Crack in brick walls (Security Control Room)

**Description:** Crack observed in the brick wall. The building engineer is required to investigate the reason and repair it with a suitable method accordingly.

| Item No | Observation | Action Plan | Timeline |
|---|---|---|---|
| 24. | Crack in brick walls (Security Control Room) | The building engineer is required to investigate the reason and repair it with suitable method accordingly. | within 6 weeks |
