# INITIAL FIRE SAFETY INSPECTION REPORT

**Silver Composite Textile Mills Ltd. (Extension)**

**RSC ID: 26398**

**Date: 07-October-2025**

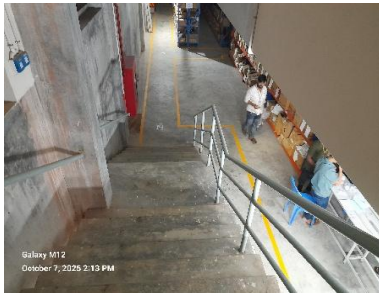
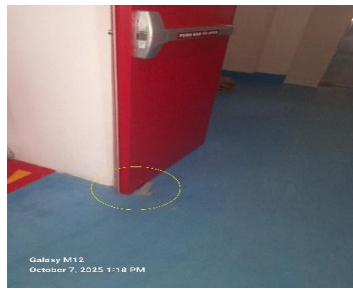
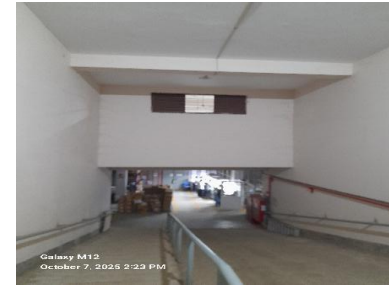
| SI No. | Category | Findings | Required Action | Remediation Time Frame |
|---|---|---|---|---|
| F-1 | Means of Egress | <p>The exit stair enclosures are not separated from work areas and other spaces on each floor by fire-rated construction</p> <p>Location(s): Garmentss Building-2,</p> <p>Non-compliance: 1. Unprotected opening at basement floors.<br/>2. Non-functional installed fire doors.<br/>3. Installed fire doors were not effectively latching.<br/>4. Open by external objects.</p> | <p>The exit stair enclosure shall be provided with a minimum of 2-hr. fire resistance rating for buildings 4 or more stories. Provide 1.5 hr. fire rated door and seal all penetrations and openings by 2 hr. fire rated fire rated barrier construction for building with 4 or more stories in accordance with section 6.3.1.2 of RSC Technical Guidelines (Standard)<sup>1</sup> V1.0.</p> <p>Provide a fire-resistive rated assembly between the exterior exit stairs and the building up to 10 ft. beyond the end of the stair to achieve the required separation. The rated assembly shall be approved and/or designed by a qualified fire protection engineer.</p> <p>Ensure that the fire doors are self-closing and positive latching and that they are provided with fire exit (panic) hardware where serving production floors. If fire doors are required to be held open for functional reasons, provide automatic closing devices tied to the fire alarm system.</p> <p>Keep proper datasheet &amp; certifications for installed fire doors &amp; accessories on-site for verification. The clearance under the bottom of a door shall be a maximum of 3/4 in. (19 mm).</p> | Within 3 Months |

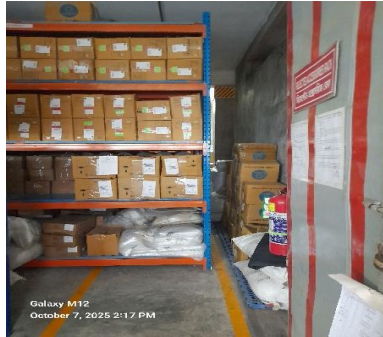
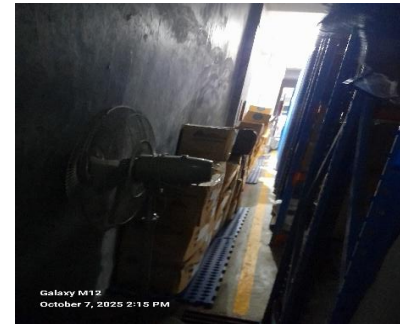
| F-2 | Means of Egress | <p>The egress path along means of egress has interrupted by storage</p> <p>Location: Basement floor of the Garments Building-2.</p> | <p>Keep egress paths and stairs clear of storage/obstruction in accordance with section 6.3.9 of RSC Technical Guidelines (Standard)<sup>1</sup> V1.0.</p> <p>Means of egress shall be maintained continuously free and clear of all obstructions or impediments to full instant use in the case of fire or other emergency. No furnishings, decorations, or other objects shall obstruct exits and access to exits. Nothing shall obstruct or impede visibility to exits.</p> | Immediately |

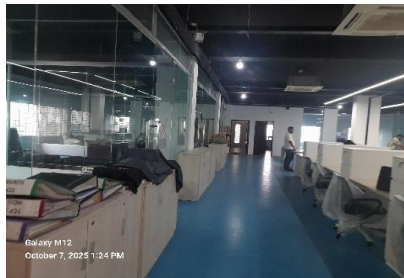
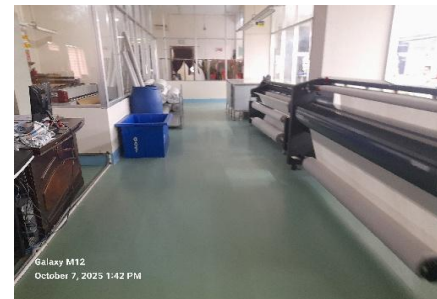
| F-4 | Means of Egress | <p>Aisles were found missing in several locations of the Garments building-2.</p> <p>Location: 4th &amp; 5th floor of the Garments Building-2.</p> | <p>Provide minimum aisle widths of 36-in. Aisles mark shall be clearly visible.</p> | Within 1 Month |

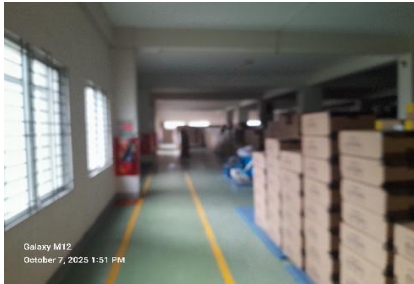
| F-5 | Means of Egress | <p>Directional signs are not provided where direction of the path of travel to an exit has changed.</p> <p>Location(s): All floors of the Garments Building-2.</p> | <p>Illuminated directional signs shall be provided where there is a change in the direction for the path of travel and the direction to an exit is not obvious in accordance with RSC Technical Guidelines (Standard)<sup>1</sup> V1.0 Section 6.11.3.</p> | Within 1 Month |

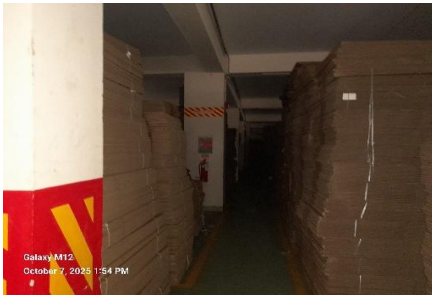
| F-6 | Means of Egress | <p>Based on the number and location of emergency lights observed, adequate illumination levels are not anticipated along egress routes.</p> <p>Location(s): All floors of the Garments Building-2.</p> | <p>Test the emergency lighting system on each floor and provide additional emergency fixtures to provide adequate illumination along the means of egress. Provide a minimum illumination of 10 lux at the floor level within exit stairs and exit discharge paths and minimum 2.5 lux along exit access aisles. Illumination on means of egress shall meet in accordance with RSC Technical Guidelines (Standard)<sup>1</sup> V1.0 Section 10.12.2.</p> | Within 3 Months |

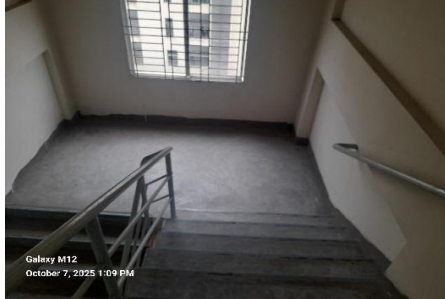
| F-8 | Means of Egress | Stair clear width was found less than 60 in.<br><br>Location: South -West & North-West of the Garments Building-2.<br>Available Stair Width: 53inch & 52inch at basement floors. | Stairs shall have a minimum clear width of 60 in for all industrial occupancies as per RSC Technical Guideline (Standard) section of 6.5.6. | Within 3 Months |

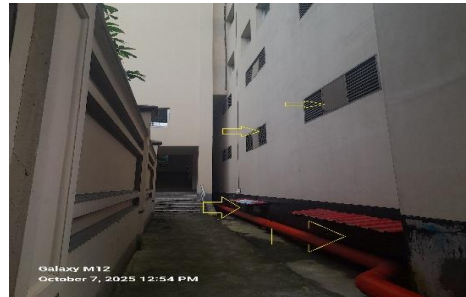
| F-9 | Means of Egress | The egress court [serving east exit] is less than 10 ft wide and is not separated from the building interior, which is not in accordance with section 6.17.2 of RSC Technical Guidelines (Standard) <sup>1</sup> V1.0.<br><br>Location: East side of the Garments Building-2. | Egress courts less than 3050 mm (10 ft) in width (as measured from the building and the adjacent property line) shall be provided with walls having a 1-hr fire resistance rated construction for a distance of 3050 mm (10 ft) above the floor of the court.<br><br>Seal all penetrations and openings to the interior of the building along the discharge path, up to a height of 10 ft. to provide a minimum 1-hr fire separation. | Within 3 Months |

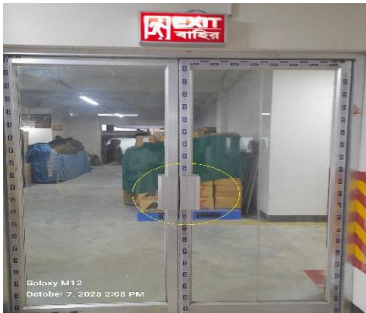
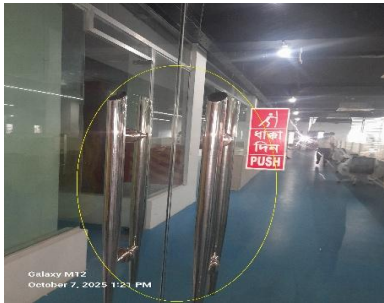
| F-10 | Means of Egress | <p>Doors along means of egress are provided with non-compliant locking devices.</p> <p>Location: Exit doors of the Ground Floor, 4th &amp; 5th floor of the Garments Building-2.</p> | <p>Remove locking devices from all egress devices in accordance with section 6.8.2 of RSC Technical Guidelines (Standard)<sup>1</sup> V1.0.</p> <p>No locks or other devices shall be installed on a means of egress component that would prevent any occupant from having safe egress from the building or structure and doors shall not be locked in the direction of egress under any conditions. All hasps, locks, slide bolts, and other locking devices are prohibited unless meet the following conditions:</p> <ul style="list-style-type: none"> <li>• Doors may be locked where the latch and lock are disengaged with one motion where the occupant load does not exceed 49 persons. Turning a door handle and disengaging a lock is considered two motions.</li> <li>• Doors may be provided with locking hardware from the ingress side provided that a panic bar is installed on any door with an occupant load exceeding 49 persons.</li> </ul> | Immediately |

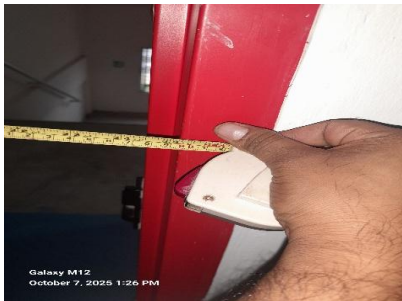
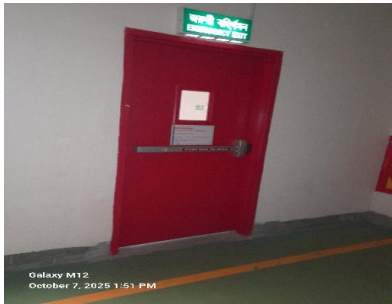
| F-11 | Means of Egress | <p>Doors in the means of egress do not have the required minimum width.</p> <p>Location: South-West &amp; East side of the all floors exit stair doors of the Garments Building-2.</p> <p>Available Width: 34inch &amp; Pocket gate of basement floor : 36inch.</p> | <p>For Interim &amp; New building, Doors in a means of egress shall have a minimum width of 1 m (39 in.). in accordance with section 6.5.6.1 of RSC Technical Guidelines (Standard)<sup>1</sup> V1.0.</p> | Within 1 Month |

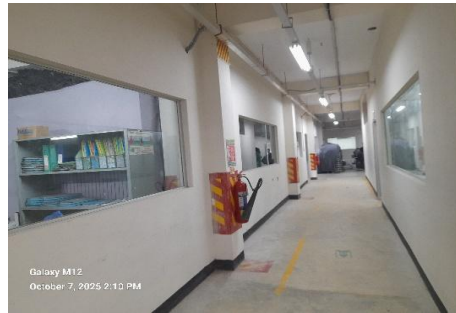
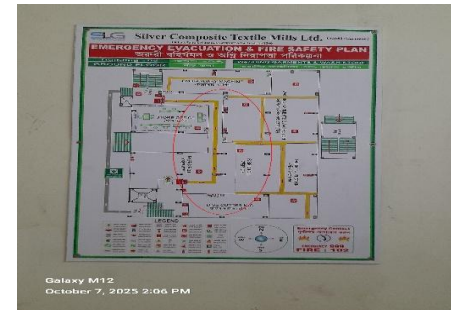
| F-14 | Means of Egress | <p>Exit access corridor(s) serving more than 30 occupants is not separated by fire rated construction or protected by sprinkler system in accordance with NFPA 13 and section 6.3.1.1 of RSC Technical Guidelines (Standard)<sup>1</sup> V1.0.</p> <p>Location: Ground floor of the Garments Building-2.</p> | <p>1. Separate the exit access corridor by a minimum 1-hr fire rated construction.<br/>Or<br/>2. Provide automatic sprinkler system throughout the storey as per NFPA 13.</p> | Within 3 Months |

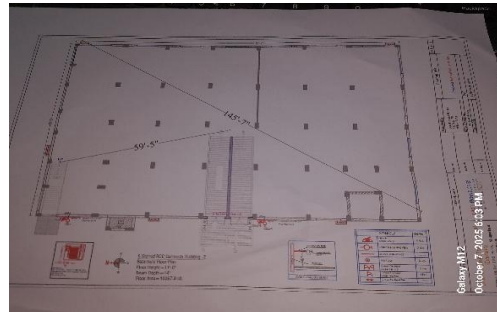
| F-15 | Means of Egress | <p>The exits are not remotely located from each other such that a single fire event could compromise both exits of the building.</p> <p>Location: Basement floor of the Garments Building-2.</p> <p>Diagonal Distance: 145feet 7inch.<br/>Exit Distance: 59 feet 5inch.</p> | <p>Provide additional exit or reconfigure the exit arrangement to ensure that the exit doors or means of egress openings are located a distance apart as per RSC Technical Guideline (Standard) section of 6.6.6.</p> | Within 3 Months |

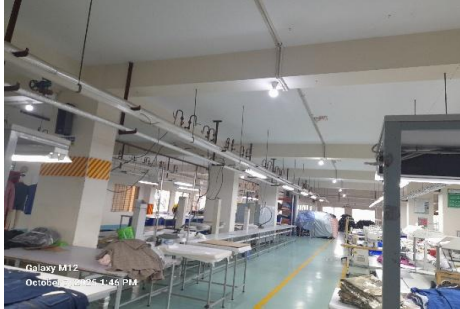
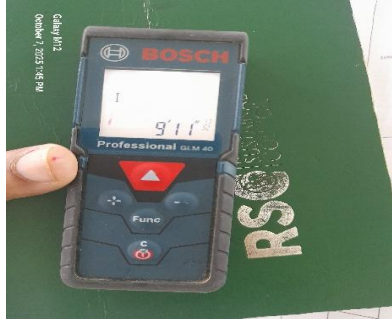
| F-16 | Means of Egress | <p>Minimum ceiling height of the production floor is less than 3.3 meter for New Building.</p> <p>Location: All floor except basement floor of the Garments Building-2.</p> <p>Available ceiling Height: 9feet 11inch.</p> | <p>The ceiling height of a production floor shall not be less than 3.3 meter as per article 1.2, chapter 1, part III and article 2.11, Part III, Chapter -2, BNBC 2020.</p> | Within 3 Months |

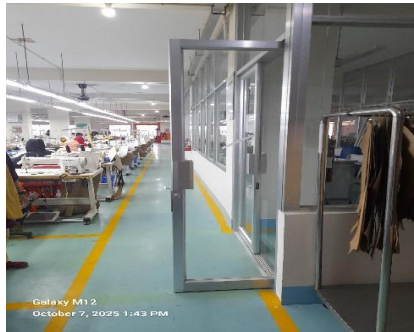
| F-17 | Means of Egress | <p>Doors are swing out over aisles.</p> <p>Location: 4th floor of Garments Building-2.</p> | <p>A landing shall be provided on both sides of doors used in the means of egress to facilitate uninterrupted egress of occupants. Door shall not swing out over stairs/aisles. Landings with same width as the stair clear width shall be provided at each level and at intermediate landings.</p> | Within 3 Months |

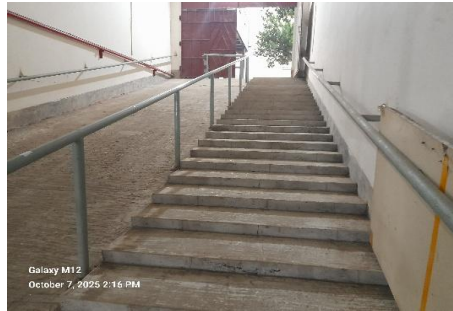
| F-18 | Means of Egress | <p>Handrails are provided on both sides of each exit stairs on all floors which height is less than as per standards.</p> <p>Location: Basement floor of the Garments Building-2.<br/>Available: 32inch.</p> | <p>Provide handrails on both sides of the exit stair. New handrails shall have a minimum height of 865 mm (34 in.) and a maximum height of 965 mm (38 in.) as measured from the leading edge of the tread. Intermediate handrails shall be provided when the stair width exceeds 2.2 m (87 in.).</p> <p>Open guards shall have intermediate rails or pattern such that a sphere 200 mm (8 in.) in diameter cannot pass through any opening up to a height of 865 mm (34 in.). Handrail shall construct in accordance with RSC Technical Guidelines (Standard)<sup>1</sup> V1.0 Section 6.12.</p> | Within 3 Months |

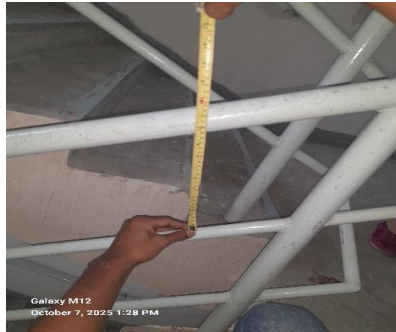
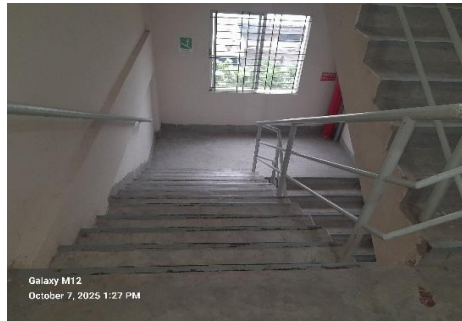
| F-19 | Means of Egres | <p>The guards have gaps that are too large, allowing a sphere 200 mm (8 in.) in diameter to pass through.</p> <p>Location: Handrail of the all Exit stairs of the Garments Building-2.</p> | <p>Open guards shall have intermediate rails or pattern such that a sphere 200 mm (8 in.) in diameter cannot pass through any opening up to a height of 865 mm (34 in.).</p> | Within 3 Months |

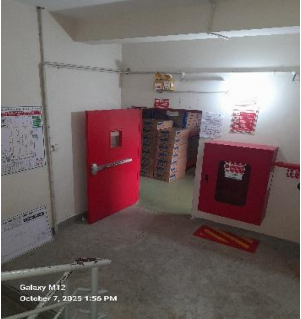
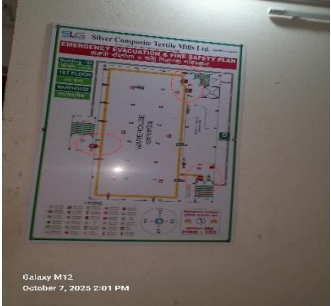
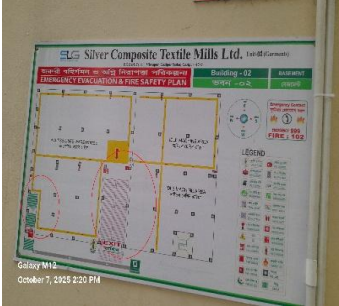
| F-20 | Means of Egress | <p>Storage areas &amp; basements and similar normally unoccupied spaces discharges directly into the exit stair enclosure.</p> <p>Location(s): Basement floors &amp; First floor to 3rd floor of the Garments Building -2.</p> | <p>Openings from exit enclosure to Storage areas/ basements/ transformer rooms/ generator rooms/ boiler rooms and similar normally unoccupied spaces shall be provided with a vestibule with fire rated construction and openings in accordance with section 6.14.3 of RSC Technical Guidelines (Standard)<sup>1</sup> V1.0. Provide a min 1-hr fire rated door on the exit stair side and a 1.5 hr./1-hr fire rated door on the Store, generator, sub-station room side . Ensure that the fire rating of the vestibule construction matches that of the exit stair enclosure as per RSC Technical Guidelines (Standard)<sup>1</sup> V1.0. section 6.14.3. The minimum width for vestibules shall not be less than 1.1m and length 1.8m.</p> | Within 3 Months |

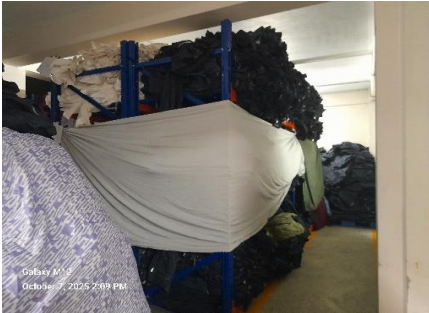
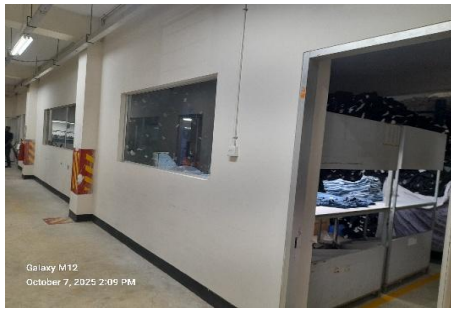
| F-21 | Fire rated construction | <p>Rooms used for storage of combustible materials are not separated from the surrounding occupancy/areas.</p> <p>Location: Ground floor of the Garments Building-2.</p> <p>Non-compliance reason: Unprotected Opening.</p> | <p>Rooms used for storage of combustible materials shall be separated from the surrounding occupancy with a minimum 1 hour construction in accordance with section 3.4.2.1.5 of RSC Technical Guideline (Standard).</p> | Within 3 Months |

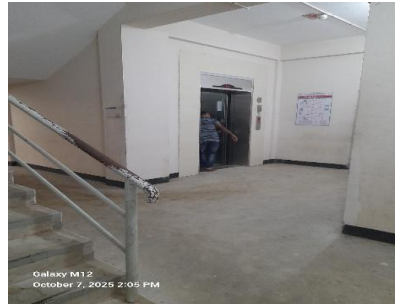
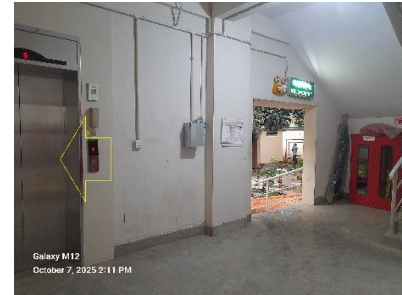
| F-22 | Fire rated construction | <p>Elevator shafts open directly into the exit enclosure, which doesn't comply with RSC Technical Guidelines (Standard), section 6.14.3.</p> <p>Location: South-West(cargo lift) &amp; North-West (passenger lift) side at ground floor of the Garments Building-2.</p> | <p>Provide a minimum 2-hr fire rated elevator shaft to separate it from stair enclosure. No discharge is accepted through elevator shaft. Seal all openings to maintain fire separations.</p> | Within 3 Months |

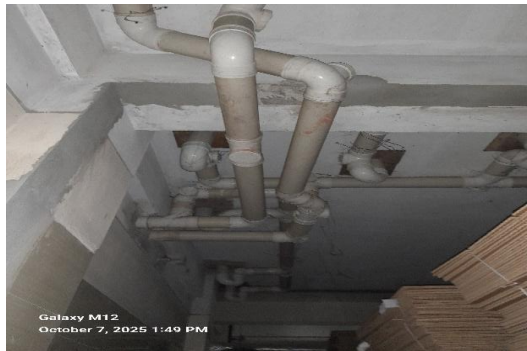
| F-23 | Fire Rated Construction | <p>Penetrations through floor/ceiling assemblies are found unsealed.</p> <p>Location: Through the plastic Plumbing Pipe of the Garments Building-2.</p> | <p>Seal all penetrations and openings in floor/ceiling assemblies by a listed through-penetration fire stop system tested in accordance with ASTM E814 or approved alternative standard to maintain minimum 3-hr. fire resistance rating. Installation shall be as per the manufacturer's published installation guidelines and the certification authority guideline to ensure the fire-rating in accordance with section 4.7 of RSC Technical Guideline (Standard)</p> <p>Or,</p> <p>Provide a minimum 2-hr fire-rated shaft to separate the penetration from each floor if required.</p> | Within 3 Months |

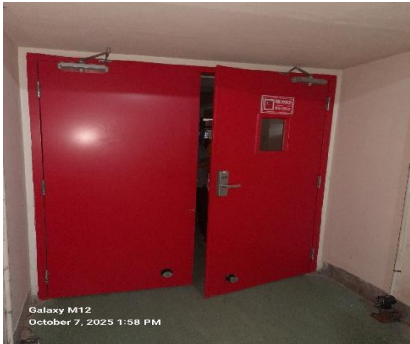
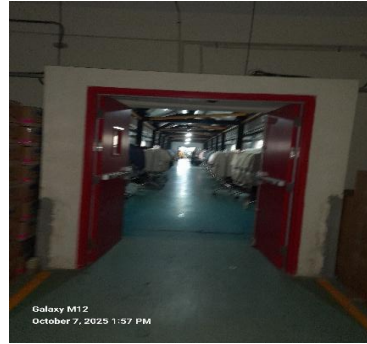
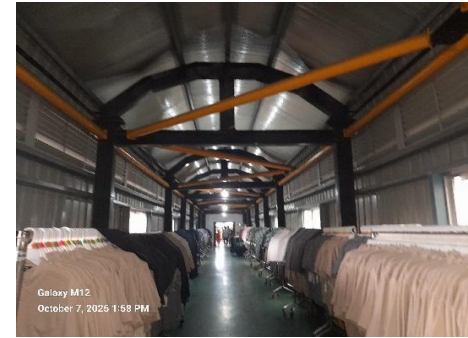
| F-24 | Fire Rated Construction | <p>A connecting corridor (enclosed_non rated) has been constructed between two buildings which is also functioning as a horizontal exit for one of the building. However, fire/smoke propagation between buildings are not restricted.</p> <p>Location: Connecting Bridge Between Garments Building-2 &amp; Building-1(Old ID-12214) on second floor.</p> <p>Non-Compliance: 1. Non-functional of the installed fire doors.</p> | <p>Separate the buildings with a minimum 2-hour fire-rated construction on both sides of the connecting corridor. Opening protection extending up to 10 feet beyond the connecting corridor shall meet section 4.6 of RSC Technical Guidelines (Standard)<sup>1</sup> V1.0.</p> | Within 3 Months |

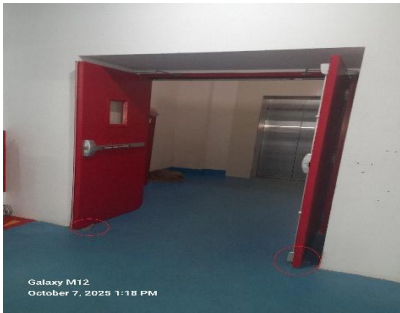
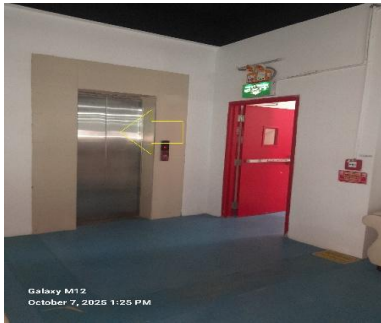
| F-25 | Fire Rated Construction | <p>Elevator shafts open directly into the production floor without proper fire separation due to unprotected opening.</p> <p>Location: 5th floor at north-west side(passenger lift) of the Garments Building.</p> <p>Non-Compliance: South-West side(Cargo lift)</p> <ol style="list-style-type: none"> <li>1. Non-functional of the installed fire doors.</li> <li>2. Open by external object.</li> <li>3. Certificate &amp; Technical data sheet missing of installed fire doors.</li> </ol> | <p>Elevator shaft shall be separated from production area by 2 hours fire rated construction. 2-hr fire barriers shall be protected with minimum 1.5-hr fire protective opening assemblies.</p> <p>Keep proper datasheet &amp; certifications for installed fire-rated doors &amp; accessories on-site for verification.</p> | Within 3 Months |

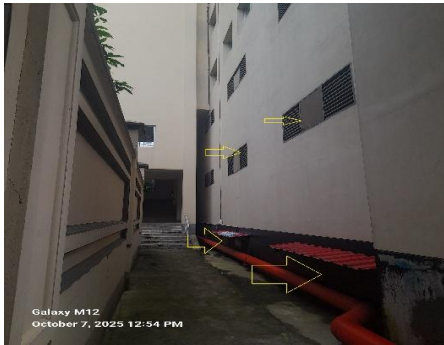
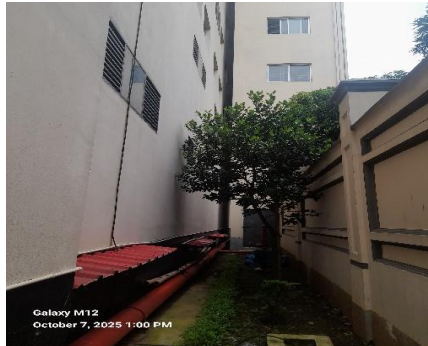
| F-26 | Fire Rated Construction | <p>The required fire separation distance for the Garments Building-2 does not comply with the requirements of BNBC 2020.</p> <p>Location: East &amp; South Side of the Garments Building-2.</p> | <p>The exterior walls shall have a fire resistance and opening protection as specified in BNBC 2020 Part 3 Table 3.2.2 &amp; 3.2.3 and BNBC 2020 Part 3 Section 2.4.1.3.</p> | Within 6 Months |

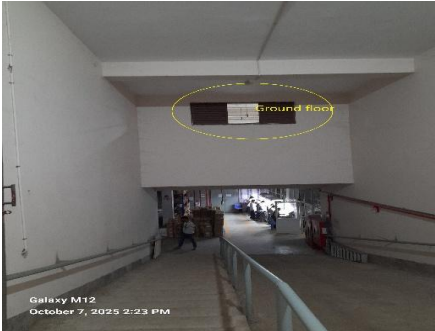
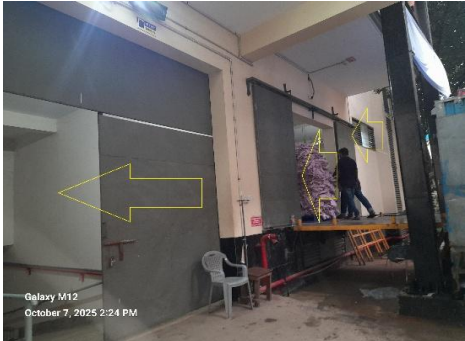
| F-27 | Fire Rated Construction | Basement floor is not separated from ground floor( loading/unloading area) under the same roof at west side by fire rated construction due to unprotected opening. | Separate each floor by fire rated construction as per BNBC-2020, Part-3, Chapter 3 and Table 3.3.1 & Table-4.1.1 of the RSC Technical Guideline Standard V1. | Within 3 Months |

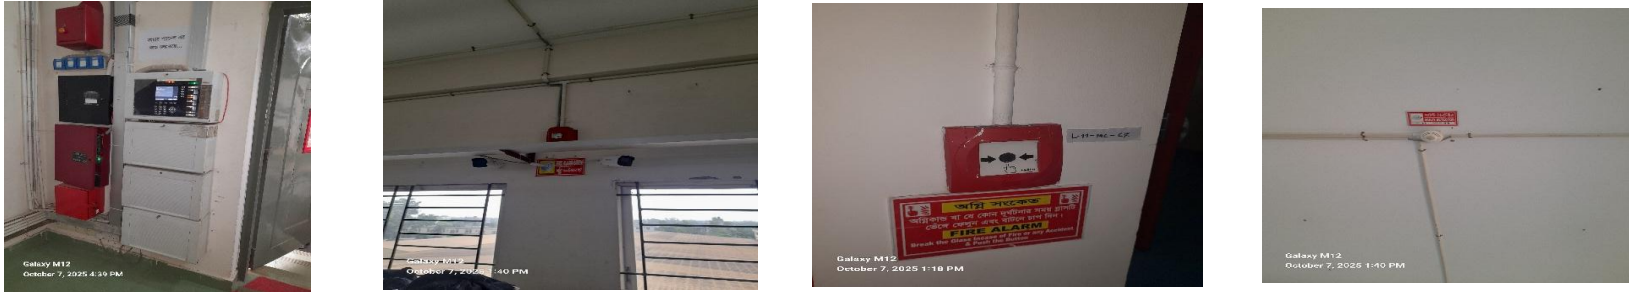
| F-28 | Fire Alarm & Detection System (FADS) | <p>It was observed that An addressable automatic fire alarm &amp; detection system (Brand: Honeywell &amp; Model: FlexES-Fx18) has been installed. One fire alarm control panel (Honeywell) is share Old ID-12214 &amp; New ID-26398. Total loop 11nos. Loop 1 to Loop 6 are share Old ID-12214 and Loop 7 to Loop 11 are share New ID-26398. The factory has installed a fire alarm and detection system that requires a detailed review to confirm compliance with NFPA 72 and RSC Technical Guidelines (Standard).</p> <p><b>Location(s): All Buildings of the IDs.</b></p> | <p><b>Option-1: Separate the fire alarm control panel for New RSC ID-26398 of the all structure and Submit the fire alarm &amp; detection system design only ID-26398 for initial review.</b></p> <p><b>Option-2: If the both IDs(12214 &amp; 26398) share one fire alarm control panel, then Submit the fire alarm and detection system initial design both IDs combinedly.</b></p> <p>Once the design is reviewed, install and modify the fire detection and alarm system throughout the building in accordance with review comment, RSC Technical Guidelines (Standard) and NFPA 72.</p> <p>After installation the owner shall conduct internal testing and commissioning and then contact the RSC for witness of final acceptance testing.</p> | Design within 2 Months and modification/ installation with 4 Months |

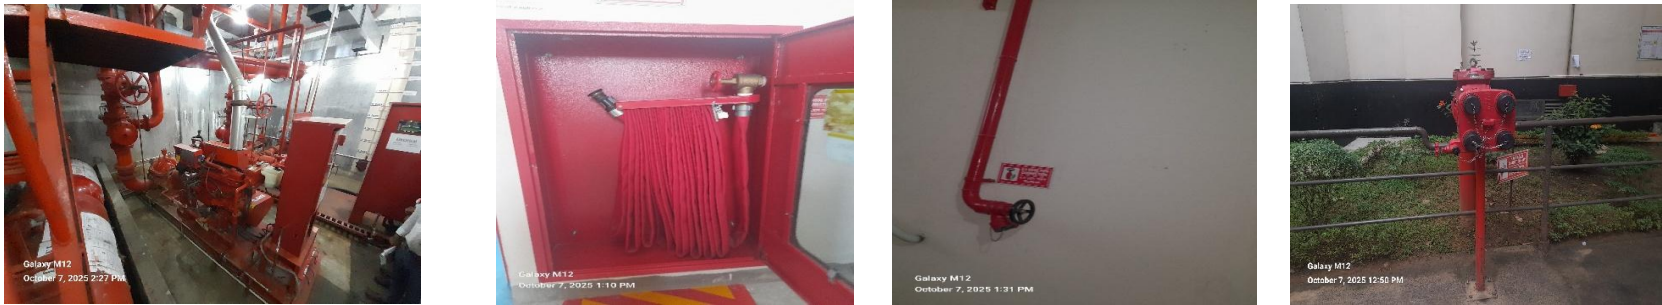
| F-30 | Fire Suppression System (SUPS) | <p>The factory has installed a standpipe &amp; Hose system that requires a detailed review to confirm compliance with NFPA 14,20, 24 and RSC Technical Guidelines (Standard).</p> <p>Location: Garments Building-2.</p> | <p>Submit the standpipe system drawing to RSC for review.</p> <p>Once reviewed, install or modify the standpipe system throughout the building in accordance with RSC Technical Guidelines (Standard)<sup>1</sup> V1.0. and NFPA 14, 20,22 and 24.</p> <p>After installation the owner shall contact the RSC for witness of conducting the final acceptance testing of the standpipe system.</p> | <p>Design within 2 Months and modification/ installation with 4 Months</p> |

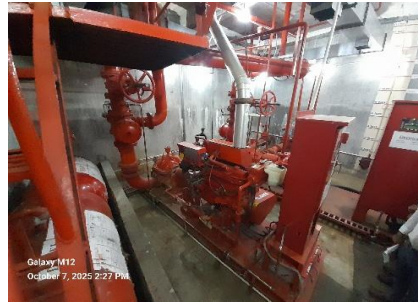
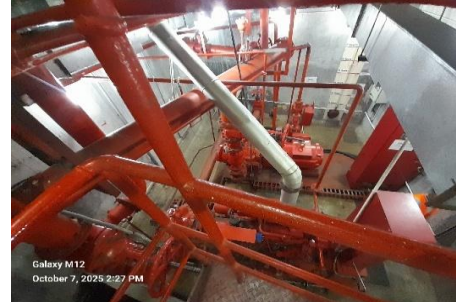
| F-31 | Fire Suppression System (SUPS) | <p>Fire pump installation requires detailed review to confirm compliance with NFPA 20 and RSC Technical Guidelines (Standard)<sup>1</sup> V1.0.</p> <p>Location: Garments Building-2.</p> | <p>Submit as-built drawings, testing records, equipment certification and other relevant documentation to the RSC for review and approval.</p> <p>Submit the standpipe system drawing to RSC for review. Once reviewed, install or modify the standpipe system throughout the building in accordance with RSC Technical Guidelines (Standard)<sup>1</sup> V1.0. and NFPA 14 and 20. The factory management shall contact RSC to conduct the final acceptance testing after the installation, testing &amp; commissioning.</p> | <p>Design within 2 Months and modification/ installation with 4 Months</p> |
