# Shamser Knit Fashions Ltd. (Unit-2) Extension

Sreepur Bus stand, Ganakbari, Savar, Dhaka

24 September 2025

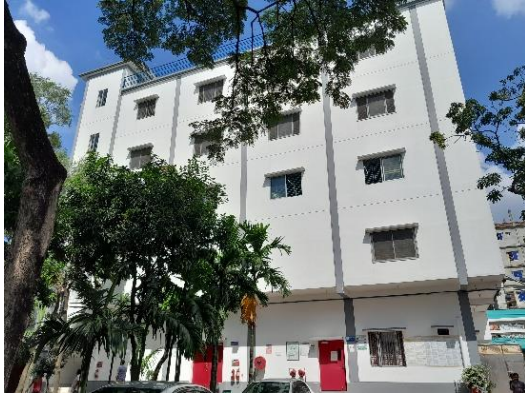
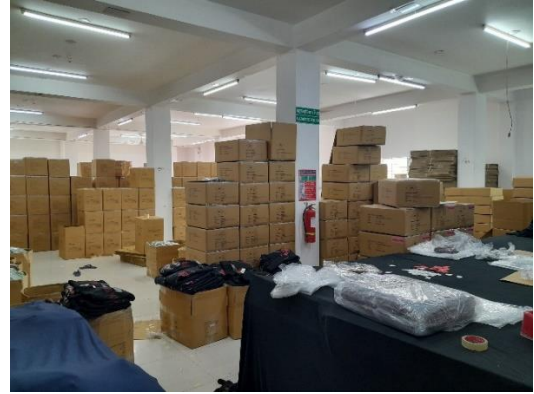
**Observation-01:** Lack of design documents, material test report, & load plan. (RCC Building 1)

**Description:** Design report, material test reports & load plan were not available during the inspection. The factory is required to prepare a design report following BNBC 1.9.1, verify in situ concrete strength by taking 100 mm diameter concrete cores from the structural members (Column, Beam-Slab), and prepare a load plan considering the structural member capacity.

| Item No | Observation | Action Plan | Timeline |
|---|---|---|---|
| 1. | Lack of design documents, material test report, & load plan. (RCC Building 1) | The factory is required to prepare a design report following BNBC 2006 | within 6 weeks |
| 2. | | Verify in situ concrete strength by taking 100 mm diameter concrete cores from the structural members (Column, Beam-Slab), | within 6 weeks |
| 3. | | Prepare load plan considering the structural member capacity and BNBC requirement | within 6 weeks |
| 4. | | Carry out the required remedial work where required. | within 6 months |

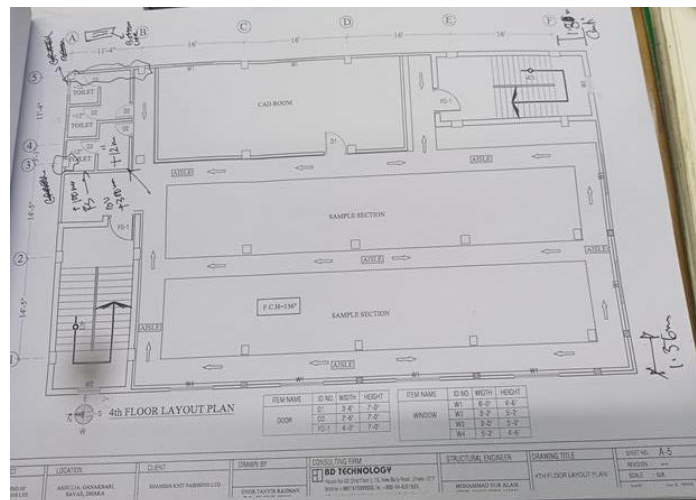
**Observation-02:** Lack of information in the as-built drawing. (RCC Building 1)

**Description:** Lack of information observed in the drawing (architectural details like cantilever dimension, false slab on toilet area, storage found instead of sewing at 2<sup>nd</sup> floor etc.). Building engineer is required to prepare detailed and accurate as-built drawings.

| Item No | Observation | Action Plan | Timeline |
|---|---|---|---|
| 5. | Lack of information in the as-built drawing. (RCC Building 1) | Building engineer is required to survey the structure and prepare accurate and detailed as-built drawings. | within 6 weeks |

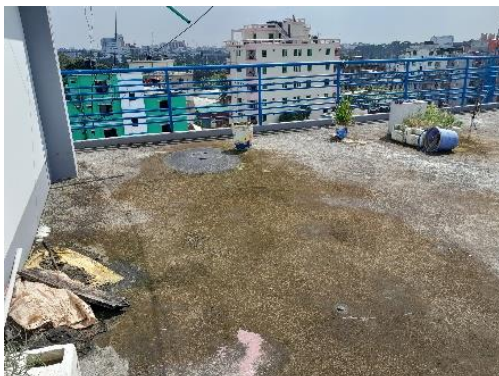
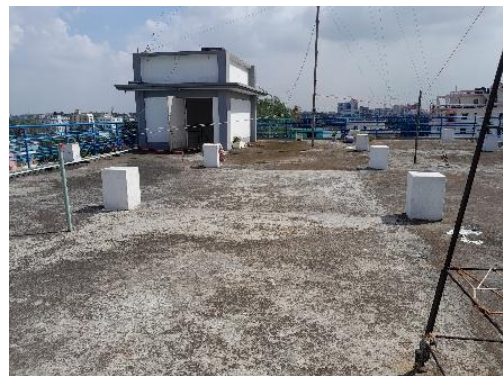
**Observation-03:** Water ponding on the roof. (RCC Building 1)

**Description:** Water ponding observed on the roof. The building engineer is required to improve the roof drainage system.

| Item No | Observation | Action Plan | Timeline |
|---|---|---|---|
| 6. | Water ponding on the roof. (RCC Building 1) | The building engineer is required to improve the roof drainage system. | within 6 weeks |

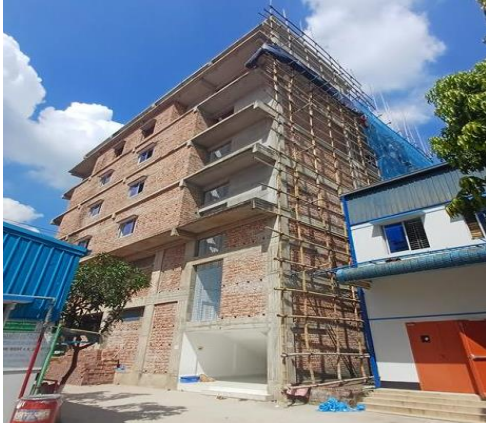
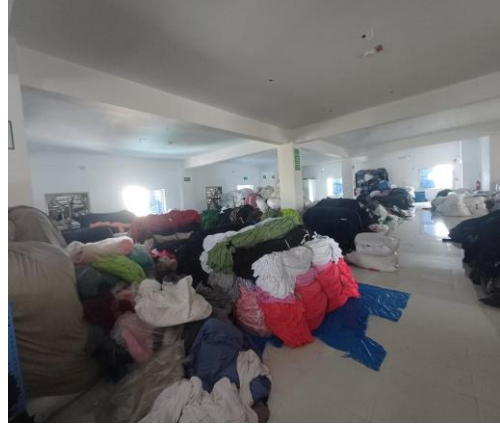
**Observation-04:** Lack of design documents, geotechnical investigation report, material test report, & load plan. (RCC Building 2)

**Description:** Design report, geotechnical investigation report, material test reports & load plan were not available during the inspection. The factory is required to prepare a design report following BNBC 1.9.1, verify in situ concrete strength by taking 100 mm diameter concrete cores from the structural members (Column, Beam-Slab), and prepare a load plan considering the structural member capacity.

| Item No | Observation | Action Plan | Timeline |
|---|---|---|---|
| 7. | Lack of design documents, geotechnical investigation report, material test report, & load plan. (RCC Building 2) | The building engineer is required to review the design load and column stress and prepare a Detailed Engineering Assessment (DEA) following BNBC 2020. | within 6 weeks |
| 8. | | Verify in situ concrete strength by taking 100 mm diameter concrete cores from the structural members (Column, Beam-Slab), | within 6 weeks |
| 9. | | Carry out a geotechnical investigation | within 6 weeks |
| 10. | | Prepare load plan considering the structural member capacity and BNBC requirement | within 6 weeks |
| 11. | | Carry out the required remedial work where required. | within 6 months |

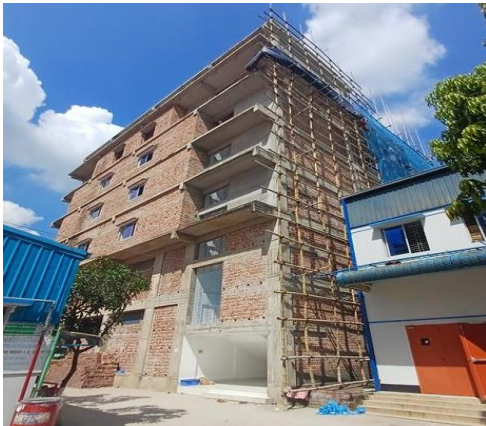
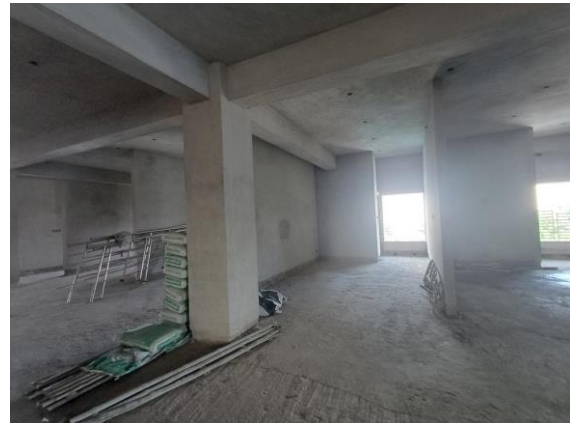
**Observation-05:** Lack of as-built architectural drawing. (RCC Building 2)

**Description:** As-built architectural drawing was not available during the inspection. The building engineer is required to survey the whole structure and prepare as-built drawings as per onsite conditions.

| Item No | Observation | Action Plan | Timeline |
|---|---|---|---|
| 12. | Lack of as-built architectural drawing. (RCC Building 2) | Building engineer is required to survey the structure and prepare accurate and detailed as-built drawings. | within 6 weeks |

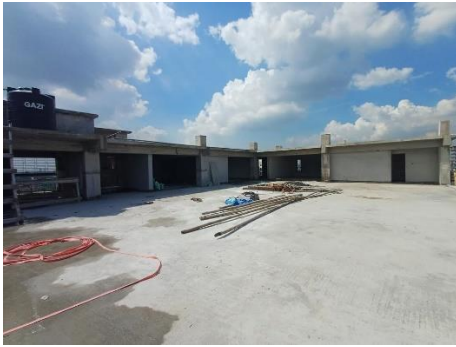
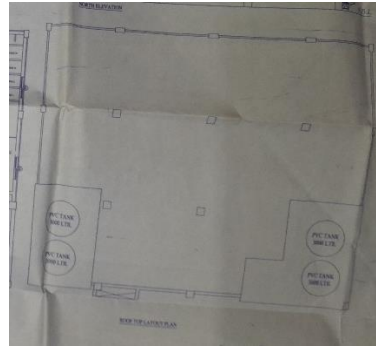
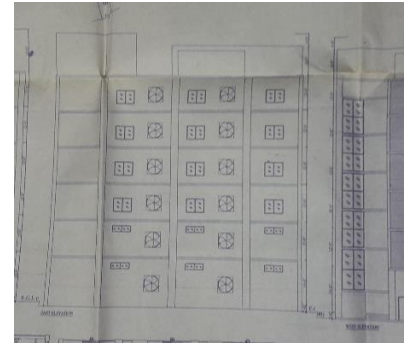
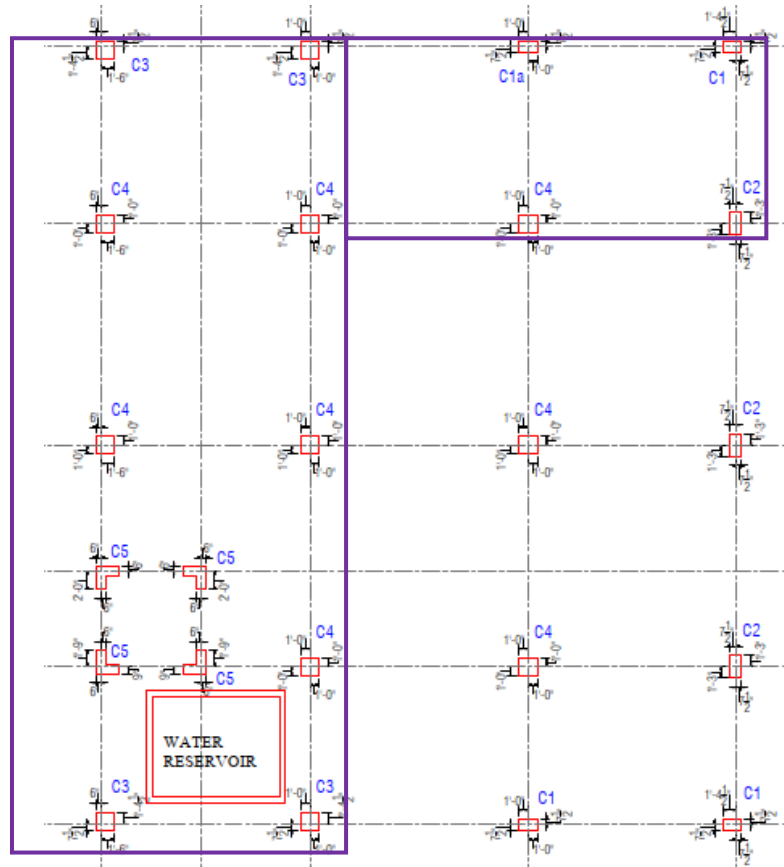
**Observation-06: Marginal column stress & unauthorized extension on the roof (RCC Building 2)**

**Description:** cursory calculation indicated that columns are stressed above the normal design limit in the extension part of the building.

As per the local authority's approval, building permits were issued for a six-story structure. However, the factory has constructed partial extensions on the roof. The Building Engineer is required to obtain revised approval for updated layout drawings reflecting these extensions.

| Item No | Observation | Action Plan | Timeline |
|---|---|---|---|
| 13. | Marginal column stress & unauthorized extension on the roof (RCC Building 2) | Obtain revised approval for updated layout drawings reflecting extensions. | within 6 months |

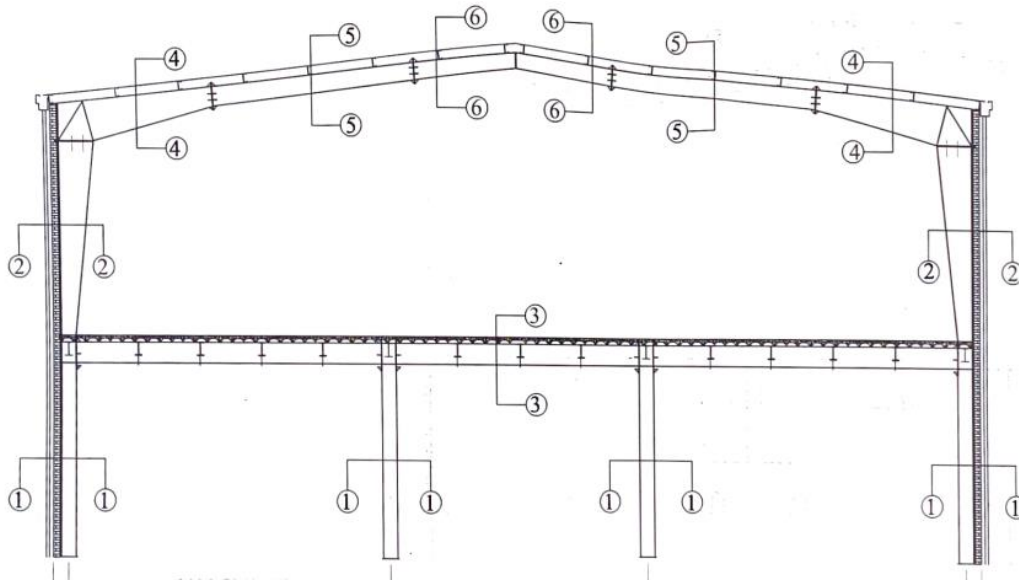
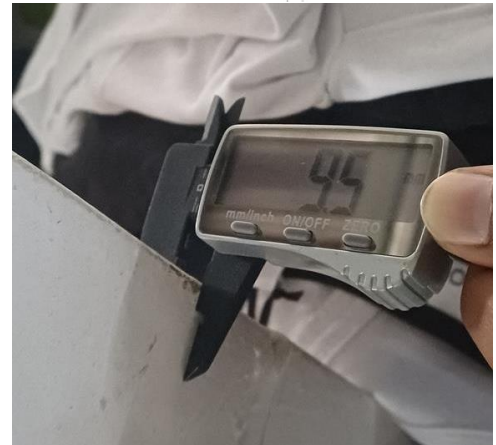
**Observation-07: Mismatches in construction drawing/ Lack of as-built drawing (Steel Building)**

**Description:** During the inspection, as-built drawings were not available. However, discrepancies were observed between the construction drawings and onsite conditions. In the construction drawings, the flange thickness of all steel columns at the ground level was specified as 10 mm, whereas the measured thickness on site was 9.5 mm.

The building engineer is required to survey the whole structure and produce as-built drawings as per onsite conditions.

| Item No | Observation | Action Plan | Timeline |
|---|---|---|---|
| 14. | Mismatches in construction drawing/ Lack of as-built drawing (Steel Building) | Building engineer is required to survey the structure and prepare accurate and detailed as-built drawings. | within 6 weeks |

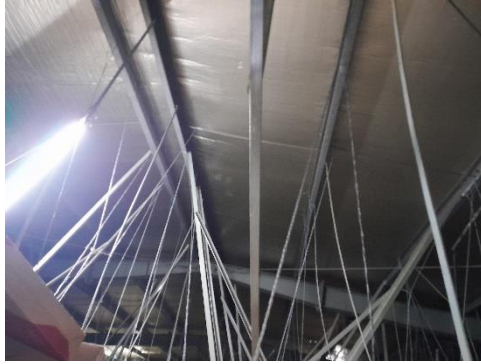
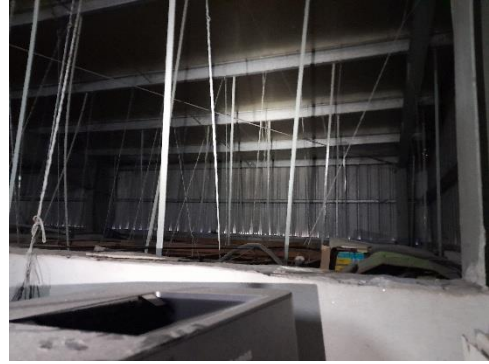
**Observation 08:** Lack of lateral stability system (Steel Building)

**Description:** Lack of load transfer media (compression strut) is missing on the roof of the steel building. Building engineer is required to check the lateral stability of the shed.

Additionally load plan and the geotechnical investigation report were not available for the building. The building engineer is required to carry out a geotechnical investigation for this building.

| Item No | Observation | Action Plan | Timeline |
|---|---|---|---|
| 15. | Lack of lateral stability system. (Steel Building) | The building engineer is required to check the lateral stability of the shed as part of the Engineering Assessment (EA) and submit the EA to RSC. | within 6 weeks |
| 16. | | Prepare load plan considering the structural member capacity and BNBC requirement | within 6 weeks |
| 17. | | Carry out geotechnical investigation | within 6 weeks |
| 18. | | Carry out the required remedial work where required. | within 6 months |

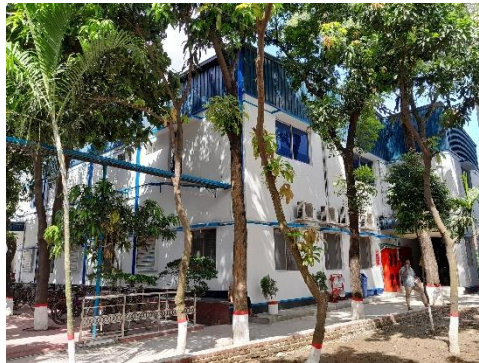
**Observation 09:** Lack of a permit drawing from the local authority. (Steel Building)

**Description:** Building permits were not available for this structure during the inspection. The building engineer is required to obtain a building permit from the local authority.

The Building Engineer is also required to obtain confirmation of the applicable building code (BNBC 2006 or BNBC 2020) from the local authority, as the building was constructed in 20... and the building permit will be obtained after 2021, if no previous permit is available.

| Item No | Observation | Action Plan | Timeline |
|---|---|---|---|
| 19. | Lack of a permit drawing from the local authority. (Steel Building) | Obtain a building permit and confirmation of the applicable building code (BNBC 2006 or BNBC 2020) from the local authority | within 6 months |
