RELIANCE DRESSES LIMITED

Biswa Colony (Block-K), Sea World Road, Akbarsha, Chittagong.
(22.373836, 91.785493)

12 October 2025

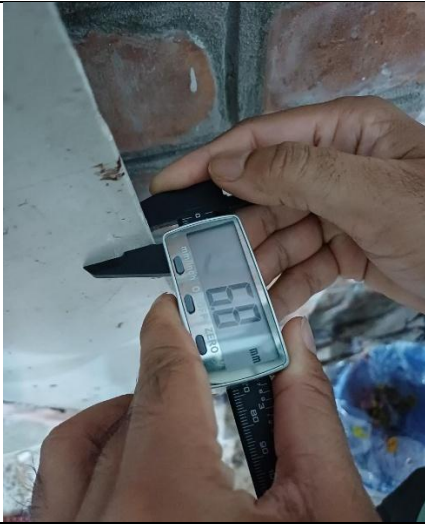
Observation-01: Mismatches in as-built drawings. (Production Shed)

Description: Discrepancies observed in the as-built drawing. Size of exterior column (SC1) was found 6 mm instead of 8 mm. Building engineer is required to survey the structure and prepare accurate and detailed as-built drawings.

Item No	Observation	Action Plan	Timeline
1.	Mismatches in as-built drawings. (Production Shed)	Building engineer is required to survey the structure and prepare accurate and detailed as-built drawings.	within 6 weeks

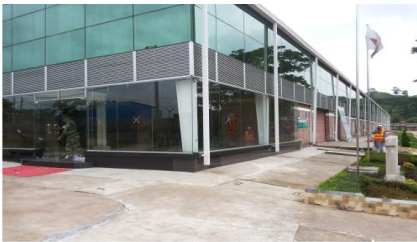
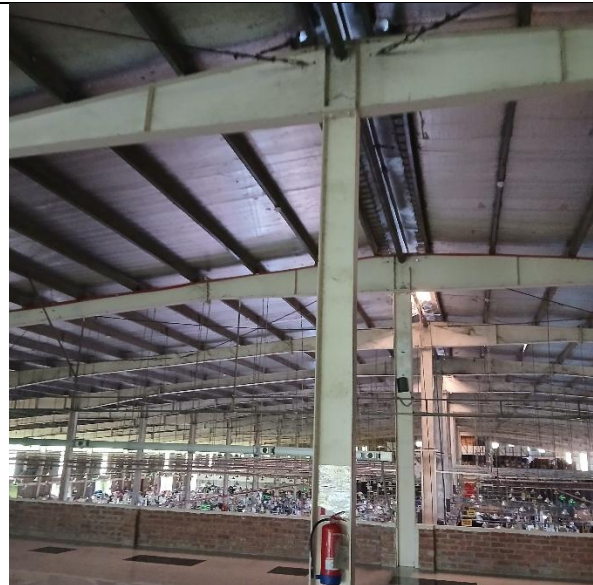
Observation-02: Design report needs to be reviewed for proposed retrofitting scheme and lateral forces. (Production Shed)

Description: A design report has been prepared for the single-storied shed. The prepared design report needs to be reviewed against lateral forces. Submit the design report to the RSC for detailed review.

2.	Design report needs to be reviewed for proposed retrofitting scheme and lateral forces. (Production Shed)	The prepared design report needs to be reviewed against lateral forces. Submit the design report to the RSC for detailed review.	within 6 weeks

3.	Design report needs to be reviewed for proposed retrofitting scheme and lateral forces. (Production Shed)	Produce and actively manage load plan.	within 6 weeks

4.	Design report needs to be reviewed for proposed retrofitting scheme and lateral forces. (Production Shed)	Implement the recommendations of the design report.	within 6 months

5.	Design report needs to be reviewed for proposed retrofitting scheme and lateral forces. (Production Shed)	Implement floor load plan.	within 6 months

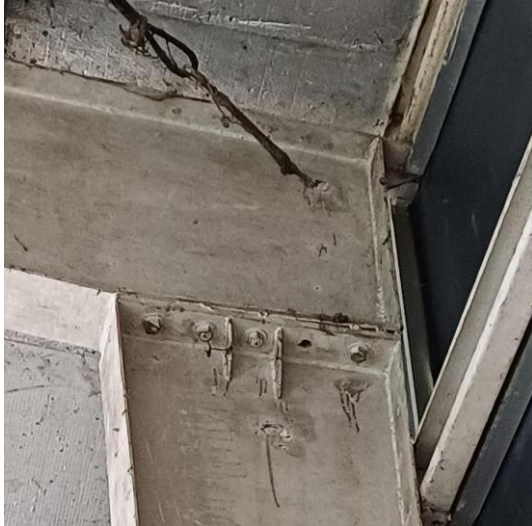
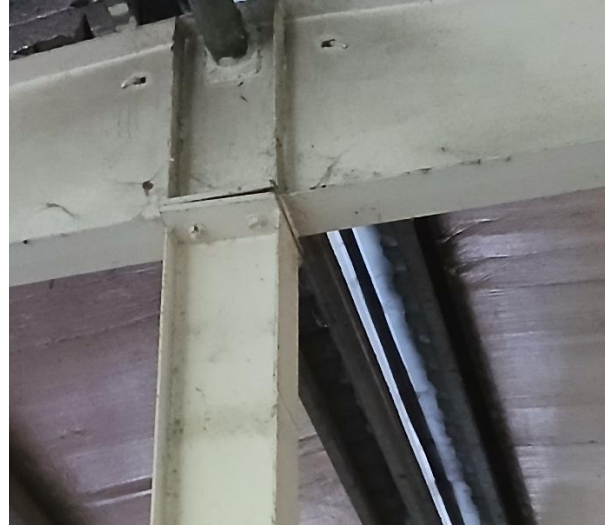
Observation-03: Bolt missing and connection gap. (Production Shed)

Description: Bolt missing and connection gaps were found in several locations. Building engineer is required to repair the connection gap with suitable method. Also install the missing bolts.

6.	Bolt missing and connection gap. (Production Shed)	Building engineer is required to repair the connection gap with a suitable method.	within 6 weeks

7.	Bolt missing and connection gap. (Production Shed)	Install the missing bolts.	within 6 weeks
8.	Loose, missing cable bracing, improper connection (Production Shed)	Building engineer is required to check the design philosophy for the requirements of the bracings and suggest proper connection details.	within 6 weeks

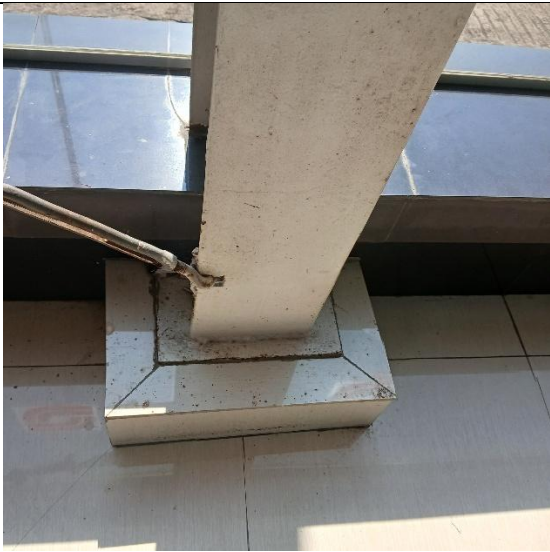
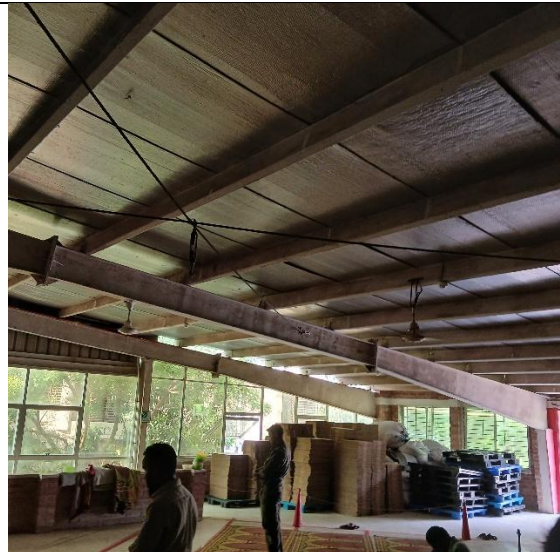
Observation-04: Loose, missing cable bracing, improper connection. (Production Shed)

Description: Missing and loose cable bracings were observed in several locations. Also, improper connections were found in all locations. Building engineer is required to check the design philosophy for the requirements of the bracings and suggest proper connection details.

9.	Loose, missing cable bracing, improper connection (Production Shed)	Implement the suggested remedial works.	within 6 months
10.	Non-structural elements not anchored/braced. (Production Shed)	Building engineer is required to adequately brace or anchor all the non-structural elements to resist lateral or earthquake forces.	within 6 weeks

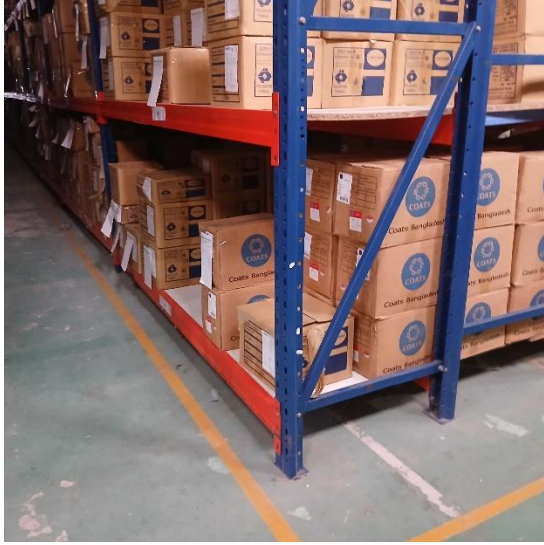
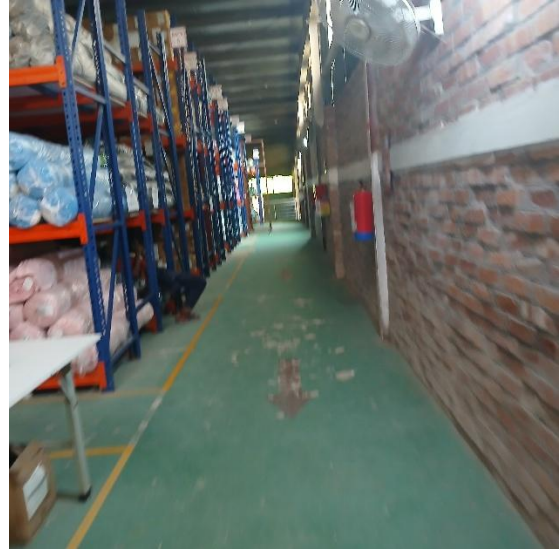
Observation-05: Non-structural elements not anchored/braced. (Production Shed)

Description: During inspection, non-anchored racking system was found on-site. Building engineer is required to adequately brace or anchor all the non-structural elements.

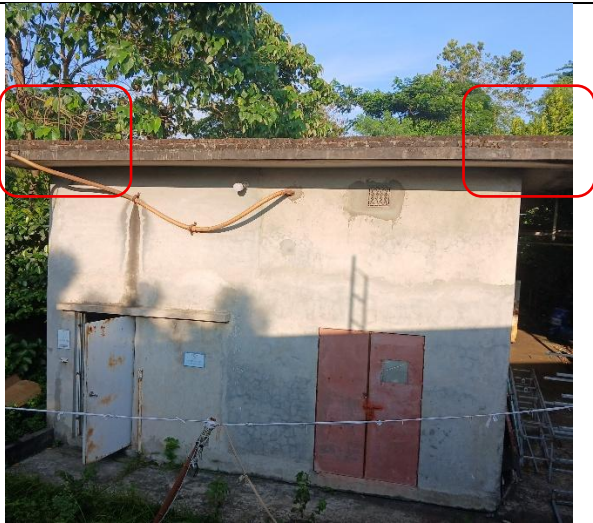
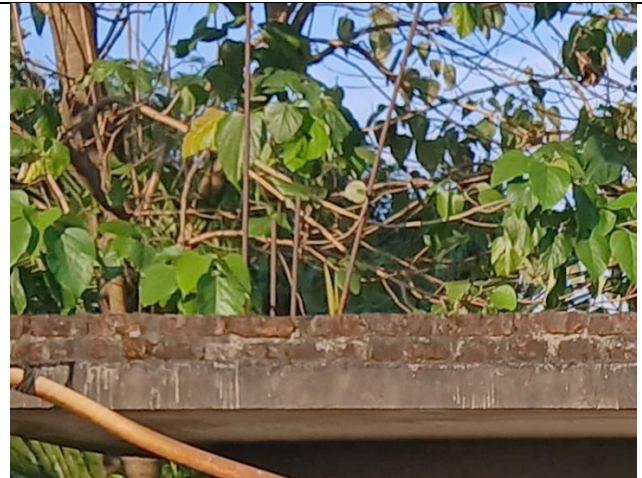
Observation-06: Exposed rebar on roof. (Sub-station Building)

Description: During the inspection, corrosion was found on the exposed rebars. The building engineer is required to apply rust-proof paint on the exposed rebars to protect them from further corrosion.

11.	Exposed rebar on roof. (Sub-station Building)	The building engineer is required to apply rust-proof paint on the exposed rebars to protect them from further corrosion.	within 6 weeks

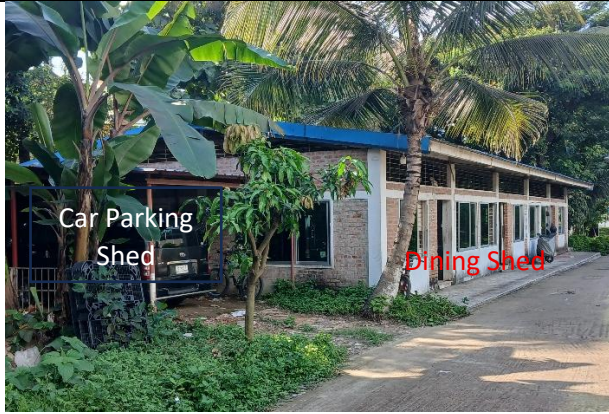
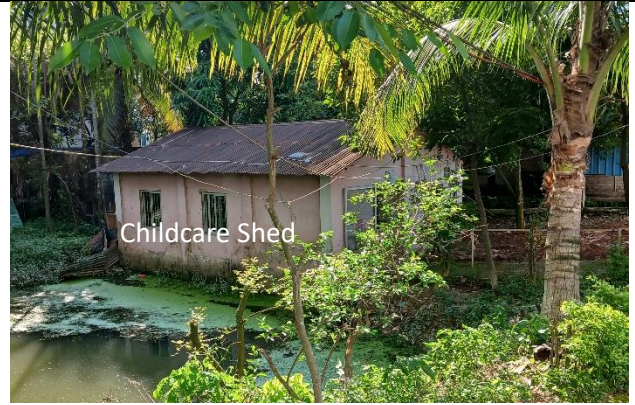
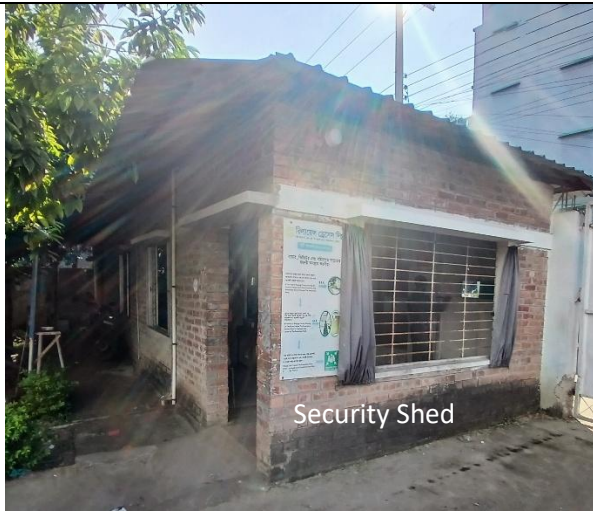
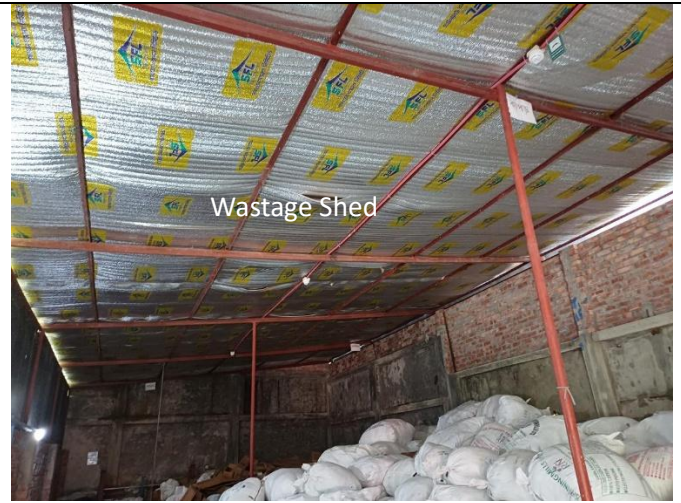
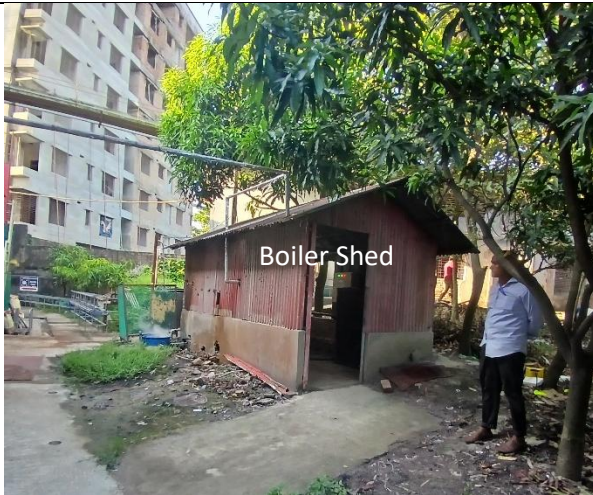
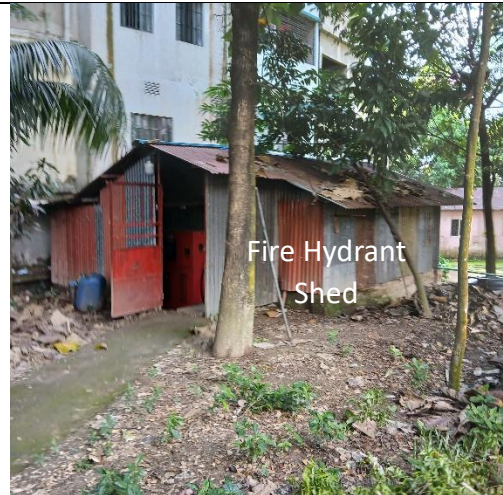
Observation-07: Lack of as-built drawing. (Dining Shed, Child Care Shed, Wastage Shed, Security Shed, Boiler Shed, Fire Hydrant Shed, Car Parking)

Description: As-built drawings were not found for these structures. Building engineer is required to prepare as-built drawings with complete structural & architectural details.

12.	Lack of as-built drawing. (Dining Shed)	Building engineer is required to prepare as-built drawings with complete structural & architectural details.	within 6 weeks

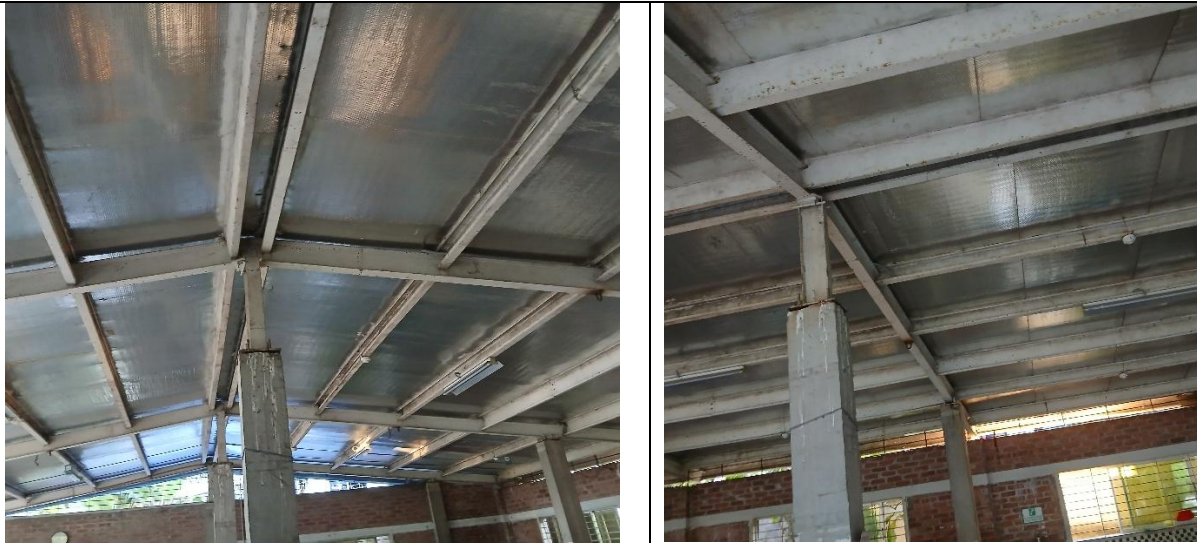
Observation-08: Lack of lateral load resisting system. (Dining Shed)

Description: Lack of lateral load resisting system observed (No Bracing, Compression Strut) in the Dining Shed. Building engineer is required to check the lateral stability system as part of the Engineering Assessment (EA).

13.	Lack of lateral load resisting system. (Dining Shed)	Building engineer is required to check the lateral stability system as part of the Engineering Assessment (EA).	within 6 weeks

14.	Lack of lateral load resisting system. (Dining Shed)	Implement the remediation after receiving EA acceptance.	within 6 months
15.	Lack of as-built drawing. (Child Care Shed)	Building engineer is required to prepare as-built drawings with complete structural & architectural details.	within 6 weeks

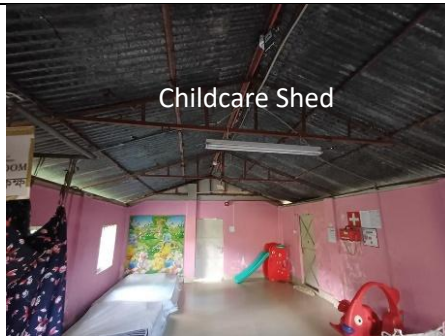
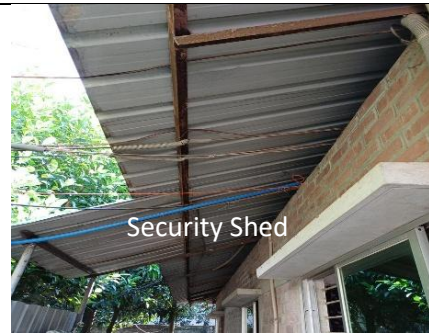
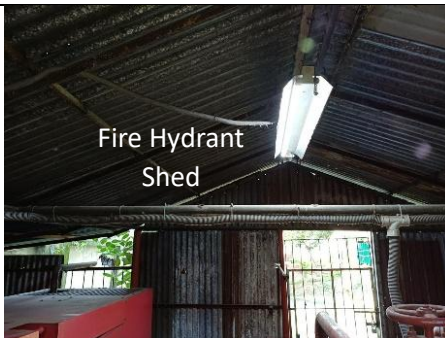
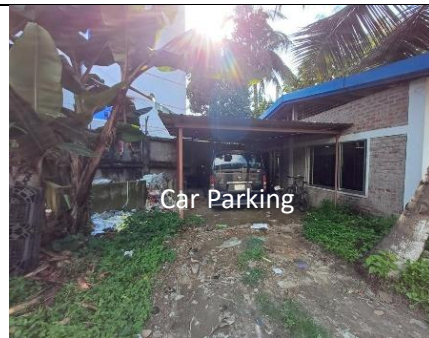
Observation-09: Inadequate connection and lack of stability. (Child Care Shed, Security Shed, Fire Hydrant Shed, Car Parking)

Description: Poor connection details were observed on the sheds. A safety check report according to the Accord Building Standard is required to be prepared to check the inadequacies. Or replace the existing structure with an engineering one where necessary.

16.	Inadequate connection and lack of stability. (Child Care Shed)	A safety check report according to the Accord Building Standard is required to be prepared to check the inadequacies.	within 6 weeks

22.	Inadequate connection and lack of stability. (Security Shed)	A safety check report according to the Accord Building Standard is required to be prepared to check the inadequacies.	within 6 weeks

28.	Inadequate connection and lack of stability. (Fire Hydrant Shed)	A safety check report according to the Accord Building Standard is required to be prepared to check the inadequacies.	within 6 weeks

31.	Inadequate connection and lack of stability. (Car Parking)	A safety check report according to the Accord Building Standard is required to be prepared to check the inadequacies.	within 6 weeks

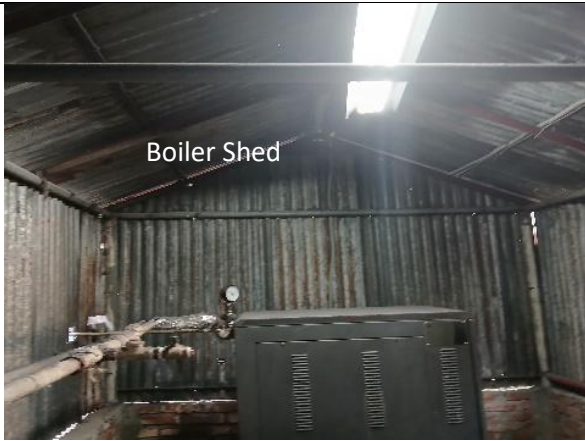
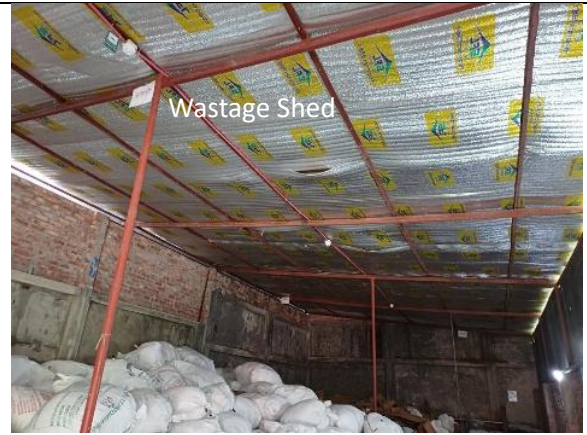
Observation-10: Inadequate member size, connection, and lack of stability. (Wastage Shed, Boiler Shed)

Description: Inadequate member sizes, poor connection details were observed on these sheds. Building engineer is required to check the connection adequacy and lateral stability as a part of EA. Or replace the existing structure with an engineering structure.

19.	Inadequate member size, connection, and lack of stability. (Wastage Shed)	Building engineer is required to check the connection adequacy and lateral stability as a part of the EA.	within 6 weeks

20.	Inadequate member size, connection, and lack of stability. (Wastage Shed)	Implement the recommendations of the safety check report. Or replace the existing structure with an engineering structure.	within 6 months

25.	Inadequate member size, connection, and lack of stability. (Boiler Shed)	Building engineer is required to check the connection adequacy and lateral stability as a part of EA.	within 6 weeks

26.	Inadequate member size, connection, and lack of stability. (Boiler Shed)	Implement the recommendations of the safety check report. Or replace the existing structure with an engineering structure.	within 6 months

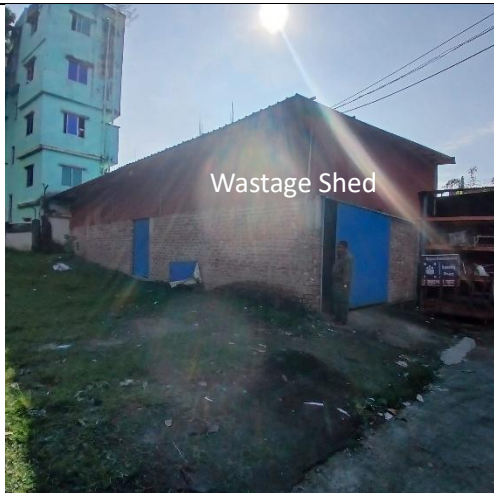
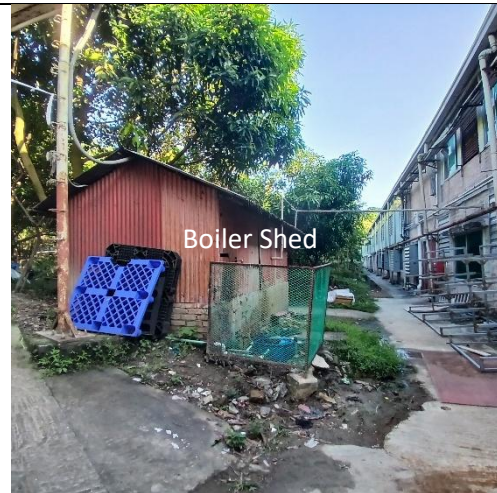
Observation-11: Lack of building permit. (Wastage Shed, Boiler Shed)

Description: The sheds were constructed between 2022 and 2023; however, permit drawings for these structures were not available during the inspection. The building engineer is required to obtain the approved permit drawings from the local authority.

32.	Inadequate connection and lack of stability. (Car Parking)	Implement the recommendations of the safety check report.	within 6 months
33.	Lack of building permit. (Wastage Shed, Boiler Shed)	The building engineer is required to obtain the approved permit drawings from the local authority.	within 6 months
