# Ananta Huaxiang Ltd. (Extension 2)

178 & 179, Adamjee EPZ, Siddirgonj, Narayanganj.

13 October 2025

## Structural Inspection Report

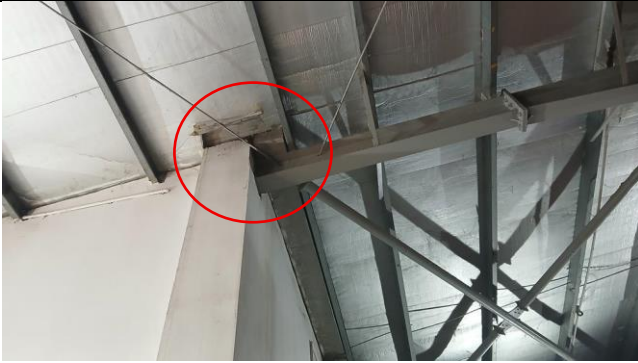
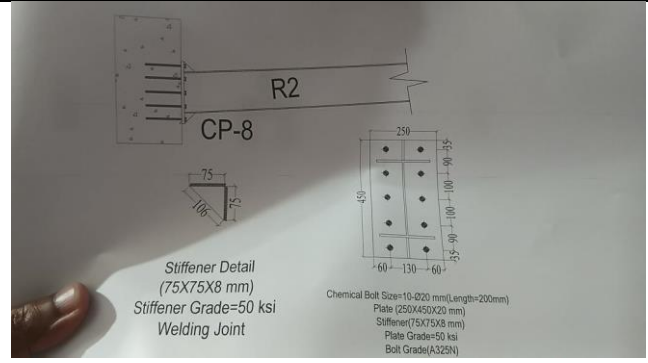
**Observation-02:** improper connection at steel rafter to RC column (Building-D)

**Description:** Improper connection observed between the steel rafter and the RC column. The Building Engineer is required to implement the connection as per the as-built drawings, check the adequacy of the connection, and include the adequacy check in the EA report.

| Item No | Observation | Action Plan | Timeline |
|---|---|---|---|
| 3. | Improper connection at the steel rafter to the RC column (Building-D) | The Building Engineer is required to implement the connection as per the as-built drawings, check the adequacy of the connection and include the adequacy check in the EA report. | within 6 weeks |

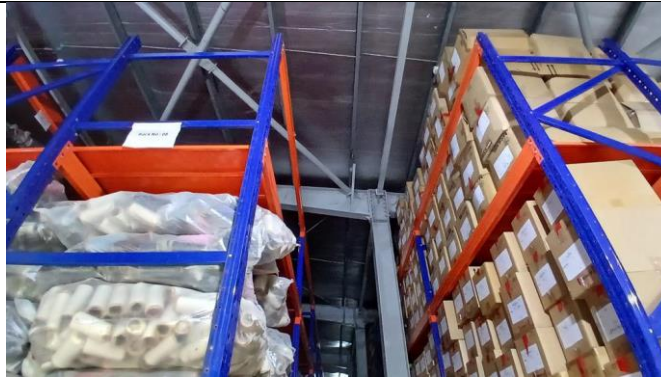
**Observation-03:** Loading on the 2F (Building D).

**Description:** Loading was found around 6 kPa on the 2F. Building engineer is required to prepare an interim load plan and maintain loading below 6 kPa. Also, implement a floor load management system. (Height marking, Signage).

| Item No | Observation | Action Plan | Timeline |
|---|---|---|---|
| 4. | Loading on the 3F (Building D). | Building engineer is required to prepare an interim load plan and maintain loading below 6 kPa. | within 6 weeks |
| 5. | | Implement a floor load management system. (Height marking, Signage). | within 6 weeks |

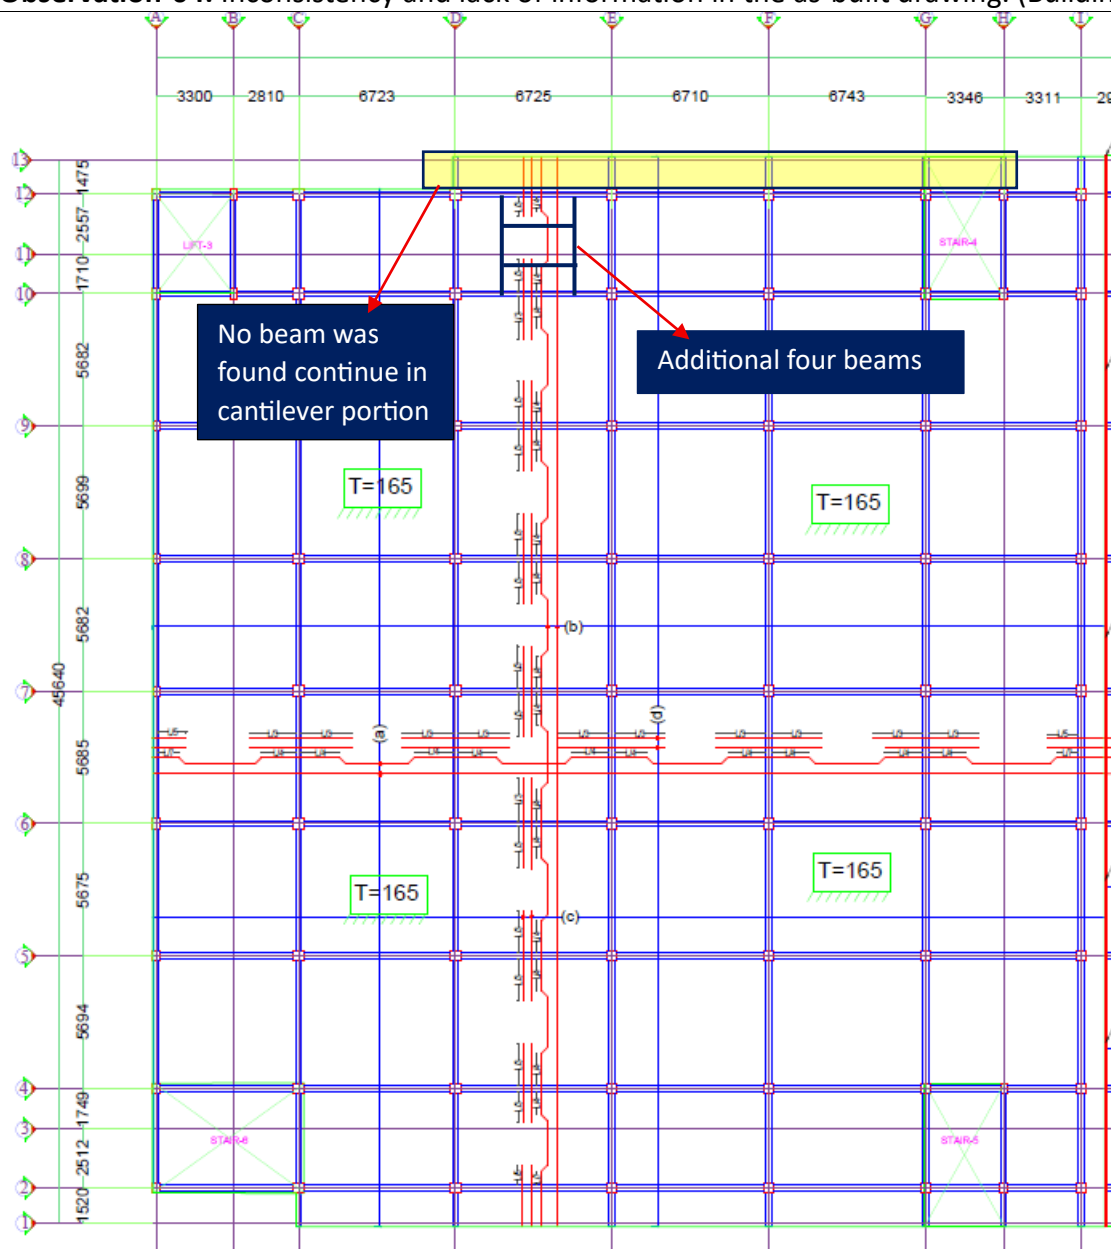
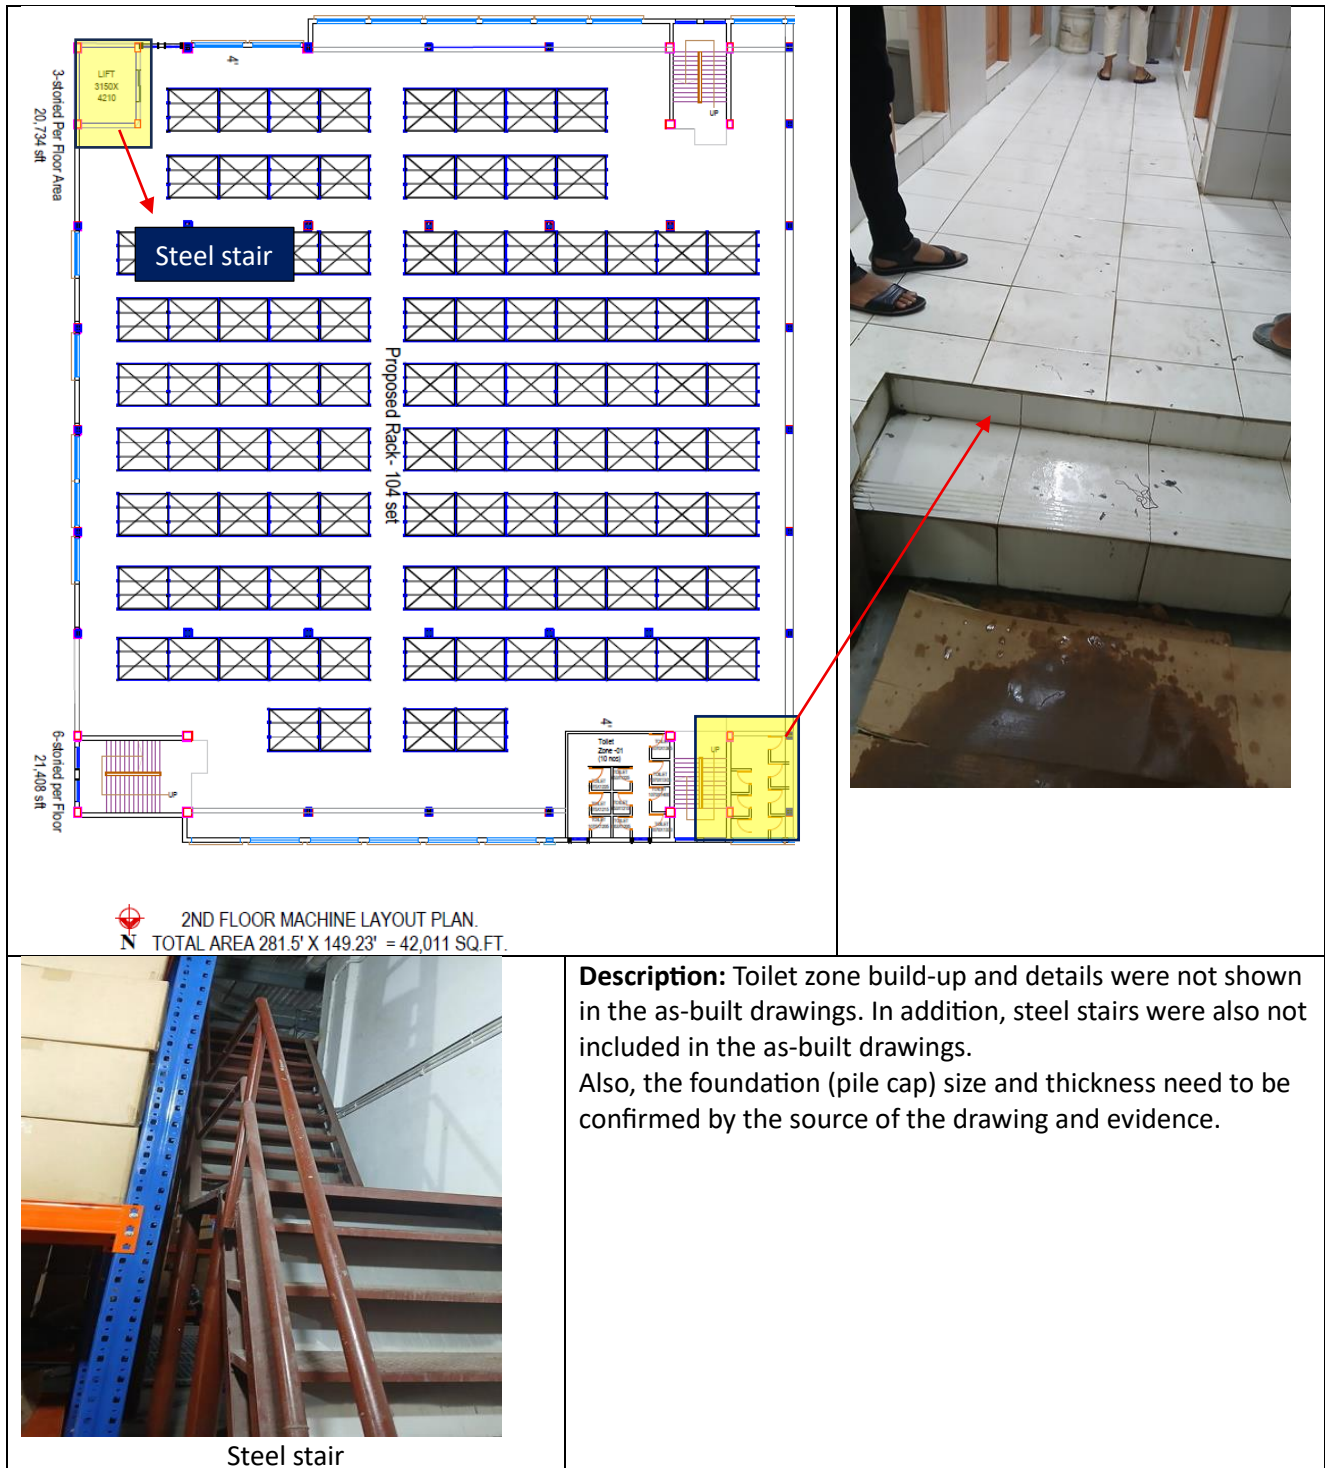
**Observation-04:** Inconsistency and lack of information in the as-built drawing. (Building-D)

**Description:** During the inspection, no beam was found in the cantilever portion, and four additional beams were found at the GF roof.

| Item No | Observation | Action Plan | Timeline |
|---|---|---|---|
| 6. | Inconsistency and lack of information in the as-built drawing. (Building-D) | The Building Engineer is required to confirm the source of the drawings to ensure the accuracy of foundation size and thickness, survey the structures, and prepare comprehensive as-built drawings. | within 6 weeks |

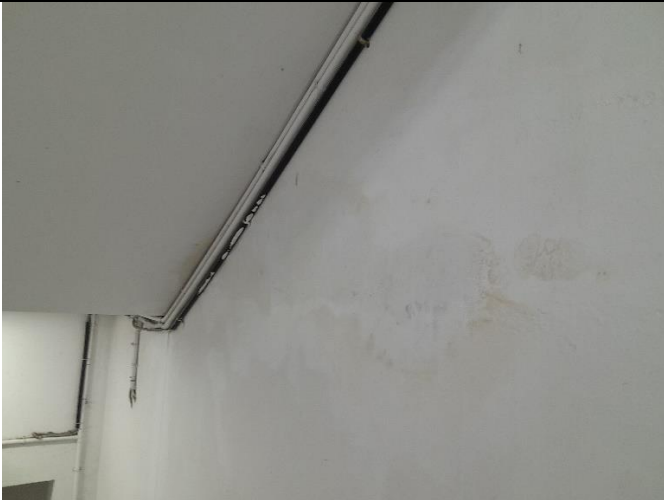
| <b>Observation-05: Dampness on a brick wall (Building D)</b> | |

| <b>Observation-05: Dampness on a brick wall (Building D)</b> | |
|---|---|
| | <p><b>Description:</b> During the inspection, Dampness was found on the brick wall.</p> <p>The building engineer is required to repair the dampness with a suitable method.</p> |

| Item No | Observation | Action Plan | Timeline |
|---|---|---|---|
| 7. | Dampness on a brick wall (Building D) | The building engineer is required to repair the dampness with a suitable method. | within 6 weeks |

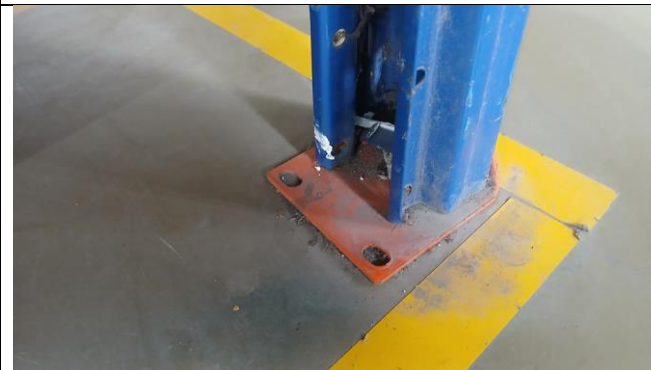
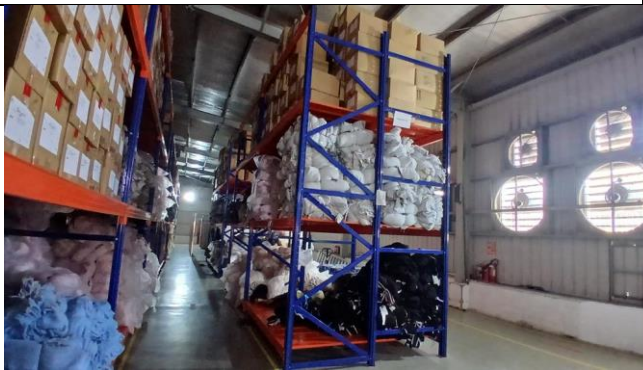
| <b>Observation-06: Storage racks found unbraced/not anchored. (Building D)</b> | |

| <b>Observation-06: Storage racks found unbraced/not anchored. (Building D)</b> | |
|---|---|
| <p><b>Description:</b> Storage racks were found unbraced/unanchored. The building engineer is required to brace/anchor all non-structural elements.</p> | |

| Item No | Observation | Action Plan | Timeline |
|---|---|---|---|
| 8. | Storage racks found unbraced/not anchored. (Building D) | Storage racks were found unbraced/unanchored. The building engineer is required to brace/anchor all non-structural elements. | within 6 months |

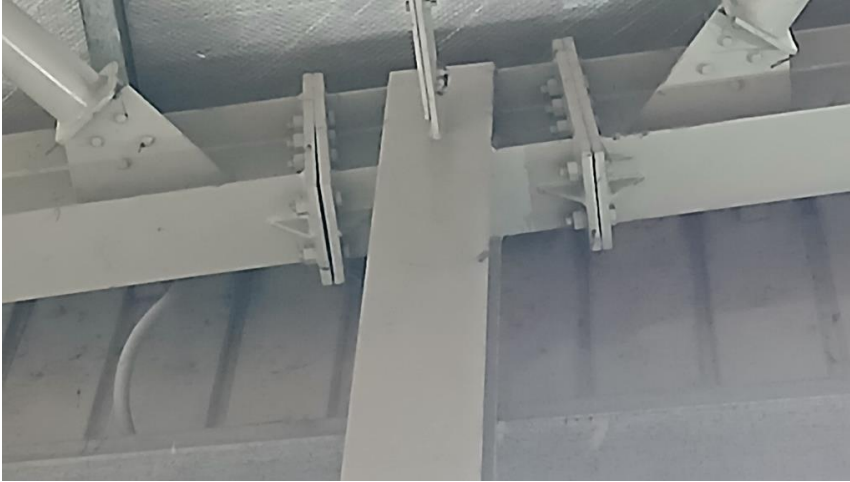
**Observation-08:** Connection gap between steel plates. (Building D)

**Description:** Connection gaps were found in the roof shed areas. The building engineer is required to repair the gaps with a suitable method and ensure adequate strengthening where necessary.

| Item No | Observation | Action Plan | Timeline |
|---|---|---|---|
| 10. | Connection gap between steel plates. (Building D) | The building engineer is required to repair the gaps with a suitable method and ensure adequate strengthening where necessary. | within 6 weeks |

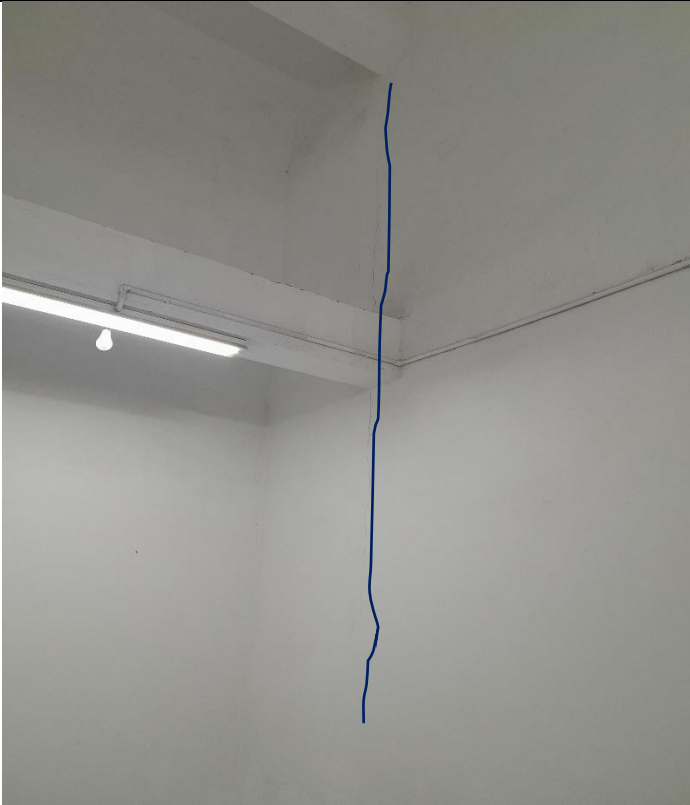
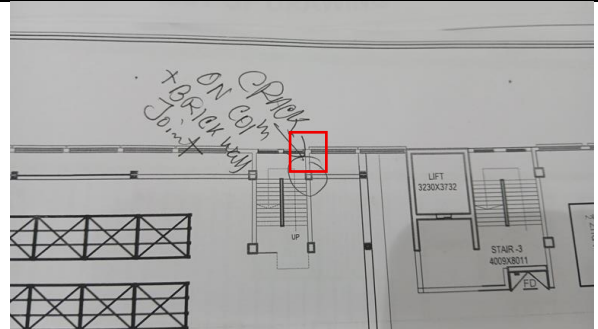
**Observation-09:** Crack on column and brick wall joint. (Building D)

**Description:** Cracks were observed on the column and the brick wall joint. The building engineer is required to investigate the reason for the crack and repair it with a suitable method.

| Item No | Observation | Action Plan | Timeline |
|---|---|---|---|
| 11. | Crack on the column and the brick wall joint. (Building D) | The building engineer is required to investigate the reason for the crack and repair it with a suitable method. | within 6 weeks |

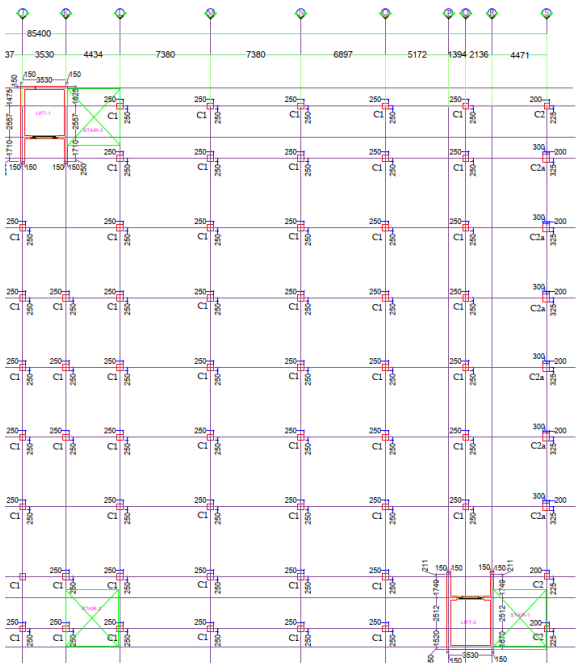
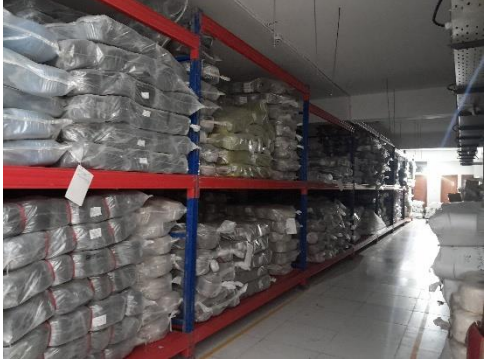
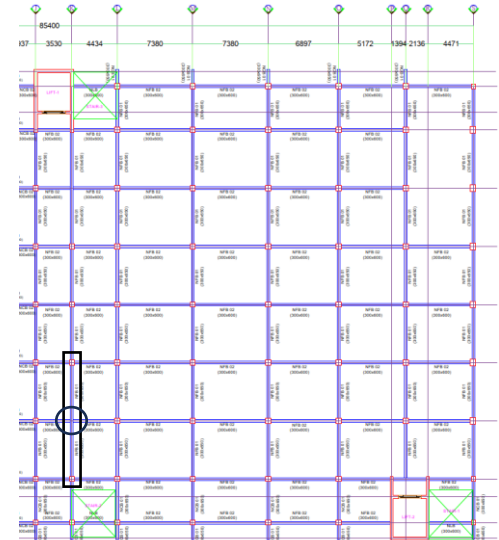
## Observation 10: Column stressed above the normal design limit. (Building E)

| <p><b>Description:</b> cursory calculations indicate that columns are stressed above the normal design limit, considering the observed live loads of 4 kPa for the typical production area &amp; 6 kPa for the store area, with a minimum concrete strength based on the aggregate type.</p> <p>Building engineer is required to review the design, load, and column stress.</p> <p>Also, a beam was found 11.2 m due to the omission of a column. Building engineer is required to review the design of the beam.</p> | |

| <b>12.</b> | Column stressed above the normal design limit. (Building E) | Building engineer is required to review the design, load and column stress. | within 6 weeks |
| <b>13.</b> | | Verify in situ concrete strength by taking 4 no. concrete cores from the lower-tier columns. As the existing cylinder test reports do not meet the BNBC 5.12.1 requirements. | Immediate |
| <b>14.</b> | | Building engineer is required to review the design of the beam. | within 6 weeks |

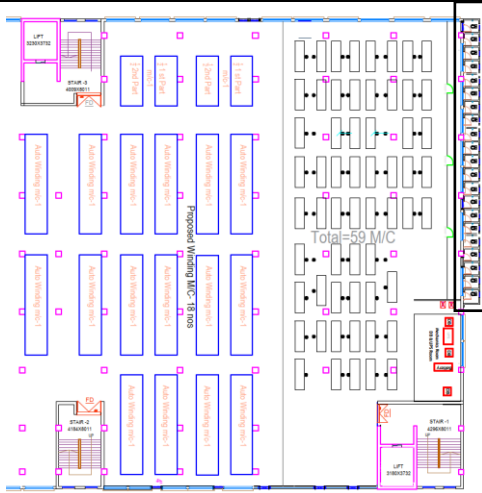
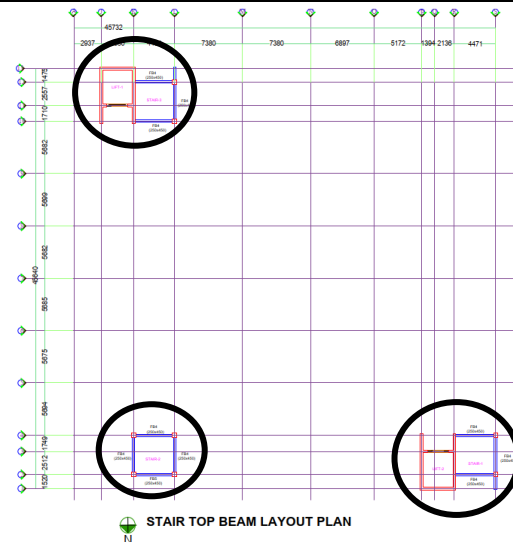
**Observation 11: Inconsistency in the as-built drawing. (Building E)**

**Description:** Inconsistency observed in the beam layout, lack of information in the as-built drawing (False slab, cantilever details), and details of the shear walls are missing.

| <b>17.</b> | Inconsistency in the as-built drawing. (Building E) | The building engineer is required to survey the full structure and prepare accurate as-built drawings based on the actual construction. | within 6 weeks |

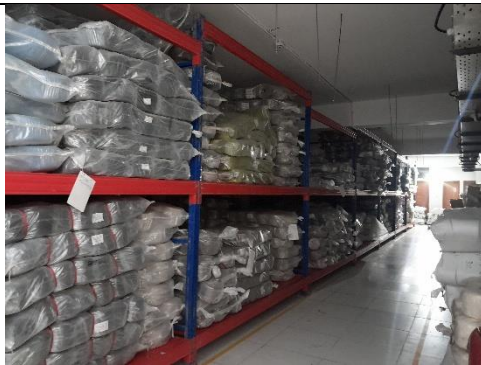
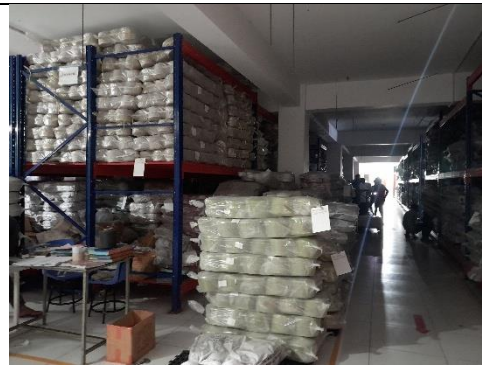
**Observation-12: Loading on the 4F. (Building E)**

**Description:** Loading was found slightly above 6 kPa on the 4F. Building engineer is required to prepare an interim load plan and maintain loading below 4 kPa. Also, implement a floor load management system. (Height marking, Signage).

| <b>18.</b> | Loading on the 4F. (Building E) | Building engineer is required to prepare an interim load plan and maintain loading below 4 kPa on the 4F. | within 6 weeks |
| <b>19.</b> | | Implement a floor load management system. (Height marking, Signage). | within 6 weeks |

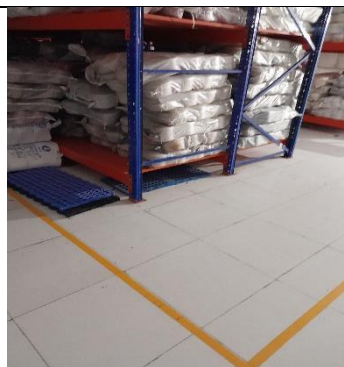
**Observation-13: Anchorage of non-structural elements. (Building E)**

**Description:** Anchorage not found on the storage racks. Building engineer is required to provide anchorage to the non-structural elements.

| <b>20.</b> | Anchorage of non-structural elements. (Building E) | The building engineer is required to anchor or brace all non-structural elements. | within 6 weeks |

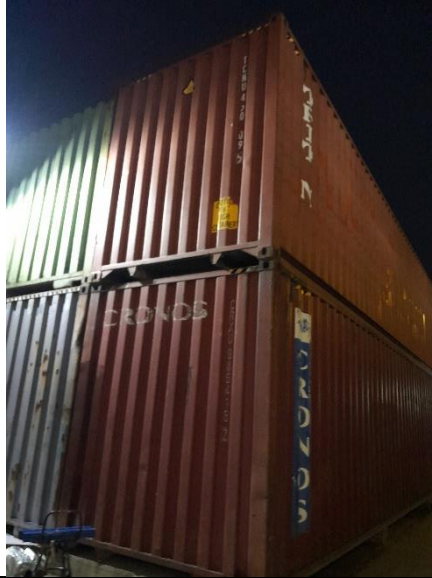
**Observation-14:** Lack of anchorage between the containers and the lack of base anchorage.  
(Containers)

**Description:** Containers are not interconnected, also anchorage is not provided in the base; these containers are prone to seismic hazards. building engineer is required to review the seismic hazard requirements in the containers and implement remediations.

| <b>22.</b> | Lack of anchorage between the containers and the lack of base anchorage. (Container) | Building engineer is required to review the seismic hazard requirements in the containers and implement remediations. | within 6 weeks |
| <b>23.</b> | | Carry out the suggested remedial works if required or remove the top containers. | within 6 months |

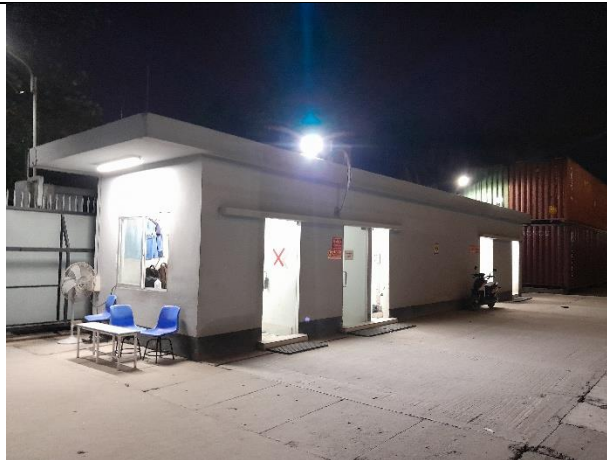
**Observation-15:** Lack of design report. (Security and Fire Pump-D)

**Description:** Design report was not prepared for the Security and Fire Pump Room. Building engineer is required to prepare the design report as per BNBC 1.9.1.

| <b>24.</b> | Lack of design report. (Security and Fire Pump-D) | Building engineer is required to prepare the design report as per BNBC 1.9.1. | within 6 weeks |
