# PRIME CAP (BD) LTD

21 October 2025

## Structural Inspection Report

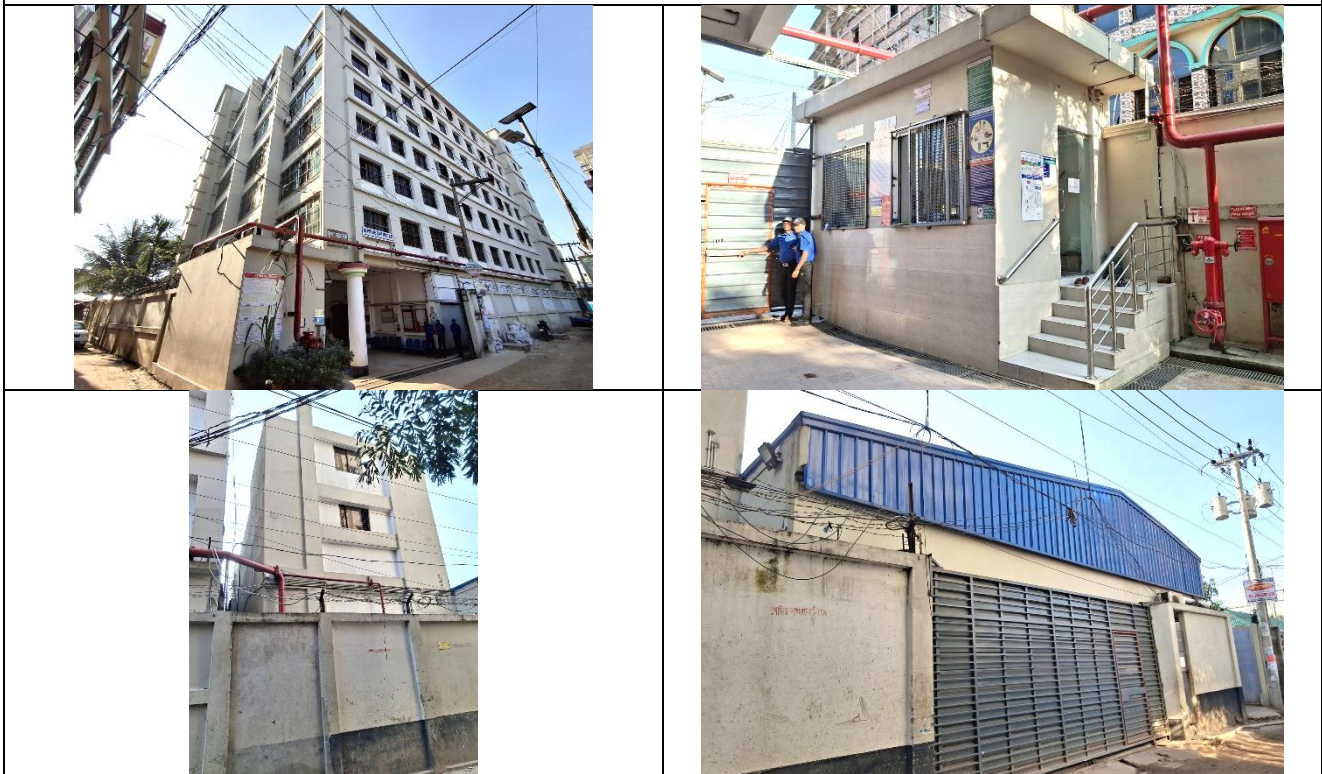
### Observation-01: Revision of design documents for lateral loads (Building-1, 2, 3, & 4)

**Description:** A set of design documents was available. The building engineer is required to update the design documents and submit to RSC for detailed review against lateral forces.

| Item No | Observation | Action Plan | Timeline |
|---|---|---|---|
| 1. | Revision of design documents for lateral loads (Building-1) | The prepared design report needs to be reviewed against lateral forces. Submit the design report to the RSC for detailed review. | within 6 weeks |
| 8. | Revision of design documents for lateral loads (Building-2) | The prepared design report needs to be reviewed against lateral forces. Submit the design report to the RSC for detailed review. | within 6 weeks |
| 10. | Revision of design documents for lateral loads (Building-3) | The prepared design report needs to be reviewed against lateral forces. Submit the design report to the RSC for detailed review. | within 6 weeks |

| 14. | Revision of design documents for lateral loads (Building-4) | The prepared design report needs to be reviewed against lateral forces. Submit the design report to the RSC for detailed review. | within 6 weeks |

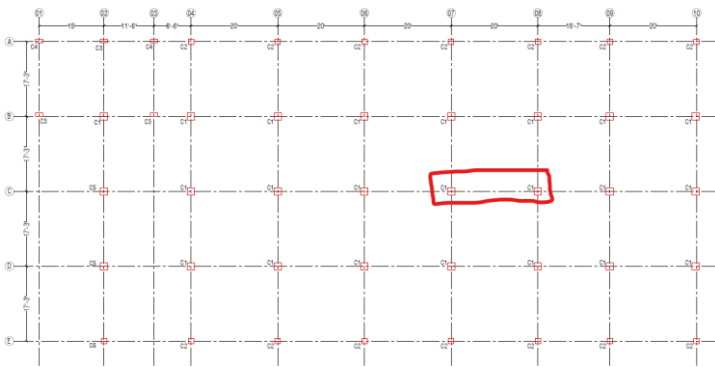
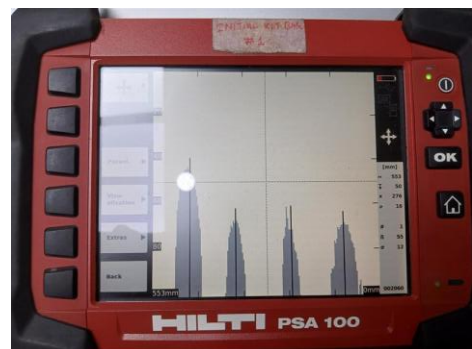
### Observation-02: Mismatch of as-built drawing for Building-1 (Main Building)

**Description:** 4 rebar was found by scanning instead of 5 rebar in C1 column at grid C-7 & C-8. Also, toilet zone rise was found more than 200 mm instead of 160 mm on the 1st floor.

| Item No | Observation | Action Plan | Timeline |
|---|---|---|---|
| 4. | Mismatch/lack of as-built drawing (Building-1) | The building engineer is required to survey the structure and prepare accurate as-built drawings reflecting on on-site condition. | within 6 weeks |

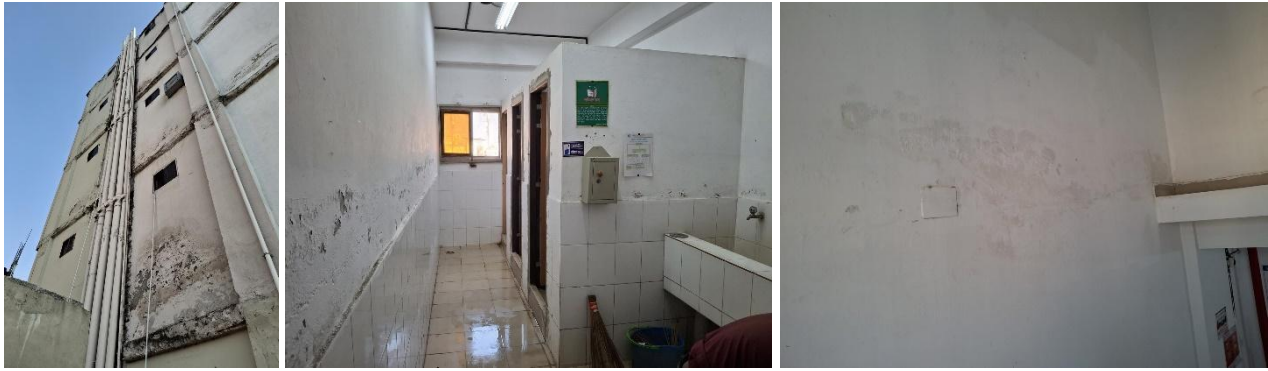
**Observation 03: Dampness on brick wall (Building-1)**

**Description:** Dampness was found on exterior wall, plumbing pipe area, toilet zone and stair walls. Seal the source of water and repair the damp area with suitable method.

| Item No | Observation | Action Plan | Timeline |
|---|---|---|---|
| 5. | Dampness on the brick wall (Building-1) | The building engineer is required to seal the source of water and repair the damp area with suitable method. | within 6 months |

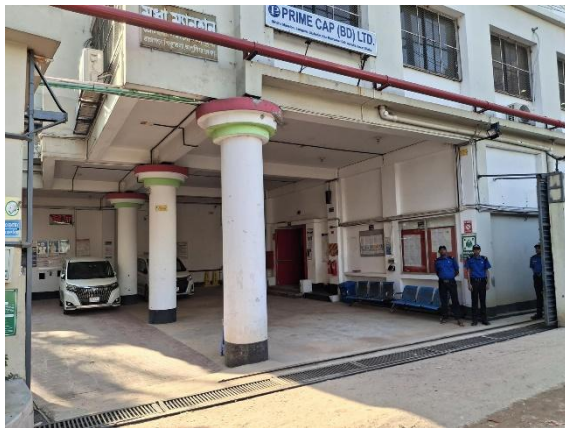
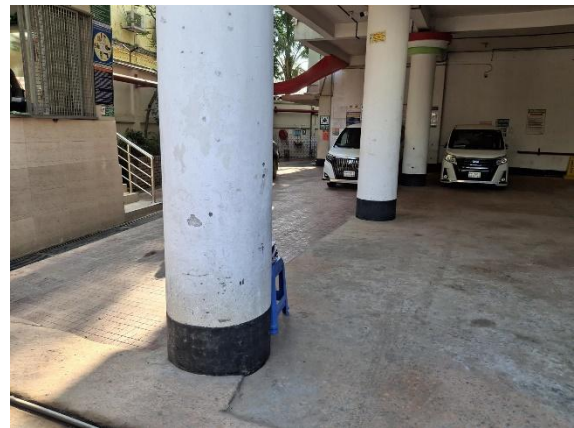
**Observation 04: Potential vehicle impact on column (Building-1)**

**Description:** Ground floor column was susceptible for vehicle impact. The building engineer is required to provide separate barriers around the columns to avoid impact on columns.

| Item No | Observation | Action Plan | Timeline |
|---|---|---|---|
| 6. | Potential vehicle impact on column (Building-1). | The building engineer is required to provide separate barriers around the columns to avoid impact on the columns. | within 6 months |

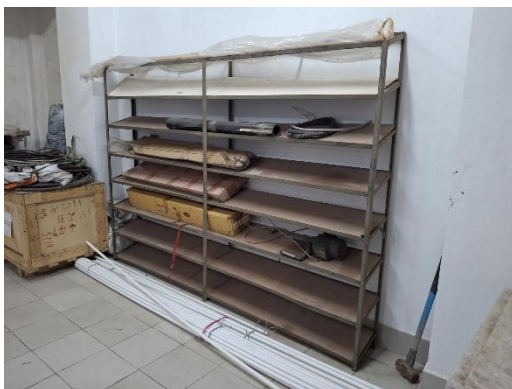
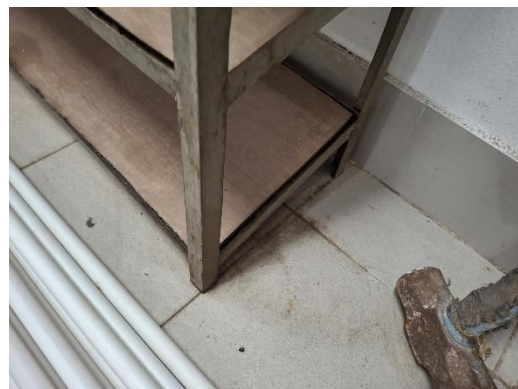
**Observation 05: Lack of anchorage for storage racks (Building-3)**

**Description:** Lack of anchorage observed for storage racks. The building engineer is required to provide adequate anchorage or brace to the non-structural elements within the building.

| 13. | Lack of anchorage for storage racks (Building-3). | The building engineer is required to provide adequate anchorage or bracing to the non-structural elements within the building. | within 6 months |

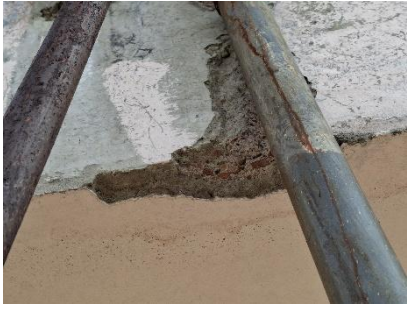
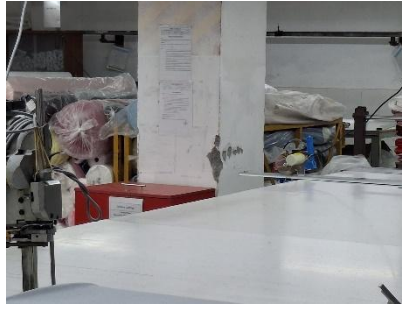
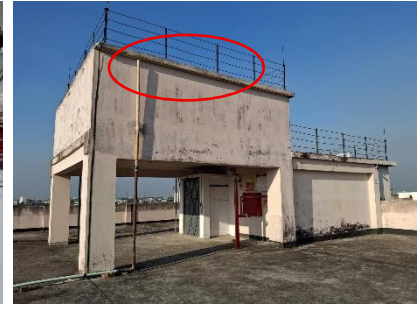
**Observation 06: Damaged concrete surface and plaster (Building-1)**

**Description:** Damaged concrete surface and plaster was observed in several locations of the building. The building engineer is required to repair the damage and provide the necessary column guard where required.

| Item No | Observation | Action Plan | Timeline |
|---|---|---|---|
| 7. | Damaged concrete surface and plaster (Building-1) | The building engineer is required to repair the damage and provide the necessary column guard where required. | within 6 weeks |

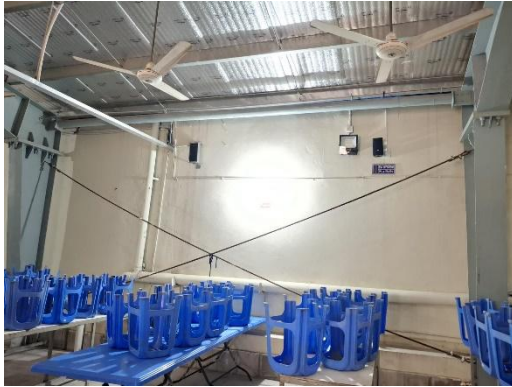
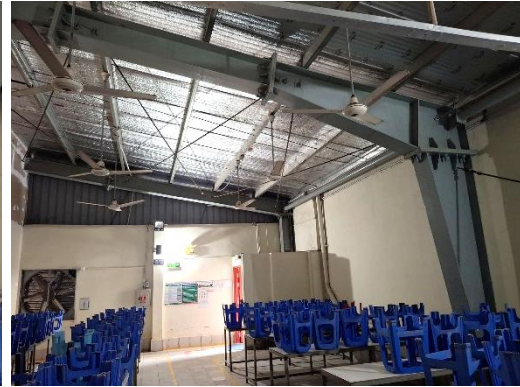
**Observation 07: Loose bracing (Building-4)**

**Description:** Loose cable bracing observed. The building engineer is required to tighten the loose bracings in the proper way.

| 17. | Loose bracing (Building-4) | The building engineer is required to tighten the loose bracings properly. | within 6 months |
