# Adury Fashion & Print Ltd

28 October 2025

Building-13 (AFPL)- six storied building.

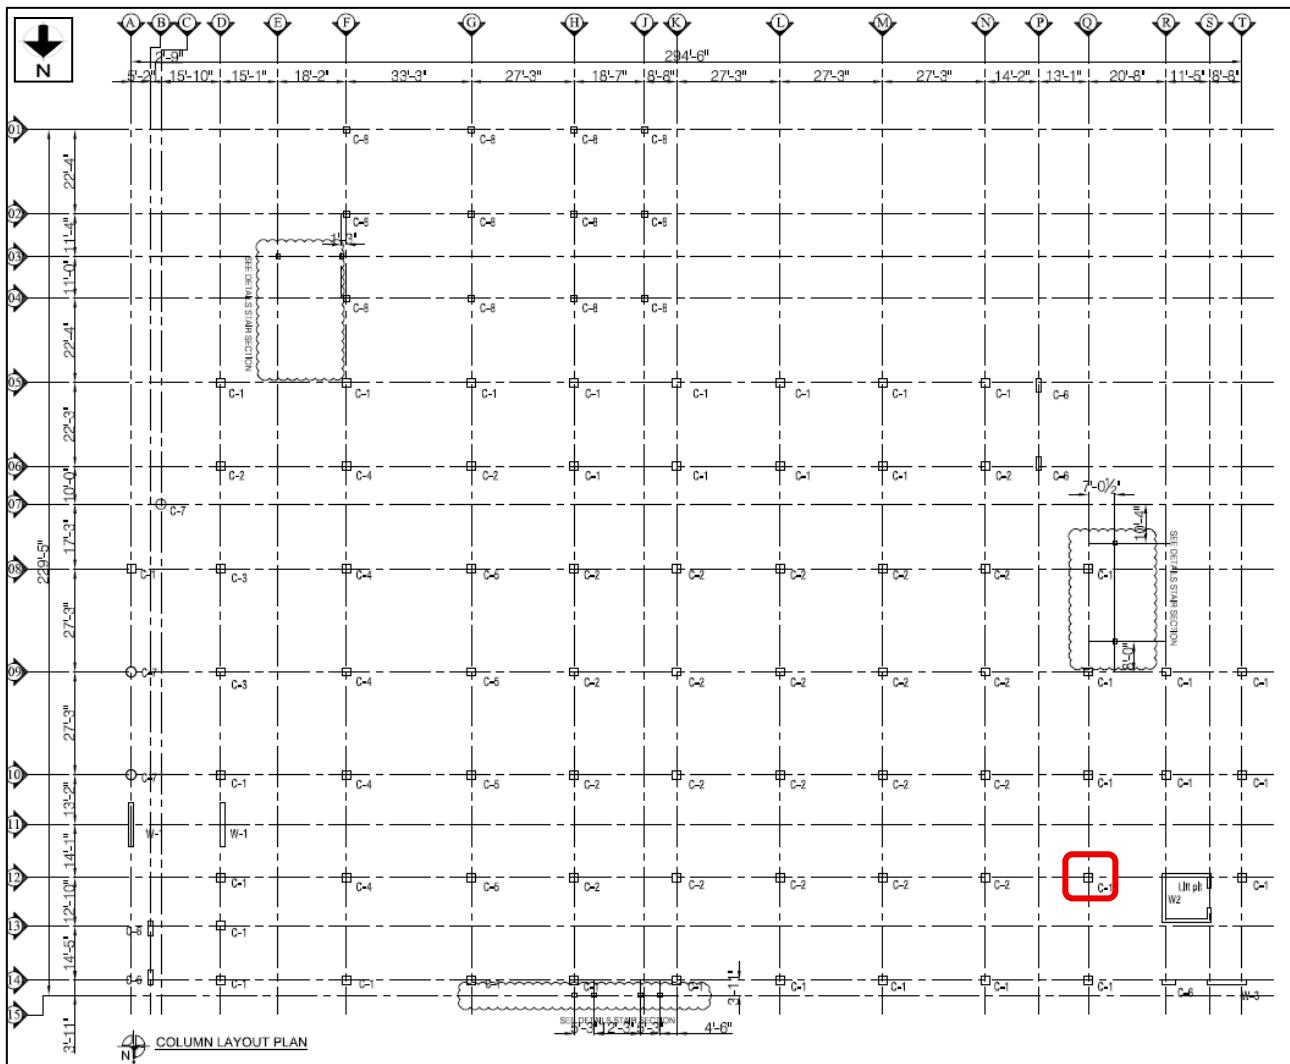
### Observation 01: Stress in column exceeds normal design limit. Building-13 (AFPL)

**Description:** Cursors calculation indicates stress in column exceeds normal design limit at marked location considering prepared floor live load and minimum concrete strength.

The building engineer is required to check the design, loads, and column stress in the structural member based on in-situ material strength and revise the prepared Detail Engineering Assessment (DEA) report accordingly.

| Item No. | Observation | Action Plan | Timeline |
|---|---|---|---|
| 3. | | The building engineer is required to check the design, loads, and column stress in the structural member based on in-situ material strength and BNBC prescribed floor load plan and revise the prepared DEA documents accordingly. Submit the revised DEA to RSC for review. | within 6 weeks |

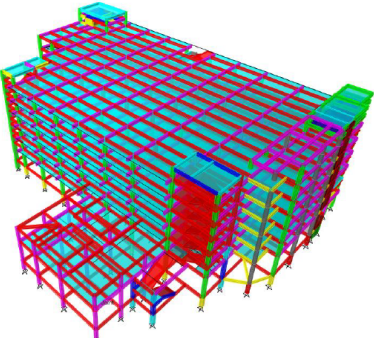
## Observation 02: Inconsistency in the prepared DEA report. Building-13 (AFPL)

**Description:** During inspection, a set of Detailed Engineering Assessment (DEA) report found onsite where several inconsistencies were observed. 27.58 MPa (4000 psi) concrete strength considered in the design having inadequate material test reports (only 12 sets of concrete cylinder test reports were available for the building which doesn't satisfy the frequency of testing requirements) as per BNBC. Also, 500 MPa (72.5 ksi) rebar strength considered in the design where two sets of test report show lower values (25mm dia-465 MPa & 32mm dia-470 MPa). Overall, 3 kPa (63 psf) floor live considered in the design where dedicated storage observed on different floors. Fully restraint column considered in the design where typical foundations are isolated shallow footing. Also, irregularity checks are not included in the design. The building engineer is required to revise the DEA documents based on actual material strength, BNBC prescribed loading, and submit them to RSC for detail review.

| Item No. | Observation | Action Plan | Timeline |
|---|---|---|---|
| 1. | * Stress in column exceeds normal design limit.<br>*Inconsistency in the prepared Detail Engineering Assessment (DEA) report<br>*Inadequate material test report.<br>*Floor load plan doesn't satisfy BNBC requirements.<br>Building-13 (AFPL) | Verify in-situ concrete strength by taking minimum 4 cores from each structural element (column, beam/slab) to confirm design strength. | within 6 weeks |
| 2. | | Update the floor load plan as per actual occupancy and BNBC minimum floor live load requirements. | within 6 weeks |

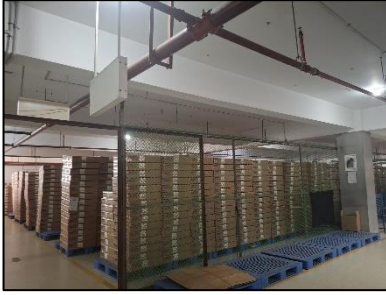
Storage on 4th floor

**Observation 03:** Undocumented storage and lack of floor load management. Building-13 (AFPL)

**Description:** At the time of inspection, floor load plan was not found posted suspended ground floor level. Also, storage area & height marking was not observed in several storage locations. The building engineer is required to post the floor load plan on all floor levels, provide storage area & height marking, and maintain floor loading accordingly.

| Item No. | Observation | Action Plan | Timeline |
|---|---|---|---|
| 5. | Undocumented storage and lack of floor load management. Building-13 (AFPL) | Post floor load plan on all floor levels, provide storage area & height marking, and maintain floor loading accordingly. | within 6 weeks |

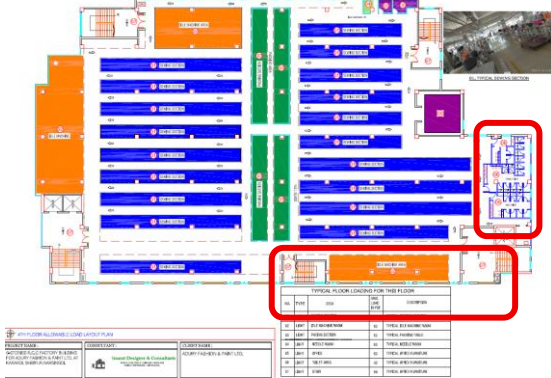
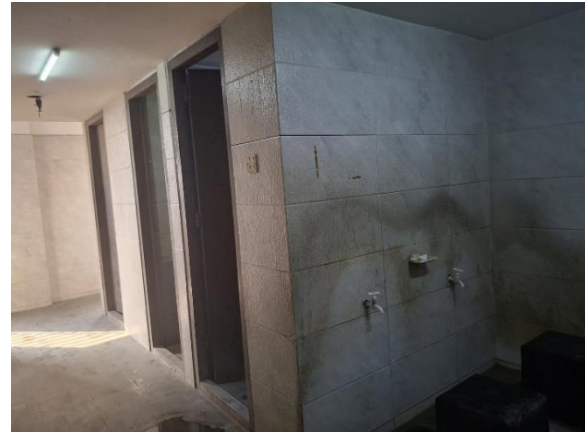
**Observation 04:** Discrepancies in as-built drawing. Building-13 (AFPL)

**Description:** Some discrepancies were observed between floor layout and as-built drawings- dedicated storage was observed in several locations instead of production occupancy. Toilet zone false ceiling was not mentioned in the drawings. The building engineer is required to survey the structure and prepare accurate as-built drawings.

| Item No. | Observation | Action Plan | Timeline |
|---|---|---|---|
| 6. | Discrepancies in as-built drawing. Building-13 (AFPL) | The building engineer is required to survey the structure and prepare accurate as-built drawings. | within 6 weeks |

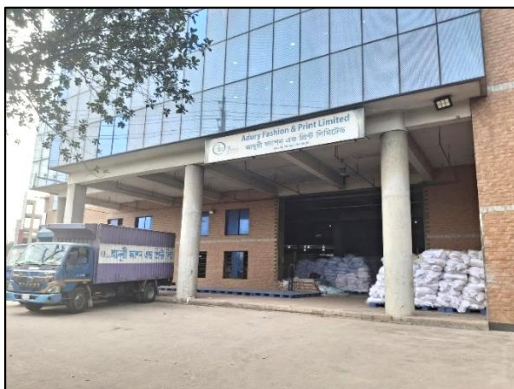
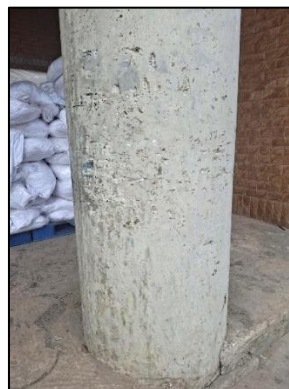
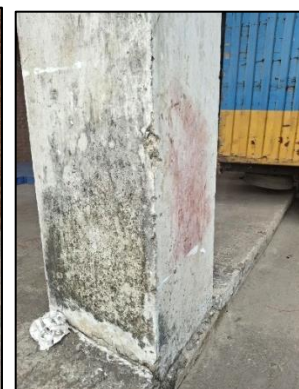
**Observation 05:** Vehicle impact on ground floor column. Building-13 (AFPL)

**Description:** There was no protection system for the ground floor columns which are susceptible to vehicle impact. During inspection, damage due to vehicle impact on columns was observed. The building engineer is required to provide separate barriers around columns to avoid vehicle impact.

| Item No. | Observation | Action Plan | Timeline |
|---|---|---|---|
| 7. | Vehicle impact on ground floor column. Building-13 (AFPL) | Provide separate barriers around ground floor columns to avoid vehicle impact. | within 6 weeks |

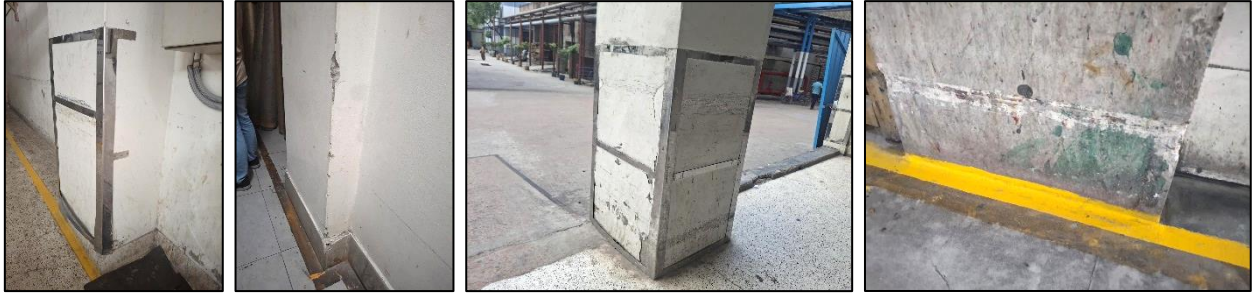
**Observation 06:** Trolley impact on columns/walls in several locations. Building-13 (AFPL)

**Description:** Column guards have been provided to prevent trolley impact on columns. However, several guards were found loose due to repeated impacts, resulting in additional damage to column and wall surfaces at various floor levels. The factory is required to repair all damaged areas and install adequate and robust column/wall guards where required.

| Item No. | Observation | Action Plan | Timeline |
|---|---|---|---|
| 8. | Trolley impact on columns/walls in several locations. Building-13 (AFPL) | Repair the damage and install adequate and robust column/wall guards where required. | within 6 weeks |

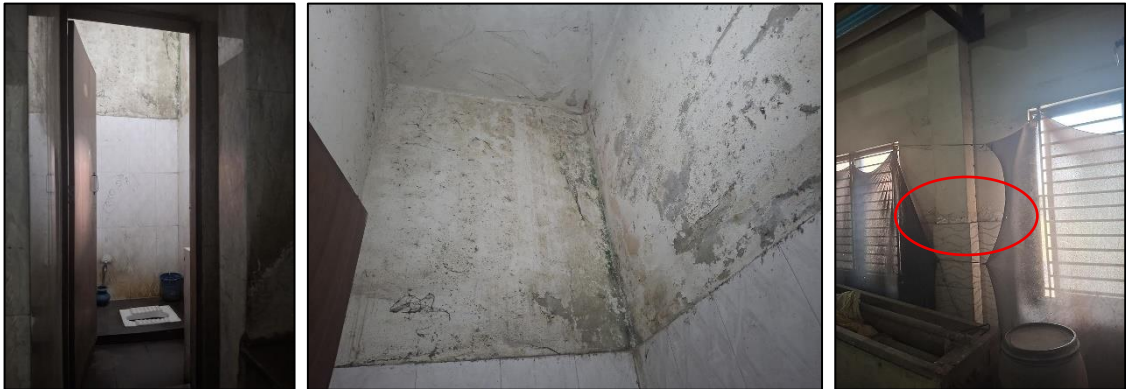
**Observation 07:** Dampness on brick walls. Building-13 (AFPL)

**Description:** Dampness on brick walls was observed in several locations, especially in toilet and washing zones. The building engineer is required to identify all the locations, seal the source of water and repair the dampness with suitable methods.

| Item No. | Observation | Action Plan | Timeline |
|---|---|---|---|
| 9. | Dampness on brick walls. Building-13 (AFPL) | The building engineer is required to identify all locations, seal the source of water and repair the dampness with suitable methods. | within 6 weeks |

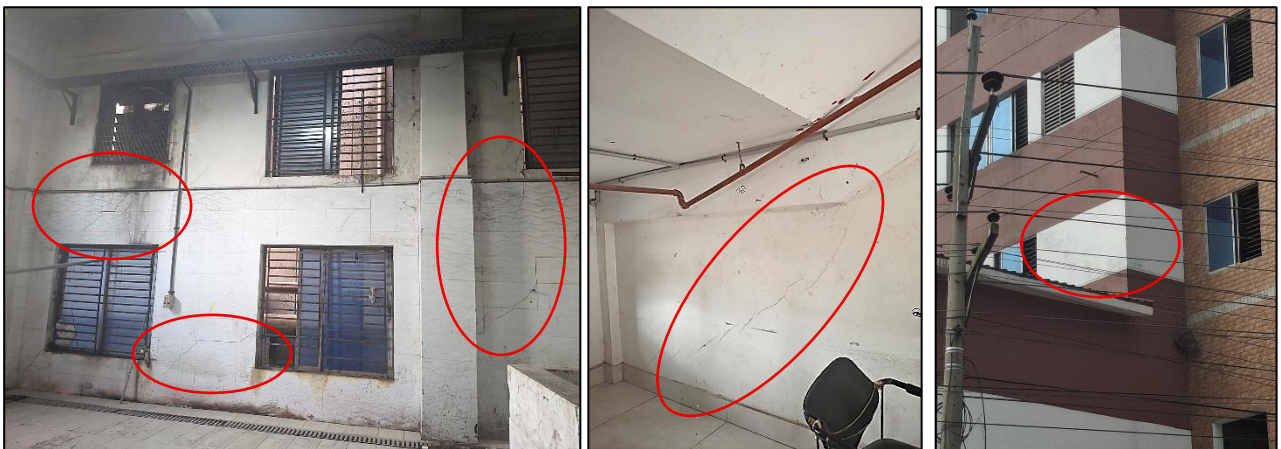
**Observation 08:** Crack on brick walls. Building-13 (AFPL)

**Description:** Crack on brick walls was observed in several locations, including stair zone and washing zone. The building engineer is required to identify all locations, investigate the reason for cracking and repair all cracks following suitable methods.

| Item No. | Observation | Action Plan | Timeline |
|---|---|---|---|
| 10. | Crack on brick walls. Building-13 (AFPL) | The building engineer is required to identify all locations, investigate the reason for cracking and repair all cracks following suitable methods. | within 6 weeks |

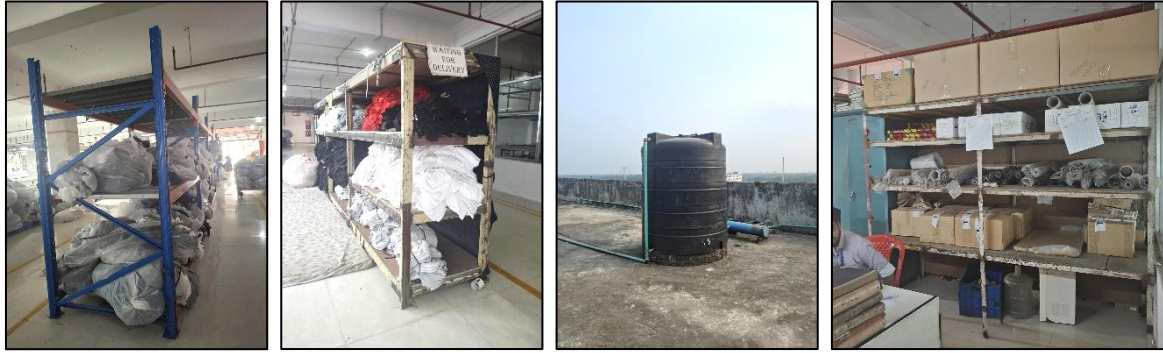
**Observation 09:** Lack of anchorage/brace for non-structural elements. Building-13 (AFPL)

**Description:** Non-structural elements, such as racks and water tanks, were observed without adequate anchorage or bracing. The Building Engineer is required to ensure all non-structural elements are securely anchored or braced as necessary.
