# ESPRIT APPARELS LTD.

8/3,Raj Nagar Road, Sataish,Tongi, Gazipur-1712, Bangladesh

20 October 2025

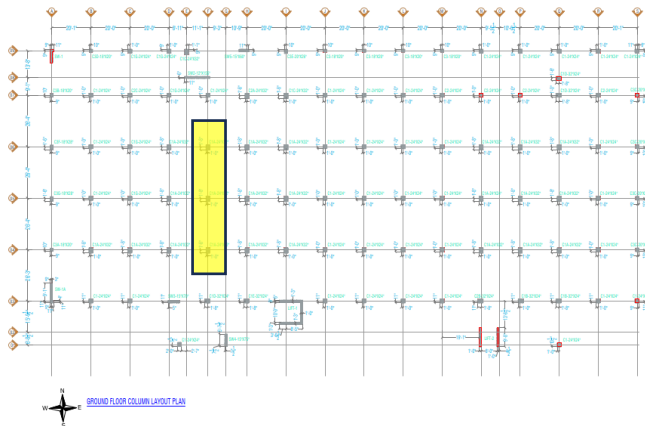
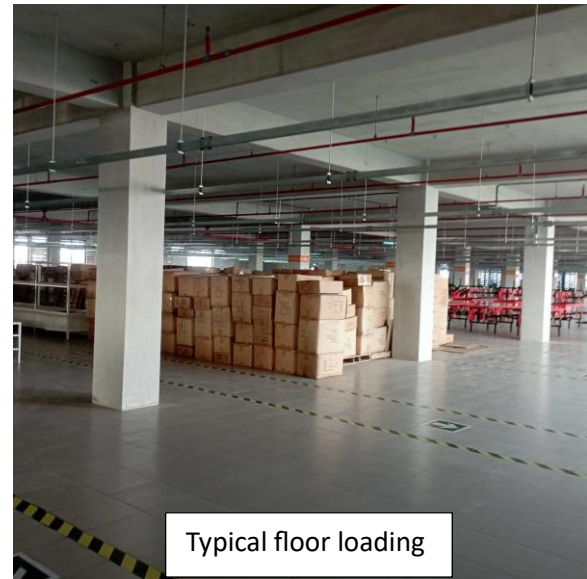
**Observation-01:** Stress in the column exceeds the normal design limit (Building-1: Production Building).

**Description:** Cursory calculation indicates that stress in column exceeds normal design limit at marked locations, considering the prepared live load plan (6 kPa for typical floor, 5 kPa for stair, and 5 kPa for roof) and minimum concrete strength (16.13 MPa) based on aggregate type. Also, an inadequate number of concrete cylinder test reports were available, which doesn't meet the frequency of testing as per BNBC. The building engineer is required to review the design, loads, and column stresses for the area identified above. Verify in-situ concrete strength by taking 4-100 mm diameter cores from the structural elements (Column, beam/slab). Produce and actively manage the loading plan.

| Item No | Observation | Action Plan | Timeline |
|---|---|---|---|
| 1. | Stress in the column exceeds the normal design limit (Building-1: Production Building). | The building engineer is required to review the design, loads, and column stresses for the area identified above. | within 6 weeks |
| 2. | | Verify in-situ concrete strength by taking 4-100 mm diameter cores from the structural elements (Column, beam/slab). | within 6 weeks |
| 3. | | Produce and actively manage the loading plan | within 6 weeks |
| 4. | | Implement remediation work if required. | within 6 months |
| 5. | | Implement the load plan. | within 6 months |

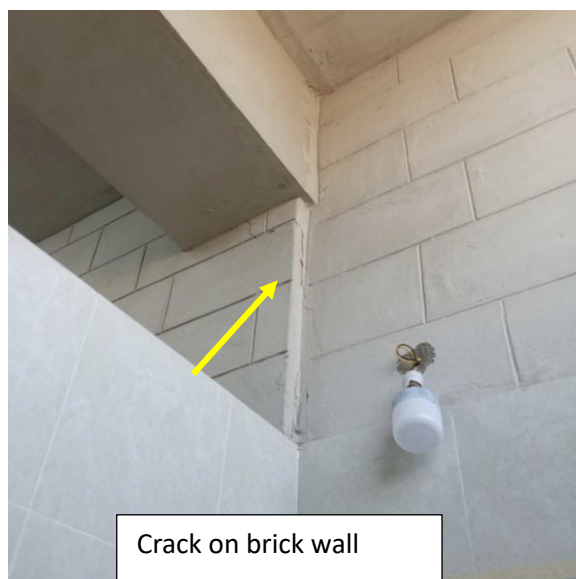
**Observation-02:** Crack on the brick wall (Building-1: Production Building).

**Description:** A crack was found on the brick wall on the 2nd-floor toilet area. The building engineer is required to repair the crack on the wall with a suitable method.

| Item No | Observation | Action Plan | Timeline |
|---|---|---|---|
| 6. | Crack on the brick wall (Building-1: Production Building). | Repair the crack on the brick wall with a suitable method | within 6 weeks |

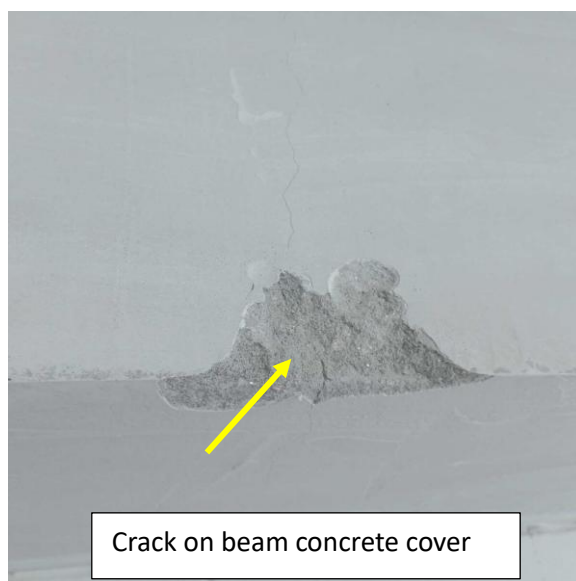
**Observation-03:** Crack on the beam concrete cover (Building-1: Production Building).

**Description:** Cracks were found on the beam on the concrete cover at several locations. The building engineer is required to investigate the crack surface of the beam and prepare an investigation report. Keep the investigation report onsite and repair the crack on the beam as per the investigation report.

| Item No | Observation | Action Plan | Timeline |
|---|---|---|---|
| 7. | Crack on beam concrete cover (Building-1: Production Building). | The building engineer is required to investigate the crack surface of the beam and prepare an investigation report. Keep the investigation report onsite and repair the crack on the beam as per the investigation report. | within 6 weeks |

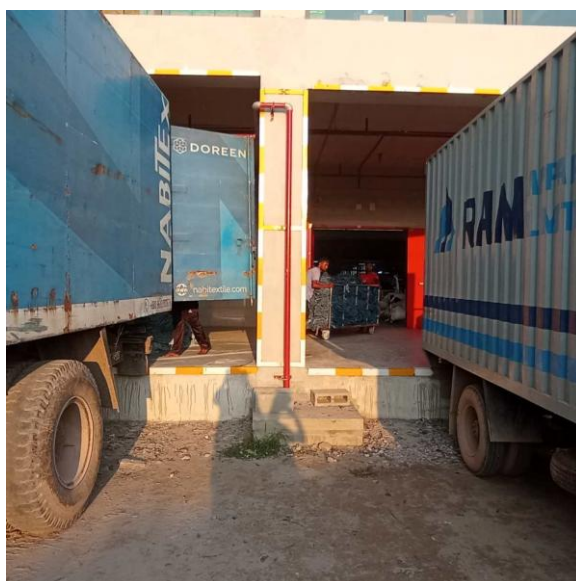
**Observation-04:** Possible vehicle impact on the ground floor (Building-1: Production Building).

**Description:** An exposed column was found on the ground floor, prone to vehicle impact. Only an angle was found installed on the column. The building engineer is required to provide an adequate barrier around all exposed columns to prevent vehicle impact.

| Item No | Observation | Action Plan | Timeline |
|---|---|---|---|
| 8. | Possible vehicle impact on the ground floor (Building-1: Production Building). | The building engineer is required to provide an adequate barrier around all exposed columns to prevent vehicle impact. | within 6 weeks |

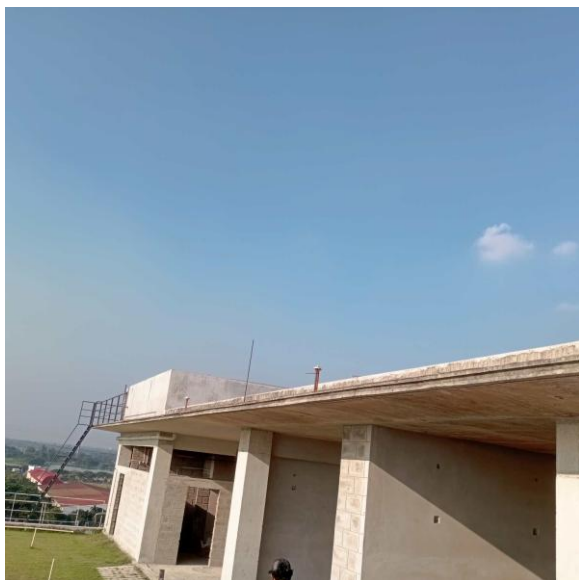
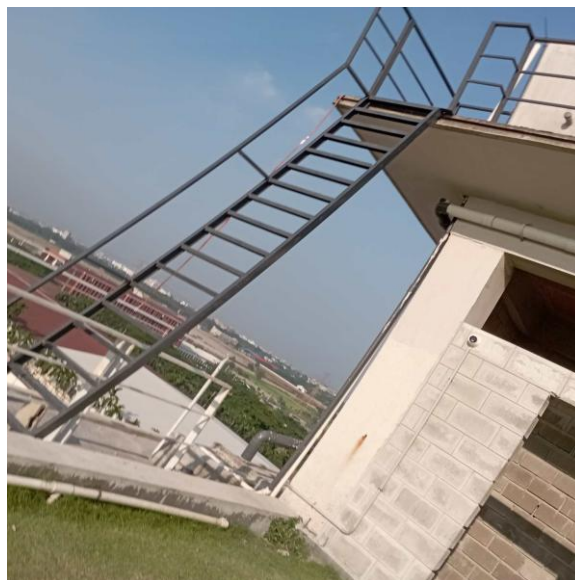
**Observation-05:** Falling hazard at roof level (Building-1: Production Building).

**Description:** The parapet was missing at the roof level, which could cause a falling hazard. The building engineer is required to provide edge protection to avoid a falling hazard. Also, provide an adequate handrail on the steel ladder.

| Item No | Observation | Action Plan | Timeline |
|---|---|---|---|
| 9. | Falling hazard at roof level (Building-1: Production Building). | The building engineer is required to provide edge protection to avoid a falling hazard. Also, provide an adequate handrail on the steel ladder. | within 6 weeks |

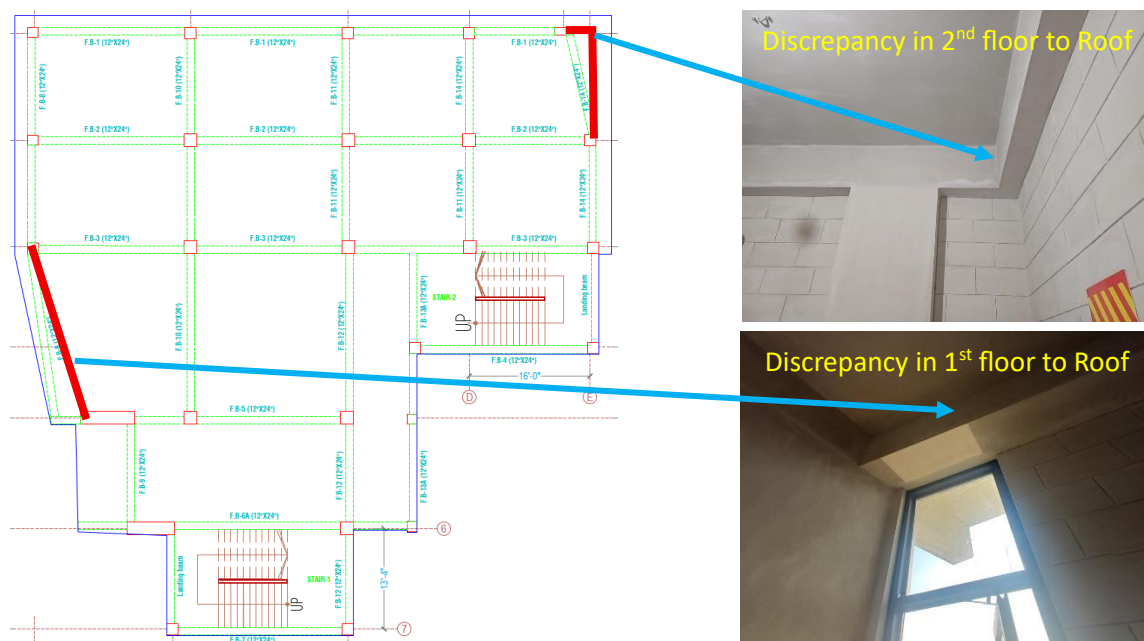
Discrepancies in beam layout at typical floor

**Description:** Several discrepancies were identified, including mismatches in beam layout, the overhead water tank not reflected in the drawing, and the occupancy type not specified in the as-built drawings. The building engineer is required to update the as-built drawing as per onsite condition.

| 12. | Discrepancies in as-built drawing (Building-2: Admin Building). | The building engineer is required to survey the structures and update the as-built drawing as per onsite condition | within 6 weeks |

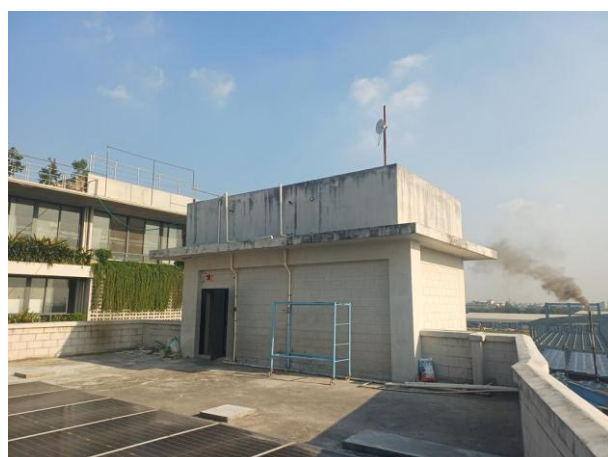
OHW – not shown

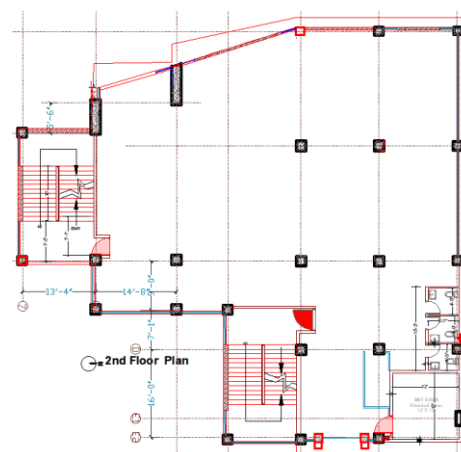
Occupancy type – not mentioned

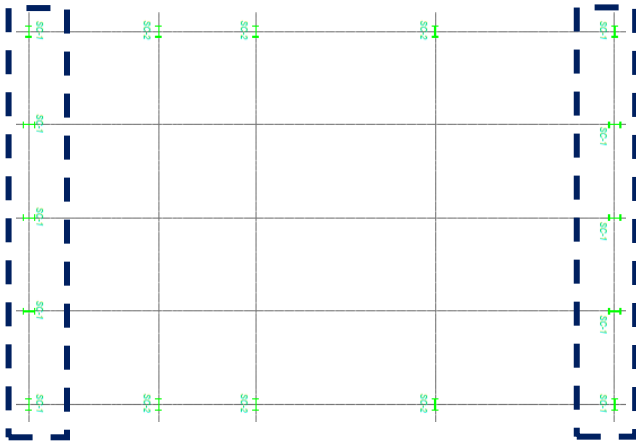
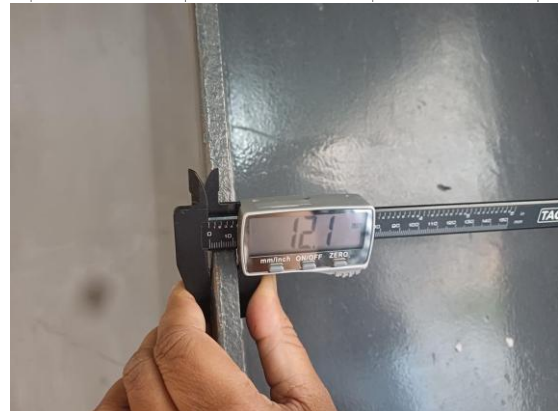
Steel column Layout

**Description:** Several discrepancies were identified, including mismatches in the flange thickness of steel columns, missing roof bracings, and the use of rod bracing instead of cable bracing. The building engineer is required to update the as-built drawing as per on-site condition.

| 18. | Discrepancies in the as-built drawing (Building-3: Utility Shed). | The building engineer is required to survey the structures and update the as-built drawing as per onsite condition | within 6 weeks |

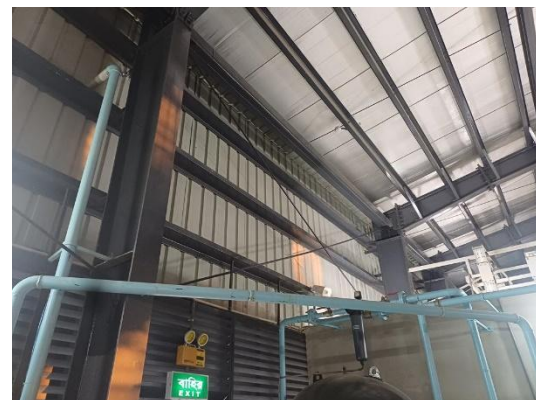
Rod bracing instead of cable bracing

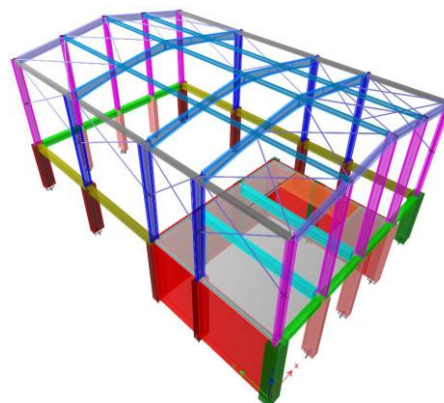
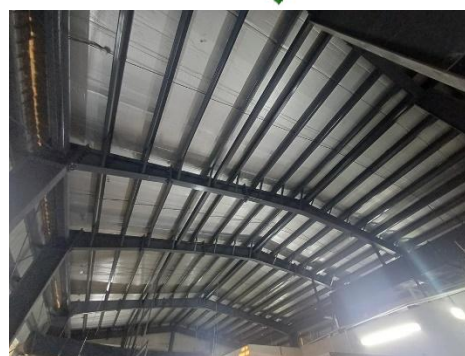
Yield strength was considered 345 MPa in EA, but test results for 8 mm and 10 mm plates were below this value

Roof bracing was considered in the EA, but was not provided at the site

**Description:** Several inconsistencies were identified in the EA. Yield strength was considered as 345 MPa in the EA; however, test results for 8 mm and 10 mm plates were below this value. Roof bracing was also considered in the EA, but was not provided at the site. The Building Engineer is required to update the EA in accordance with BNBC, address all identified inconsistencies, and submit the revised documents to RSC.

| 19. | Inconsistencies in the EA report (Building-3: Utility Shed). | The Building Engineer is required to update the EA in accordance with BNBC, address all identified inconsistencies, and submit the revised documents to RSC. | within 6 weeks |
| 20. | | Implement remediation work if required. | within 6 months |

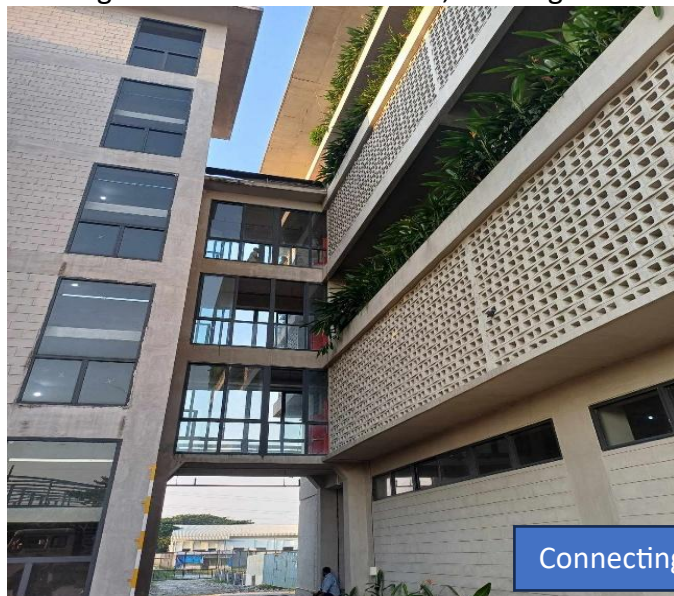
Connecting Bridge

**Observation-10:** Absence of design report. (Connecting Bridge, Building-5: Security Room, Building-6: Medical and Childcare, Building-7: Wastage Shed).

**Description:** As per BNBC, every building or structure designed shall have its design documents prepared following the provisions of Section 1.9.1. The design report was not available for the Factory Building. The building engineer is required to prepare a design report following BNBC (Part-6, section 1.9.1) and submit it to RSC for review against lateral forces.

| Item No | Observation | Action Plan | Timeline |
|---|---|---|---|
| 10. | Absence of design report. (Connecting Bridge) | The building engineer is required to prepare a design report following BNBC (Part-6, section 1.9.1) and submit it to RSC. | within 6 weeks |
| 11. | | Implement the recommendations of the design report. | within 6 months |

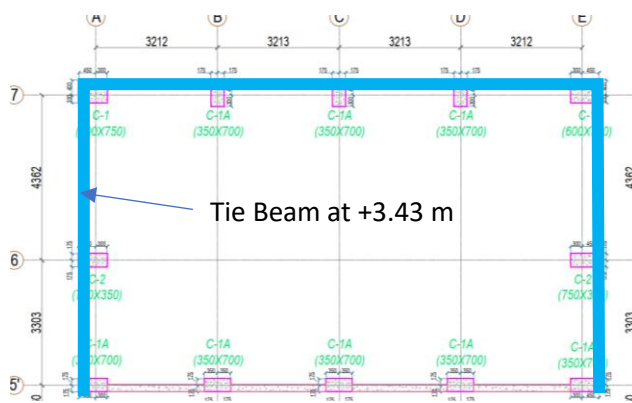
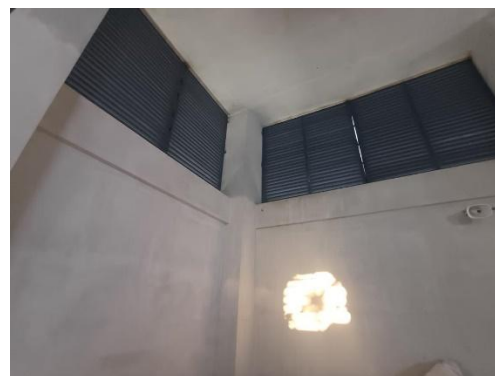
Tie Beam – not shown in drawing

**Description:** The tie beam layout is missing in the drawings. Additionally, the drawings for the Utility Shed and Boiler Building were prepared together, although the two structures are not connected structurally or architecturally. The Building Engineer is required to prepare separate drawings for each structure and update the drawings as per onsite conditions.

| 27. | Discrepancies in as-built drawing (Building-8: Boiler Building). | The Building Engineer is required to prepare separate drawings for each structure and update the drawings as per onsite conditions. | within 6 weeks |

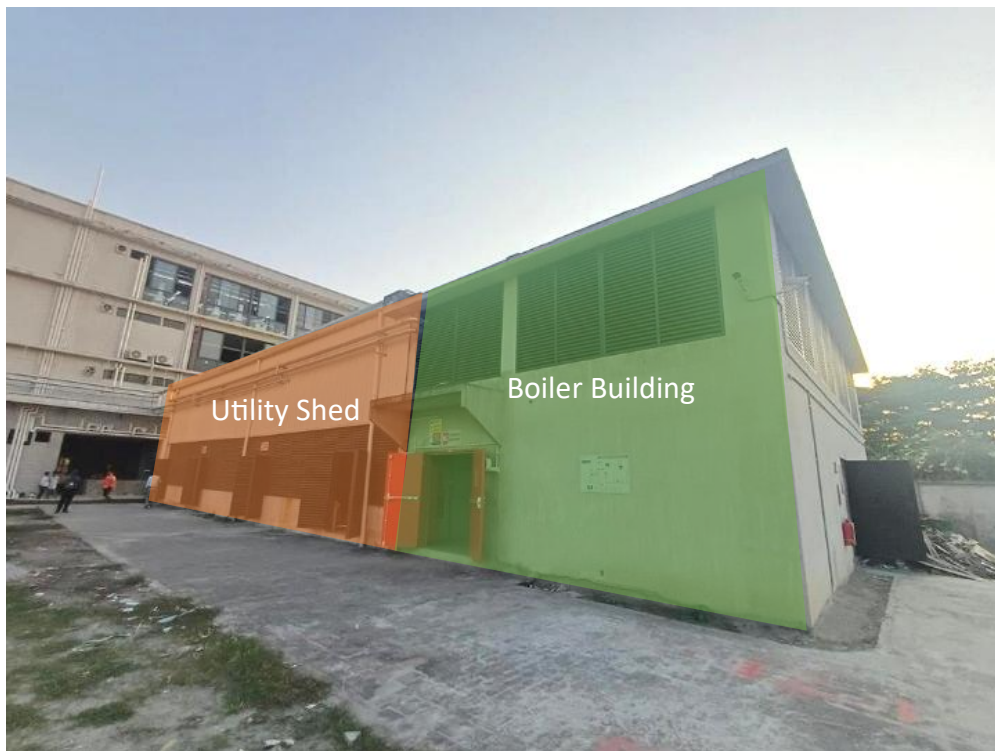
**Observation-13:** Lack of building permit from local authority (Building 3: Utility Shed, Building 8: Boiler Building)

**Description:** Building permit from local authority was not available for Building 3: Utility Shed, Building 8: Boiler Building. The building engineer is required to obtain building permit for both structures from local authority.

| 31. | Lack of building permit from the local authority (Building 3: Utility Shed, Building 8: Boiler Building) | The building engineer is required to obtain a building permit for both structures from the local authority. | within 6 months |
