# DMC Apparels Ltd

Holding, 157/8, Road-01, Ward-08, Block-D, Zirabo, Ashulia, Savar, Dhaka-1341

4 November 2025

## 2. Observation

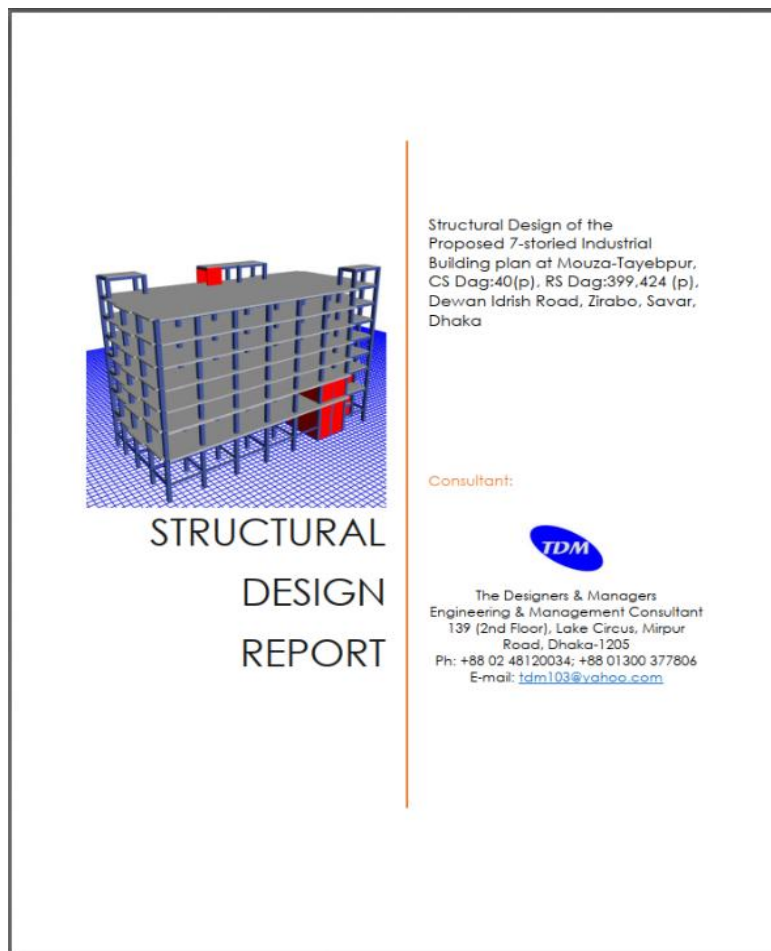
### Observation-01: Inconsistency in the design report. [Block-J (Factory Building)]

**Description:** A set of design documents was available. The report did not include shear wall, retaining wall, and slab adequacy checks. Detailed calculation of wind and seismic calculations, FEM assignment & base reactions comparison, structural irregularity checks, and IMRF framing checks were not incorporated in the design report.

The building engineer is required to update the design report in full compliance with BNBC and submit it to RSC for detailed review.

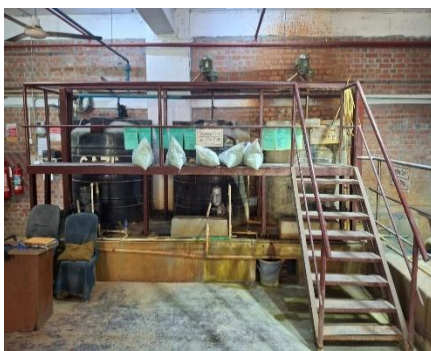
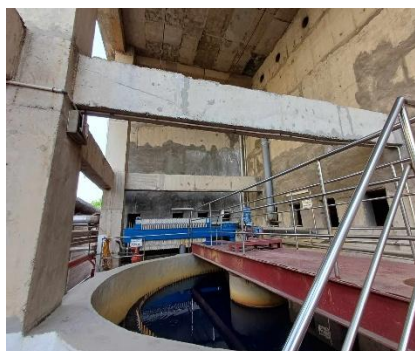
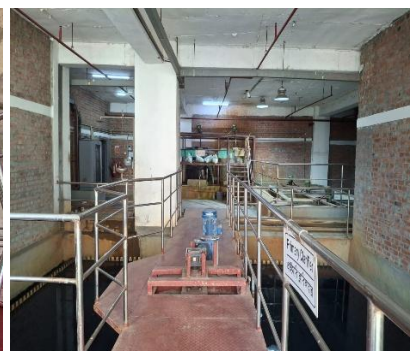
### Observation-02: Lack of load plan for the ETP portion suspended floor. [Block-J (Factory Building)]

**Description:** During the inspection, load plan was not found for the ETP portion suspended slab.

The building engineer is required to update the prepared load plan and submit it to RSC along with the design report.

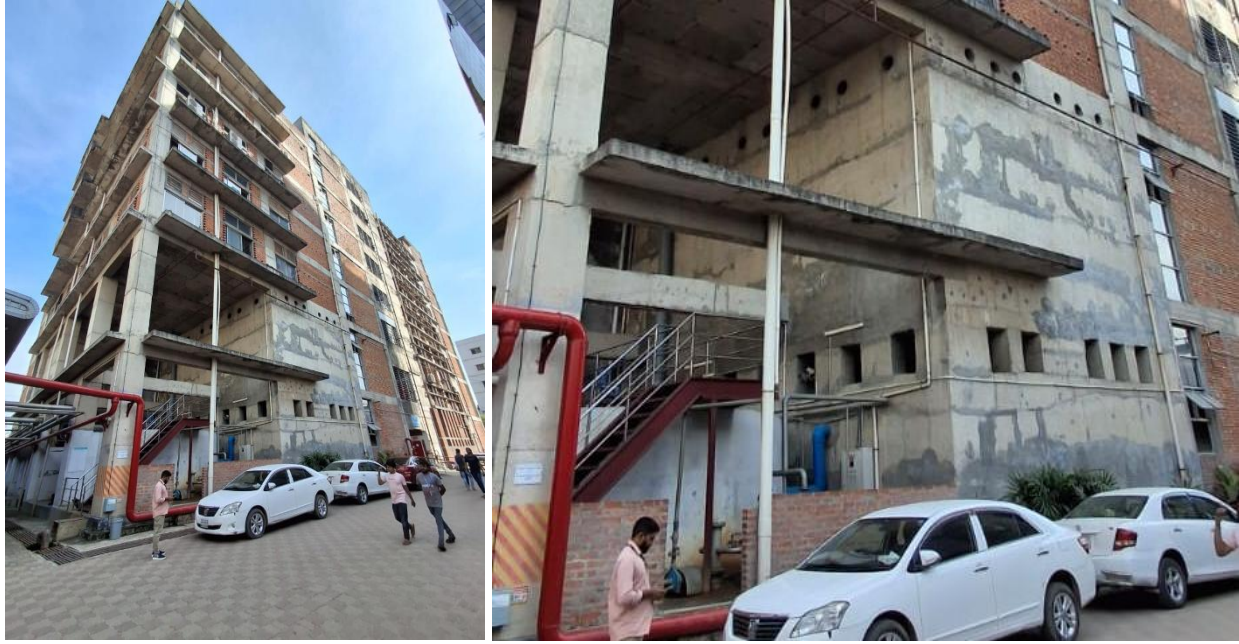
**Observation 03:** Void in concrete retaining wall. [Block-J (Factory Building)]

**Description:** During the inspection, rectangular and circular concrete voids were found in the ETP retaining walls. The voids were not shown in the provided drawing.

The building engineer is required to verify whether any main re-bar has been compromised due to the voids and assess the adequacy of the retaining wall, considering the impact of these voids. The findings, along with the updated design report, shall be submitted to RSC for review.

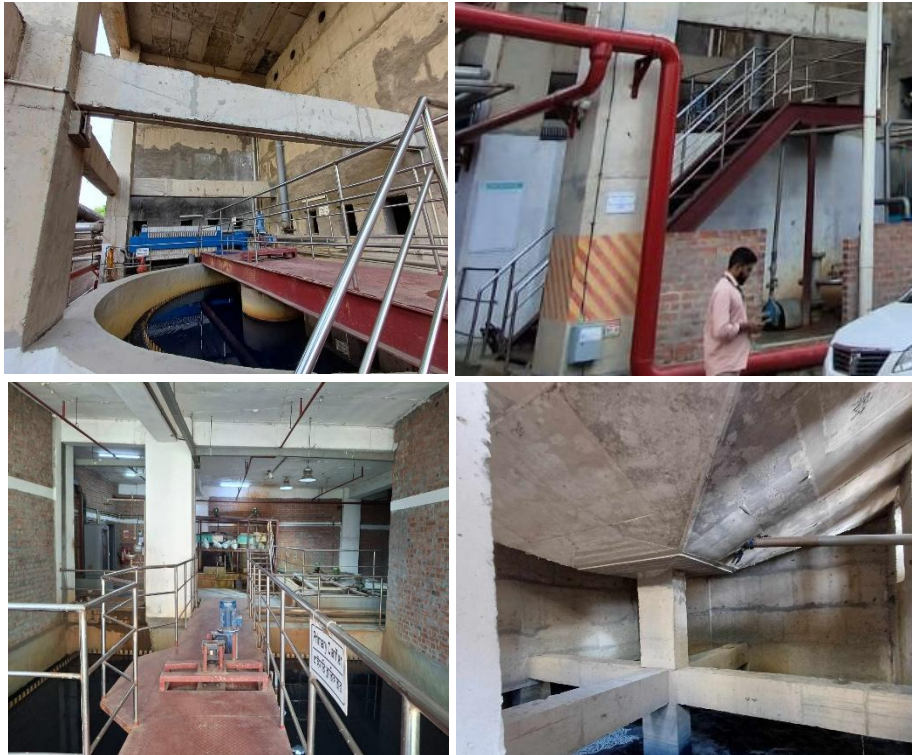
**Observation 04:** Lack of information in the as-built drawing. [Block-J (Factory Building)]

**Description:** ETP steel platforms and all types of retaining wall details were not provided in the as-built drawing.

The building engineer is required to update the as-built drawing and submit to RSC.

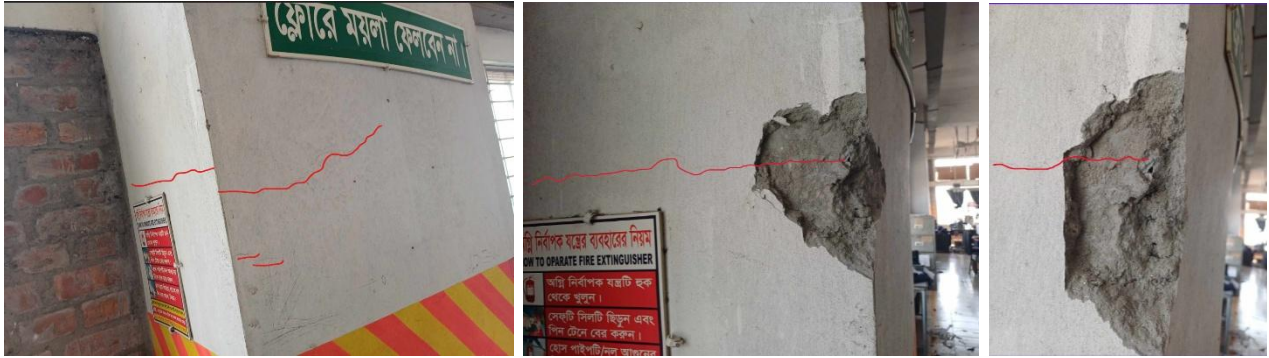
Hairline crack on the column

**Description:** During the inspection, hairline cracks were observed on the 6th-floor columns and roof beam-slabs. The cracks may propagate due to poor construction workmanship.

The building engineer is required to investigate the cracks and prepare an investigation report with proper remediation methodology and submit it to RSC. The factory is required to repair the crack as per the investigation report after receiving the acceptance from RSC.

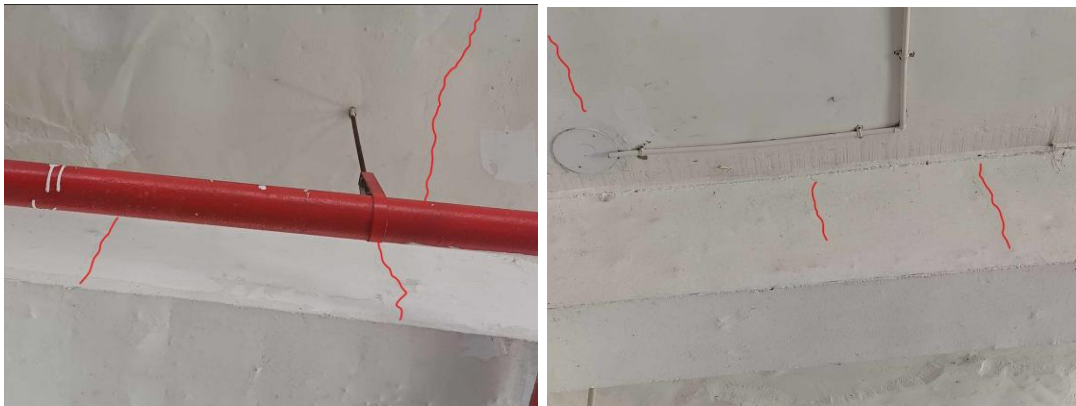
Hairline crack on beam-slab

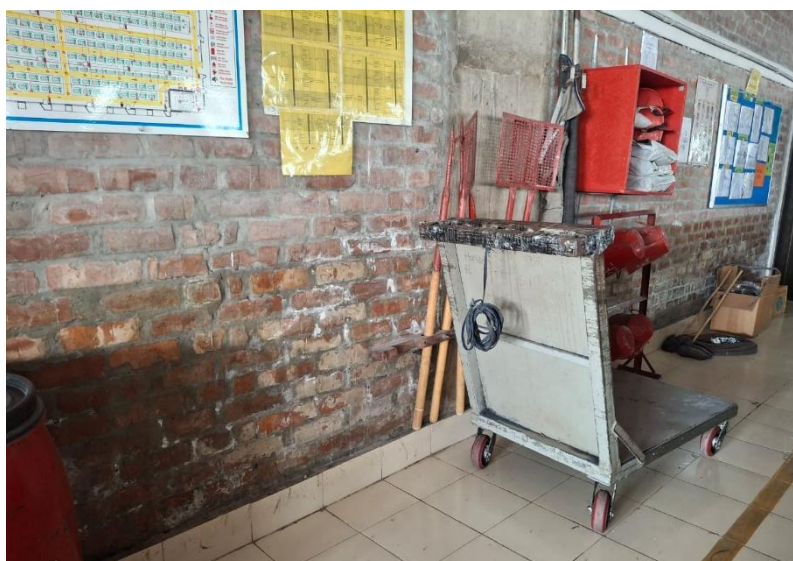
**Observation 06:** Dampness on the brick wall. [Block-J (Factory Building)]

**Description:** During the inspection, dampness was observed on the brick wall beside the toilet.

The factory is required to seal the source of water and repair the damp area with a suitable method.

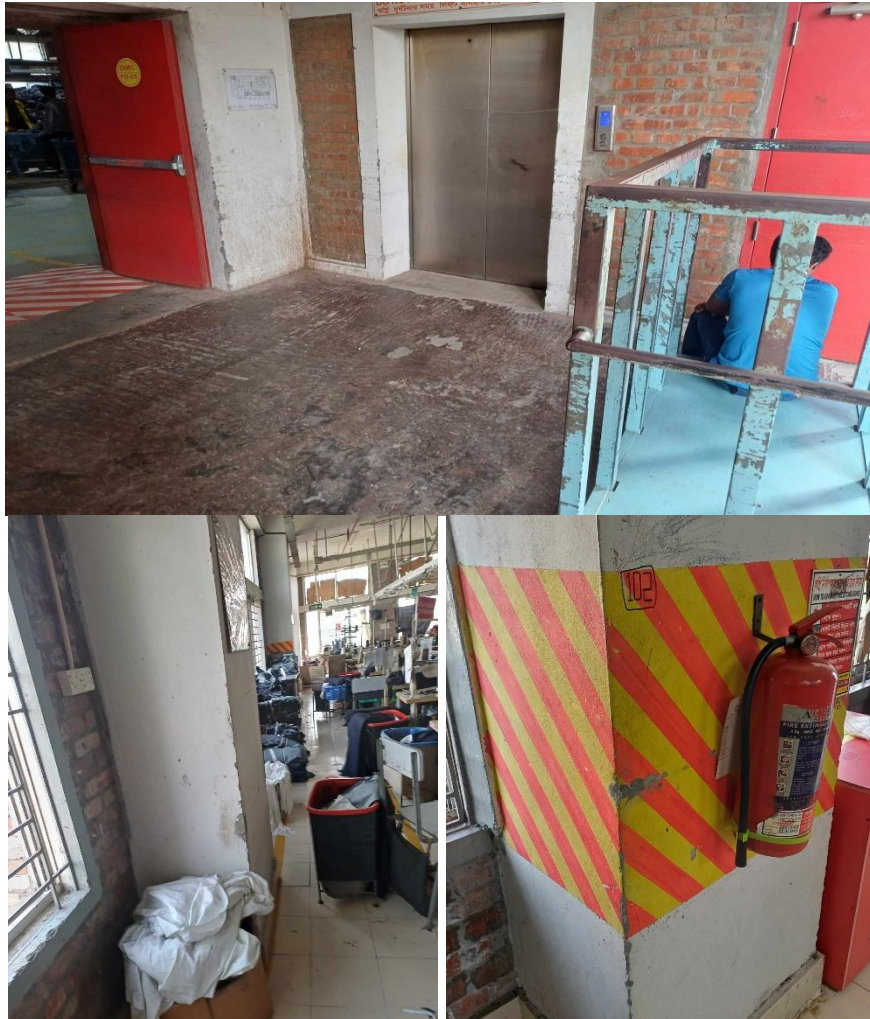
**Observation 07: Trolley impact on columns and brick walls. [Block-J (Factory Building)]**

**Description:** During the inspection, trolley impacts were observed on the floor column and walls. The factory is required to provide column and wall guard where required.

| Item No | Observation | Action Plan | Timeline |
|---|---|---|---|
| 11. | Trolley impact on columns and brick walls.<br>[Block-J (Factory Building)] | The factory is required to provide column and wall guard where required. | within 6 weeks |

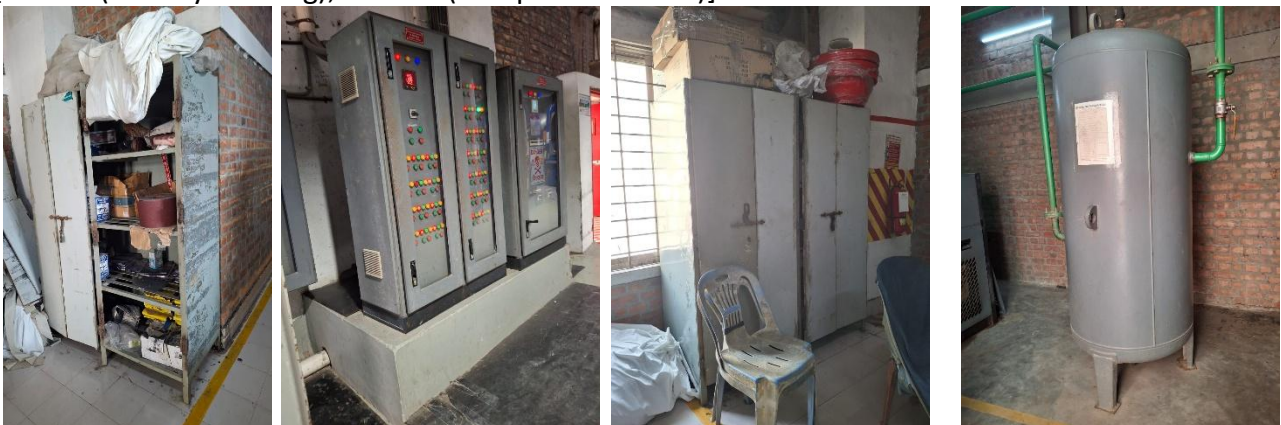
**Observation 08: Lack of anchorage in the non-structural elements. [Block-J (Factory Building); Block-K (Compressor Room)]**

**Description:** During the inspection, lack of anchorage in the non-structural elements on both structures. The factory is required to brace/anchor all non-structural elements.

| Item No | Observation | Action Plan | Timeline |
|---|---|---|---|
| 12. | Lack of anchorage in the non-structural elements.<br>[Block-J (Factory Building)] | The factory is required to brace/anchor all non-structural elements. | within 6 weeks |
| 15. | Lack of anchorage in the non-structural elements.<br>[Block-K (Compressor Room)] | The factory is required to brace/anchor all non-structural elements. | within 6 weeks |

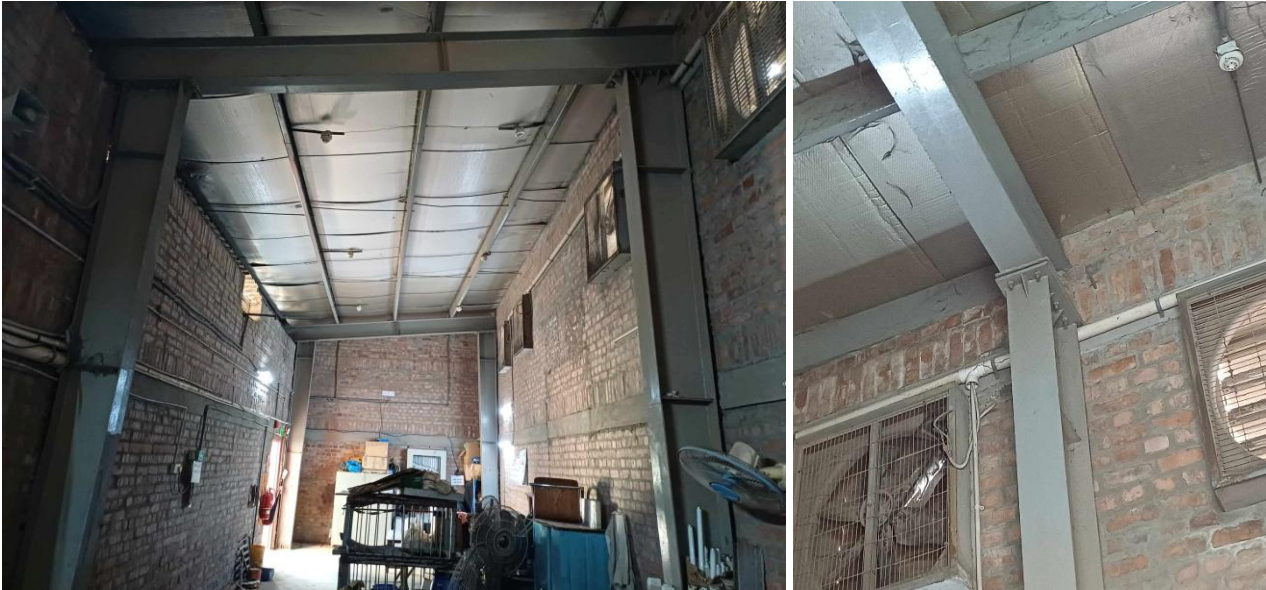
No lateral load transfer media in long direction

**Description:** Lateral load transfer media in the long direction is missing, only the rafter is available in the short direction in each grid. However, it is considered in the analysis and design report.

The building engineer is required to review the design and the lateral stability of the shed considering the on-site condition.

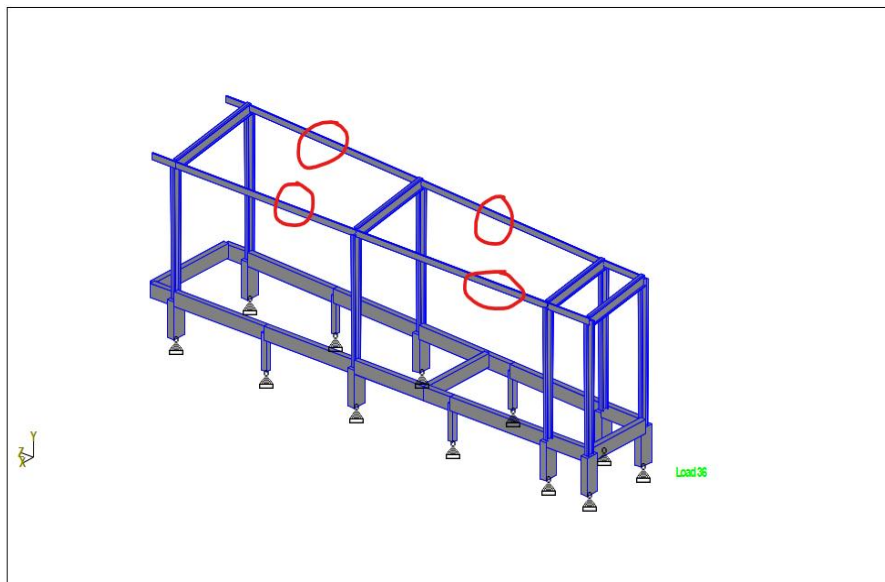
Lateral load transfer media are considered in the long direction for the analysis and design report
