# VANGUARD GARMENTS LTD

388/617, COLONEL JONES ROAD, NORTH KATTALI, PAHARTALI, CHATTOGRAM.  
(22.36679477524, 91.7748365293)

20 October 2025

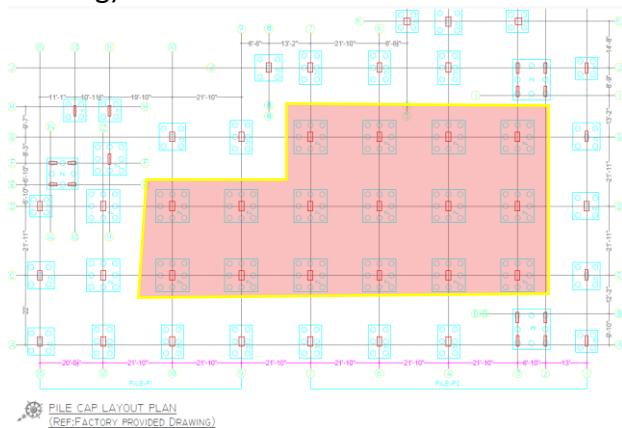
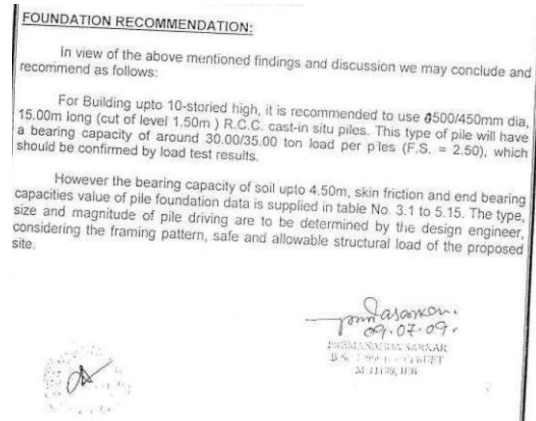
**Observation-01:** Stress in the pile foundation exceeds the normal design limit. (Main Production Building)

During the inspection and document review, preliminary calculations indicate that the typical internal pile foundations (P1 and P2) of the Main Production Building are below the required design capacity. No credible structural drawings were available for the partially nine-storied building. According to the provided as-built drawings, the pile lengths are 35 feet (P1) and 40 feet (P2); however, the pile type was not mentioned in the pile layout plan.

The factory is required to engage a qualified structural and geotechnical consultant to:

- Verify actual pile lengths and capacities, and
- Conduct a Detailed Engineering Assessment (DEA) based on verified data.

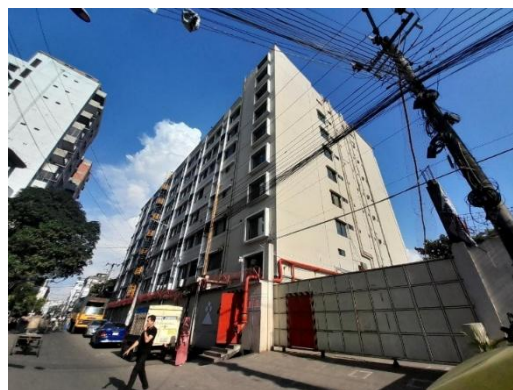
## Observation-02: Inconsistency in the DEA report. (Main Production Building)

### Insufficient concrete core test report

### Lack of re-bar test report

IMRF is considered in the analysis model

**Description:** A design report has been prepared for the 9-storied Main Production Building. Several inconsistencies were observed in the DEA report.

- Steel rebar strength was 500 MPa (72.5 ksi), considered in the design report without any test report.
- Factory collected six core samples (four from columns, one from a beam, and one from a slab). However, during inspection, the core locations could not be identified, and no core layout plan was available. Additionally, the number of cores tested for the beams and slabs in the submitted report is insufficient.
- The Intermediate Moment Resisting Frame (IMRF) system was adopted in the software-based analysis without proper justification. Necessary checks must be incorporated to confirm the IMRF framing system and ensure it does not adversely affect structural irregularities.

The Building Engineer is required to verify the actual material strengths and revise the design documents based on verified data and the actual framing system and submit to RSC for detailed review against lateral loadings.

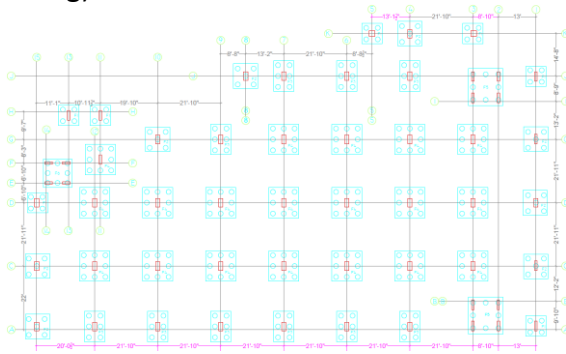
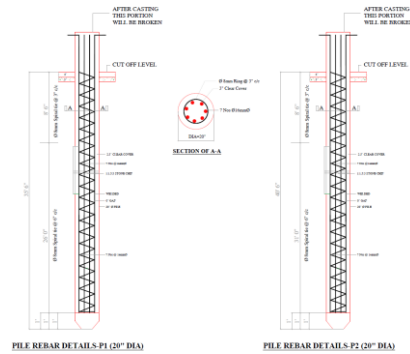
There are two types of pile P1 and P2. But in the pile layout plan pile type was not mentioned.

The building engineer is required to survey the structural components and produce accurate as-built structural drawings.

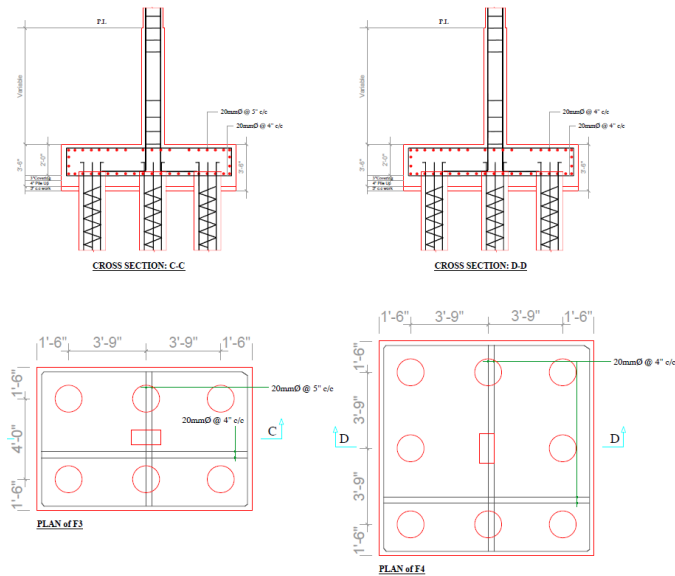
Grade beam and basement slab level was not shown in the drawing

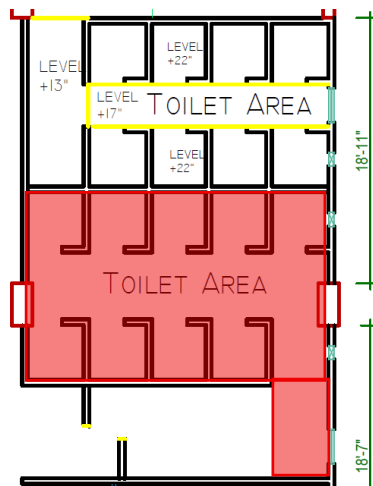
In the marked area floor build-up was found, but not shown in the drawing

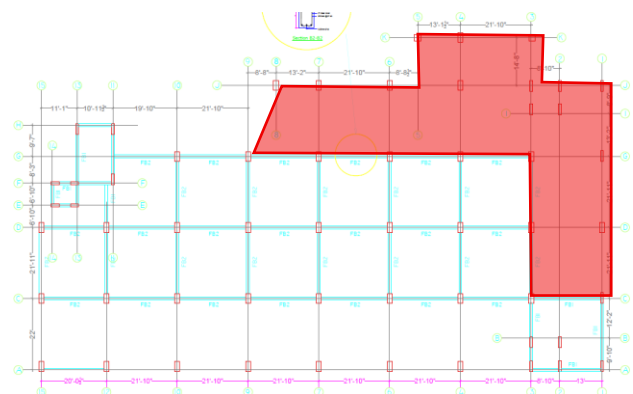
Beam layout missing at marked area at top level (101.5 ft level).

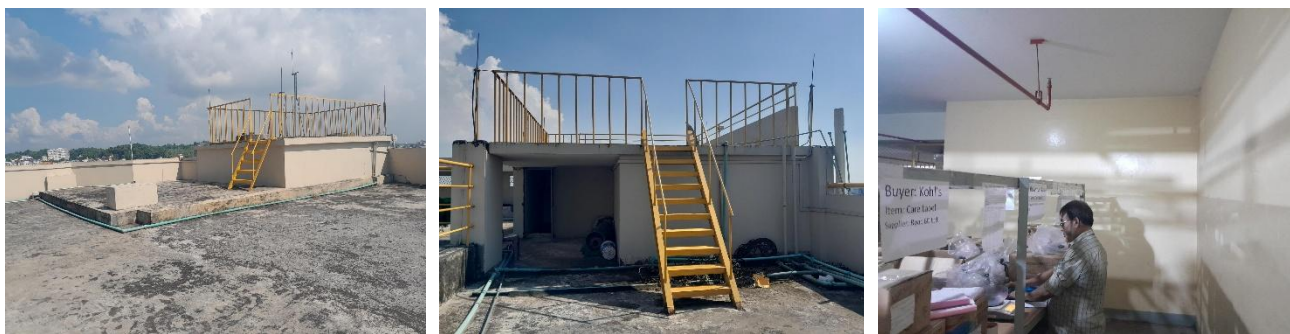
#### Lack of structural information of O.H.W.T. and U.G.W.R

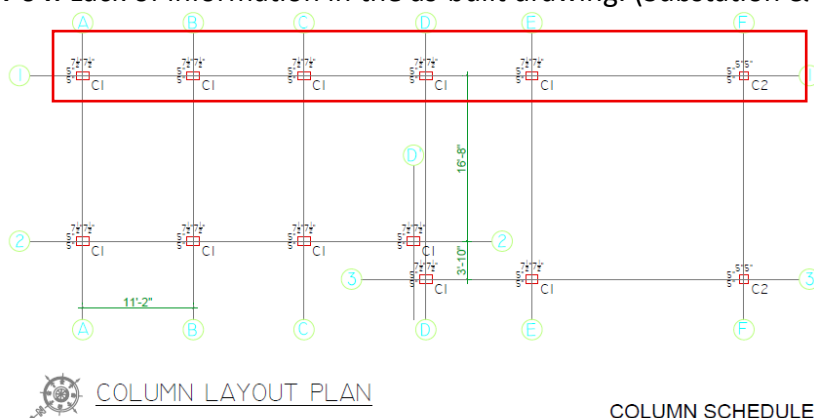
#### **Observation-04:** Lack of information in the as-built drawing. (Substation & Generator Building)

**Description:** During inspection, lack of information was observed between drawings and the existing condition. The grid dimension was found missing in the provided as-built drawing. The building engineer is required to survey the structural components and produce accurate as-built structural drawings.

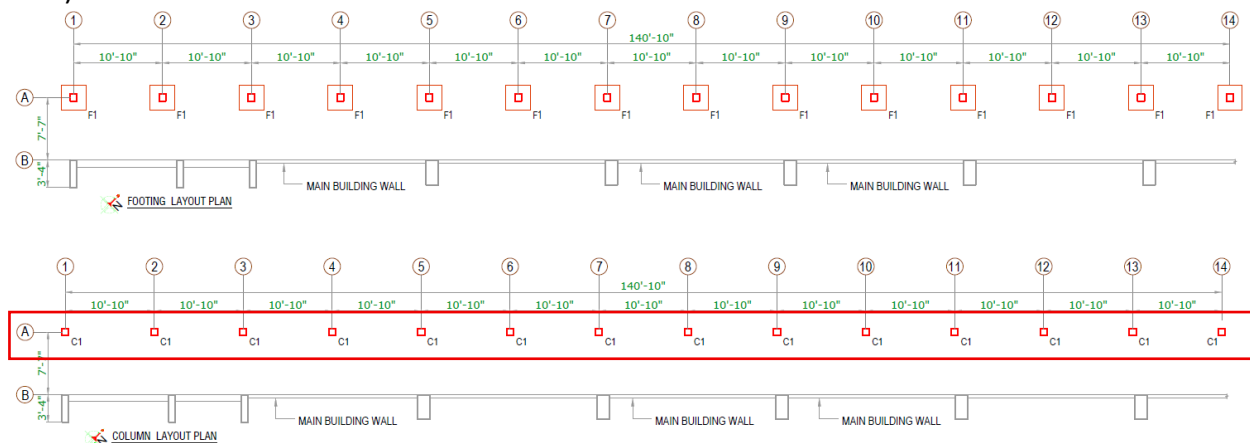
**Observation-05: Discrepancies in the as-built drawing. (Wastage Go-down, Security Room and IPS Room)**

**Description:** During inspection, mismatches were observed between drawings and the existing condition. At the “A” grid, the grid distance and position of the marked columns were found changed from the as-built drawing. Also, during inspection, 4 rebars were found at the C1 column instead of 8 rebars. The building engineer is required to survey the structural components and produce accurate as-built structural drawings.

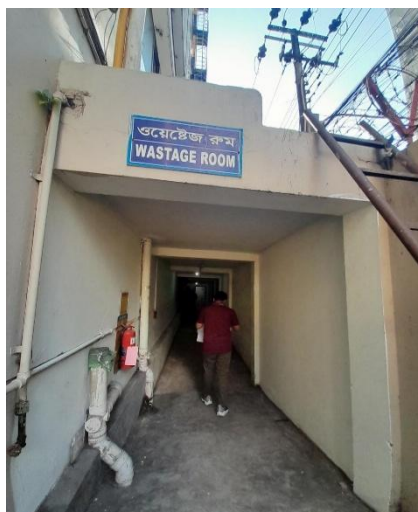
**Observation-06: Lack of design documents. (Wastage Go-down, Security Room and IPS Room)**

**Description:** As per BNBC, every building or structure designed shall have its design documents prepared under the provisions of Section 1.9.

At the time of inspection, no design report and material test reports were available on-site. Building engineer is required to prepare a safety check report.

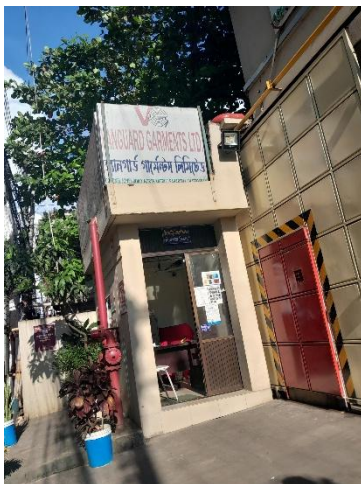
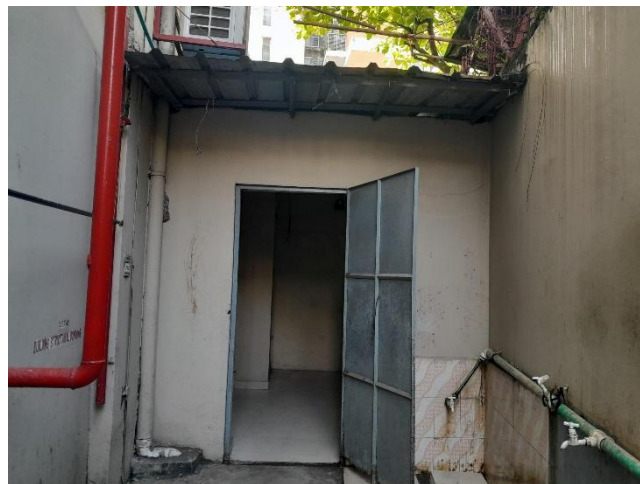
**Observation-07:** Lack of design documents. (Prayer, Gas Meter & Security Room)

**Description:** As per BNBC, every building or structure designed shall have its design documents prepared under the provisions of Section 1.9.

At the time of inspection, no design report and material test reports were available on-site. Building engineer is required to prepare a safety check report.

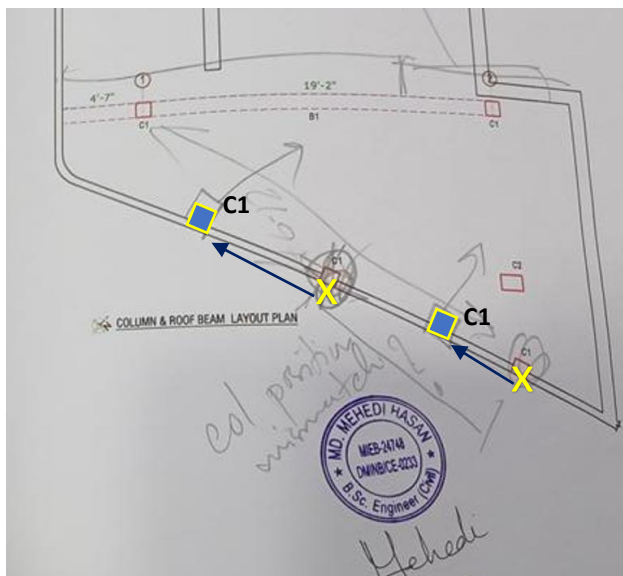
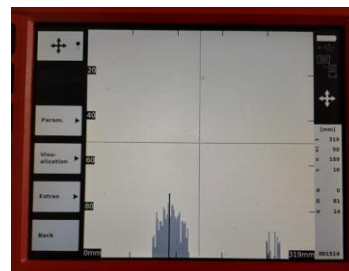
**Observation-08:** Discrepancies in the as-built drawing. (Fire Pump Room)

**Description:** During inspection, mismatches were observed between drawings and the existing condition. At the inclined grid, grid distance and position of the marked columns were found changed from the as-built drawing. Also, during inspection 4 rebars was found at C1 column instead of 8 rebars. The building engineer is required to survey the structural components and produce accurate as-built structural drawings.

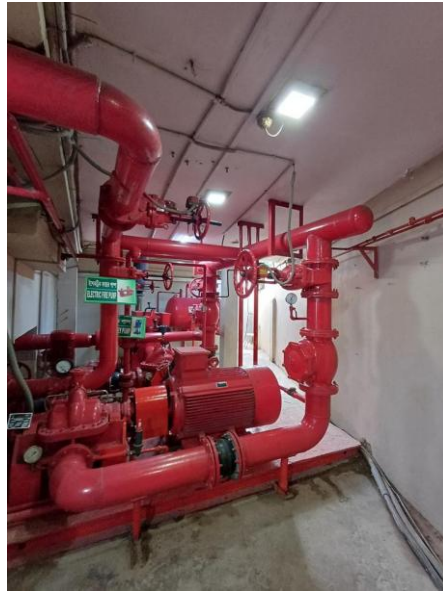
**Observation-09:** Lack of design documents. (Fire Pump Room)

**Description:** As per BNBC, every building or structure designed shall have its design documents prepared under the provisions of Section 1.9.

At the time of inspection, no design report and material test reports were available on-site. Building engineer is required to prepare a safety check report.

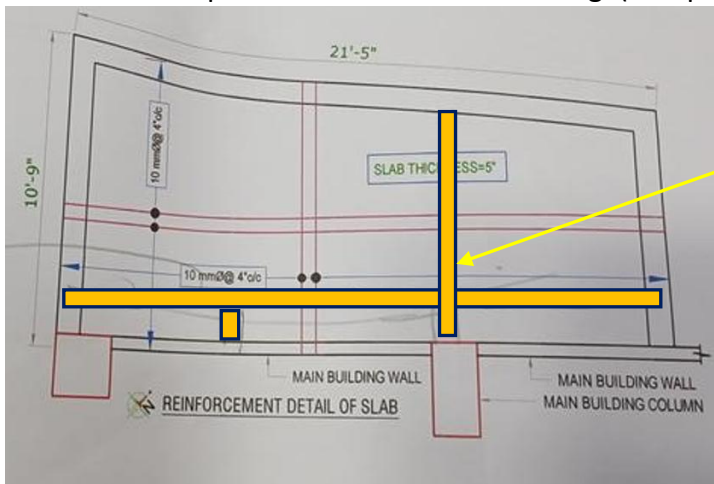
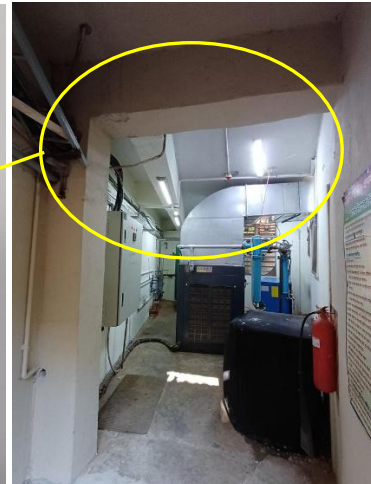
**Observation-10:** Discrepancies in the as-built drawing. (Compressor Room)

**Description:** During inspection, mismatches were observed between the as-built drawings and the existing condition. Beam layout was found changed with the on-site condition. Also, sectional details of beam not provided in the as-built drawings. The building engineer is required to survey the structural components and produce accurate as-built structural drawings.

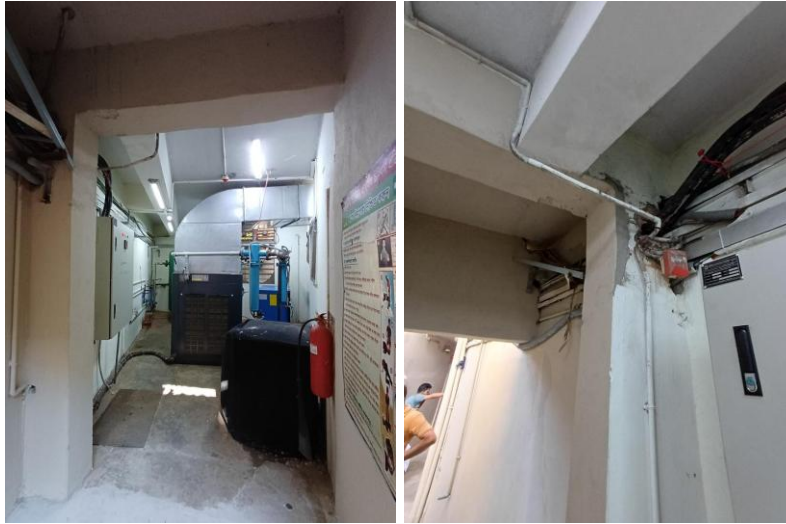
**Observation-11:** Unclear structural load path. (Compressor Room)

**Description:** The Compressor room has been constructed as an extension, projecting outward from the Main Production Building. This extension is connected to the Main Building's beam. However, the slab is supported mostly on the brick walls. Given this unconventional structural configuration, the unclear structural load path must be thoroughly investigated and structurally evaluated to ensure safety, stability, and compliance.

| 16. | Unclear structural load path. (Compressor Room) | The unclear structural load path must be thoroughly investigated and structurally evaluated to ensure safety, stability, and compliance. | within 6 weeks |
