# Magnum BD (Pvt) Ltd; International Classic Composite Ltd (ICCL) (Extension)

Naojur, Kodda, Joydebpur  
(23.992545, 90.357336)  
6 November 2025

- a. 3-Storied Steel Building

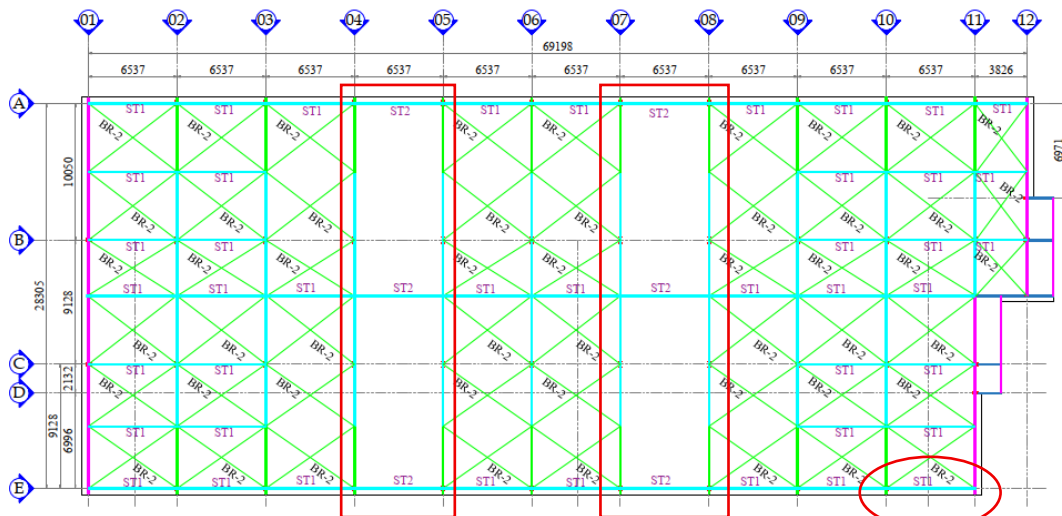
Roof bracing layout

### Observation-1: Mismatch in prepared as-built drawings. [Three (3) Storied Steel Building]

**Description:** Roof bracings found on site at the marked location but not provided in the as-built drawings. The compression strut was found missing in the E/10-11 grid.

| Item No | Observation | Action Plan | Timeline |
|---|---|---|---|
| 1. | Mismatch in prepared as-built drawings. (Three (3) Storied Steel Building) | Building engineer is required to survey the structure and prepare the as-built drawing. | within 6 weeks |

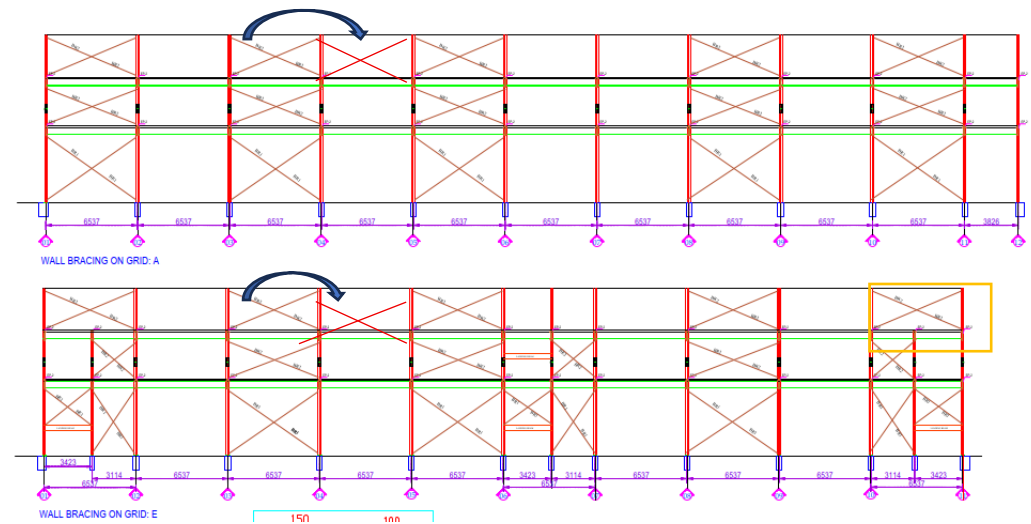
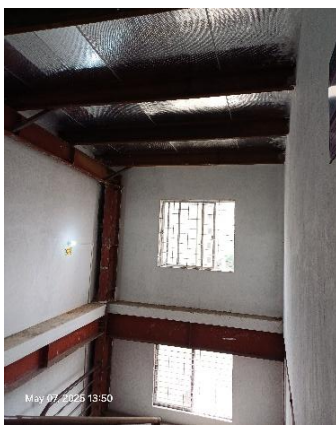
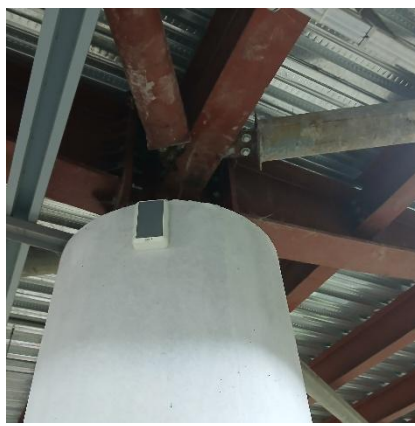
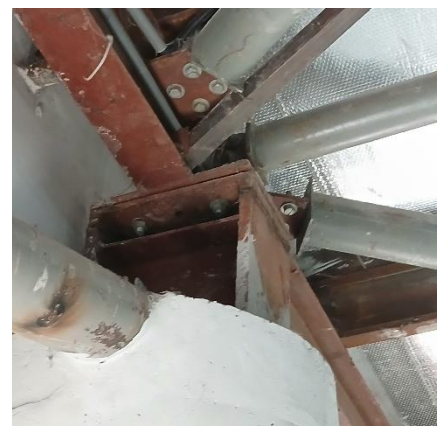
Wall bracing layout

**Description:** Wall bracings shifted to the adjacent bay at the marked location. Also, wall bracing was not found in the E/10-11 grid. Moreover, mismatch found in connection joint between rafter-column and roof bracing. Building engineer is required to survey the structure and prepare an accurate as-built drawing.

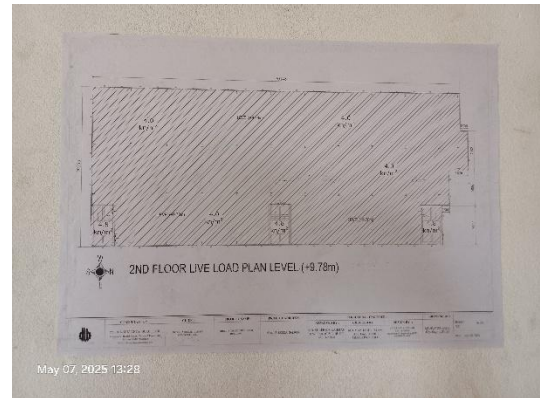
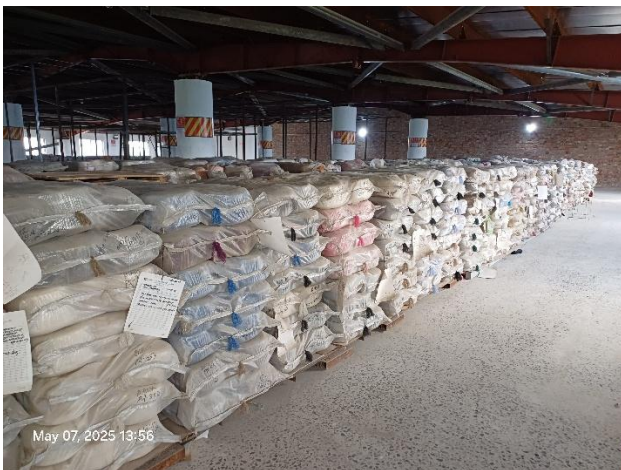
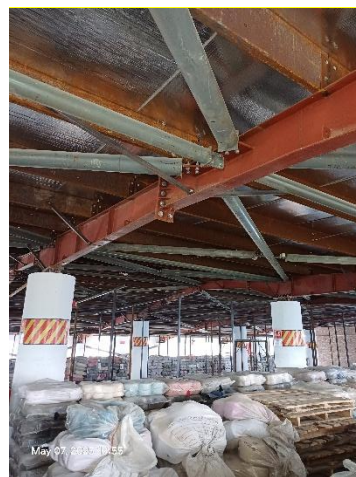
**Observation-2:** Load plan does not comply with BNBC requirements. (Three (3) Storied Steel Building)

**Description:** The 2<sup>nd</sup> floor of the building is allotted for storage. As per BNBC, the minimum floor live load for storage is 6 kN/m<sup>2</sup> (125 psf). But the 2<sup>nd</sup> floor of the building is designed for 4 kN/m<sup>2</sup> live loads.

Building engineer is required to revise the load plan and related design documents based on BNBC requirements.

| Item No | Observation | Action Plan | Timeline |
|---|---|---|---|
| 2. | Load plan does not comply with BNBC requirements. (Three (3) Storied Steel Building) | Building engineer is required to prepare a live load plan as per BNBC requirements. | within 6 weeks |
| 3. | Load plan does not comply with BNBC requirements. (Three (3) Storied Steel Building) | Prepared assessment report to be checked against lateral loads following BNBC 2020 by RSC. | within 6 weeks |
| 4. | Load plan does not comply with BNBC requirements. (Three (3) Storied Steel Building) | Carry out the suggested remedial works (if any). | within 6 months |
| 5. | Load plan does not comply with BNBC requirements. (Three (3) Storied Steel Building) | Implement and maintain the floor live load as per the prepared load plan. | within 6 months |

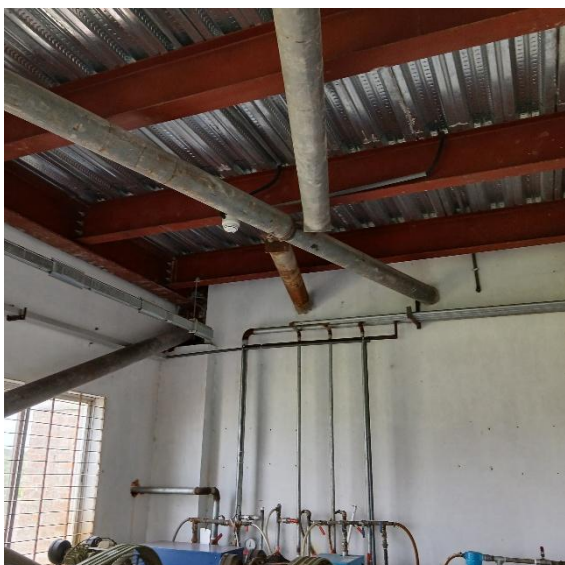
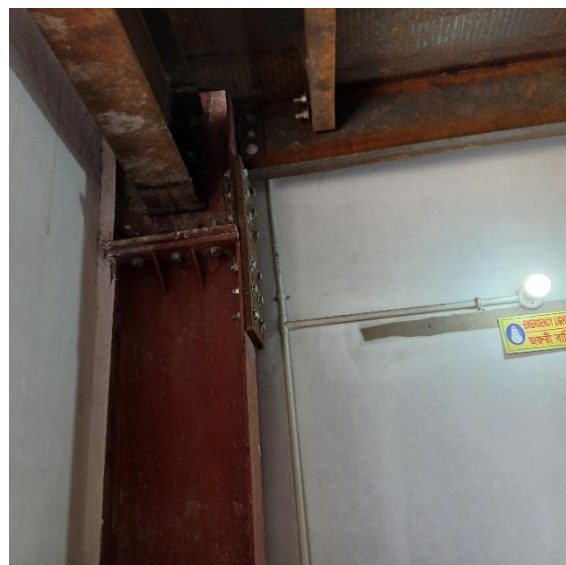
**Observation-3:** Corrosion on the steel members. [Three (3) Storied Steel Building]

**Description:** During the inspection, corrosion was observed on several steel members. The factory is required to remove rust and apply anti-corrosive paint on steel members.

| Item No | Observation | Action Plan | Timeline |
|---|---|---|---|
| 6. | Corrosion on the steel members. (Three (3) Storied Steel Building) | The factory is required to remove rust and apply anti-corrosive paint on steel members. | within 6 weeks |
