# Newage Garments Ltd. (Extension)

Holding-6/66/1, Road-11, Block-L, Ward-6,  
Nischintapur, Purbo Norshingpur, 1341, Ashulia, Savar, Dhaka  
(23.925080, 90.307923)

4 December 2024

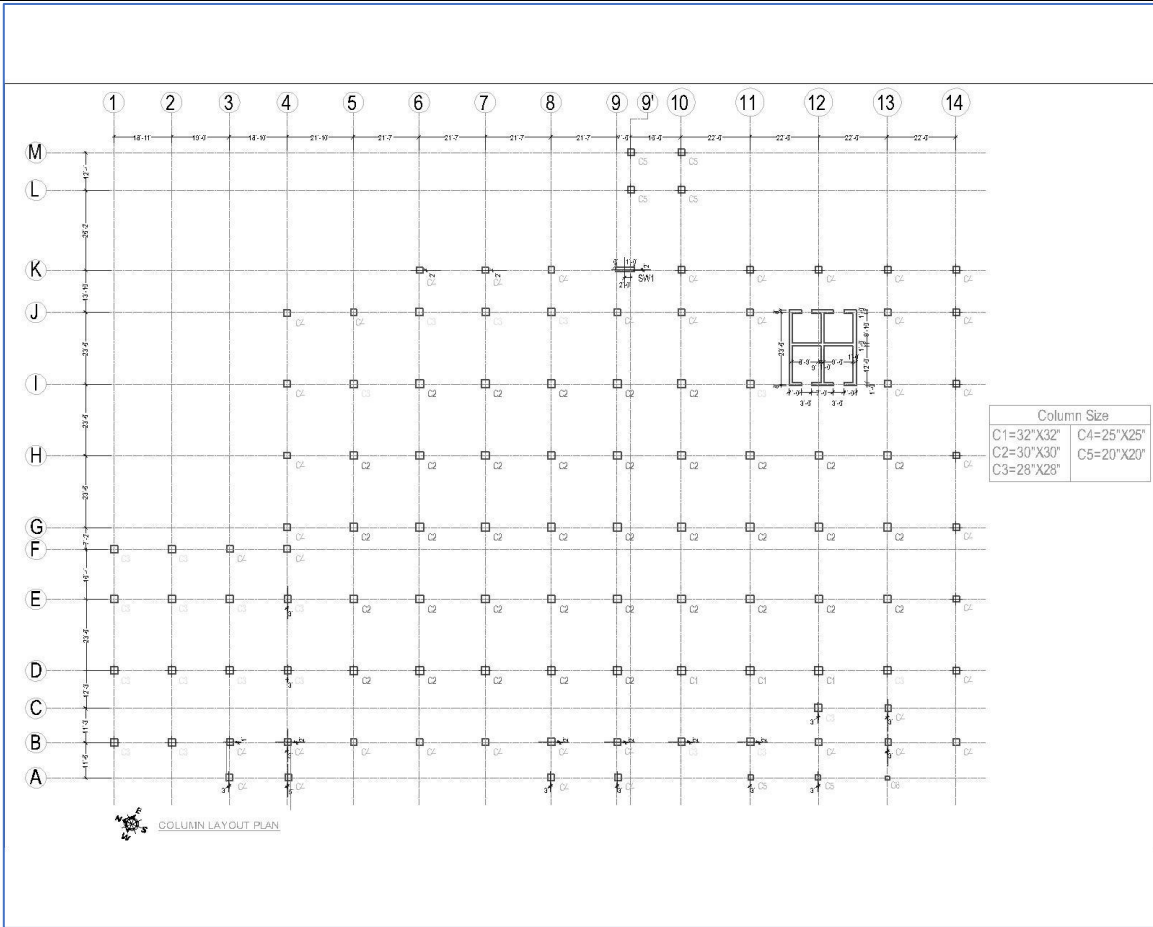
### Column layout plan

**Observation-1:** Stress in the column & foundation exceeds the normal design limit (Production Building-03)

**Description:** The cursory calculation indicated that the columns are stressed above the normal design limit considering the prepared live load plan and minimum concrete strength based on aggregate type as the frequency of testing is not met in compliance with BNBC 5.12.1.

Building engineer is required to review the design load and column stress based on the insitu material strength.

Also, building engineer is required to review the design load and MAT stress based on the insitu material strength.

| Item No. | Observation | Action Plan | Timeline |
|---|---|---|---|
| 1. | Stress in the column & foundation exceeds the normal design limit (Production Building-03) | Verify in-situ concrete strength by taking a 100-diameter concrete core from the lower-tier columns. | Immediate |
| 2. | | The building engineer is required to review the design, load and column and foundation adequacy check as per the in-situ material strength. | within 6 weeks |
| 3. | | Carry out necessary remediation work if required. | within 6 months |
| 4. | | Implement floor loading plan (posting load plan, marking storage area & height& maintaining floor loading). | within 6 months |

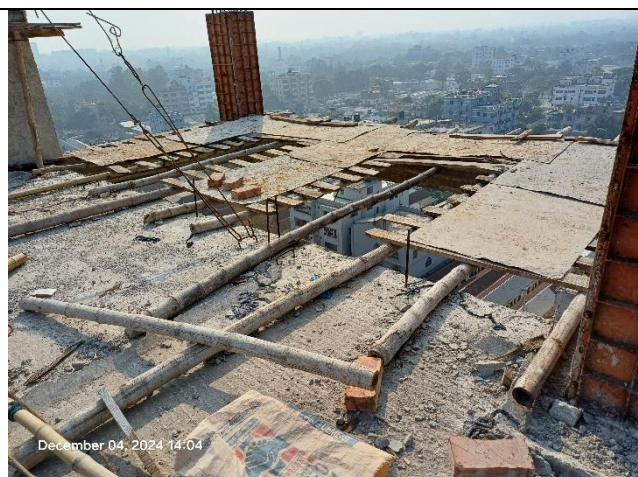
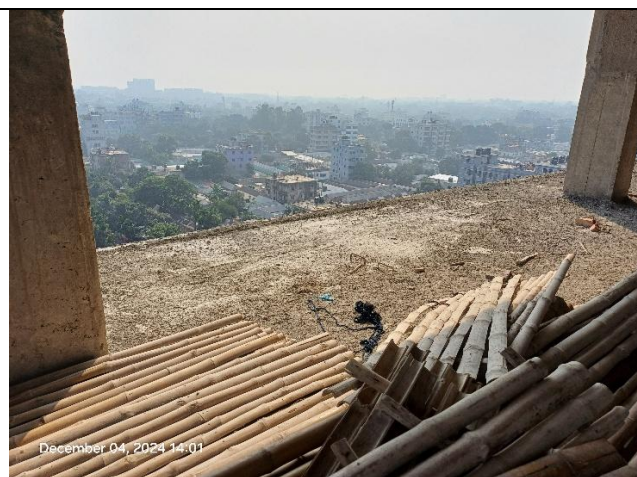
**Falling hazards**

**Observation 2: Construction safety practice on the factory premises. (Production Building-03)**

**Description:** Lack of construction safety practices observed on the factory premises. The building engineer is required to follow all the construction safety practices according to BNBC 2020, Part 7, Chapter 3.

| Item No. | Observation | Action Plan | Timeline |
|---|---|---|---|
| 5. | Construction safety practices on the factory premises. (Production Building -03) | The building engineer is required to ensure the health & safety of the workers and follow the construction safety practices according to BNBC 2020, Part 7, Chapter 3. | Immediate |

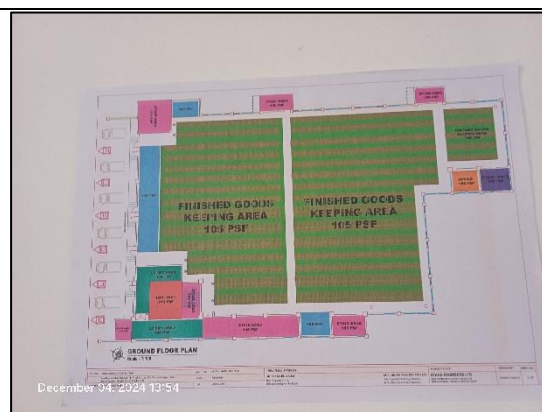
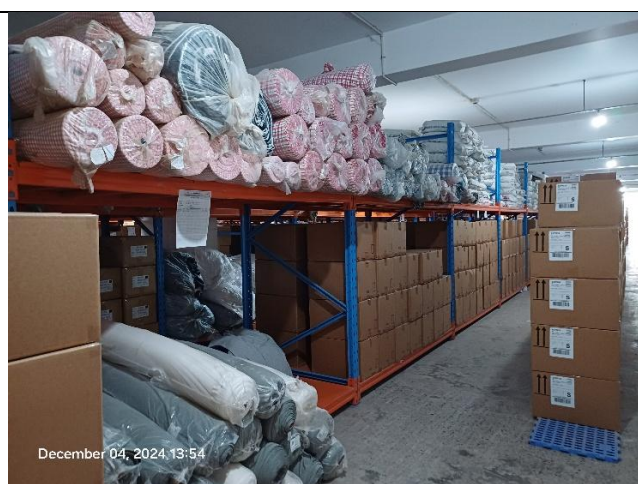
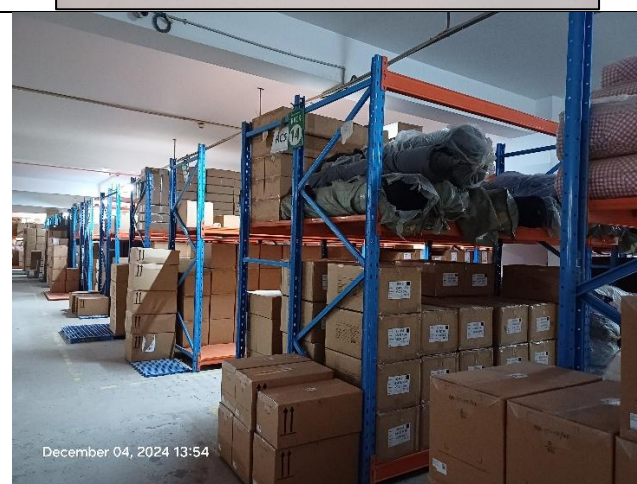
**Storage on the ground floor**

**Observation 3: Load plan does not comply with BNBC requirements. (Production Building-03)**

**Description:** The suspended ground floor of the production building-03 is allotted for storage. As per BNBC, the minimum floor live load for storage is 6 kN/m<sup>2</sup> (126 psf). However, the ground floor of the building is designed for 5 kN/m<sup>2</sup> live loads. The building engineer is required to revise the load plan and related design documents based on BNBC requirements.

| Item No. | Observation | Action Plan | Timeline |
|---|---|---|---|
| 6. | The load plan does not comply with BNBC requirements. (Production Building -03) | The building engineer is required to revise the load plan based on BNBC requirements. | within 6 weeks |

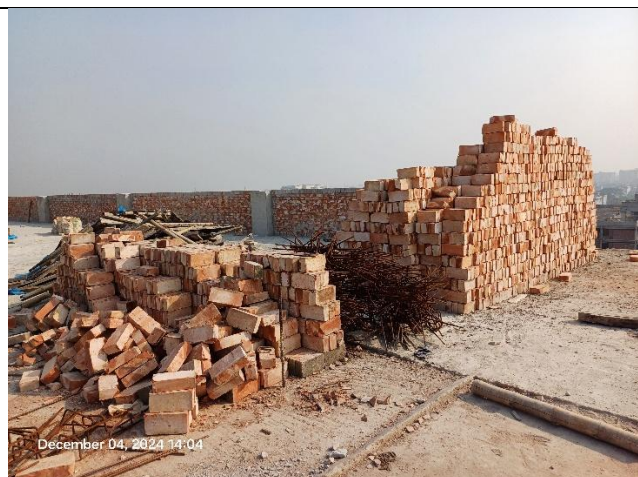
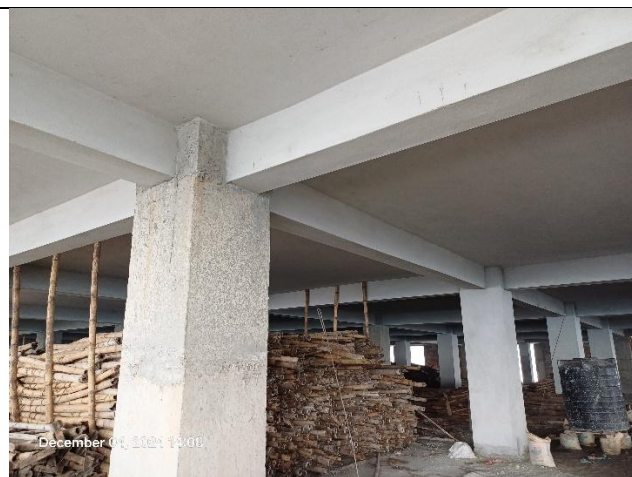
**Observation 4:** Construction materials/debris on the floor and roof level. (Production Building-03)

**Description:** Construction materials/debris were found almost everywhere on the roof and some other floor levels. The building engineer is required to remove all kinds of construction materials from the floor and roof.

| Item No. | Observation | Action Plan | Timeline |
|---|---|---|---|
| 7. | Construction materials/debris on the floor and roof level. (Production Building -03) | The building engineer is required to remove all kinds of construction materials from the floor and roof. | within 6 weeks |

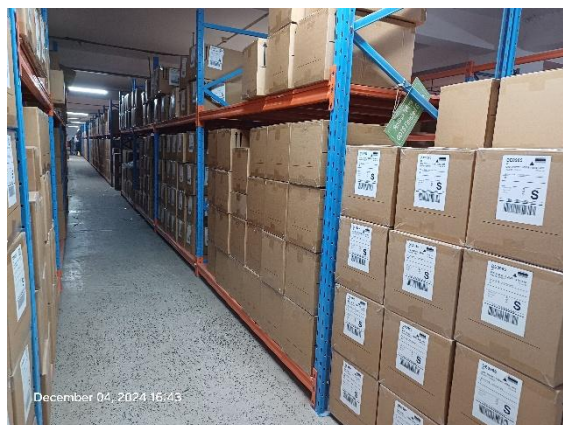
**Observation-5:** Unbraced storage racks on different floors (Production Building-03).

**Description:** Unbraced storage racks were observed on different floors. The building engineer is required to provide anchorage/bracing to the storage racks to protect them from falling hazards.

| Item No. | Observation | Action Plan | Timeline |
|---|---|---|---|
| 8. | Unbraced storage racks on different floors (Production Building -03) | The building engineer is required to provide anchorage/bracing to the storage racks to protect them from falling hazards. | within 6 months |

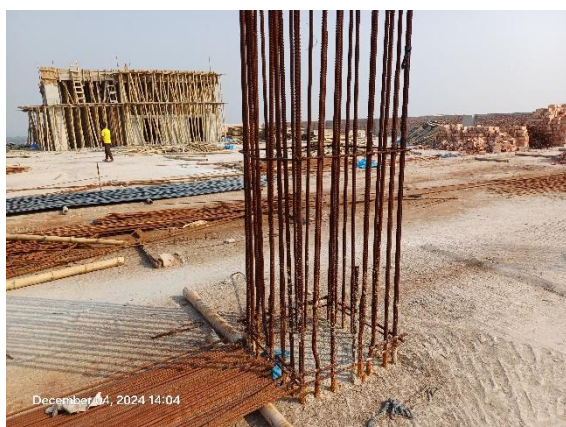
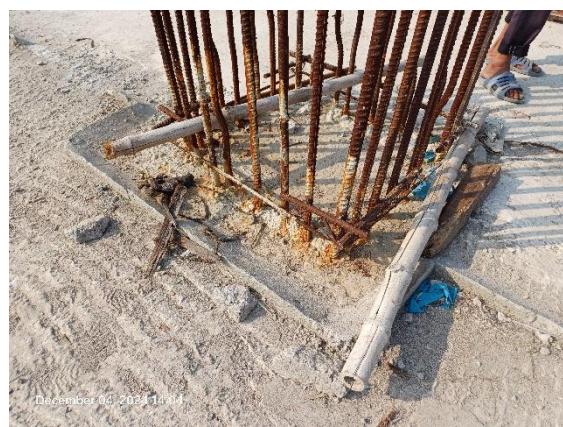
**Observation-6:** Exposed rebar on roof level (Production Building-03).

**Description:** Exposed re-bar was observed on the roof, which is prone to corrosion. The building engineer is required to provide anti-corrosive coating on the exposed rebar.

| Item No. | Observation | Action Plan | Timeline |
|---|---|---|---|
| 9. | Exposed re-bar on roof level (Production Building -03). | The building engineer is required to provide anti-corrosive coating on the exposed rebar. | within 6 months |

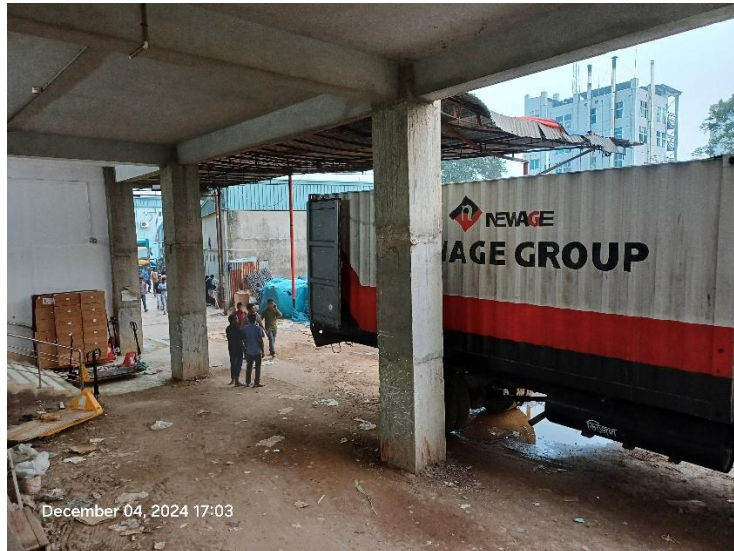
**Observation-7:** Column susceptible to vehicle impact (Production Building-03).

**Description:** Column at the ground floor loading/unloading area was found susceptible to vehicle impact. The building engineer is required to provide separate barriers around the column to avoid vehicle impact.

| Item No. | Observation | Action Plan | Timeline |
|---|---|---|---|
| 10. | Column susceptible to vehicle impact (Production Building -03). | The building engineer is required to provide barriers around the column to prevent vehicle impact. | within 6 weeks |

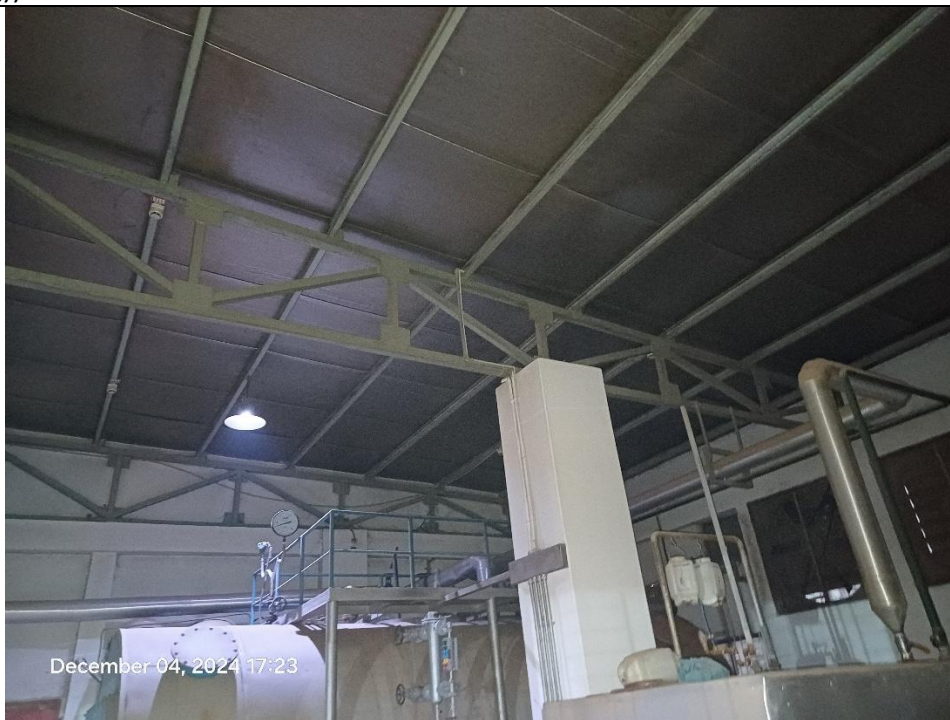
Truss in North-South direction

**Observation 8:** Lack of lateral stability system at roof (Ancillary Building-01 (Captive Generator & EGB Building)).

**Description:** Lack of lateral stability system (bracing & strut) at roof level was found along the long direction. So, lateral stability in the long direction is incomplete. The building engineer is required to check the stability system of the existing structure, prepare an assessment report and submit it to RSC for review.

| Item No. | Observation | Action Plan | Timeline |
|---|---|---|---|
| 11. | Lack of lateral stability system (Ancillary Building - 01 (Captive Generator & EGB Building)) | The building engineer is required to check the stability system of the existing structure, prepare an assessment report and submit it to RSC for review. | within 6 weeks |
| | | Implement remediation work if required. | within 6 months |

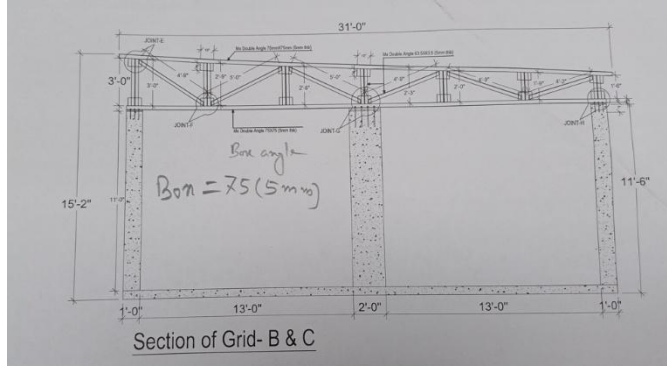
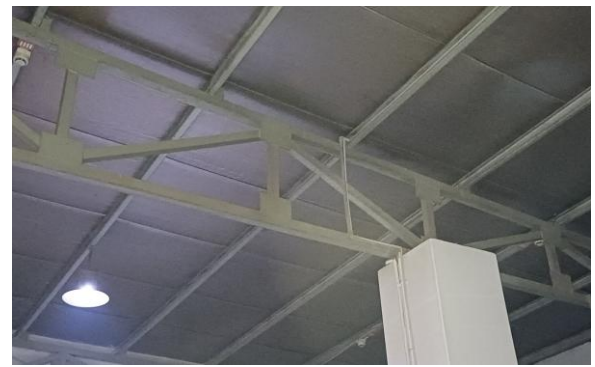
**Observation 9:** Discrepancies in as-built drawing (Ancillary Building-01 (Captive Generator & EGB Building)).

**Description:** During the inspection, the roof truss was found made of steel box members. But the as-built structural drawing showed a double angle. Also, the floor height was found to be higher than the provided height. The building engineer is required to survey the structure and update the as-built drawing as per BNBC.

| 12. | Discrepancies in as-built drawing (Ancillary Building-01 (Captive Generator & EGB The building )) | The building engineer is required to survey the structure and update the as-built drawing as per onsite conditions. | within 6 weeks |

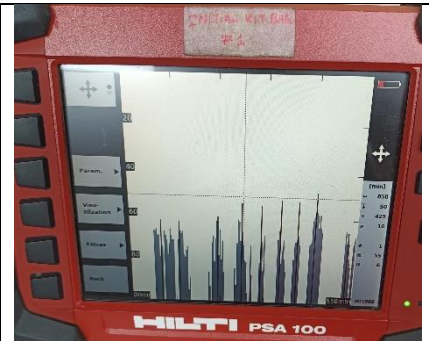
**Observation 10:** Mismatches in as-built drawings (Ancillary Building-02 (Fire Control Room & Office Building)).

**Description:** Rebar at C-3 type column not matched with drawings. The number of rebar found 20 instead of 24. Building engineer is required to confirm the amount of rebar in the column and update the drawing.

| 13. | Mismatches in as-built drawings (Ancillary Building-02 (Fire Control Room & Office The building )). | The building engineer is required to confirm the amount of rebar in the column and update the drawings. | within 6 weeks |

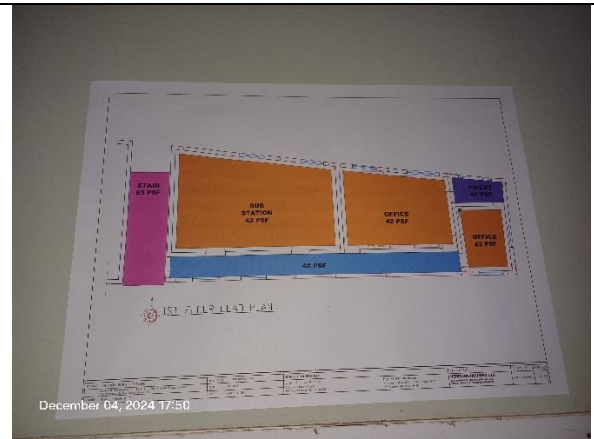
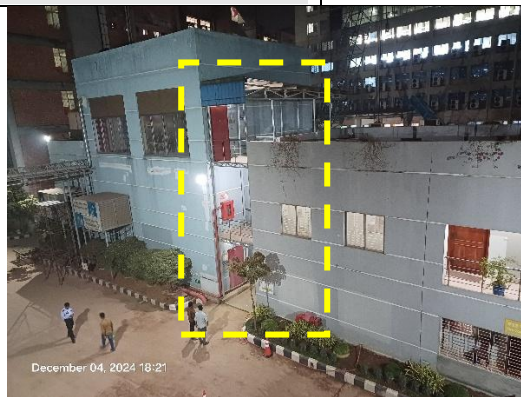
**Observation 11:** Load plan does not comply with BNBC requirements (Stair Portion) (Ancillary Building-02 (Fire Control Room & Office Building)).

**Description:** There is a steel staircase between Ancillary Building-01 and Ancillary Building-02. As per BNBC, the minimum floor live load for stairs is 4.8 kN/m<sup>2</sup> (100 psf). But the stair is designed for 3 kN/m<sup>2</sup> (63 psf) live loads.

The building engineer is required to revise the load plan and related design documents based on BNBC requirements.

| 14. | Load plan does not comply with BNBC requirements (Stair Portion) (Ancillary Building-02 (Fire Control Room & Office Building)). | The building engineer is required to revise the load plan and related design documents based on BNBC requirements. | within 6 weeks |
| | | Implement remediation work if required. | within 6 months |

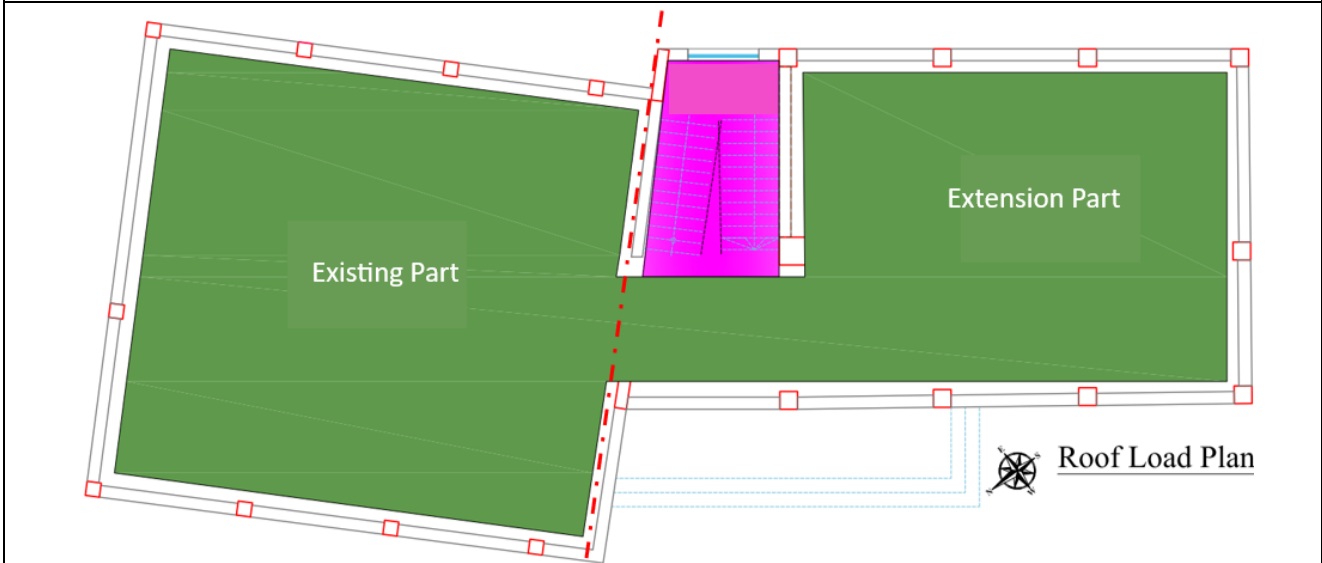
**Observation 12:** Concrete strength for the phase construction (Ancillary Building-03 (Diesel Generator & Compressor Building)).

**Description:** The existing part was constructed in 2014-2015 and the extension part was constructed in 2017-2018, so phase construction was conducted. Building engineer is required to confirm the in-situ concrete strength of the separate parts due to the phase of construction.

| 15. | Concrete strength for the phase construction (Ancillary Building-03 (Diesel Generator & Compressor The building )). | The building engineer is required to verify in-situ concrete strength for each separate part of the building. | within 6 weeks |

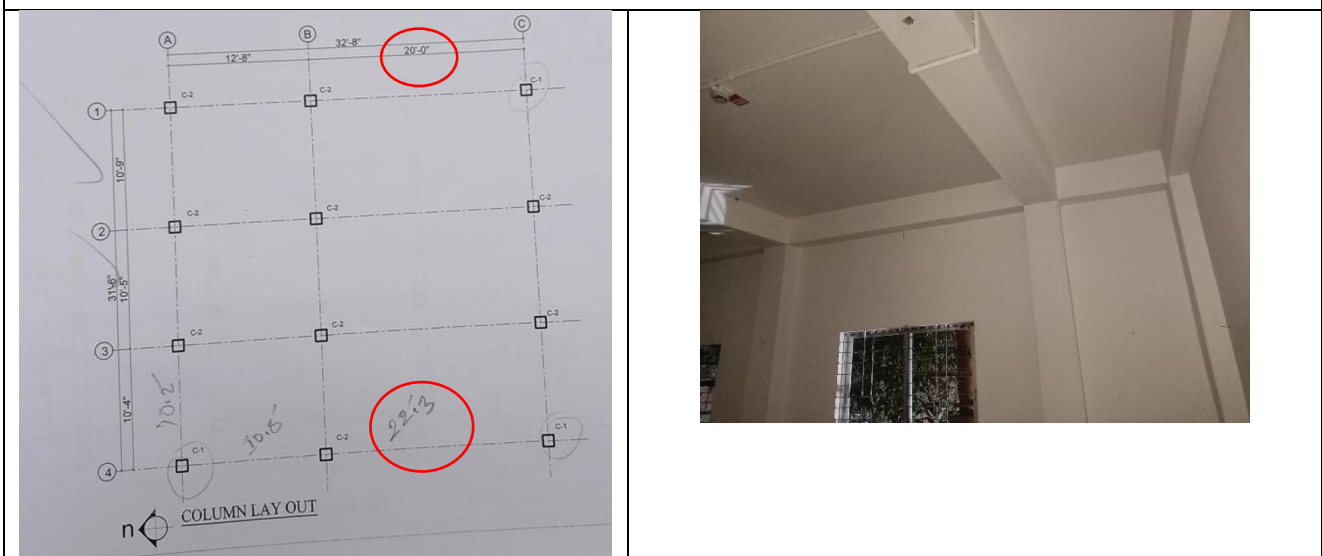
**Observation 13:** Mismatches in as-built drawings (Ancillary Building-03 (Diesel Generator & Compressor Building)).

**Description:** The C1 column was found to be 300mmx300mm (12X12 inches) instead of 350mmx350mm and the down stand of the beam was 300 mm instead of 450 mm. Also, one grid was measured at 6.7m (22 feet), whereas the drawing shows 6.1 m (20 feet). The building engineer is required to survey the structure and update the as-built drawing as per onsite conditions.

| 16. | Mismatches in as-built drawings (Ancillary Building-03 (Diesel Generator & Compressor The building )). | The building engineer is required to survey the full structure and revise the as-built drawing as per on-site conditions. | within 6 weeks |

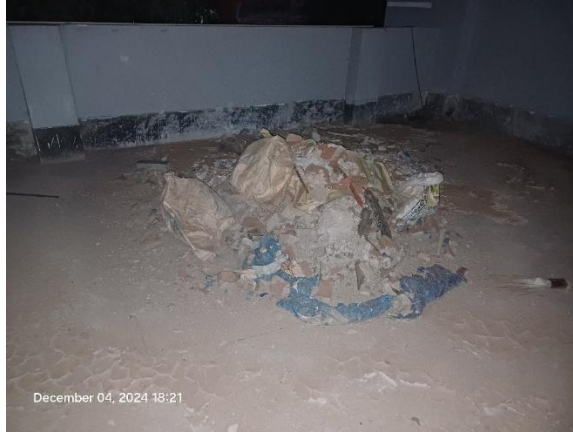
**Observation 14:** Construction debris on the roof level. (Ancillary Building-03 (Diesel Generator & Compressor Building)).

**Description:** Construction debris was found on the roof level. The building engineer is required to remove all kinds of construction debris from the roof.

| 17. | Construction debris on the roof level. (Ancillary Building-03 (Diesel Generator & Compressor Building)) | The building engineer is required to remove all kinds of construction debris from the roof. | within 6 months |

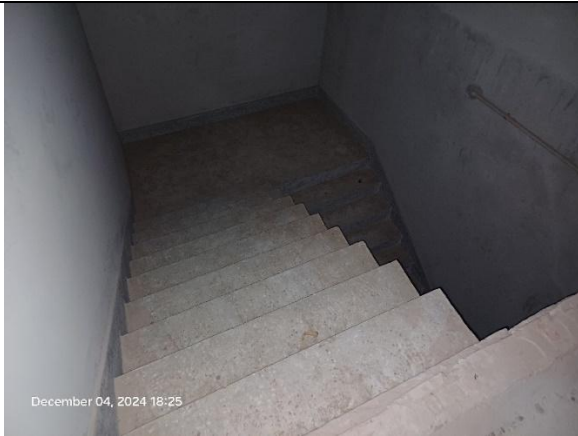
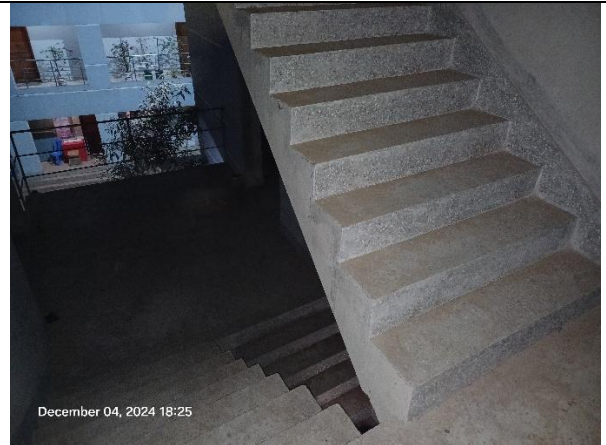
**Observation 15:** Falling Hazard (Ancillary Building-03 (Diesel Generator & Compressor Building)).

**Description:** Falling hazard due to a lack of railing was observed in the stair locations. The building engineer is required to take necessary measures to avoid possible falling hazards.

| 18. | Falling Hazard at stair zone (Ancillary Building-03 (Diesel Generator & Compressor Building)) | The building engineer is required to provide a railing/barrier to the open stairs to avoid possible falling hazards. | Immediate |

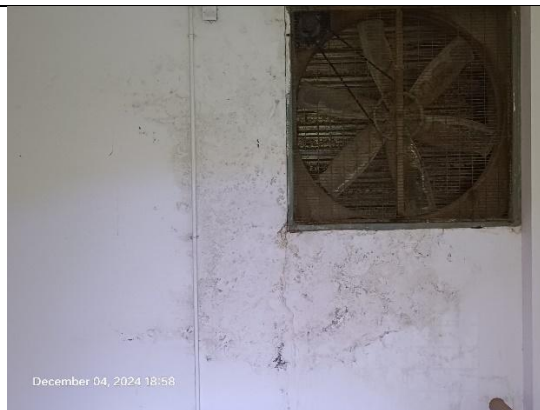
**Observation 16:** Dampness on the brick wall (Ancillary Building-04 (Fire Pump Room & Boiler Building)).

**Description:** Dampness on the brick wall was observed. The building engineer is required to seal the source of water and repair the damp areas with suitable methods.

| 19. | Dampness on the brick wall (Ancillary Building-04 (Fire Pump Room & Boiler The building )) | The building engineer is required to seal the source of water and repair the damp areas with suitable methods. | within 6 months |

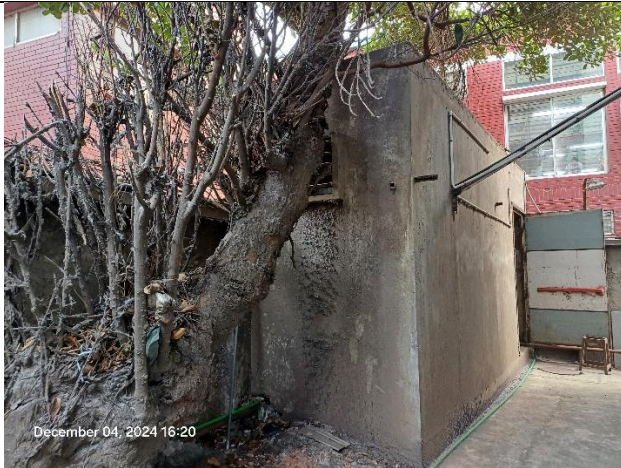
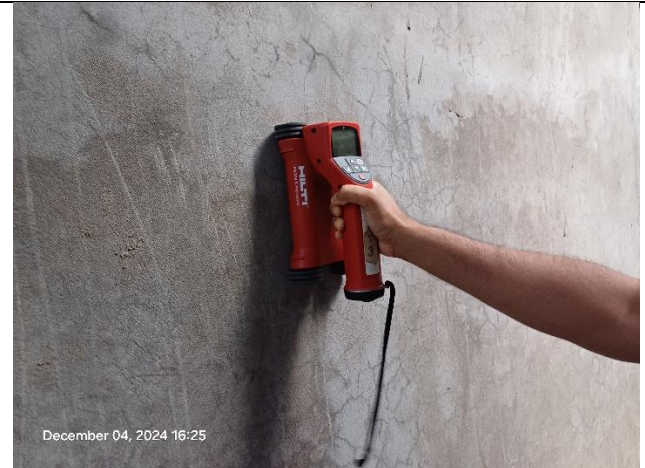
**Observation 17:** Mismatches in as-built drawings (Compressor Room-01 (NGL Compressor Room)).

**Description:** No RC column was found in Compressor Room-01 (NGL Compressor Room). But as built drawings showed RC columns. The building engineer is required to confirm the presence of RC columns and update the drawing.

| 20. | Mismatches in as-built drawings (Compressor Room-01 (NGL Compressor Room)) | The building engineer is required to confirm the presence of RC columns and update the drawing. | within 6 weeks |

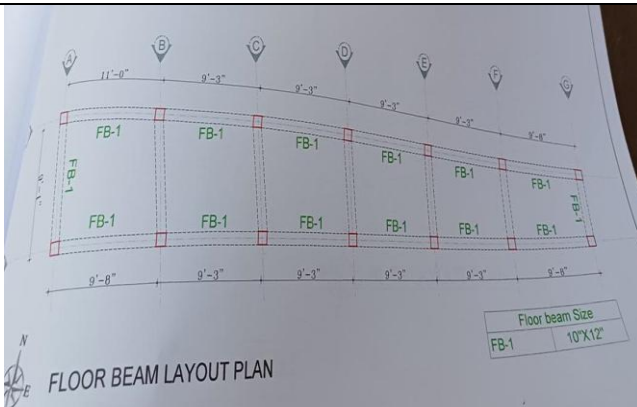
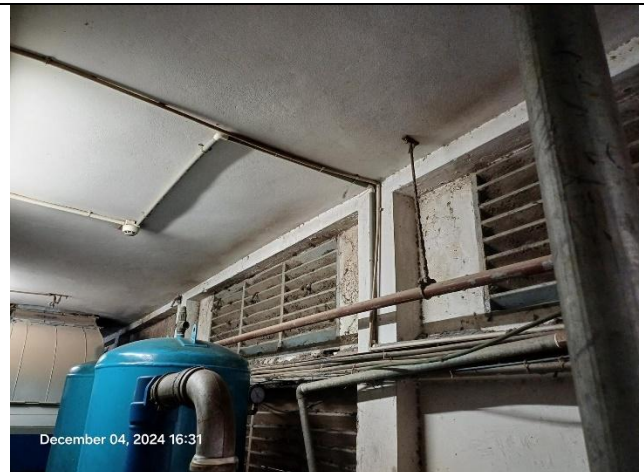
**Observation 18:** Mismatches in as-built drawings (Compressor Room-02 (NAL Compressor Room)).

**Description:** The beam layout did not match with as built condition. In the short direction, no beam was found on site. Building engineer is required to survey the structure and update the drawing.

| 21. | Mismatches in as-built drawings (Compressor Room-02 (NAL Compressor Room)) | The building engineer is required to survey the structure and update the drawing. | within 6 weeks |

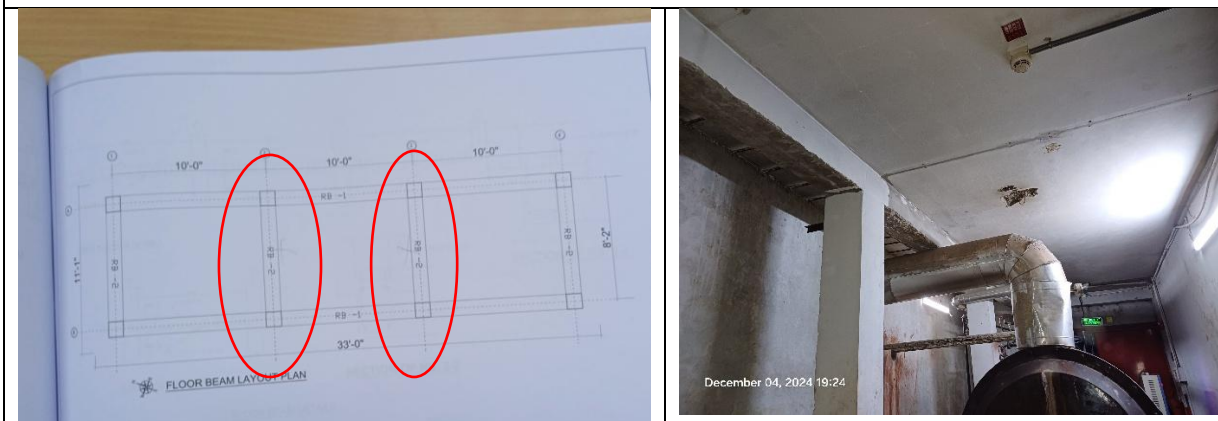
**Observation 20:** Mismatches in as-built drawings (Ancillary Building-05 (New Boiler Room)).

**Description:** During the inspection, the roof beam was not found onsite as shown in the as-built drawing. Building engineer is required to survey the structure and update the drawings.

| 23. | Mismatches in as-built drawings (Ancillary Building-05 (New Boiler Room)) | The building engineer is required to survey the structure and update the drawings. | within 6 weeks |

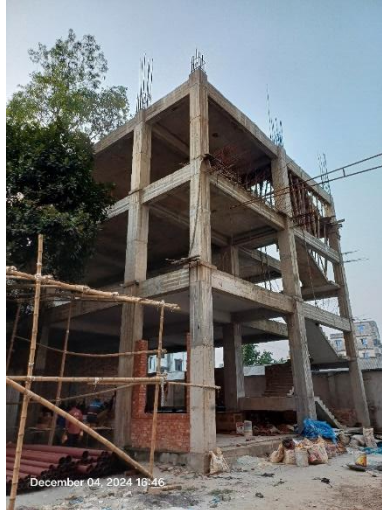
**Observation 21:** Building permit from local authority not available. (Ancillary Building-07 (03 Storied Boiler Building)).

**Description:** During the inspection, a building permit from the local authority was not available for the 03 Storied Boiler Building. The factory authority is required to collect building permits from the BNBC prescribed local authority.

| 24. | The building permit from local authorities are not available. (Ancillary Building-07 (03 Storied Boiler Building)). | The factory authority is required to collect The building permits from the BNBC-prescribed local authority. | within 6 months |

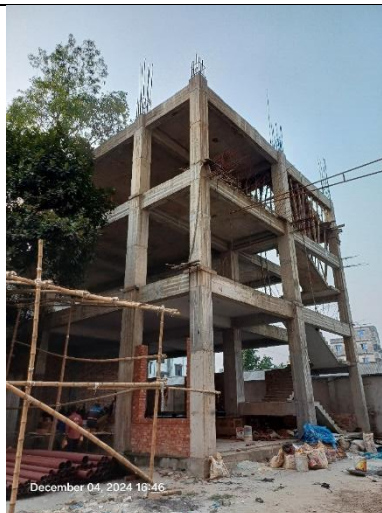
**Observation 22:** Lack of design documents (Ancillary Building-07 (03 Storied Boiler Building)).

**Description:** As per BNBC, every building or structure designed shall have its design documents prepared following the provision of Section 1.9.1. The design document shall include a design report, and a set of structural drawings, which shall be prepared in compliance with section 1.9.1.1 and section 1.9.1.2 as per BNBC.

At the time of inspection, design documents (design report, load plan, and material test reports) were not available which are required to be prepared in compliance with section 1.9.1 (part-6, BNBC).

| 25. | Lack of design documents (Ancillary Building-07 (03 Storied Boiler Building)). | The building engineer is required to prepare design documents (including design reports, load plans, and material test reports) in compliance with section 1.9.1 (part-6, BNBC) and submit them to RSC. | within 6 weeks |
| | | Implement remediation work if required. | within 6 months |
