# INITIAL FIRE SAFETY INSPECTION REPORT

**DMC Apparels Ltd**

**RSC ID: 26420**

**Date: 04-November-2025**

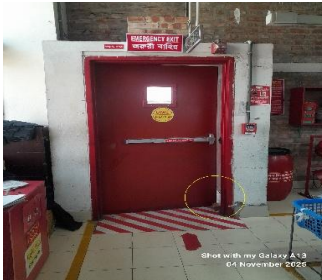
| SI No. | Category | Findings | Required Action | Remediation Time Frame |
|---|---|---|---|---|
| F-1 | Means of Egress | <p>The fire doors were found tied by unauthorized means and also interfacing with the fire alarm system &amp; door closers were not properly functional during the inspection.</p> <p><b>Location: 5th floor at north-East side exit stair, Block-J.</b></p> | <p>Ensure that the fire doors are self-closing and positive latching. If fire doors are required to be held open for functional reasons, provide automatic closing devices tied to the fire alarm system.</p> | Within 3 Months |

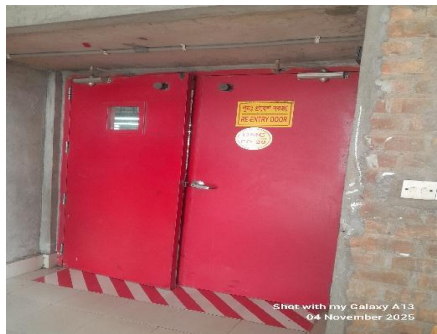
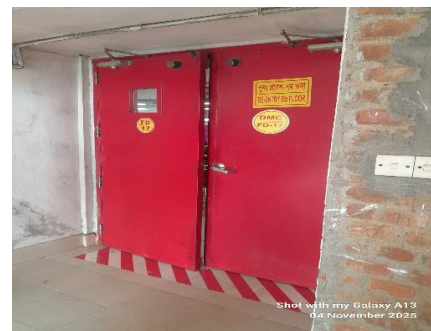
| SI No. | Category | Findings | Required Action | Remediation Time Frame |
|---|---|---|---|---|
| F-2 | Means of Egress | <p>During the inspection, it was noted that the fire doors were not effectively latching and door coordinator were not properly functional.</p> <p><b>Location: All floors, Block-J.</b></p> | <p>Ensure that the fire doors are self-closing and positive latching. If fire doors are required to be held open for operational purposes, provide automatic closing devices tied to the fire alarm system.</p> | Within 3 Months |

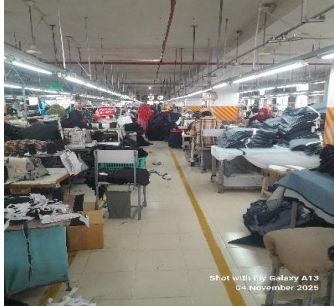
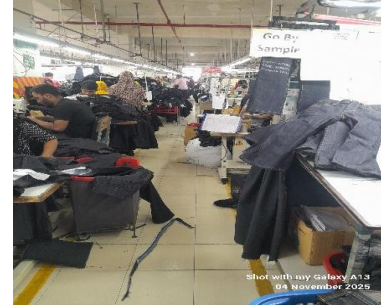
| F-4 | Means of Egress | <p>The egress path along means of egress has interrupted by obstruction/storage/process work/machineries.</p> <p><b>Location: 3rd floor to 6th floor, Block-J.</b></p> | <p>Keep egress paths and stairs clear of storage/obstruction in accordance with section 6.3.9 of RSC Technical Guidelines (Standard)<sup>1</sup> V1.0.</p> <p>Means of egress shall be maintained continuously free and clear of all obstructions or impediments to full instant use in the case of fire or other emergency. No furnishings, decorations, or other objects shall obstruct exits and access to exits. Nothing shall obstruct or impede visibility to exits.</p> | Immediately |

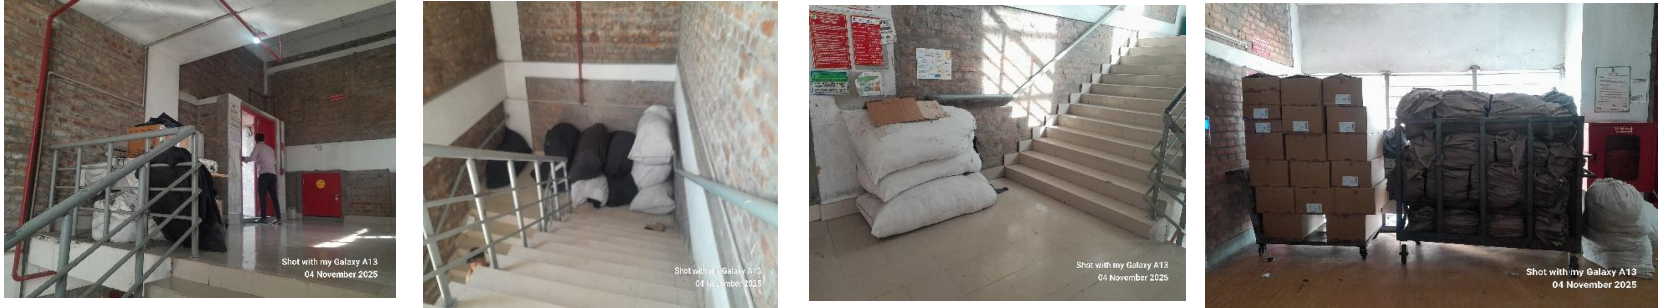
| F-8 | Means of Egress | <p>Storage was located in the exit stair/stair enclosure.</p> <p><b>Location: All exit stair, All floors, Block-J.</b></p> | <p>Remove all storage from exit stairs and egress path in accordance with section 13.8 of RSC Technical Guidelines (Standard)<sup>1</sup> V1.0.</p> <p>Means of egress shall be maintained continuously free and clear of all obstructions or impediments to full instant use in the case of fire or other emergency. No furnishings, decorations, or other objects shall obstruct exits and access to exits. Nothing shall obstruct or impede visibility to exits.</p> | Immediately |

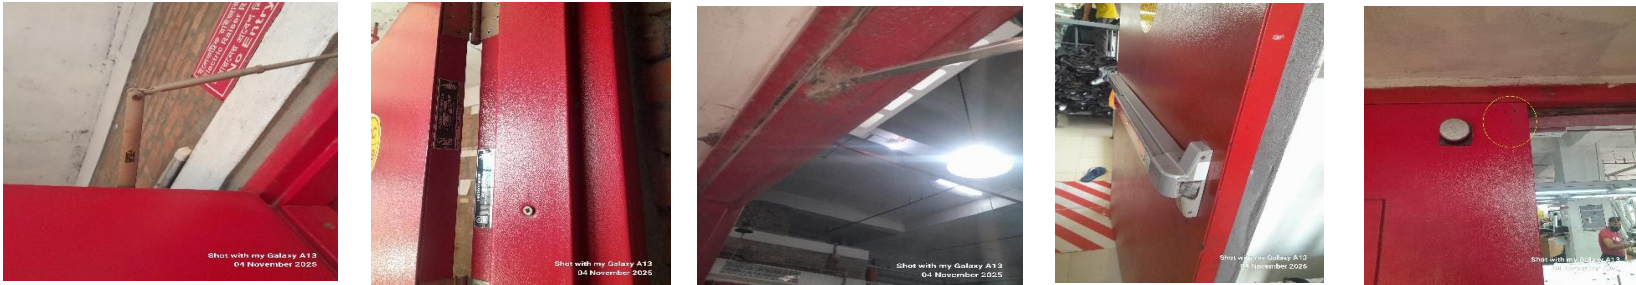
| F-9 | Means of Egress | <p>It was observed that installed some fire doors accessories are missing/damaged, normal printed on the fire doors, some door were holes, smoke sealing missing &amp; listing label missing.</p> <p><b>Location: West &amp; West-south side exit stair, Block-J.</b></p> | <p>Replace/install the non-functional/missing fire door accessories and properly inspect, test &amp; maintain fire door as per NFPA 80.</p> <p>In cases of a field modification, the laboratory with which the product or component being modified is listed shall be contacted through the manufacturer and a written or graphic description of the modifications shall be presented to that laboratory. A written authorization from that laboratory is required. Field modification shall conduct as per NFPA 80.</p> | Within 3 Months |

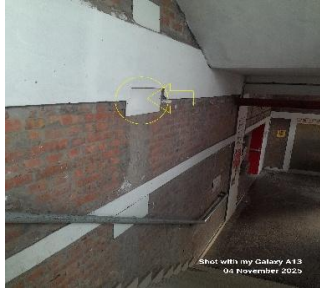
| F-11 | Means of Egress | <p>Unsealed penetrations and openings are located in exit stair enclosures.</p> <p><b>Location(s): West side exit stair , Block-J.</b></p> <p><b>Non-Compliance: Unseal penetration through electrical cable Box.</b></p> | <p>No other penetration into and through the exit enclosure except for fire alarm equipment electrical raceway, required exit doors, sprinkler piping, standpipes, and electrical conduit serving the exit enclosure is permitted in accordance with section 6.14.4 of RSC Technical Guidelines (Standard)<sup>1</sup> V1.0. So, relocate the electrical wires/raceways to somewhere else avoiding the exit enclosure, and seal the created unprotected openings with a minimum of 1.5 hours listed/certified fire-rated materials. Installation shall be as per manufacturer published installation guideline and the certification authority guideline to ensure the fire-rating.</p> <p>Or</p> <p>seal the penetration by 2-hr masonry construction.</p> | Within 3 Months |

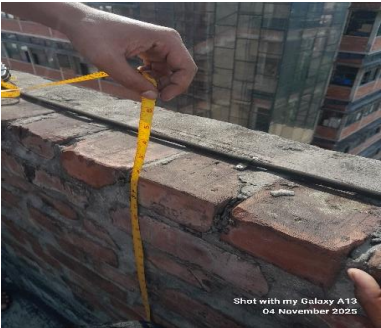
| F-13 | Means of Egress | <p>Parapets is provided which less than 42inch in occupiable roof.</p> <p><b>Location: Block-J.</b></p> <p><b>Available: 38 inch.</b></p> | <p>Provide parapets or guards with a minimum height of 1067mm (42 inch.) in accordance with RSC Technical Guidelines (Standard)<sup>1</sup> V1.0 Section 6.12.</p> | Within 3 Months |

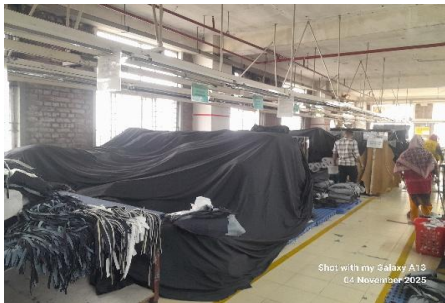
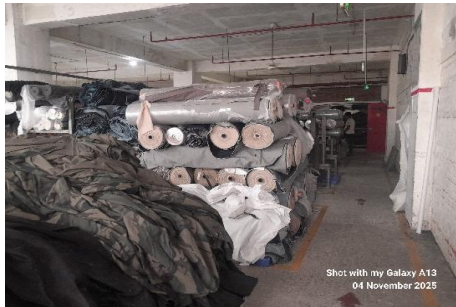
| <b>F-17</b> | Fire rated construction | <p>Areas used for in-process storage of combustible materials are open to the surrounding occupancy.</p> <p><b>Location: 3rd &amp; 4th Floors, Block-J.</b></p> | <p>Provide defined storage areas and limit the storage arrangement as follows:</p> <p>Maximum height of 2.45 m and maximum area of 23 m<sup>2</sup> and is separated by a minimum 3.0 m (10ft) from other storage areas and they do not exceed 10 percent of the building area of the story in which they occur.</p> <p>or,</p> <p>If sprinkler protected, Maximum height 12 ft (3.66 m) and maximum area of 1000 ft<sup>2</sup> (93 m<sup>2</sup>) and separated by at least 25 ft (7.62 m) and does not constitute more than 10 percent of the building area or 4000 ft<sup>2</sup> (372 m<sup>2</sup>) of the sprinklered area, whichever is greater.</p> <p>or,</p> <p>Enclose the storage area from the surrounding occupancy with a minimum 1 hour construction.</p> | Within 3 Months |

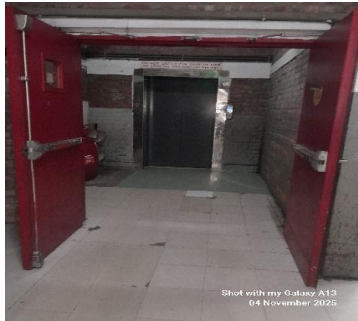
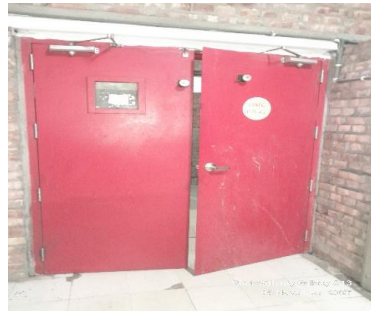
| F-18 | Fire rated construction | <p>It was observed that one Cargo lift shafts open directly into the production floors which is separated by 2 hr. fire-rated barrier, and the installed fire doors for opening protection which not properly functional.</p> <p><b>Location: Block-J.</b></p> <p><b>Non-Compliance: 1. Installed fire doors are not functional.</b></p> <p><b>2. Installed fire doors certificate are not available for verification.</b></p> | <p>Elevator shaft shall be separated from the production area by 2 hours fire fire-rated construction. 2-hr fire barriers shall be protected with minimum 1.5-hr fire protective opening assemblies.</p> <p>Keep proper datasheet &amp; certifications for installed fire-rated doors &amp; accessories on-site for verification.</p> | Within 3 Months |

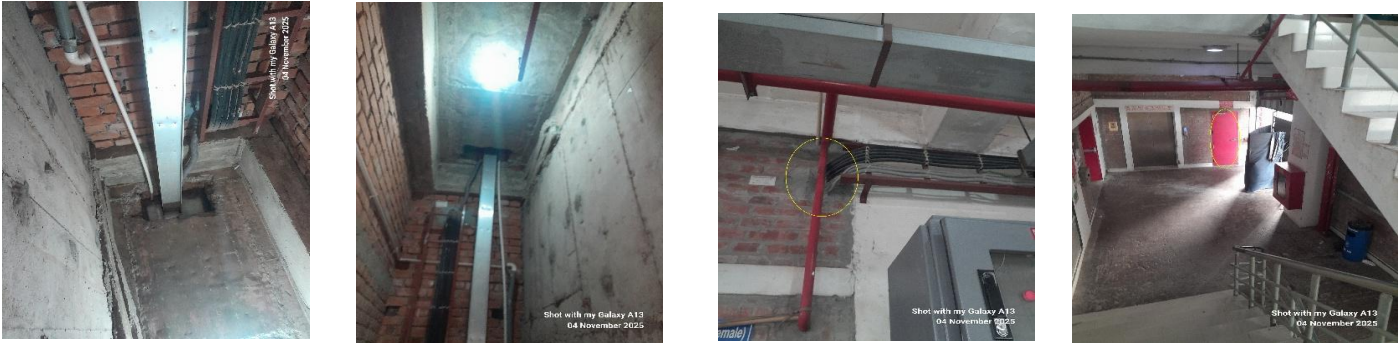
| F-19 | Fire Rated Construction | <p>Penetrations through floor/ceiling &amp; wall assemblies are found unsealed for BBT &amp; electrical cable.</p> <p>Factory has installed fire-rated sealant materials to seal electrical cable penetrations &amp; installed fire doors but required documents, relevant design ,certificate etc. not available on-site.</p> <p><b>Location: All floors, Block-J.</b></p> <p><b>Non-compliance: 1. Installed fire door certificate are not available for verification.</b><br/> <b>2. Smoke sealing missing.</b><br/> <b>3. Certificate &amp; design are not available for provided fire stop sealant materials for horizontal penetration purpose.</b></p> | <p>Seal all penetrations and openings in floor/ceiling assemblies by a listed through-penetration fire stop system tested in accordance with ASTM E814 or approved alternative standard to maintain minimum 3-hr. fire resistance rating. Installation shall be as per the manufacturer's published installation guidelines and the certification authority guideline to ensure the fire-rating in accordance with section 4.7 of RSC Technical Guideline (Standard)</p> <p>Or,</p> <p>Provide a minimum 2-hr fire-rated shaft to separate the penetration from each floor if required.</p> <p>Installation shall be as per the manufacturer's published installation guidelines and the certification authority guidelines to ensure the fire rating.</p> <p>Keep proper datasheet ,certifications &amp; design for installed fire-stop sealant materials &amp; installed fire doors on-site for verification.</p> | Within 3 Months |

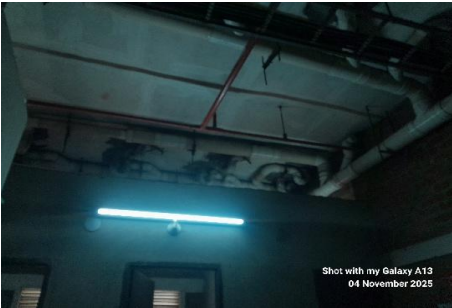
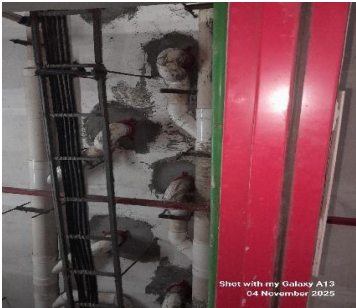
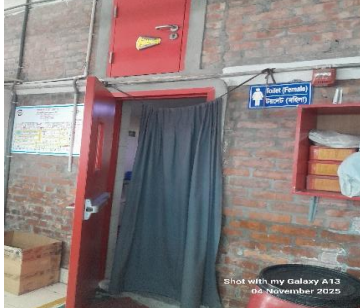
| F-20 | Fire Rated Construction | <p>It was observed that plastic plumbing pipe penetrations through floor/ceiling assemblies are found unsealed due to installed fire rated collar certificate, design and installed fire doors certificate are not available on side for verification.</p> <p><b>Location: All floors, Block-J.</b></p> <p><b>Non-Compliance: 1. Installed fire door certificate &amp; datasheet are not available on side.</b></p> <p><b>2. Installed fire door are not proper functional.</b></p> <p><b>2. Installed fire rated collar certificate &amp; design are not available on side.</b></p> | <p>Seal all penetrations and openings in floor/ceiling assemblies by a listed through-penetration fire stop system tested in accordance with ASTM E814 or approved alternative standard to maintain minimum 3-hr. fire resistance rating. Installation shall be as per the manufacturer's published installation guidelines and the certification authority guideline to ensure the fire-rating in accordance with section 4.7 of RSC Technical Guideline (Standard)</p> <p>Or,</p> <p>Provide a minimum 2-hr fire rated shaft to separate the penetration from each floor if required.</p> <p>Keep proper datasheet ,certifications &amp; design for installed fire rated collar &amp; installed fire doors on-site for verification. If fire doors are required to be held open for operational purposes, provide automatic closing devices tied to the fire alarm system.</p> | Within 3 Months |

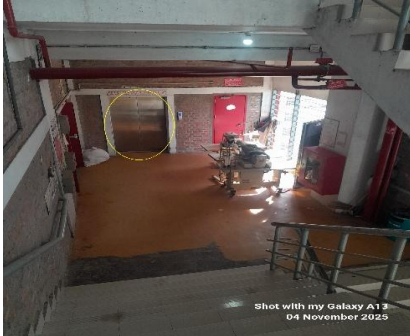
| F-21 | Fire Rated Construction | <p>Elevator shafts open directly into the exit enclosure, which doesn't comply with RSC Technical Guidelines (Standard), section 6.14.3.</p> <p><b>Location: West side exit stair, Block-J.</b></p> | <p>Provide a minimum 2-hr fire rated elevator shaft to separate it from stair enclosure. No discharge is accepted through elevator shaft. Seal all openings to maintain fire separations.</p> | Within 3 Months |

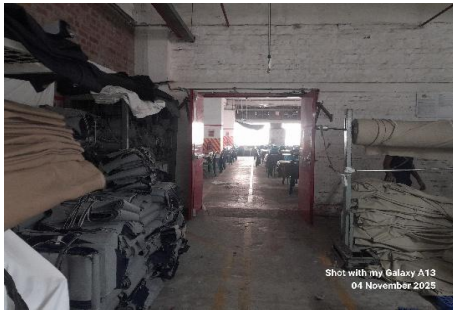
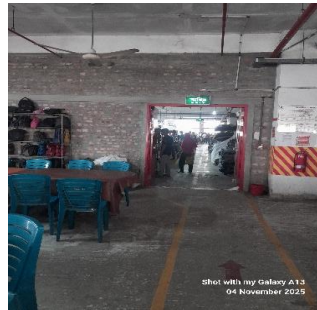
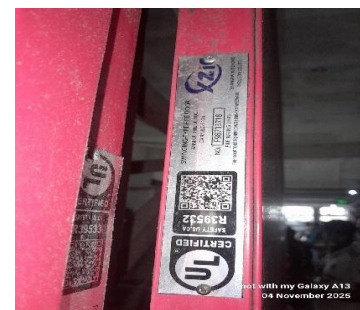
| F-22 | Fire Rated Construction | <p>Dining (E4=224) area is not separated from the production due to installed 2hr fire-rated door on the store &amp; non functional fire doors.</p> <p><b>Location: 3rd Floor, Block-J.</b></p> <p><b>Non-Compliance: 1. Installed 2hr fire door with non functionality.</b></p> <p><b>2. Exit through production floor.</b></p> <p><b>3. Installed fire door technical datasheet &amp; certificate are not available on side.</b></p> | <p>Separate the dining area from other occupancies with 3-hr fire rated construction, provide minimum 3-hr. rated doors for the openings and seal the unprotected penetrations.</p> <p>Provide required exits that lead directly to the street or exit stairwell or leading to a corridor or open space. Assemblies of Occupancy E3, E4 and E5 shall have at least two means of exits leading directly to the street or leading to a corridor or open space having access to exits in two independent and different directions. (part-4, section-3.21.3, BNBC-2006).</p> | Within 3 Months |

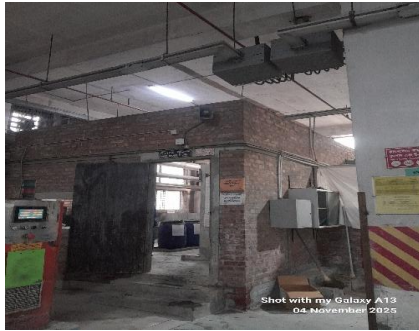
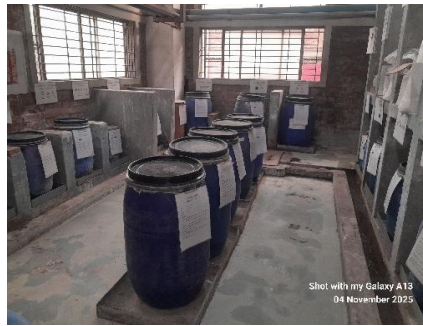
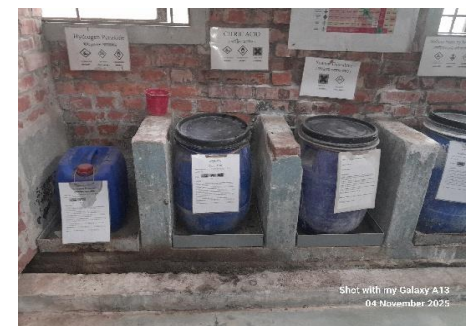
| F-23 | Fire Rated Construction | <p>Chemical storage area(hydrogen peroxide&amp; Acid) is not proper separated by fire-rated construction due to unprotected opening &amp; unsealed penetrations.</p> <p><b>Location: Ground floor, Block-J.</b></p> | <p>Provide a 4-hour fire-rated construction barrier to separate the chemical store from the surrounding production/combustible storage areas. The 4-hour fire-resistive separation shall have no openings/ no unprotected openings therein and shall provide a fire resistance for at least four hour.</p> <p>Chemical stores shall comply with BNBC 2006, Part 3, Section 2.13.</p> <p>Or,</p> <p>Ensure exempt amounts of chemical are located on chemical stores with other occupancy as per Table 3.2.7 (BNBC 2006).</p> | Within 3 Months |

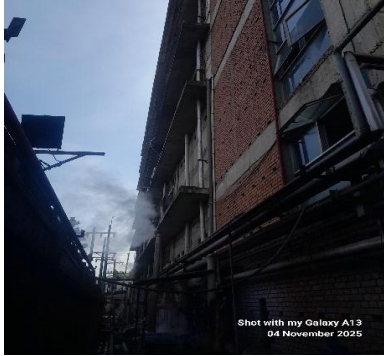
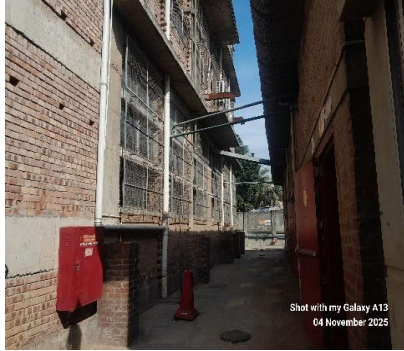
| F-24 | Fire Rated Construction | <p>The required fire separation distance for the (BLOCK-J (FACTORY BUILDING)) does not comply with the requirements of BNBC 2006.</p> <p><b>Location: South, North &amp; east side, Block-J.</b></p> | <p>The exterior walls shall have a fire resistance and opening protection as specified in BNBC 2006, Tables 3.2.2 and Part 3 Section 2.4.1.3.</p> | Within 6 Months |

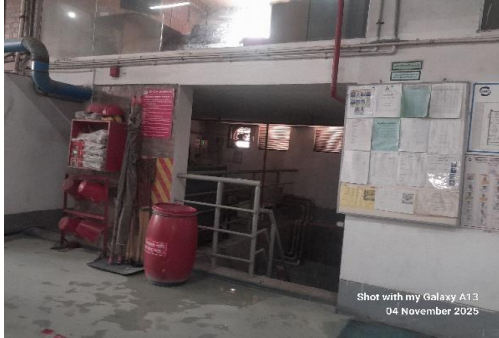
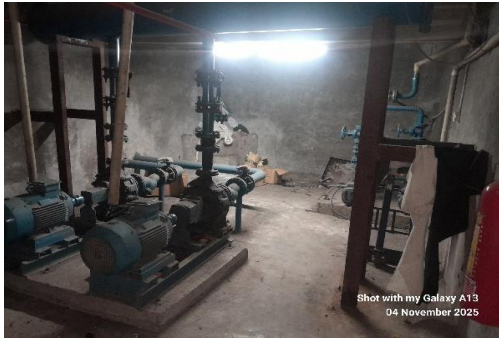
| F-25 | Fire Rated Construction | <p>The ETP pump room is not provided with adequate fire separation.</p> <p><b>Location: Basement, Block-J.</b></p> <p><b>Non-compliance reason: Unprotected opening.</b></p> | Separate the ETP pump room from ground floor by 2hr fire rated construction. | Within 3 Months |

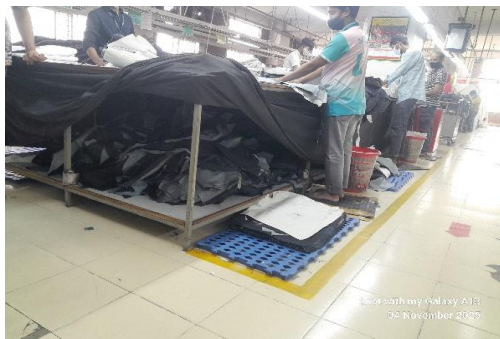
| F-26 | Fire Rated Construction | <p>Storages were found underneath the cutting tables.</p> <p><b>Location: 3rd &amp; 4th floors, Block-J.</b></p> | <p>Storage underneath the cutting tables shall be kept clear of combustibles at all time, except as provided for miscellaneous storage in accordance with 3.4.2.1.6</p> <p>Or,</p> <p>Where an automatic sprinkler system is installed sprinklers are required to be installed beneath cutting tables greater than 4 ft in width that are used for storage of combustibles.</p> | Within 3 Months |

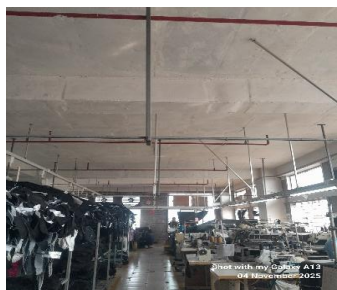
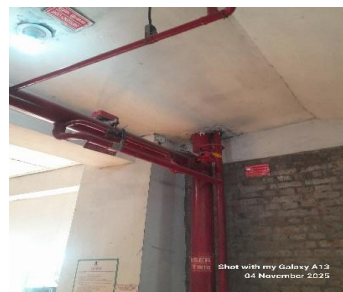
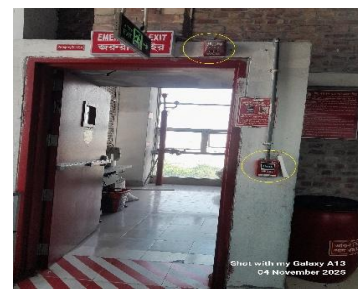
| F-27 | Fire Alarm & Detection System (FADS) | <p>The factory has installed a fire alarm and detection system that requires a detailed review to confirm compliance with NFPA 72 and RSC Technical Guidelines (Standard).</p> <p><b>Location(s): Block-J, Block-K &amp; Block-M.</b></p> | <p>Submit the fire alarm and detection system design to RSC for review.</p> <p>Once the design is reviewed, install and modify the fire detection and alarm system throughout the building in accordance with review comment, RSC Technical Guidelines (Standard) and NFPA 72.</p> <p>After installation the owner shall conduct internal testing and commissioning and then contact the RSC for witness of final acceptance testing.</p> | <p>Design within 2 Months and modification/ installation with 4 Months</p> |

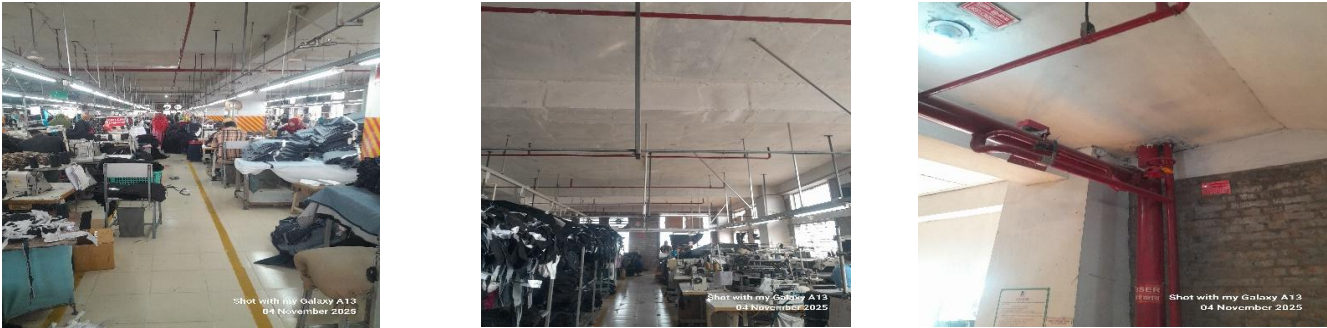
| F-29 | Fire Suppression System (SUPS) | <p>The highest occupied floor of the main building is over 75 feet above grade, mandating a sprinkler system along with a class I standpipe. The factory has installed a sprinkler system with a class III standpipe, requiring a detailed review to ensure compliance with NFPA 13, 14, 20, 22, and 24 and RSC Technical Guidelines (Standard).</p> <p><b>Location: Block-J.</b></p> | <p>Submit the fire Suppression System (fire pump, standpipe and sprinkler) design to RSC for review.</p> <p>Once the design is reviewed, install and modify the fire Suppression System throughout the building in accordance with review comment, RSC Technical Guidelines (Standard) and NFPA 13, 14, 20, 22 and 24.</p> <p>After installation the owner shall conduct internal testing and commissioning and then contact the RSC for witness of final acceptance testing.</p> | Design within 2 Months and modification/ installation with 4 Months |

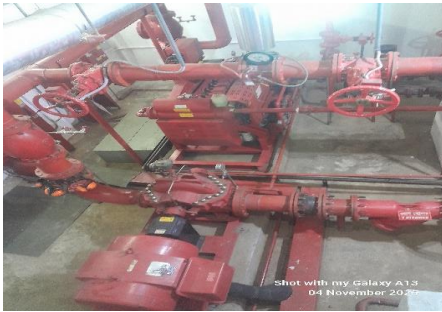
| F-30 | Fire Suppression System (SUPS) | <p>Fire pump installation requires detailed review to confirm compliance with NFPA 20 and RSC Technical Guidelines (Standard)<sup>1</sup> V1.0.</p> <p><b>Location: Block-J.</b></p> | <p>Submit as-built drawings, testing records, equipment certification and other relevant documentation to the RSC for review and approval.</p> <p>Submit the standpipe system drawing to RSC for review. Once reviewed, install or modify the standpipe system throughout the building in accordance with RSC Technical Guidelines (Standard)<sup>1</sup> V1.0. and NFPA 14 and 20. The factory management shall contact RSC to conduct the final acceptance testing after the installation, testing &amp; commissioning.</p> | <p>Design within 2 Months and modification/ installation with 4 Months</p> |
