Radial International Ltd. (Unit-2) (Extension)

Zirani Bazar, Kashimpur, Gazipur
(23.998095, 90.255065)
12 November 2025

1. Executive Summary

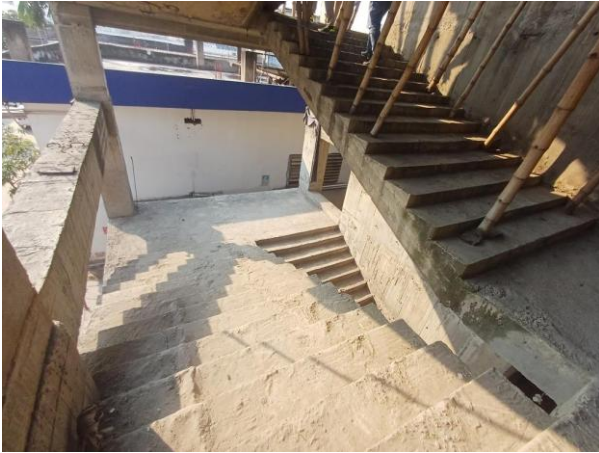
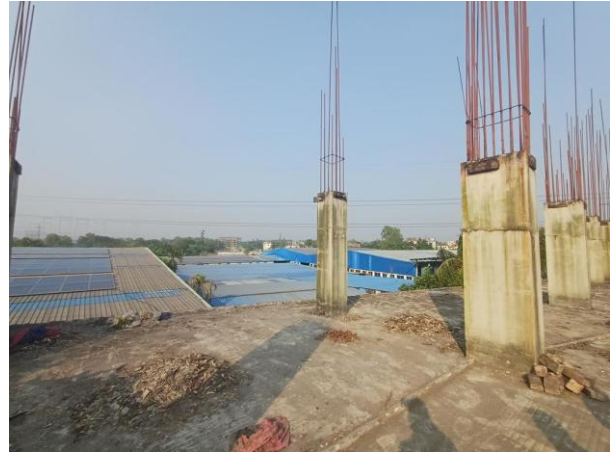
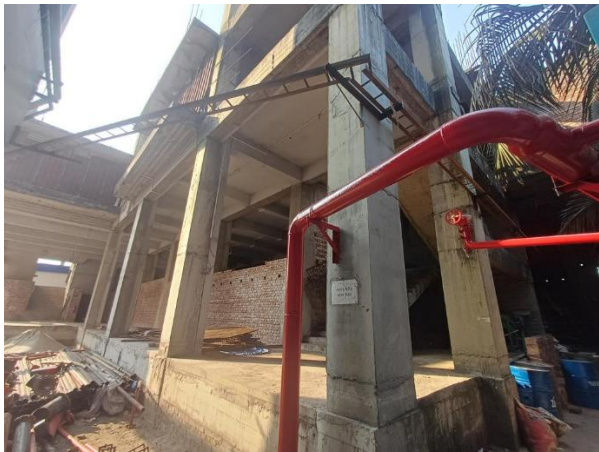
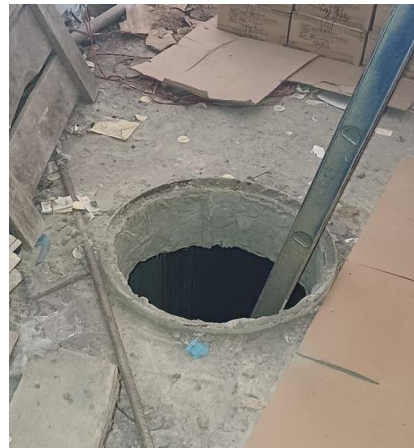
Observation 01: Falling hazard (Saara Complex Building)

Description: During inspection, falling hazard was observed at ground floor, roof & staircase and manhole of underground water tank (UGWT) was found uncovered. The factory is required to provide railing at all fall risk locations and cover the UGWT manhole properly.

Item No.	Observation	Action Plan	Timeline
1.	Falling hazard (Saara Complex Building)	The factory is required to provide railing at all fall risk locations and cover the UGWT manhole properly.	Immediate

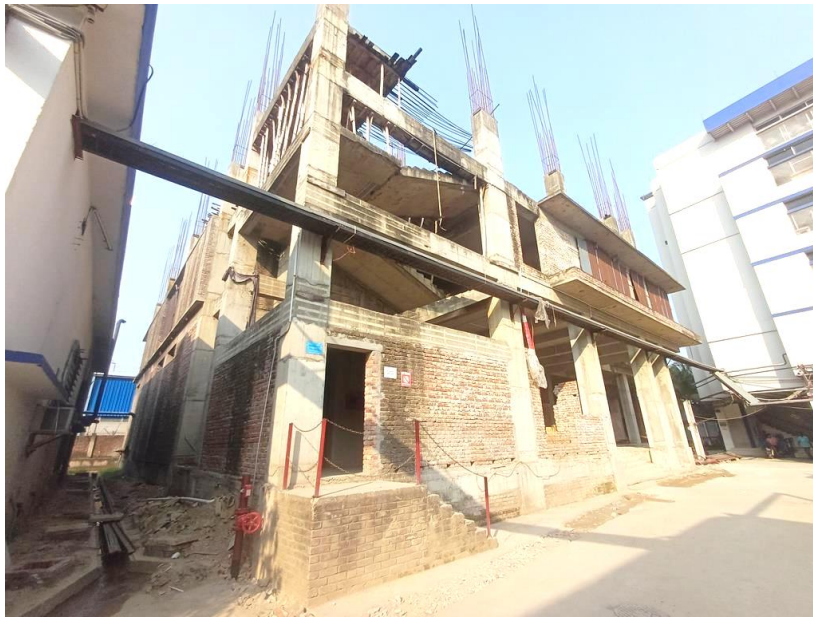
Observation-2: Lack of design documents & load plan and insufficient material test report for existing 2-storied building (Saara Complex Building)

Description: Design report & load plan were not available during the inspection. The factory is required to prepare a design report following BNBC 2020, verify in situ concrete strength by taking 100 mm diameter concrete cores from the structural members (Column, Beam-Slab), and prepare a load plan considering the structural member capacity.

2.	Lack of design documents & load plan and insufficient material test report for existing 2-storied building (Saara Complex Building)	The factory is required to prepare a design report following BNBC 2006	within 6 weeks

3.	Lack of design documents & load plan and insufficient material test report for existing 2-storied building (Saara Complex Building)	Verify in situ concrete strength by taking 100 mm diameter concrete cores from the structural members (Column, Beam-Slab),	within 6 weeks

4.	Lack of design documents & load plan and insufficient material test report for existing 2-storied building (Saara Complex Building)	Prepare load plan considering the structural member capacity and BNBC requirement	within 6 weeks

5.	Lack of design documents & load plan and insufficient material test report for existing 2-storied building (Saara Complex Building)	Carry out the required remedial work where required.	within 6 months

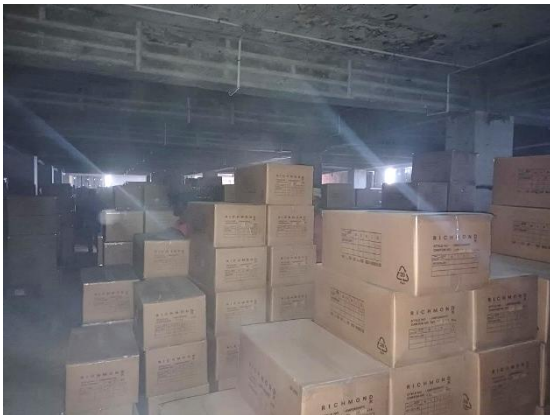
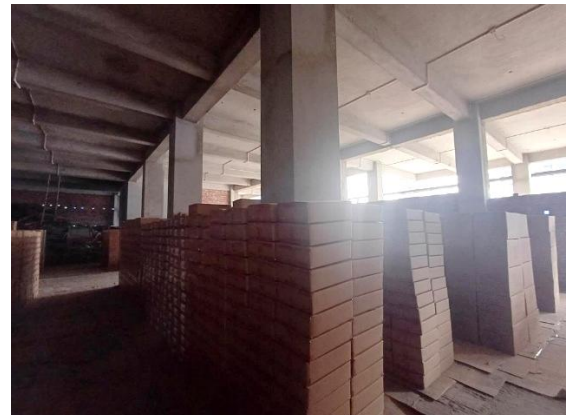
Observation 03: Lack of floor load management (Saara Complex Building)

Description: During the inspection, the building was found to be used for storage; however, no load plan or storage area and height markings were provided. The building engineer is required to produce load plan as per BNBC, post the load plan at each floor, provide a storage area & height marking and maintain floor loading accordingly.

6.	Lack of floor load management (Saara Complex Building)	Provide storage area & height marking and maintain floor loading accordingly.	within 6 weeks
7.	Discrepancies in the as-built drawing (Saara Complex Building)	The building Engineer is required to survey the entire structure and update the drawings to reflect the on-site conditions.	within 6 weeks

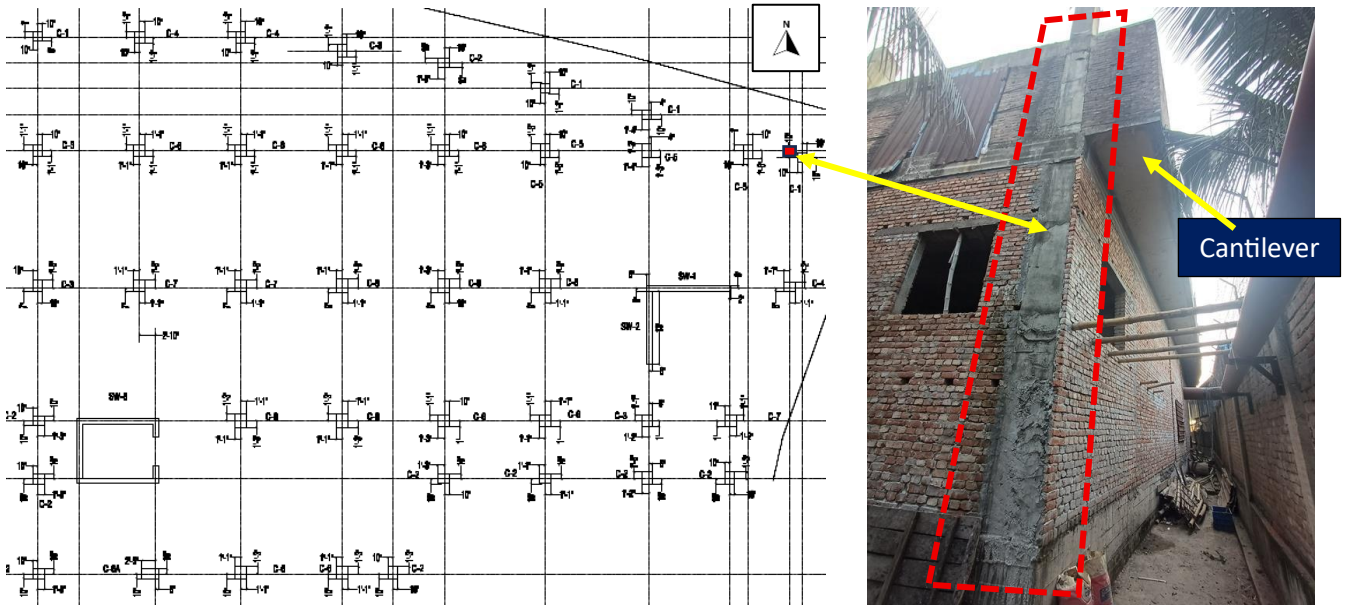
Observation-4: Discrepancies in the as-built drawing (Saara Complex Building)

marked column was shifted west

Description: Several discrepancies were identified, such as relocation of the marked column and the cantilever dimension being missing in the drawing. The building Engineer is required to survey the entire structure and update the drawings to reflect the on-site conditions.

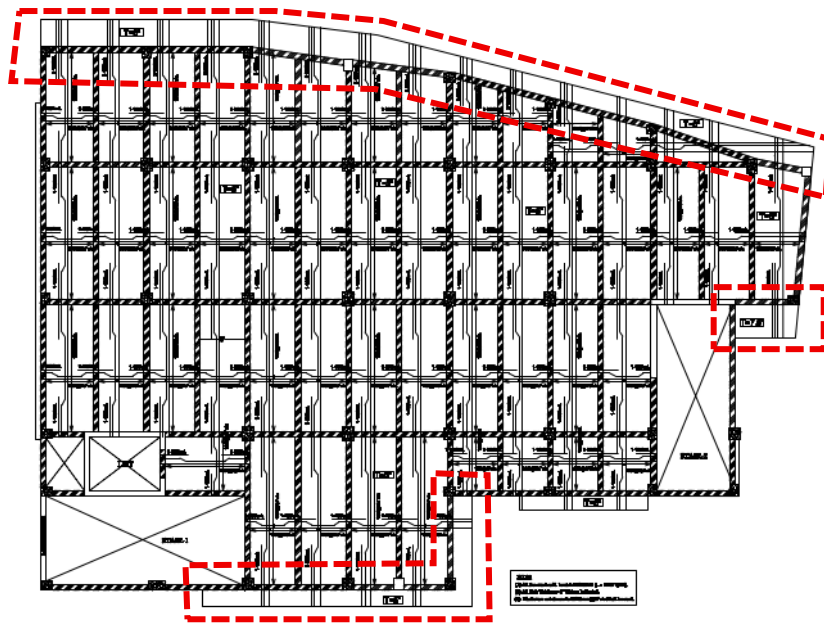
Dimension of cantilever portion – not mentioned

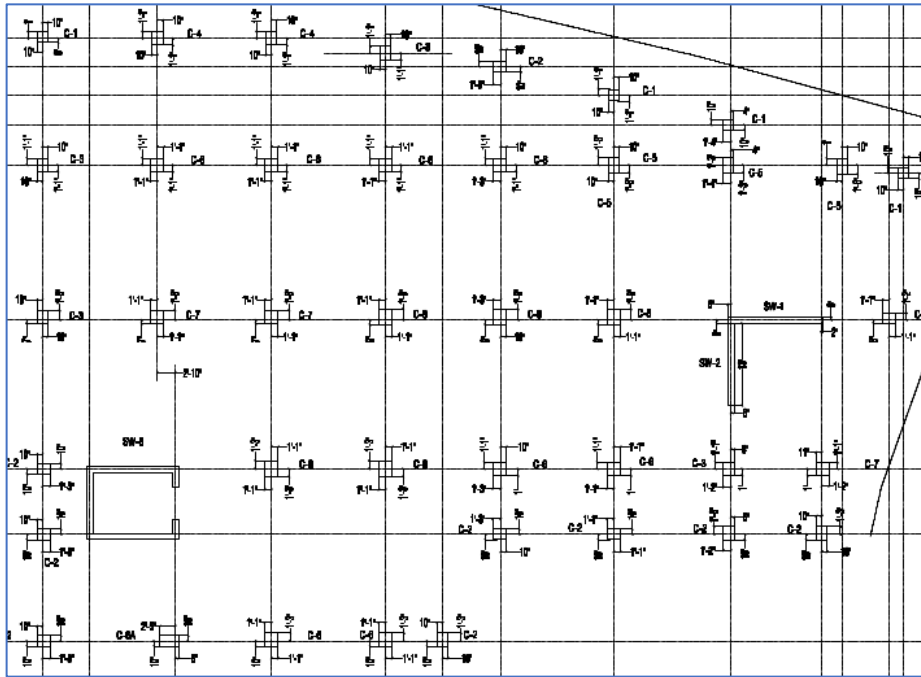
Observation-5: Stress in column and foundation exceeds normal design limit for proposed 7 storied building (Saara Complex Building)

Description: For proposed seven storied building, cursory calculation indicates stress in column and foundation exceeds normal design limit at marked location, considering minimum floor live load 6 kPa for storage occupancy and minimum concrete strength. The building engineer is required to check the design, loads, and column & foundation stress based on in-situ material strength and carry out Detail Engineering Assessment (DEA) before commencing further construction.

8.	Stress in column and foundation exceeds normal design limit for proposed 7 storied building (Saara Complex Building)	The building engineer is required to check the design, loads, column and foundation stress based on in-situ material strength (obtain from design report) and BNBC prescribed floor load plan and prepare DEA documents accordingly. Prior to doing any vertical extension work it required design acceptance from the RSC.	within 6 weeks

9.	Stress in column and foundation exceeds normal design limit for proposed 7 storied building (Saara Complex Building)	Carry out the required remedial work where required.	within 6 months

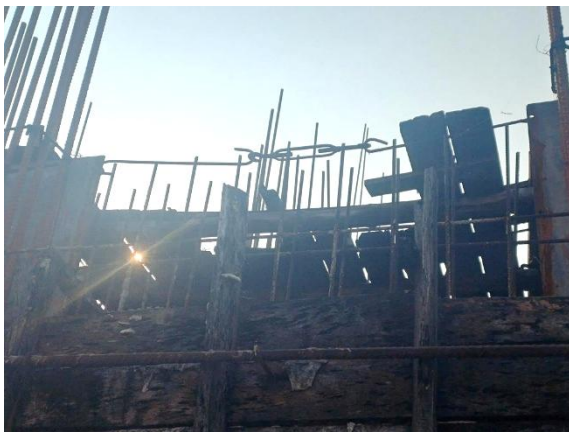
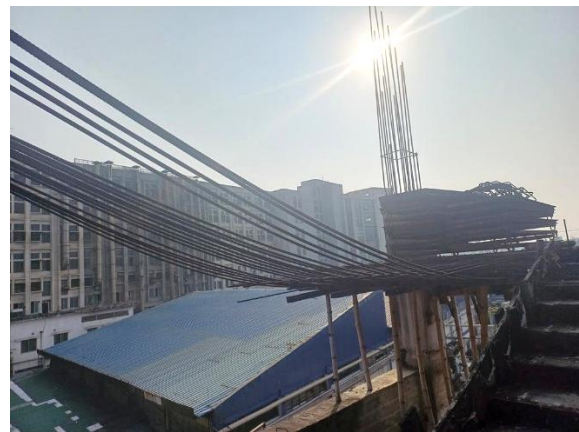
Observation 06: Exposed rebar on the roof (Saara Complex Building)

Description: During inspection, exposed rebars were found on the roof. The factory is required to remove rust and apply anti-corrosive coating on exposed rebar.

10.	Exposed rebar on the roof (Saara Complex Building)	The factory is required to apply anti-corrosive coating on exposed rebar.	within 6 weeks
11.	Formwork materials stacked on roof (Saara Complex Building)	The factory is required to remove the materials or store them in a designated safe area to prevent unintended roof loading and ensure proper drainage flow.	within 6 weeks

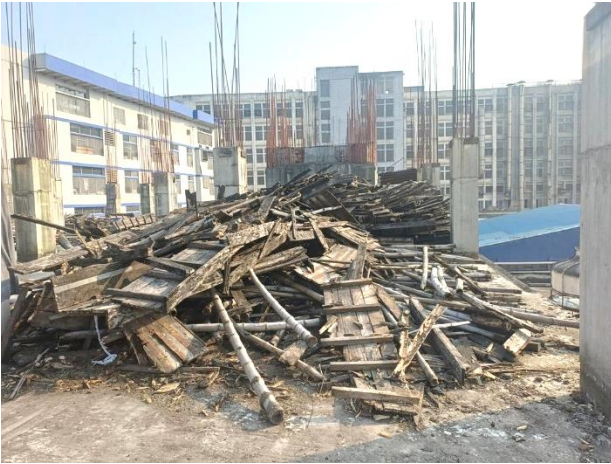
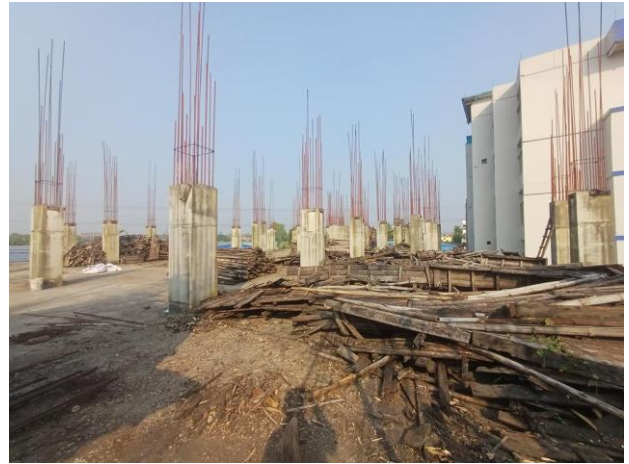
Observation 7: Formwork materials stacked on the roof (Saara Complex Building)

Description: During the inspection, construction formwork materials were found improperly stacked on the roof, causing additional loading and obstructing rainwater drainage. The factory is required to remove the materials or store them in a designated safe area to prevent unintended roof loading and ensure proper drainage flow.

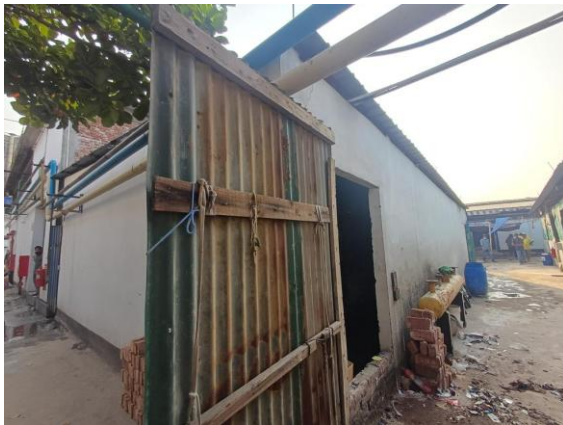
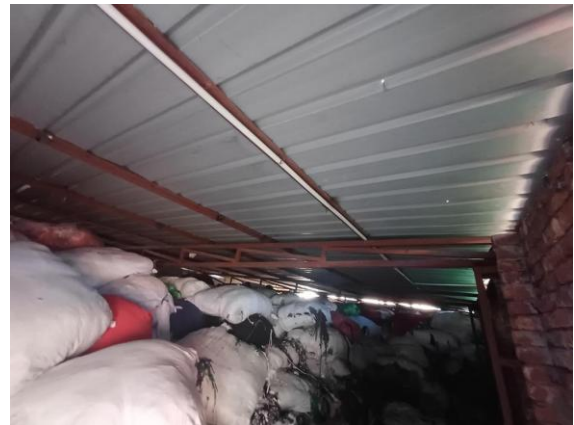
Observation 8: Lack of design documents (Empty Cartoon Shed)

Description: As per BNBC, every building or structure designed shall have its design documents prepared in accordance with the provision of Section 1.9.1. The design document shall include a design report, and a set of structural drawings, which shall be prepared in compliance with section 1.9.1.1 and section 1.9.1.2 as per BNBC. At the time of inspection, design documents (including design report, as-built drawings and material test reports) were not available which are required to be prepared in compliance with section 1.9.1 (part-6, BNBC 2020).

14.	Lack of design documents (Empty Cartoon Shed)	The building engineer is required to prepare a design report in compliance with section 1.9.1, part 6 of BNBC 2020.	within 6 weeks

15.	Lack of design documents (Empty Cartoon Shed)	Carry out the required remedial work where required.	within 6 months
16.	Lack of building permit drawing from the local authority. (Empty Cartoon Shed)	Obtain a building permit and confirmation of the applicable building code (BNBC 2006 or BNBC 2020) from the local authority	within 6 months

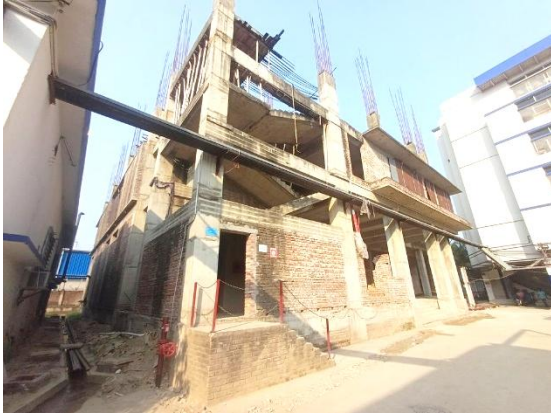
Saara Complex Building

Description: Building permits were not available for any structure during the inspection. The building engineer is required to obtain a building permit from the local authority. The Building Engineer is also required to obtain confirmation of the applicable building code (BNBC 2006 or BNBC 2020) for Empty Cartoon shed from the local authority, as the building was constructed in 2020 and the building permit will be obtained after 2021, if no previous permit is available.

12.	Lack of building permit drawing from the local authority. (Saara Complex Building)	Obtain building permit from the local authority	within 6 months
13.	Lack of design documents (Empty Cartoon Shed)	The building Engineer is required to survey the entire structure and update the drawings to reflect the on-site conditions.	within 6 weeks
