# REMIX COLLECTIONS LTD

Sa-34, Mulaid, Telihaty, Sreepur, Gazipur, Bangladesh

18 November 2025

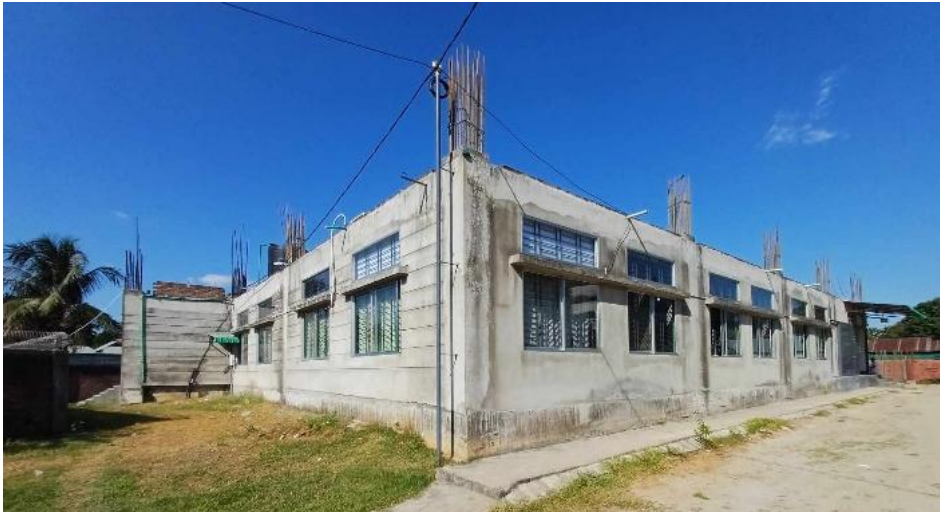
### Observation-01: Lack of design report (Production Building).

**Description:** As per BNBC, every building or structure designed shall have its design documents prepared in accordance with the provision of Section 1.9.1. The design document shall include a design report, and a set of structural drawings, which shall be prepared in compliance with section 1.9.1.1 and section 1.9.1.2 as per BNBC. At the time of inspection, the design report was not available, which is required to be prepared in compliance with section 1.9.1 (part-6, BNBC).

| Item No | Observation | Action Plan | Timeline |
|---|---|---|---|
| 1. | Lack of design report (Production Building). | The building engineer is required to prepare the design report in compliance with BNBC and submit it to RSC for review. | within 6 weeks |
| 2. | | Implement remediation work if required. | within 6 months |

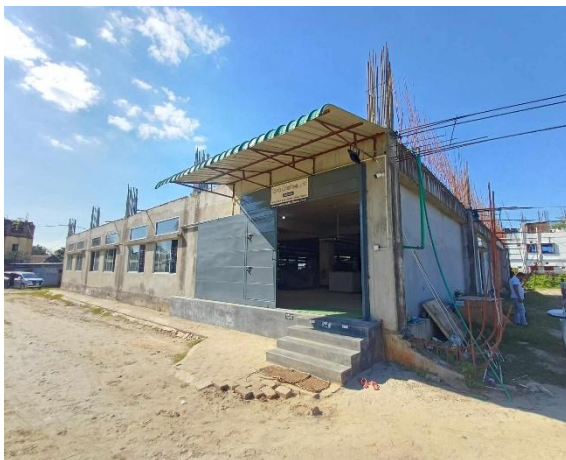
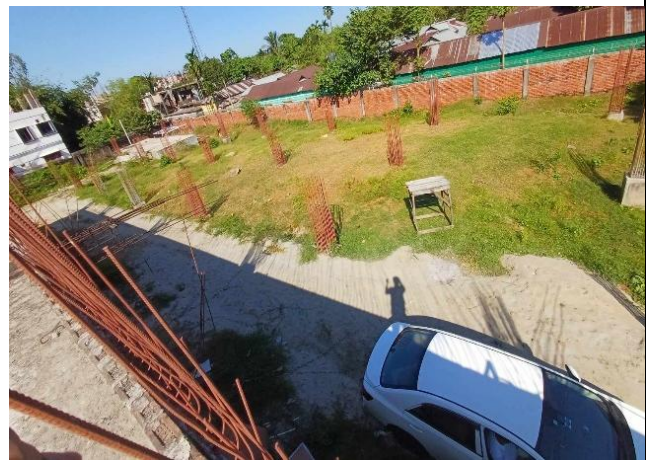
### Observation-02: Possible horizontal and vertical extension (Production Building).

**Description:** Some exposed rebar was found on the roof and projected horizontally, which indicates the possibility of future extension. The factory has a plan to conduct the future extension. The building is currently single-storied but is proposed as a five-story building, as per the local authority permit drawing. Before conducting any future extension, prepare a Detailed Engineering Assessment (DEA) and submit it to RSC for review.

| Item No | Observation | Action Plan | Timeline |
|---|---|---|---|
| 3. | Possible horizontal and vertical extension (Production Building). | The building engineer is required to prepare a Detailed Engineering Assessment (DEA) report prior to conducting any horizontal or vertical expansion. | within 6 weeks |
| 4. | | The building engineer is required to follow the construction safety measures during the commencement of further extension work. | within 6 months |

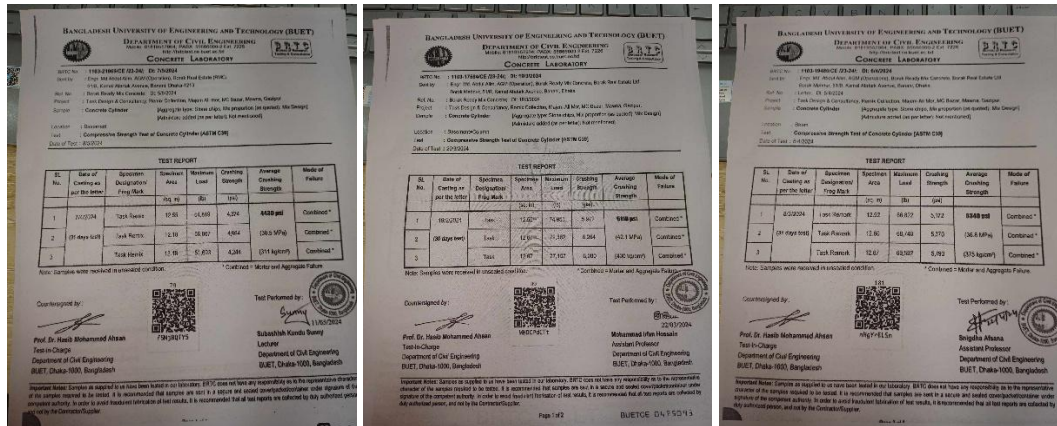
### Observation-03: Inadequate number of concrete cylinder test reports (Production Building).

**Description:** Only one concrete cylinder test report was available for the column, four from the footing, and one from the beam, which doesn't meet the frequency of testing as per BNBC. Also, no test report was available from the slab. The building engineer is required to take a minimum 4- 100mm diameter concrete core from structural elements (column and beam/slab).

| Item No | Observation | Action Plan | Timeline |
|---|---|---|---|
| 5. | Inadequate number of concrete cylinder test reports (Production Building). | The building engineer is required to take a minimum 4- 100mm diameter concrete core from structural elements (column and beam/slab). | within 6 weeks |

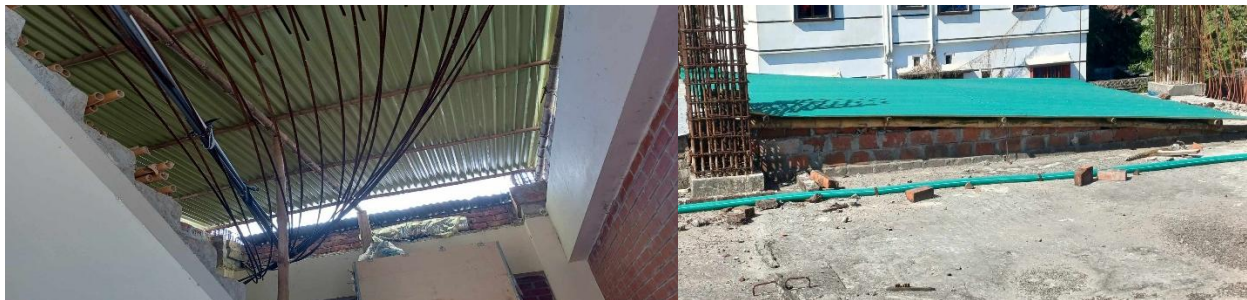
### Observation-04: Poorly constructed bamboo shed over the staircase (Production Building).

**Description:** A poorly constructed bamboo shed over the staircase was observed. The building engineer is required to replace the bamboo shed over the staircase with a well-designed structure.

| Item No | Observation | Action Plan | Timeline |
|---|---|---|---|
| 6. | Poorly constructed bamboo shed over the staircase (Production Building). | The building engineer is required to replace the bamboo shed over the staircase with a well-designed structure. | within 6 weeks |

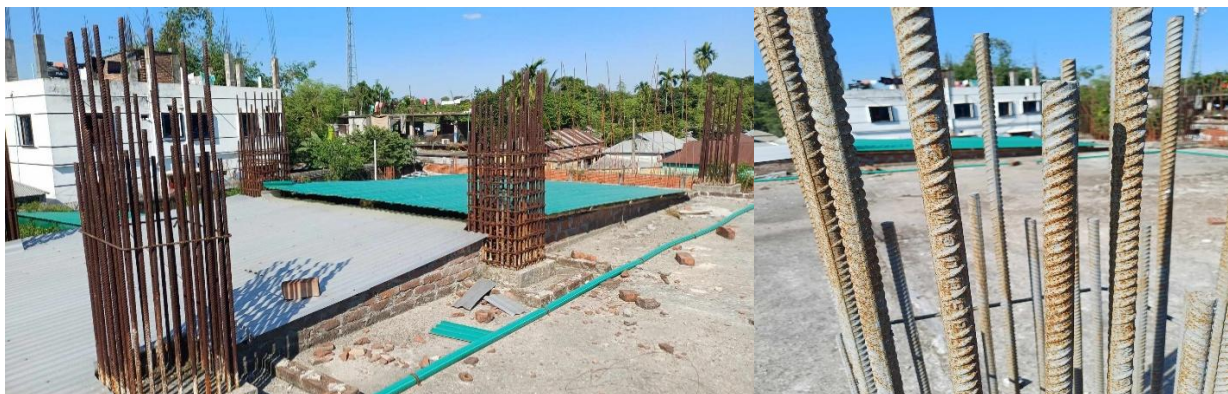
### Observation-05: Exposed rebar is prone to corrosion (Production Building).

**Description:** Exposed rebar was found prone to corrosion. Provide rust-proof coating on exposed rebar to protect from corrosion.

| Item No | Observation | Action Plan | Timeline |
|---|---|---|---|
| 7. | Exposed rebar is prone to corrosion (Production Building). | The factory is required to provide rust-proof coating on exposed rebar to protect it from corrosion. | within 6 weeks |

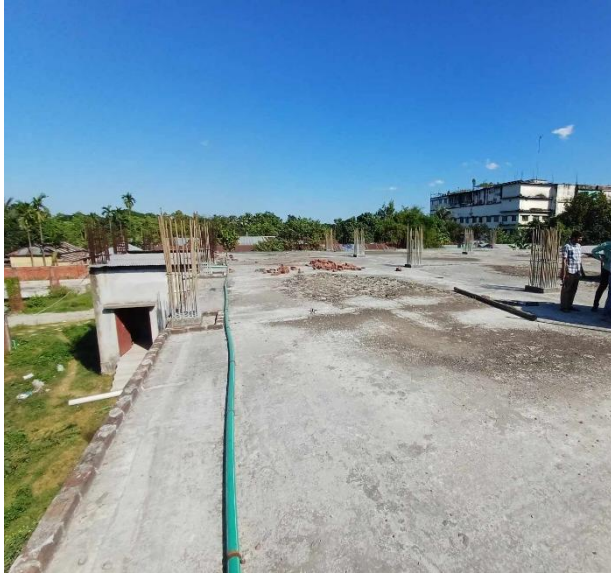
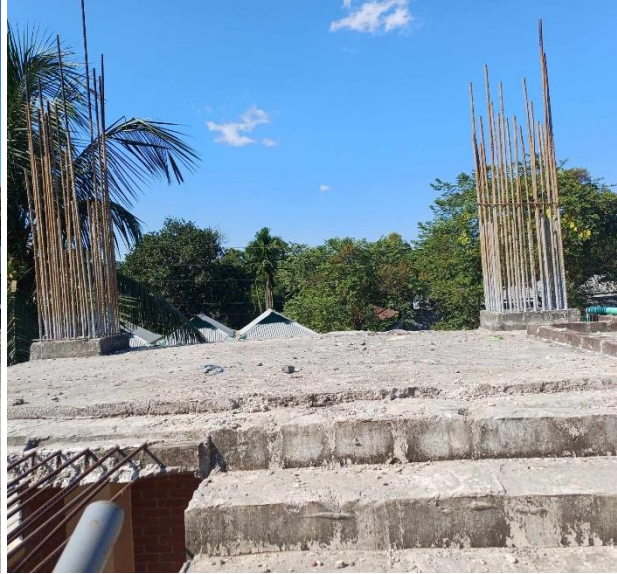
**Observation-06: Falling hazard at roof level (Production Building).**

**Description:** No parapet/railing was found at the roof level and on the staircase. Provide edge protection immediately at the roof and stairs to avoid falling hazards.

| Item No | Observation | Action Plan | Timeline |
|---|---|---|---|
| 8. | Falling hazard at roof level (Production Building). | The factory is required to provide edge protection immediately at the roof and stairs to avoid falling hazards. | within 6 weeks |

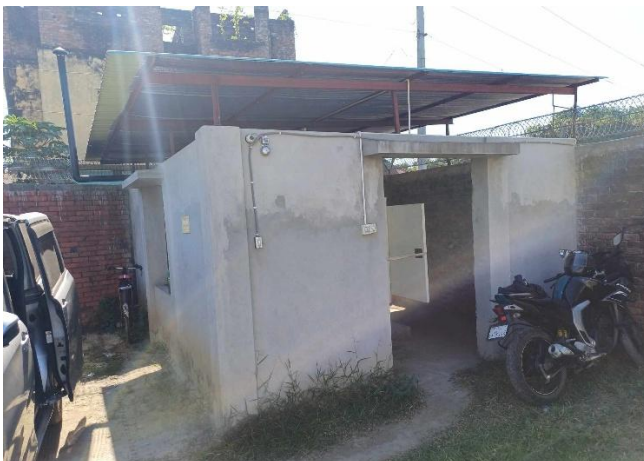
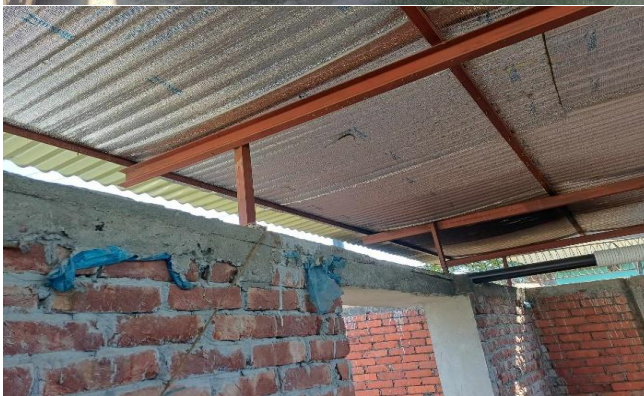
Generator Shed

**Observation-7: Inadequate member size and connection (Generator Shed, Toilet Shed).**

**Description:** Inadequate member size and connections were observed for both sheds. Check the member adequacy as part of EA and submit it to RSC for review.

| Item No | Observation | Action Plan | Timeline |
|---|---|---|---|
| 9. | Inadequate member size and connection (Generator Shed). | The building engineer is required to check the member and connection adequacy as part of EA and submit it to RSC for review. | within 6 weeks |
| 10. | | Implement the recommendations of the design report. | within 6 months |

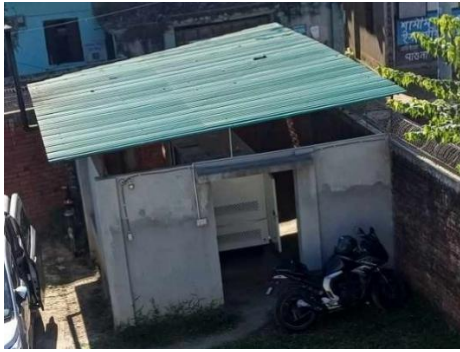
**Observation-8:** Lack of local authority approval drawing (Generator Shed, Toilet Shed).

**Description:** Local authority permits were not found for the Generator Shed and Toilet Shed. The factory is required to collect the building permit from the local authority.

| Item No | Observation | Action Plan | Timeline |
|---|---|---|---|
| 11. | Lack of local authority approval drawing (Generator Shed). | The factory is required to collect the building permit from local authority. | within 6 months |

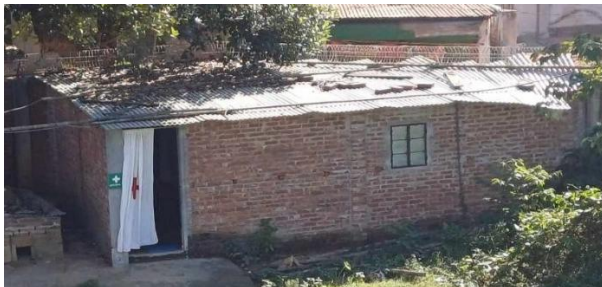
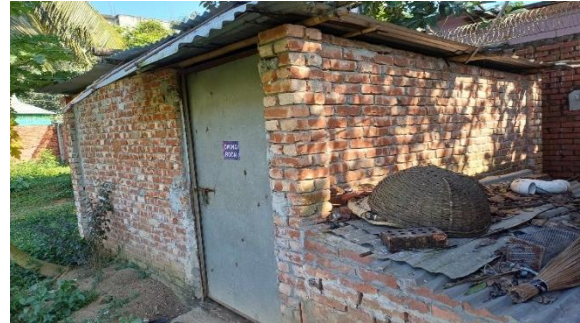
Doctor's Shed

**Observation-9:** Poor condition of bamboo sheds (Doctor's Shed, Pantry Shed, Wastage Shed).

**Description:** Poorly constructed bamboo sheds were observed. The building engineer is required to replace the bamboo sheds with a well-designed structure.

| Item No | Observation | Action Plan | Timeline |
|---|---|---|---|
| 15. | Poor condition of bamboo sheds (Doctor's Shed). | The building engineer is required to replace the bamboo sheds with well-designed structure. | within 6 weeks |
