# Radiance Fashion Ltd (Extension)

Khajur Bagan, Ashulia, Savar, Dhaka

24 November 2025

1. RFL (Extension) Building 1: Four-storied reinforced concrete (RC) building with underground water reservoir.

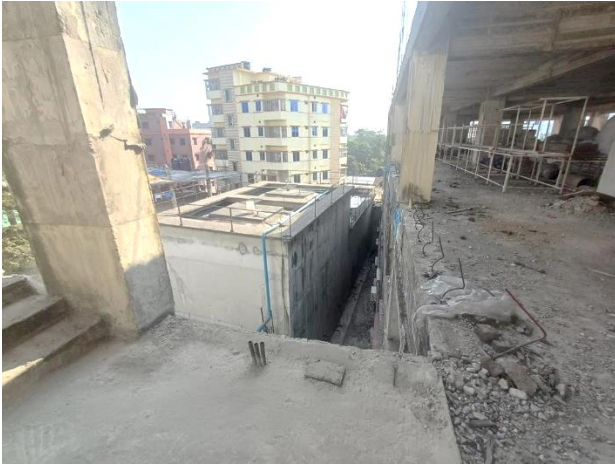
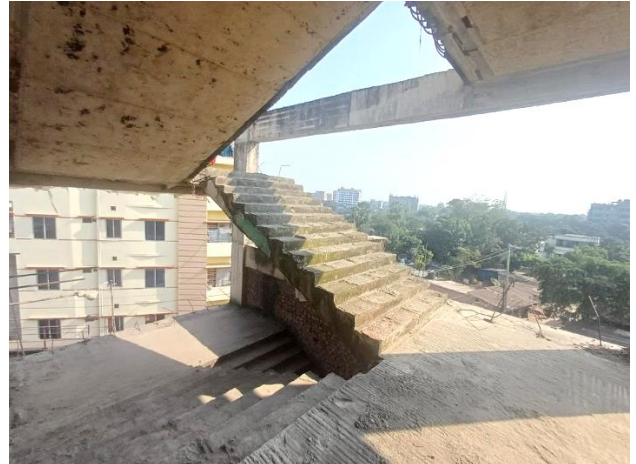
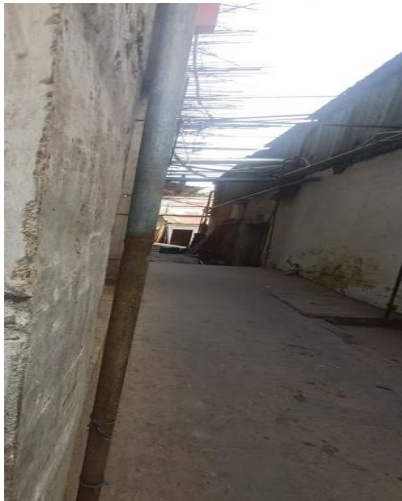
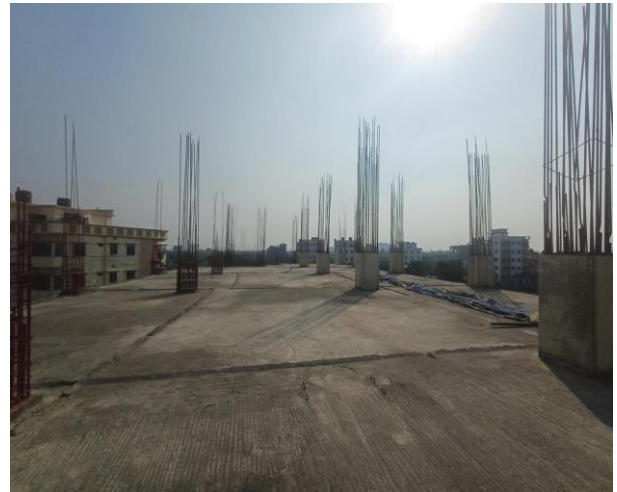
**Observation 01:** Construction safety practice & falling hazard.

**Description:** During the inspection, ongoing construction activities were observed without adequate safety measures, including the absence of fall protection, safety barriers, and proper edge protection on the roof. The building engineer is required to ensure that all construction safety provisions comply with BNBC Part 7, Chapter 3. The ongoing vertical extension and renovation work must be carried out in accordance with the required safety measures specified in the BNBC.

| Item No. | Observation | Action Plan | Timeline |
|---|---|---|---|
| 1. | Construction Safety practice & falling hazard. | The building engineer is required to ensure all the construction safety according to BNBC Part 7, Chapter 3. The ongoing vertical extension and renovation work should be carried out following the required safety measures as per BNBC. | Immediate |

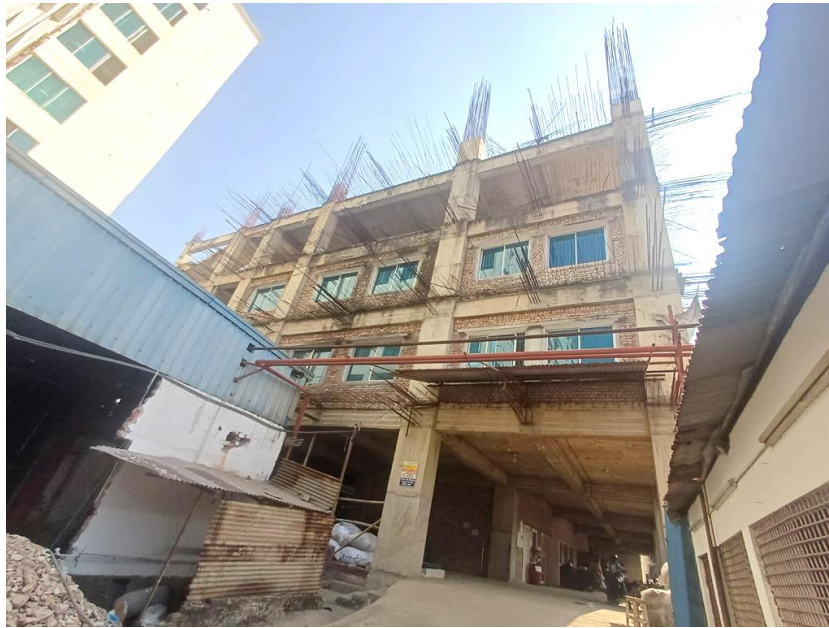
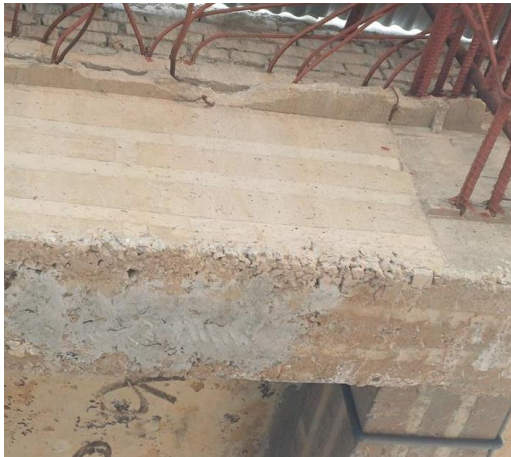
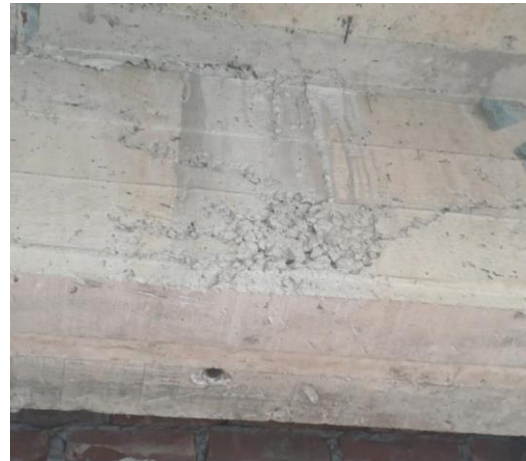
**Observation 02:** Lack of design report, load plan, and material test report.

**Description:** The design report, load plan, and adequate material test reports were not available during the inspection. The factory is required to prepare a design report in accordance with BNBC 2006, develop a load plan based on the capacity of the structural members, and verify the in-situ concrete strength by extracting 100 mm diameter cores from four columns (preferably from the lower tier of the building), as well as from beam and slab. Additionally, the building engineer's monitoring of construction quality and workmanship was found to be insufficient. Evidence of concrete segregation was observed in beams.

| Item No. | Observation | Action Plan | Timeline |
|---|---|---|---|
| 2. | Lack of design report, load plan, and material test report. | The building engineer is required to verify the in-situ concrete strength by extracting 100mm diameter cores from four columns (Preferably from the lower tier of the building), as well as from the beam and slab. | within 6 weeks |
| 3. | | The factory is required to prepare a design report following BNBC 2006 | within 6 weeks |
| 4. | | Check the construction quality by Non-Destructive Test (NDT) & Destructive Test (DT). | within 6 weeks |
| 5. | | Prepare load plan considering the structural member capacity as well as BNBC requirement. | within 6 weeks |
| 6. | | Carry out the required remedial work where required. | within 6 months |

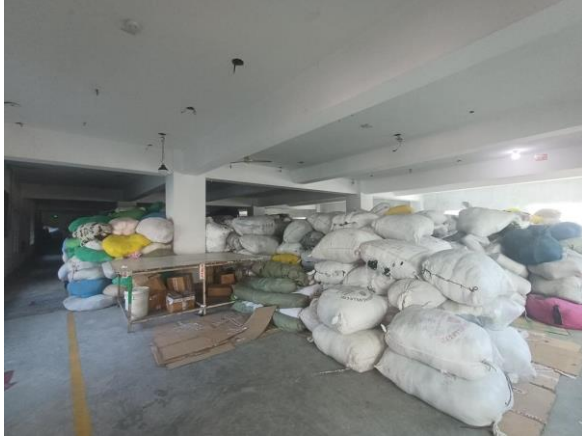
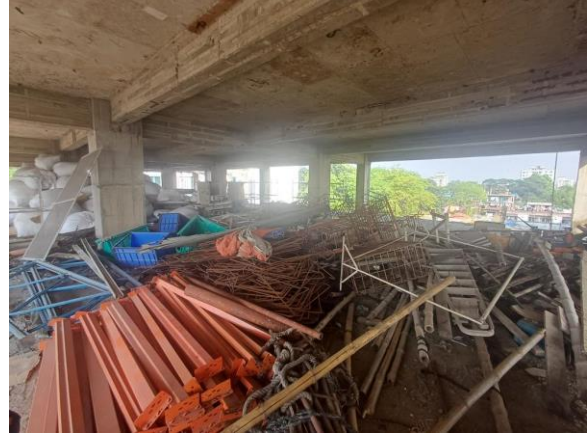
**Observation 03:** Lack of floor load management.

**Description:** During the inspection, the building was found to be used for storage; however, no load plan or storage height markings were provided. The building engineer is required to produce load plans as per BNBC, post the load plans at each floor, provide storage height marking and maintain floor loading accordingly.

| Item No. | Observation | Action Plan | Timeline |
|---|---|---|---|
| 7. | Lack of floor load management. | Implement floor load management program (post load plan, mark storage height and maintain floor loading accordingly. | within 6 weeks |

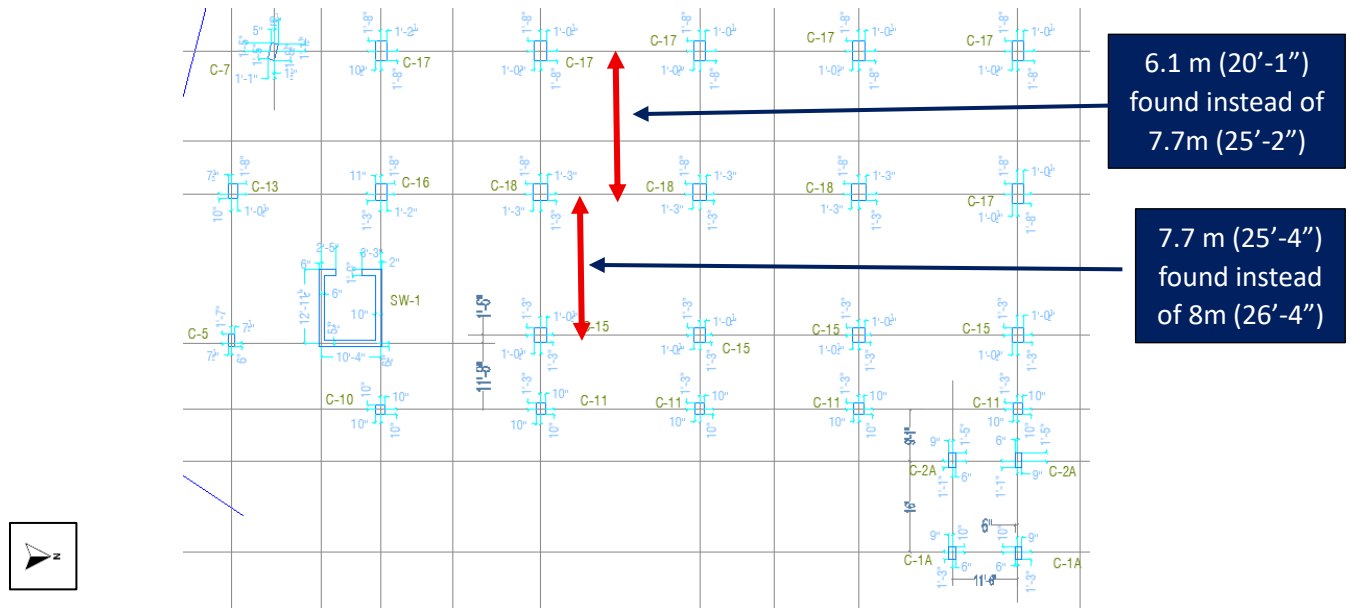
**Observation 04: Discrepancies in construction drawing.**

**Mismatches in grid dimension**

**Description:** Several discrepancies were identified, including mismatched grid dimensions and an undocumented extension (boiler room). The building Engineer is required to survey the entire structure and produce the as-built drawings to reflect the on-site conditions.

| Item No. | Observation | Action Plan | Timeline |
|---|---|---|---|
| 8. | Discrepancies in construction drawing. | The building Engineer is required to survey the entire structure and produce the as-built drawings to reflect the on-site conditions. | within 6 weeks |

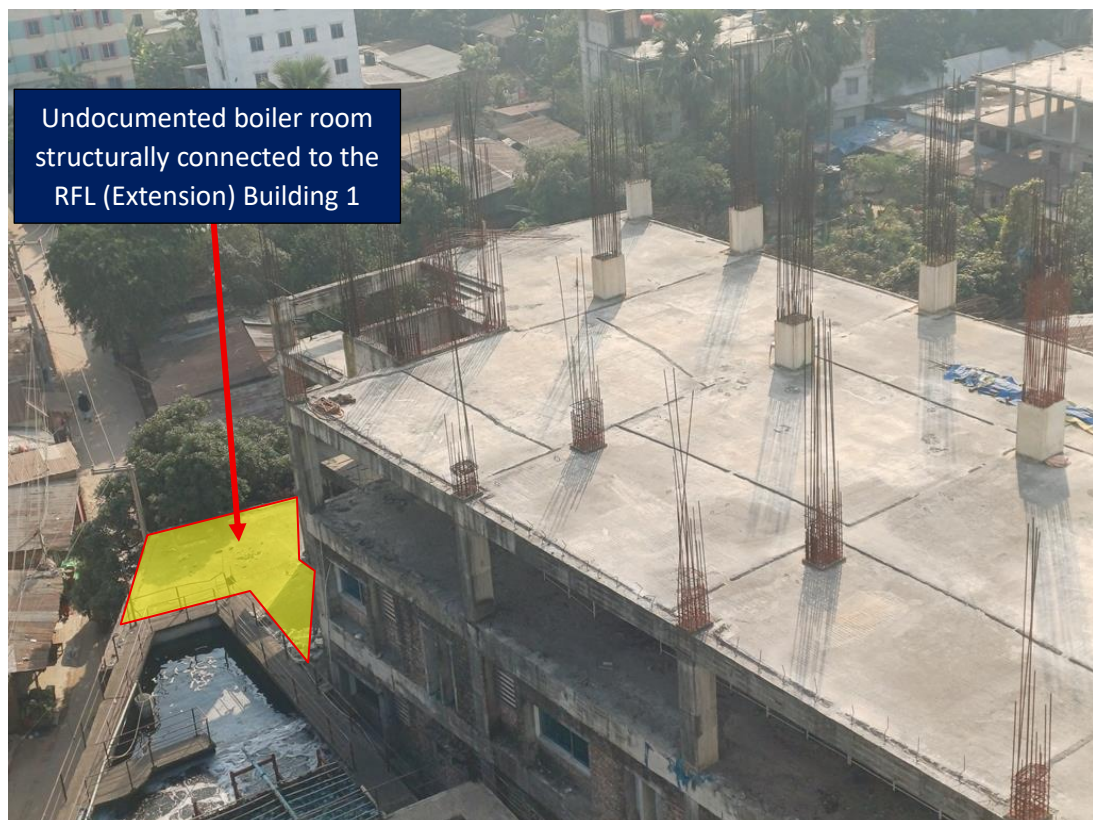
**Extended portion (boiler room) at ground floor - not included**

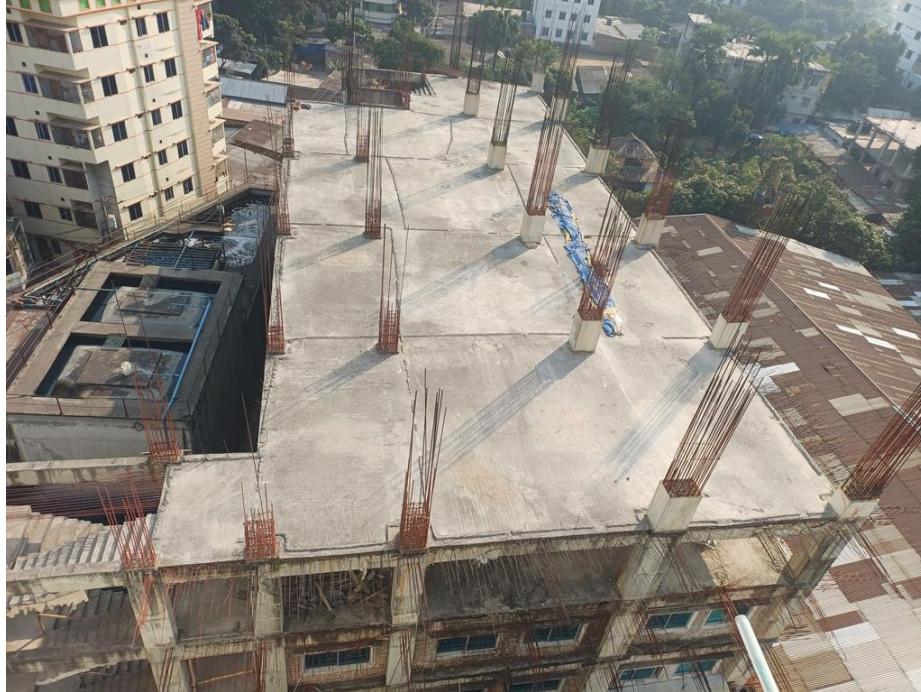
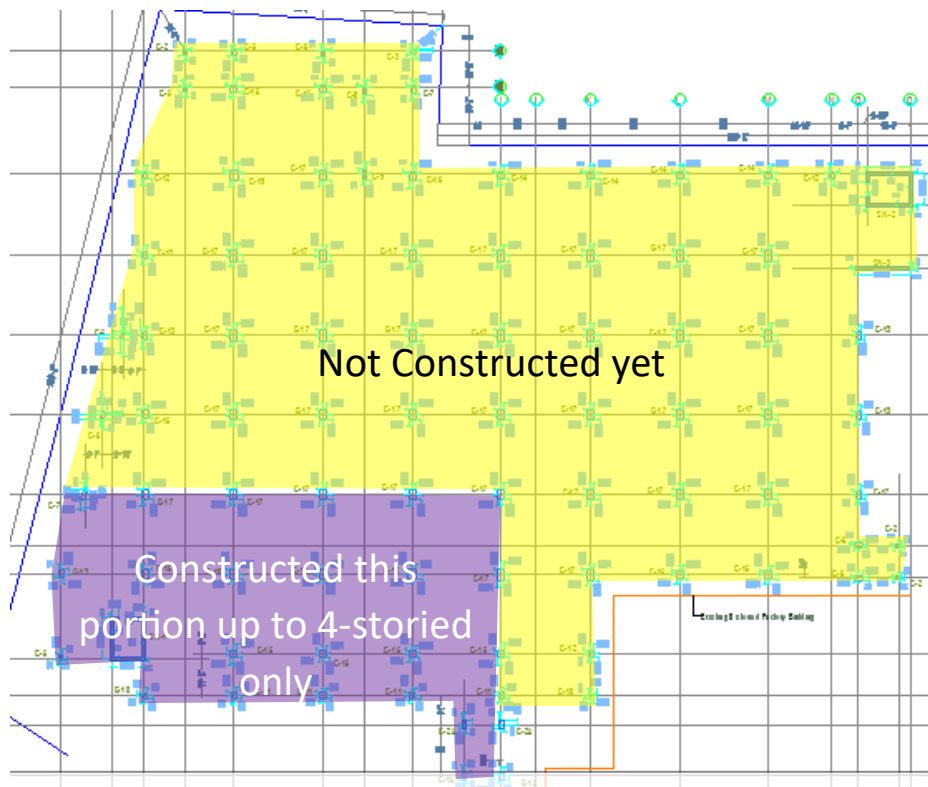
**Observation 05:** Possible horizontal & vertical extension.

**Description:** The factory has a plan to conduct vertical & horizontal expansion. Projected reinforcement left at west & north side slab-beam and columns at roof which indicates possible future horizontal & vertical extension. The factory is required to prepare a Detailed Engineering Assessment (DEA) report prior to conducting any vertical & horizontal expansion.

| Item No. | Observation | Action Plan | Timeline |
|---|---|---|---|
| 9. | Possible horizontal & vertical extension. | The factory is required to prepare a Detailed Engineering Assessment (DEA) report prior to conducting any horizontal & vertical extension. | within 6 weeks |
| 10. | | Carry out the required remedial work where required. | within 6 months |

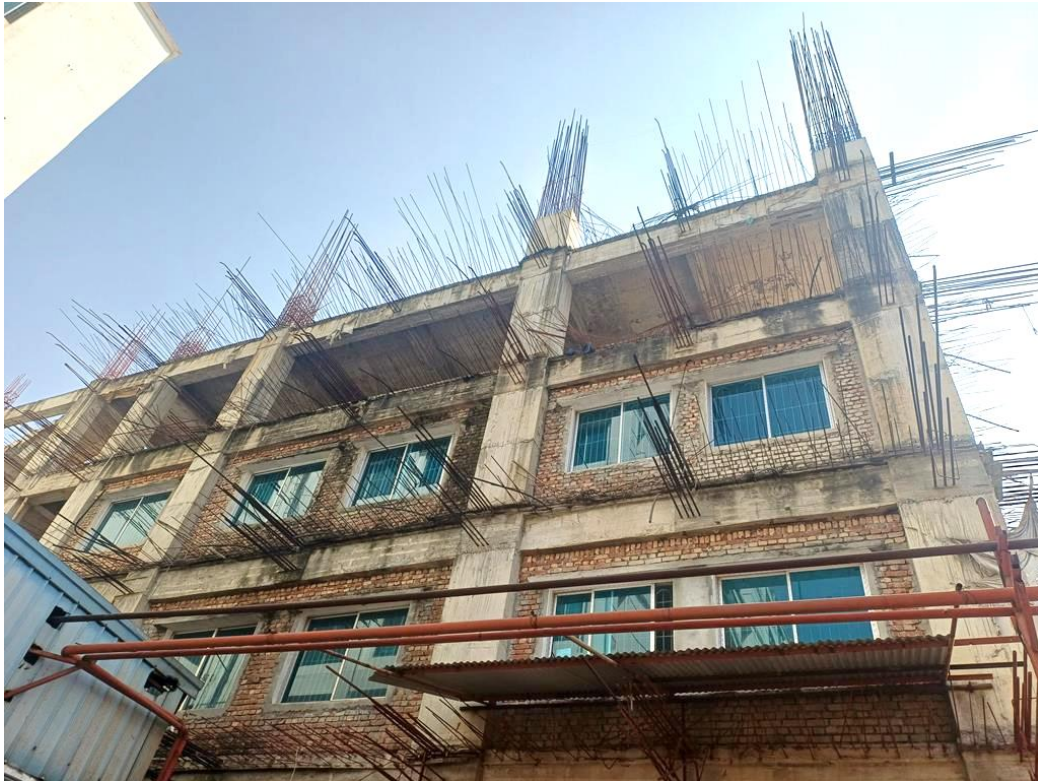
**Observation 06:** Exposed rebar of columns and west & north side beam-slabs.

**Description:** During inspection, exposed rebars were found at west & north side beam-slab and columns at roof. The factory is required to remove rust and apply anti-corrosive coating on exposed rebar.

| Item No. | Observation | Action Plan | Timeline |
|---|---|---|---|
| 11. | Exposed rebar of columns and west & north side beam-slabs. | The factory is required to remove rust and apply anti-corrosive coating on exposed rebar. | within 6 weeks |

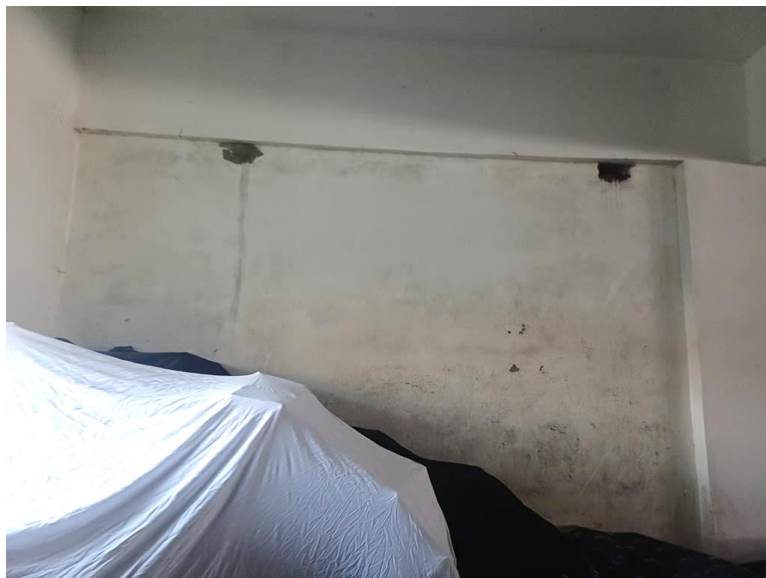
**Observation 07:** Dampness on brick wall.

**Description:** During inspection, dampness was found on brick wall. The factory is required to repair the dampness with suitable measures.

| Item No. | Observation | Action Plan | Timeline |
|---|---|---|---|
| 12. | Dampness on brick wall. | The factory is required to repair the dampness with suitable measures. | within 6 weeks |
