# Shipra Fashion Ltd (Extension)

Shailat, Nijmawna, Sreepur, Gazipur, Bangladesh

4 December 2025

## Structural Inspection Report

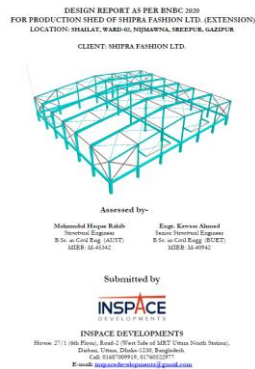
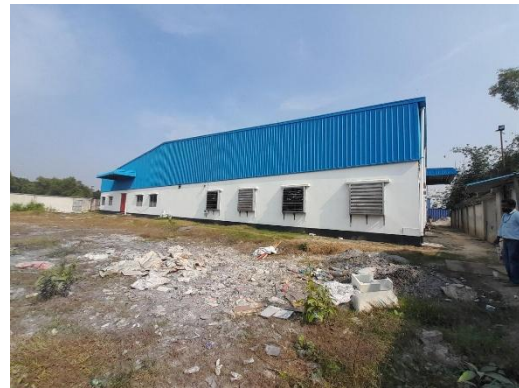
### Observation-01: Design report to be checked against lateral loading. (Production Shed)

**Description:** A design report was available at the time of inspection. The building engineer is required to submit the prepared design report to RSC to check the structure against the lateral loading.

| Observation | Action Plan | Timeline |
|---|---|---|
| Design report to be checked against lateral loading.<br>(Production Shed) | The building engineer is required to submit the prepared design report to RSC to check the structure against the lateral loading. | within 6 weeks |
| | Implement remediation work if required. | within 6 months |

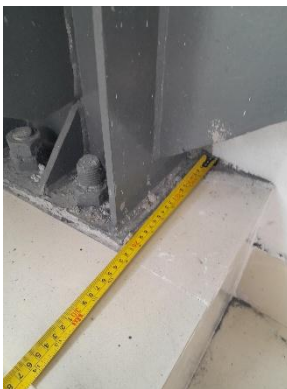
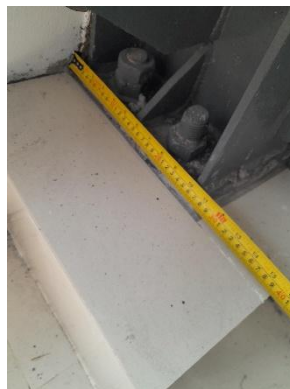
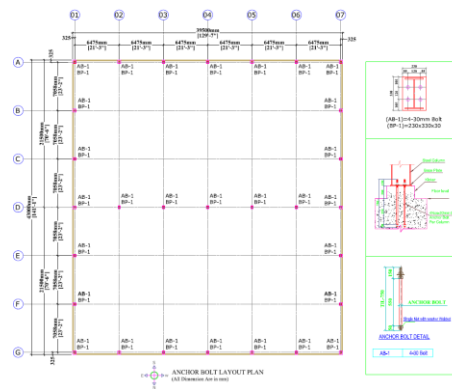
### Observation 02: Mismatch in as-built drawing. (Production Shed)

**Description:** During inspection, mismatch was found in steel column base plate size and roof bracing identification.

- Base plate size was found 280 x 200 mm instead of 330 x 230 mm.
- Roof bracing was found 16 mm rod bracing in mid part shown in figure which was not mentioned in drawing.

The building engineer is required to update the drawing and design documents based on the as-constructed structure.

| Observation | Action Plan | Timeline |
|---|---|---|
| Mismatch in as-built drawing.<br>(Production Shed) | The building engineer is required to update the drawing and design documents based on the as-constructed structure. | within 6 weeks |

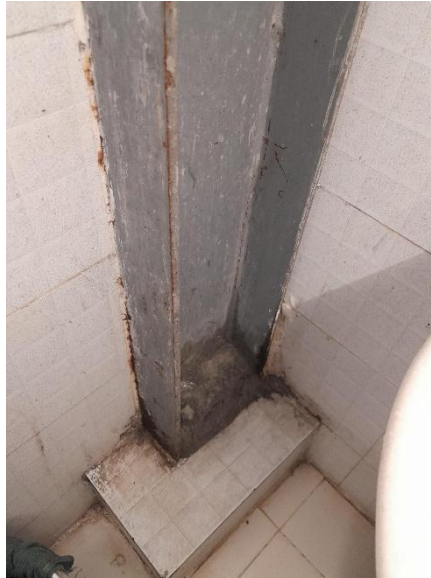
**Observation-03:** Corrosion on steel member. (Production Shed)

**Description:** Corrosion was observed on the steel members at toilet area. The building engineer is required to remove the corrosion with a suitable method and provide anti-corrosive coating.

| Observation | Action Plan | Timeline |
|---|---|---|
| Corrosion on steel member.<br>(Production Shed) | The building engineer is required to remove the corrosion with a suitable method and provide anti-corrosive coating. | within 6 months |

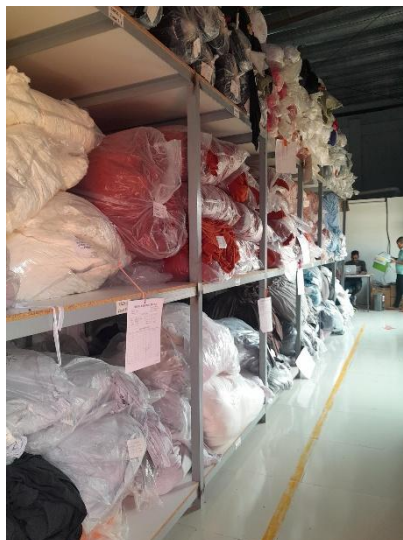
**Observation-04:** Non-structural element not anchored. (Production Shed)

**Description:** Factory is required to anchor all non-structural elements adequately.

| Observation | Action Plan | Timeline |
|---|---|---|
| Non-structural element not anchored. (Production Shed) | Factory is required to anchor all non-structural elements adequately. | within 6 months |

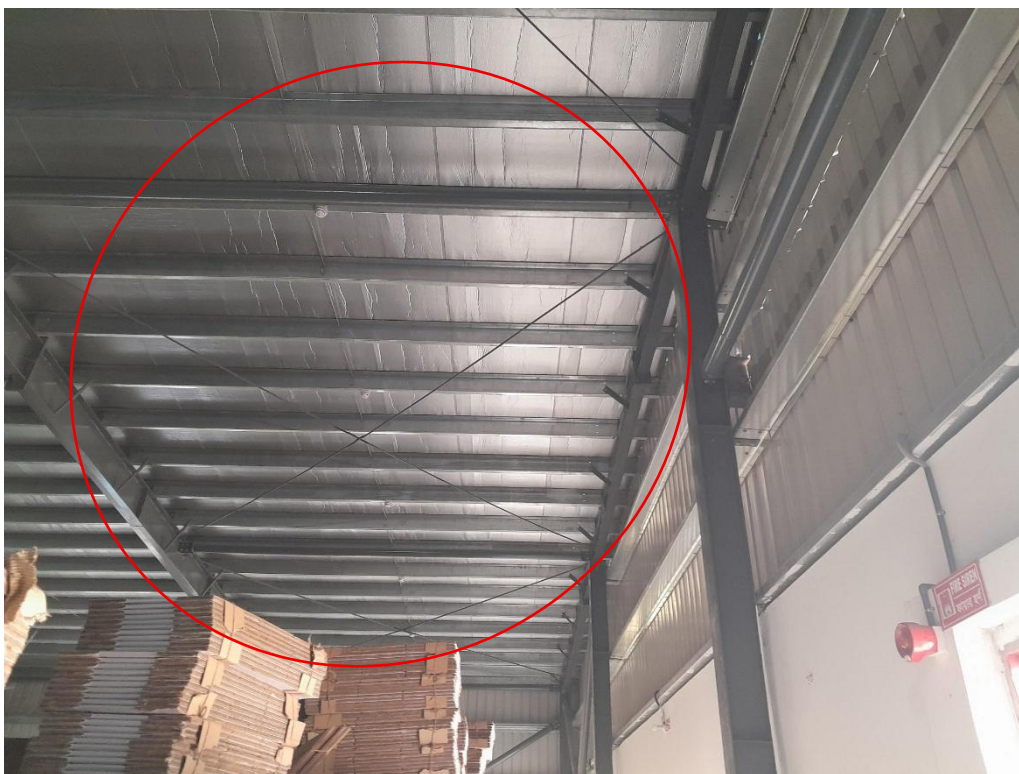
**Observation-05: Loose roof bracing. (Production Shed)**

**Description:** Factory is required to tighten all loose bracing.

| Observation | Action Plan | Timeline |
|---|---|---|
| Loose roof bracing.<br>(Production Shed) | Factory is required to tighten all loose bracing. | within 6 months |
