# INITIAL FIRE SAFETY INSPECTION REPORT

**Scandex (Bd) Ltd. (Extension)**

**RSC ID: 26526**

**Date: 02-December-2025**

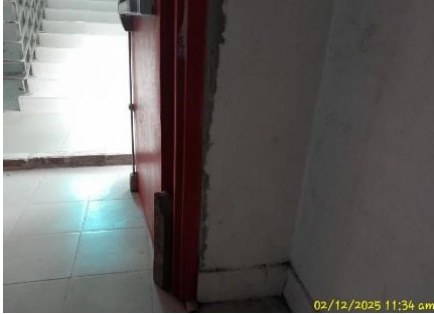
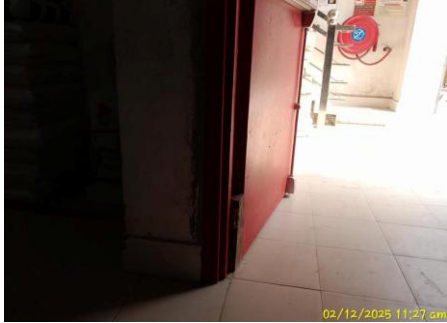
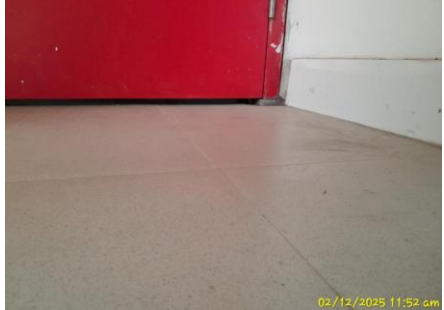
| SI No. | Category | Findings | Required Action | Remediation Time Frame |
|---|---|---|---|---|
| F-1 | Means of Egress | <p>The fire doors were held open by unauthorized means.</p> <p>The clearance under the bottom of the door was more than 19 mm.</p> <p><b>Location(s): All floors (Store Building)</b></p> | <p>Ensure that the fire doors are self-closing and positive latching. If fire doors are required to be held open for functional reasons, provide automatic closing devices tied to the fire alarm system.</p> <p>The clearance under the bottom of a door shall be a maximum of 3/4 in. (19 mm).</p> | Within 3 Months |

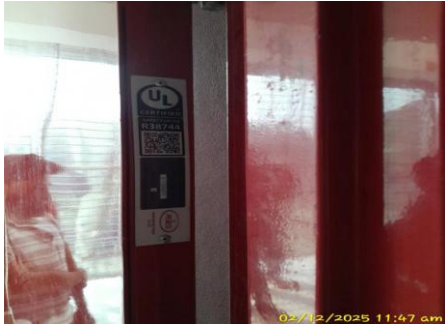
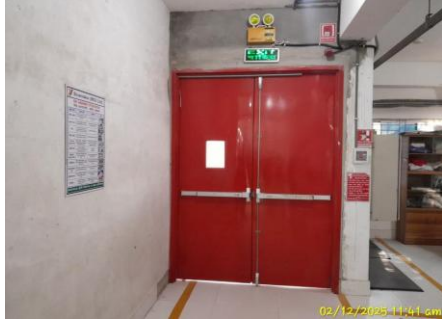
| F-2 | Means of Egress | <p>Proper certification was not available for fire rated doors and door accessories installed in the factory.</p> <p><b>Location(s): All floors (Store Building)</b></p> | Keep proper datasheet & certifications for installed fire doors & accessories on-site for verification. | Within 3 Months |

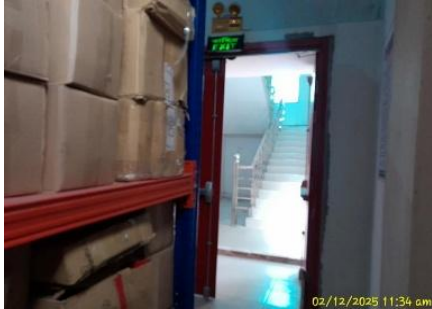
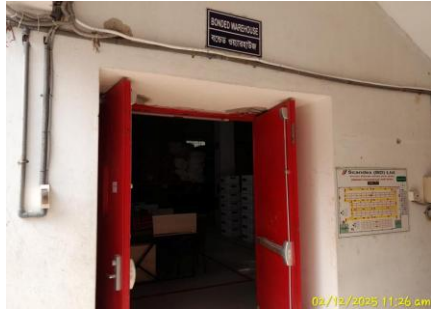
| F-3 | Means of Egress | <p>Storage areas discharge directly into the exit stair enclosure.</p> <p><b>Location(s): Ground floor &amp; 2nd F (Store Building).</b></p> | <p>Openings from the exit enclosure to Storage areas shall be provided with a vestibule with fire-rated construction and openings in accordance with section 6.14.3 of RSC Technical Guidelines (Standard)<sup>1</sup> V1.0. Provide a min 1-hr fire-rated door on the exit stair side and a 1-hr fire-rated door on the Store side. Ensure that the fire rating of the vestibule construction matches that of the exit stair enclosure as per RSC Technical Guidelines (Standard)<sup>1</sup> V1.0. section 6.14.3. The minimum width for vestibules shall not be less than 1.1m, and the length shall be 1.8m.</p> | Within 3 months |

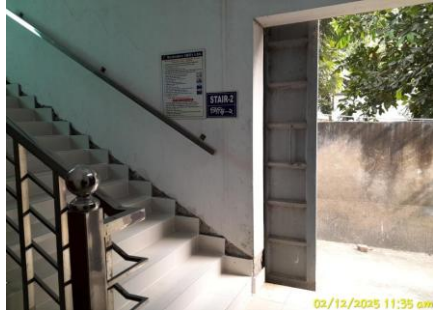
| <b>F-4</b> | Means of Egress | <p>Stair clear width was found less than 60 in.</p> <p><b>Location(s): North Stair (Store Building).</b></p> | <p>Stairs shall have a minimum clear width of 60 in. for all industrial occupancies as per RSC Technical Guideline (Standard) section 6.5.6</p> | Within 3 Months |

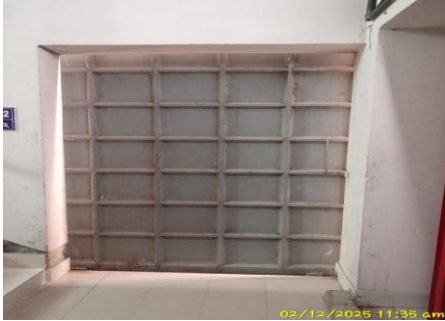
| F-5 | Means of Egress | <p>Sliding door has been provided in the North Stair exit.</p> <p><b>Location(s): Ground floor, North Stair (Store Building).</b></p> | <p>Replace all sliding-type doors &amp; gates with the side-hinged swinging type doors in accordance with section 6.8.1 of RSC Technical Guidelines (Standard)<sup>1</sup> V1.0.</p> <p>All doors in a means of egress shall be of the side-hinged swinging type.</p> <p>Roll-down and sliding gates and shutters shall not be allowed.</p> <p>Doors serving an occupant load of more than 50 shall swing in the direction of egress travel.</p> | Within 1 Month |

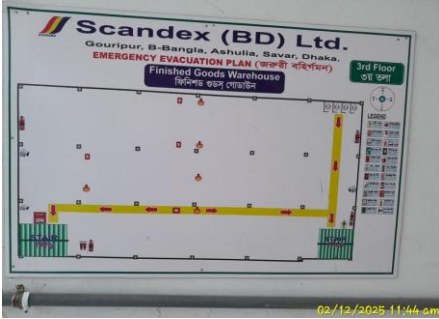
| F-6 | Means of Egress | <p>Fire evacuation maps are not updated as per site condition.</p> <p><b>Location(s): All floors (Store Building).</b></p> | <p>Fire evacuation maps shall be posted at the entrance to each exit stair in accordance with RSC Technical Guidelines (Standard)<sup>1</sup> V1.0 Section 13.3.</p> | Within 1 Month |

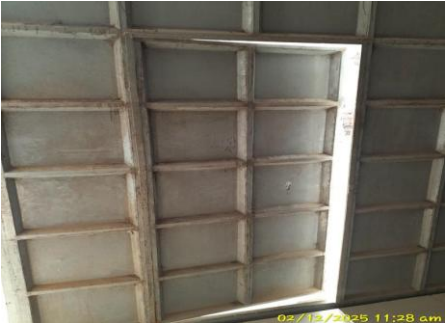
| F-9 | Means of Egress | <p>Doors in the means of egress do not have the required minimum width (32 inches available).</p> <p><b>Location(s): South exit (Store Building).</b></p> | <p>Doors in a means of egress shall have a minimum width of 1 m (39 in.). in accordance with section 6.5.6.1 of RSC Technical Guidelines (Standard)<sup>1</sup> V1.0.</p> | Within 1 Month |

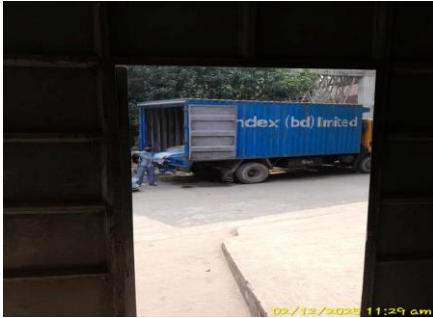
| <b>F-10</b> | Means of Egress | <p>Headroom measured less than 80 inches (76 inches available).</p> <p><b>Location(s): South exit (Store Building).</b></p> | <p>All means of egress shall have a minimum ceiling height of 2.3 m (7 ft 6 in.) with projections from the ceiling not less than 2.03 m (6 ft 8 in.). The minimum ceiling height shall be maintained for at least 2/3 of the space or room as long as the remaining area shall be not less than 2.03 m (6 ft 8 in.). Headroom on stairs shall not be less than 2.03 m (6 ft 8 in.) as per RSC Technical Guideline (Standard) section of 6.3.3.</p> | Within 3 Months |

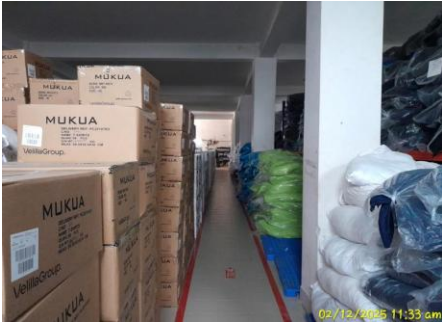
| F-11 | Means of Egress | <p>Directional signs are not provided where direction of the path of travel to an exit has changed.</p> <p><b>Location(s): All floors (Store Building).</b></p> | <p>Illuminated directional signs shall be provided where there is a change in the direction for the path of travel and the direction to an exit is not obvious in accordance with RSC Technical Guidelines (Standard)<sup>1</sup> V1.0 Section 6.11.3..</p> | Within 1 Month |

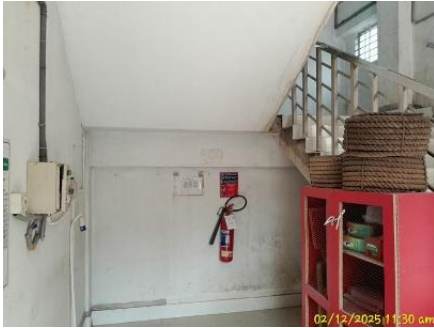
| <b>F-12</b> | Means of Egress | <p>Electrical panels, circuit breakers were located in the exit stair enclosure.</p> <p><b>Location(s): Ground floor, South stair (Store Building).</b></p> | <p>Remove and relocate all Electrical panels &amp; appliances from exit stair enclosures.</p> <p>Or,</p> <p>Provide fire separation with stair enclosure in accordance with section 6.3.1 of RSC Technical Guidelines (Standard)<sup>1</sup> V1.0.</p> | Within 3 Months |

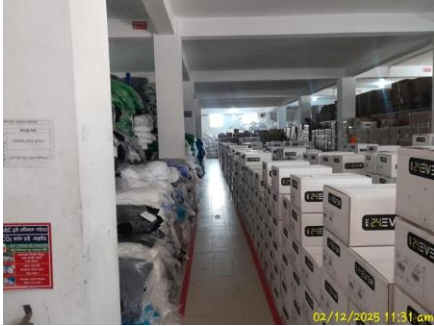
| <b>F-13</b> | Means of Egress | <p>Based on the number and location of emergency lights observed, adequate illumination levels are not anticipated along egress routes.</p> <p><b>Location(s): All floors (Store Building).</b></p> | <p>Test the emergency lighting system on each floor and provide additional emergency fixtures to provide adequate illumination along the means of egress. Provide a minimum illumination of 10 lux at the floor level within exit stairs and exit discharge paths and minimum 2.5 lux along exit access aisles. Illumination on means of egress shall meet in accordance with RSC Technical Guidelines (Standard)<sup>1</sup> V1.0 Section 10.12.2.</p> | Within 3 Months |

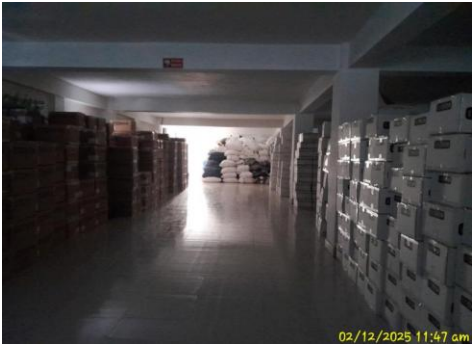
| F-14 | Means of Egress | <p>Aisles were found missing in several locations throughout the building.</p> <p><b>Location(s): 2nd floor (Store Building).</b></p> | <p>Provide minimum aisle widths of 36-in. Aisles mark shall be clearly visible.</p> | <p>Within 1 Month</p> |

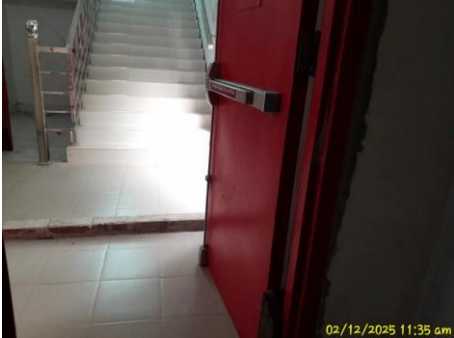
| F-15 | Means of Egress | <p>Abrupt changes in the elevation of walking surfaces were observed, not meeting the RSC Technical Guidelines (Standard)<sup>1</sup> V1.0 Section 6.3.4.</p> <p><b>Location(s): Ground floor (Store Building).</b></p> | <p>Abrupt changes in elevation of walking surfaces shall not exceed ¼ in. unless provided with a beveled slope of 1 in 2 that do not exceed ½ in. Changes greater than ½ in. shall meet the requirements for RSC Technical Guidelines (Standard)<sup>1</sup> V1.0 Section 6.3.5..</p> | Within 3 Months |

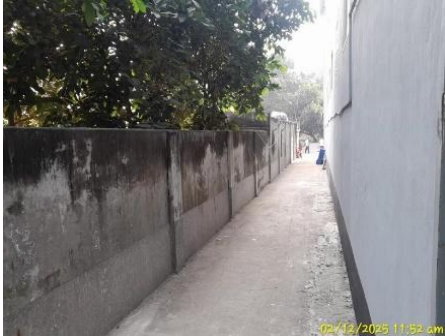
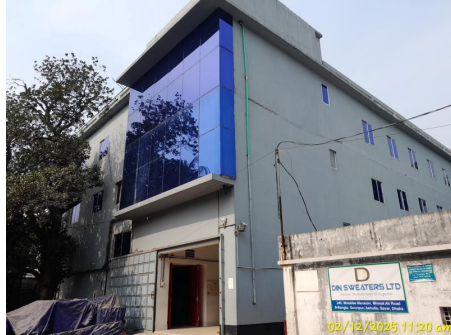
| F-16 | Fire Rated Construction | <p>The required fire separation distance for Store Building does not comply with the requirements of BNBC 2006.</p> <p><b>Location: North, East &amp; West Side.</b></p> | <p>The exterior walls shall have a fire resistance and opening protection as specified in BNBC 2006, Tables 3.2.2 and Part 3 Section 2.4.1.3.</p> | Within 6 Months |

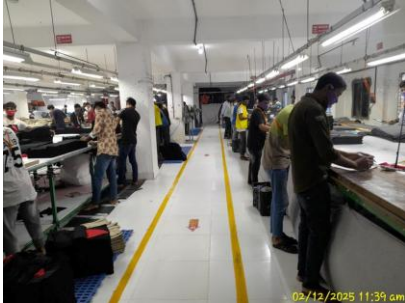
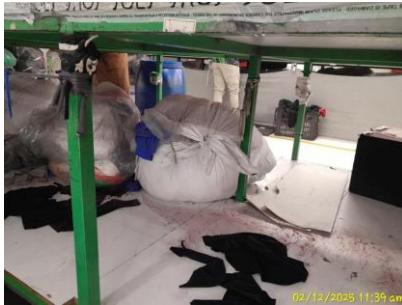
| F-17 | Fire Rated Construction | <p>Storages were found underneath the cutting tables.</p> <p><b>Location: 1st Floor (Store Building).</b></p> | <p>Storage underneath the cutting tables shall be kept clear of combustibles at all time, except as provided for miscellaneous storage in accordance with 3.4.2.1.6.</p> | Within 3 Months |

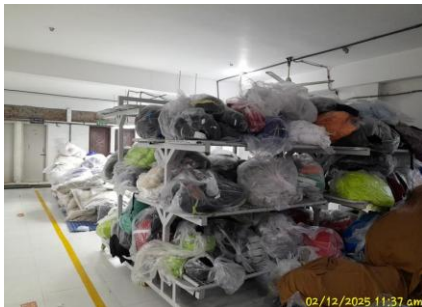
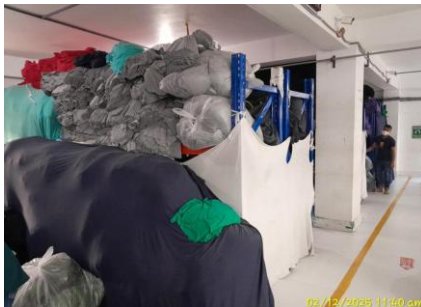
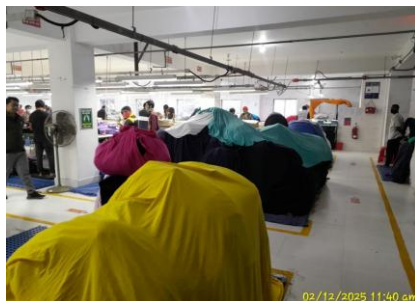
| F-18 | Fire Rated Construction | <p>Areas used for in-process storage of combustible materials are open to the surrounding occupancy.</p> <p><b>Location(s): 1st Floor (Store Building).</b></p> | <p>Provide defined storage areas and limit the storage arrangement as follows:</p> <p>Maximum height of 2.45 m and maximum area of 23 m<sup>2</sup> and is separated by a minimum 3.0 m (10ft) from other storage areas and they do not exceed 10 percent of the building area of the story in which they occur.</p> <p>or,</p> <p>If sprinkler protected, Maximum height 12 ft (3.66 m) and maximum area of 1000 ft<sup>2</sup> (93 m<sup>2</sup>) and separated by a at least 25 ft (7.62 m) and does not constitute more than 10 percent of the building area or 4000 ft<sup>2</sup> (372 m<sup>2</sup>) of the sprinklered area, whichever is greater.</p> <p>or,</p> <p>Enclose the storage area from the surrounding occupancy with a minimum 1 hour construction.</p> | Within 3 Months |

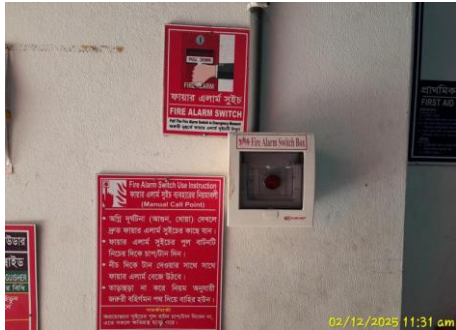
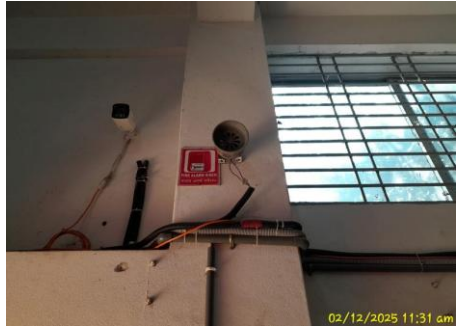
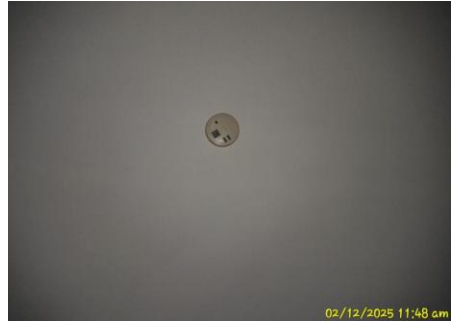
| F-19 | Fire Alarm & Detection System (FADS) | <p>The fire alarm system is antiquated, not a listed system and does not provide alarm and notification features consistent with acceptable standards.</p> <p><b>Location(s): Store Building.</b></p> | <p>Replace the fire alarm system with a new, listed addressable fire alarm system in accordance with NFPA 72 to meet section 5.7.3 of RSC Technical Guideline (Standard)</p> <p>Submit the proposed fire alarm system design to RSC for review. Once the design is reviewed, install and modify the fire detection and alarm system throughout the building in accordance with review comments, RSC/ RSC Technical Guidelines (Standard), and NFPA 72. After installation, the owner shall conduct internal testing and commissioning, and then contact the RSC for witness of final acceptance testing.</p> | Design within 2 Months and modification/ installation with 4 Months |
