# Scandex (Bd) Ltd (Extension)

B-Bangla, Gouripur, Ashuliya, Savar

1 December 2025

**1. Store Building: 3-storied (G+2) RC building.**

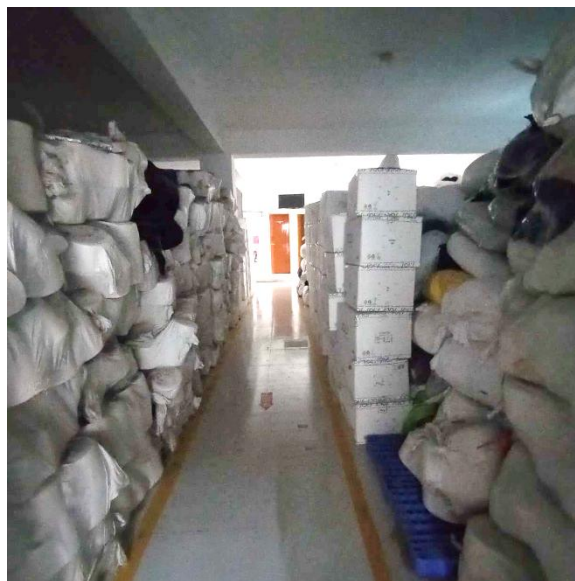
**Observation-02:** Load plan doesn't comply with BNBC (Store Building).

**Description:** Live load on the 2nd floor is considered as 4 kPa in the prepared load plan. As per BNBC- Part 6, live load for light storage areas is required to be considered a minimum 6 kPa. However, the factory engineer is required to revise the load plan as per the BNBC requirement and check the design accordingly.

| Item No | Observation | Action Plan | Timeline |
|---|---|---|---|
| 2. | The load plan doesn't comply with BNBC (Store Building). | The building engineer is required to revise the live load plan as per the BNBC requirement and check the design accordingly. | within 6 weeks |
| 3. | | Implement floor live load plan (post accepted allowable load plan, mark storage height & area & maintain floor loading below limit) | within 6 months |

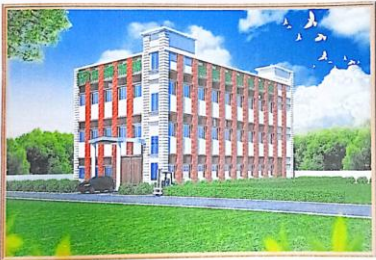
**Observation-03:** Lack of information in design report (Store Building).

**Description:** A design report was available, which doesn't include the punching/flexural capacity check of the foundation, serviceability and irregularity check of the building as per BNBC. The building engineer is required to update the design report as per 1.9.1 BNBC and submit it to RSC for detailed review.

| Item No | Observation | Action Plan | Timeline |
|---|---|---|---|
| 4. | Lack of information in the design report (Store Building). | The building engineer is required to update the design report as per 1.9.1 BNBC and submit it to RSC for review. | within 6 weeks |
| 5. | | Implement remediation work if required. | within 6 months |

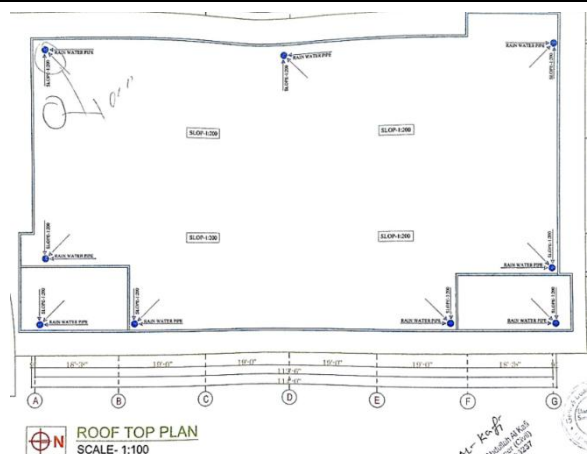
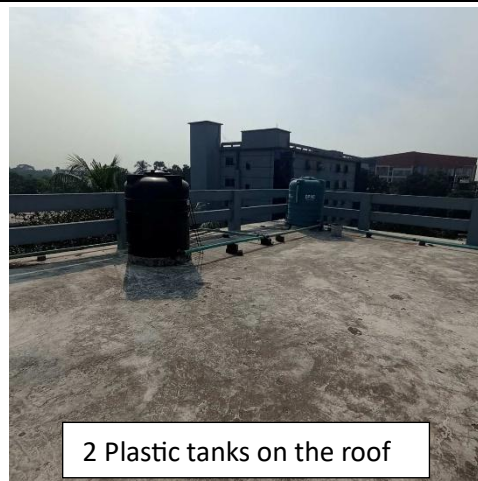
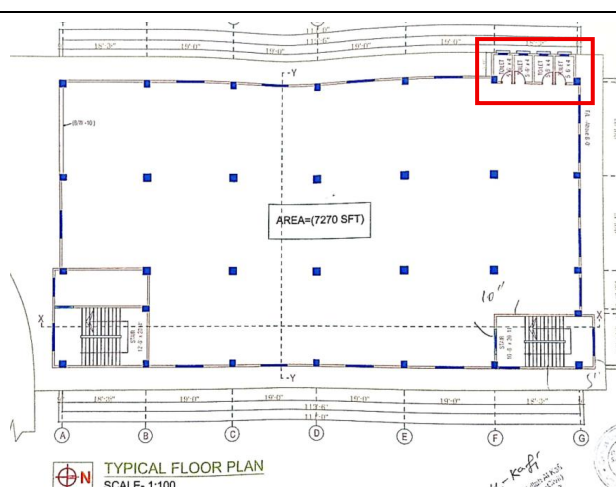
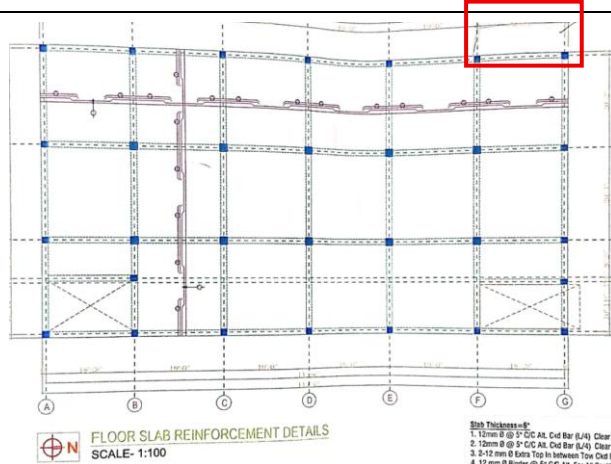
**Observation-04:** Lack of information in the provided drawing (Store Building).

**Description:** 2 plastic tanks (1000 liters each) were found on the roof slab, which were not shown in the roof layout. Also, the cantilever part (red marked) shown in the architectural layout is not shown in the slab layout. The building engineer is required to survey the as-built condition and prepare an accurate set of as-built drawings.

| Item No | Observation | Action Plan | Timeline |
|---|---|---|---|
| 6. | Lack of information in the provided drawing (Store Building). | The building engineer is required to survey the structure and prepare accurate set of as-built drawings. | within 6 weeks |

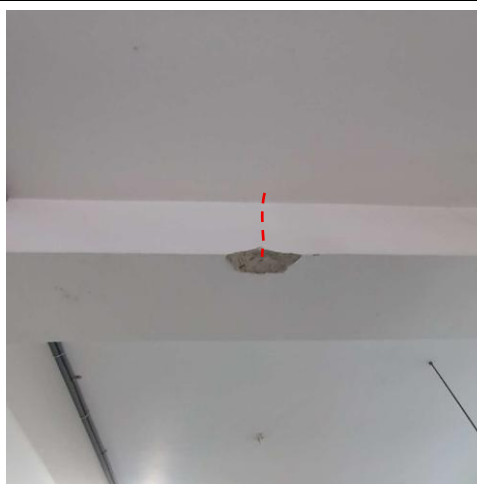
**Observation-05:** Plaster Crack on the beam (Store Building).

**Description:** Cracks (plaster) were found on the beam at several locations. The building engineer is required to identify all areas and repair the crack with a suitable method.

| Item No | Observation | Action Plan | Timeline |
|---|---|---|---|
| 7. | Plaster crack on the beam (Store Building). | The building engineer is required to identify all areas and repair the crack with a suitable method. | within 6 weeks |

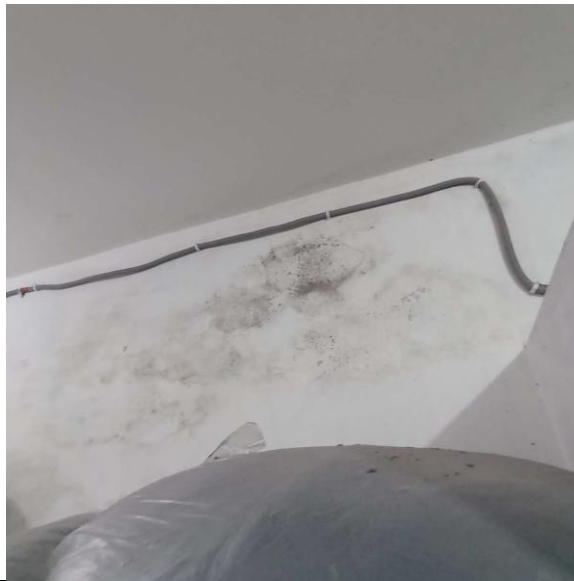
**Observation-06:** Dampness on brick wall (Store Building).

**Description:** Dampness was found in the brick wall at several locations. The building engineer is required to repair the dampness with a suitable method.

| Item No | Observation | Action Plan | Timeline |
|---|---|---|---|
| 8. | Dampness on brick wall (Store Building). | The building engineer is required to seal the source of water & repair the dampness with a suitable method. | within 6 months |

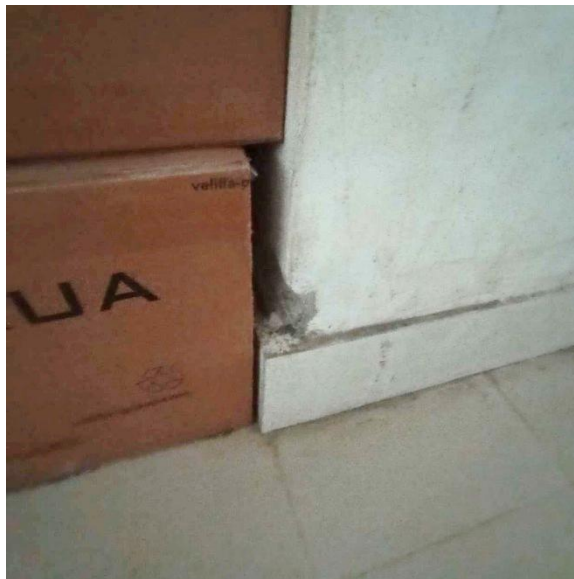
**Observation-07:** Column plaster damaged due to trolley impact (Store Building).

**Description:** Column plaster damage was found on the ground floor. The building engineer is required to repair damaged plaster and provide a column guard.

| Item No | Observation | Action Plan | Timeline |
|---|---|---|---|
| 9. | Column plaster damaged due to trolley impact (Store Building). | The building engineer is required to repair damaged plaster and provide a column guard. | within 6 months |

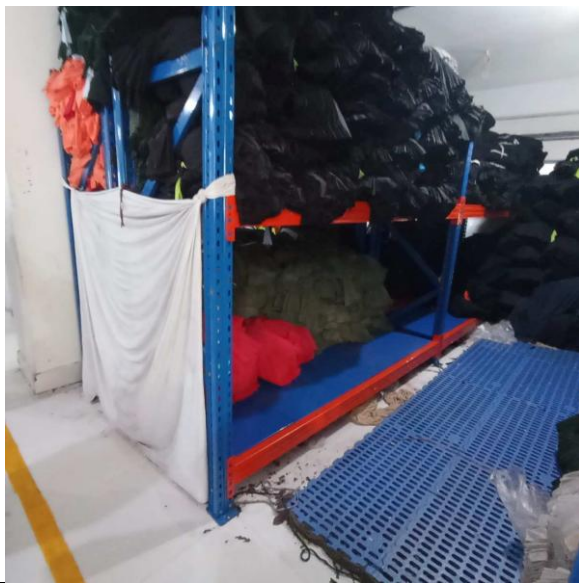
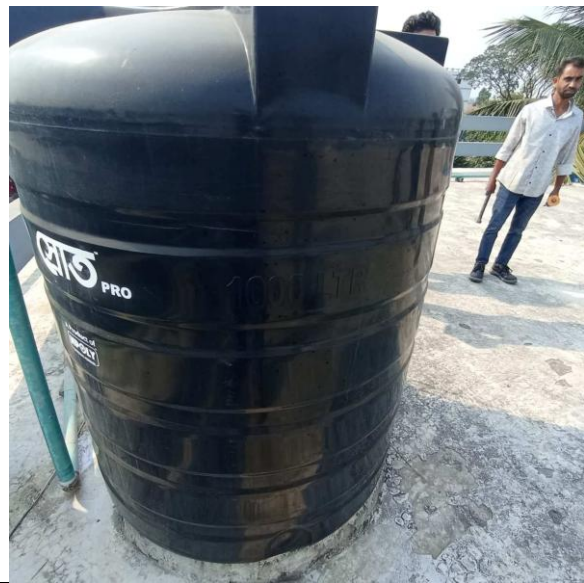
**Observation-08:** Nonstructural elements found unanchored/unbraced (Store Building).

**Description:** Nonstructural elements found unanchored/unbraced. Anchor/brace all nonstructural elements within the building.

| Item No | Observation | Action Plan | Timeline |
|---|---|---|---|
| 10. | Nonstructural elements found unanchored/unbraced (Store Building). | Anchor and/or brace all nonstructural elements within the building. | within 6 months |

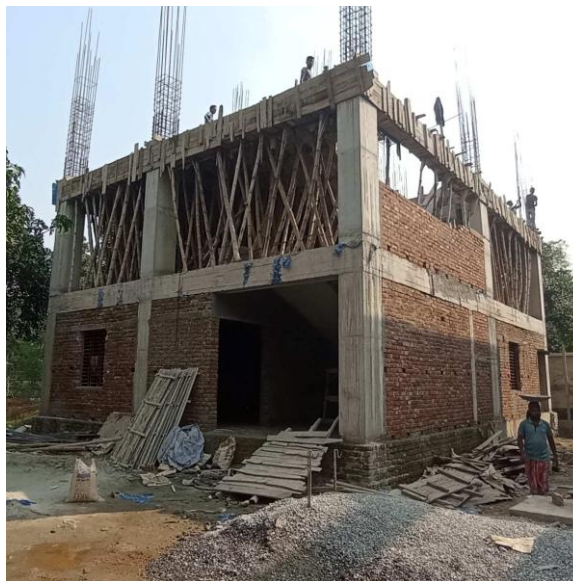
**Observation-09:** Construction safety is not being maintained (Under-construction Building).

**Description:** Construction safety is not being maintained at the under-construction Building. Maintain construction safety practice as per BNBC, Part VII, Chapter 3.

| Item No | Observation | Action Plan | Timeline |
|---|---|---|---|
| 11. | Construction safety is not being maintained (Under-construction Building). | Maintain standard construction safety practice as per BNBC (Part VII, Chapter 3). | within 6 weeks |
