# Fashion Plus Ltd.

Gorat, Ashulia, Savar, Dhaka-1341.

9 December 2025

## 1. Building Information

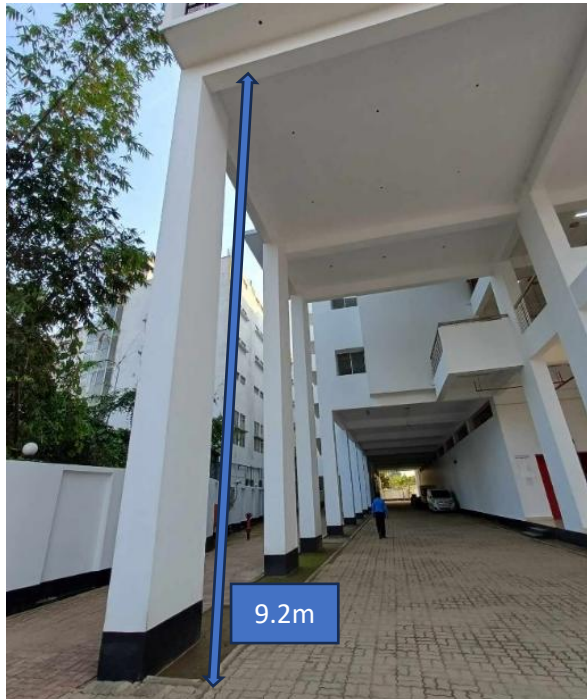
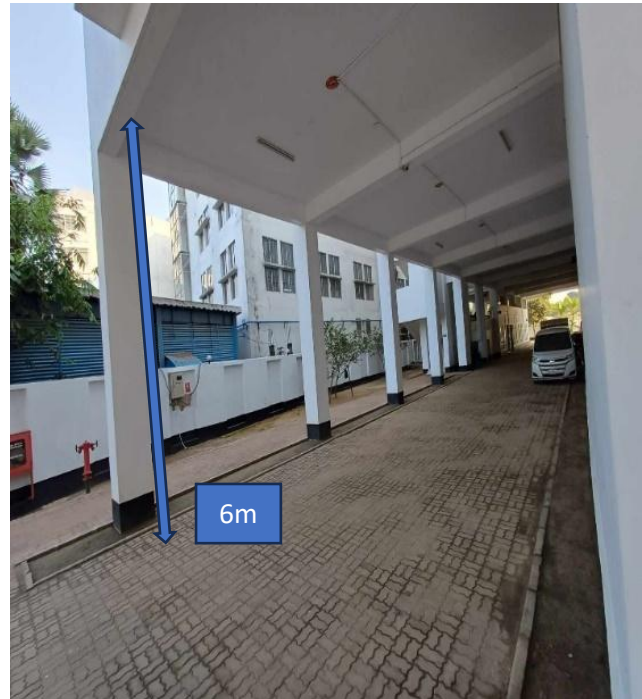
### Observation-02: Slenderness exists in the shear walls and columns. (Main Building)

**Description:** The RC column (600mm X 600mm) unsupported length is 6m. Also, the shear wall (450mm X 1200mm) unsupported length is 9.2m. The height-to-thickness ratio of the shear wall and RC column exceeds the limit.

The building engineer is required to consider the slenderness effects in the design report.

| Item No | Observation | Action Plan | Timeline |
|---|---|---|---|
| 1. | Inconsistencies in the design report and slenderness effect of column & shear wall.<br>(Main Building) | The building engineer is required to address all the inconsistencies and slenderness effect in the revised design report and submit to RSC for detailed review. | within 6 weeks |

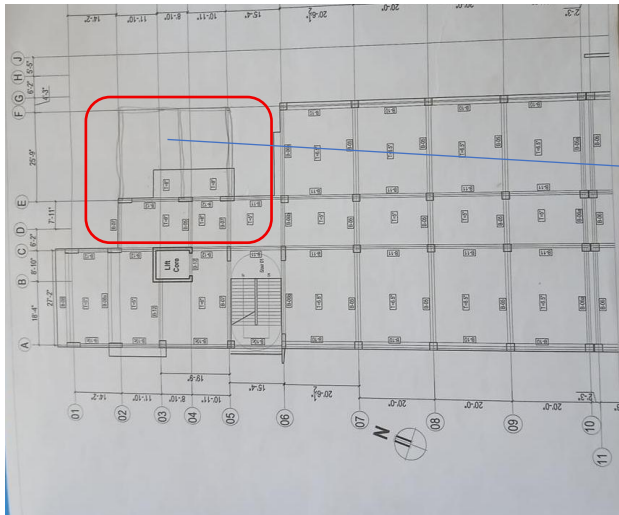
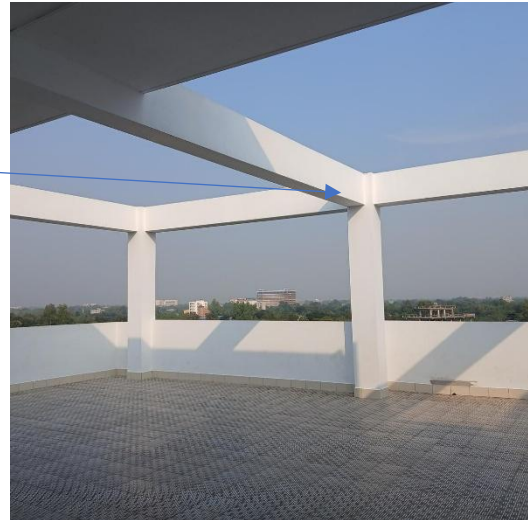
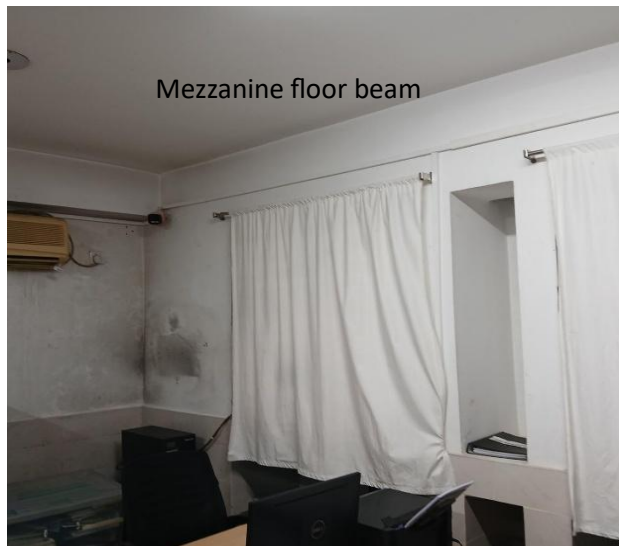
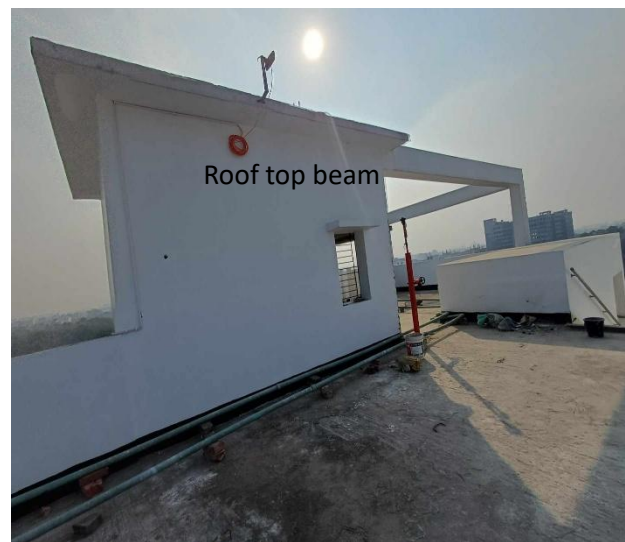
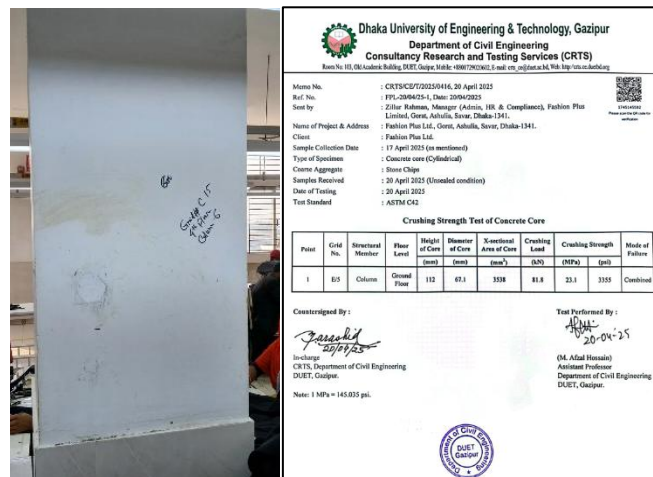
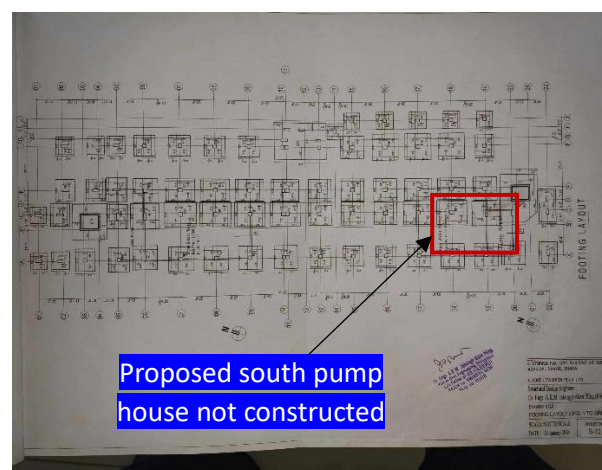
### Observation-03: Mismatches/lack of as-built drawings. (Main Building)

**Description:** Beam layout of roof floor didn't fully match with as-built conditions. At the North open beams are not shown in drawings. Also, beam layout for mezzanine floor & roof top and concrete core layouts were missing in the provided drawings. Moreover, Pump House of the South side has not been constructed.

| Item No | Observation | Action Plan | Timeline |
|---|---|---|---|
| 5. | Mismatches in as-built drawings<br>(Main Building) | The building engineer is required to survey the whole structure and produce an accurate as-built drawing. | within 6 weeks |

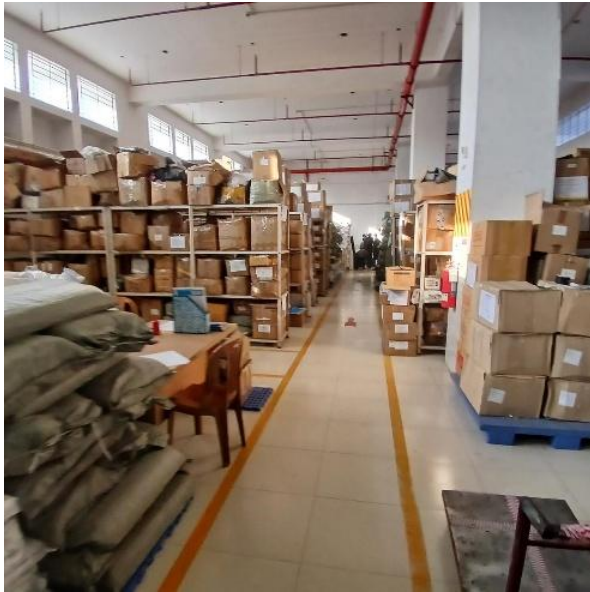
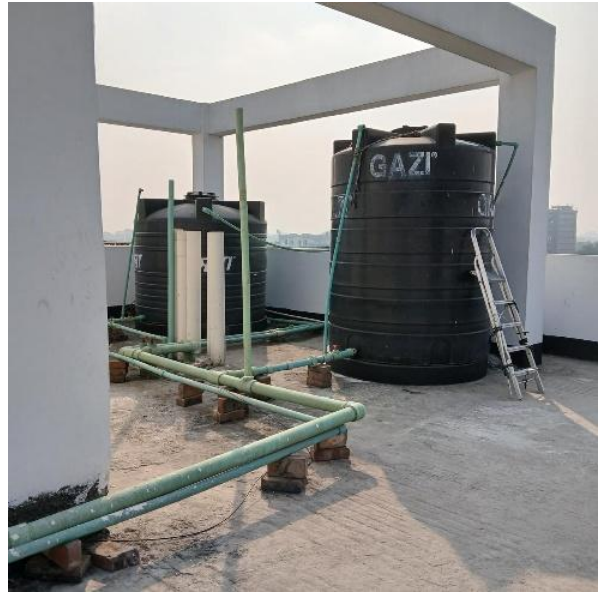
**Observation-04:** Non-structural elements found unbraced/unanchored. (Main Building)

**Description:** Non-structural elements storage racks and PVC tanks were found unbraced/unanchored. The building engineer is required to brace/anchor all non-structural elements.

| Item No | Observation | Action Plan | Timeline |
|---|---|---|---|
| 6. | Non-structural elements found unbraced / unanchored.<br>(Main Building) | The building engineer is required to brace/anchor all non-structural elements. | within 6 months |

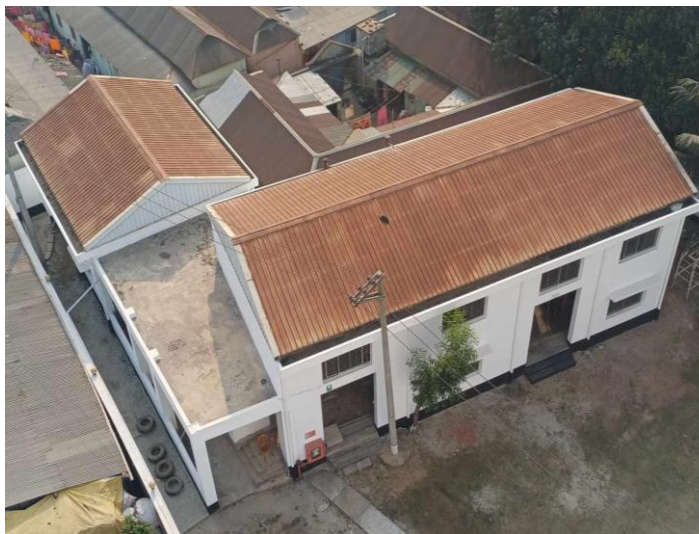
**Observation-05:** Lack of structural drawings and design documents.  
(Utility Shed; Fire Control & Security Room)

**Description:** As-built structural drawings and design documents were not available for Utility Shed and Fire Control & Security Room. Building engineer is required to survey the whole structures and prepare as-built structural drawings with complete structural details. Also prepare design report for both structures.

| Item No | Observation | Action Plan | Timeline |
|---|---|---|---|
| 7. | Lack of structural drawings and design documents.<br>(Utility Shed) | Building engineer is required to survey the whole structures and prepare as-built structural drawings with complete structural details. | within 6 weeks |
| 8. | | Prepare complete design report for the structures. | within 6 weeks |
