Tazkia Apparels Ltd.

Plot: A-113, BSCIC Industrial Estate, Tongi, Gazipur.

11 December 2025

Structural Inspection Report

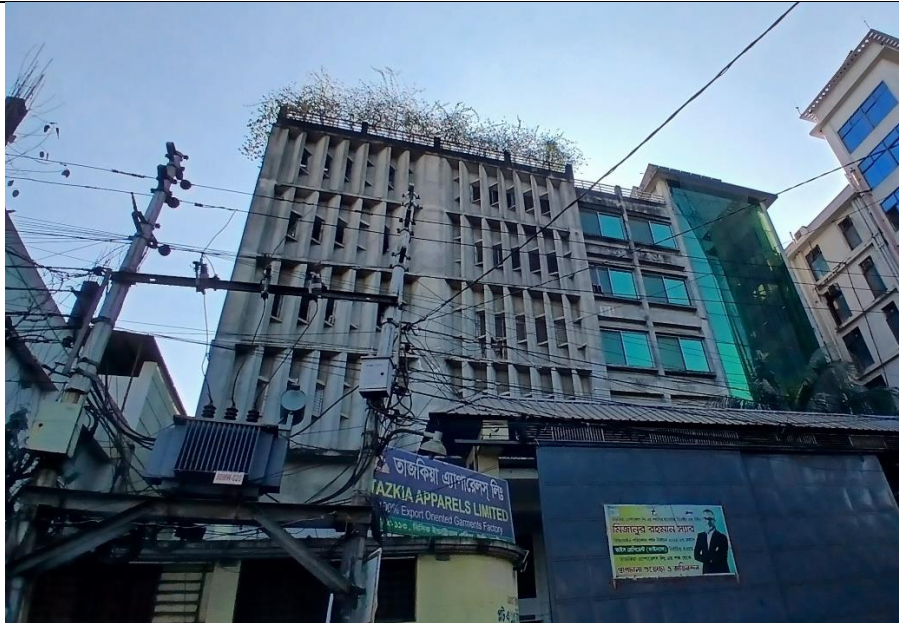
Observation-01: Lack of Design report and material test report. (Main Production Building)

Description: During the inspection, the as-built drawings and soil test report of the structure were available; however, no material test reports and structural design reports were found on-site. The building engineer is required to prepare a structural design report considering in-situ material strengths in accordance with Section 1.9.1 of the BNBC and submit it to RSC for review.

Item No	Observation	Action Plan	Timeline
1.	Lack of Design report and material test report. (Main Production Building)	The building engineer is required to prepare an Engineering Assessment (EA) report considering in-situ material strengths in accordance with Section 1.9.1 of the BNBC and submit it to RSC for review.	within 6 weeks

2.		Verify in-situ material strength by taking concrete cores from the lower tier of the building (min. 4 cores from columns and 4 cores from beam/slab).	within 6 weeks

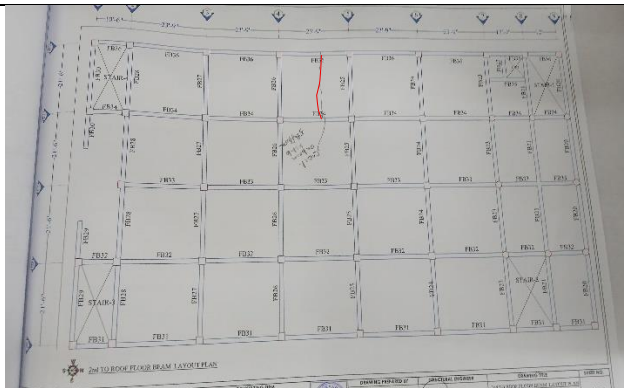
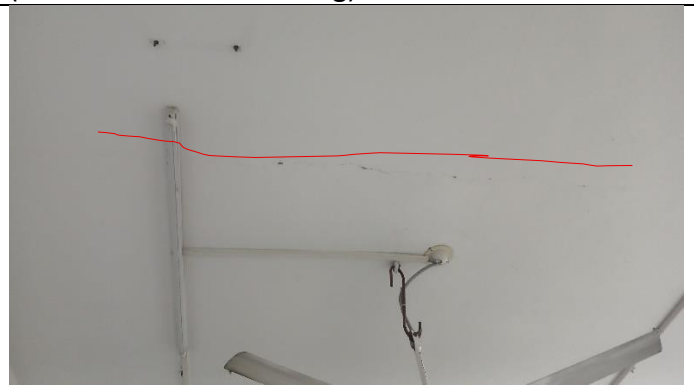
Observation-02: Hairline cracks on beam and slab (Main Production Building)

Description: During the inspection, hairline cracks were found on beam and slab at 5th floor roof. The building engineer is required to investigate the extent of crack and prepare an investigation report with remedial measures and submit it to RSC for review.

6.	Hairline cracks on beam and slab (Main Production Building)	The building engineer is required to investigate the extent of cracks and prepare an investigation report with remedial measures and submit it to RSC for review. Repair the crack as per the RSC accepted investigation report.	within 6 weeks

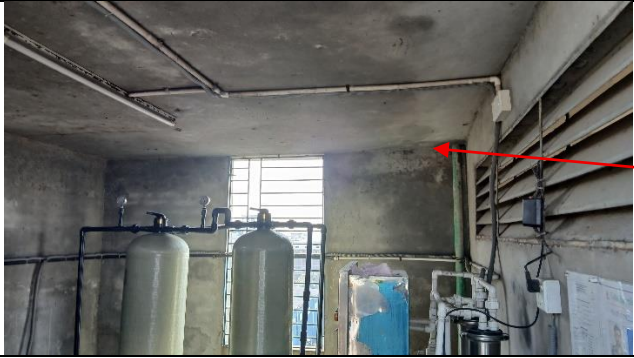
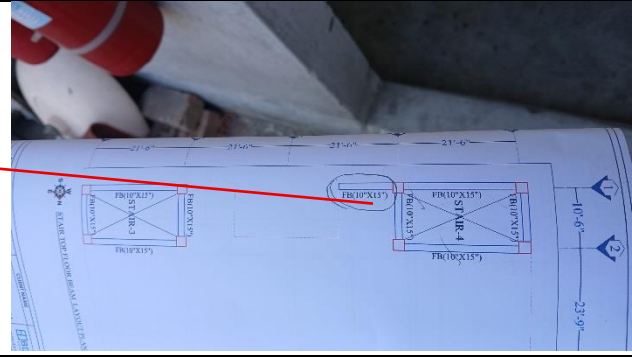
Missing cantilever beam on stair roof

Description: During the inspection, several mismatches were observed between the as-built drawings and on-site conditions. The building engineer is required to survey the full structure and update the as-built drawing as per site conditions.

7.	Mismatch/Lack of information in the as-built drawing. (Main Production Building)	The building engineer is required to survey the full structure and update the as-built drawing as per site conditions.	within 6 weeks

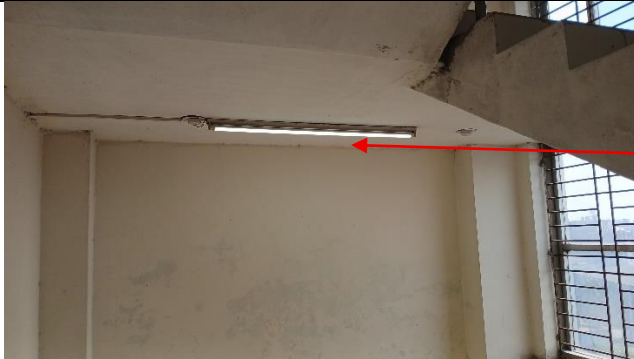
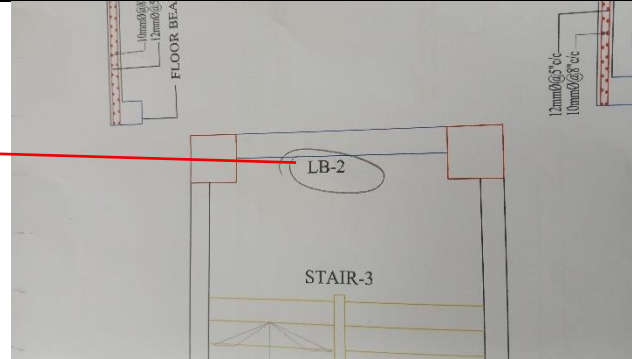
Missing landing beam on stair zone.

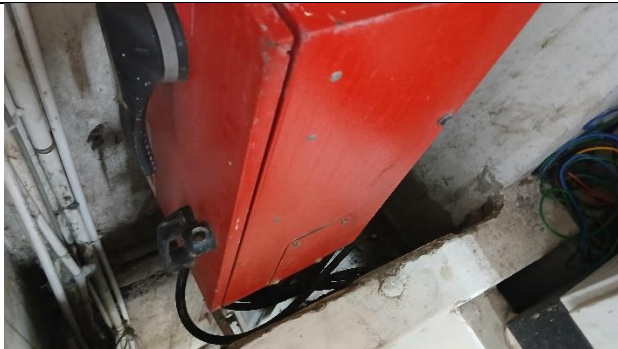
Floor punch not shown in drawing

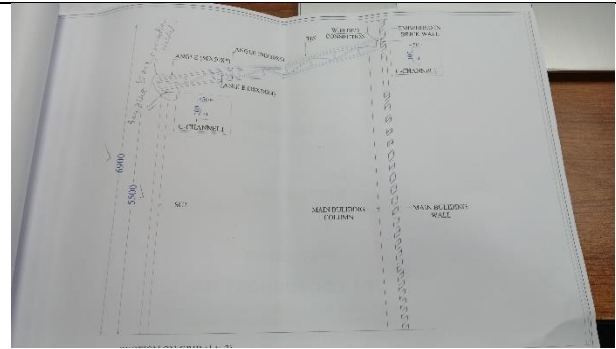
Mismatch in truss layout and missing connection details at boiler room

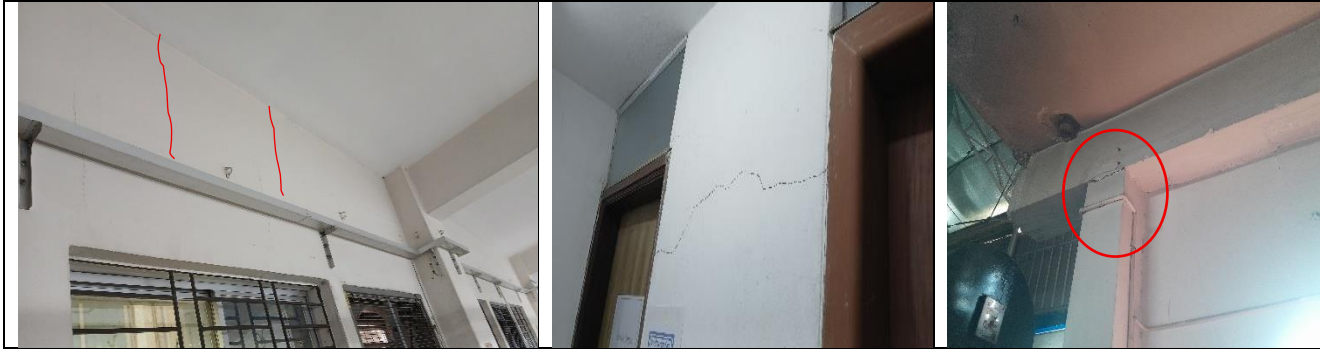
Observation-04: Cracks on brick wall of Main Production Building

Periphery brick wall	Internal brick wall	Boiler Room
----------------------	---------------------	-------------

Description: During the inspection, cracks were found in periphery brick wall on the 3rd, 4th and 5th floor of the Main Production Building. Also, several cracks were found on the internal brick wall, and a horizontal crack was found between beam and brick pier joint at Boiler room. The building engineer is required to investigate the extent and causes of the observed crack. Necessary repairs shall be carried out as per recommendations.

8.	Cracks on brick wall of Main Production Building	The building engineer is required to investigate the extent and causes of the observed crack repair with a suitable method.	within 6 weeks

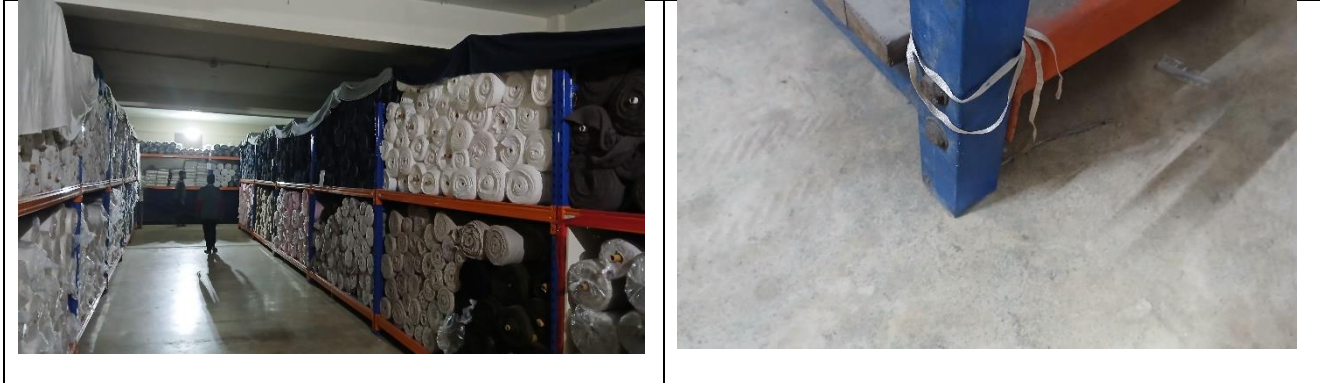
Observation-05: Non-structural elements found not anchored/braced. (Main Production Building)

Description: Non-structural elements were found on different floors of the building, which were not fully anchored or braced. The building engineer is required to anchor or brace all non-structural elements to avoid a falling hazard during an earthquake.

9.	Non-structural elements found not anchored/braced. (Main Production Building)	The building engineer is required to anchor or brace all non-structural elements to avoid a falling hazard during an earthquake.	within 6 months

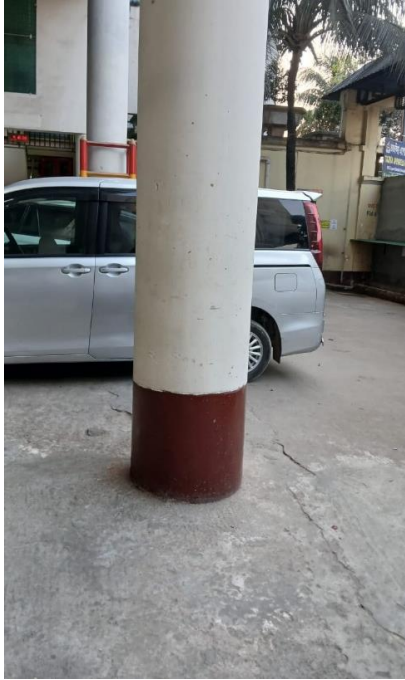
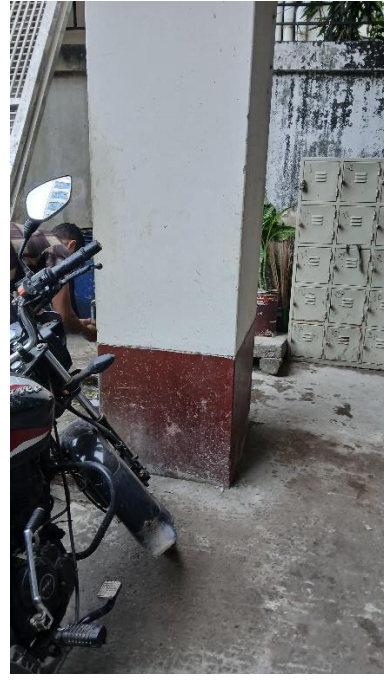
Observation-06: Columns susceptible to vehicle impact (Main Production Building)

Description: Columns at the ground-floor driveaway area were found susceptible to vehicle impact.

The building engineer is required to provide separate barriers around the column to avoid vehicle impact on columns.

10.	Columns susceptible to vehicle impact (Main Production Building)	The building engineer is required to provide separate barriers around the column to avoid vehicle impact on column.	within 6 months

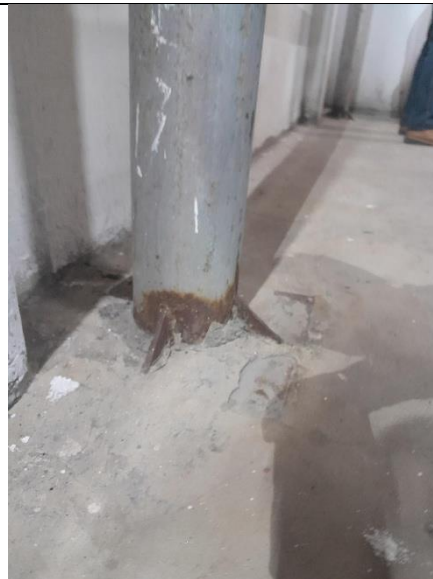
Observation-07: Corrosion on steel member at boiler room. (Main Production Building).

Description: During inspection, corrosion was observed at the steel column of the boiler room. The building engineer is required to remove rust and provide rust proofing paint to avoid future corrosion.

11.	Corrosion on steel member in boiler room. (Main Production Building).	The building engineer is required to remove rust and provide rust proofing coating to avoid future corrosion.	within 6 months

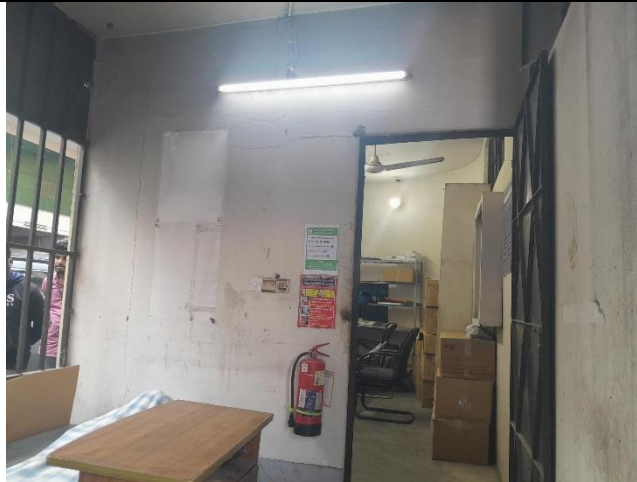
Observation-08: Cracks on brick wall of Security Building.

Description: During the inspection, cracks were found in the brick wall. The building engineer is required to investigate the extent and causes of the observed crack. Necessary repairs shall be carried out as per recommendations.

12.	Cracks on brick wall of Security Building.	The building engineer is required to investigate the extent and causes of the observed crack repair with a suitable method.	within 6 weeks
13.	Possible falling hazards. (Utility Building)	The building engineer is required to provide a fall protection parapet/ barrier to avoid falling hazards.	within 6 months

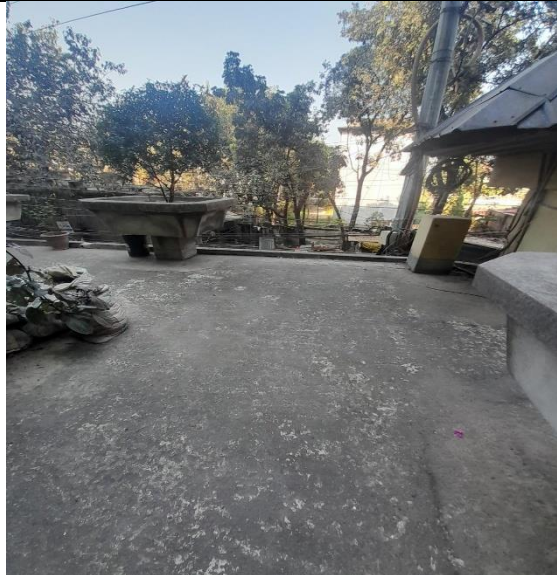
Observation-09: Possible falling hazard. (Utility Building)

Description: Falling hazard was observed on the roof. The building engineer is required to provide a barrier to avoid falling hazards.
