FIRE SAFETY INSPECTION REPORT

RENAISSANCE APPARELS LTD

**RENAISSANCE APPARELS LTD. C-S PLOT # 659 &
660, MOUZA 93, GAZIPUR**

June 9, 2014

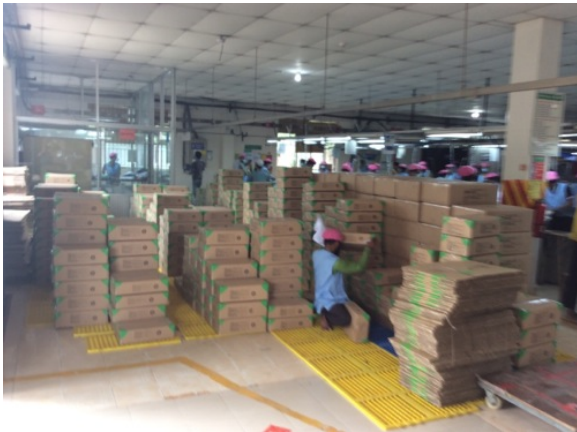
No.	Category	Finding	Recommendation	Remediation Timeframe
F-1	Fire Rated Construction	A large amount of process storage was observed in the finishing area open to the production floor.	Where separate storage rooms are not feasible, provide defined storage areas and limit the storage arrangement as follows: - Maximum height of 2.4m and maximum area of 23m ² - If sprinkler protected: maximum height of 3.66m and maximum area of 93m ² Separate areas of unenclosed combustible storage by a minimum clear distance of 3m.	Within 3 months

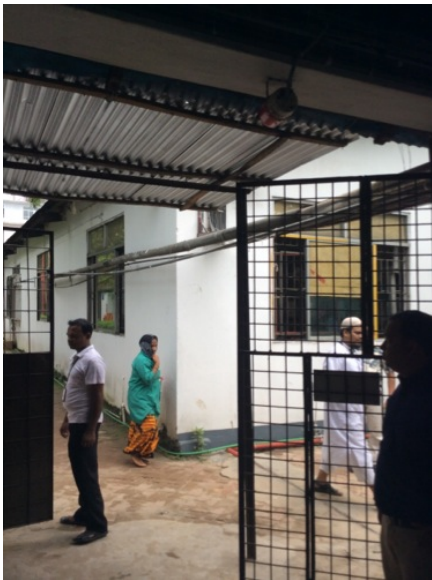
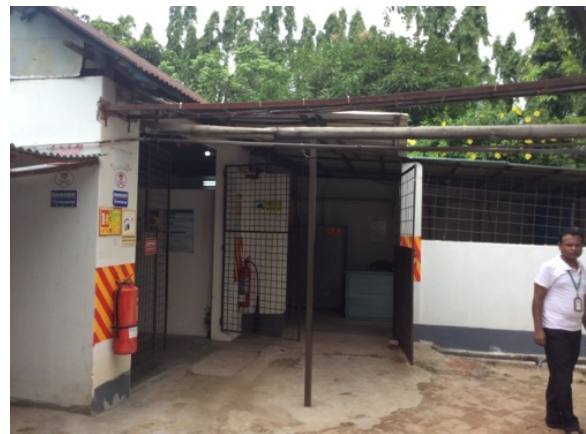
F-2	Fire Rated Construction	The boiler, generator, and compressor rooms in the utility shed are not separated by fire-rated construction from the factory building due to unprotected openings. The utility shed is only 10 feet from unprotected windows on the factory building.	Separate the boiler, generator, and compressor rooms by a minimum 2-hr fire-rated construction. Seal and/or protected all openings to maintain the required fire separations	Within 3 months
-----	-------------------------	--	--	-----------------

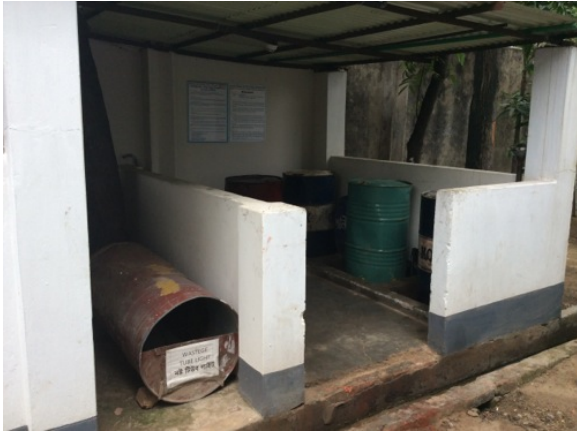
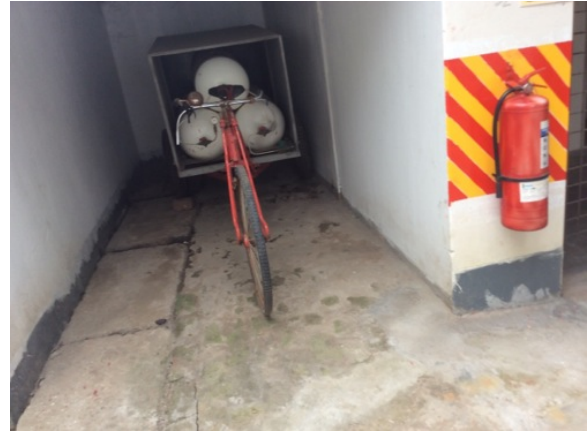
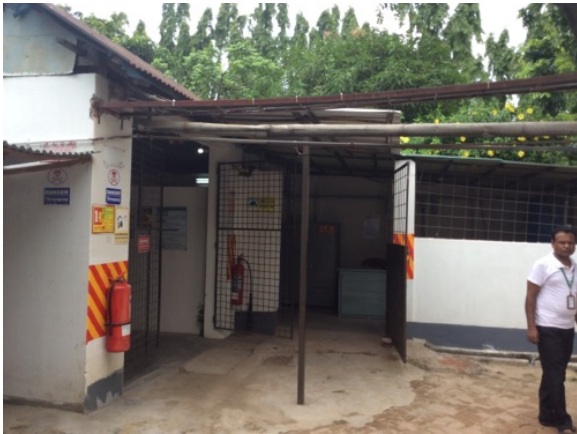
F-3	Fire Rated Construction	The diesel and gas storage rooms in the utility shed are not separated by fire-rated construction from the factory building due to unprotected openings. The utility shed is only 10 feet from unprotected windows on the factory building.	Separate the hazardous materials / flammable liquid storage room by a minimum 2-hr fire-rated construction. Seal and/or protected all openings to maintain the required fire separations.	Within 3 months
-----	-------------------------	---	---	-----------------

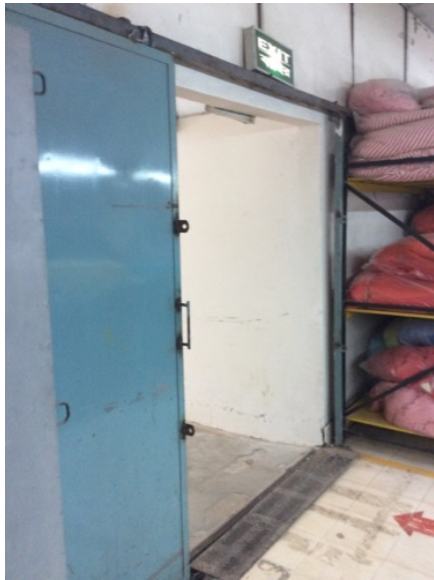
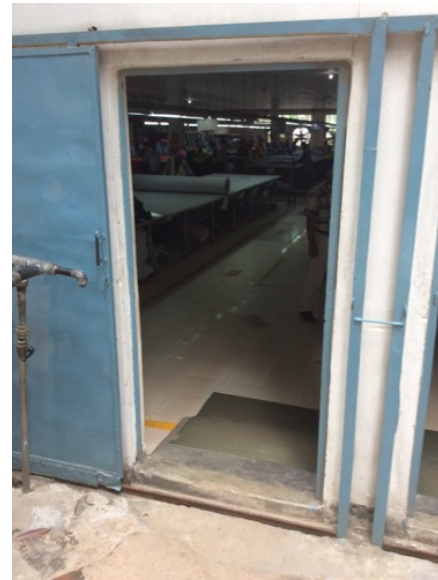
F-4 Egress

Egress doors with locking features are provided at building exits.

All doors were open and unlocked during the inspection.

Remove locking features from all egress doors.

If locks are required for security reasons, utilize special door locking features complying with NFPA 101.

Immediate

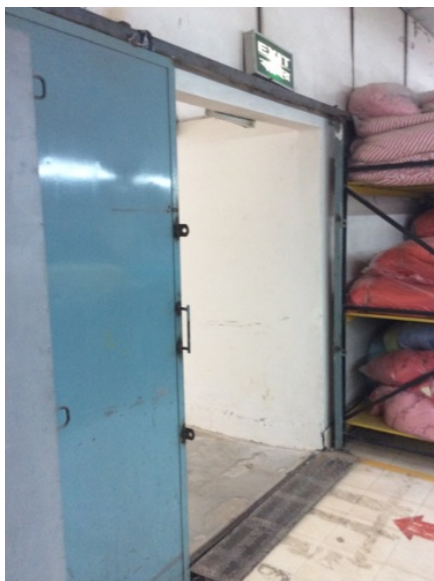
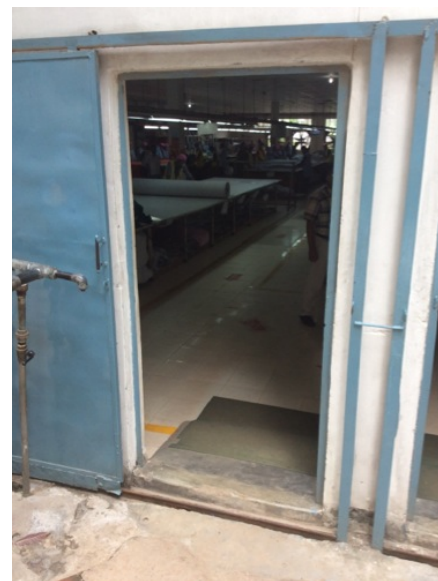
F-5 Egress

Sliding doors are provided at building exits.

Replace all sliding doors along the means of egress with side-hinged, swinging egress doors.

Within 1 month

If locks are required for security reasons, utilize special door locking features complying with NFPA 101.

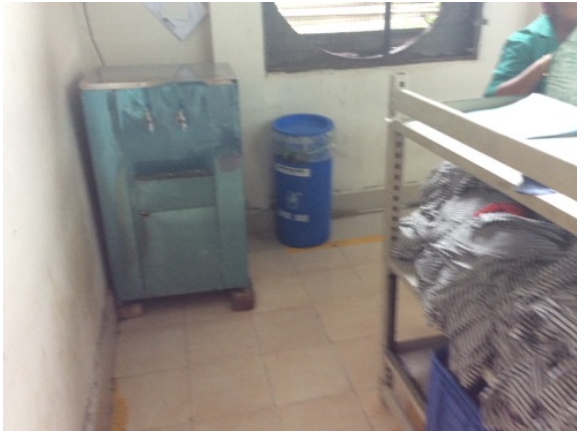
F-6	Egress	An aisle in the sewing section, near the samples room, was restricted in width due to a drinking water dispenser encroaching on the aisle.	Provide minimum aisle widths of 36-in.	Within 3 months
-----	--------	--	--	-----------------

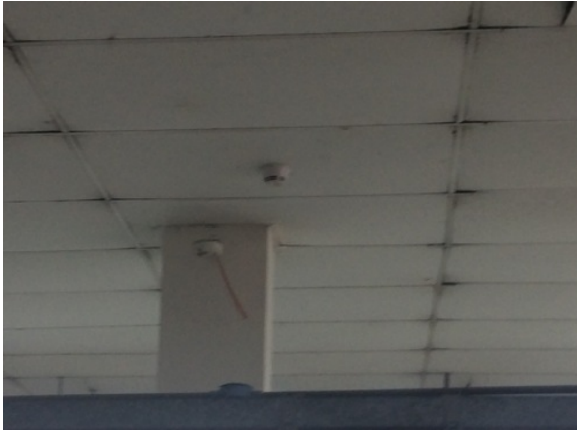
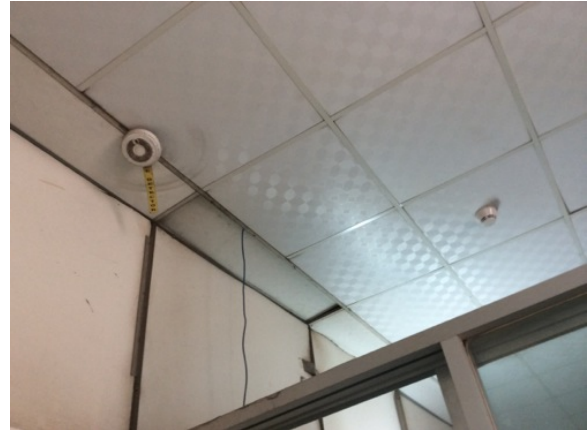
F-7	Fire Protection	The building is equipped with single-station smoke alarms in addition to the interconnected smoke/heat detectors. Smoke alarm activation sounds only a local alarm and does not provide automatic fire alarm notification of occupants.	Remove single-station smoke alarms.	Within 1 month
-----	-----------------	---	-------------------------------------	----------------

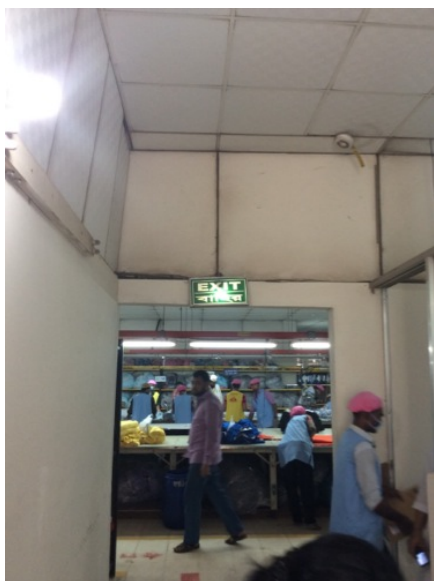
F-8	Fire Protection	Inspection, testing, and maintenance for the fire alarm system were not in accordance with NFPA 72.	Inspect, test and maintain the fire alarm system, and keep written records on-site, in accordance with NFPA 72.	Within 3 months
F-9	Egress Lighting	At the West exit a lighted sign was provided that directs people back into the building, away from the exit.	Remove exit signs that do not direct people to the closest egress path.	Within 1 month
