# Thanbee Print World Ltd. and Parkway Packaging & Printing PLC

Sardagonj, Kashimpur, Gazipur-1349  
(23.978112, 90.304102)  
20 August 2025

## Structural Inspection Report

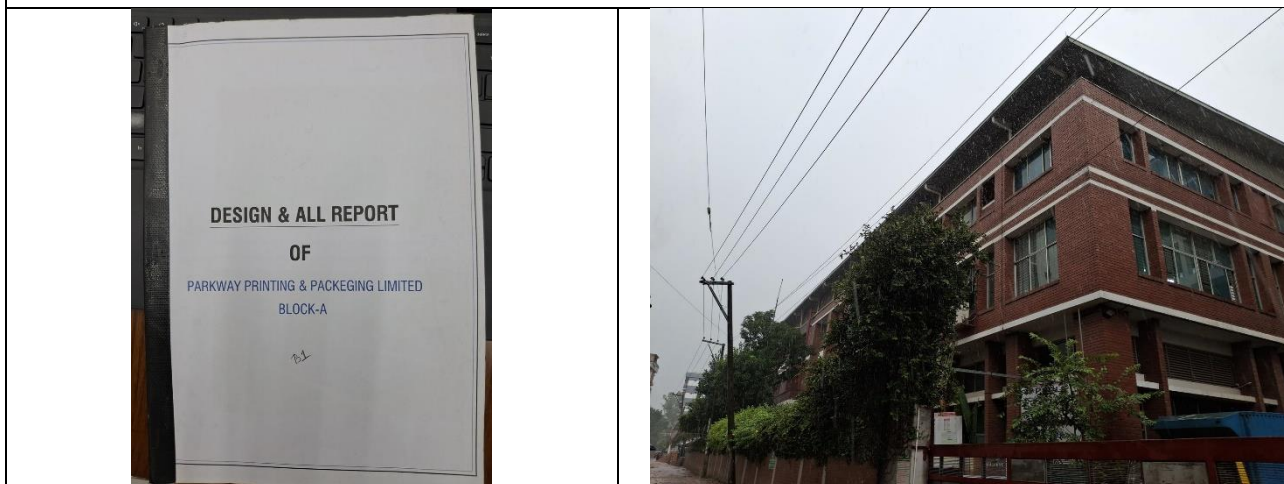
### Observation 01: Incomplete design report [Building 1: Production Building (Block-A)]

**Description:** A design report was available onsite. The design report did not cover all the adequacy checks as per BNBC 1.9.1. The building engineer is required to revise the design report following BNBC 1.9.1 based on as-built member sizes & in-situ material strength and submit to RSC for detailed review against lateral forces.

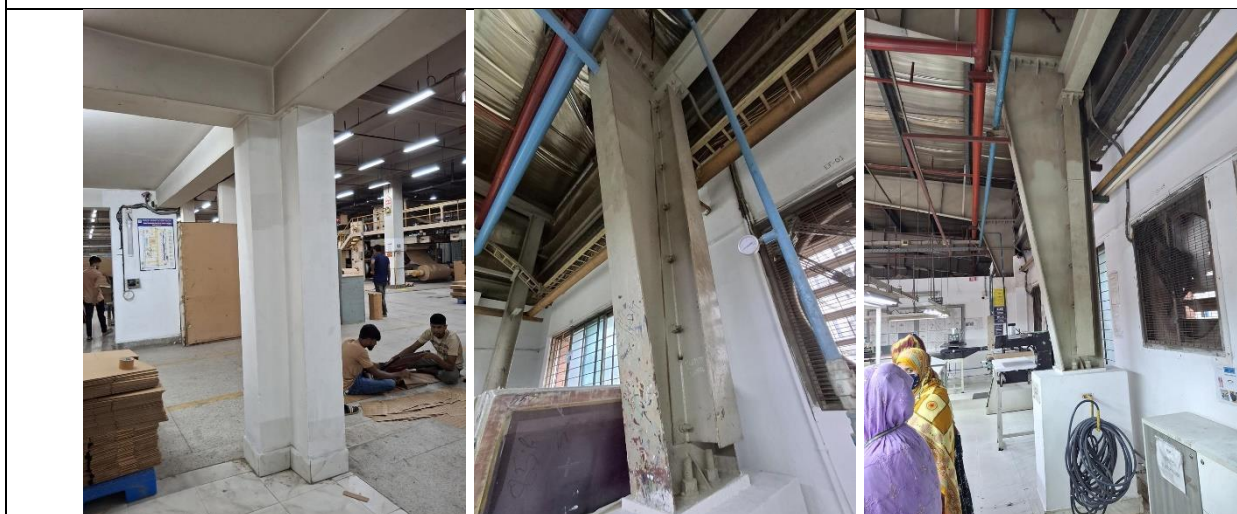
### Observation 02: Mismatch/lack of as-built drawing [Building 1: Production Building (Block-A)]

**Description:** L-shaped column found below mezzanine floor instead rectangular column, portal bracing details not provided in the drawings, and a RC column found around 2.1 m high on the 2<sup>nd</sup> floor, where the drawing shows 1 m for all typical RC columns. The building engineer is required to survey the structure and prepare accurate as-built drawings with all necessary connection details.

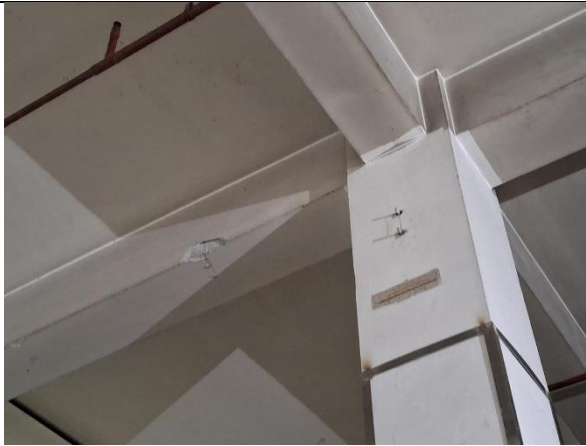
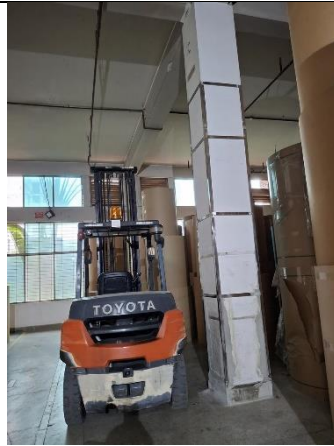
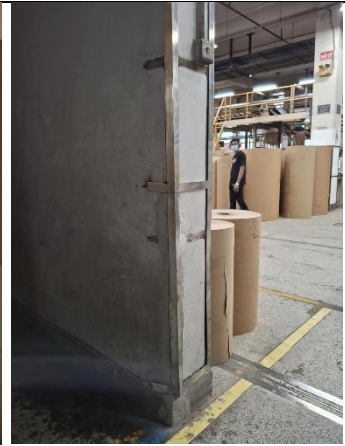
**Observation 03:** Forklift impact on beam and surface damage [Building 1: Production Building (Block-A)]

**Description:** Beam damage was found due to the impact of forklifts. Also, a sign of impact was observed on columns. Repair the damage to the beam and take precautionary measures to prevent further impact.

| Item No. | Observation | Action Plan | Timeline |
|---|---|---|---|
| 5. | Forklift impact on beam and surface damage [Building 1: Production Building (Block-A)] | Repair the damage to the beam and take precautionary measures to prevent further impact. | within 6 weeks |

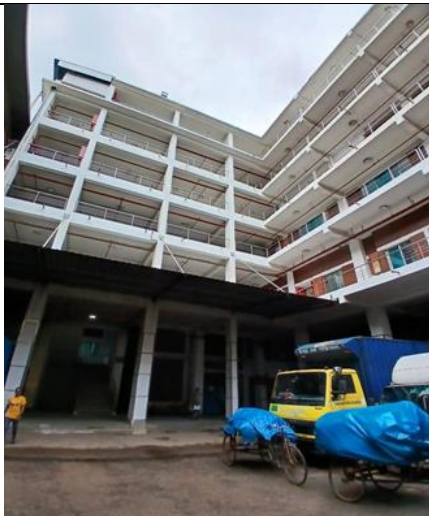
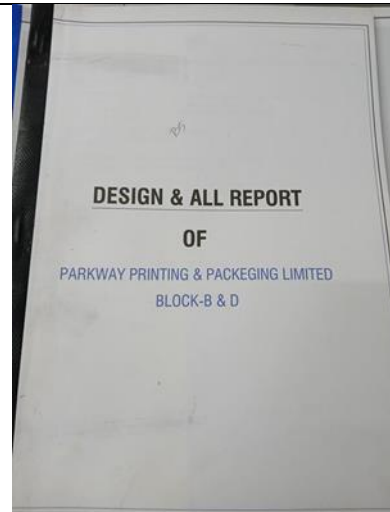
**Observation 04:** Inconsistencies in the EA report (Building-2: OFFICE BUILDING WITH WTP & GENERATOR (BLOCK-B & D))

**Description:** The response modification coefficient (R value) was considered as 8 for IMRF; however, no calculation or justification was provided. Moreover, no irregularity check was provided. The building engineer is required to address the inconsistencies in the revised EA report and submit the revised EA to RSC.

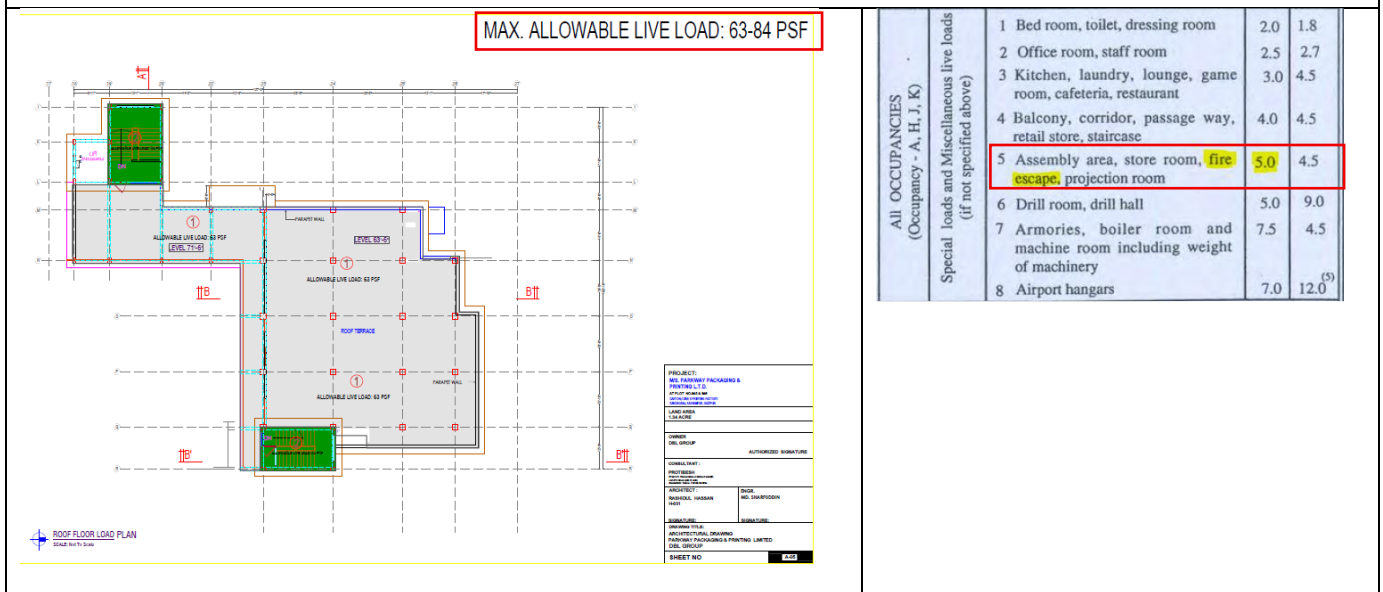
**Observation-05:** Load plan does not comply with BNBC requirements (Building-2: OFFICE BUILDING WITH WTP & GENERATOR (BLOCK-B & D))

**Description:** There are two staircases in the building. According to BNBC, the minimum floor live load for staircases used as fire escapes is 5.0 kN/m<sup>2</sup>. However, the stairs have been designed for a live load of only 4.0 kN/m<sup>2</sup> (84 psf).

The building engineer is required to revise the load plan and associated design documents to ensure compliance with BNBC requirements.

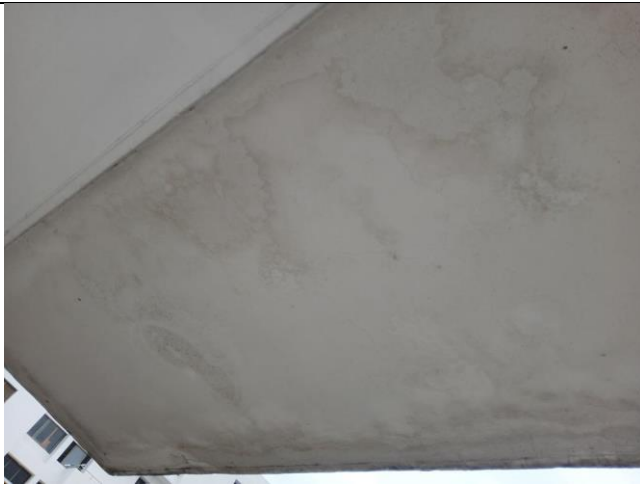
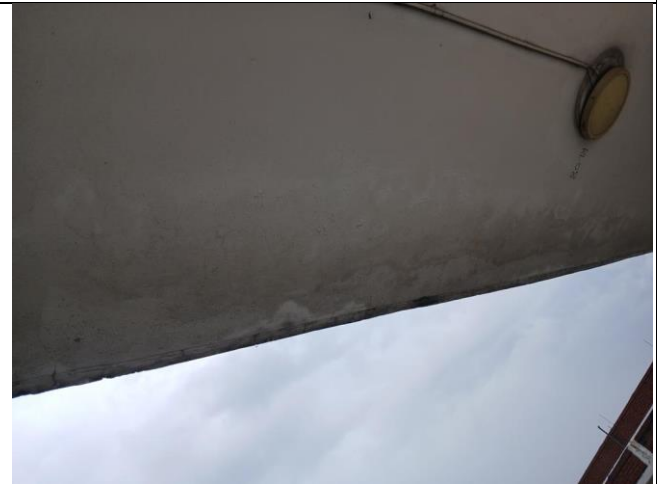
**Observation-07:** Dampness on the rooftop slab. (Building-2: OFFICE BUILDING WITH WTP & GENERATOR (BLOCK-B & D))

**Description:** During the inspection, dampness on the rooftop slab was observed. Factory engineer is required to seal the source of water and repair the damp areas with a suitable method.

| Item No. | Observation | Action Plan | Timeline |
|---|---|---|---|
| 10. | Dampness on the rooftop slab. (Building-2: OFFICE BUILDING WITH WTP & GENERATOR (BLOCK-B & D)) | Factory engineer is required to seal the source of water and repair the damp areas with a suitable method. | within 6 weeks |

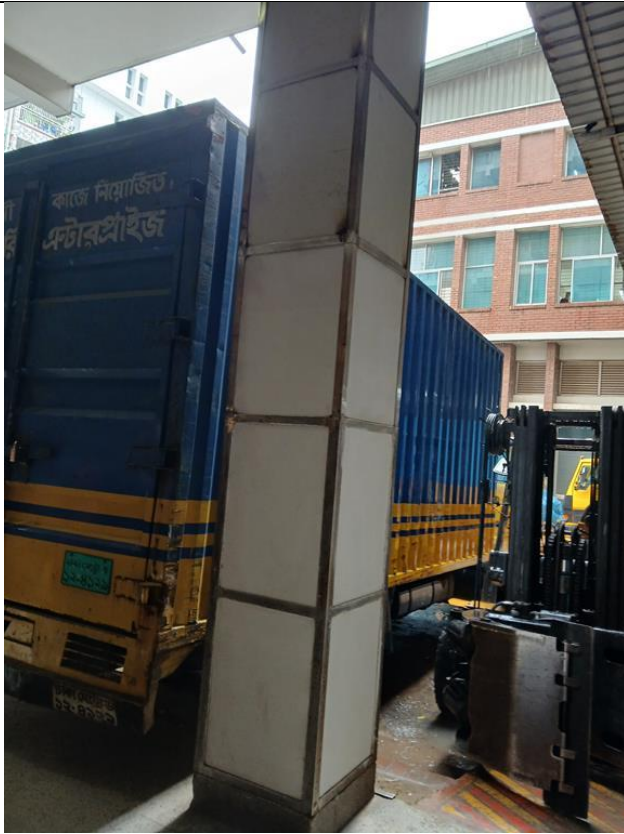
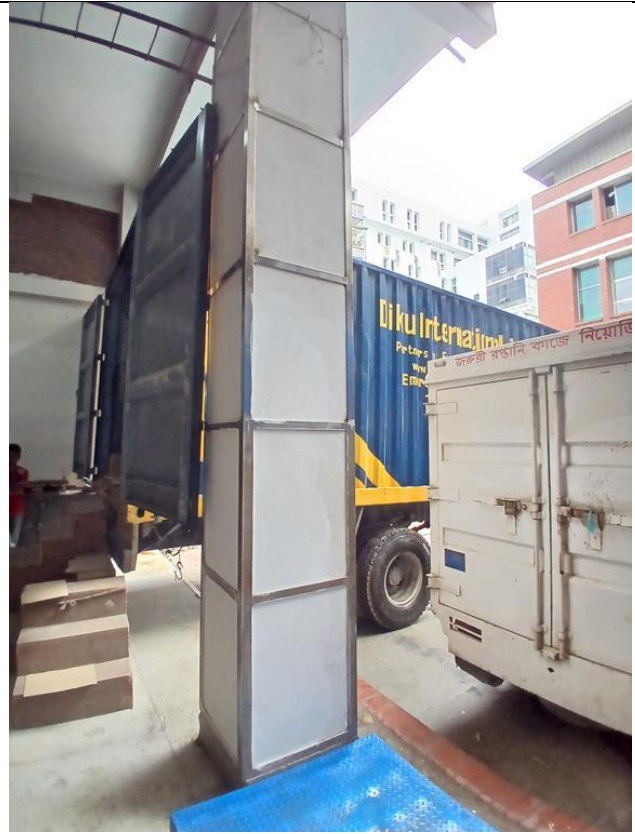
**Observation-08:** Columns susceptible to vehicle impact. (Building-2: OFFICE BUILDING WITH WTP & GENERATOR (BLOCK-B & D))

**Description:** Columns at the ground-floor driveway area were found susceptible to vehicle impact. The building engineer is required to provide separate barriers around the column to prevent vehicle impact.

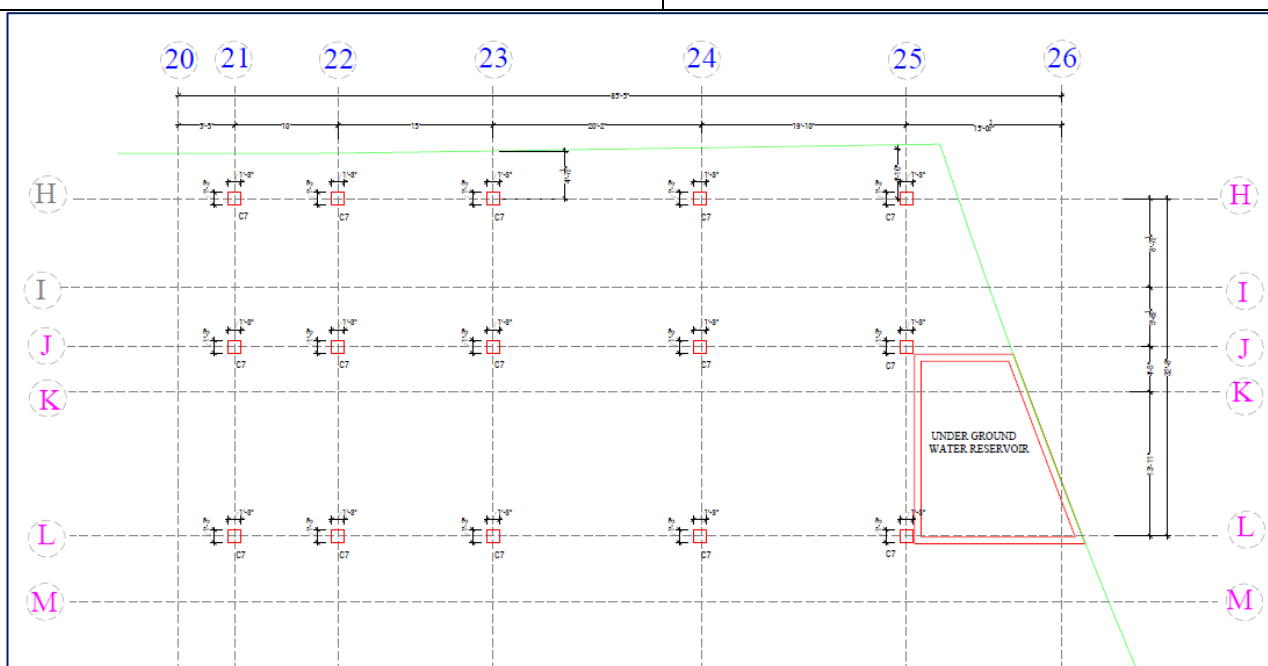
## Observation 09: Inconsistencies in the EA report. (Building-3: Utility Building (BLOCK-C))

**Description:** In the EA report, the column and foundation adequacy checks do not match the column sizes and IDs shown in the as-built drawings.

The building engineer is required to address the inconsistencies in the revised EA report and submit the revised EA to RSC.

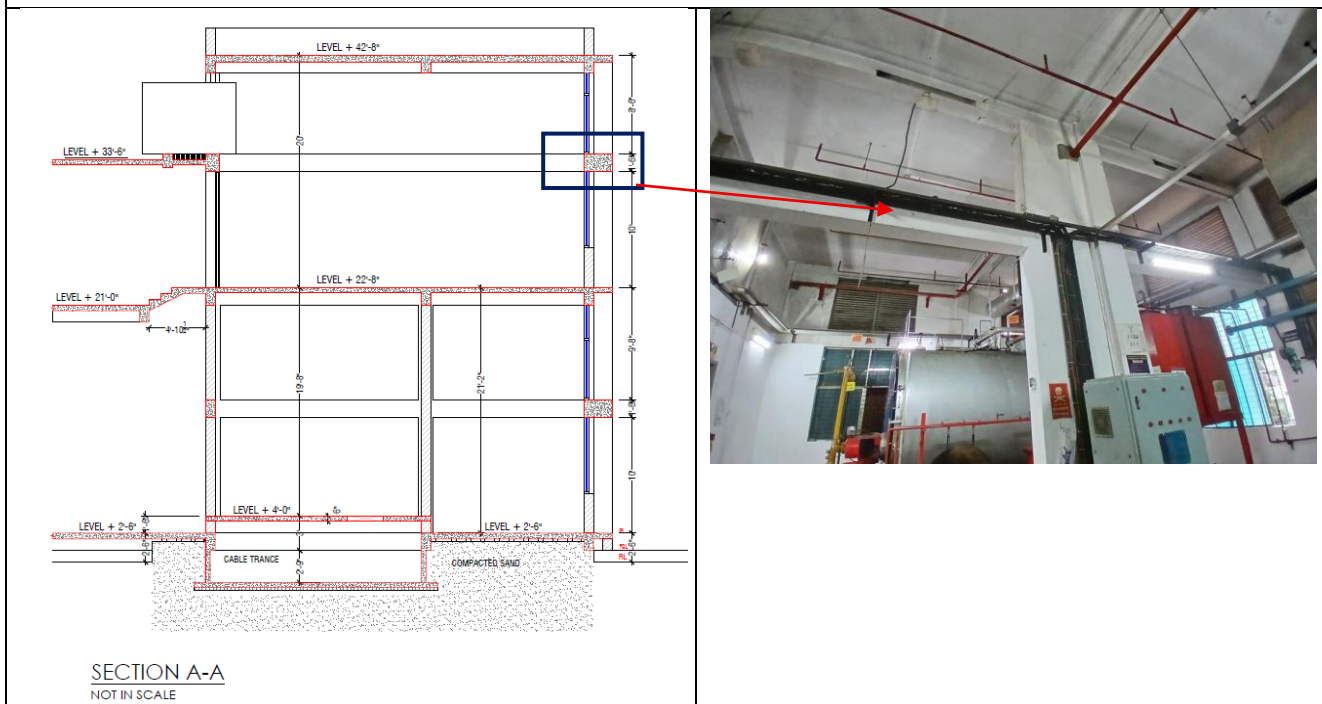
**Observation 10: Lack of information in the as-built drawing (Building-3: Utility Building (BLOCK-C))**

**Description:** A tie beam (250 x 450 mm) was found at 10 ft above the floor slab, which details were not shown in the as-built structural drawings.

The building engineer is required to survey the structures and prepare a comprehensive as-built drawings.

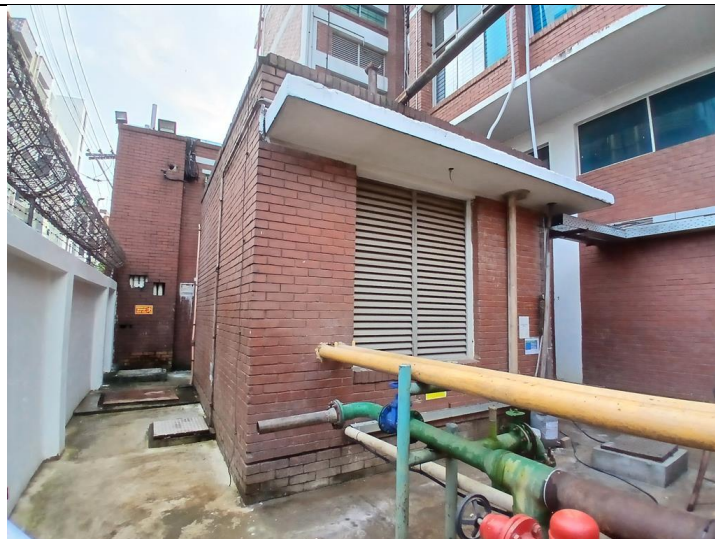
Building-5: RMS Room

**Description:** As-built structural & architectural drawings were not available for those structures. The building engineer is required to survey the structures and prepare as-built drawings, including foundation details, and necessary connection information.

| <b>15.</b> | Lack of as-built drawings (Building-5: RMS Room) | The building engineer is required to survey the structures and prepare as-built drawings, including foundation details. | within 6 weeks |

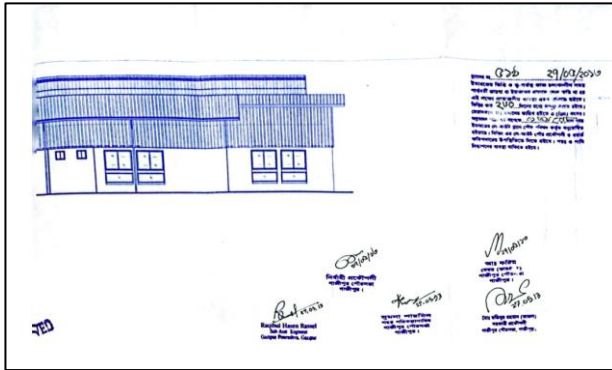
**Observation 12:** The design report needs to be revised. (Building-6: Storage Shed-1)

**Description:** The local authority approval for the Shed-1 was 27-05-2013, but the construction was started in Mar 2021. Also, the design report was prepared considering the BNCB 2006 standard.

The building engineer is required to get new approval from the local authority and revise the design report according to the BNBC 2020 guideline and submit it to RSC for review.

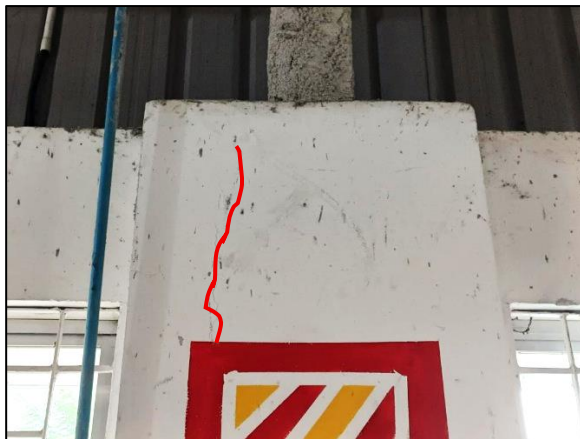
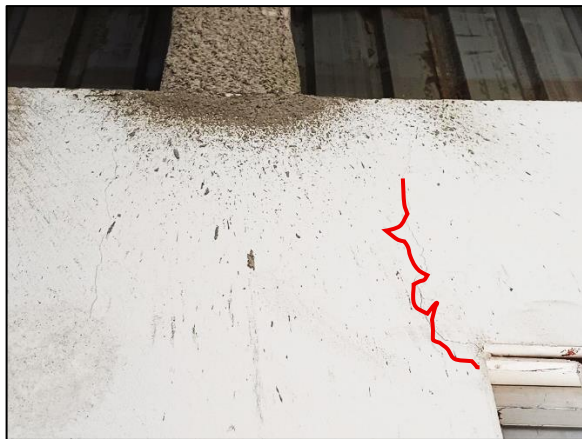
**Observation 13:** Crack in column & beam. (Building-6: Storage Shed-1)

**Description:** During inspection, cracks were found on the column and beam in grid 1-J, 5-L, and 5-K. The building engineer is required to investigate the reason for cracks, prepare an investigation report with remedial measures, and repair the cracks accordingly.

| <b>19.</b> | Crack in column & beam. (Building-6: Storage Shed-1) | The building engineer is required to investigate the reason for cracks, prepare an investigation report with remedial measures, and repair the cracks accordingly. | within 6 weeks |

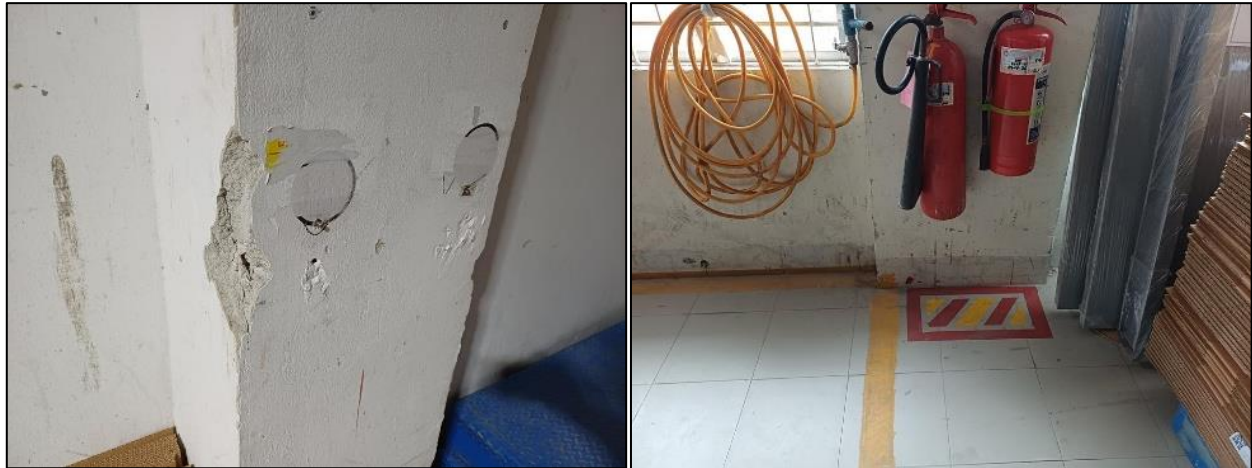
**Observation 14:** Trolley impact on column. (Building-6: Storage Shed-1)

**Description:** During inspection, an impact was found on the RC column. The building engineer is required to provide a column guard around the column to avoid trolley impact.

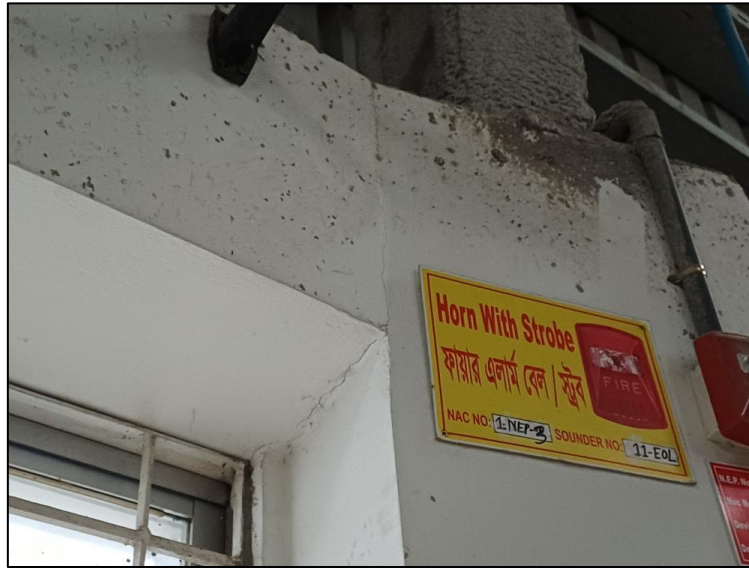
**Observation 16:** Crack in column & beam joint. (Building-7: Storage Shed-2)

**Description:** During inspection, cracks were found on several joints of the column and beam. The building engineer is required to investigate the reason for cracks, prepare an investigation report with remedial measures, and repair the cracks accordingly.

| <b>23.</b> | Crack in column & beam joint. (Building-7: Storage Shed-2) | The building engineer is required to investigate the reason for cracks, prepare an investigation report with remedial measures, and repair the cracks accordingly. | within 6 weeks |

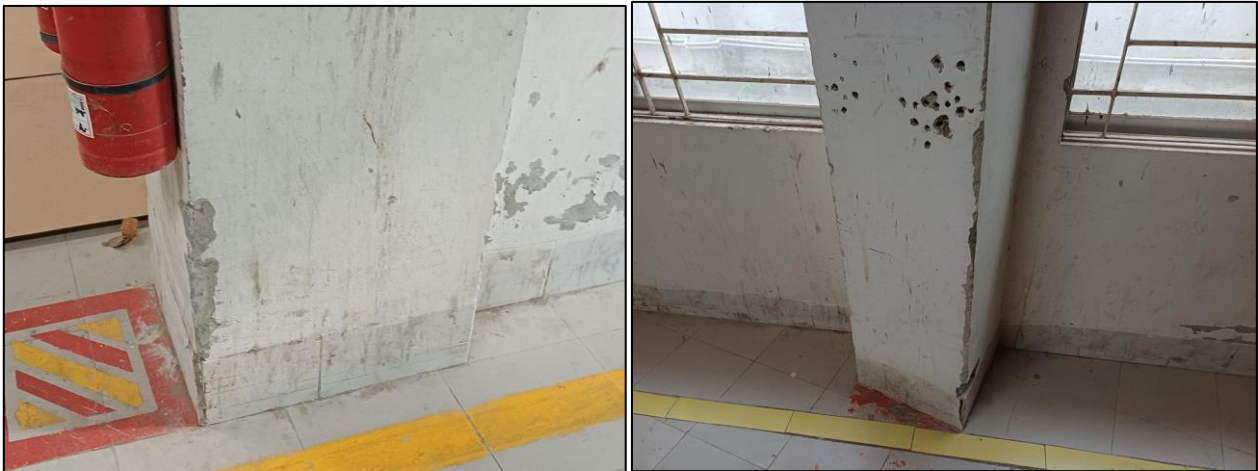
**Observation 17:** Trolley impact on column. (Building-7: Storage Shed-2)

**Description:** During inspection, several impacts were found on the RC column. The building engineer is required to provide a column guard around the column to avoid trolley impact.

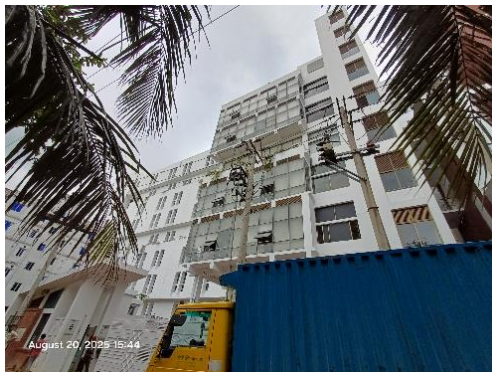
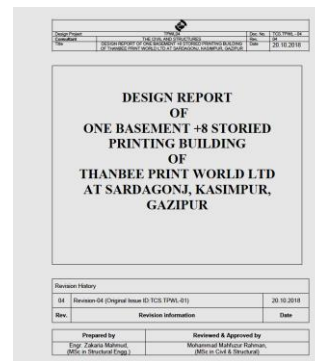
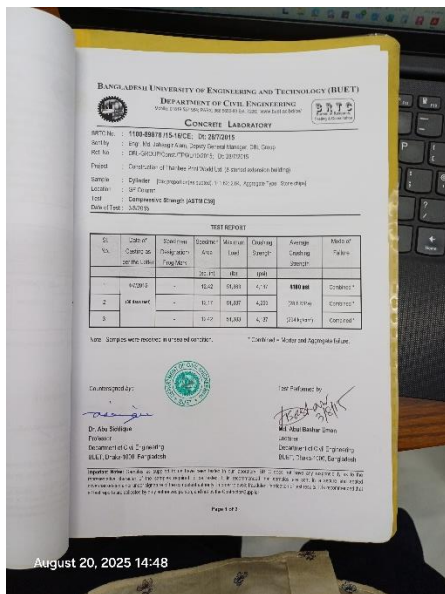
**Observation 18:** Inconsistencies in the assessment report. (Building-9: Thanbee Print World Extension Building)

An inadequate number of concrete cylinder test reports were found on site to confirm the design strengths of 4000 psi (Columns) and 3500 psi (beams and slabs).

Response modification coefficient,  $R$  value considered as 8 for IMRF, but no calculation/justification is provided for the

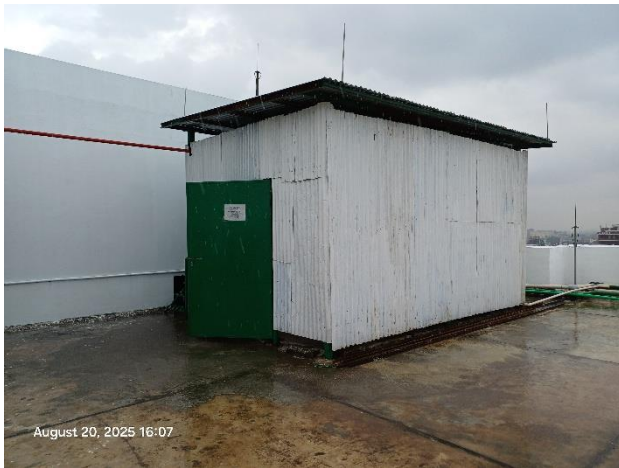
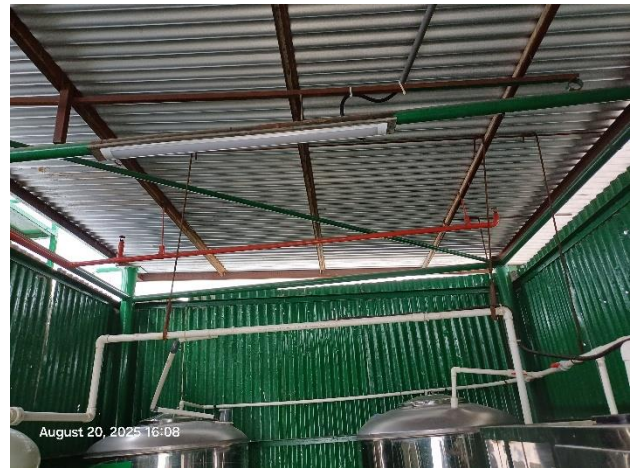
**Observation-19:** Lack of information in the prepared as-built drawings. (Building-9: Thanbee Print World Extension Building)

**Description:** A roof shed was found for the RO plant. No details drawing was prepared. Building engineer is required to survey the structure and prepare the as-built drawing.

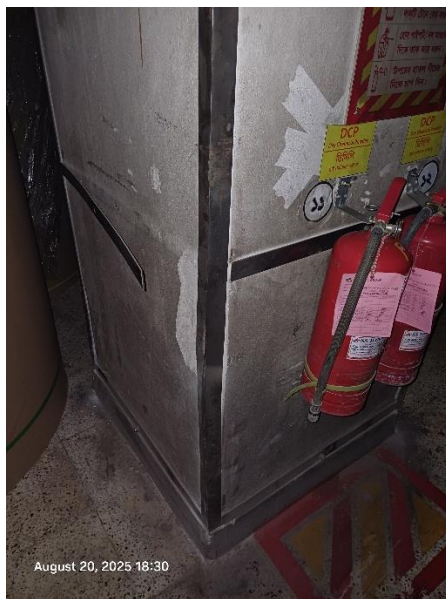
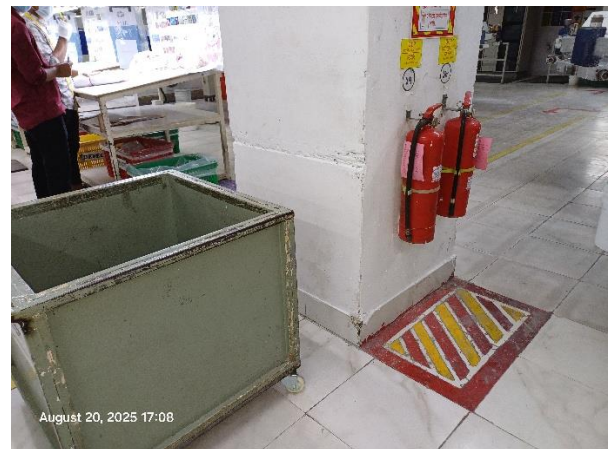
**Observation-20:** Column Susceptible to trolley impact. (Building-9: Thanbee Print World Extension Building)

**Description:** Columns are susceptible to trolley impact. Building engineer is required to take necessary action to prevent the trolley from impacting the columns.

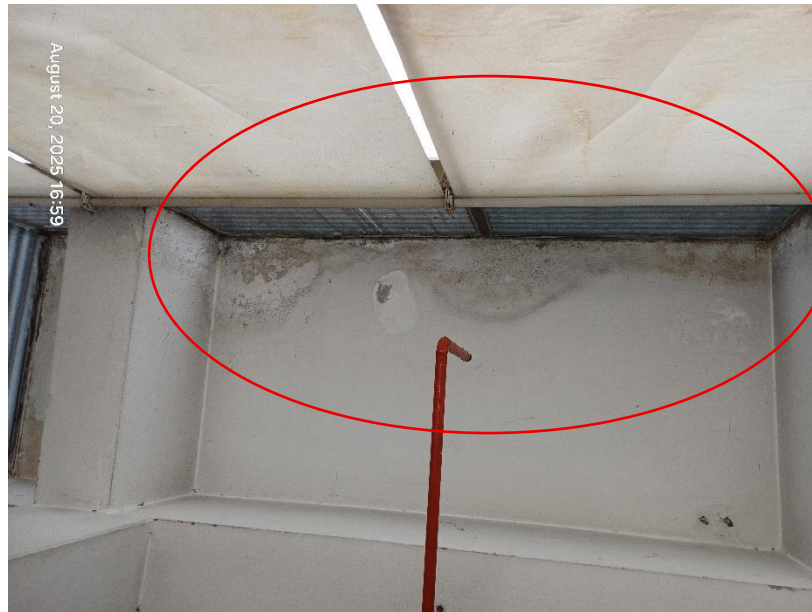
**Observation-21:** Dampness on the ceiling of the 5<sup>th</sup> floor. (Building-9: Thanbee Print World Extension Building)

**Description:** During the inspection, dampness on the fifth-floor slab soffit was observed. Factory engineer is required to seal the source of water and repair the damp areas with a suitable method.

| <b>29.</b> | Dampness on the ceiling of the 5 <sup>th</sup> floor. (Building-9: Thanbee Print World Extension Building) | Factory engineer is required to seal the source of water and repair the damp areas with a suitable method. | within 6 weeks |

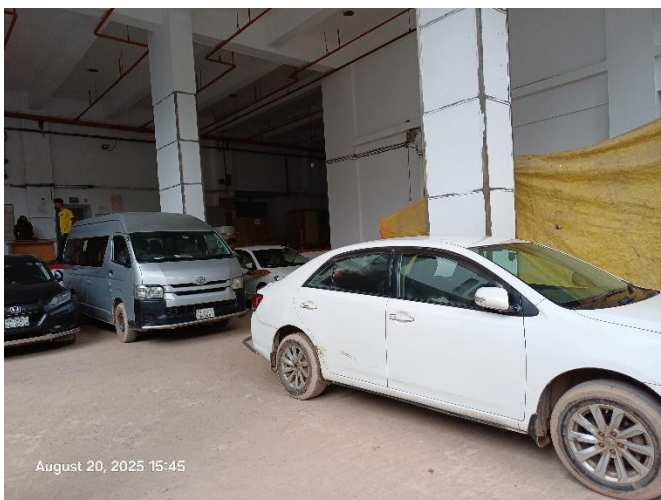
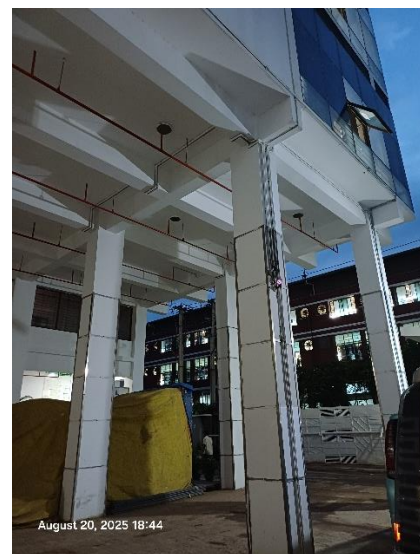
**Observation-22:** Columns susceptible to vehicle impact. (Building-9: Thanbee Print World Extension Building)

**Description:** Columns at the ground-floor driveway area were found susceptible to vehicle impact. The building engineer is required to provide separate barriers around the column to prevent vehicle impact.

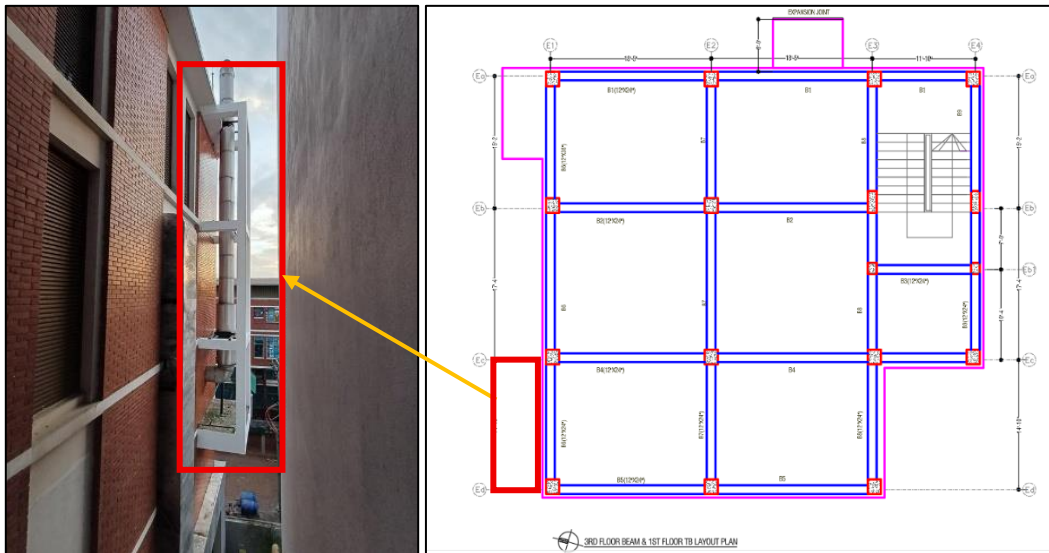
**Observation 24:** Discrepancy in the as-built drawings. (Building-10: ETP Building)

**Description:** During inspection, cantilever beam was found on the north portion of the building. The building engineer is required to update the as-built drawing as per the actual site condition.

| <b>33.</b> | Discrepancy in the as-built drawings. (Building-10: ETP Building) | The building engineer is required to update the as-built drawing as per the actual site condition. | within 6 weeks |

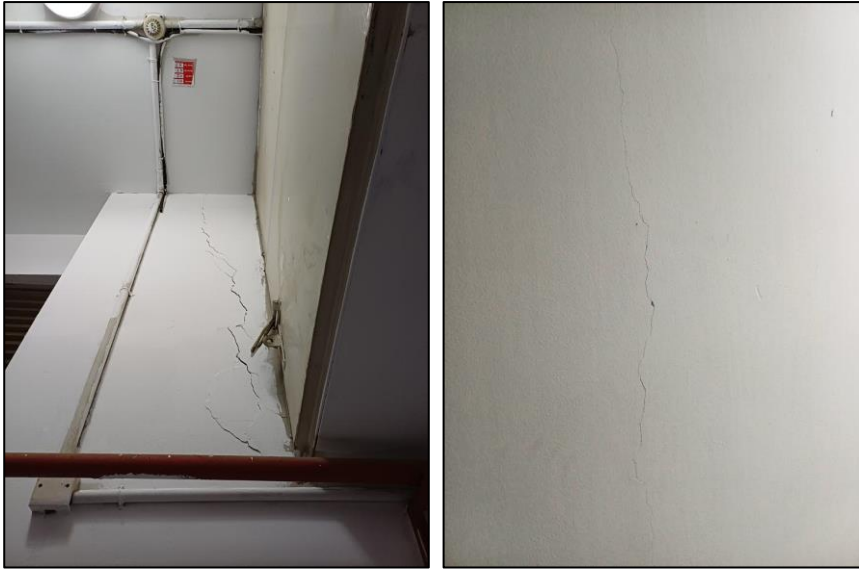
**Observation 25:** Crack in the brick wall. (Building-10: ETP Building)

**Description:** During inspection, several cracks were found on the brick wall. The building engineer is required to investigate the reason for cracks, prepare an investigation report with remedial measures, and repair the cracks accordingly.

| <b>34.</b> | Crack in the brick wall. (Building-10: ETP Building) | The building engineer is required to investigate the reason for cracks, prepare an investigation report with remedial measures, and repair the cracks accordingly. | within 6 weeks |

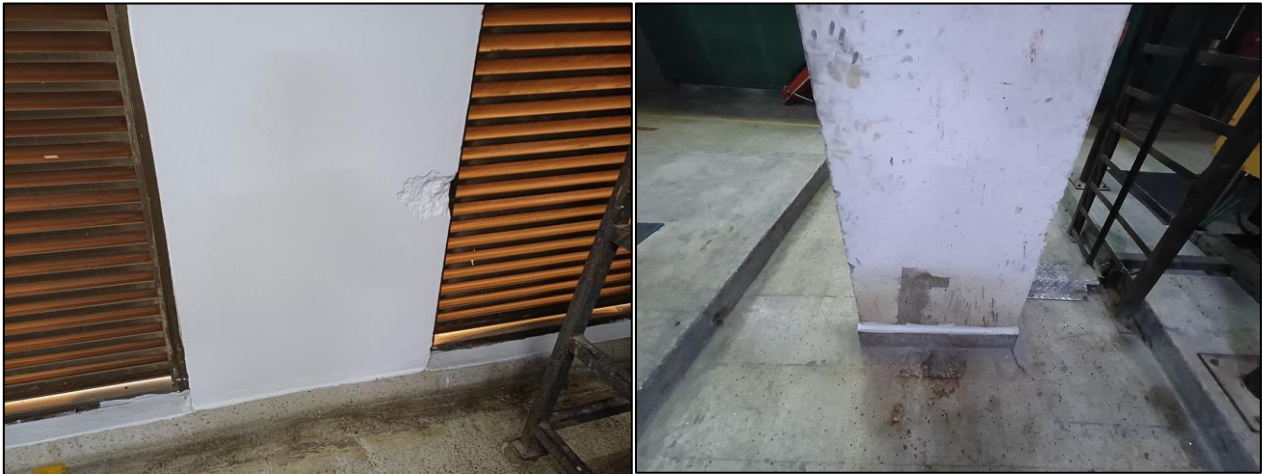
**Observation 26:** Trolley impact on column. (Building-10: ETP Building)

**Description:** During inspection, several impacts were found on the RC column. The building engineer is required to provide a column guard around the column to avoid trolley impact.

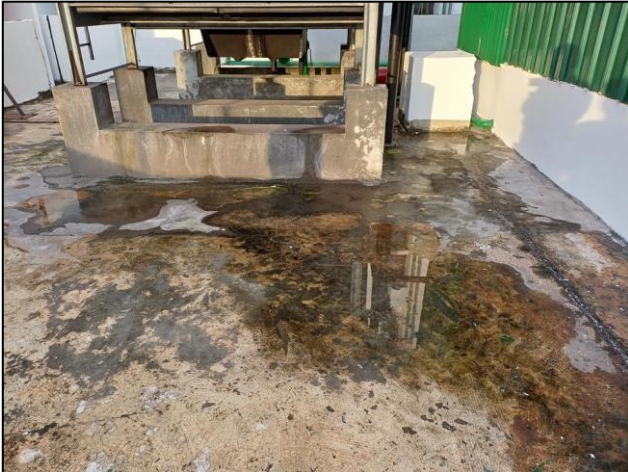
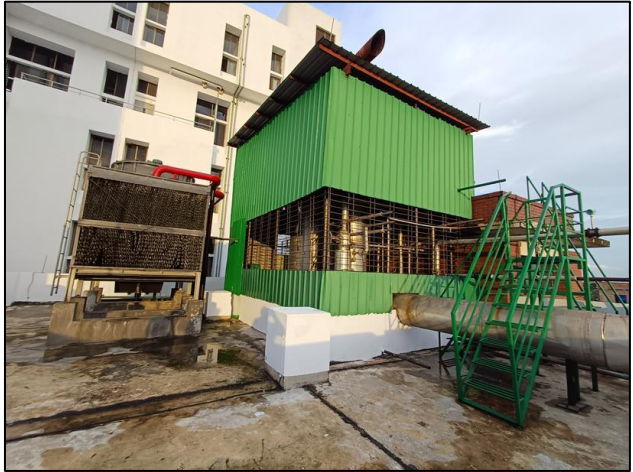
**Observation 27:** Water ponding on the roof. (Building-10: ETP Building)

**Description:** During inspection, water ponding was found on the roof. The building engineer is required to improve the drainage system with an adequate slope.

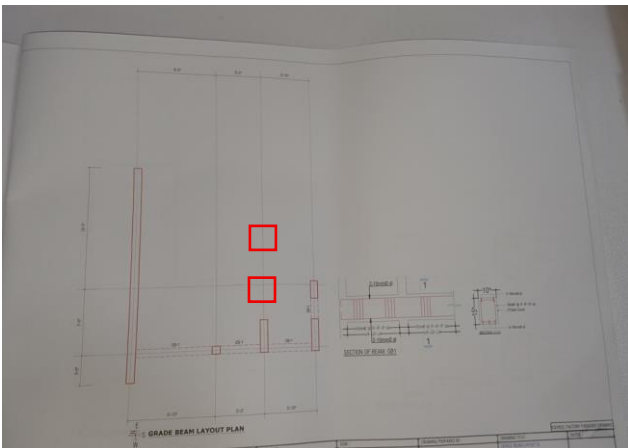
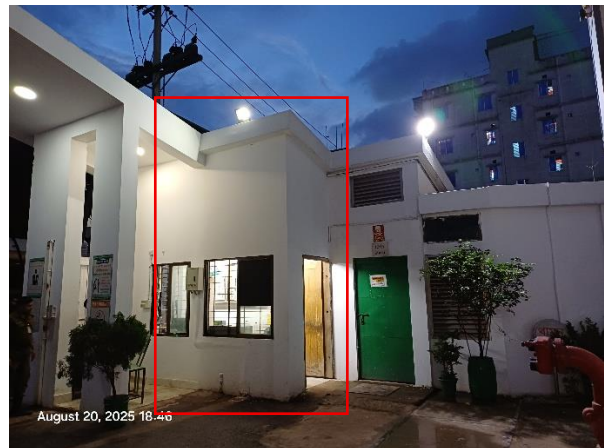
**Observation-28:** Mismatch found in prepared drawings. (Building-11: Gate & RMS Room)

**Description:** Column layout and numbers do not match the prepared as-built drawing. Building engineer is required to survey the structure and prepare the as-built drawing.

| <b>37.</b> | Mismatch found in prepared drawings. (Building-11: Gate & RMS Room) | Building engineer is required to survey the structure and prepare the as-built drawing. | within 6 weeks |
