# Panmark Apparels (Pvt) Ltd

18 December 2025

## 1. Building Information

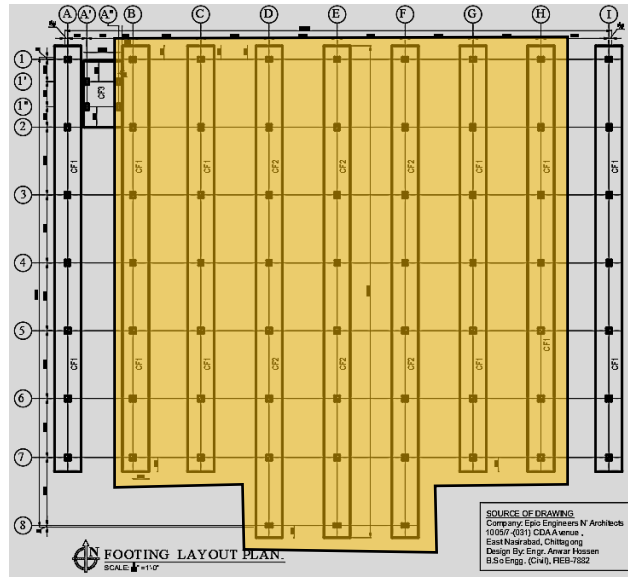
**Observation-01:** Stress in the strip footing exceeds the normal design limit. (Main Production Building)

**Description:** During the inspection and document review, preliminary calculations indicated that the typical strip footings (CF1 and CF2) of the Main Production Building are below the required design capacity. In addition, one footing was shown as retrofitted in the drawings; however, no credible supporting documents were found on site.

The factory is required to engage a qualified structural and geotechnical consultant to:

- Verify the dimensions of the existing and retrofitted footings and review the design assumptions, applied loads, and foundation stresses.
- Conduct a Detailed Engineering Assessment (DEA) based on verified onsite data & material strength.

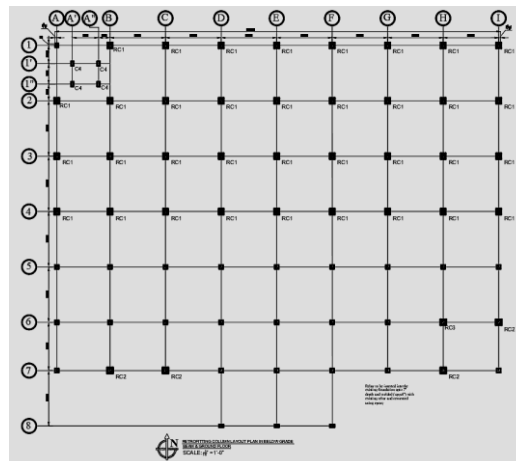
**Discrepancy in no. of retrofitting columns between DEA report and retrofitting drawing**

- A total of 80 columns are recommended for retrofitting in the design report, whereas a lesser number is shown in the retrofitting drawings.
- At the rooftop dining area, excessive dead loads from concrete seats and tables were observed; however, these loads were not considered in the FEA model.
- Detailed and proper adequacy checks for serviceability, structural irregularities, and foundation stresses were not incorporated in the design report.

The Building Engineer is required to revise the design documents, check the lateral stability of the roof shed and submit all the required documents to RSC for detail review.

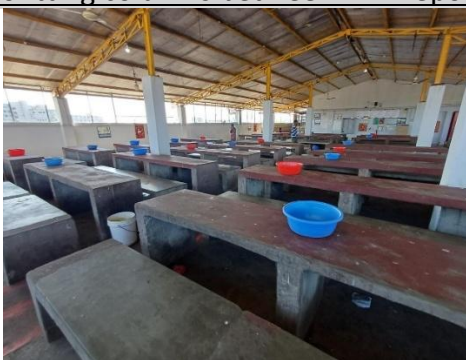
**Concrete dining table has excess dead load at roof top which not considered in DEA**

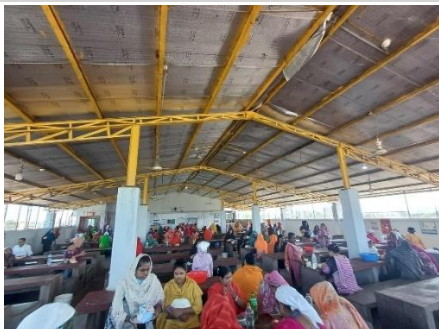
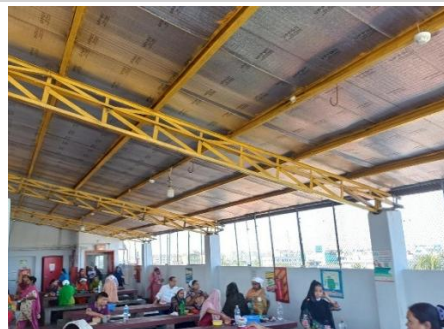
**Lack of lateral stability at Roof Shed**

Also, no load transfer media or no lateral load resisting bracing was found at the roof shed of the Main Production Building.

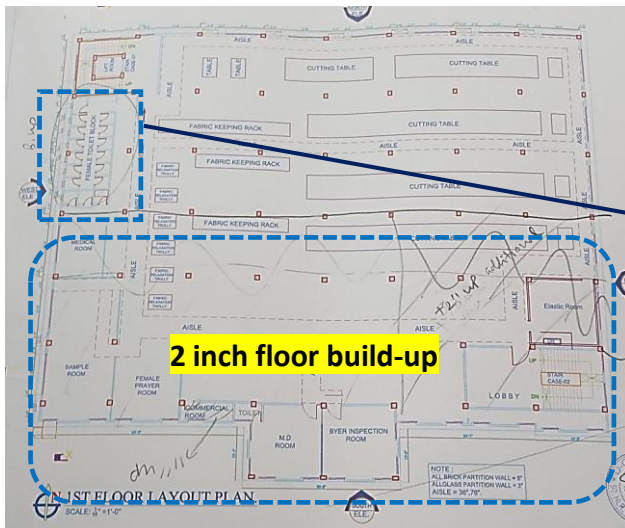
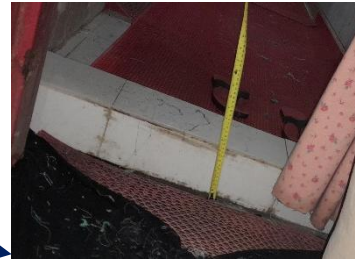
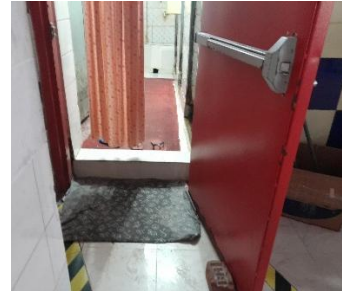
#### Build-up not mentioned in the drawing

- 2-inch floor build-up was observed at the 1st floor (south side) but is not shown in the architectural drawings. Additionally, toilet floor build-ups for all floors are not mentioned.
- In the retrofitting drawings, the F-grid is shown as a truss; however, an I-section was found on site. Furthermore, the steel column sections shown in the as-built drawings do not match the actual site condition.

The Building Engineer is required to survey the full structure and prepare as-built as well as retrofitting drawings as per actual site condition.

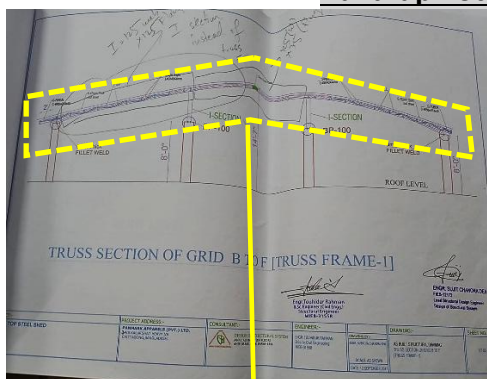
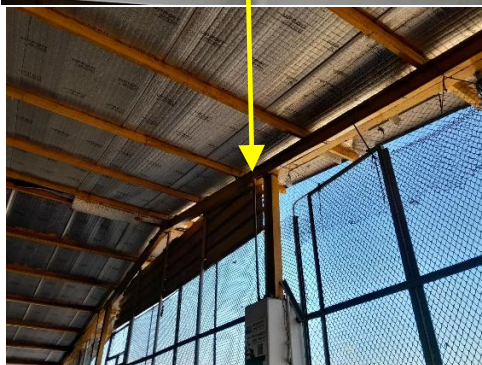
#### I section found instead of truss at F-grid

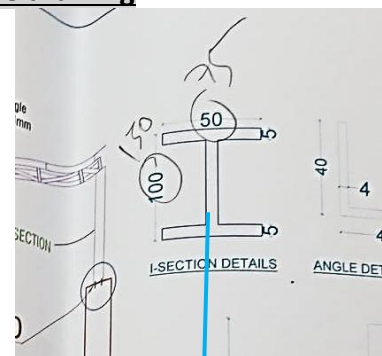
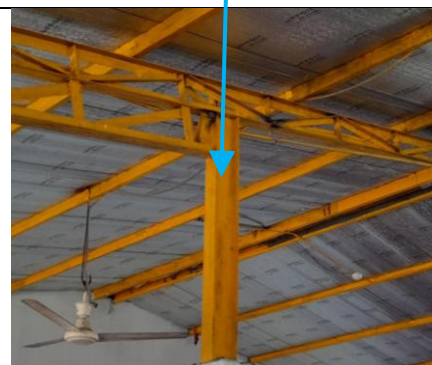
#### Section size mismatch

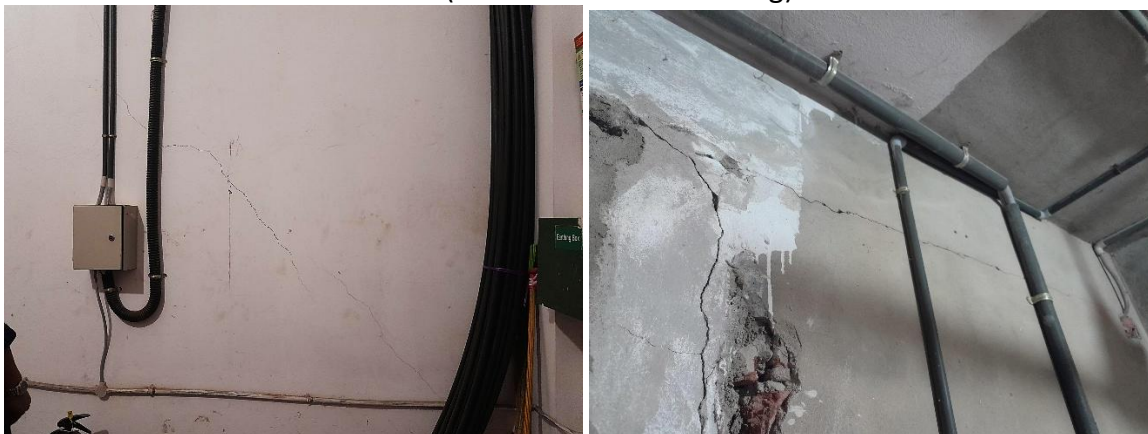
**Observation-04:** Cracks on brick walls. (Main Production Building)

**Description:** During inspection, cracks were found on brick walls at several locations. The building engineer is required to investigate the reason & extent of crack and prepare an investigation report with proper remedial measure. Also, repair the wall cracks as per suggestion of the crack investigation report.

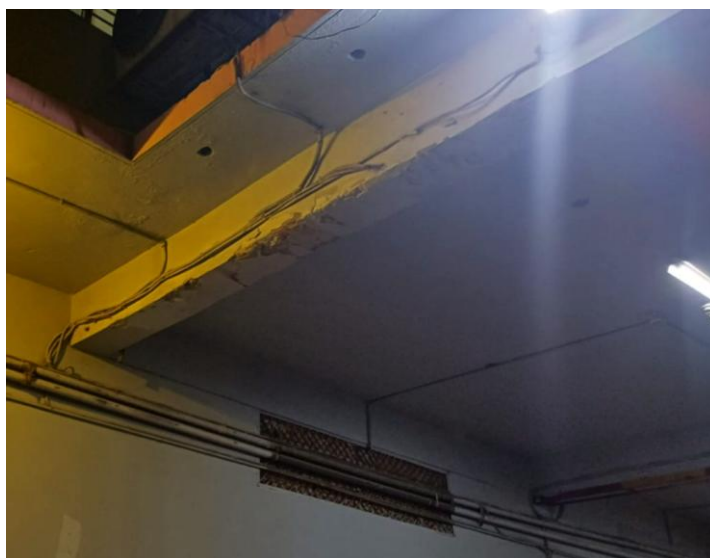
**Observation-05:** Vehicle impact on ground floor roof beams. (Main Production Building)

**Description:** During inspection, vehicle impact was found on ground floor roof beams of loading unloading zone. The building engineer is required to repair the beam surface and provide barriers around the beams to prevent vehicle impact.

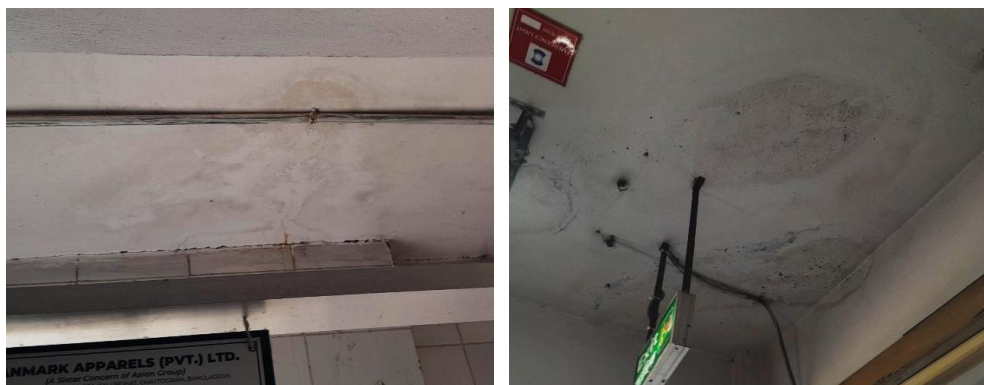
**Observation-06:** Dampness on brick wall and slab. (Main Production Building)

**Description:** During inspection, dampness was found on walls and slabs. The building engineer is required to repair all the dampness with a suitable method.

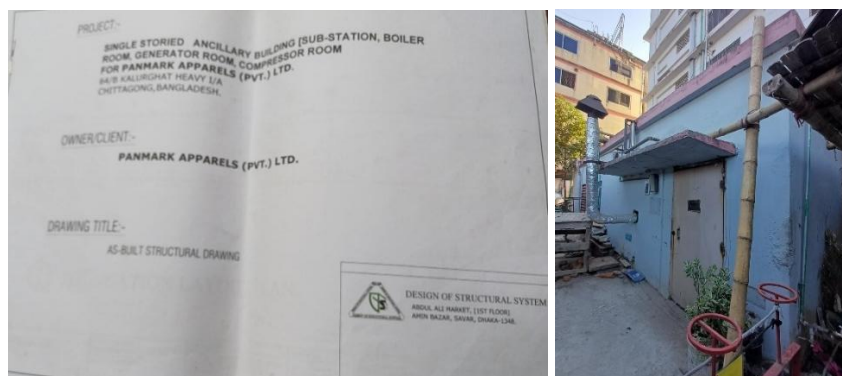
Sub-station and Boiler Room

**Observation-07:** Incomplete as-built drawings. (Sub-station and Boiler Room)

**Description:** During inspection, complete as-built drawings with detailed information on structural members were not available on-site. The building engineer is required to prepare and submit a complete set of as-built drawings, reflecting the actual site conditions, to RSC for review.

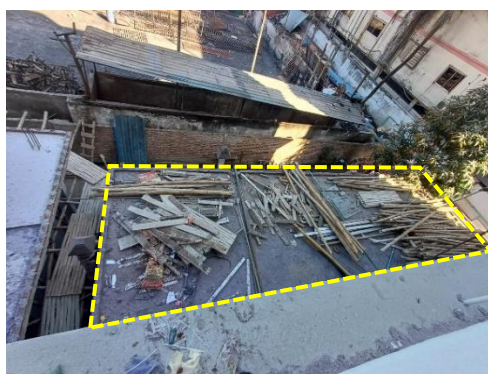
**Observation-08:** Construction debris on roof. (Sub-station and Boiler Room)

**Description:** During inspection, construction debris was found on roof of Sub-station and Boiler Room. The building engineer is required to remove the debris and maintain allowable roof loading.
