# A.T.S. Apparels Limited (Extension)

414, Kochakuri, Talirchala, Mouchak, Gazipur

23 December 2025

1. Two storied Finished Goods Storage Shed-2.

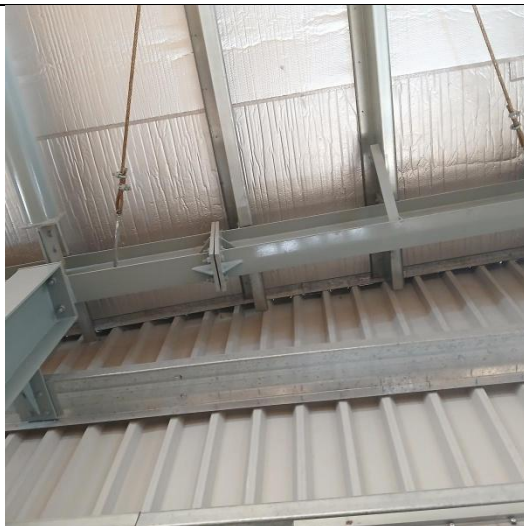
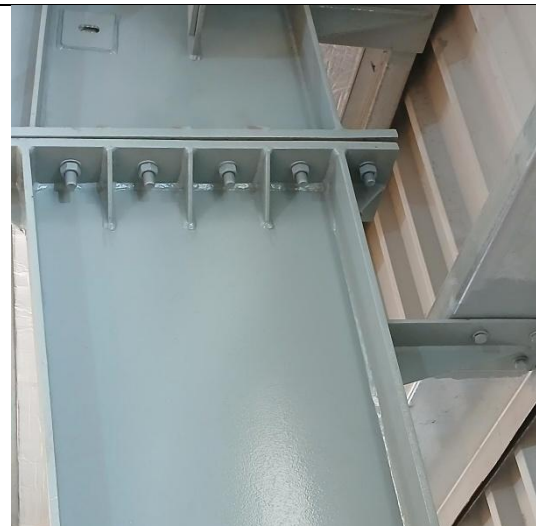
### Observation-02: Connection gap in steel joint. (Finished Goods Storage Shed-2)

**Description:** Connection gaps were found in several locations. Building engineer is required to repair the connection gap with suitable method.

| Item No | Observation | Action Plan | Timeline |
|---|---|---|---|
| 4. | Connection gap in steel joint. (Finished Goods Storage Shed-2) | Building engineer is required to repair the connection gap with a suitable method. | within 6 weeks |

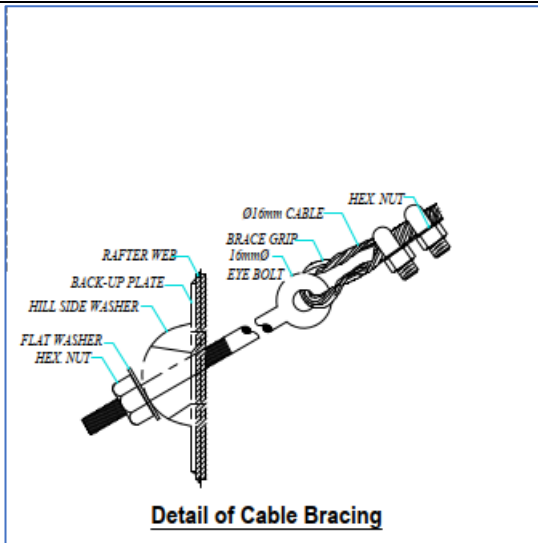
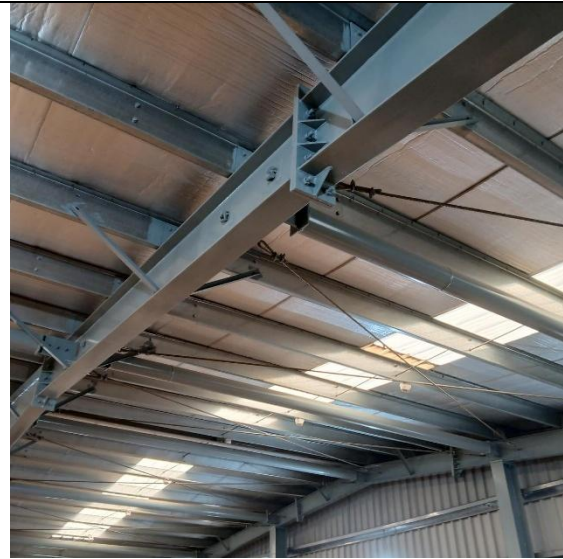
**Observation-03:** Improper cable bracing connections. (Finished Goods Storage Shed-2)

**Description:** Improper connections were found in all locations. Almost all the hillside washers were found damaged and flat washer & nut were not found in many connections. The factory is required to repair the cable bracing connection as per the drawings.

| Item No | Observation | Action Plan | Timeline |
|---|---|---|---|
| 5. | Improper cable bracing connections. (Finished Goods Storage Shed-2) | The factory is required to repair the cable bracing connection as per the drawings. | within 6 weeks |

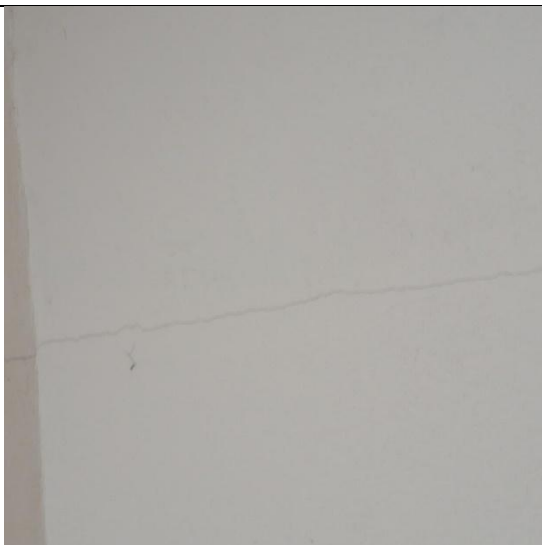
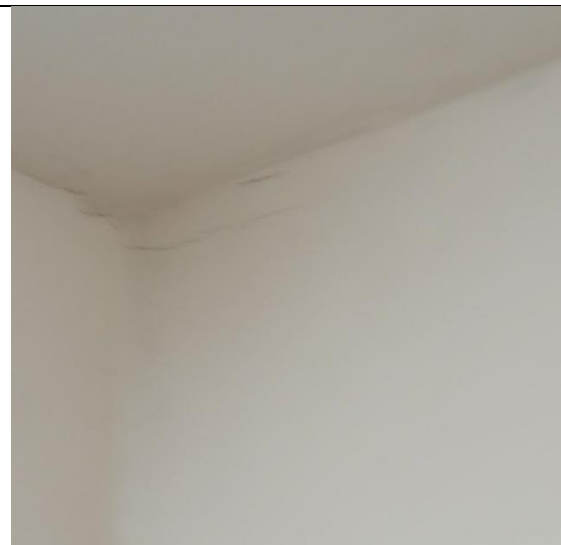
**Observation-04:** Brick wall crack. (Finished Goods Storage Shed-2)

**Description:** A crack was found on the brick wall on the 1st-floor stair area. The building engineer is required to repair the crack on the wall with a suitable method.

| Item No | Observation | Action Plan | Timeline |
|---|---|---|---|
| 6. | Brick wall crack. (Finished Goods Storage Shed-2) | The building engineer is required to repair the crack on the wall with a suitable method. | within 6 weeks |
